## ODI RESUME

| <b>Investigation:</b> | PE 14-006 | <b>Date Closed:</b> | 05/22/2015 |
| <b>Subject:</b> | Motorcycle steering lockup | | |

| <b>Products:</b> | 2008-2015 Vision |

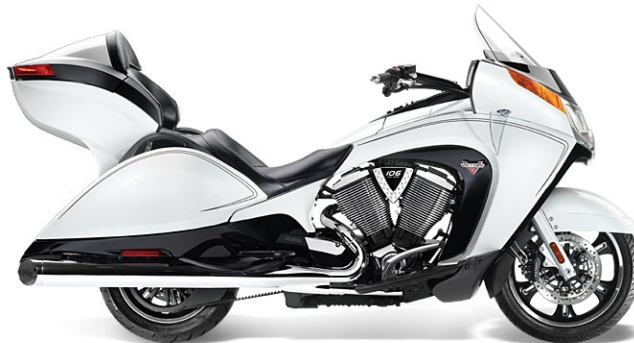
The subject motorcycles are equipped with a two-piece, plastic, front fender. The back half (the all-black portion in the photo below) is secured to the fork with a single fastener on each side. It is secured to the front half of the fender with two plastic pushpins.

The back half of the subject 2-piece fender is alleged to cause steering lockup when it partially separates and becomes wedged in the lower faring.
