# ODI RESUME

**Investigation:** PE 14-014  
**Date Opened:** 05/20/2014  
**Investigator:** Jeff Quandt  
**Approver:** Stephen Ridella  
**Subject:** Excessive Brake Pedal Travel  
**Date Closed:** 05/13/2015  
**Reviewer:** Jeff Quandt

**Manufacturer:** Nissan North America, Inc.  
**Products:** 2013-2014 Nissan Sentra, Versa Sedan and Versa Note  
**Population:** 605,963  
**Problem Description:** The brake pedal may gradually sink when applied very slowly or when the vehicle is stopped with light pressure applied to the brake pedal.

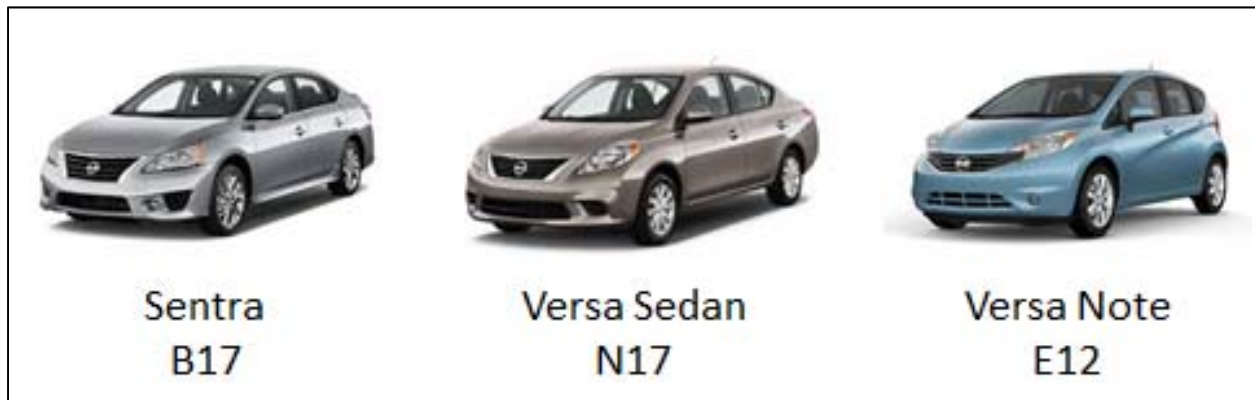
Figure 1. Subject Vehicles.

On May 20, 2014, ODI opened PE14-014 based on eight complaints alleging incidents of excessive brake pedal travel in model year (MY) 2013 through 2014 Nissan Sentra, Versa Sedan and Versa Note passenger cars (Figure 1) and information in Early Warning Reporting field reports indicating issues with master cylinder internal seals. In response to an information request letter sent by ODI, Nissan identified a condition with the master cylinder in early production subject vehicles that could result in a slow internal leak past one of the recuperating seals to the brake reservoir when the brake pedal is depressed very slowly or lightly (Figure 2). The subject vehicles are equipped with fixed seal master cylinders supplied by TRW. To address concerns with water hammer noise with the standard seal design, the master cylinders in the early production subject vehicles used AWH (anti-water hammer) seals. The AWH seals are sensitive to contamination from assembly plant cleanliness issues, which can produce the internal leak condition during slow or light brake applies but perform as designed with normal or emergency brake applications. TRW indicated that the risk of contamination interacting with the subject seals is greatest after the evacuation and pressure fill process used to fill the brake system during the manufacturing process (early life issue). TRW developed a new master cylinder seal design (EVO seal) that addresses the noise concern and eliminates the internal leak concern associated with contamination by providing a secondary seal (Figure 3).
