AQ14-002

FOREST RIVER

ProLo Hatch Rear Support Receiver Replacement Instructions

Forest River, Inc. has decided that a defect which relates to motor vehicle safety exists in certain 2010, 2011, 2012, 2013 Sunseeker, Forester, and Lexington model Class C motorhomes. We believe that you currently have or previously have owned one of these vehicles. For this reason we ask that you arrange for your authorized servicing dealer to correct your vehicle without delay. The service and required parts will be provided to you free of charge.

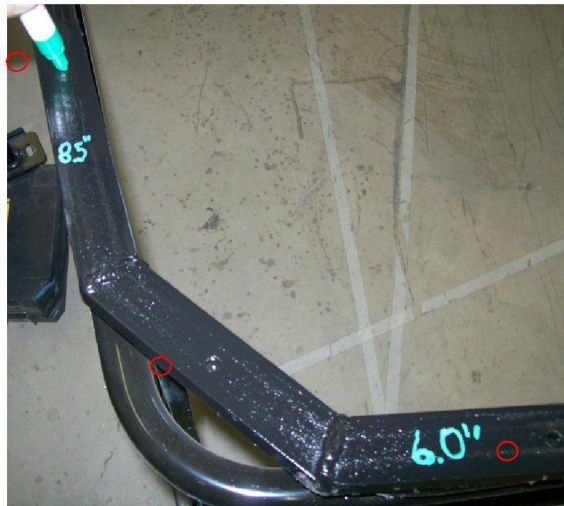
*Figure 6: Seat frame reinforcement bracket –seat frame side view
The longer bracket side fits on the back of the seat (as shown)*

4. Place the reinforcement bracket on the outside seat frame tube, closest to the aisle, (two different brackets are provided, select the best fitting). While keeping the bracket centered on that tube, mark the 3 mounting holes or clamp the bracket to the tube. Note: reinforcement bracket is only needed on the aisle side of frame.
