Kia Motors America Field Product Quality Report

Subject/Title: Panoramic Sunroof Shattered

Model Desc: OPTIMA EX

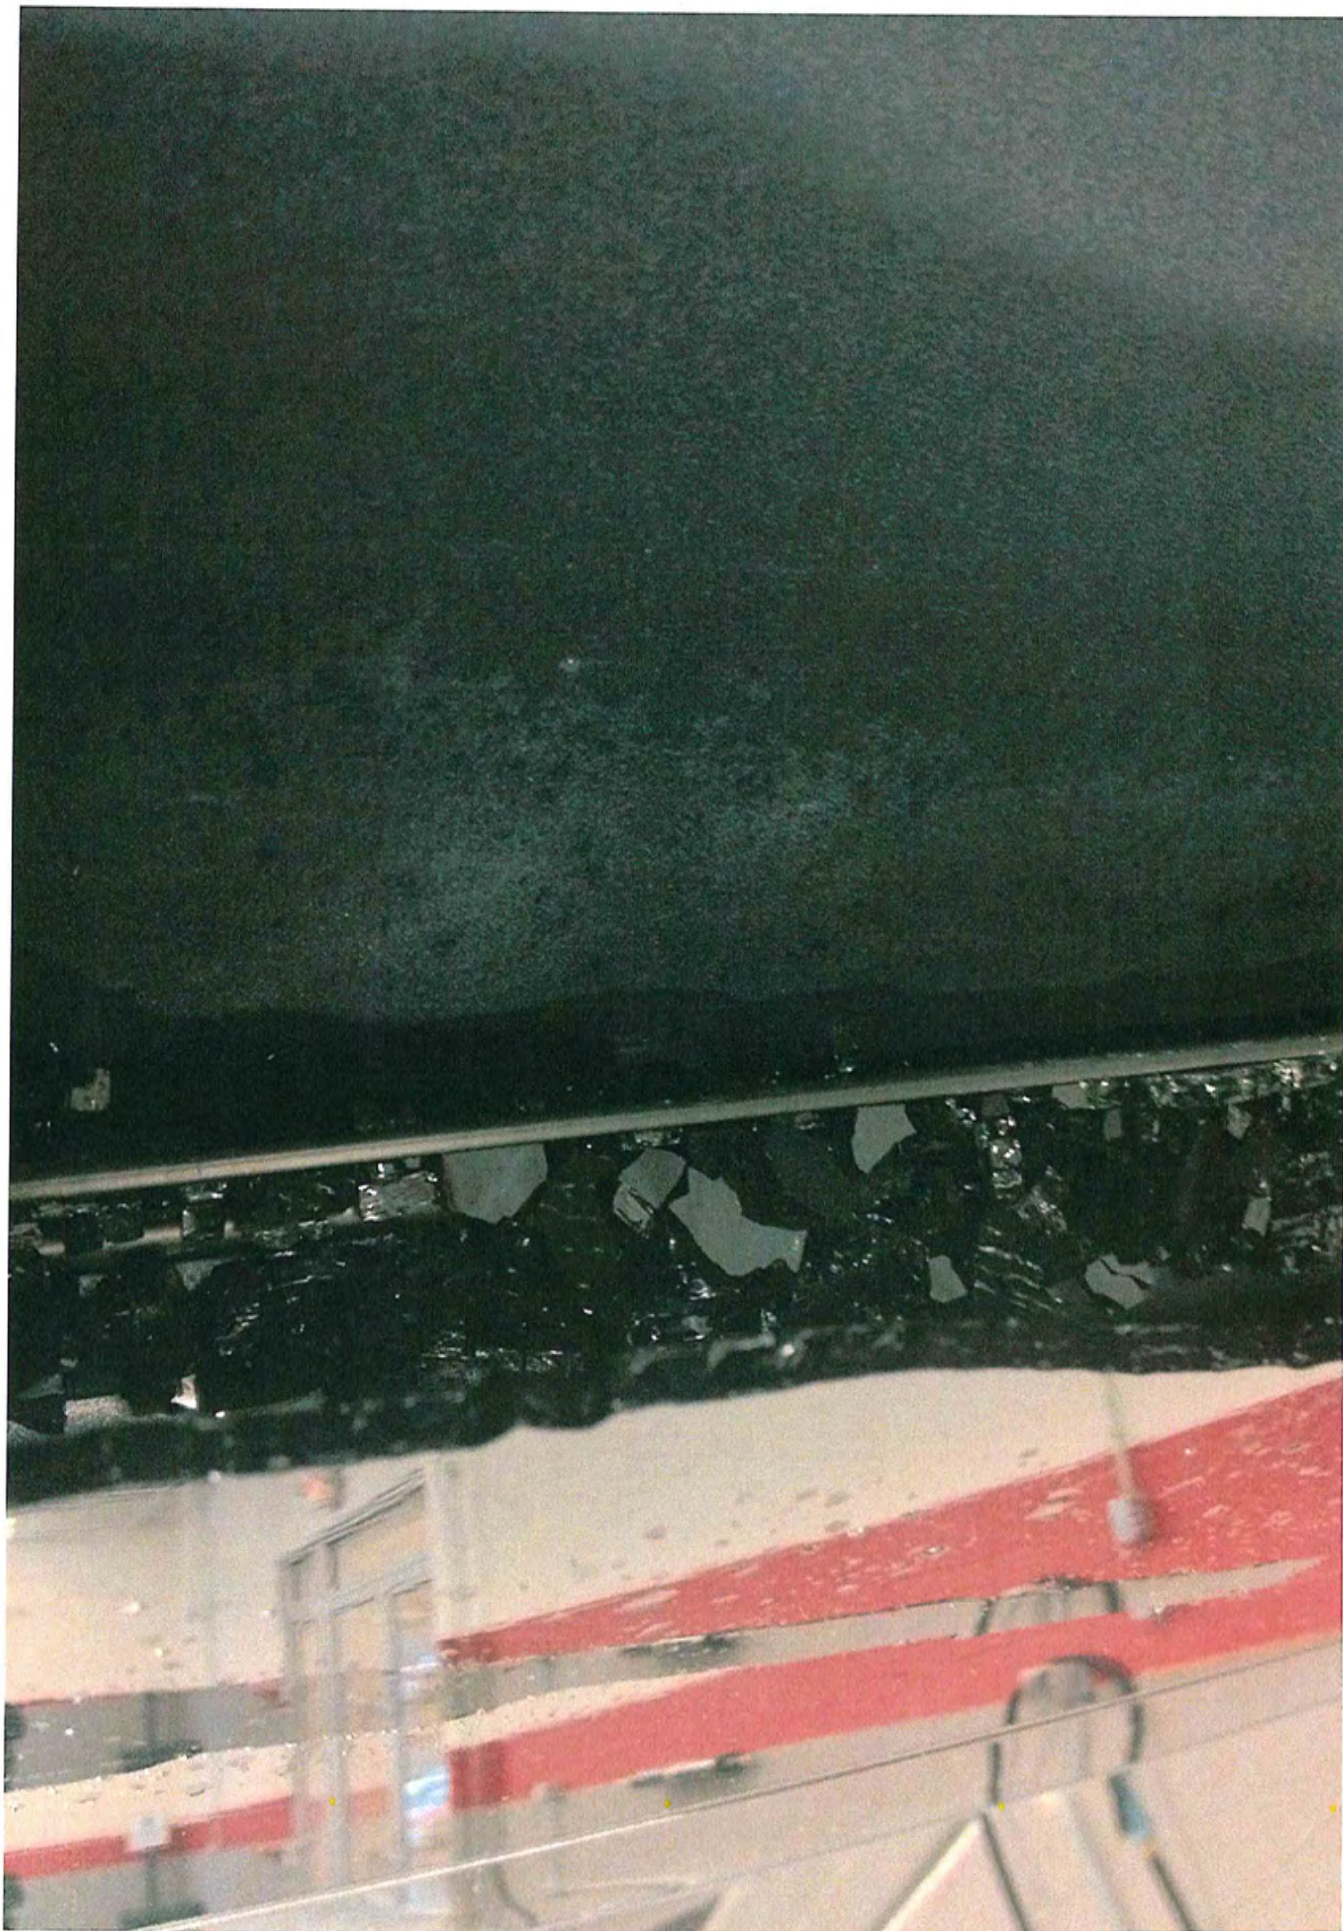
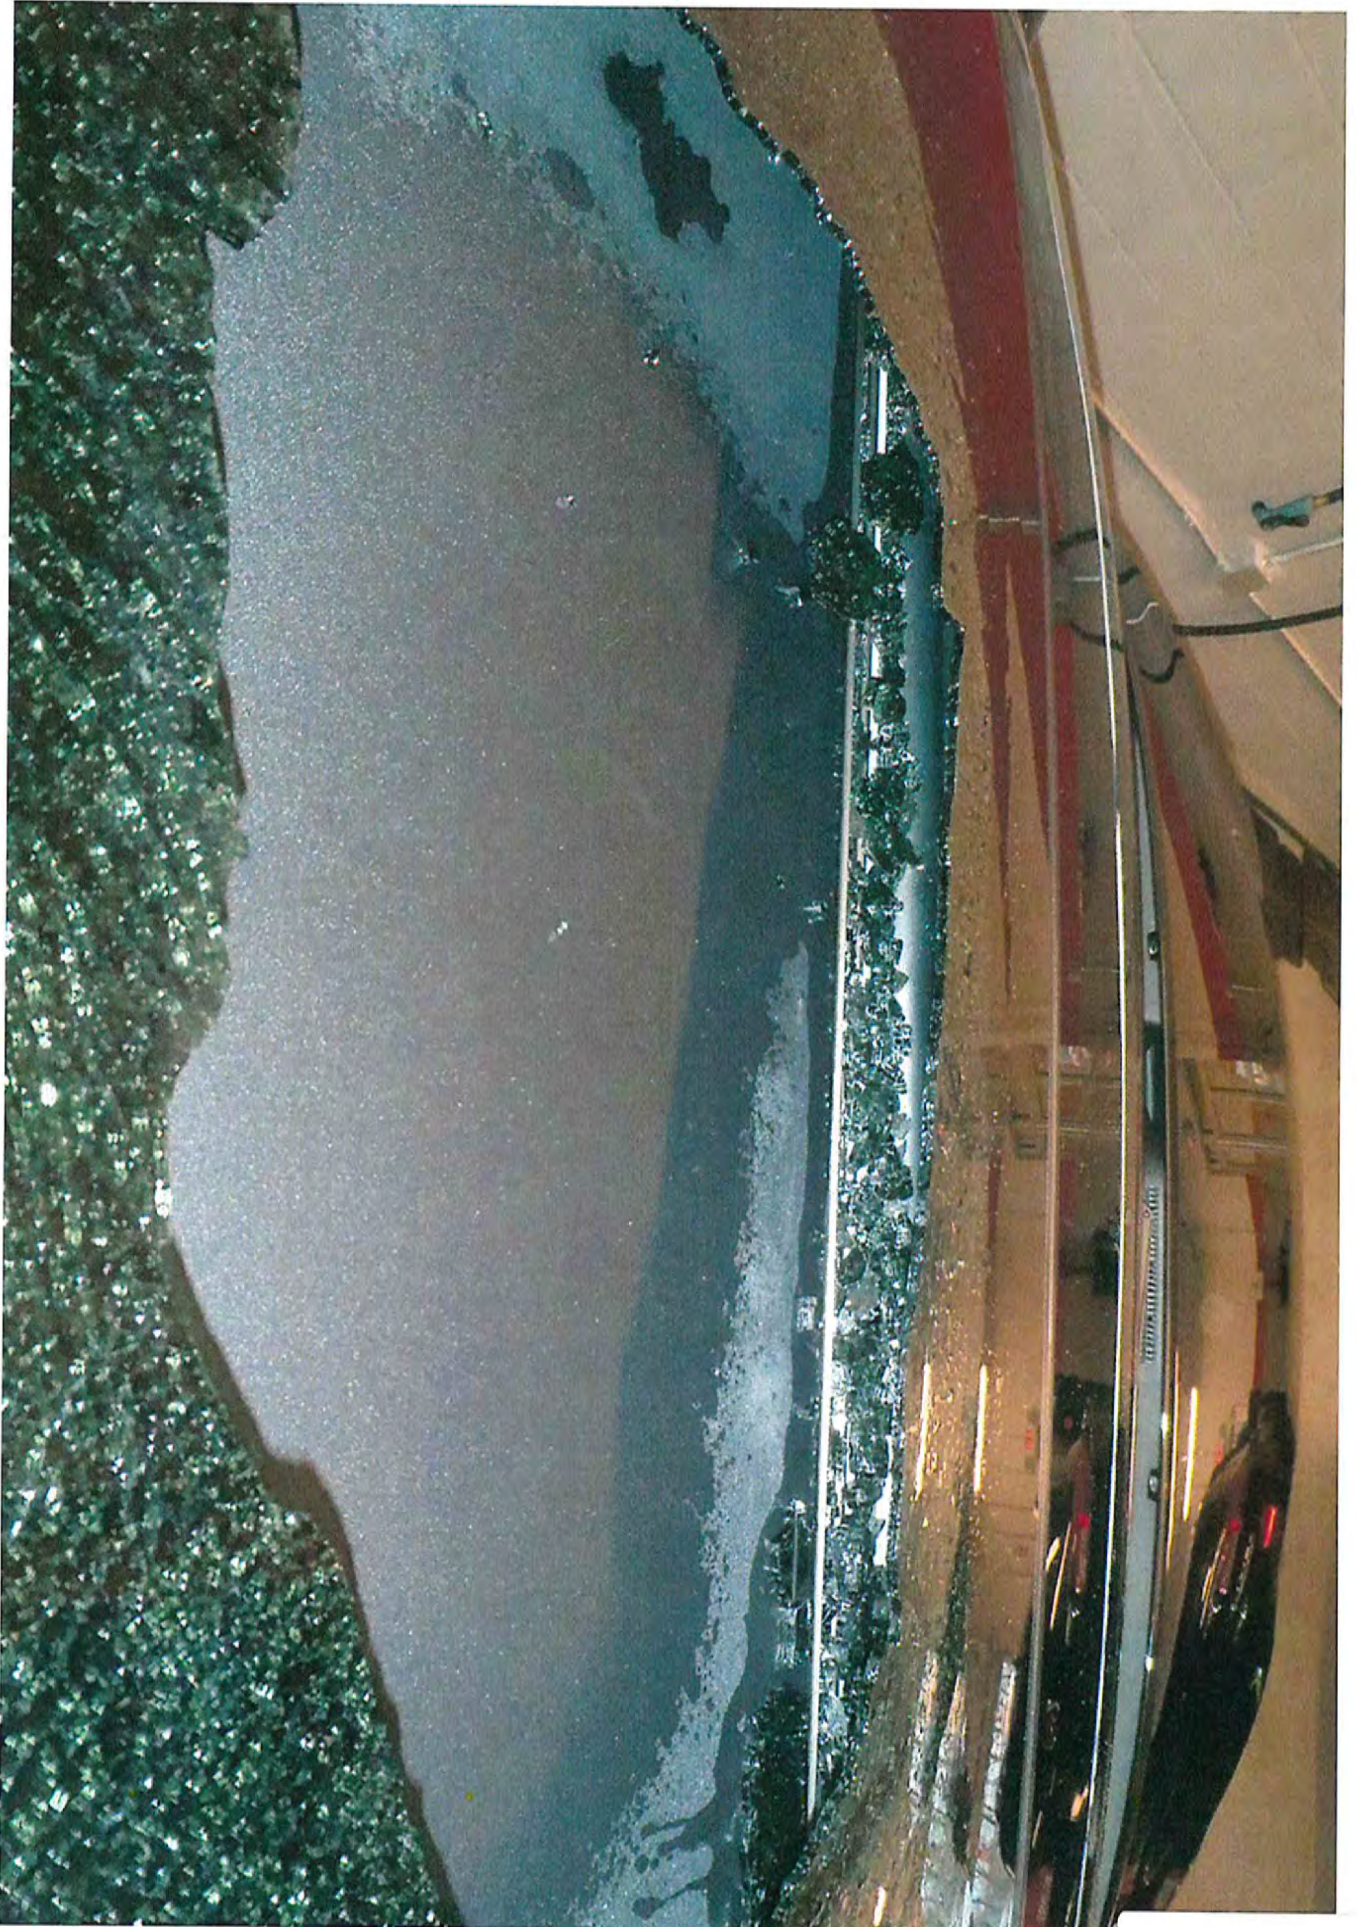
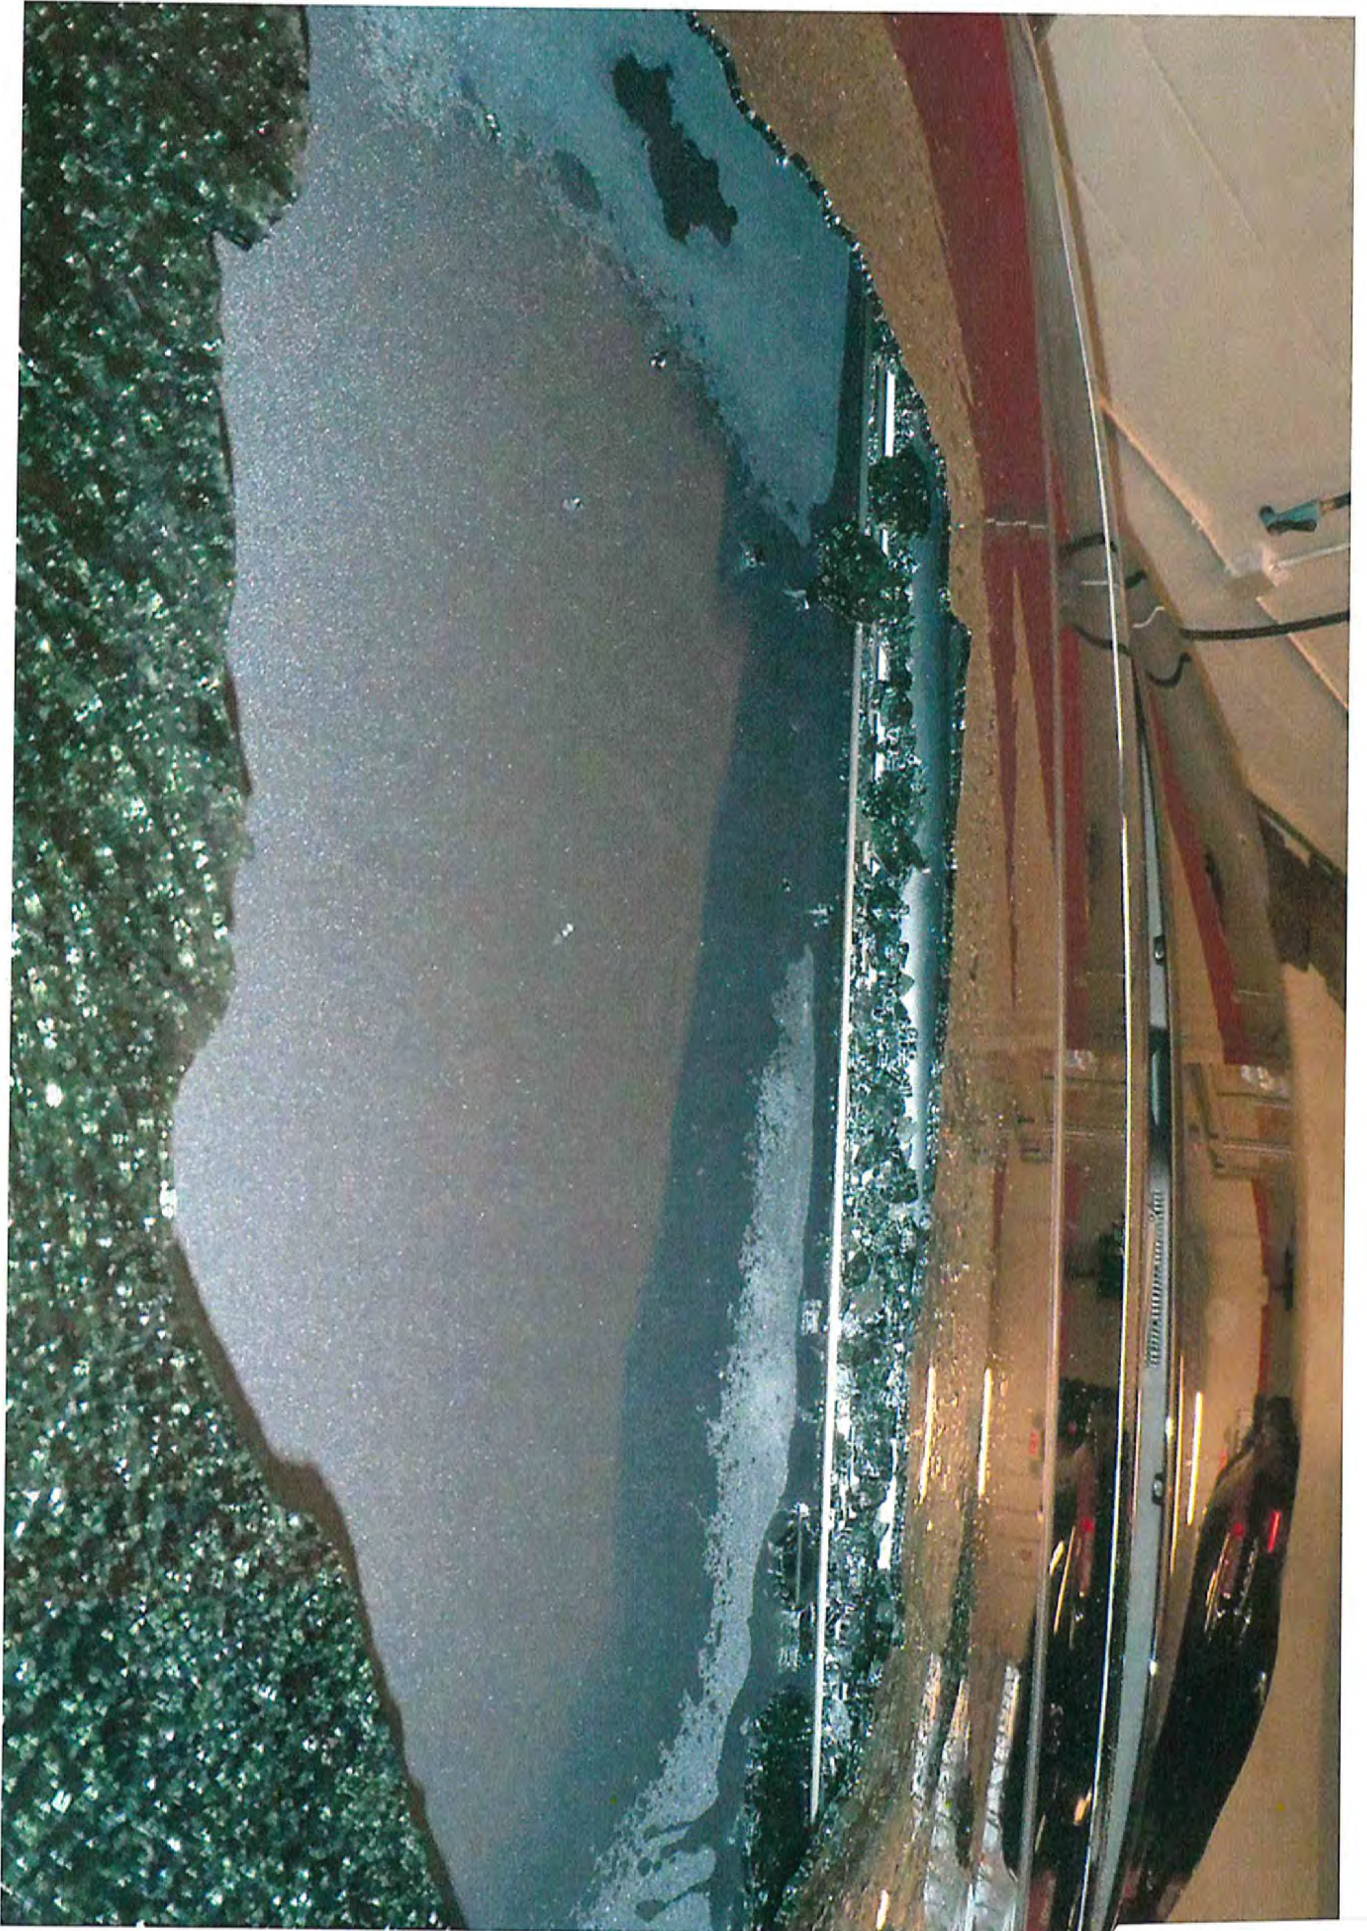
FTR inspected vehicle and found front panel of panoramic roof shattered. The sunroof was closed as well as the sunshade. The glass debris sitting on top of the sunshade.

A hole was in the center of the closed glass sunroof panel. (see photo) An outward crack was at the front of the glass that remained in place and cracks were throughout the rest of the panel. A paint chip was found on the hood down to the metal. No rust was on the exposed metal suggesting the chip was recent. A chip was in the windshield was also found. (see photos attached) other small chips in the paint and windshield were noted as well.

Possible roof glass failure due to impact from outside source resulting in weakening of glass integrity. Signs of impact on hood and windshield was found.

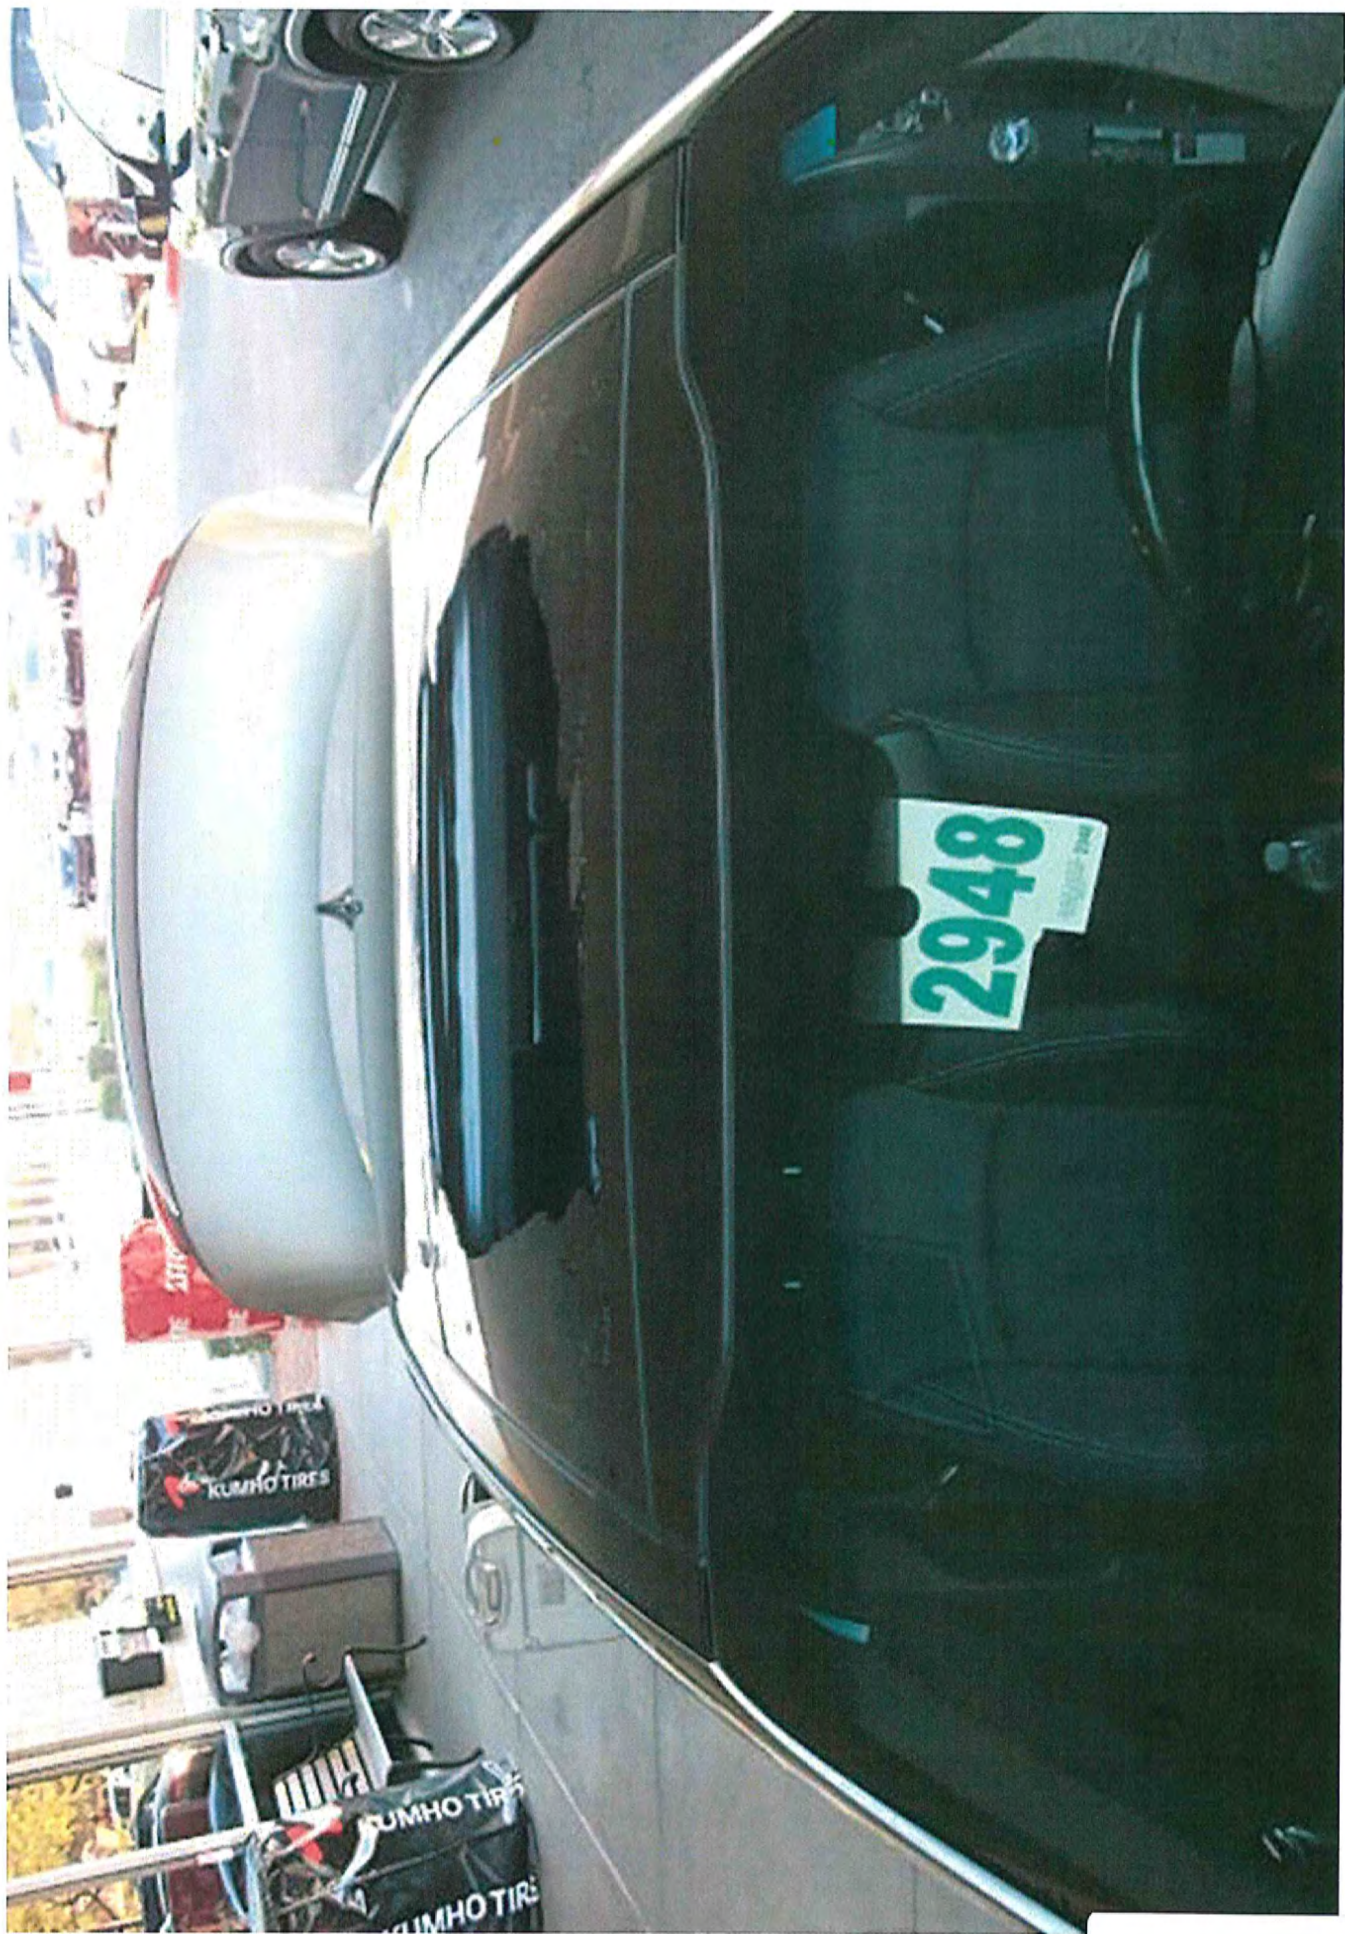
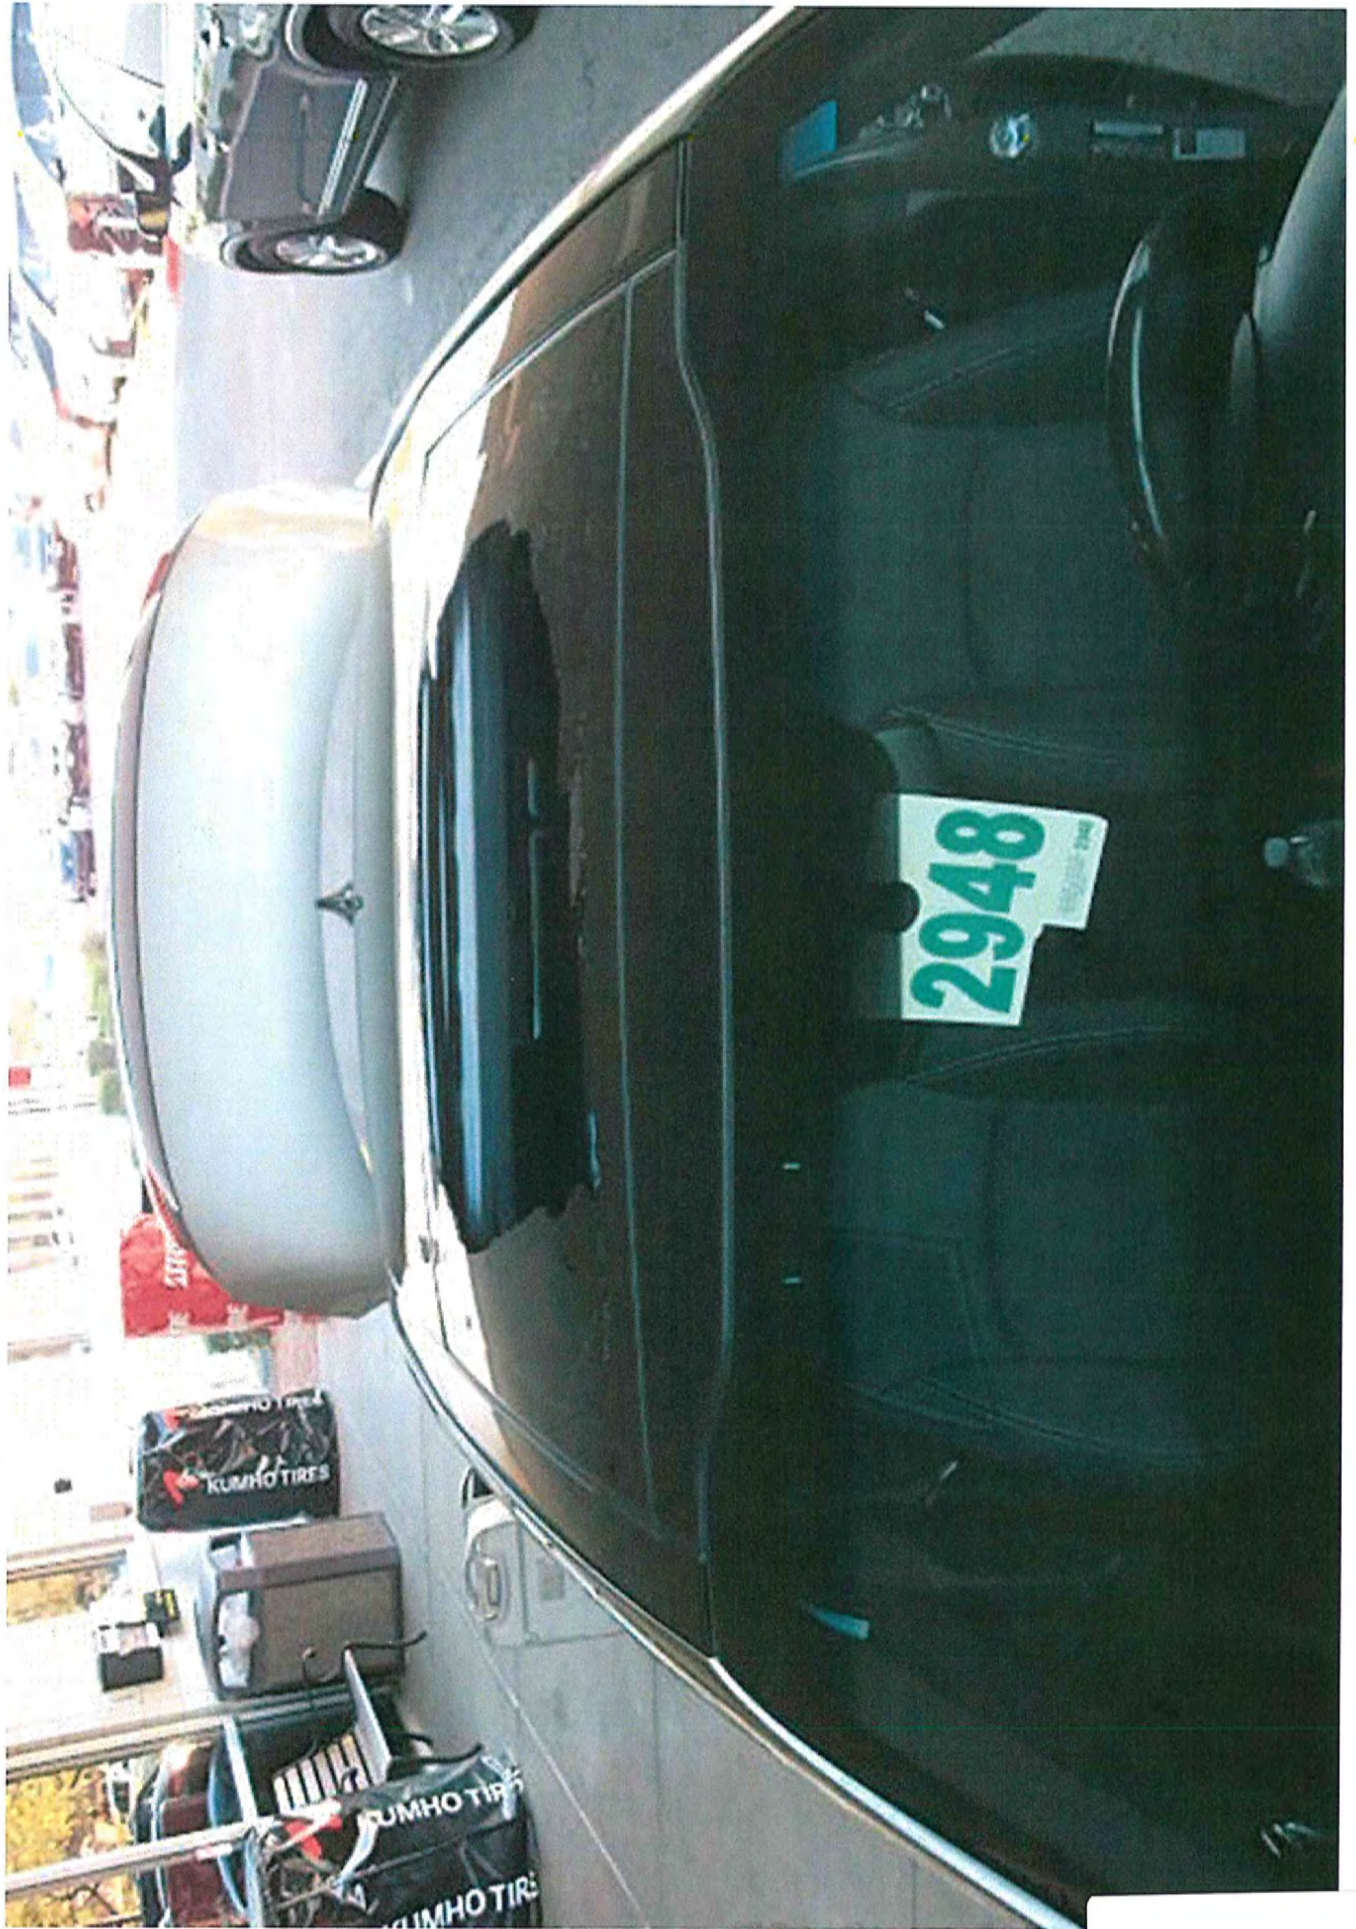
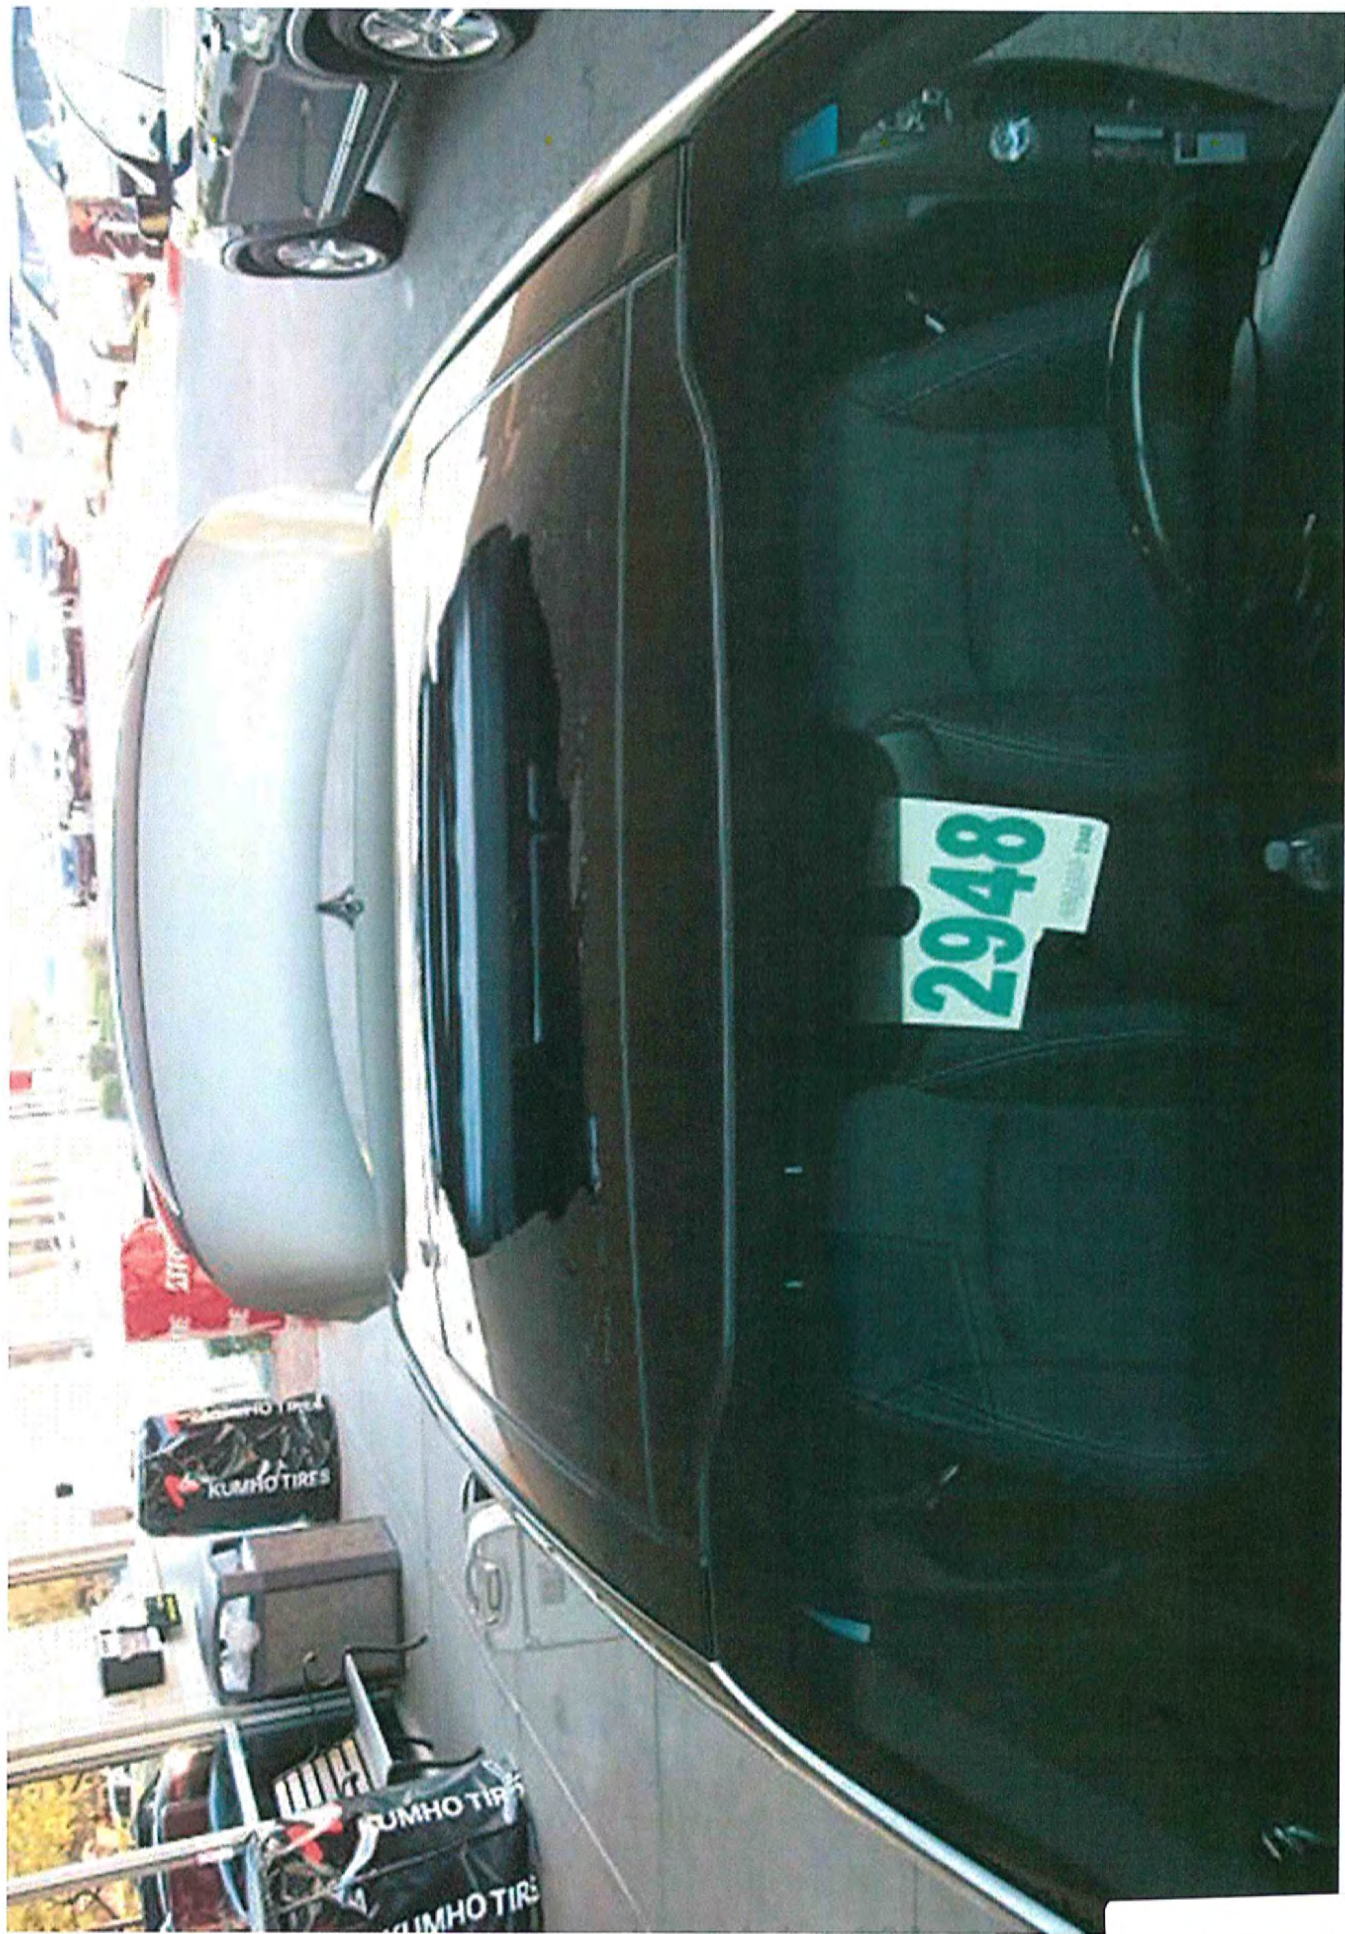
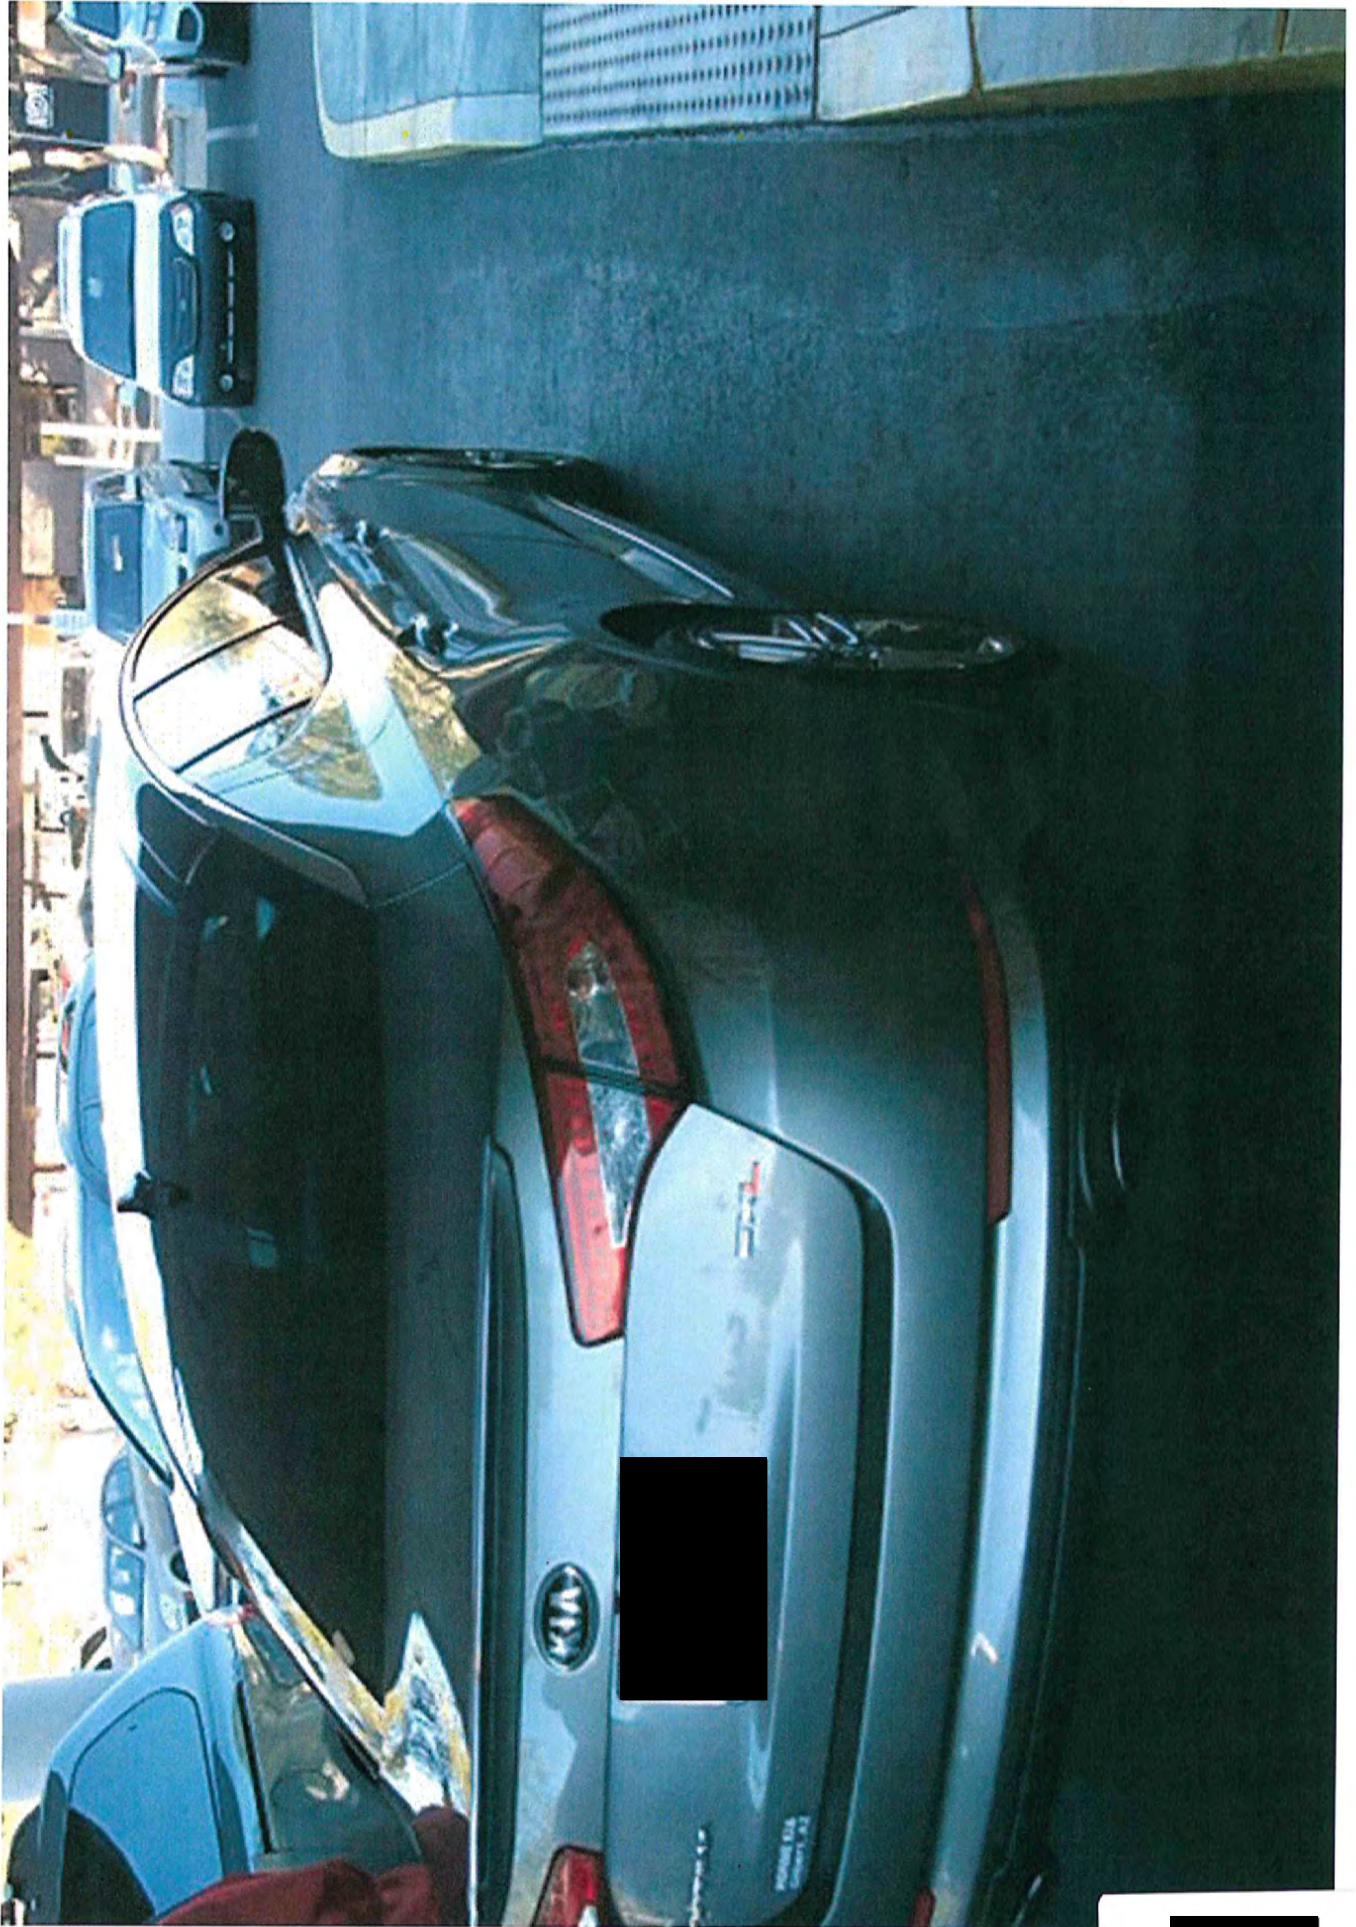
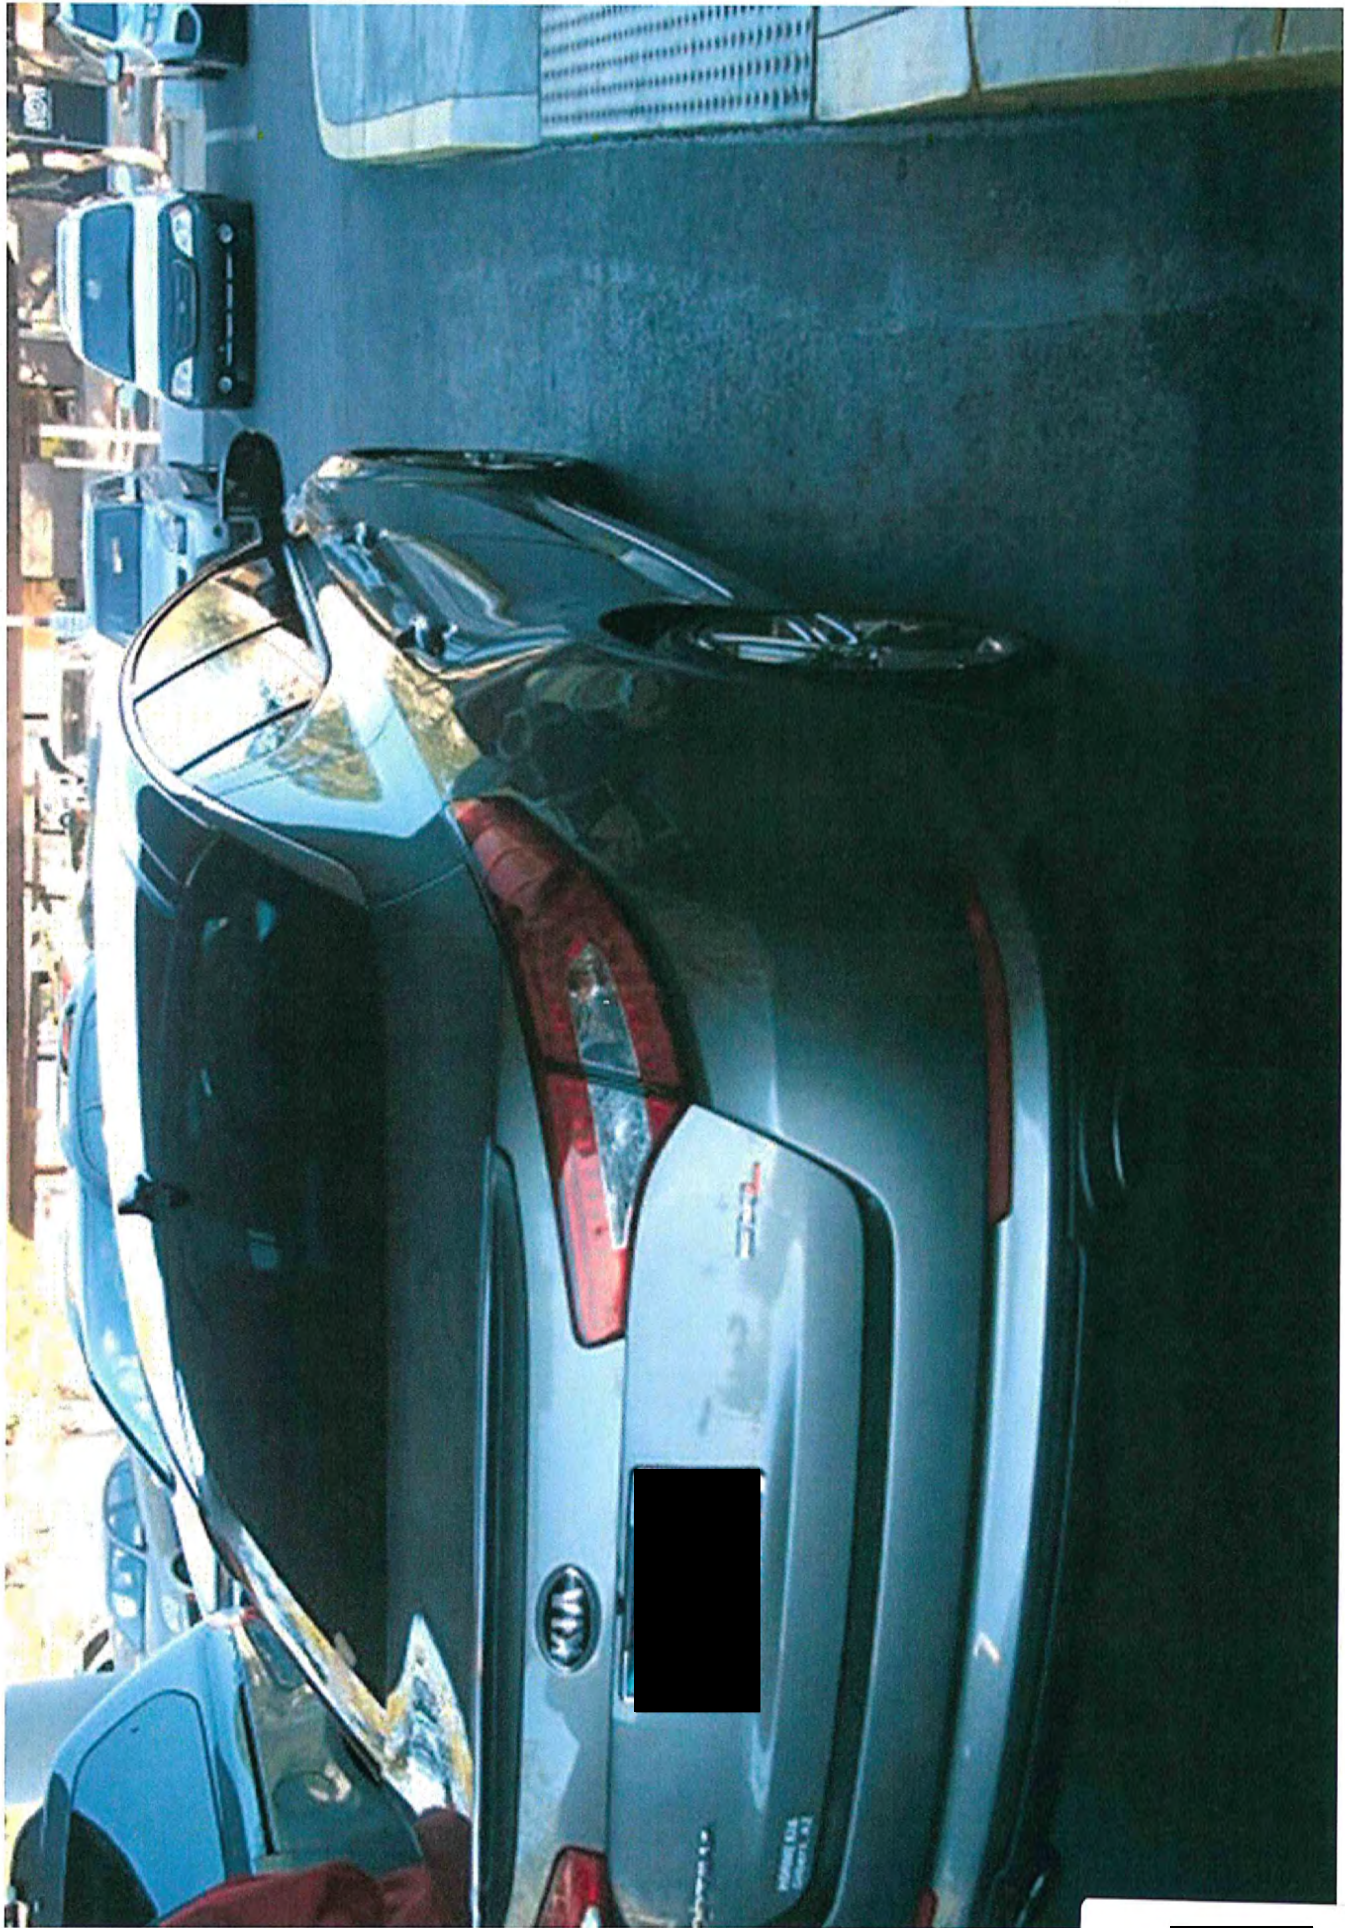
Condition: N59BROKEN / CRACKED

Cause: C06BROKEN, SPLIT, TORN

Replace shattered panoramic sunroof glass
