Kia Motors America Field Product Quality Report

Subject/Title: Panoramic Sunroof Shattered

Model Desc: OPTIMA EX

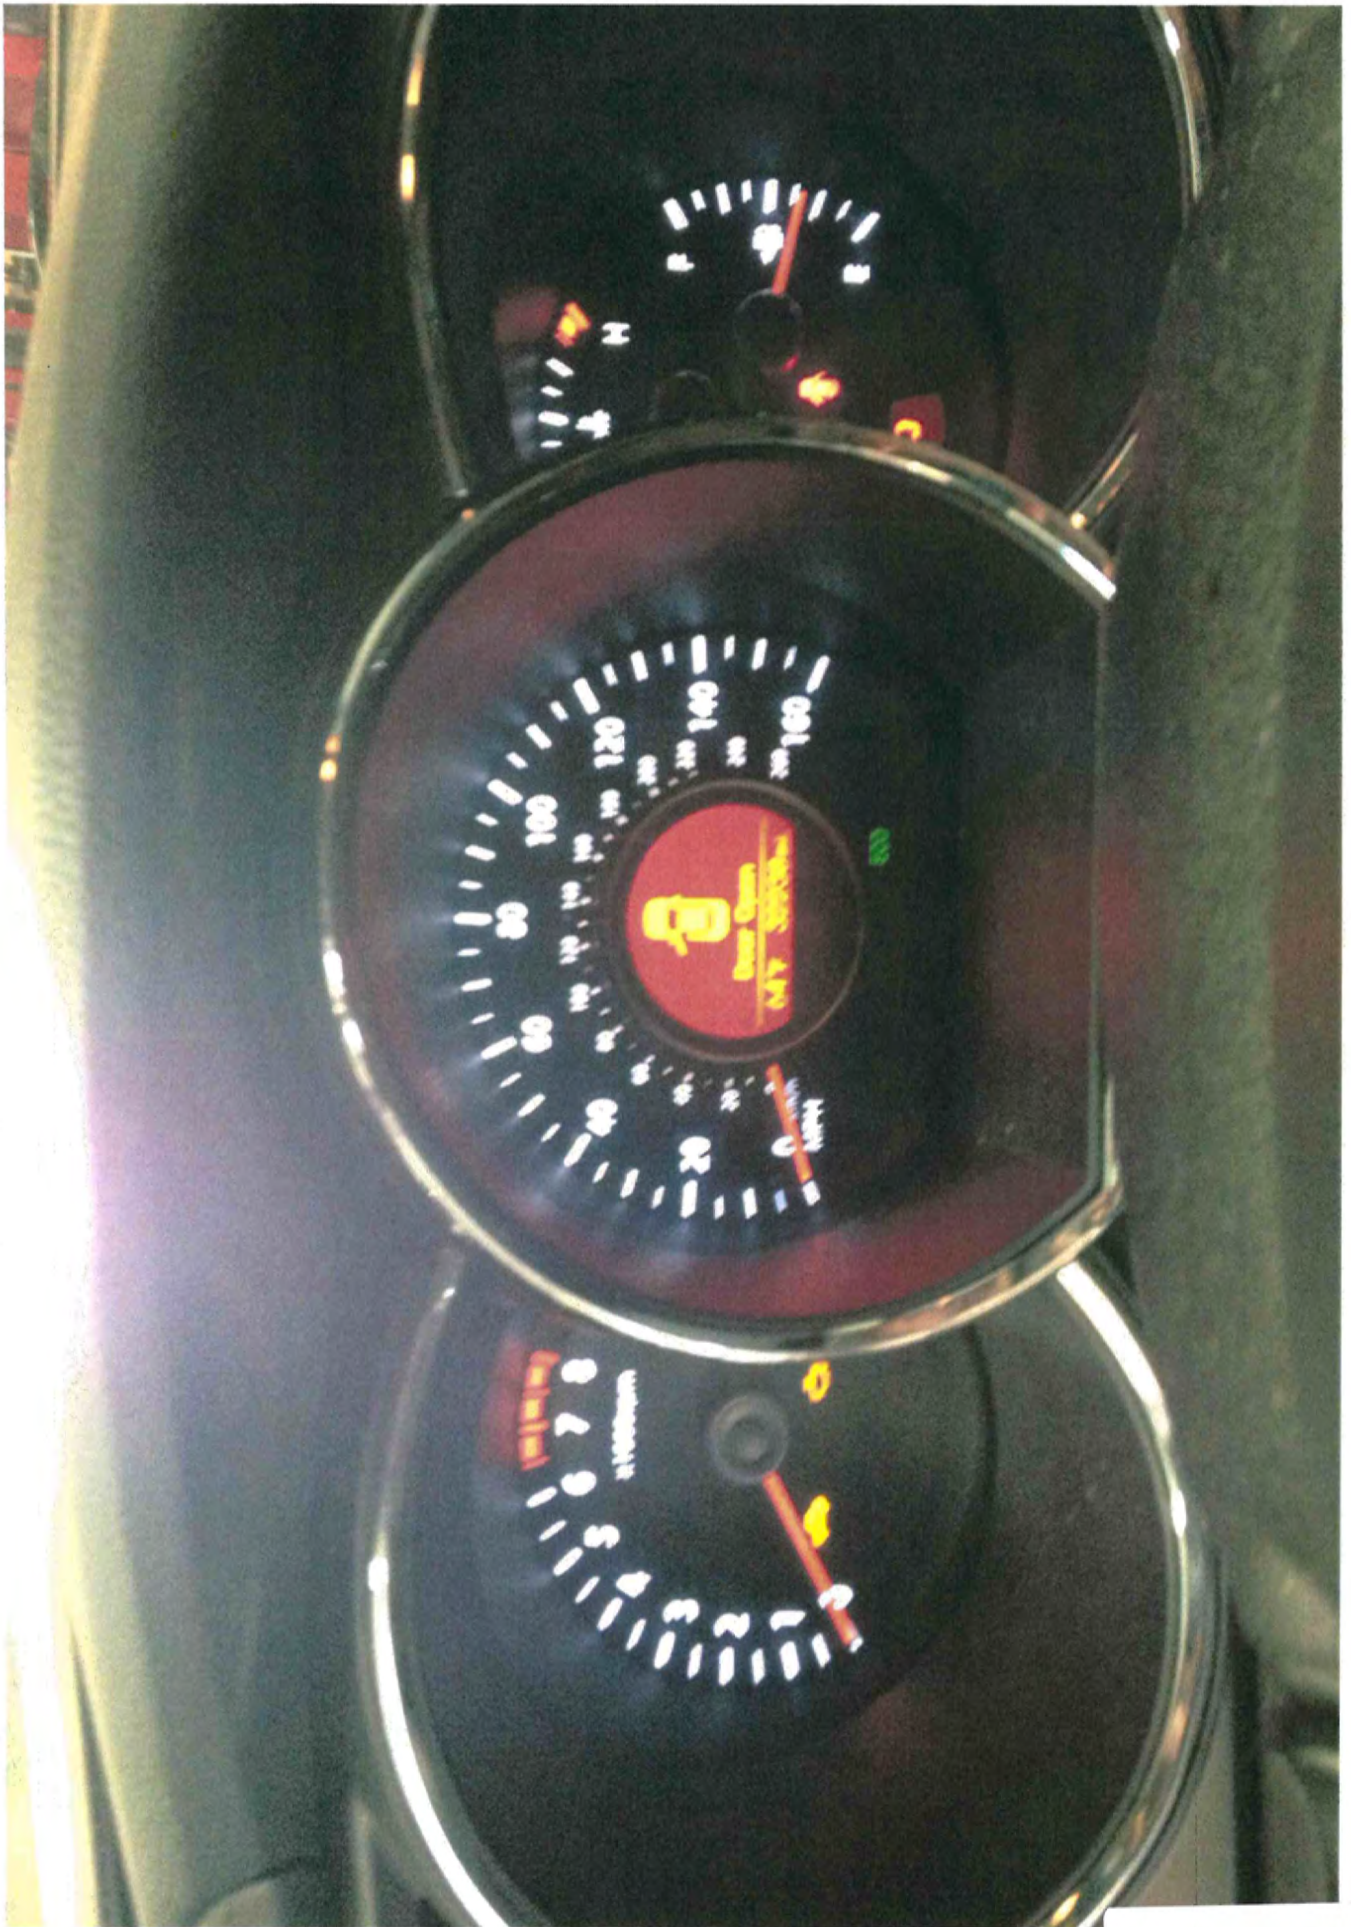
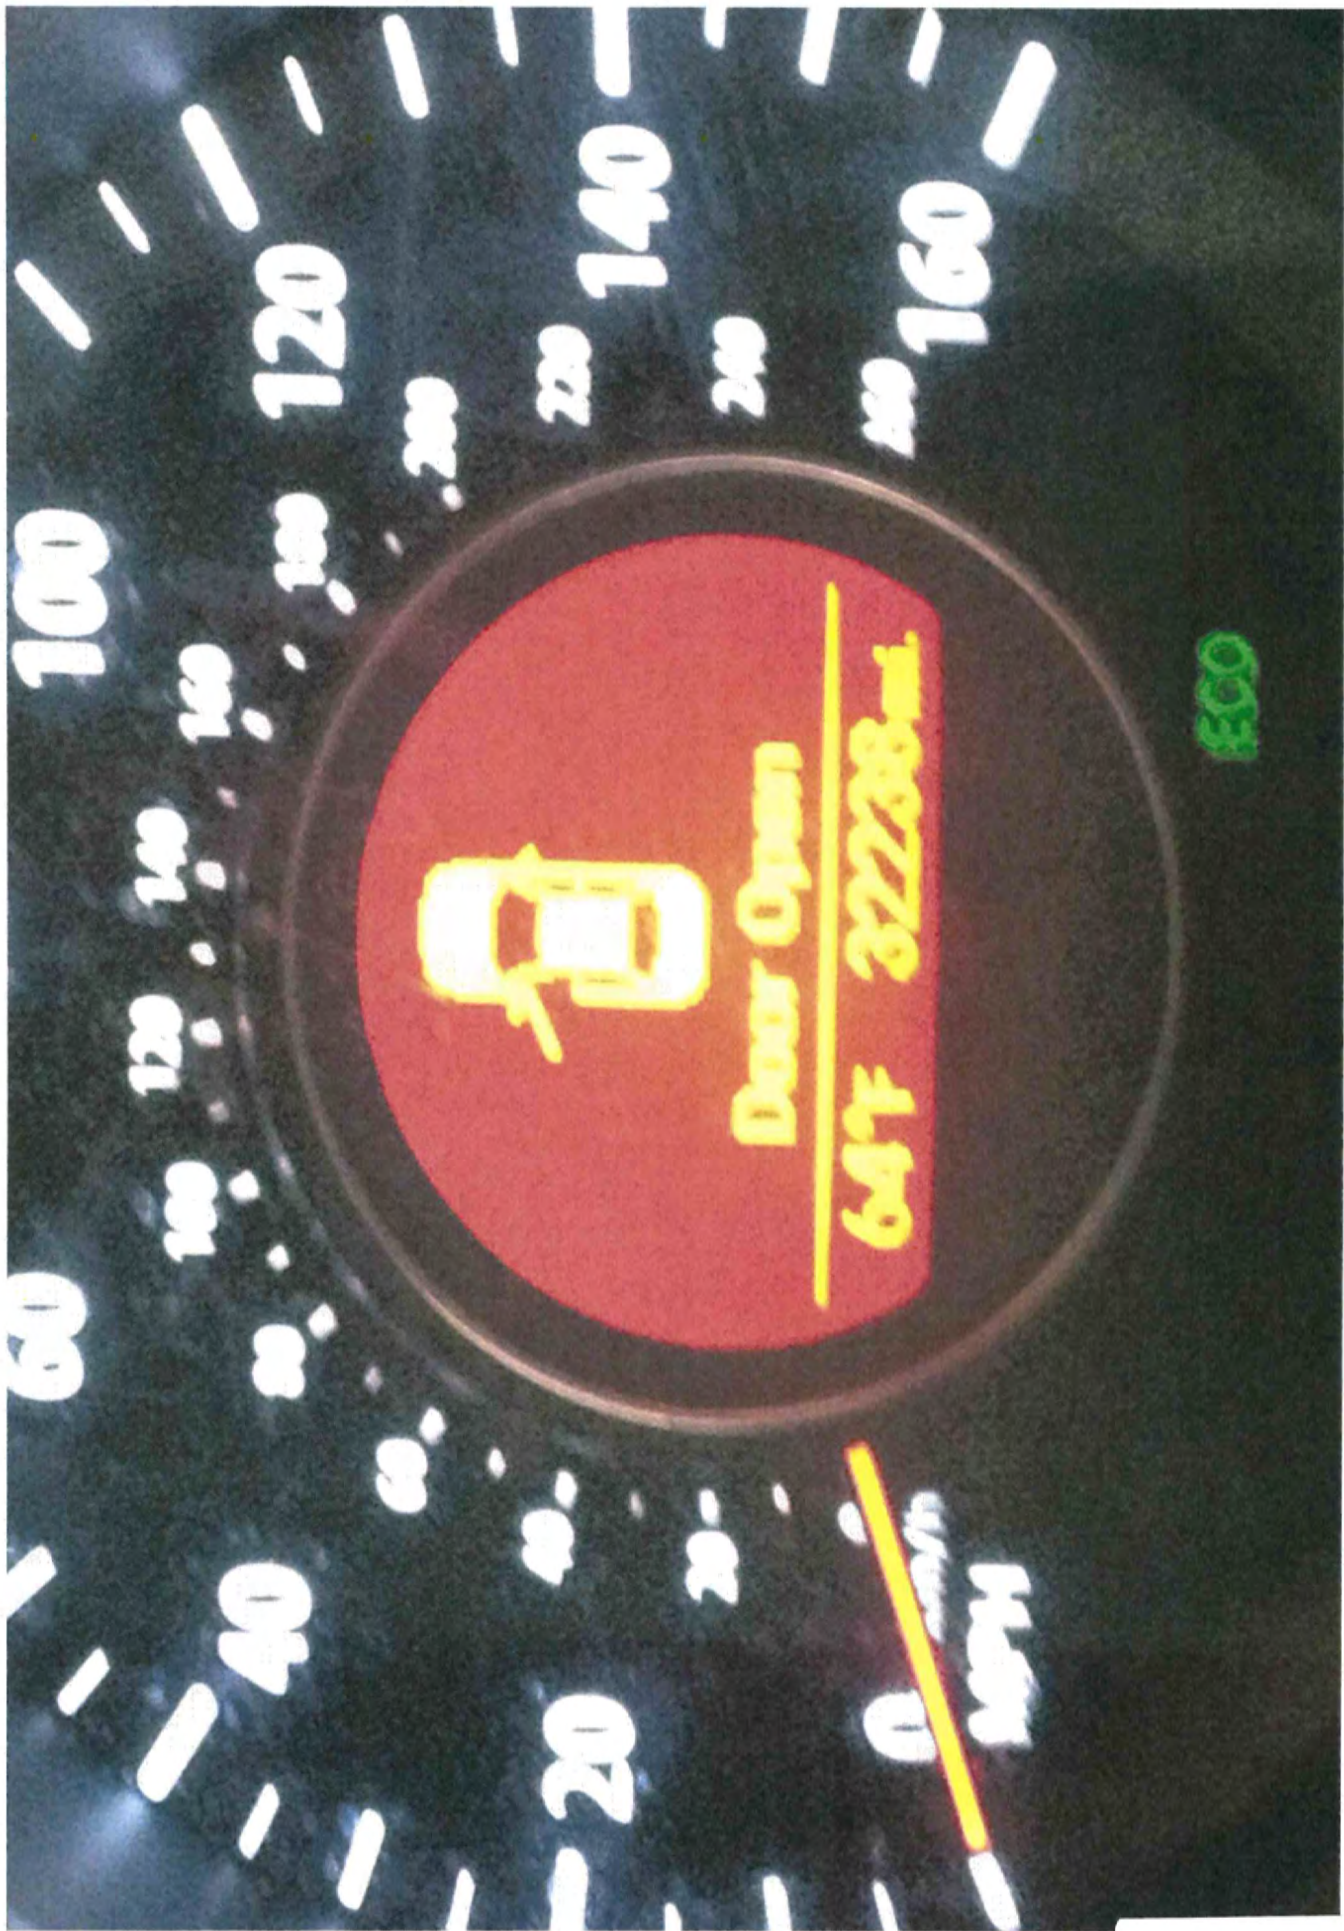
Part Number: 81630 2T000	Part Name: GLASS ASSY-PANORAMAR	
Condition: N59BROKEN / CRACKED	Cause: C06BROKEN, SPLIT, TORN	
Part ID/Lot:	Other Part No:	Other Part No:

Replace shattered panoramic glass
