Kia Motors America
Field Product Quality Report

Report No.: SO2013PR02151

Subject/Title: Customer states the Sunroof glass

Model Desc: SORENTO SX FWL

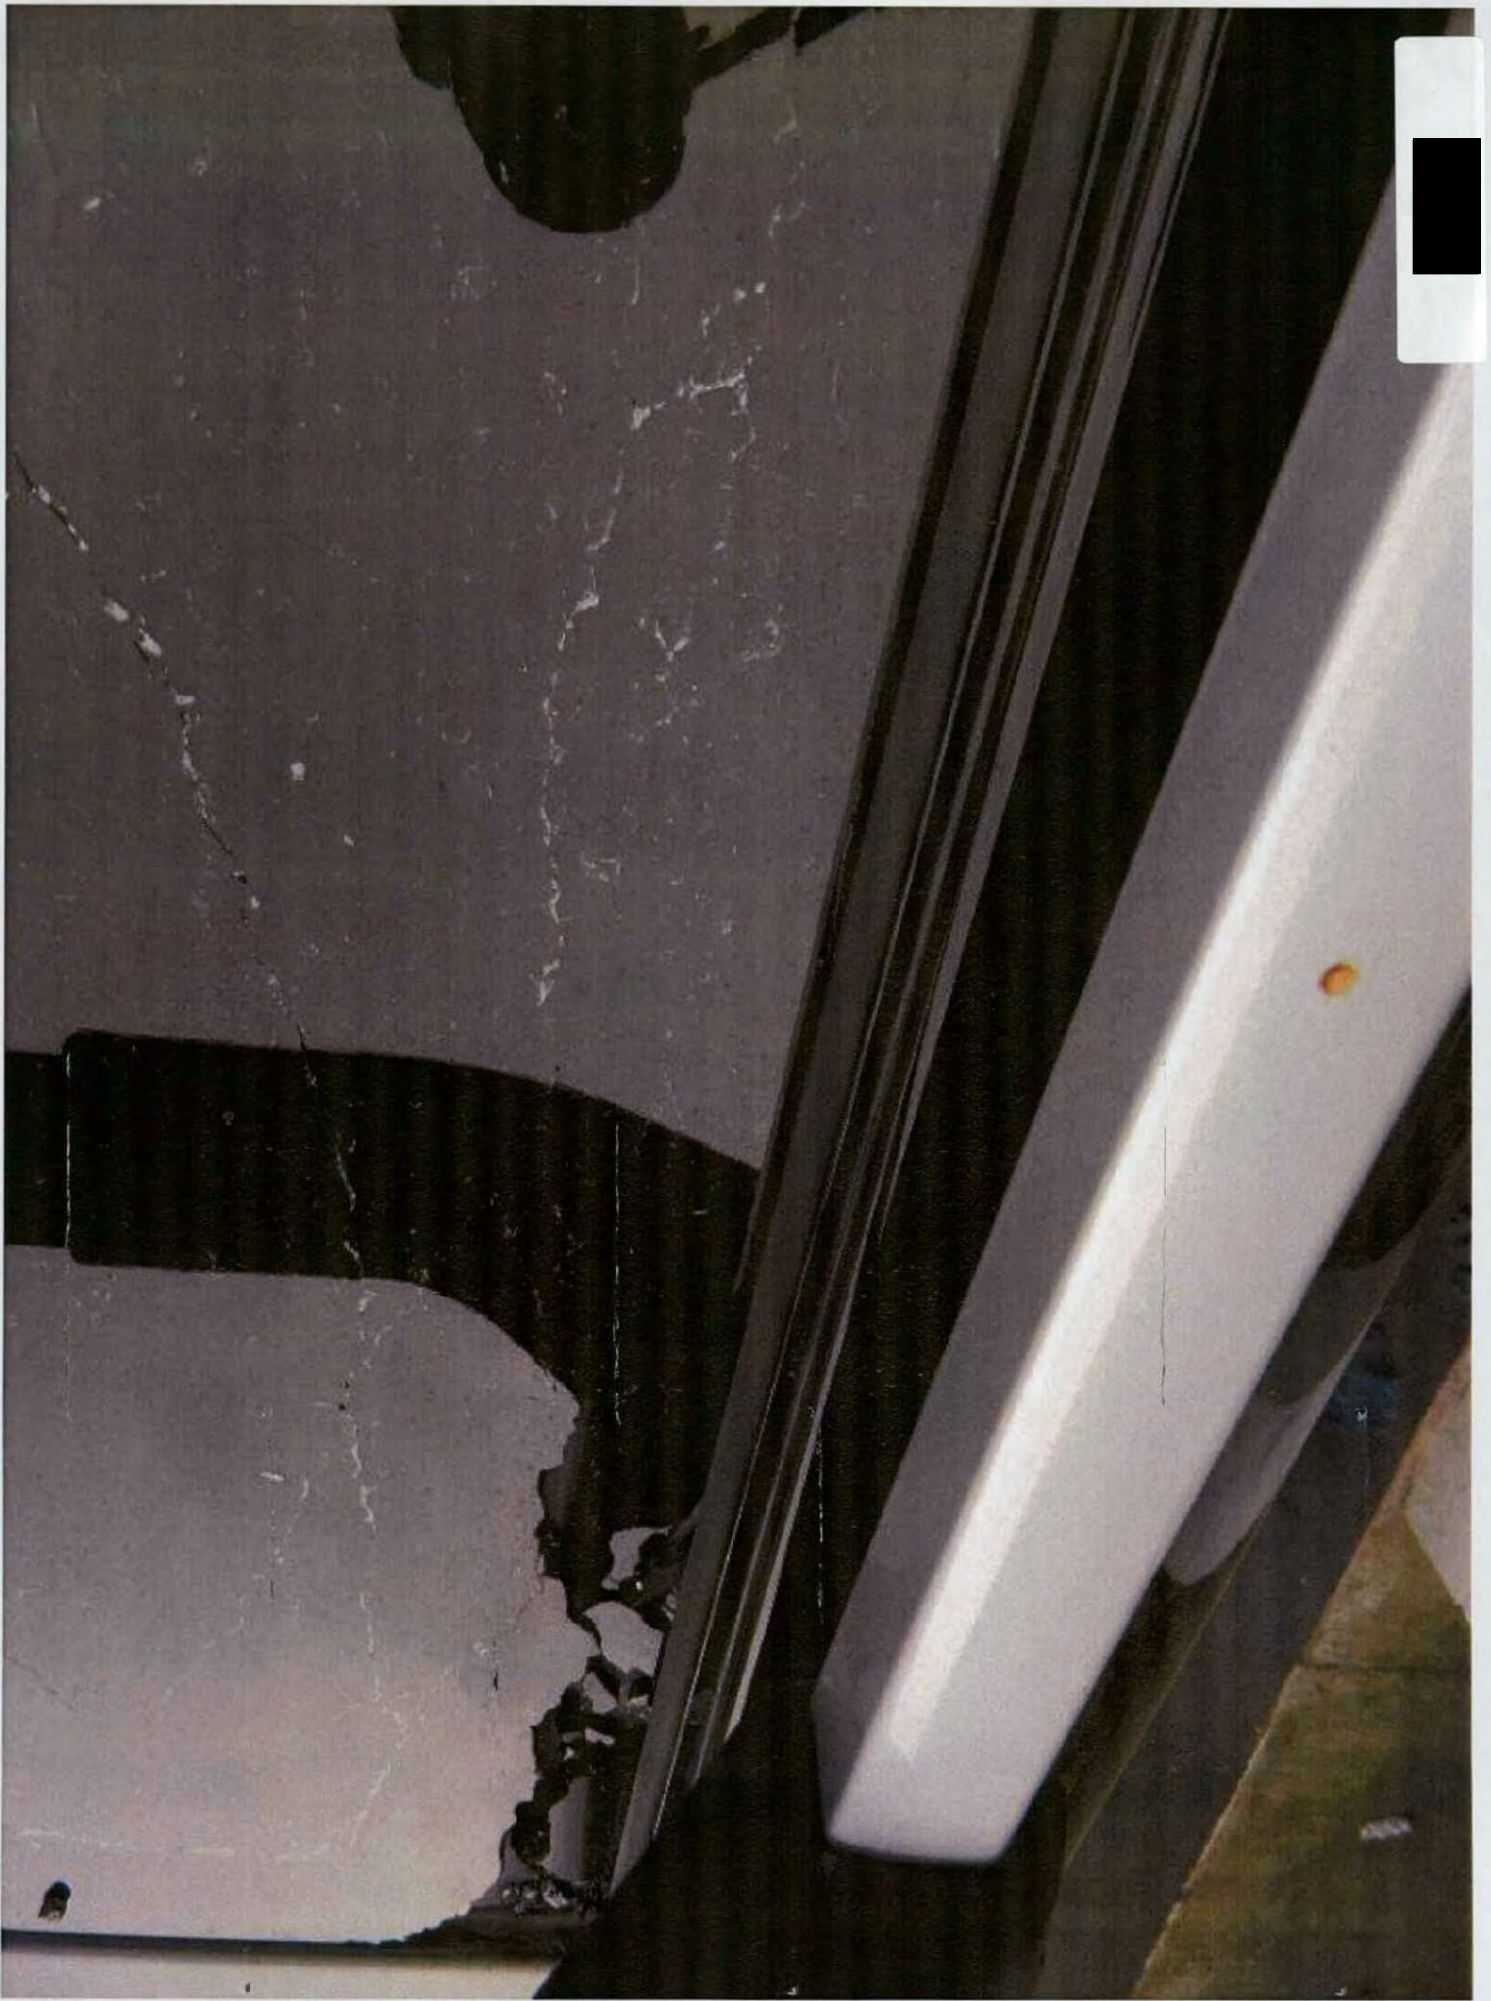
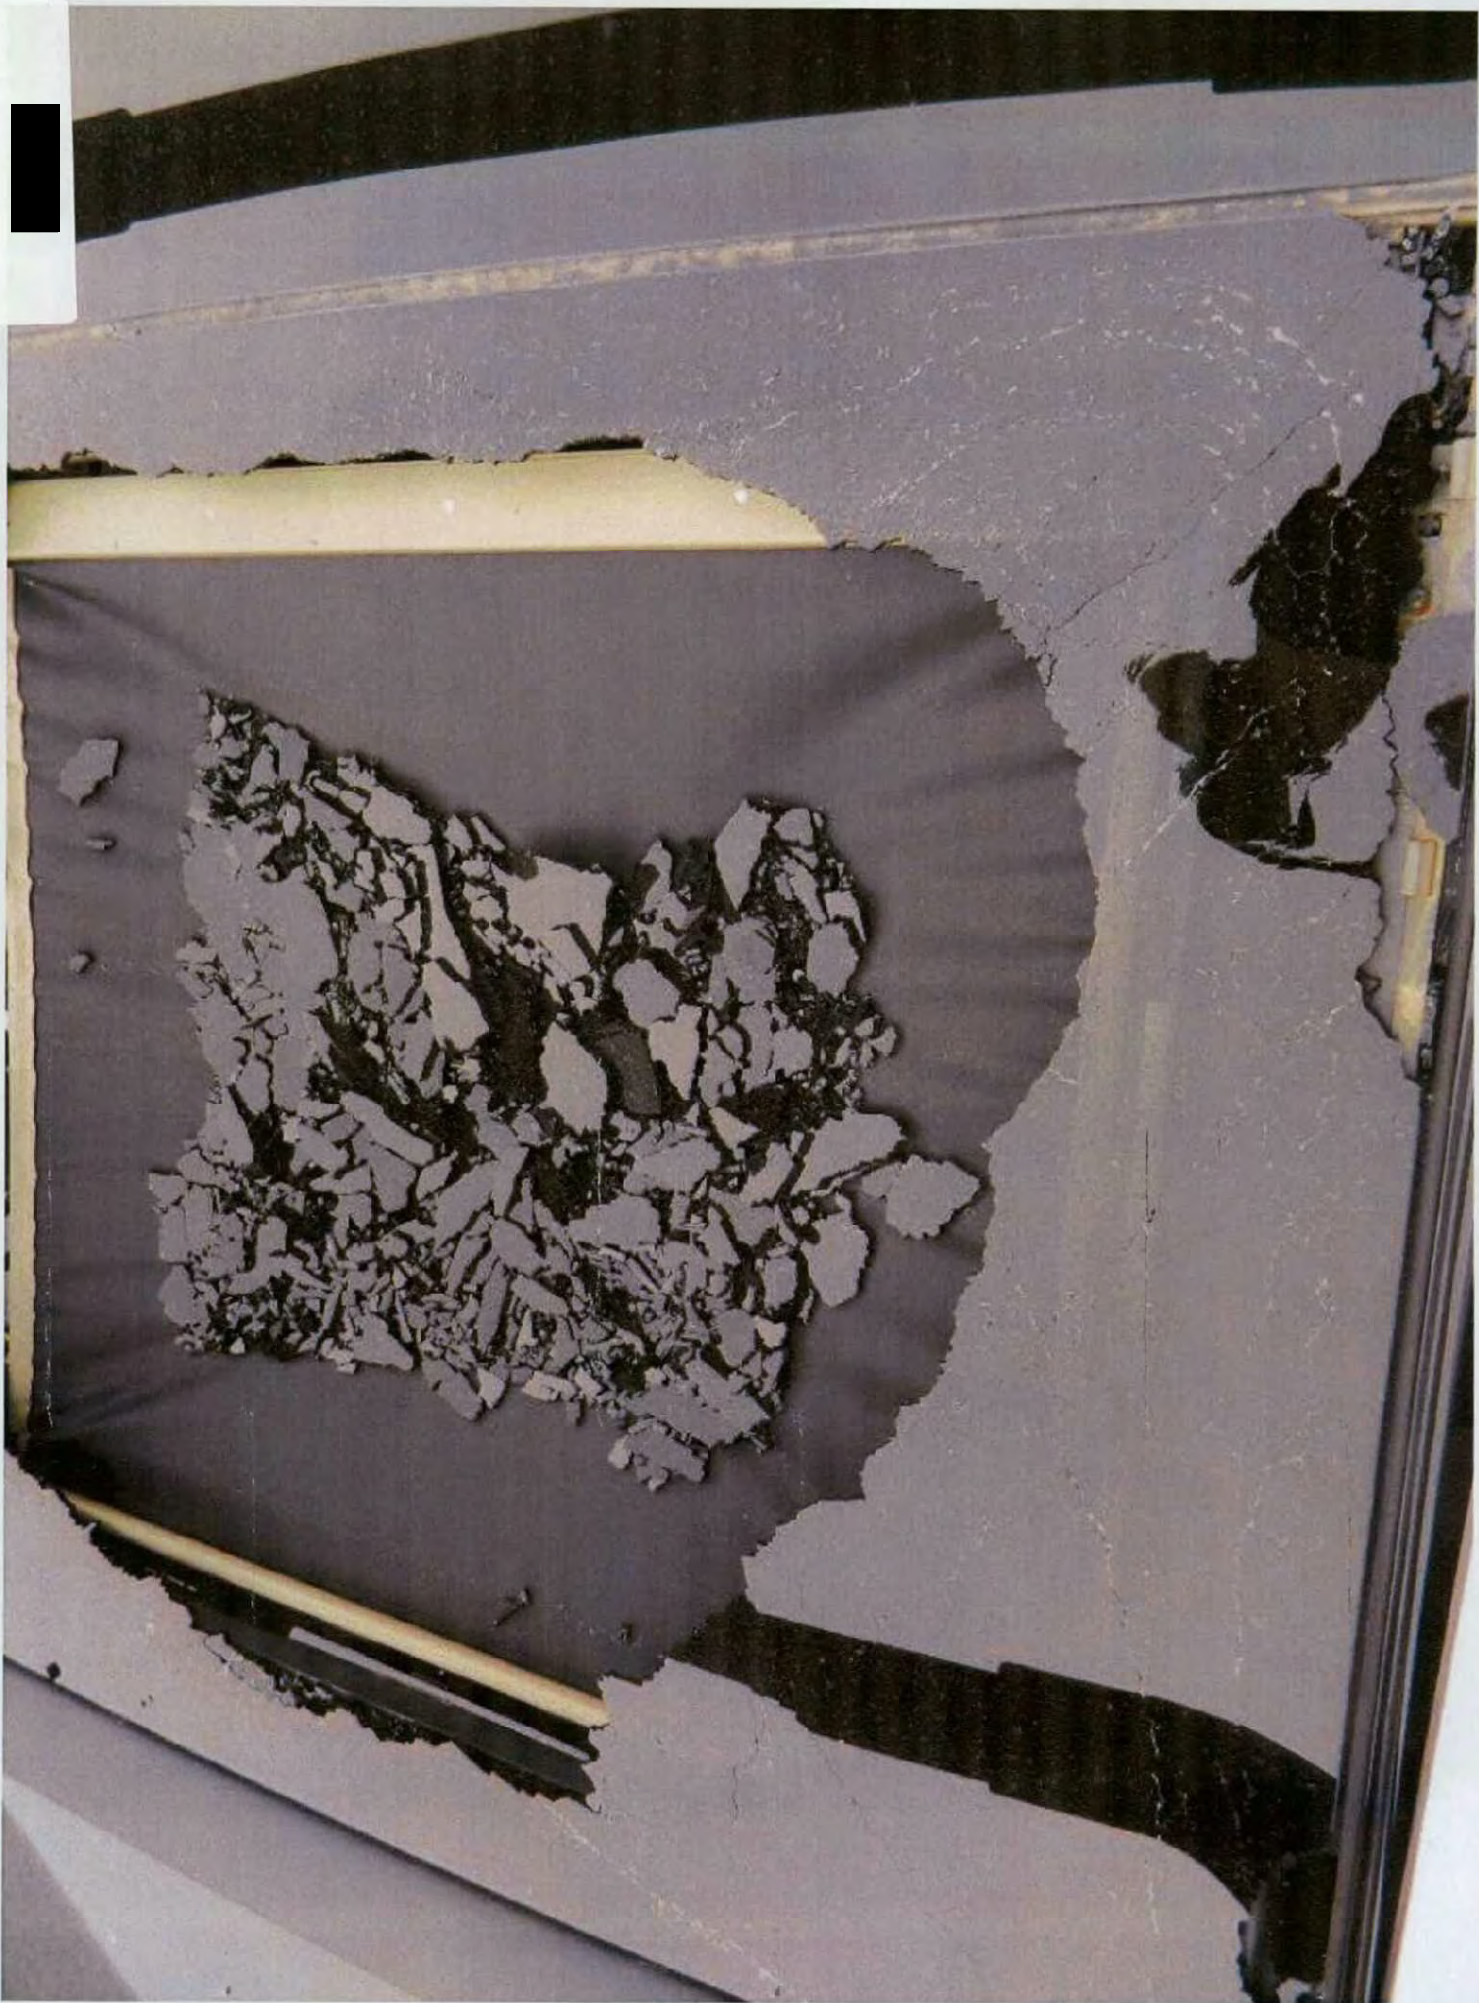
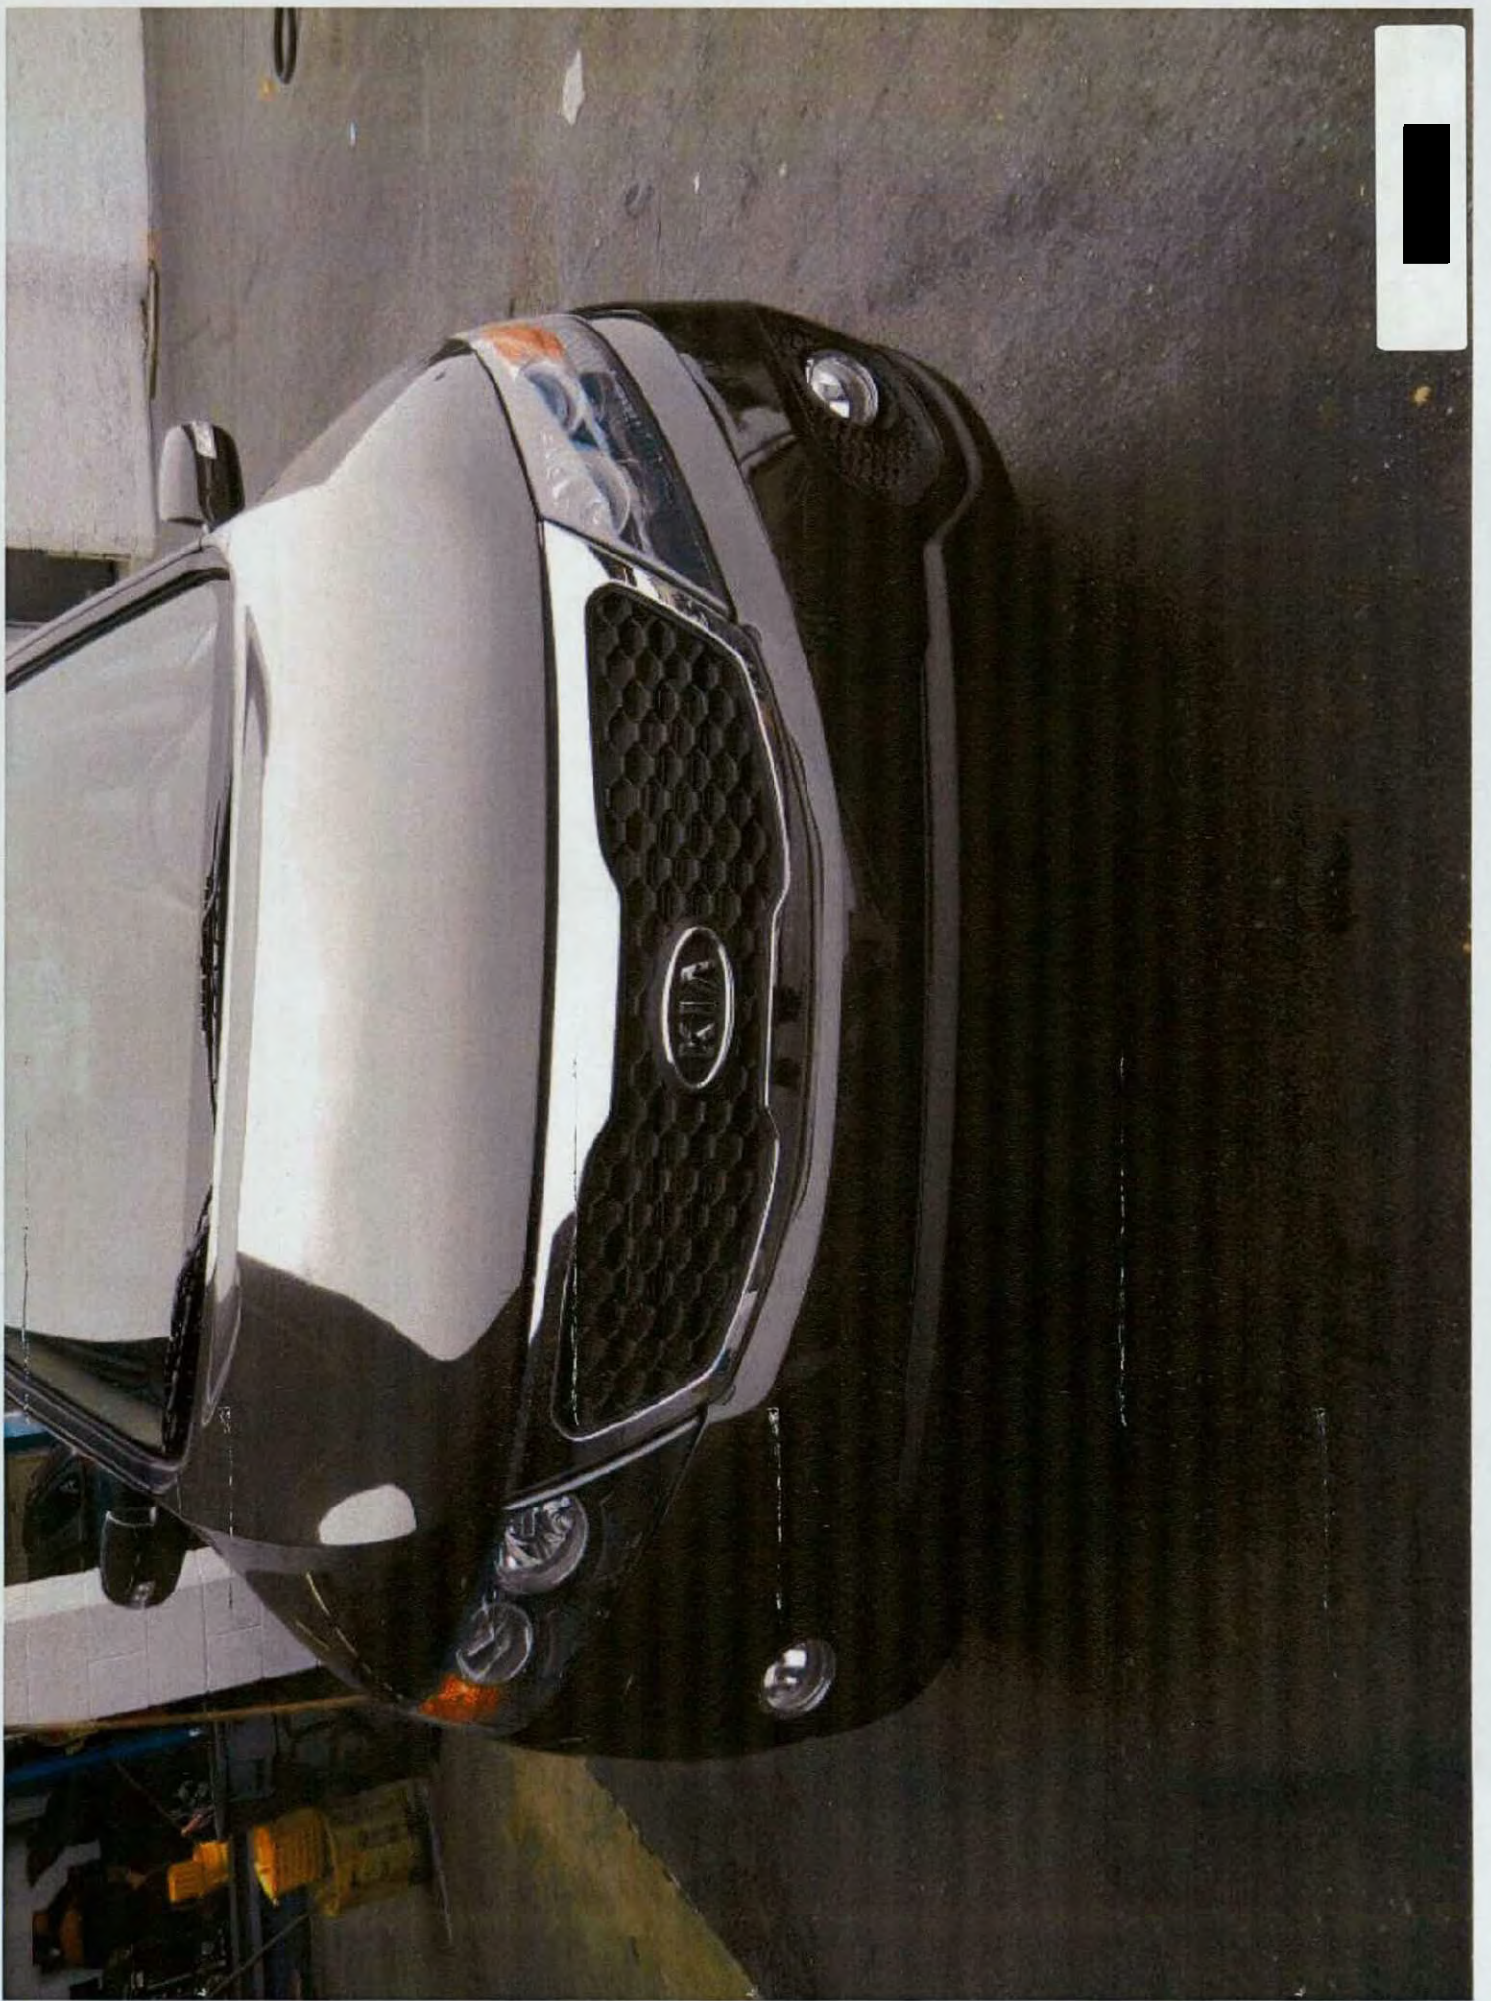
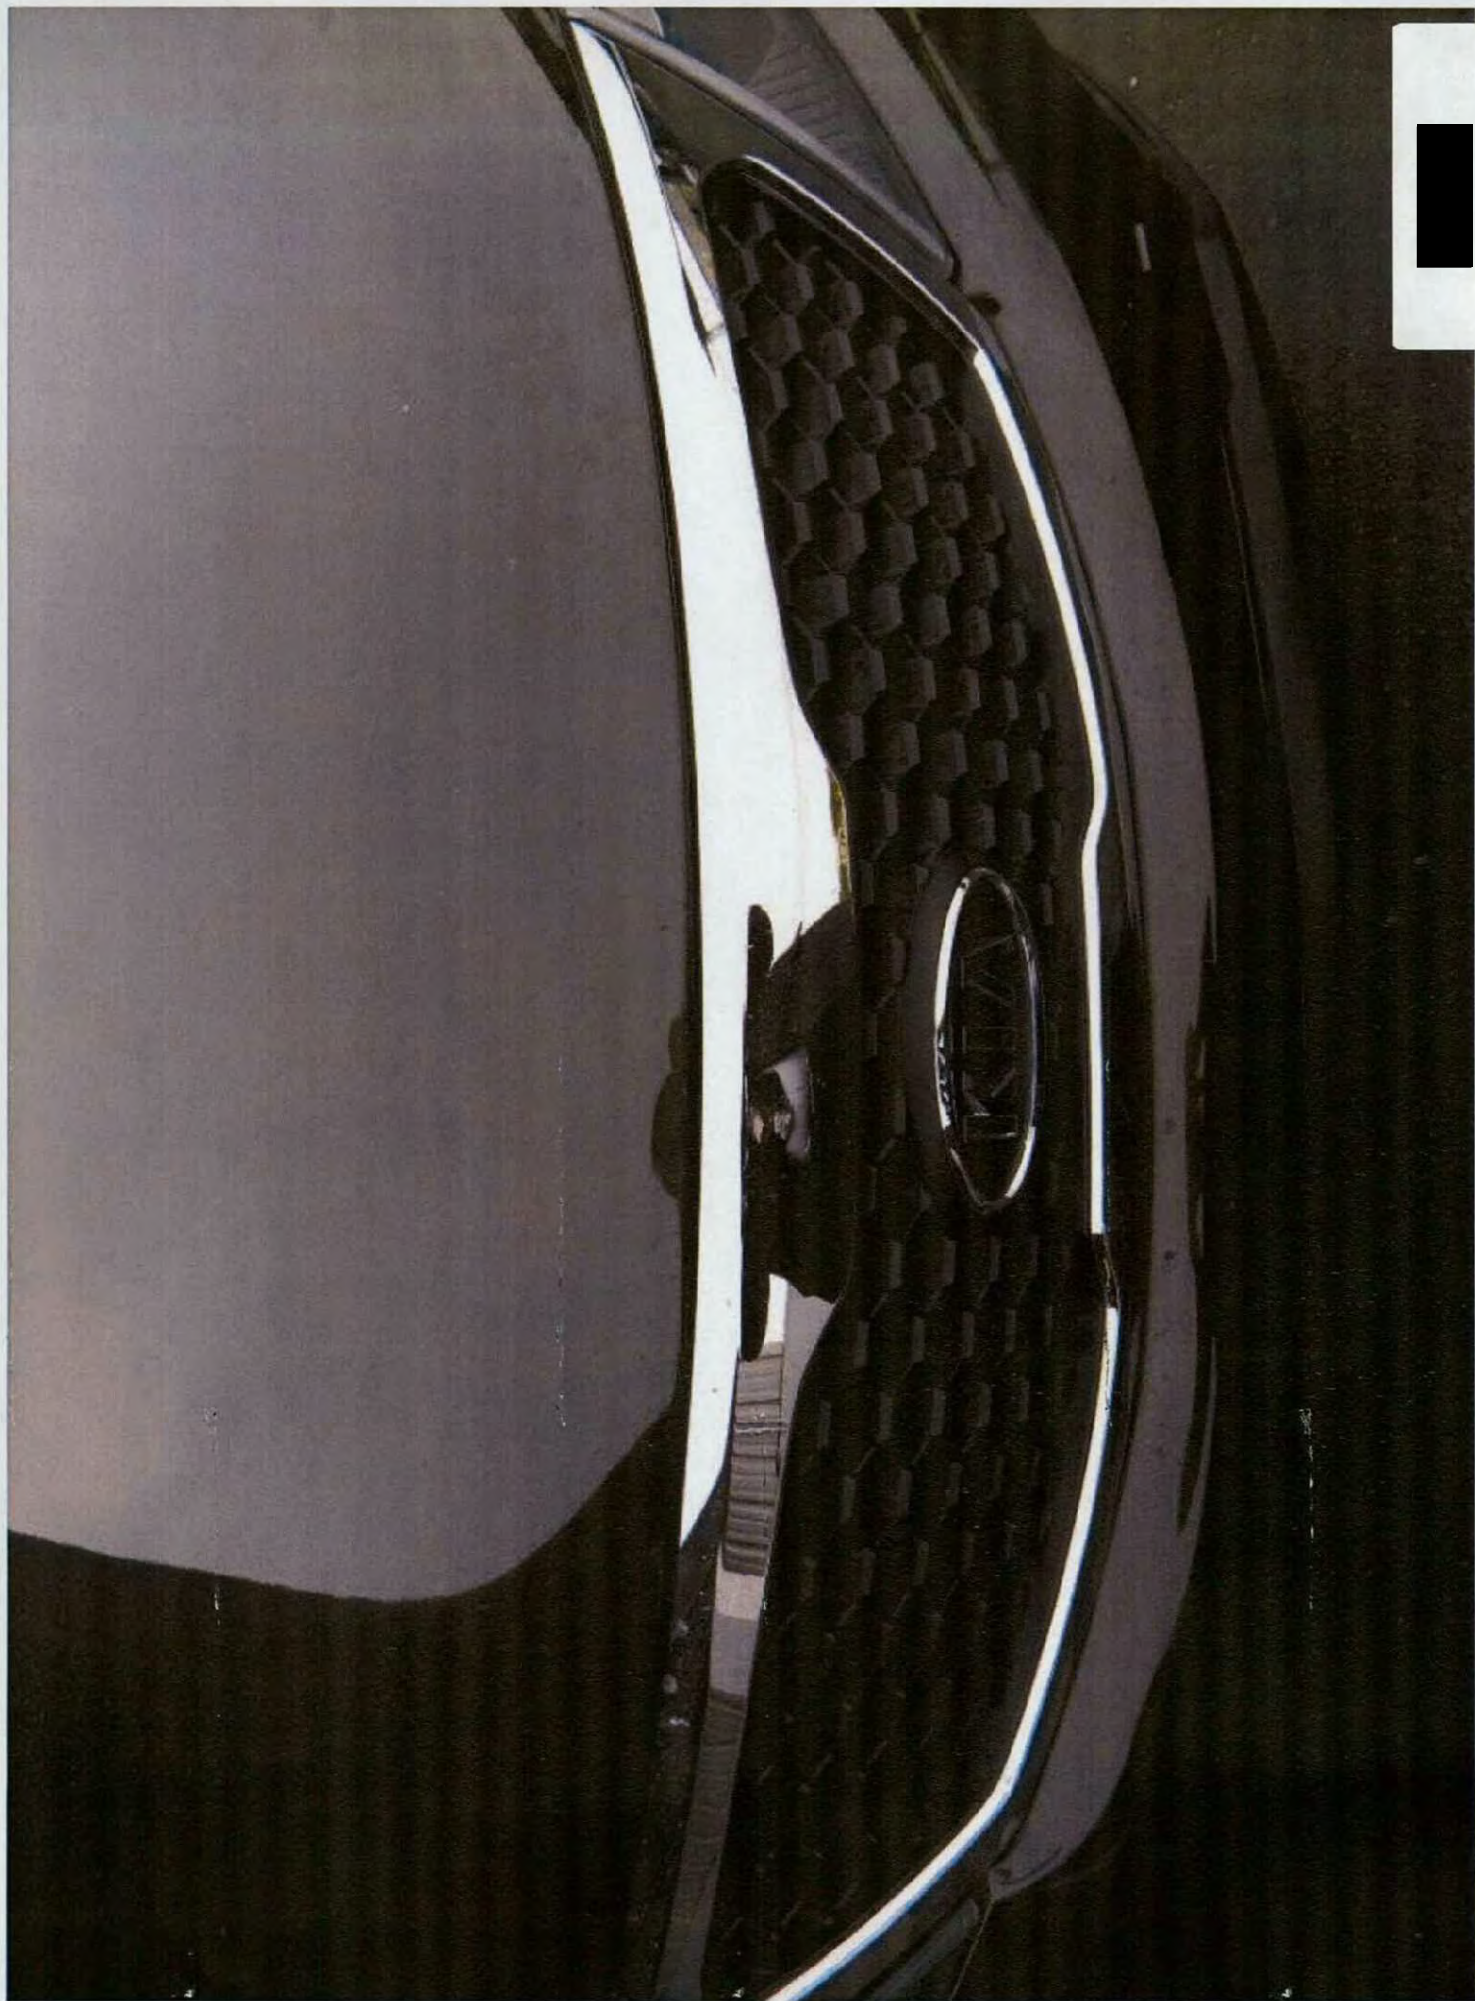
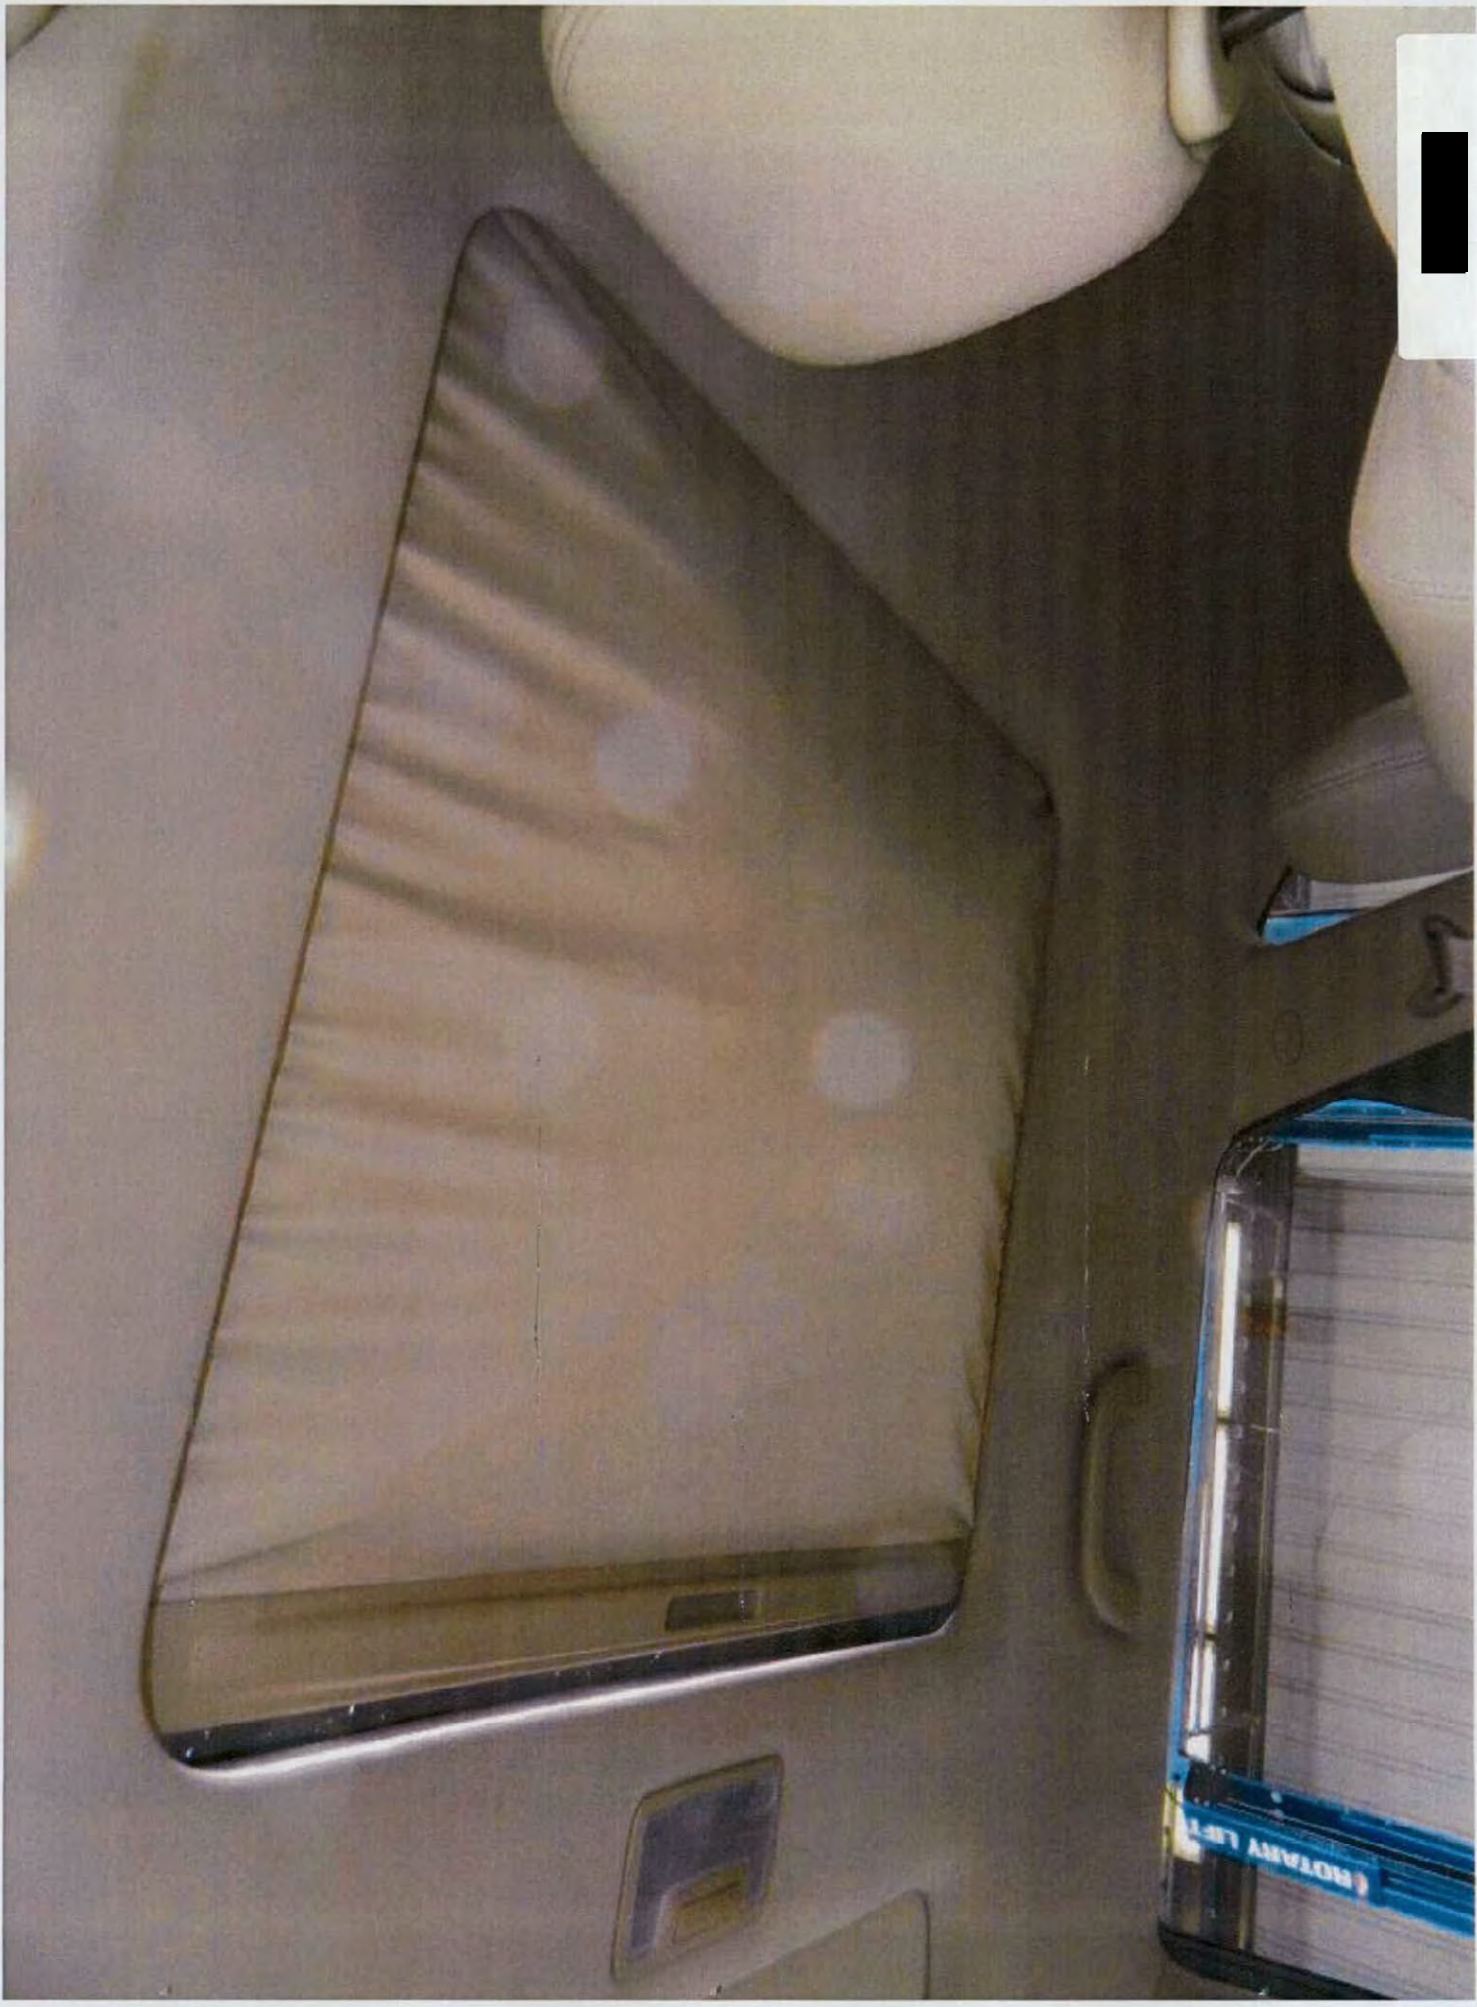
Found sunroof glass shattered

Found Sunroof glass shattered. Scratches on the top rear of vehicle from glass debris.

Replace the sunroof glass
