Kia Motors America
Field Product Quality Report

Report No.: WE2014LG00047

Subject/Title: Shattered Sunroof

Model Desc: SORENTO EX AWE

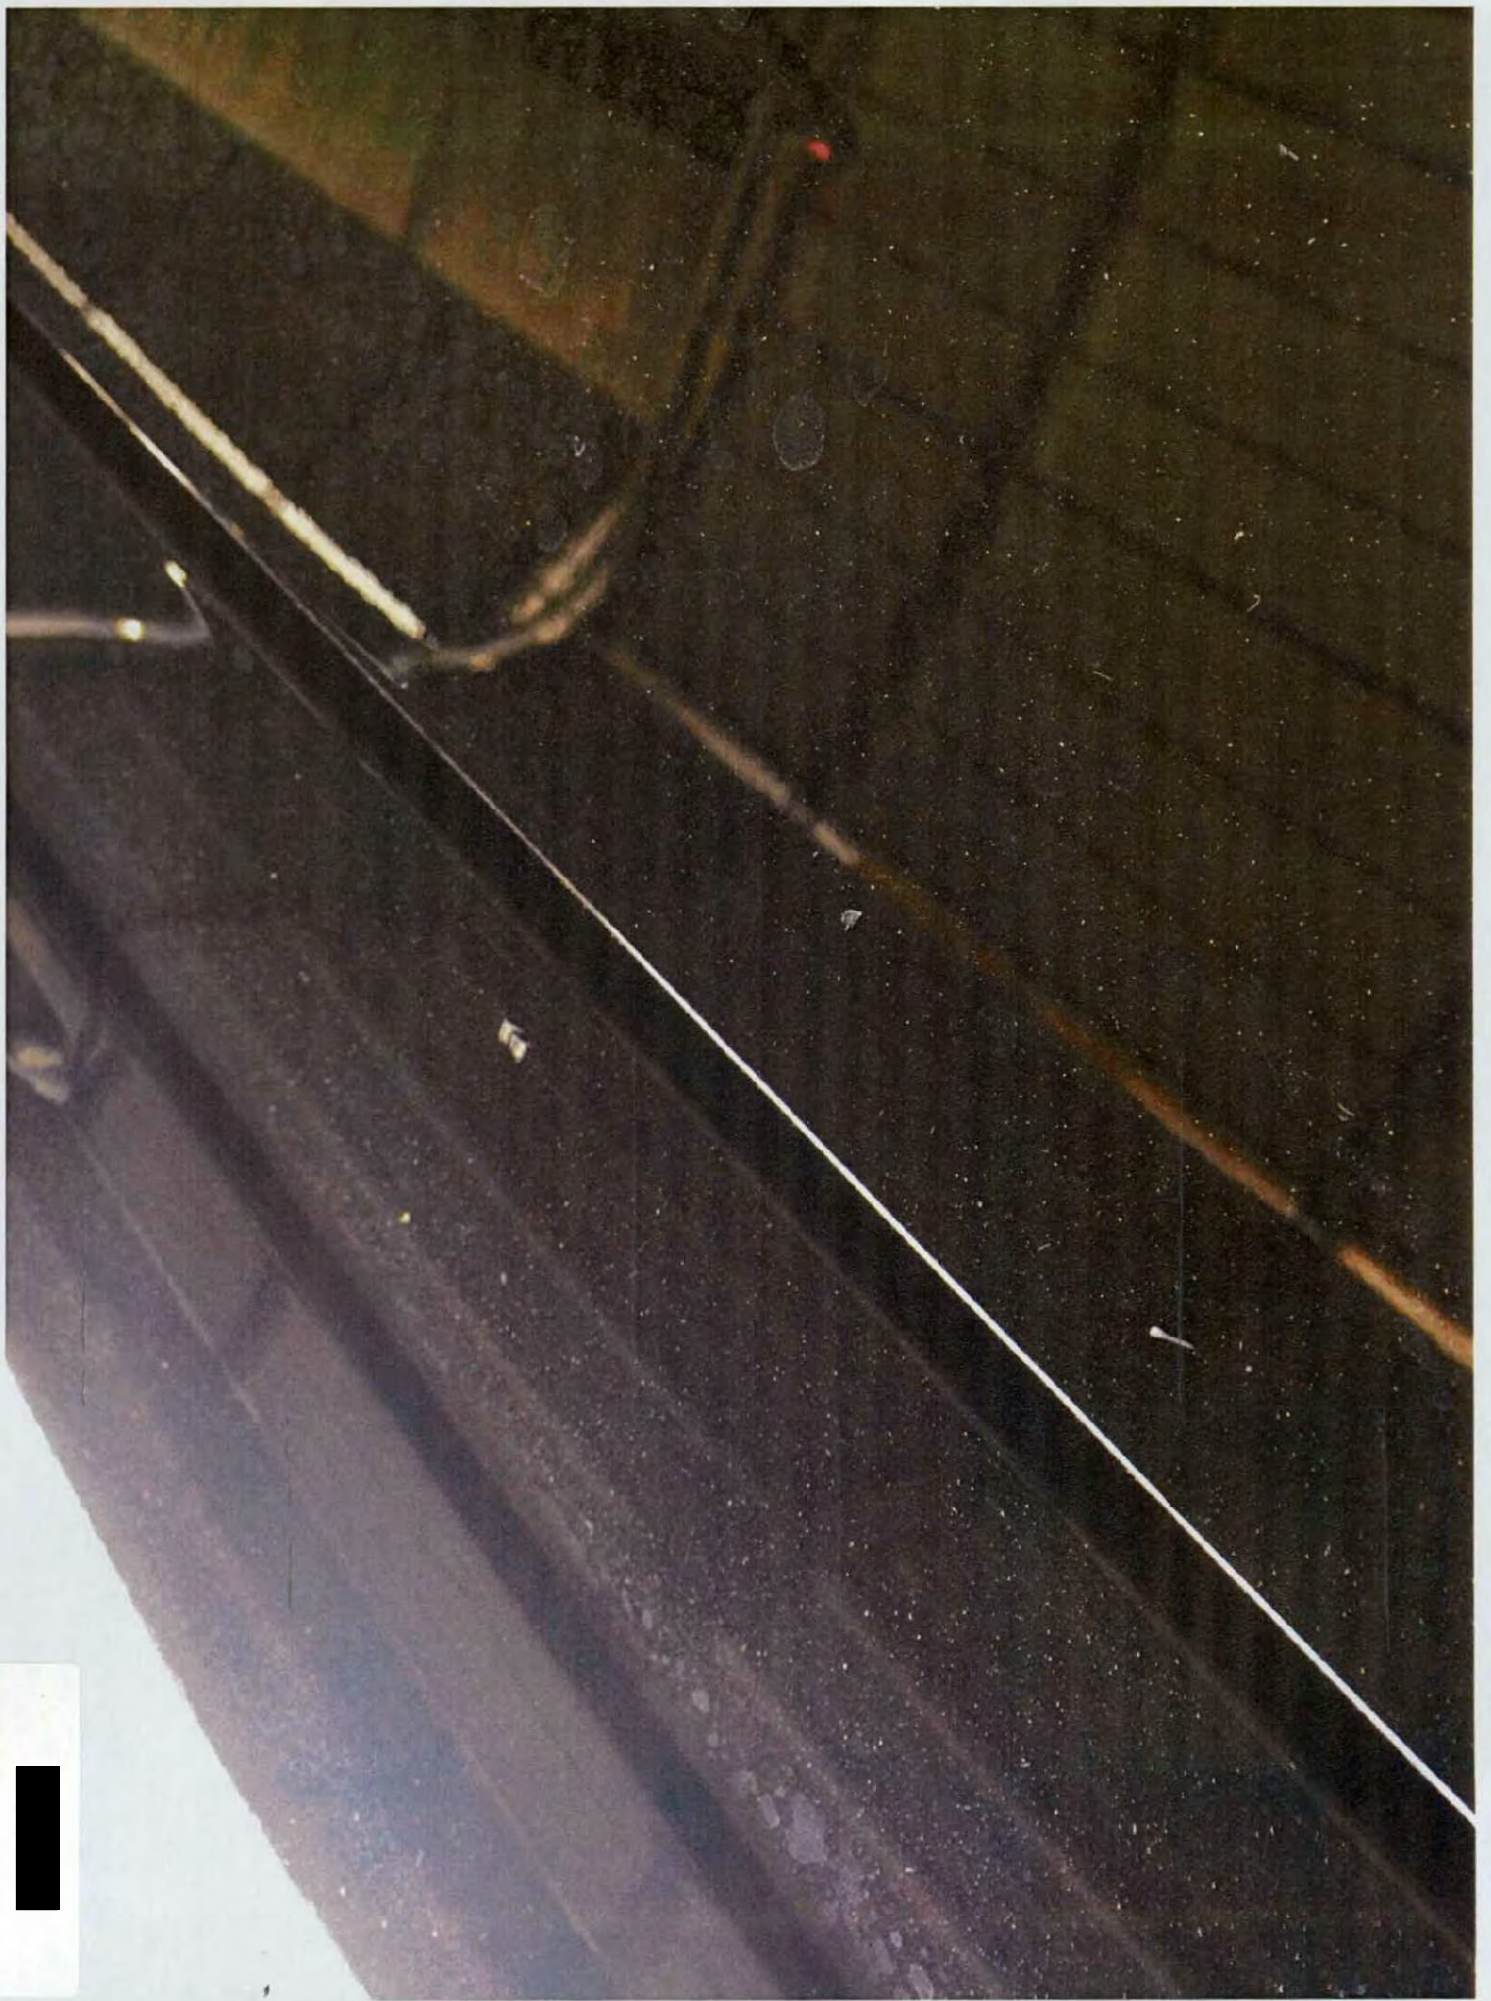
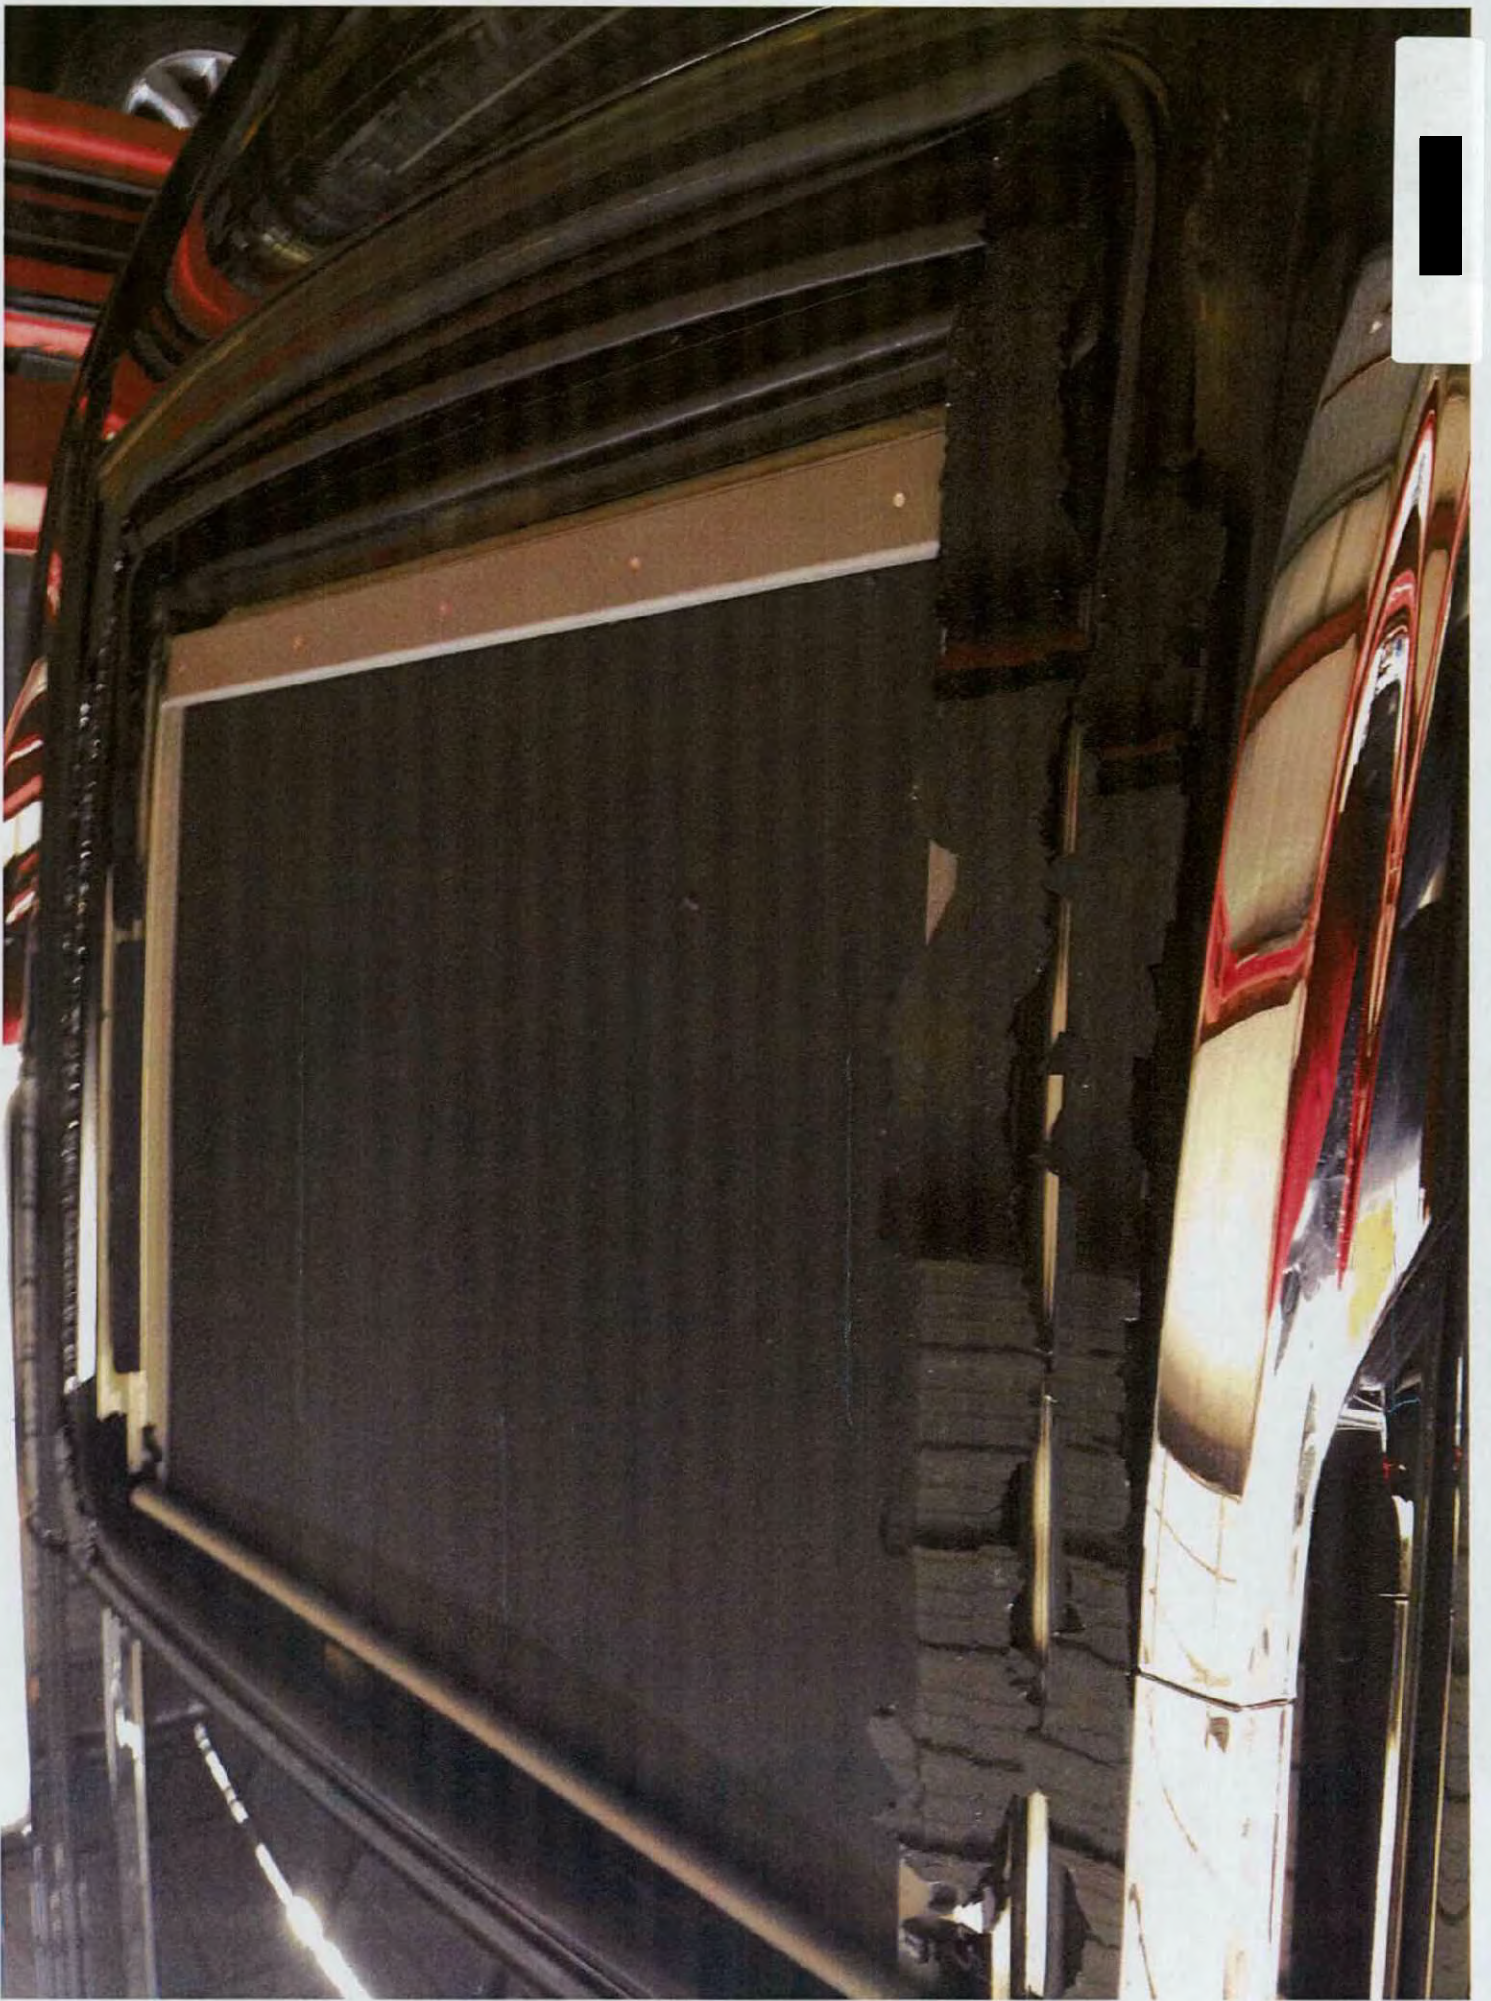
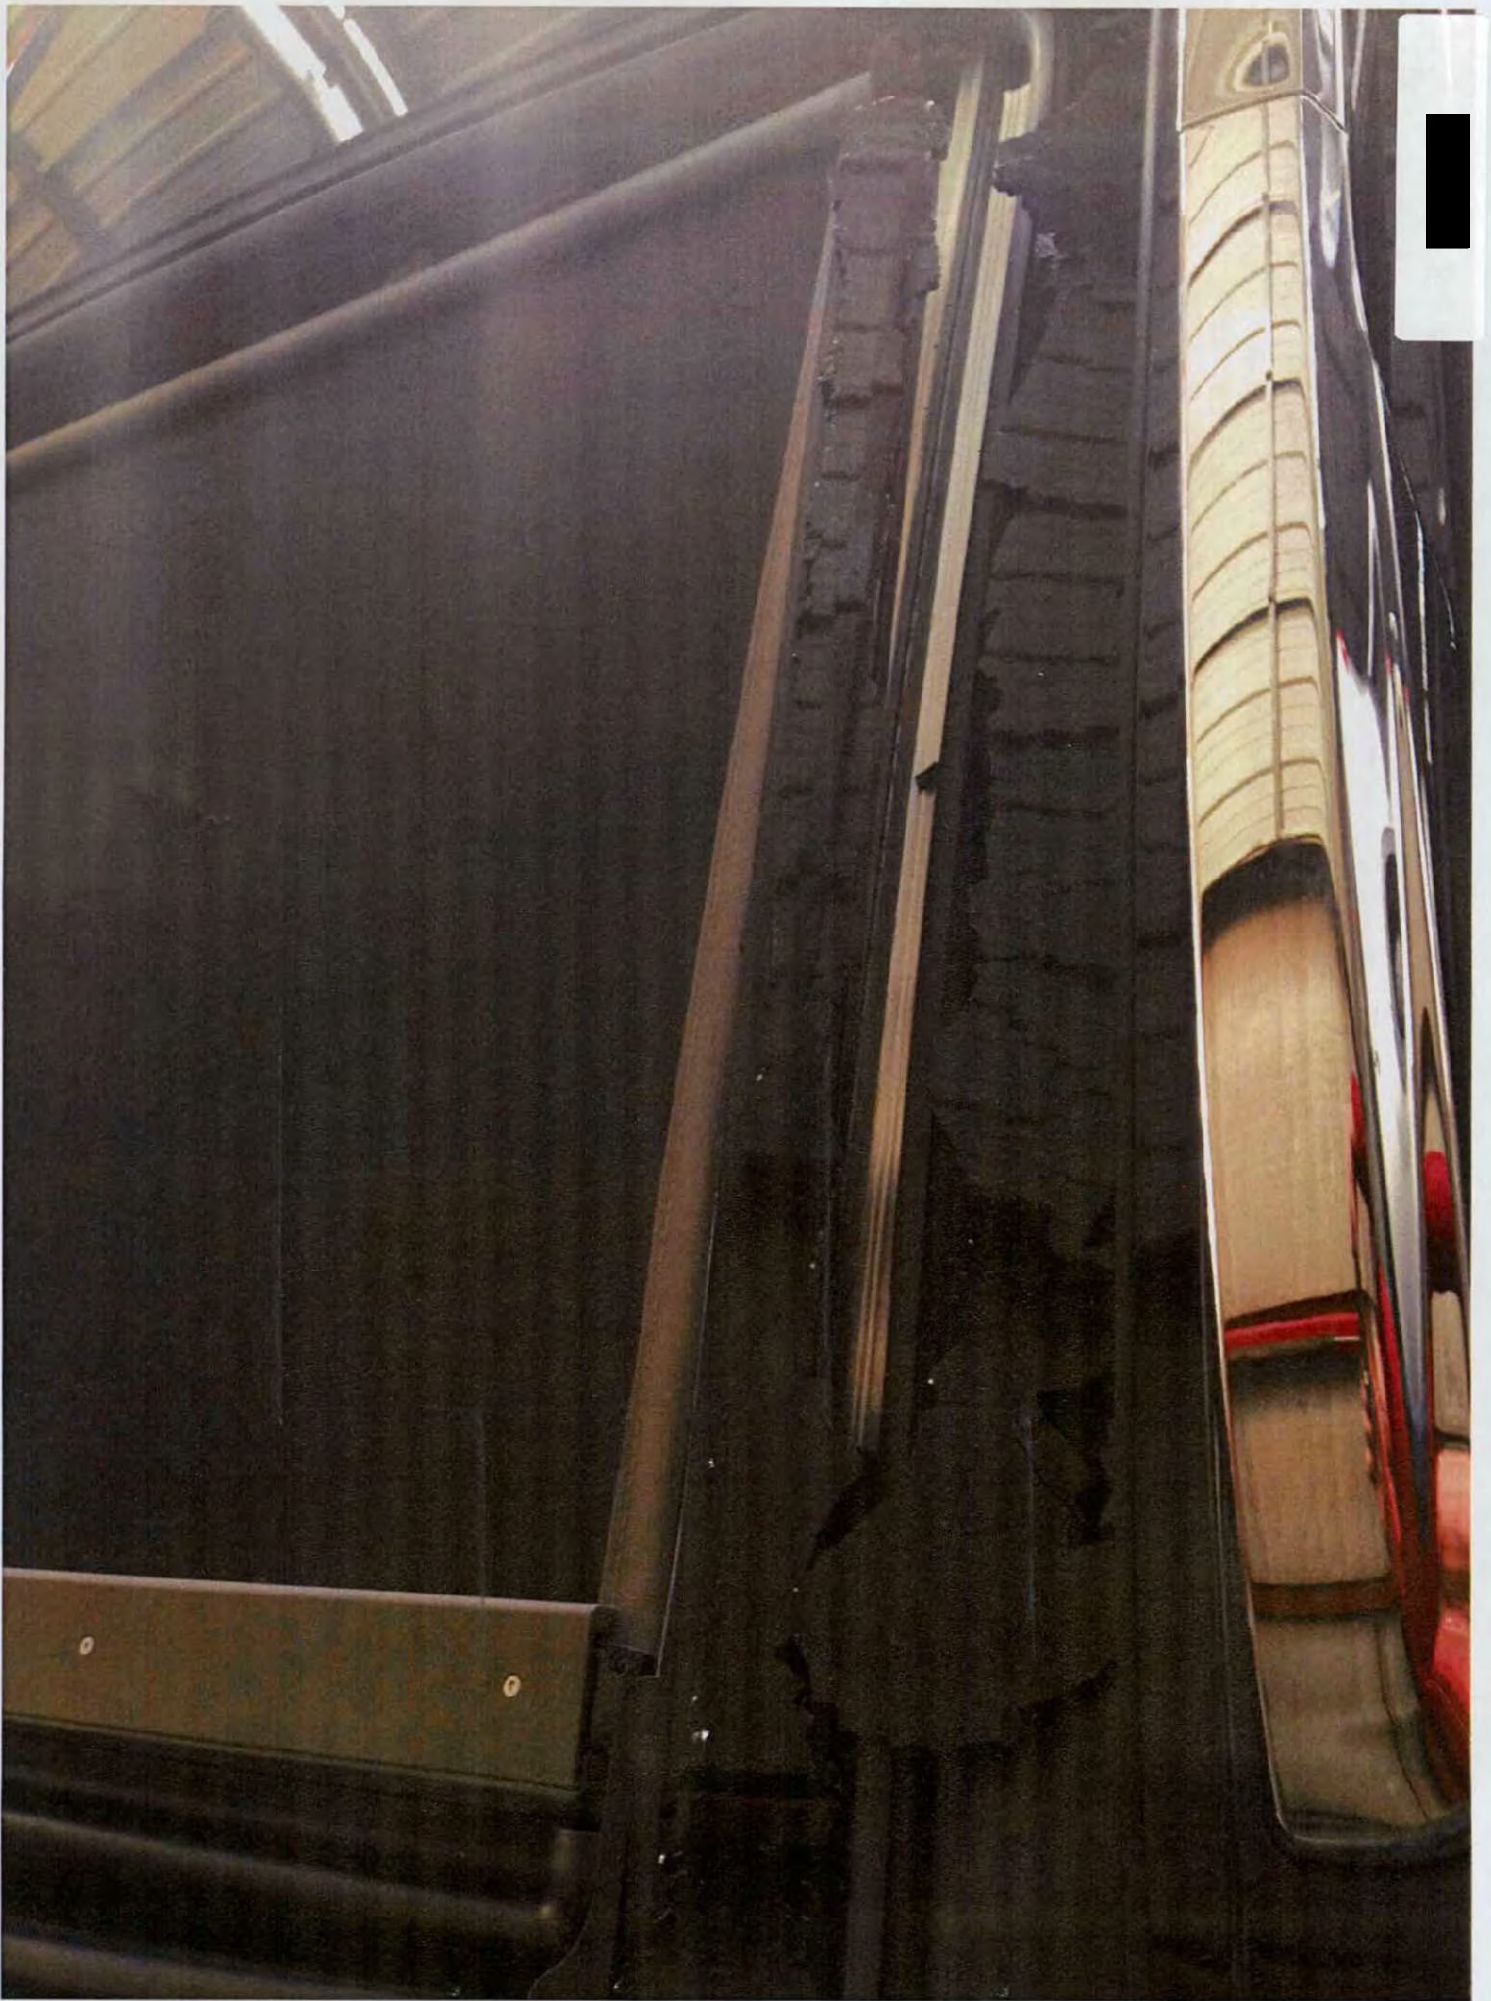
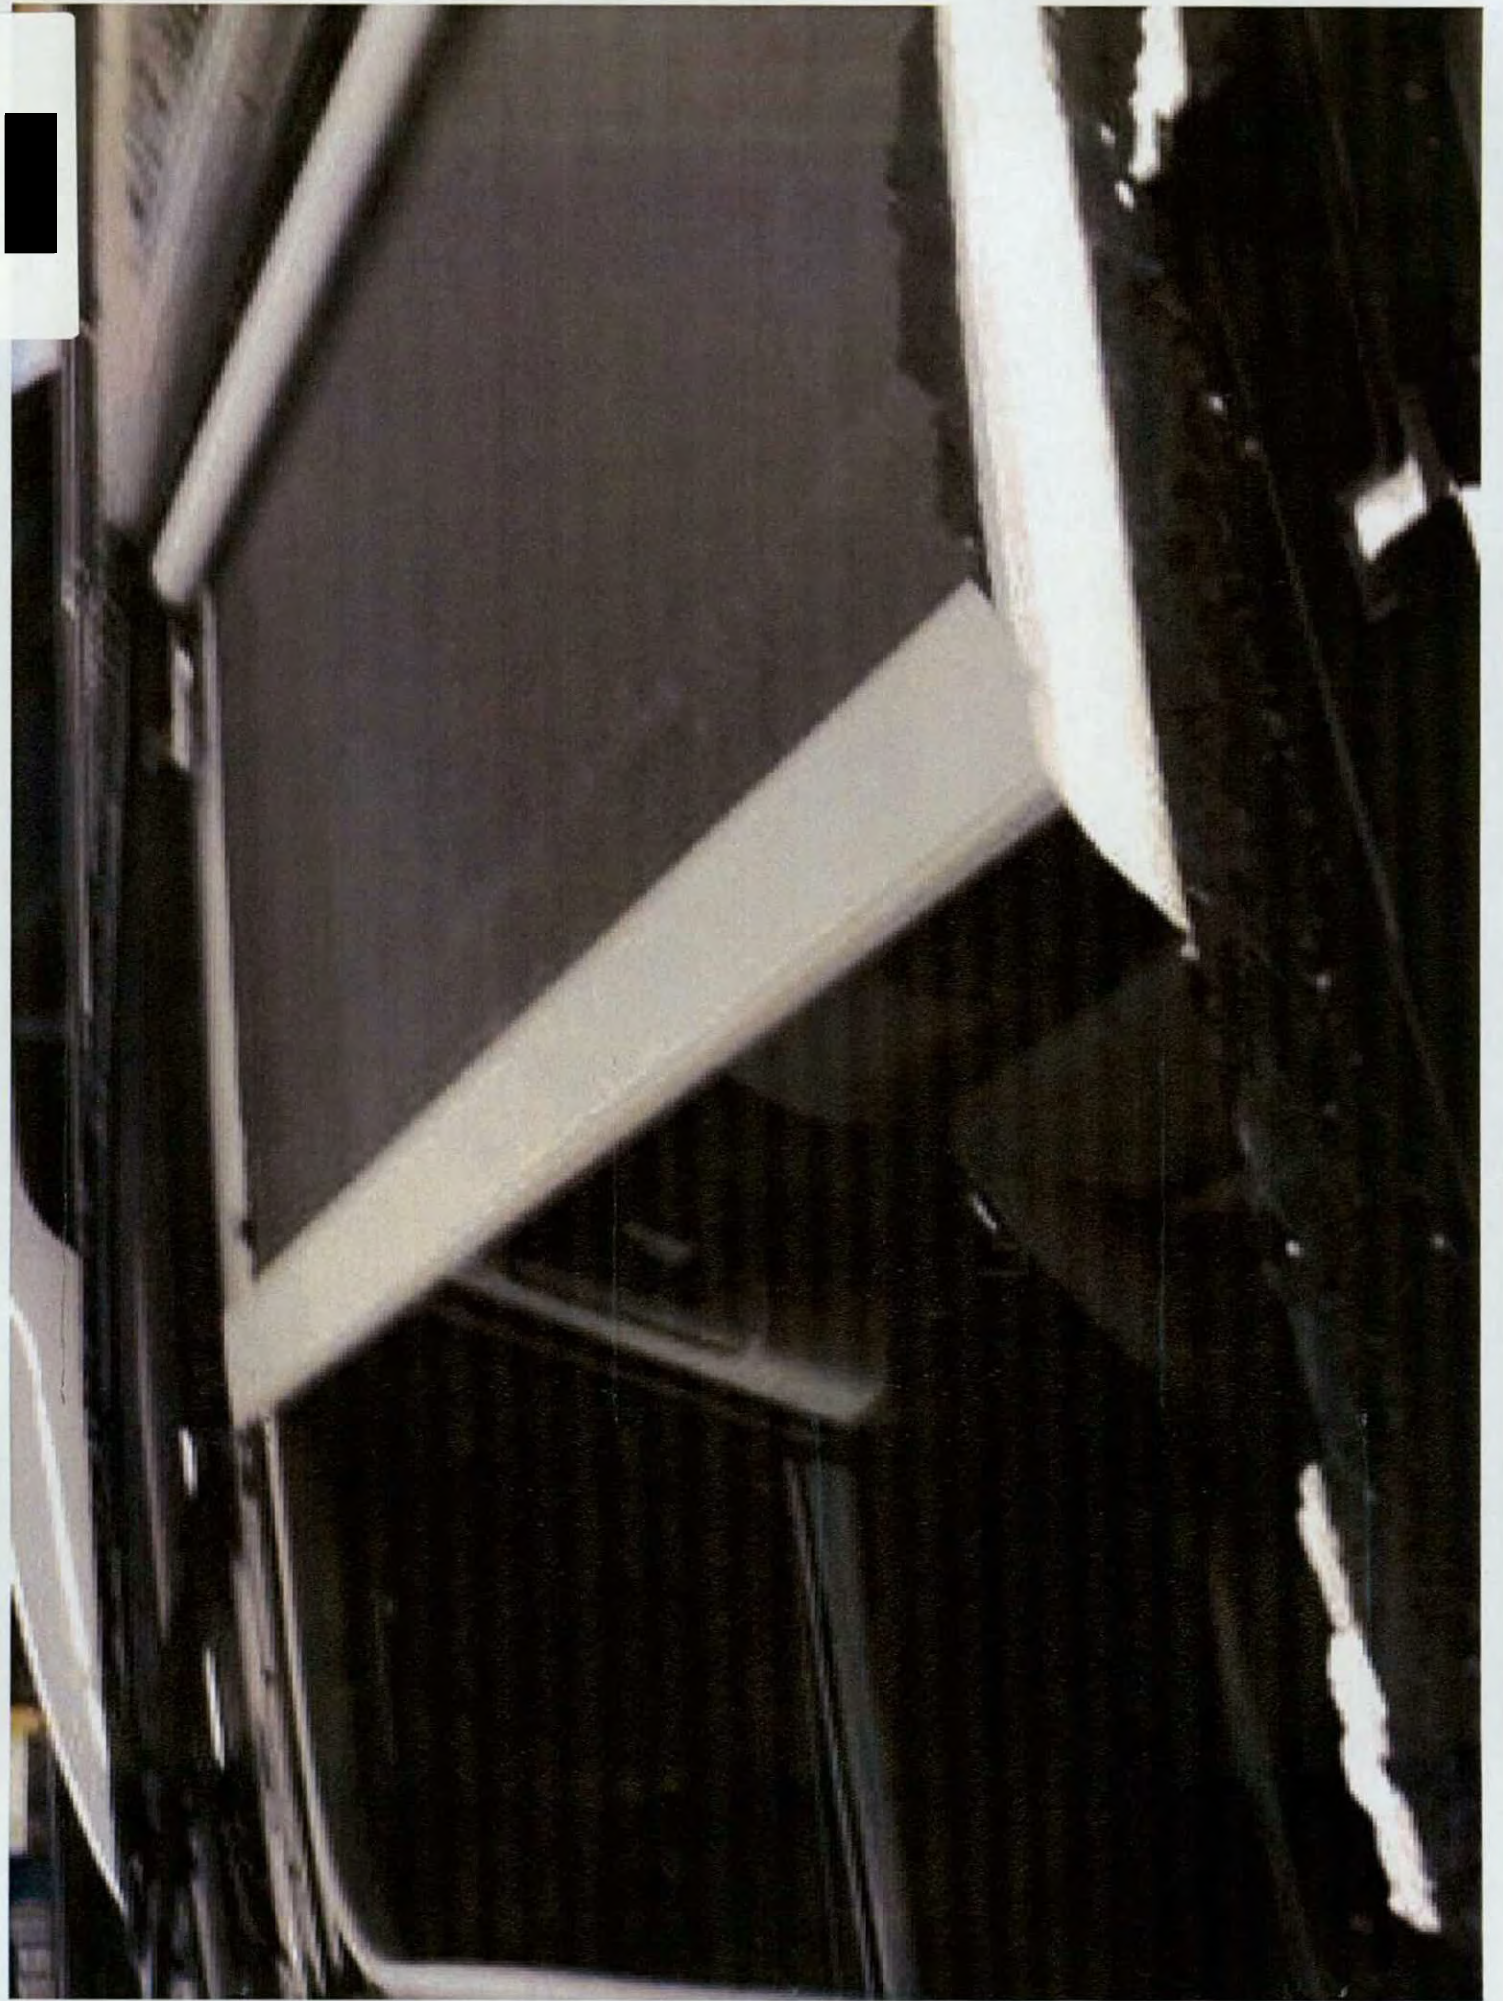
Pictures for sunroof – 2013 Sorento – VIN# 5XYKUDA25DG [REDACTED]

While driving the sunroof glass shattered. Customer did not hear anything impact the glass and we could not find anything inside the vehicle that could have caused it to break.

Panoramic glass shattered outwards away from vehicle

DPSM and dealership inspected vehicle and could not any signs of impact.

Undetermined

Replace Panoramic Glass
