Kia Motors America Field Product Quality Report

Report No.: CE2014FJ00181

Subject/Title: Panoramic Roof

Model Desc: SORENTO SX

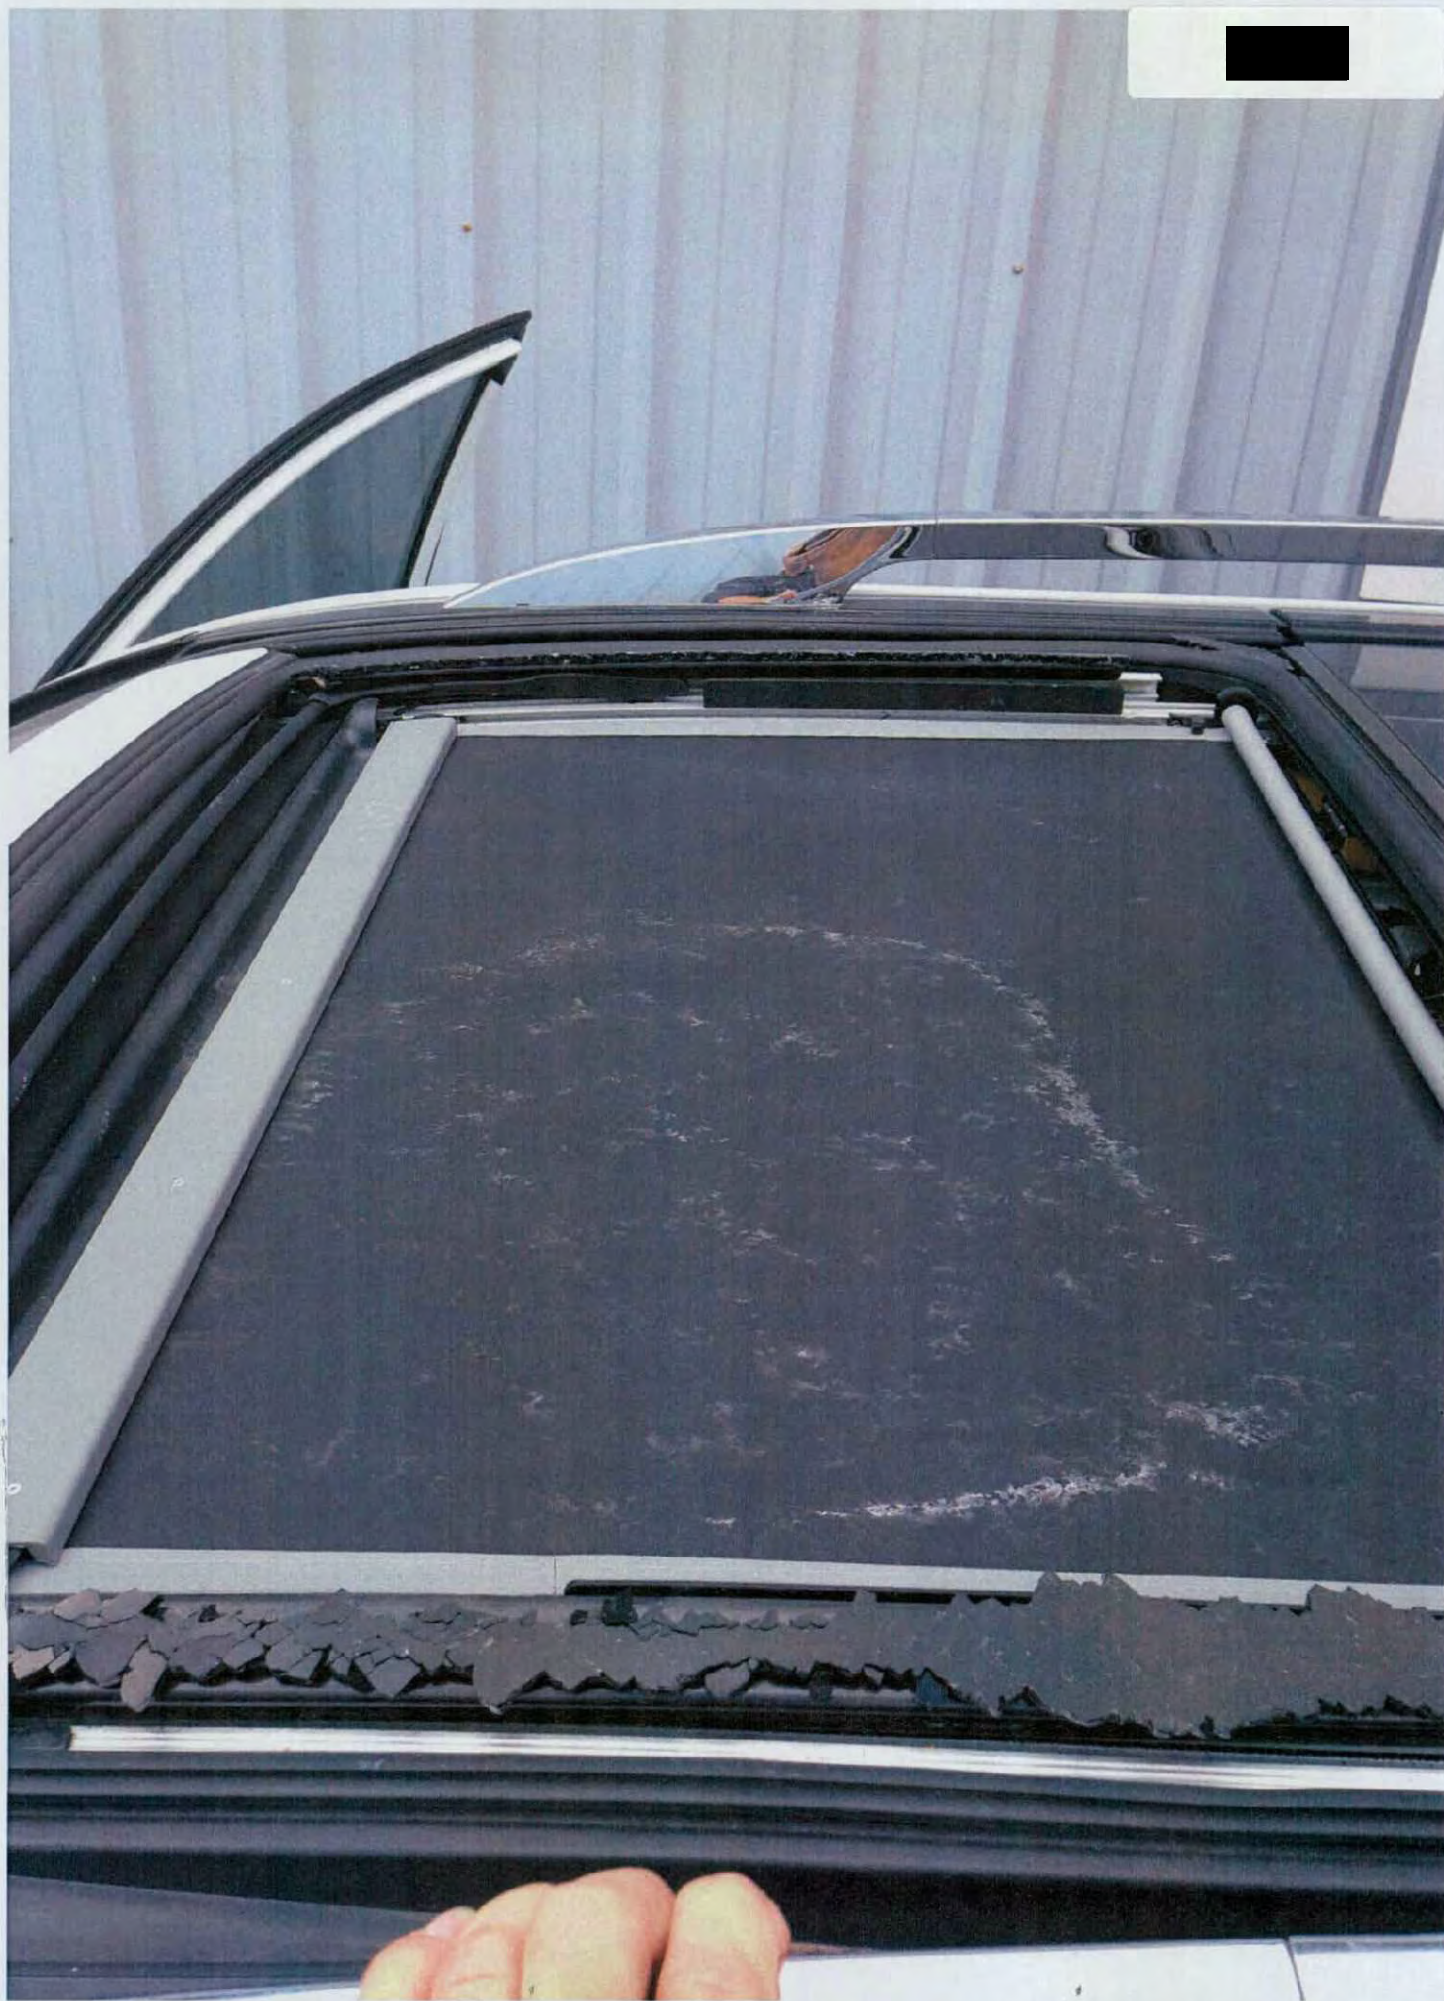
Sunroof shattered while closing rear hatch

All glass gone with the exception of the side rails

Unknown

Replace pano roof assy
