PE14-001

TOYOTA

Additional Consumer
Complaint Documents

FIELD TECHNICAL REPORT - INCIDENT INSPECTION

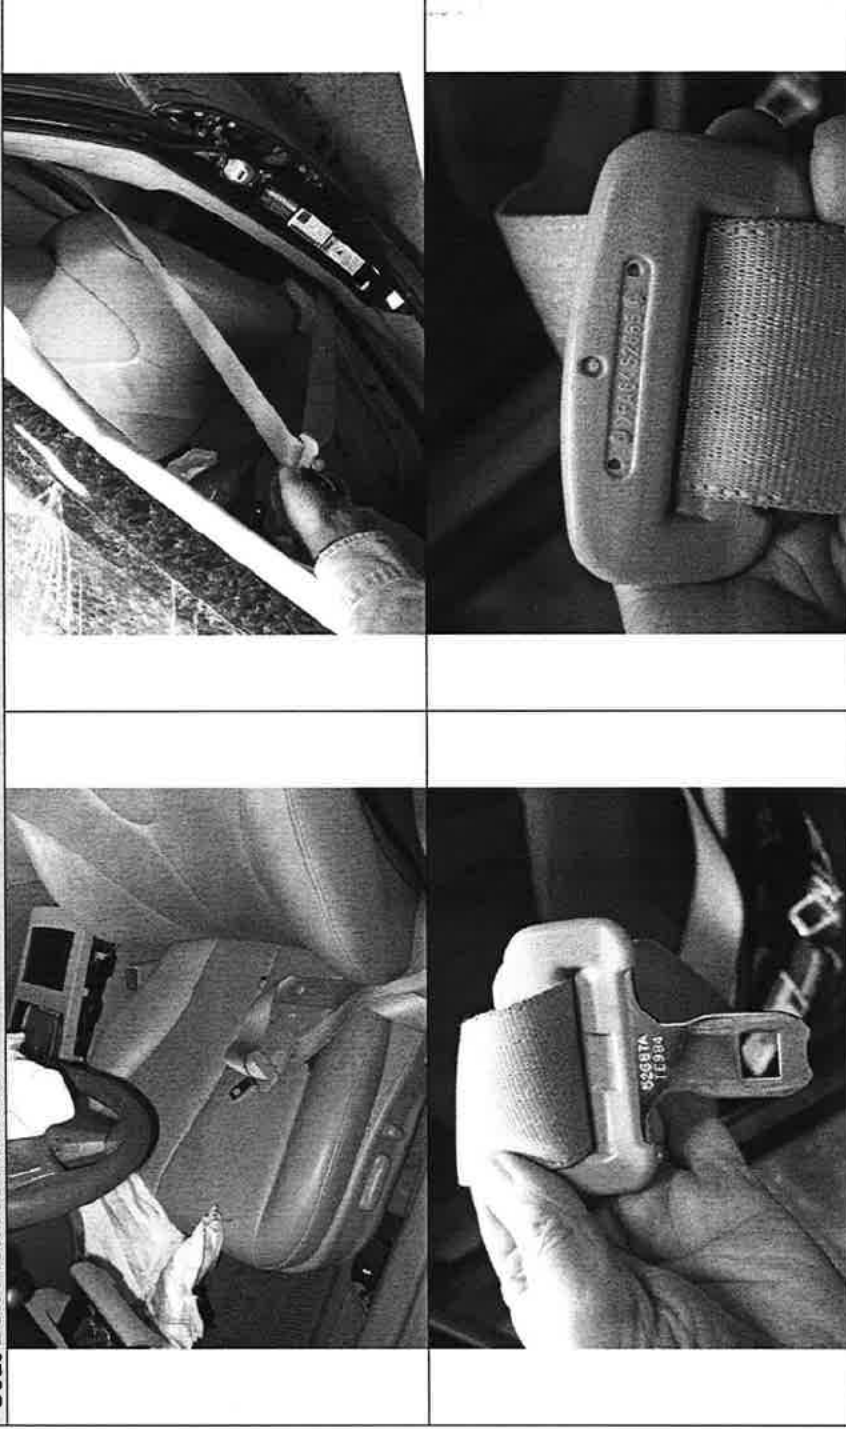
Seat Belt Pictures / Videos

Inspection Area		Notes & Observations
Left Front Position	Seat	Seat track is 80mm forward of center position. Seatback is 13° back of vertical. No physical damage observed.
	Seatbelt	Pretensioner is deployed. Latch functions normally.
Right Front Position	Seat	No damage or discrepancies observed.
	Seatbelt	Functions as designed.
Left Rear Position	Seat	No damage or discrepancies observed.
	Seatbelt	Functions as designed.
Center Rear Position	Seat	No damage or discrepancies observed.
	N/A: <input type="checkbox"/>	Functions as designed.
Right Rear Position	Seat	No damage or discrepancies observed.
	Seatbelt	Functions as designed.
Third Row	Seat	
	N/A: <input checked="" type="checkbox"/>

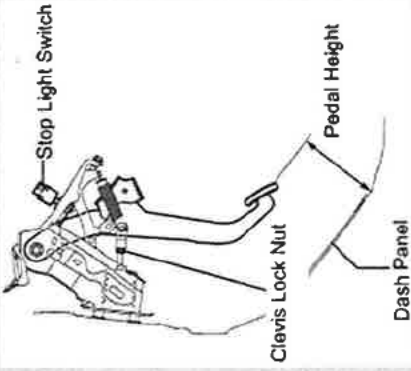
Brake Pedal Height inspection:

Pull the carpet back and measure to the dash panel (floor pan)

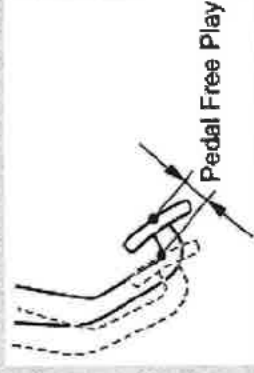
Brake Pedal Free Play Inspection:

Measurement: 0 (due to displaced floor pan)

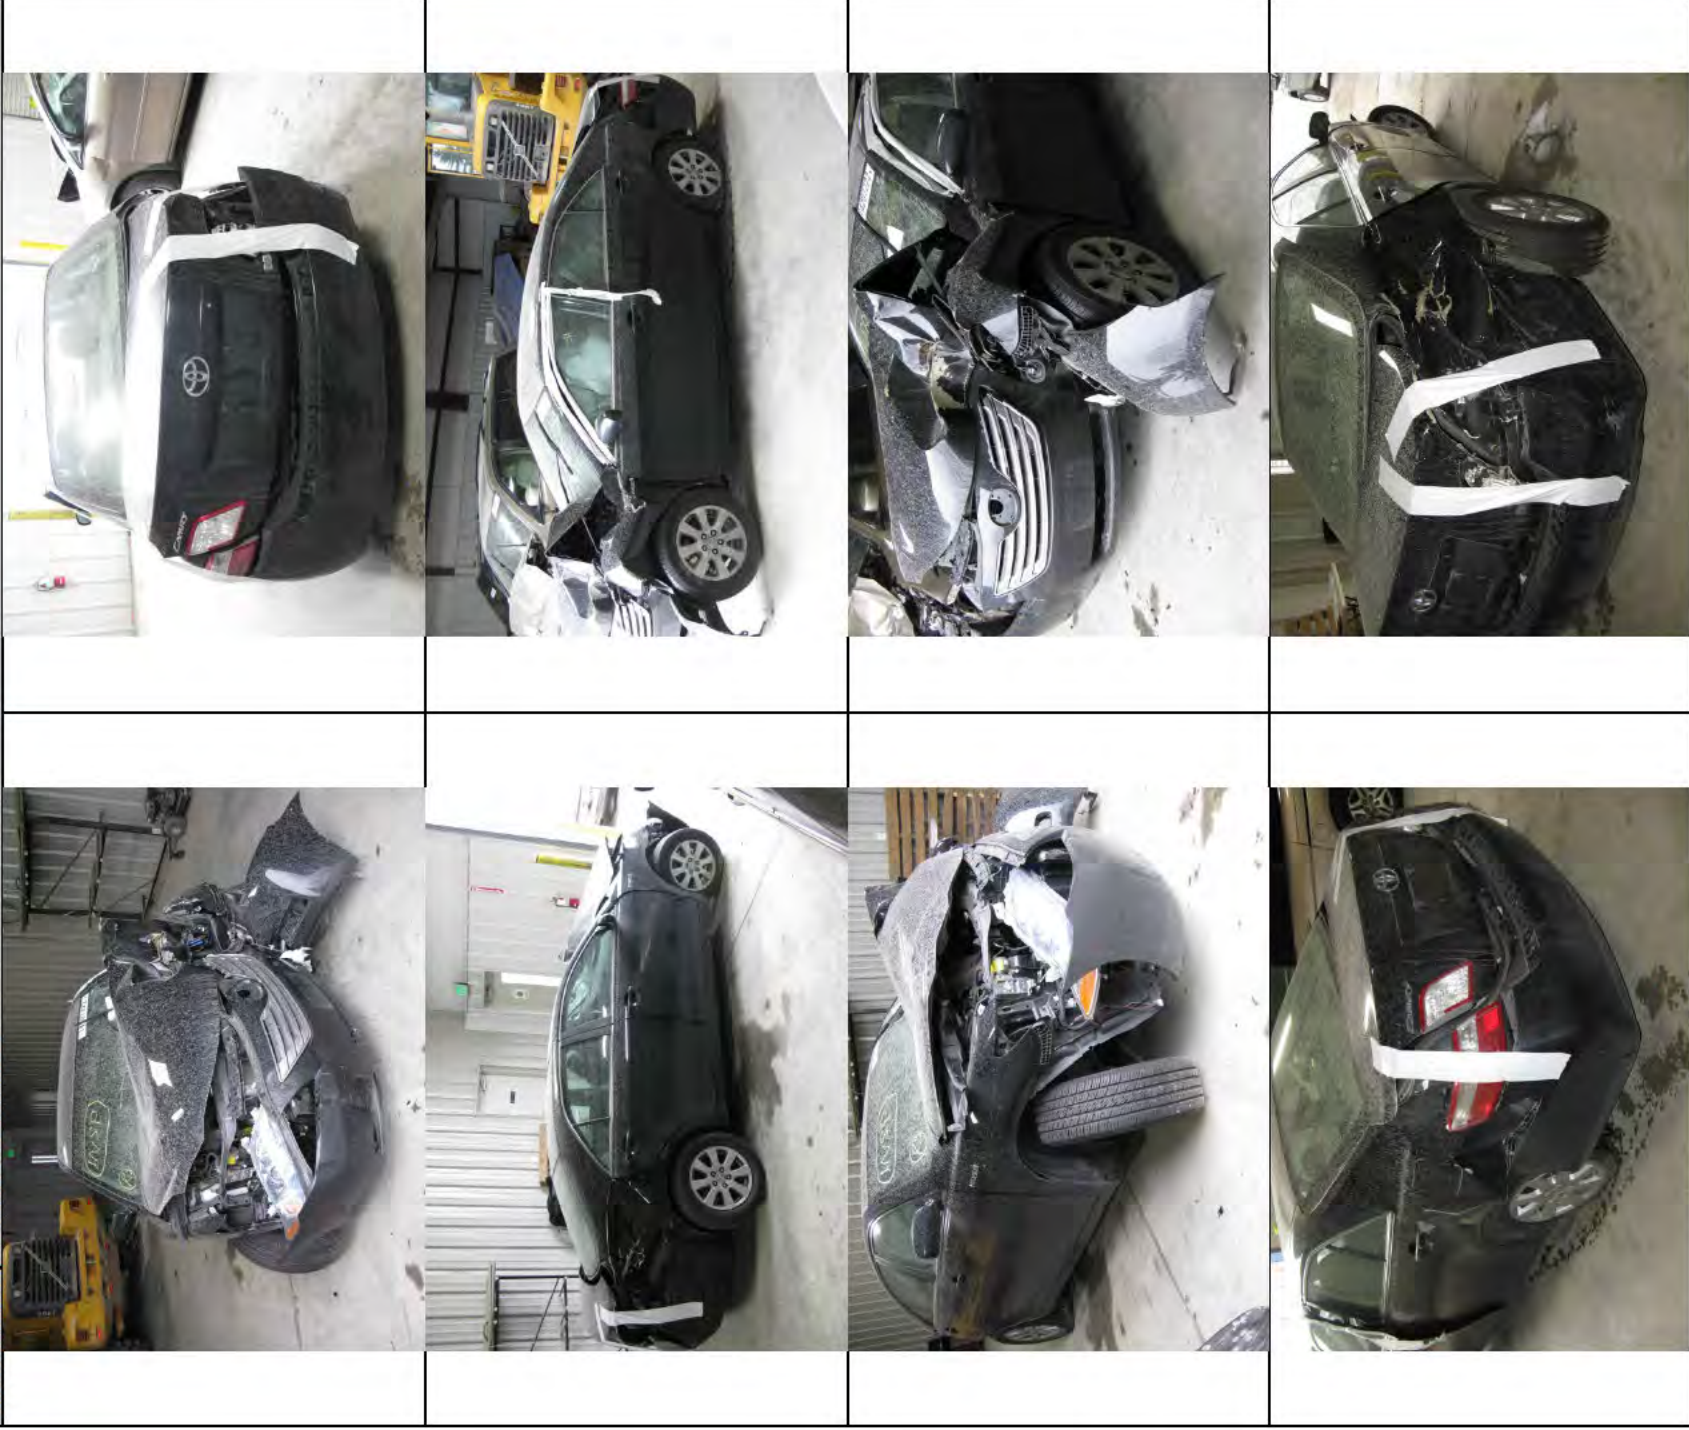
2. Vehicle Identification & Condition (NOTE: If no impact, document overall vehicle condition.)
Incident/Impact Area Pictures

I looked at the damage to the Toyota Camary and I could see that both front air bags had deployed inside the vehicle. The vehicle sustained heavy front end damage as well.

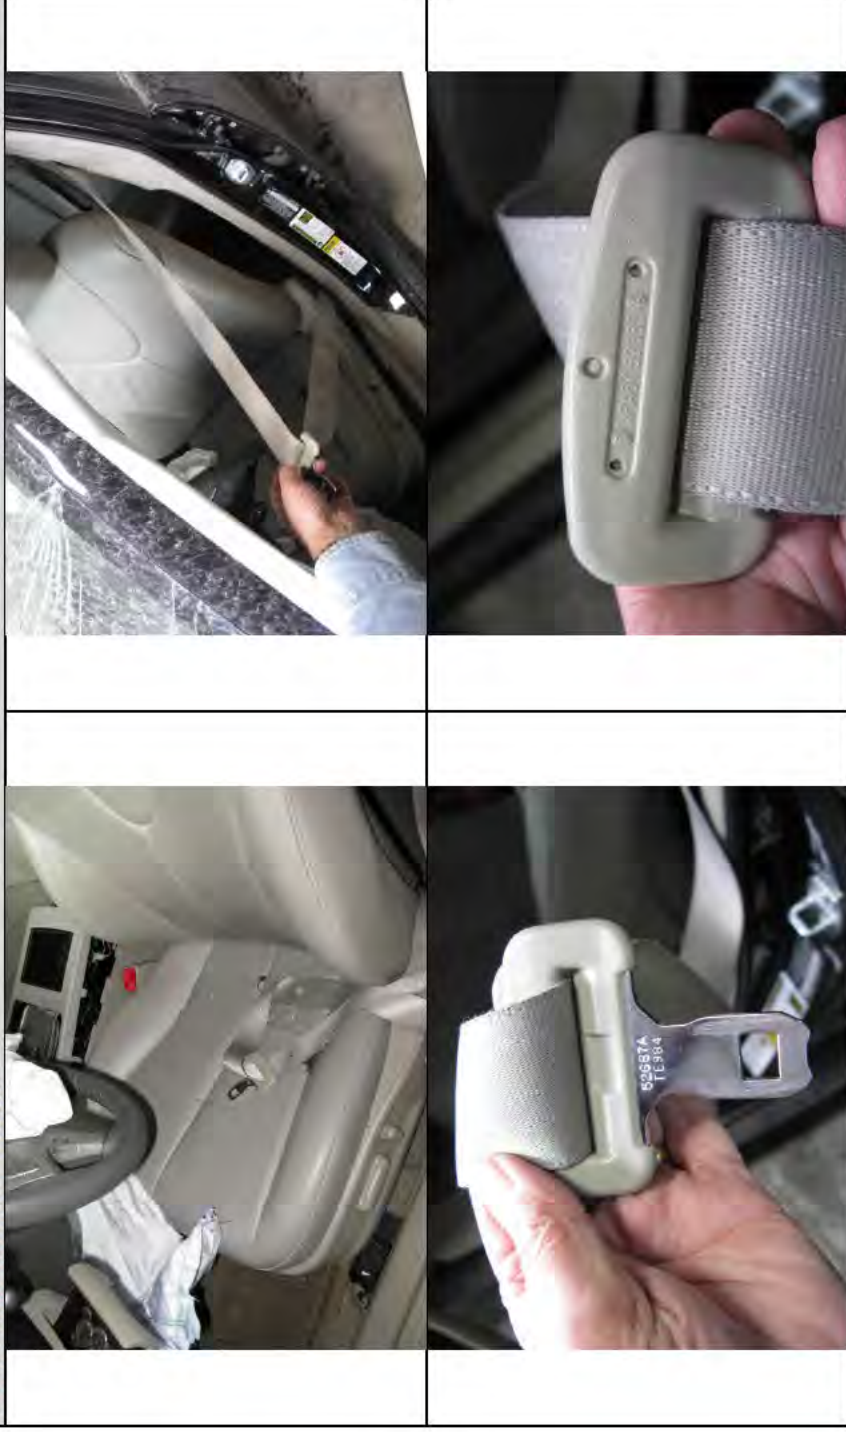
Seat Belt Pictures / Videos

Inspection Area		Interior
Notes & Observations		
Left Front Position	Seat	Seat track is 80mm forward of center position. Seatback is 13° back of vertical. No physical damage observed.
	Seatbelt	Pretensioner is deployed. Latch functions normally.
Right Front Position	Seat	No damage or discrepancies observed.
	Seatbelt	Functions as designed.
Left Rear Position	Seat	No damage or discrepancies observed.
	Seatbelt	Functions as designed.
Center Rear Position	Seat	No damage or discrepancies observed.
N/A: <input type="checkbox"/>	Seatbelt	Functions as designed.
Right Rear Position	Seat	No damage or discrepancies observed.
	Seatbelt	Functions as designed.
Third Row	Seat	
N/A: <input checked="" type="checkbox"/>	Seatbelt

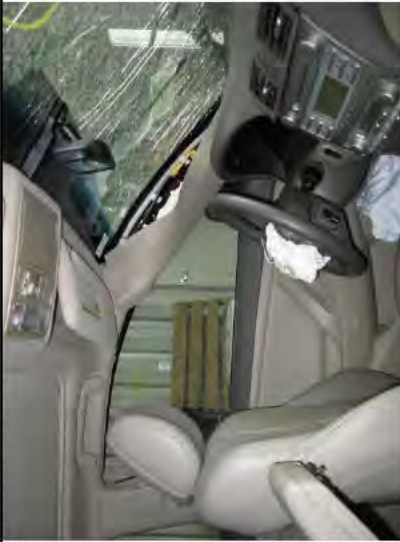
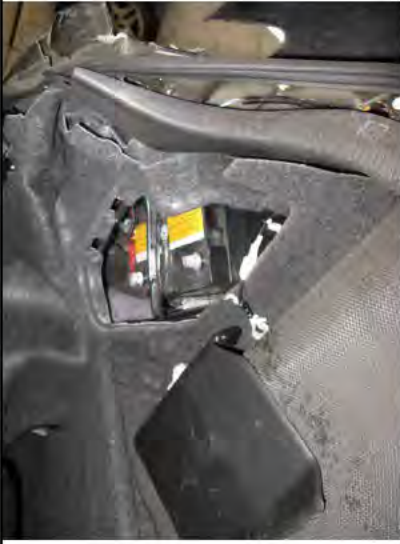
Interior Other Pictures

Inspection Area		Notes & Observations
Warning Light Status		<input checked="" type="checkbox"/> Unable to check, vehicle will not start / Ready ON <input type="checkbox"/> Equipped with Safety Connect, note system status here:
Instrument Cluster		Housing is distorted. Visible part of cluster appears intact but is inoperative due to no power.
Steering Wheel & Column		Lower column is displaced rearward.
Shift Lever & Linkage		Moves when manually released. Otherwise, condition is unknown.
Pedal Assembly	Accelerator	Pedal movement is restricted by contact with carpet, caused by displaced floor pan. When carpet is pulled away, pedal appears to operate normally.
	Brake	Brake pedal is trapped at the top of its normal travel by the displaced floor pan, preventing pedal from moving up or down.
	Clutch N/A: <input checked="" type="checkbox"/>	
Floormat & Floorpan	Left Front	Unretained aftermarket rubber floor mat on top of a properly positioned and retained OEM mat. Floor pan is displaced upward and rearward trapping mats against brake pedal.

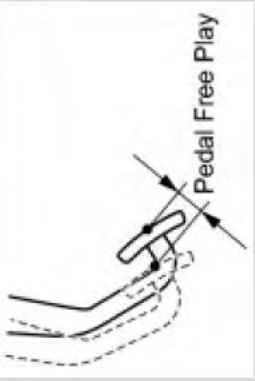
Brake Pedal Free Play Inspection:
Stop the engine. Press the pedal several times until no vacuum is left in the booster. Release the pedal.

Measurement: 0 (due to displaced floor pan)
