From: [REDACTED]
Sent: Wednesday, May 14, 2014 8:39 AM
To: [REDACTED]
Subject: FW: Follow-up & Ford Focus BEV vehicle VIN - Quebec

From: [REDACTED]
Sent: Thursday, May 15, 2014 4:31 PM
To: [REDACTED]
Subject: RE: Warranty Return

From: [REDACTED]
Sent: Monday, May 05, 2014 10:48 PM
To: [REDACTED]
Cc: [REDACTED]
Subject: Re: Power Xpress coupler and vehicle inlet photo's
Attachments: Focus Charge Port2.zip

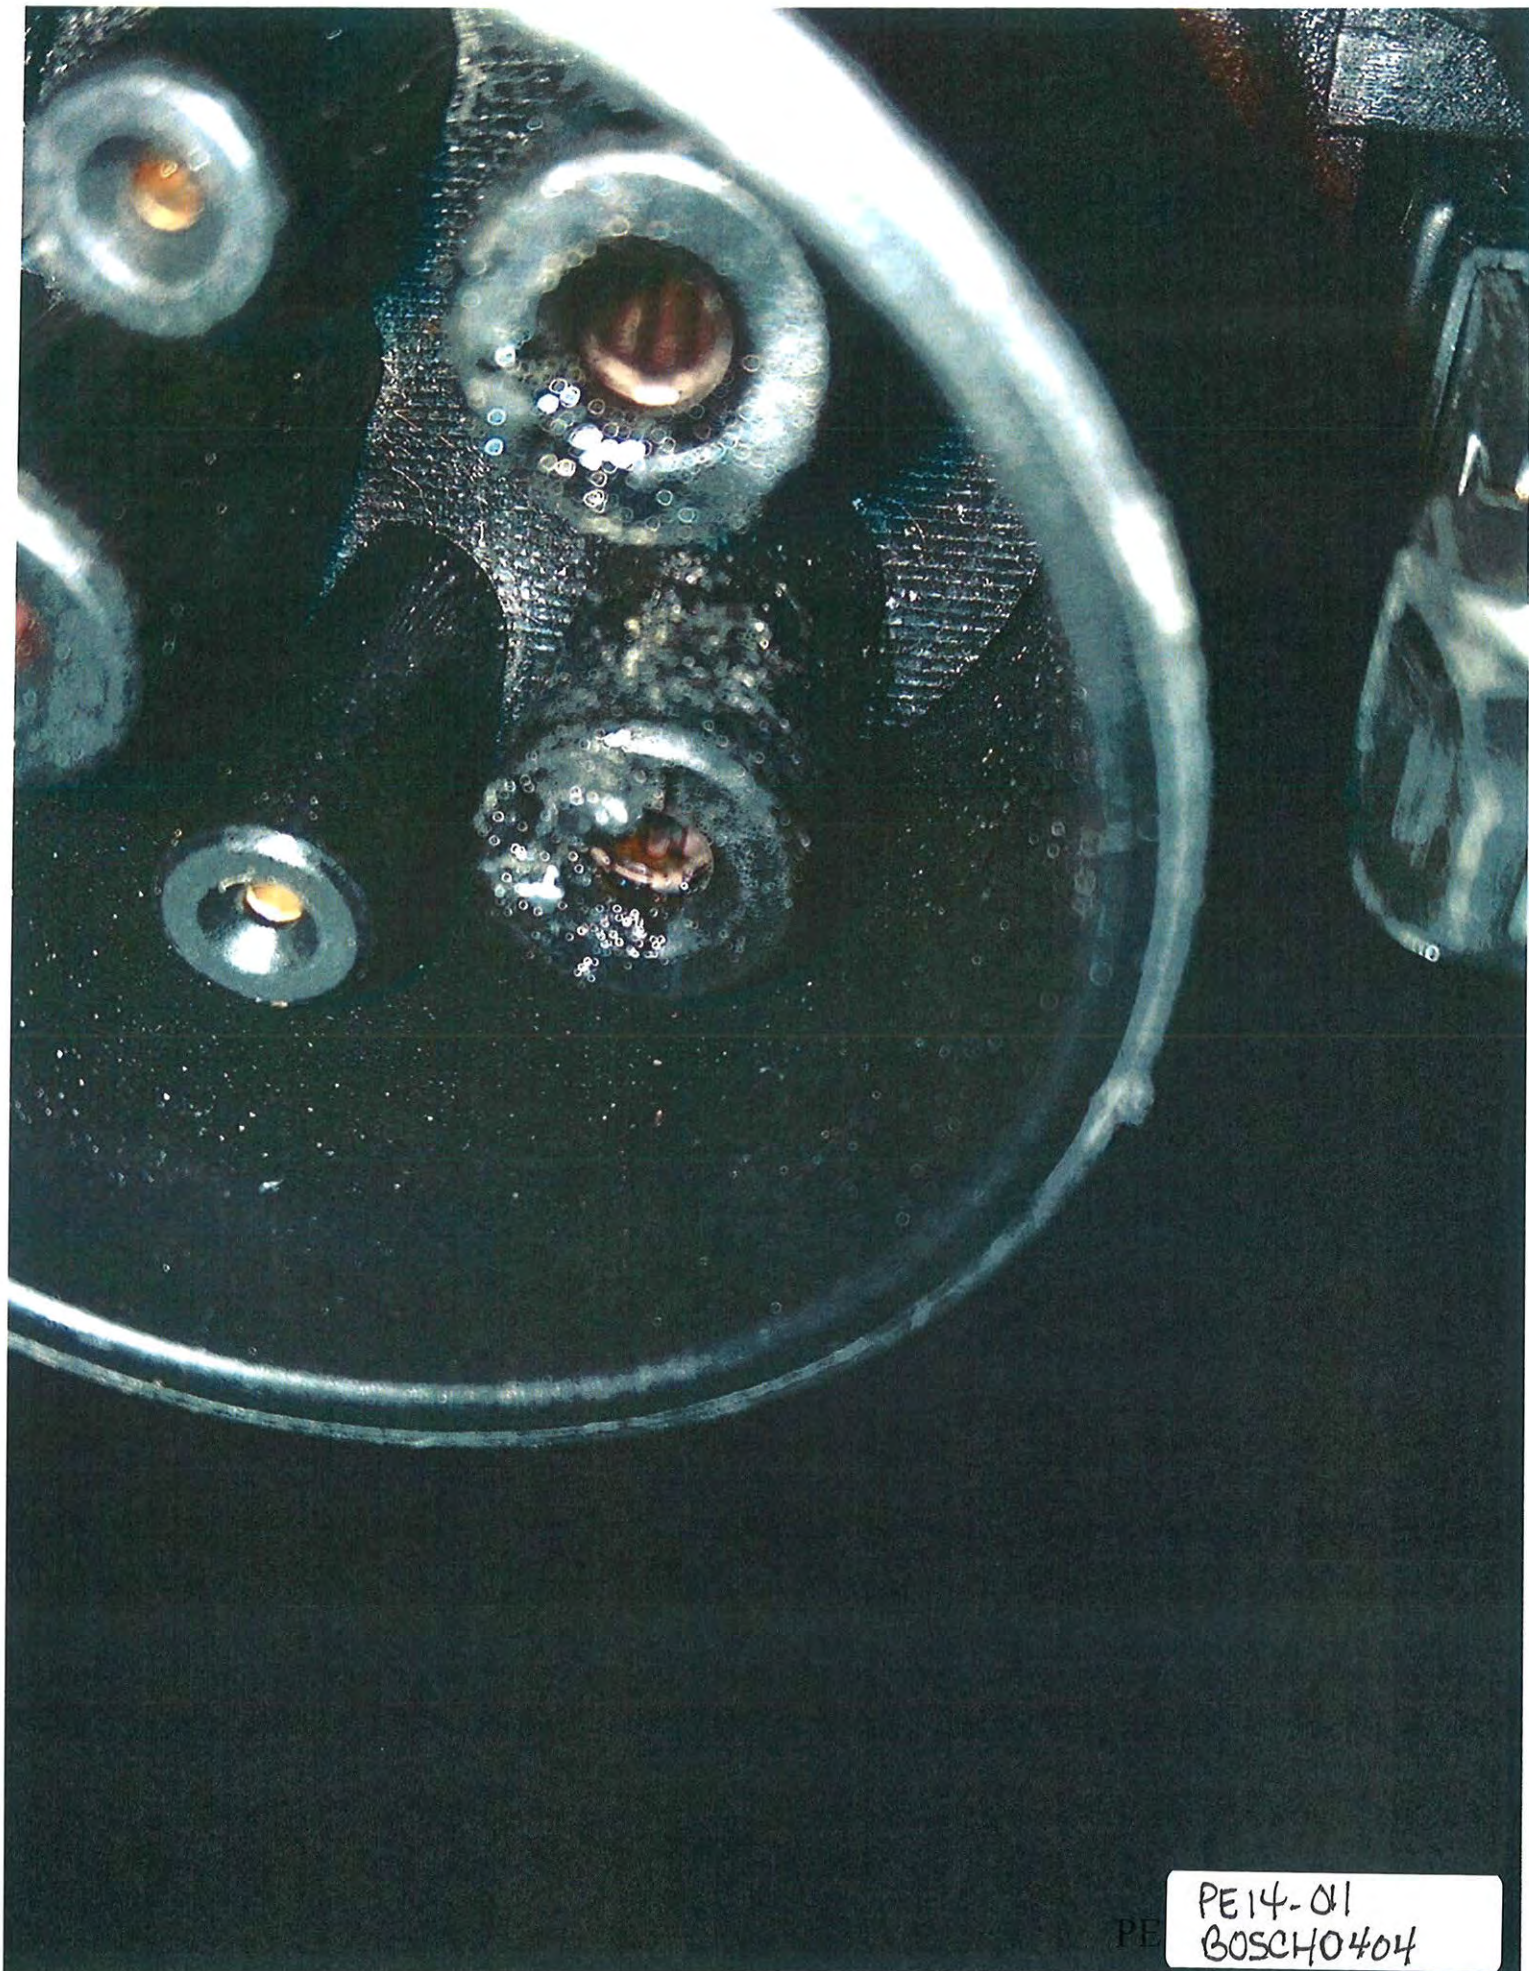
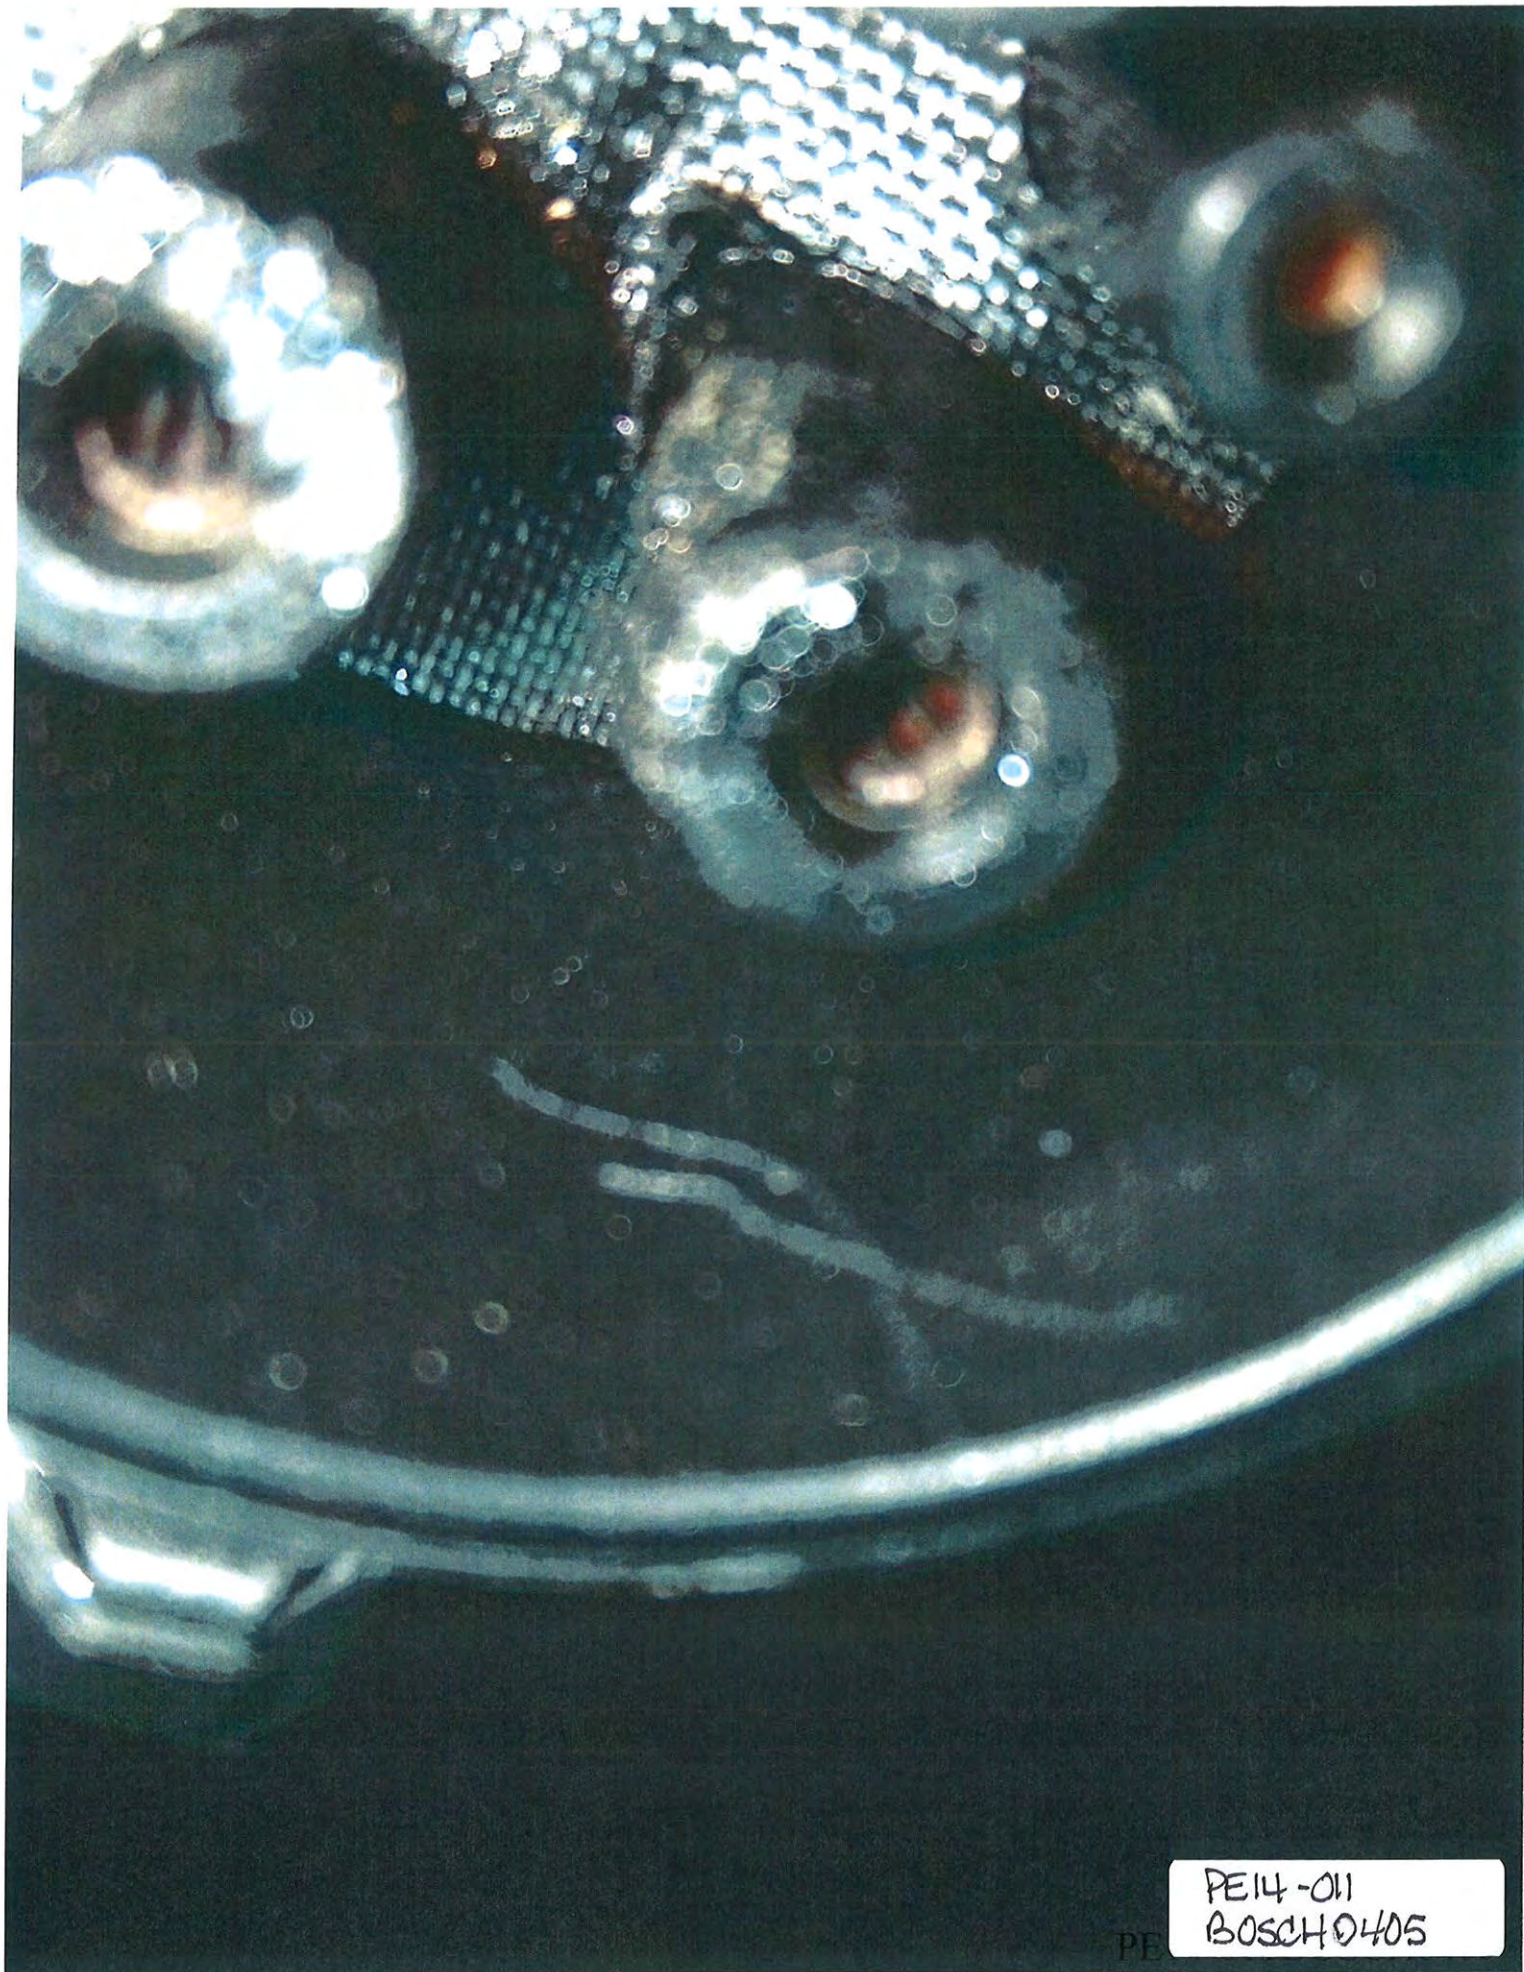
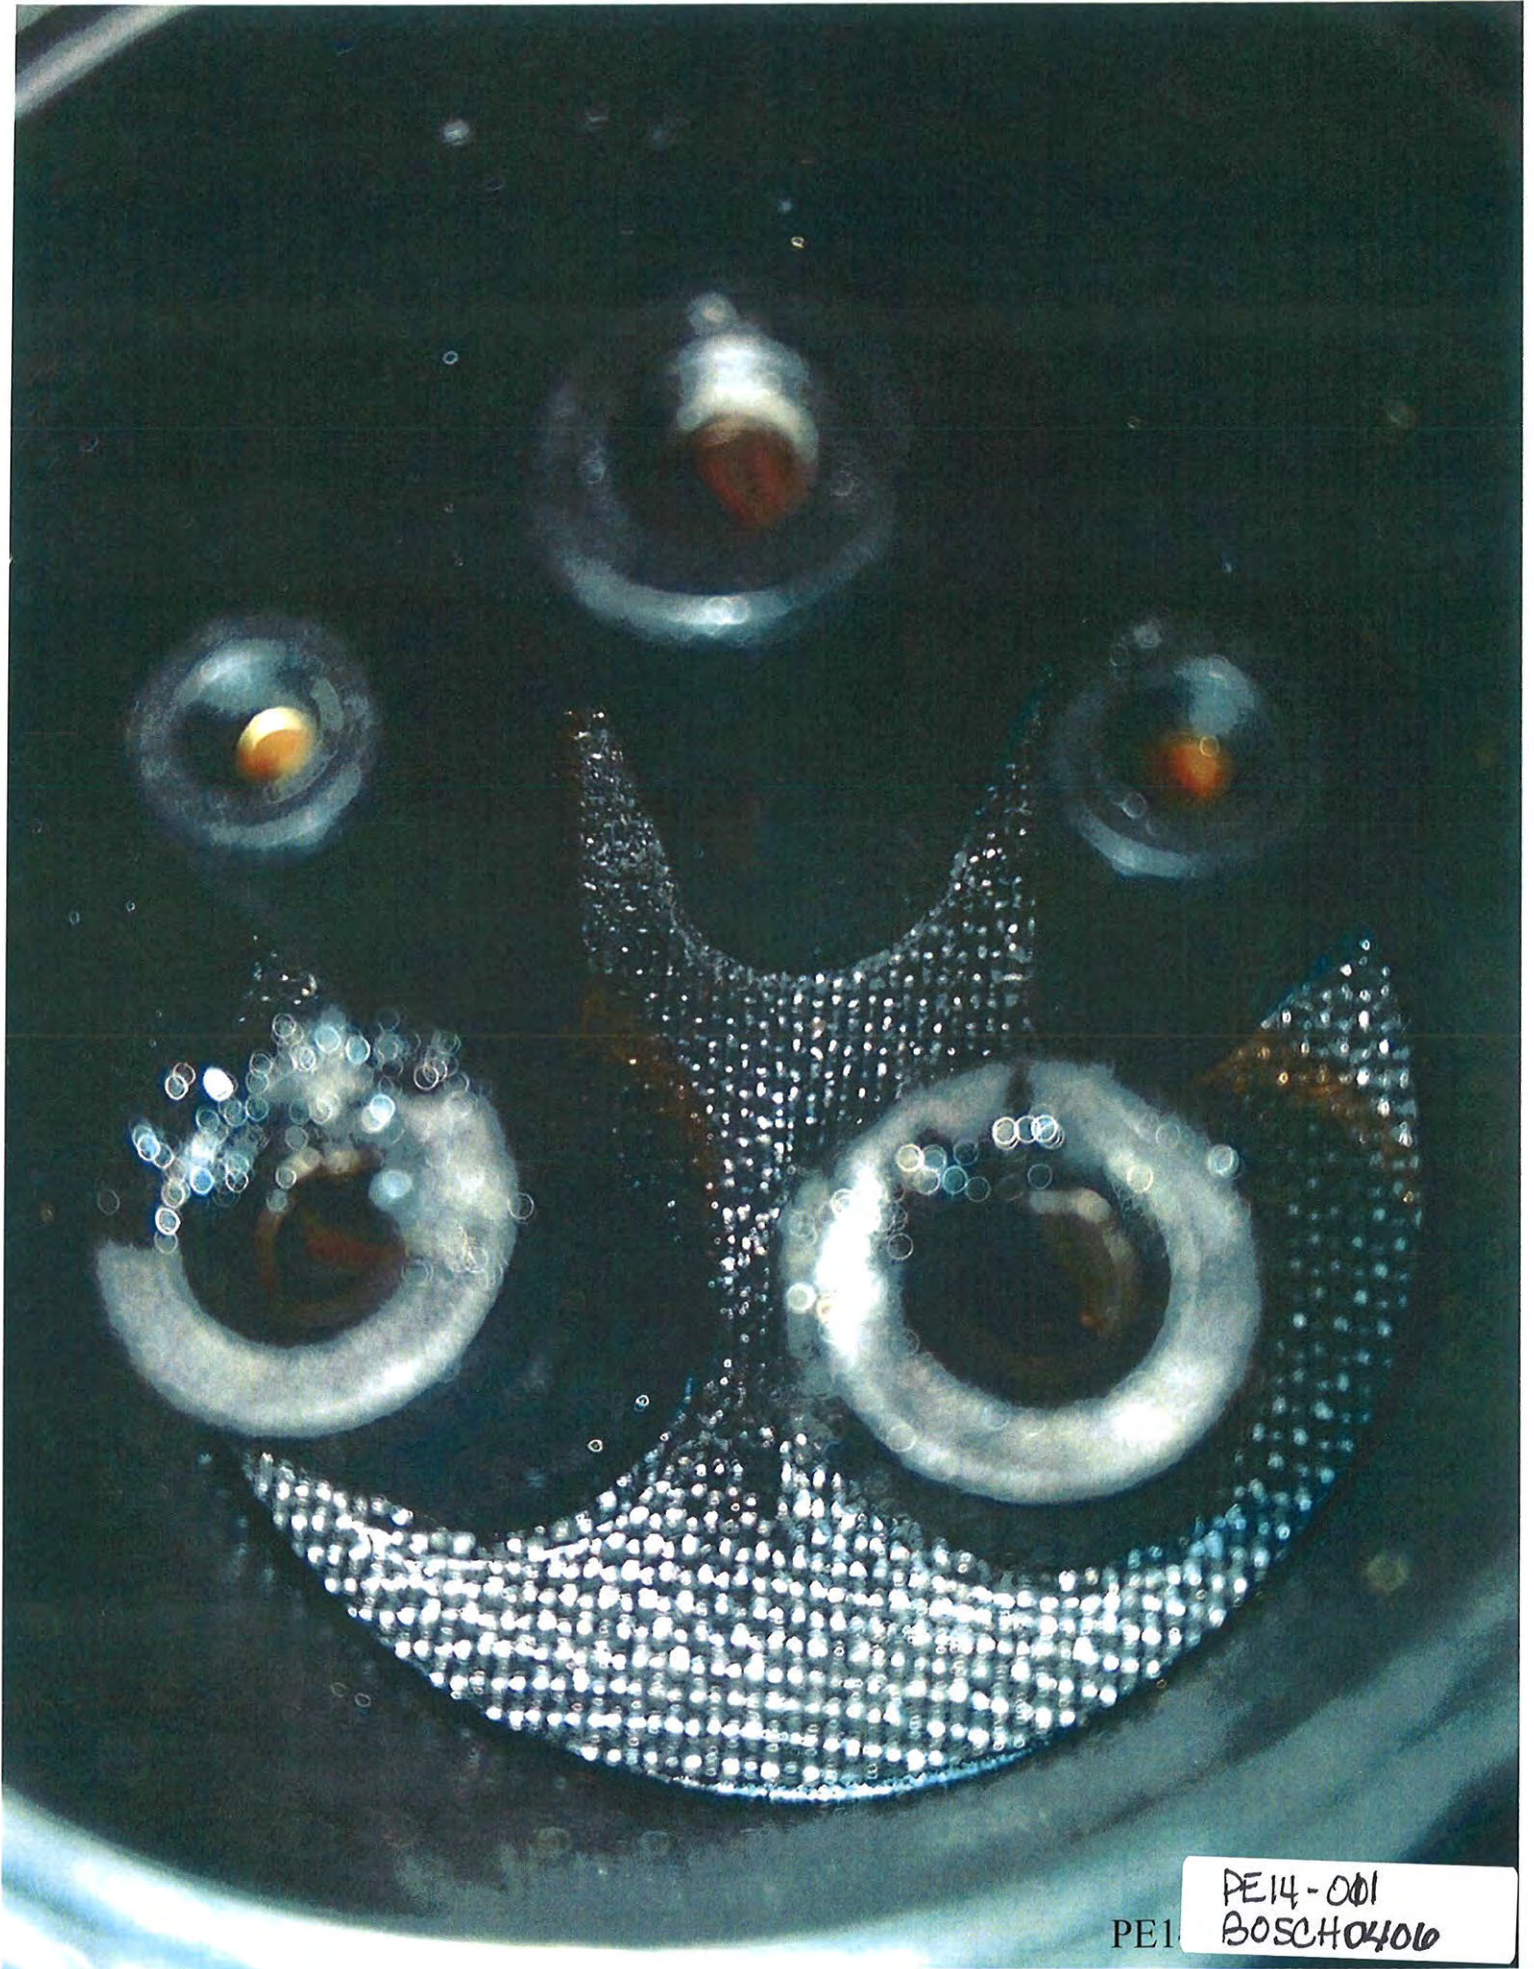
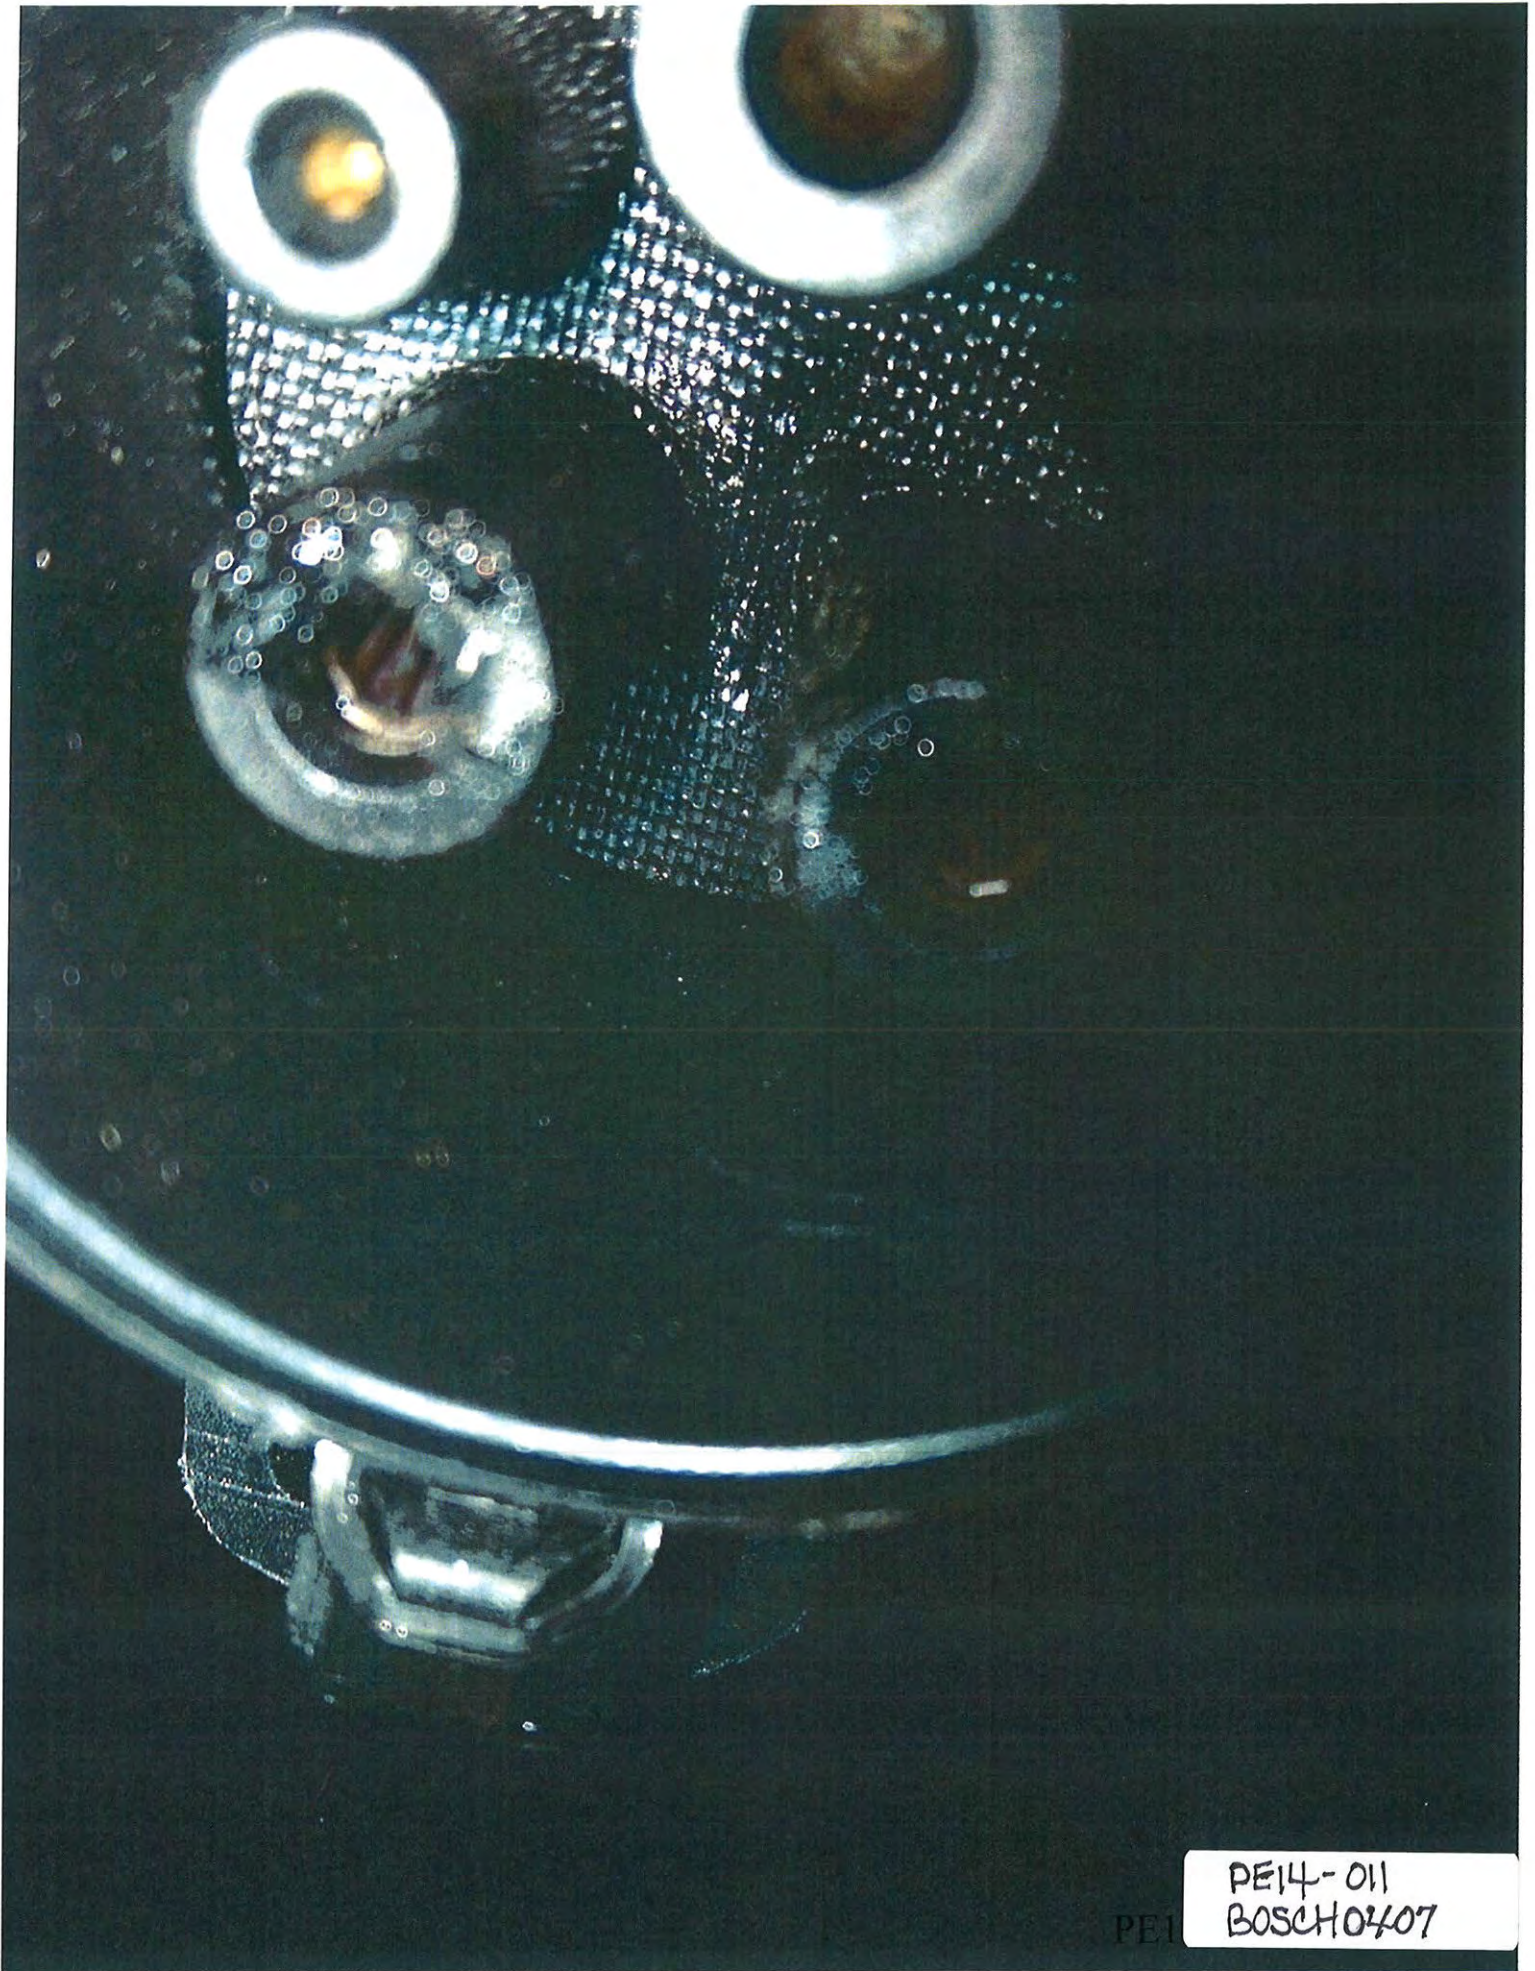
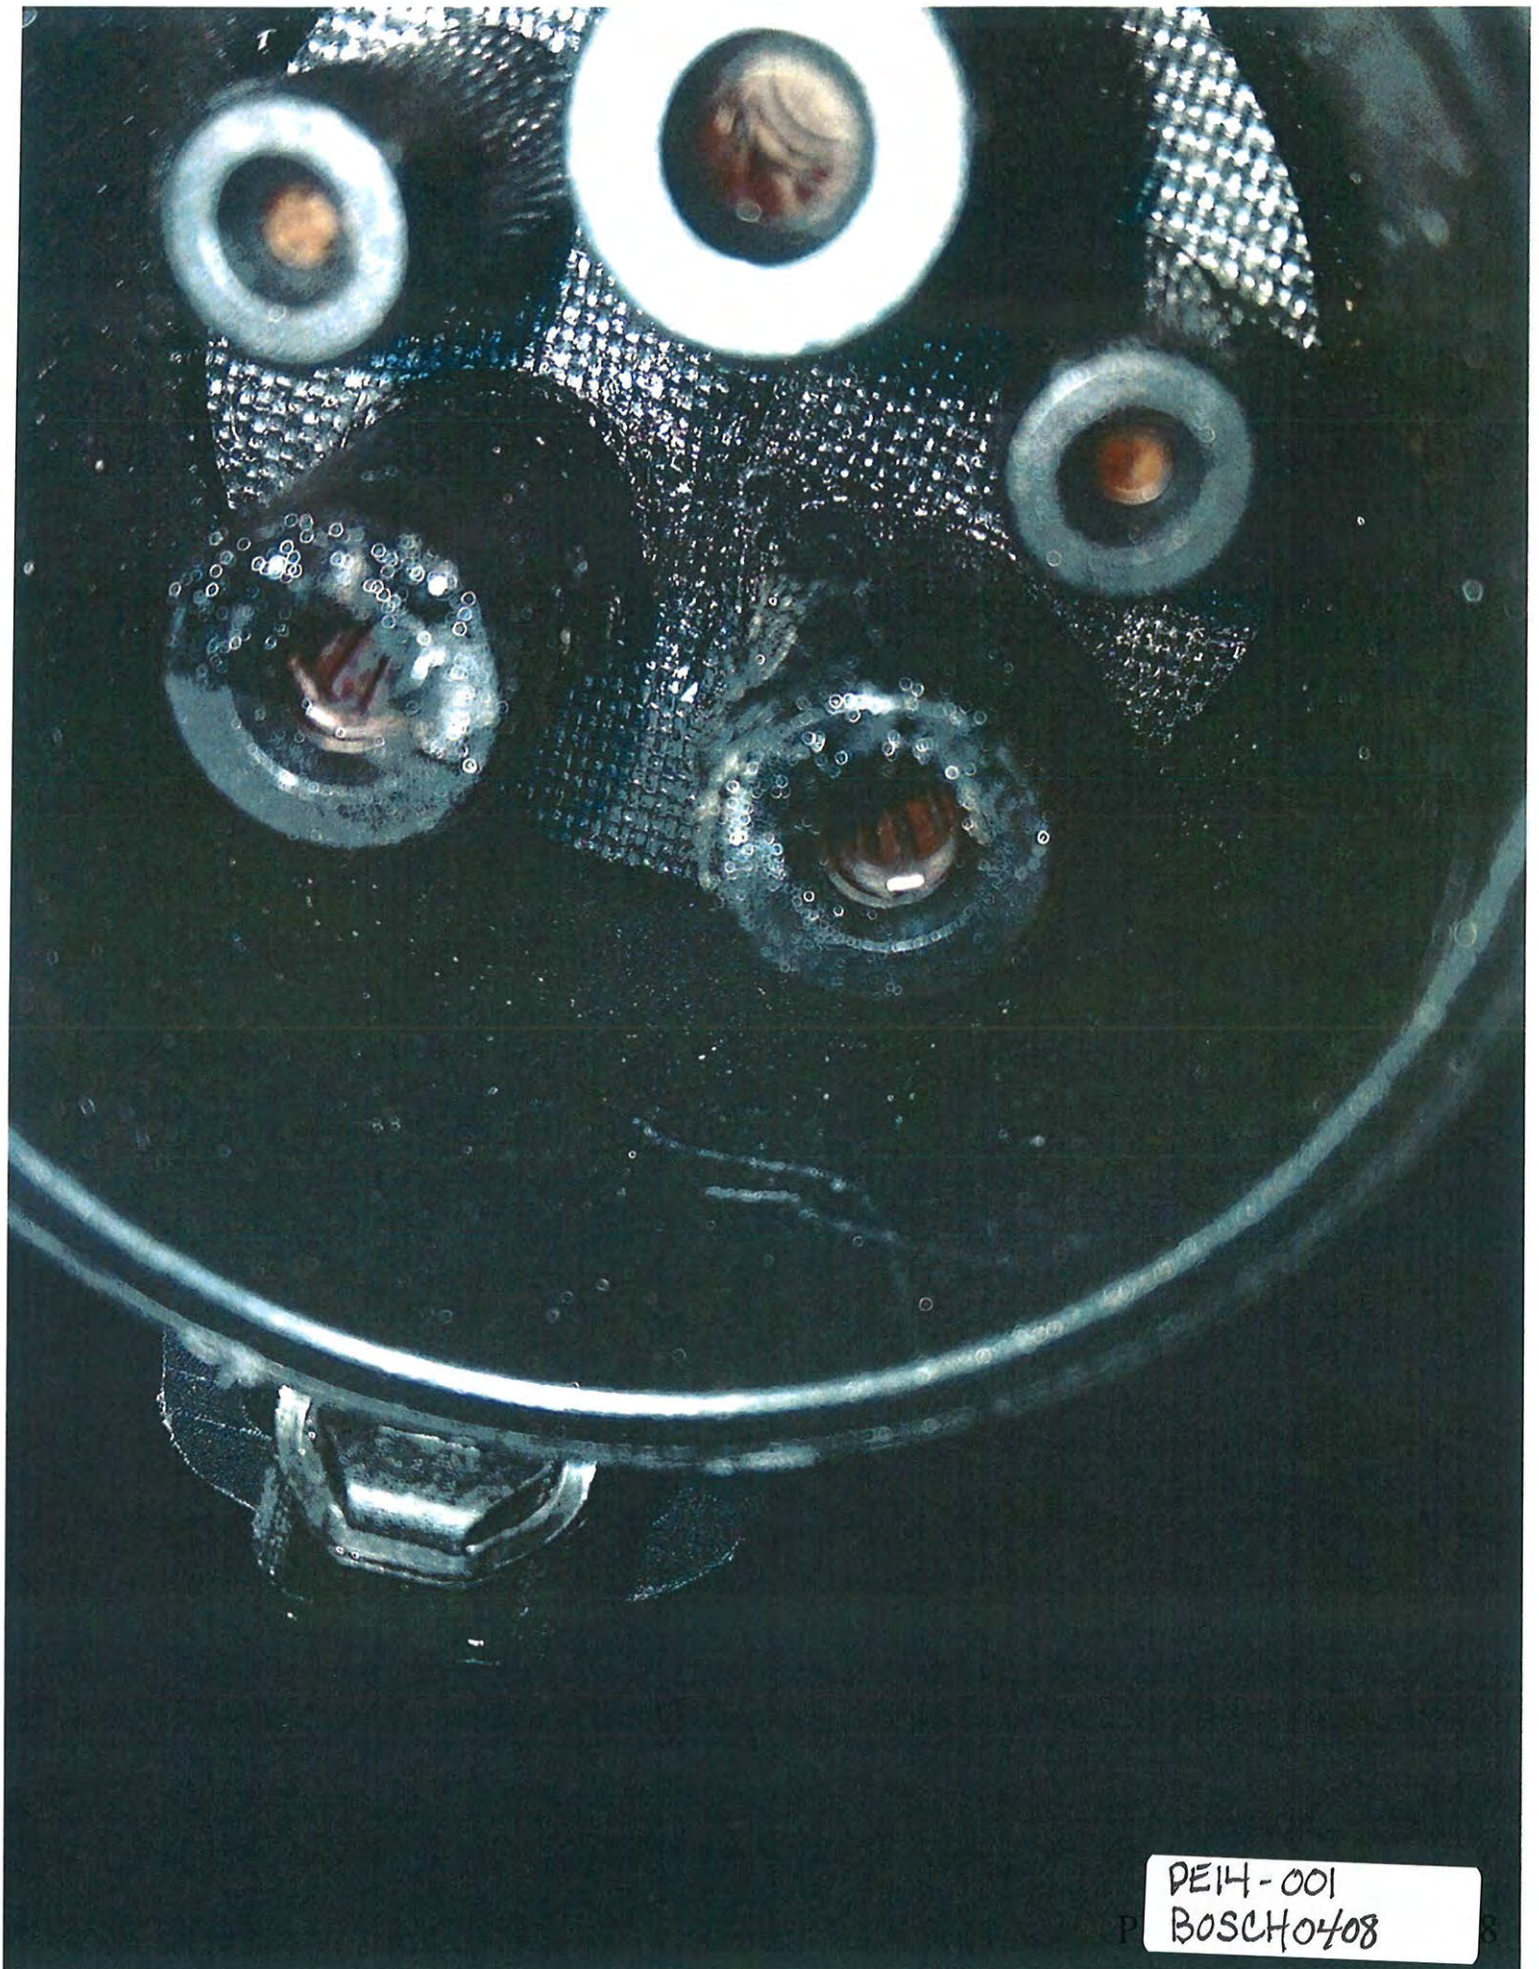
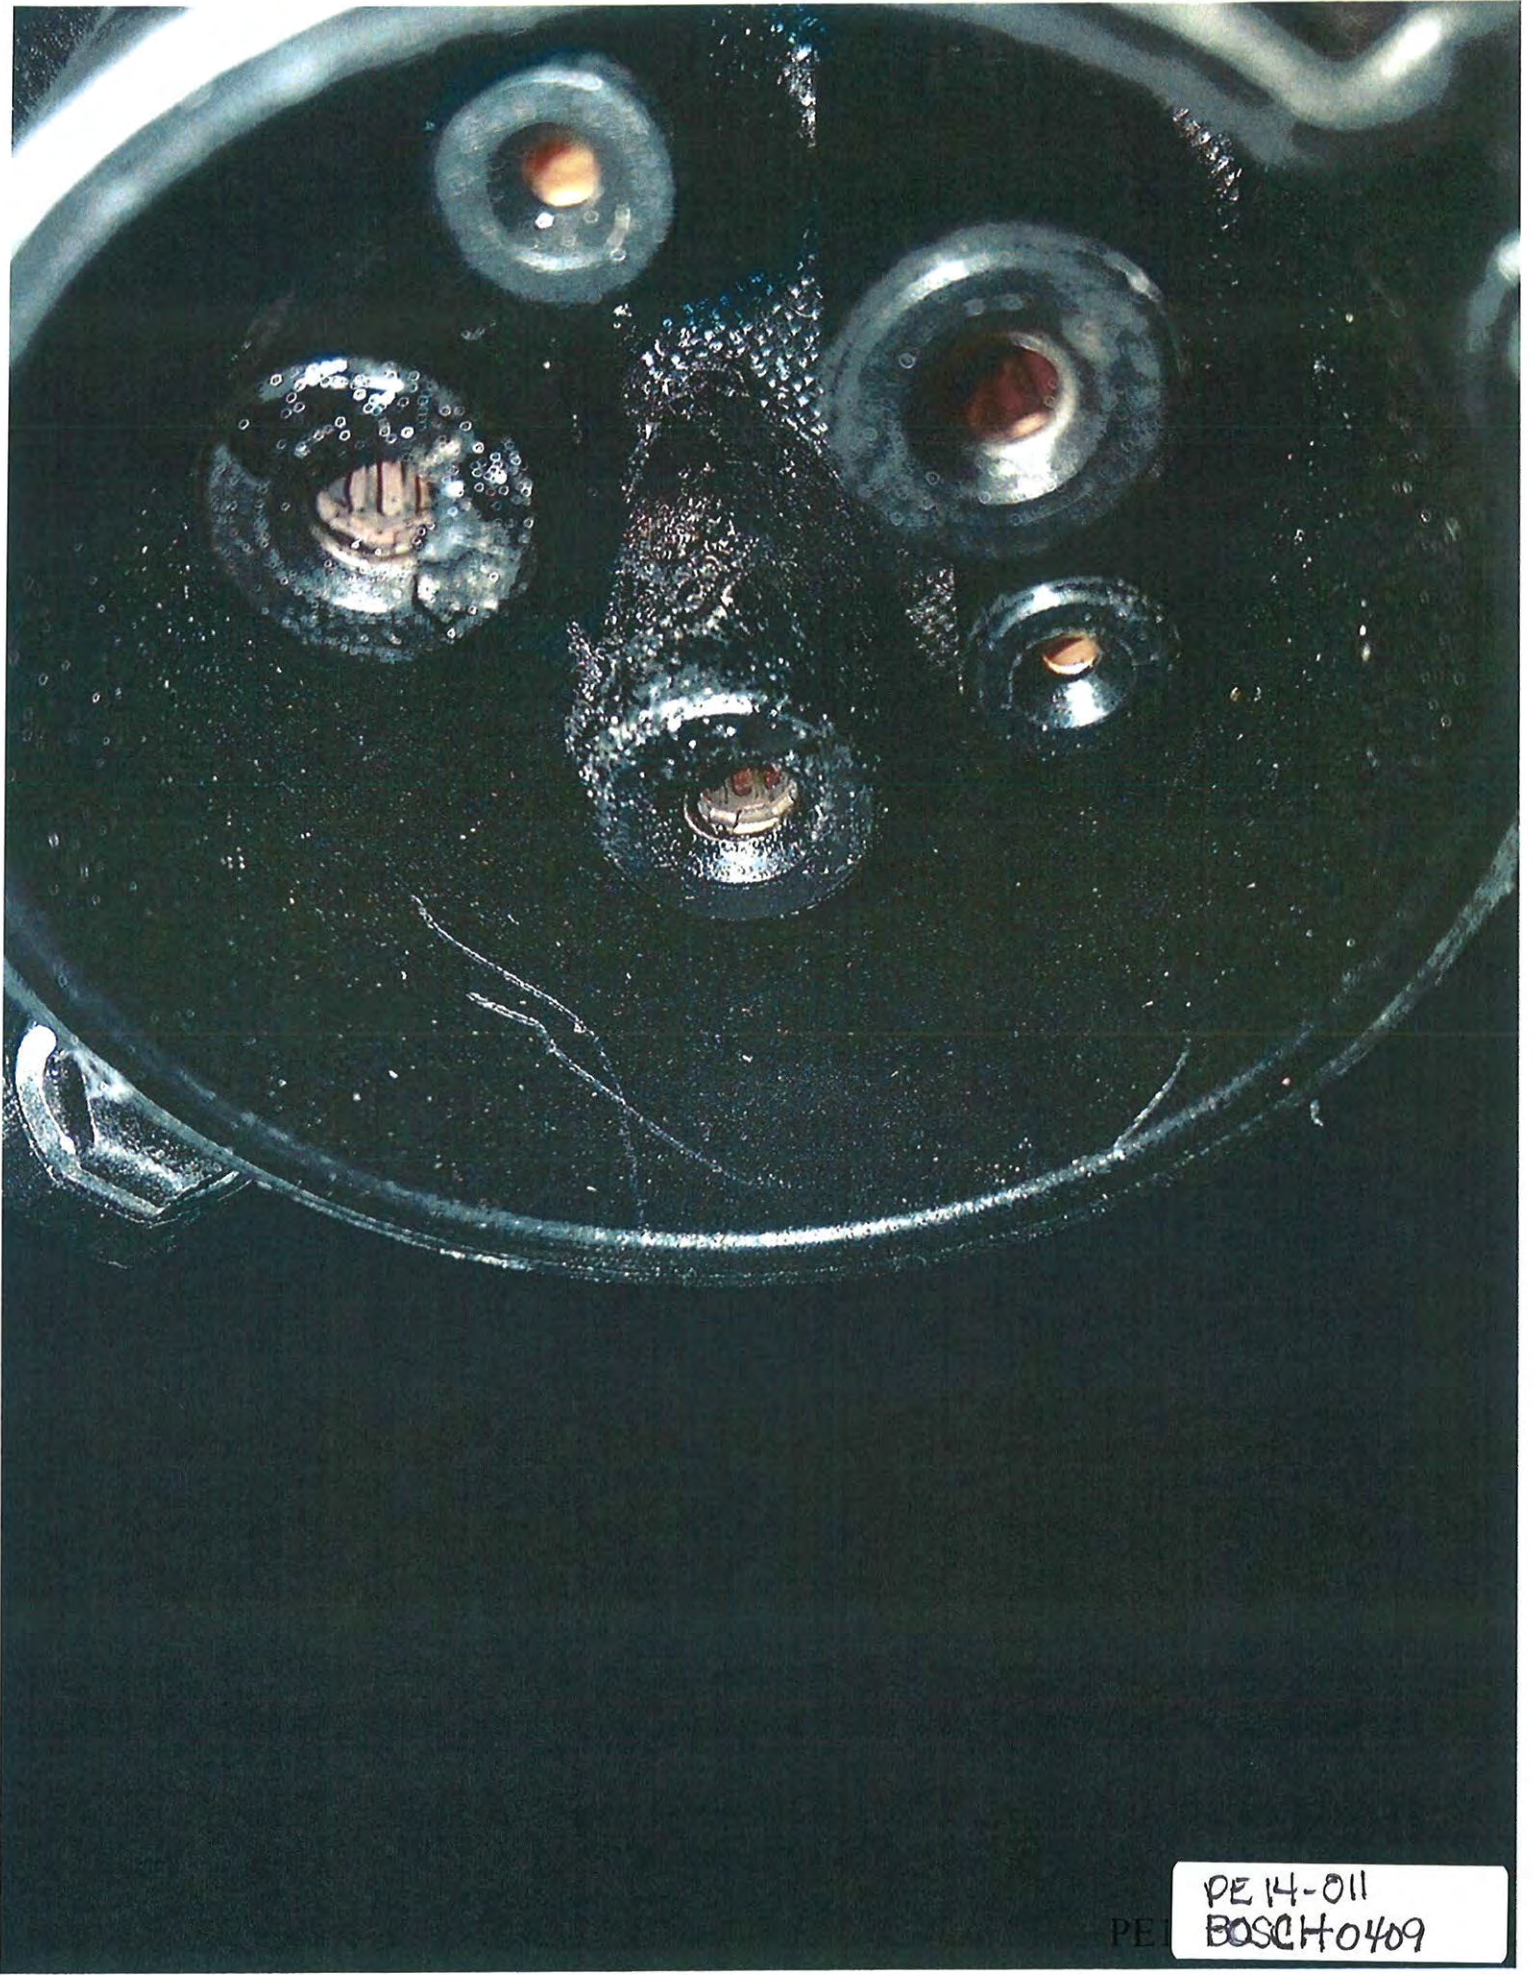
On 3/27/14 I noticed firsthand the issue while getting in the car in the morning. The vehicle was still pre-conditioning when I unplugged it. The charger was melted at the charging station coupler end and the vehicle charge inlet port was also melted. I touched the charging station coupler after unplugging it from main power and the tips of the contacts were basically molten plastic that burnt the tip of my finger. I decided to schedule a warranty repair with Ford.

My concern is of possible fire or injury from an overheated and/or improperly insulated connection between the charging station and the vehicle.

On 3/28/2014 I took the vehicle in for warranty service with Ford Motor Company and they replaced the charge port under warranty. On 4/8/2014 I called Bosch about the charger and they opened a case to replace the charger under warranty. The claim was accepted and processed on 4/11/2014.

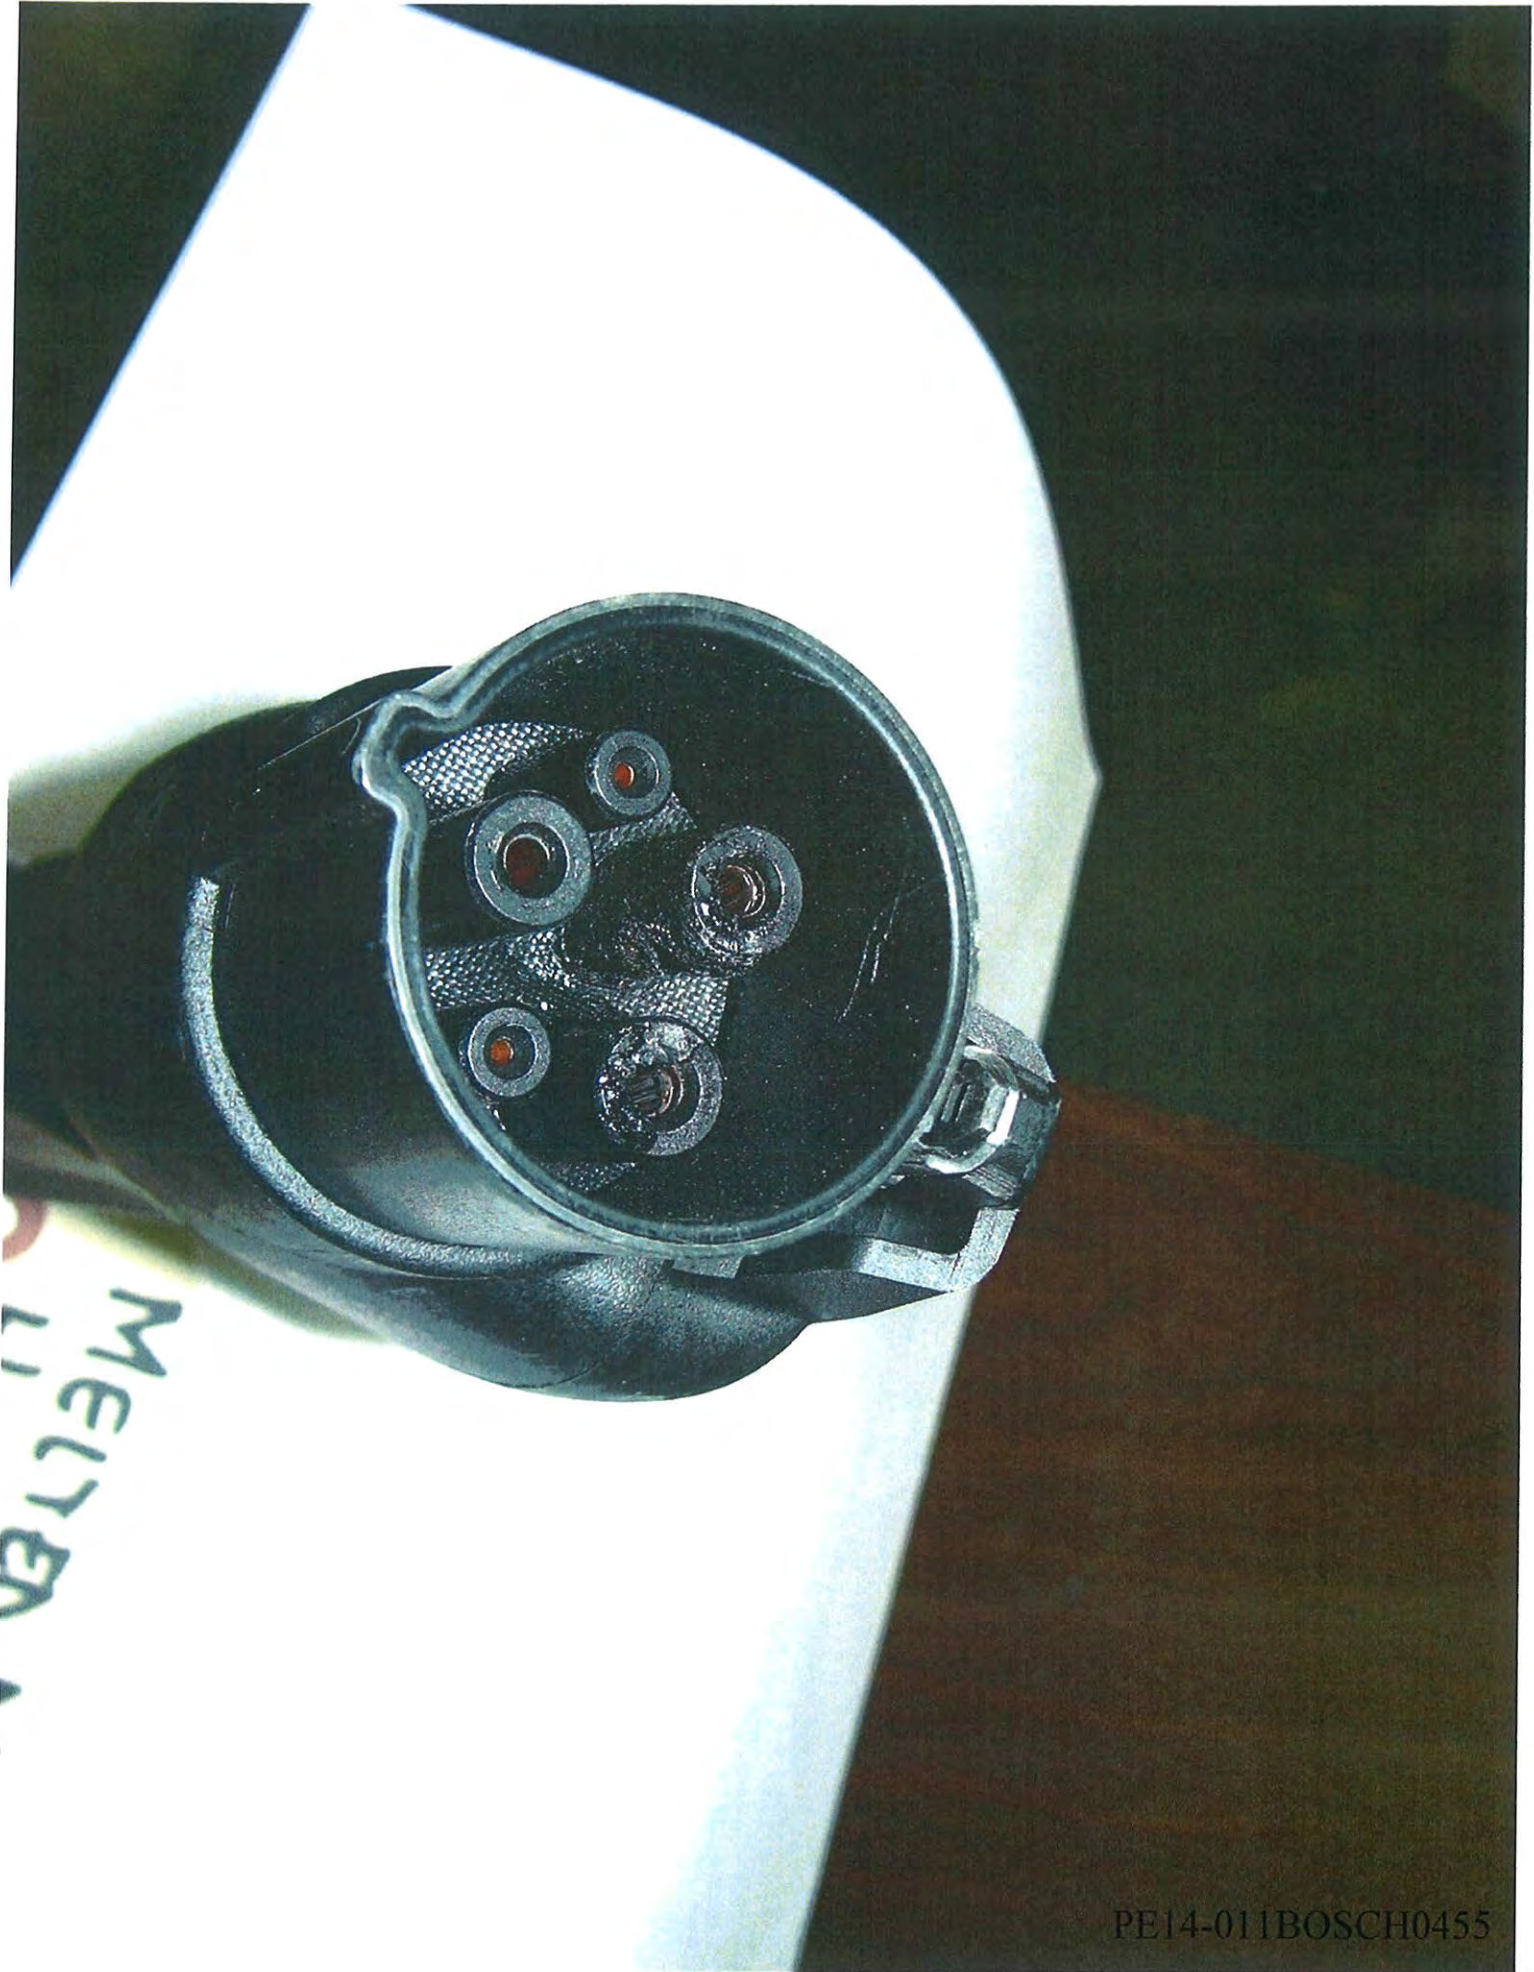
PE14-011BOSCH0455

MELTED NISSAN
Hartland, MI
5/23/14 #3
