From: [REDACTED]
Sent: Wednesday, May 14, 2014 8:39 AM
To: [REDACTED]
Subject: FW: Follow-up & Ford Focus BEV vehicle VIN - Quebec

From: [REDACTED]
Sent: Thursday, May 15, 2014 4:31 PM
To: [REDACTED]
Subject: RE: Warranty Return

From: [REDACTED]
Sent: Monday, May 05, 2014 10:48 PM
To: [REDACTED]
Cc: [REDACTED]
Subject: Re: Power Xpress coupler and vehicle inlet photo's
Attachments: Focus Charge Port2.zip

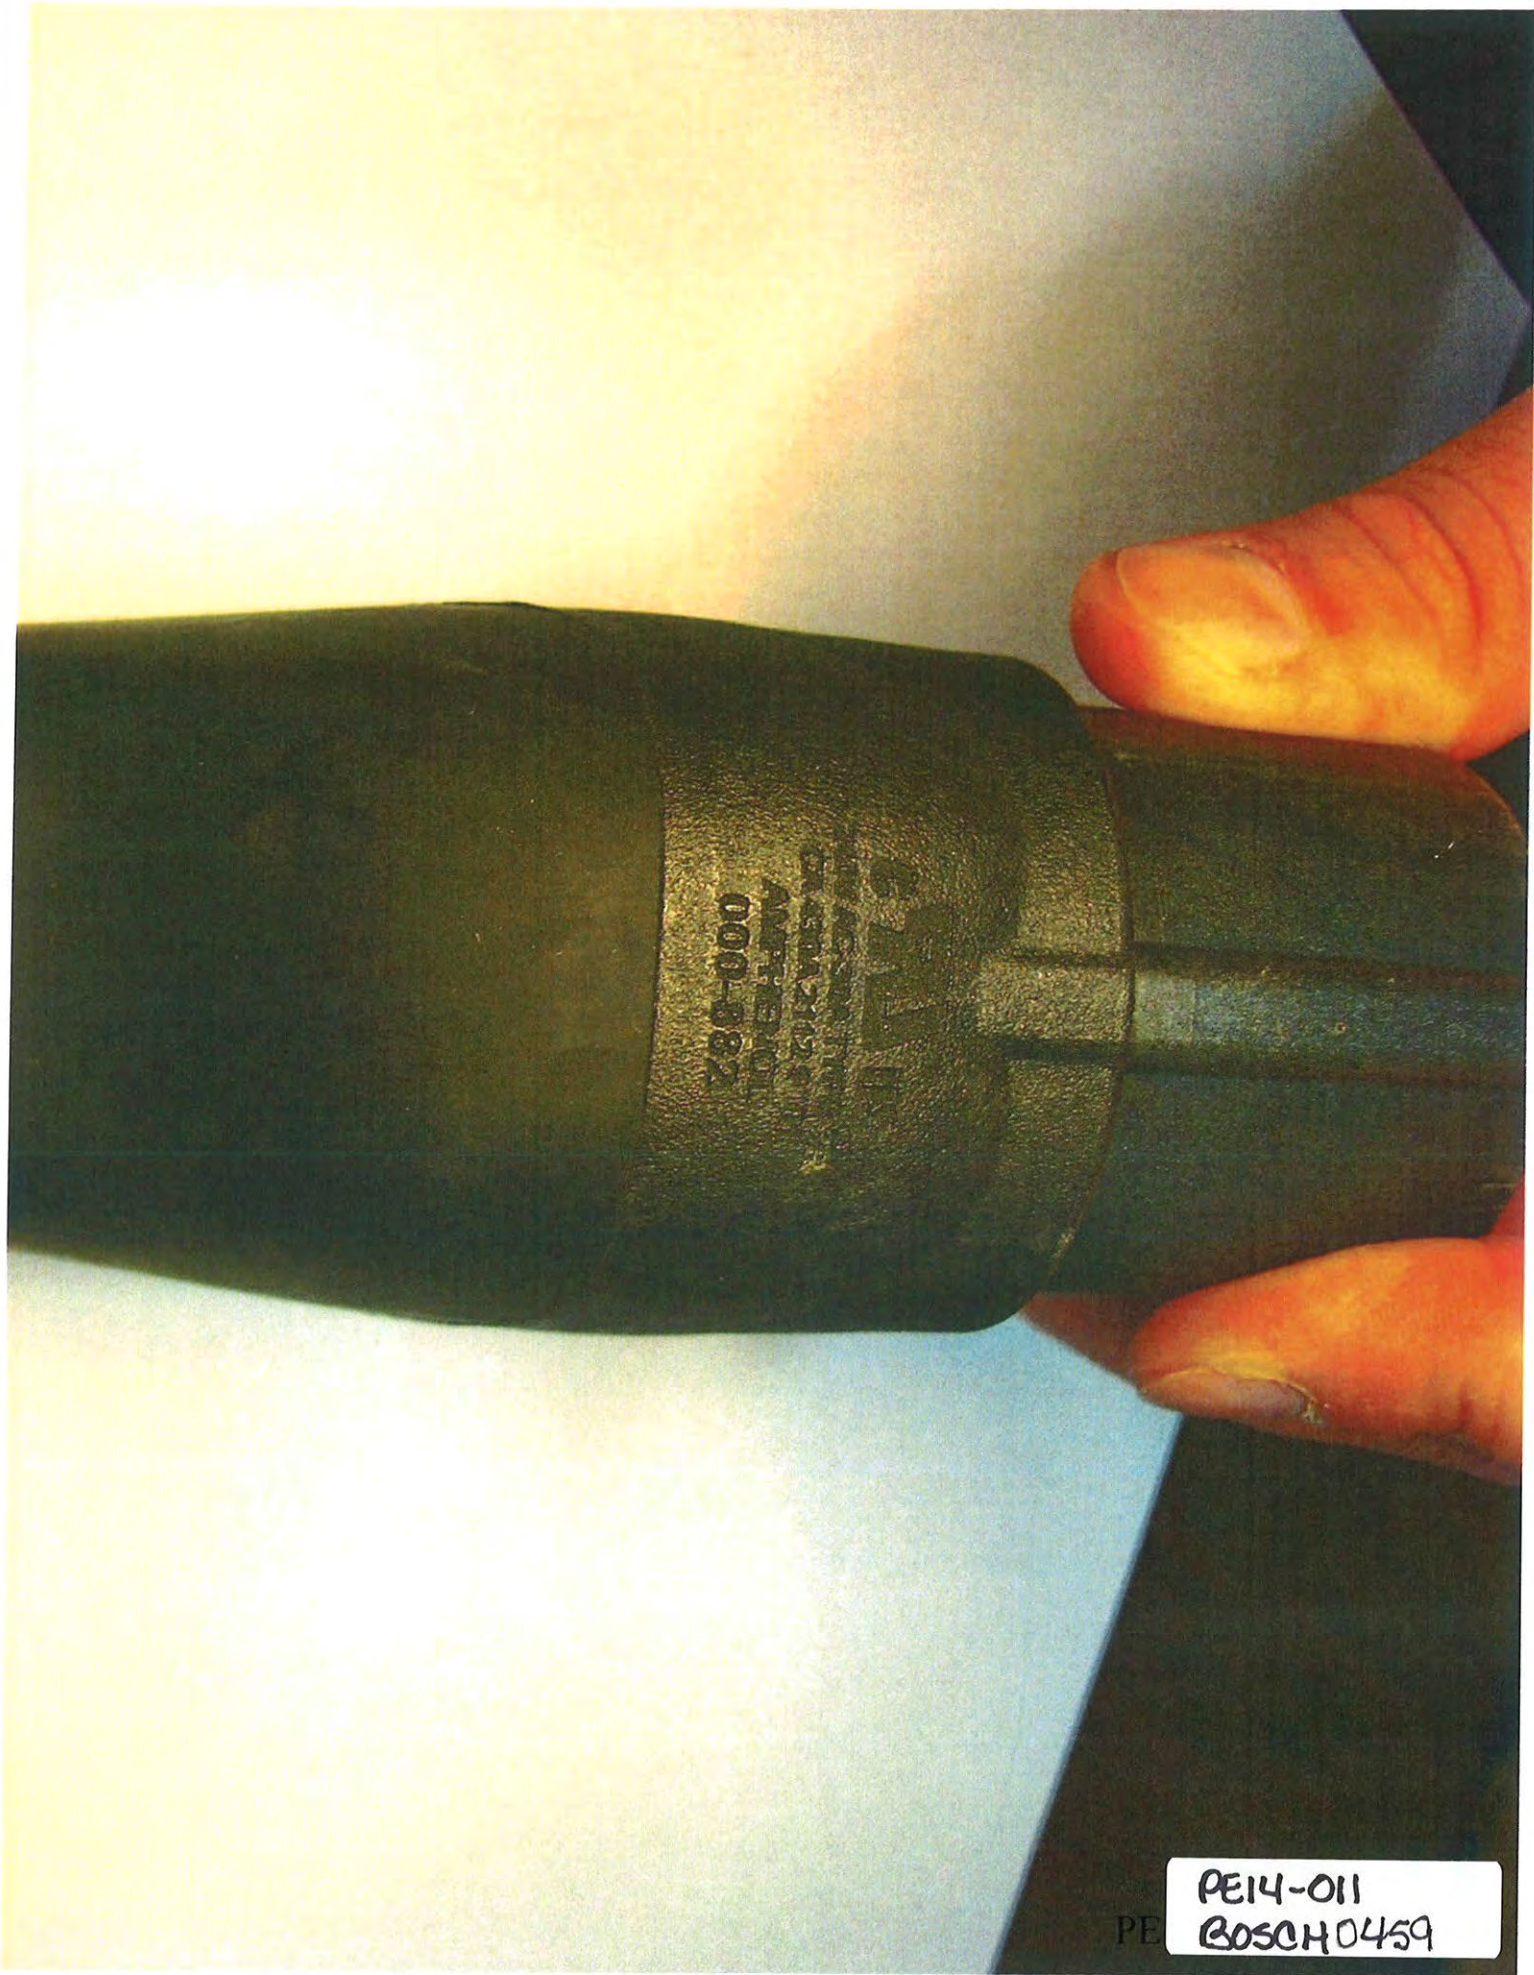
PE14-011
BOSCH 0459

20 Nissan
Portland, MI
123/19 #3
