PE14-020

DATA TO ODI

This on-site investigation focused on the Compressed Natural Gas (CNG) fuel system of a 2014 Freightliner M2 112 (**Figure 1**). One of the five CNG fuel cylinders was punctured by the left fork of an unsecured Yale Type E forklift located in the cargo box of the Freightliner resulting in an explosion of the fuel cylinder. There was no fire. This investigation was initiated by the National Highway Traffic Safety Administration (NHTSA) on April 15, 2014 through the Office of Defects Investigation (ODI), which was responding to an on-line news article. This investigation was assigned on April 17, 2014 when cooperation to inspect the Freightliner was finalized with the vehicle's owner. The incident involved the Freightliner and the Yale Type E forklift located within the cargo box of the vehicle. This incident occurred in April 2014 at 1335 hours, in Wisconsin and was investigated by a local police agency. The Freightliner and incident scene were inspected on April 22, 2014. Interviews with the front right passenger of the Freightliner, the owner of the Freightliner, and the city public safety director were also conducted on April 22, 2014.

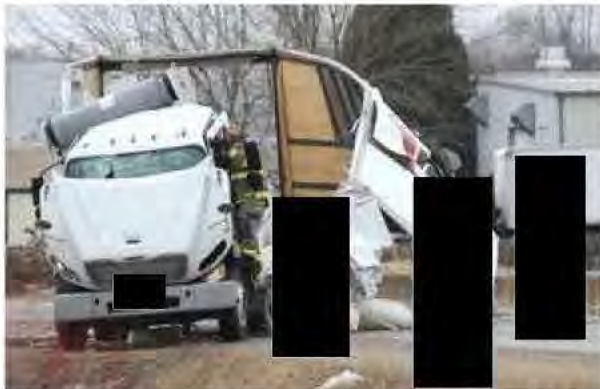
*One person was killed after the truck he was driving exploded Thursday on Pamperin Road in Howard. / H. Marc Larson/Press-Gazette Media*

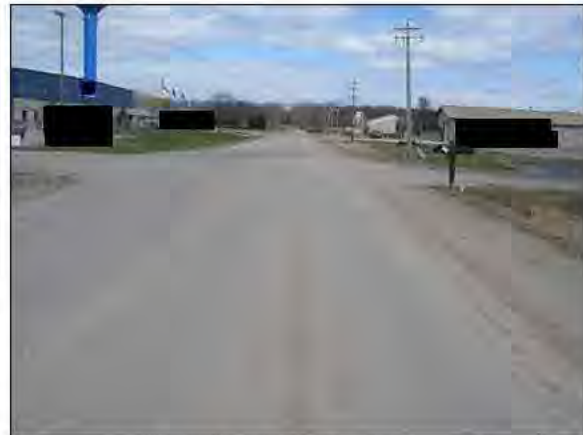
**Figure 2:** Freightliner's eastbound approach to the driveway (on right) and area of explosion

**Incident:** The unsecured forklift traveled forward in the cargo box as the driver braked. The front forks pierced the front panel of the cargo box and the left fork impacted the lowest of five CNG fuel cylinders that were oriented horizontally and stacked vertically within an aluminum cabinet located between the truck cab and cargo box. The impact site on the CNG cylinder was located 65 cm (25.6 in) left of the right cylinder end. This impact resulted in a rupture and explosion of the cylinder. There was no fire. The Freightliner's air lines were severed and the wheels locked, leaving police-reported skid marks that ranged from 4.3 - 7.44 m (14.1 - 24.4 ft) in length as the vehicle skidded to final rest, heading southeast. A speed to skid to a stop calculation based on the longest skid mark length and a deceleration value range<sup>1</sup> of 0.41 - 0.56 g yielded a speed range at the onset of the skid

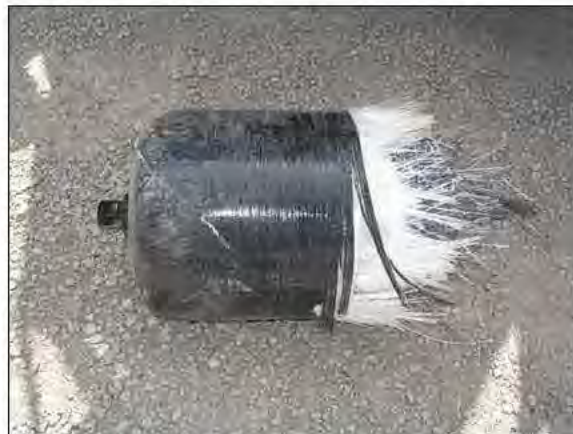
**Figure 10:** Displaced section of ruptured CNG cylinder

4. The composite fracture apparently progressed approximately in a longitudinal direction and then turned and ran circumferentially, separating one of the cylinder ends and ejecting it from the driver's side of the truck.

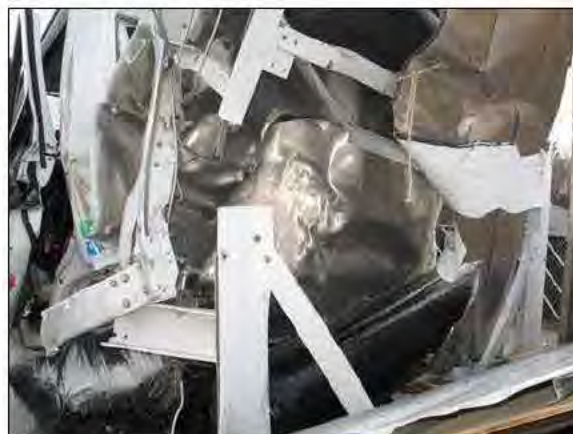
The interior of the Freightliner sustained severe damage from the CNG cylinder explosion. There were a total of twelve intrusions to the passenger compartment. The most severe intrusions occurred in the driver's space and were to the back wall of the cab and the backlight header (**Figures 12 and 13**), which intruded longitudinally approximately 80 cm (31 in), and 30 cm (12 in), respectively, and the floor, which intruded vertically approximately 40 cm (16 in). The driver was projected forward by the explosion and he loaded the steering assembly (**Figure 13**), displacing it forward approximately 25 cm (10 in). Scuff marks were noted on the roof above the driver's seat, possibly from contact by the driver's head. The rearview mirror was also displaced from possible contact by the driver's right hand. Fragments of fiber glass from the ruptured CNG tank were also deposited throughout the cab. Some of the fragments cut the ceiling upholstery in the front right passenger's space, and fragments were embedded in the roof and damaged a plastic storage compartment in this area. Both doors were jammed shut and the left door was mechanically pried open by rescue personnel. The windshield was in place and holed due to explosion forces. The right and left glazings as well as the backlight all disintegrated due to the explosion. The only undamaged glazings were the small windows on each door.

**Figure 12:** Exterior view of intrusion of back wall of Freightliner's cab
