PE14-028

FORD

APPENDIX G

Engineering Review

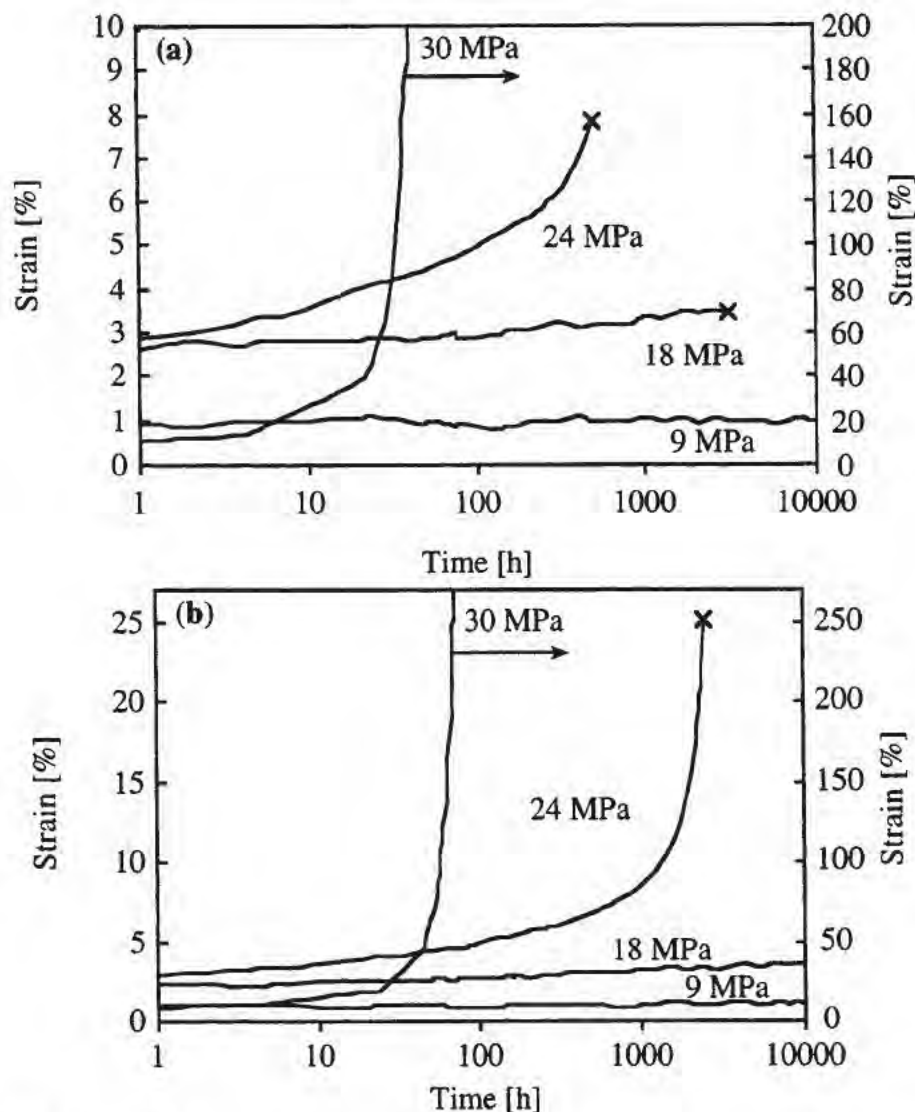
Fig. 2. Tensile creep for (a)  $M_n = 41$  kg/mol and (b)  $M_n = 66$  kg/mol at  $60^\circ\text{C}$  at various stresses (the arrows indicate those curves that should be referred to the right-hand strain axis).

Figure 2 shows the nominal strain in specimens with  $M_n = 41 \text{ kg/mol}$  and  $66 \text{ kg/mol}$  as a function of time in creep tests at  $60^\circ\text{C}$  at different constant nominal stresses, illustrating the behavior described in the introduction. At 30 MPa, all the specimens showed fully ductile behavior and stable plastic necking up to at least 250% strain (that is, the upper limit of the extensometer). At 24 MPa, however, specimens with  $M_n = 41 \text{ kg/mol}$  failed at a strain of 8% after about 500 h. This compares with a failure time of 2500 h and a failure strain of 25% for  $M_n = 66 \text{ kg/mol}$  at the same stress. The failure strain for  $M_n = 41 \text{ kg/mol}$  dropped further to 3% when the stress was decreased to 18

MPa, although the time to failure (3000 h) was considerably longer than at 24 MPa. Indeed, specimens with  $M_n = 41$  kg/mol tested at 9 MPa, and specimens with  $M_n = 66$  kg/mol tested at 18 MPa and 9 MPa remained load bearing up to the maximum test time of 10,000 h. Similar behavior has also been observed in specimens tested at higher temperatures, with failure occurring at about 5% strain for  $M_n = 41$  kg/mol loaded at 15 MPa at  $80^\circ\text{C}$ , whereas fully ductile behavior was seen in specimens loaded at 25 MPa (7).

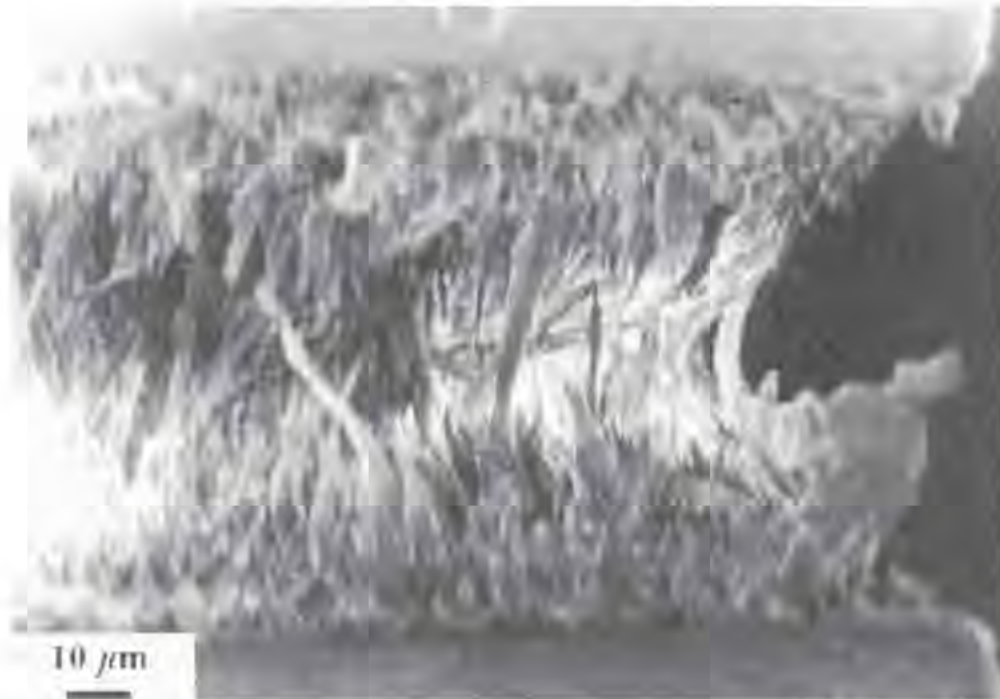
Fig. 3. SEM image of part of a fibrillar deformation zone observed at the surface of a specimen with  $M_n = 41$  kg/mol deformed at  $80^\circ\text{C}$  at a constant stress of 20 MPa (the tensile axis is vertical in the image).

This transition to "brittle" behavior was associated with the formation of highly localized planar fibrillar deformation zones. They appeared in the form of parallel crack-like features on the specimen surfaces when these were inspected optically after the tests. The SEM micrograph in Fig. 3 shows the interior of one such deformation zone that had undergone partial

breakdown, showing the fibrils to be between 0.1 and 1  $\mu\text{m}$  in diameter. This compares with typical values of about 10 nm for crazes in glassy polymers (8). Nevertheless, crazes with fibril diameters comparable to those in Fig. 3 have often been associated with deformation in other semicrystalline polymers above their  $T_g$  (9), and with SCG in PE in particular (2).

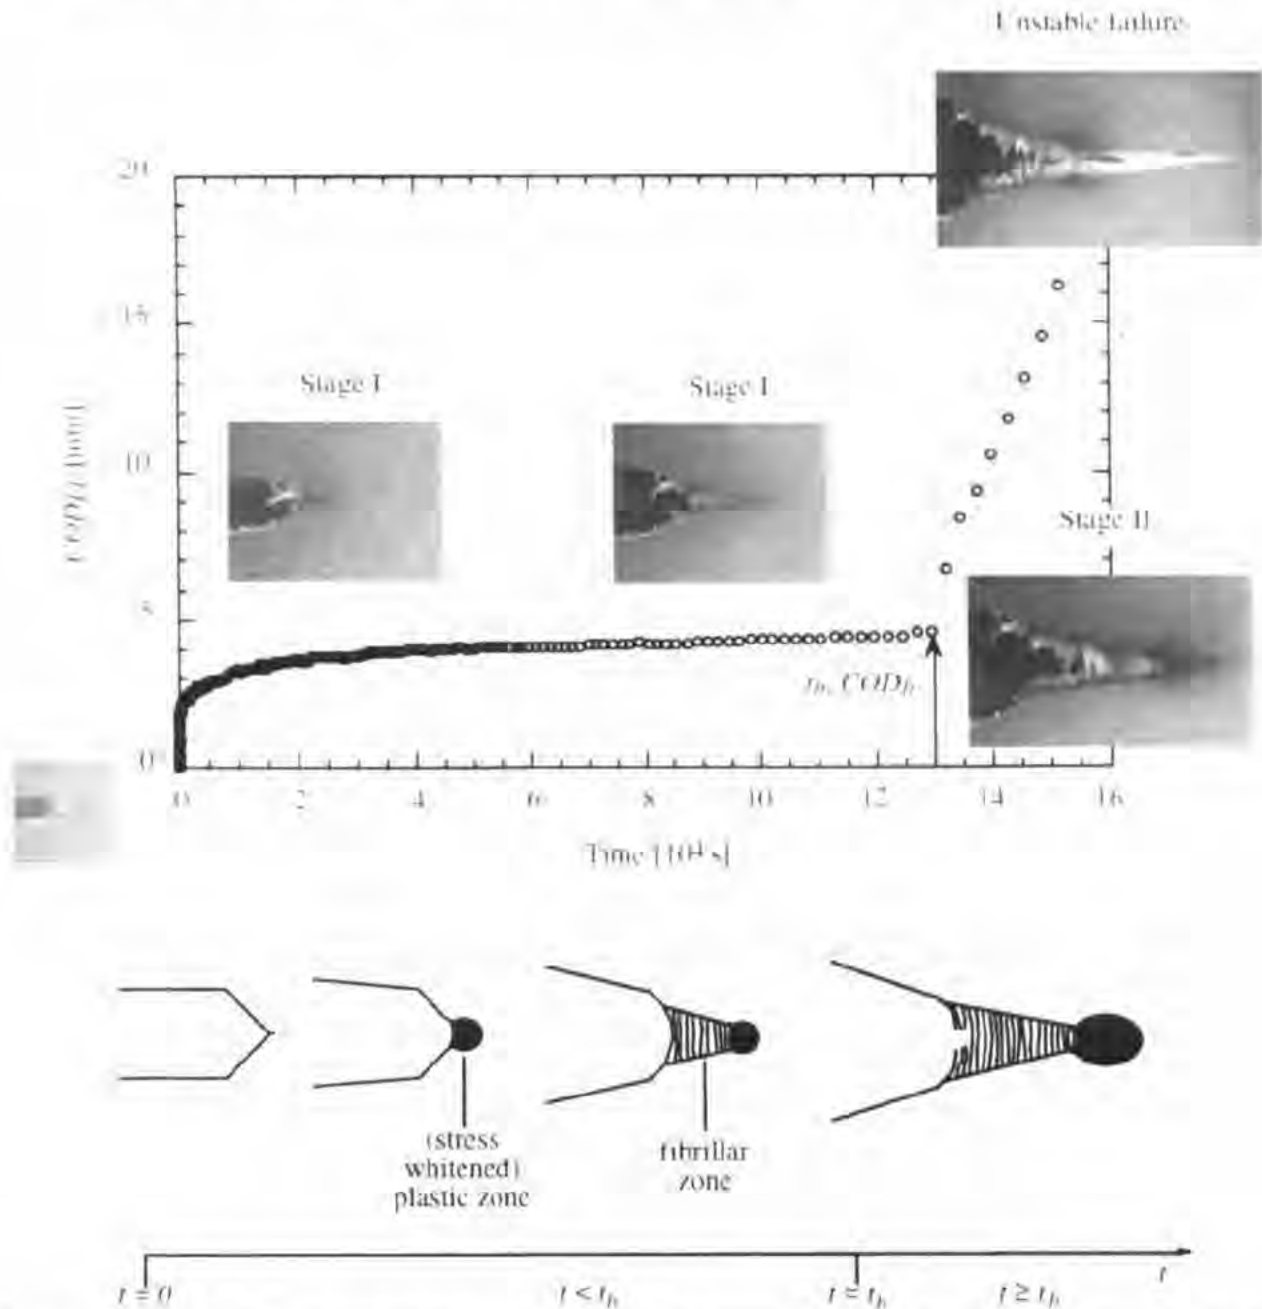
Fig. 4. The evolution of  $COD_{II}$  in a CT specimen with  $M_n = 41$  kg/mol deformed at  $100^\circ\text{C}$  at constant load, with an initial nominal applied stress intensity factor of  $K_{app}$  of  $1.67 \text{ MPa}\cdot\text{m}^{1/2}$ . Also shown are video captures at different stages of the test, along with sketches of the different regimes of crack tip deformation.

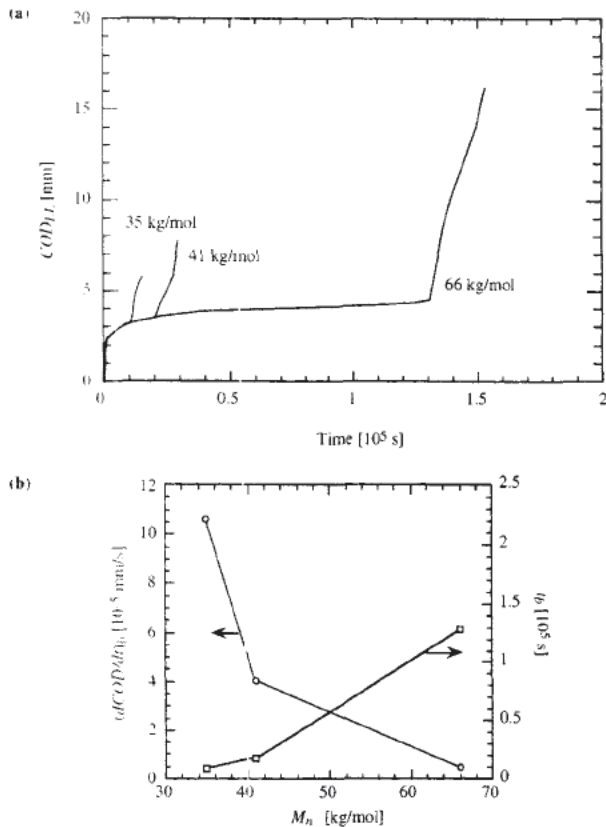
Fig. 5. (a) The evolution of  $COD_L$  in CT specimens with different molar masses ( $M_n = 35, 41,$  and  $66$  kg/mol) at  $100^\circ\text{C}$  and  $K_{app} = 1.67 \text{ MPa}\cdot\text{m}^{1/2}$ ; (b) the corresponding evolution in  $t_b$  and  $(dCOD/dt)_b$  with  $M_n$ .

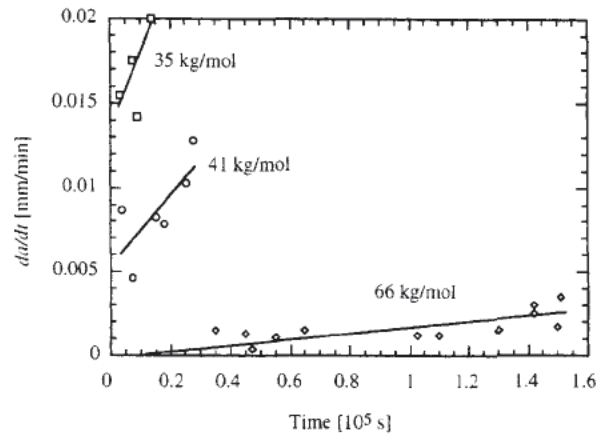
Fig. 6. The influence of  $M_n$  on the rate of advance of the tip of the fibrillar deformation zone,  $da/dt$ , at  $100^\circ\text{C}$  with  $K_{app} = 1.67 \text{ MPa}\cdot\text{m}^{1/2}$ .

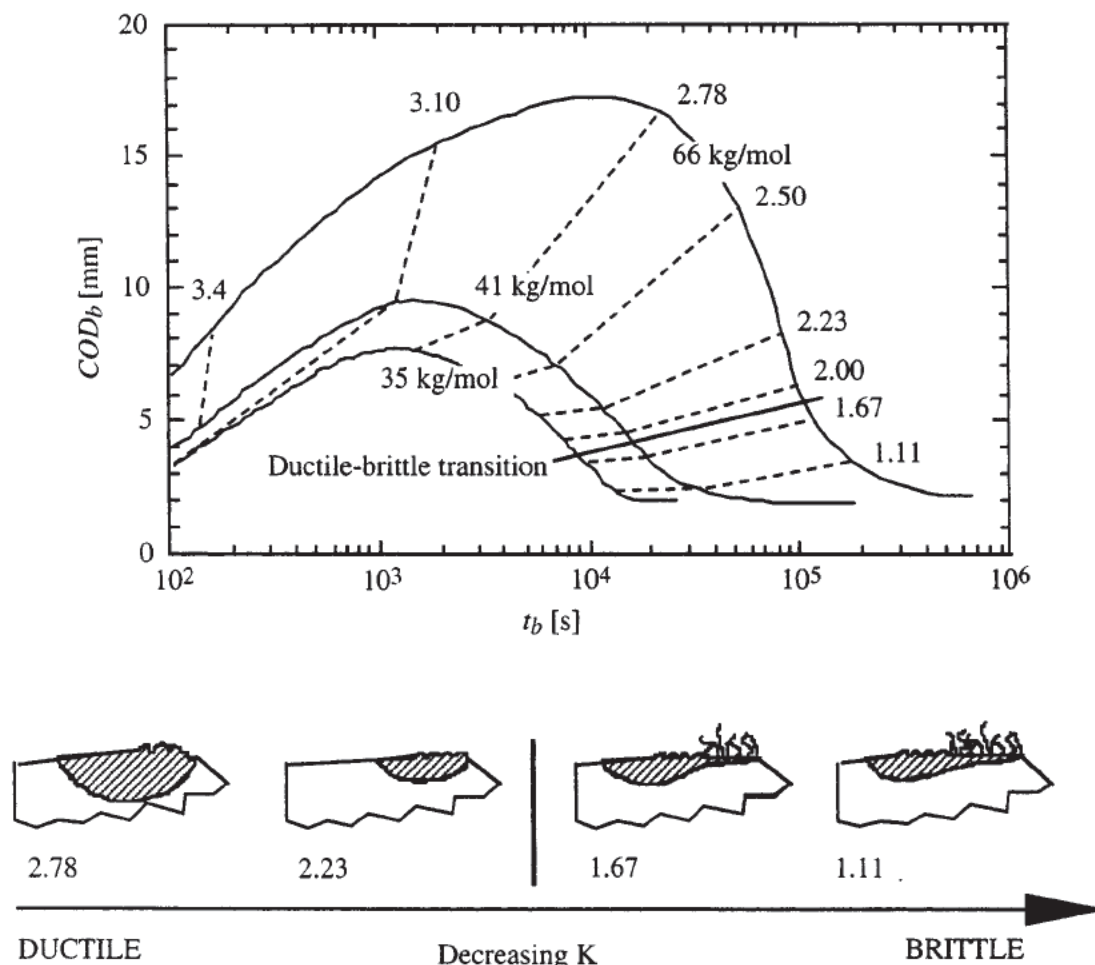
discussed. This value was sufficiently low to ensure stable crack growth via the formation of a fibrillar damage zone for all values of  $M_n$  at  $100^\circ\text{C}$ , while not being so low as to result in prohibitively long test times. In Fig. 7,  $COD_b$  has been plotted against  $t_b$  for a range of  $K_{app}$  and all the  $M_n$ , using data from tests carried out at  $100^\circ\text{C}$ , permitting an overview of the behavior and the establishment of a window for stable crack growth. The data points for the highest  $K_{app}$  ( $3.34 \text{ MPa}\cdot\text{m}^{1/2}$ ) corresponded to unstable failure, and indeed this  $K_{app}$  value

As the applied load was reduced both  $COD_b$  and  $t_b$  initially increased. This behavior was associated with the formation of a large stress-whitened region at the crack tip, but subsequent failure continued to intervene in an unstable manner, without the formation of a fibrillar deformation zone. For  $K_{app}$  less than about  $2.8 \text{ MPa}\cdot\text{m}^{1/2}$ ,  $COD_b$  began to decrease. It was only when  $K_{app}$  reached  $1.67 \text{ MPa}\cdot\text{m}^{1/2}$  that stable growth and fibrillar deformation were observed, as shown in Fig. 7b. This was true of all the grades regardless of  $M_n$ , although  $M_n$  clearly influenced  $COD_b$  over the full range of  $K_{app}$  investigated at this temperature.

Fig. 7. (a) COD<sub>b</sub> vs t<sub>b</sub> for the different values of K<sub>app</sub> indicated at 100°C and for different M<sub>n</sub> (the dotted lines represent lines of constant K<sub>app</sub>); (b) SEM images of the fracture surfaces corresponding to M<sub>n</sub> = 41 kg/mol and various K<sub>app</sub>.

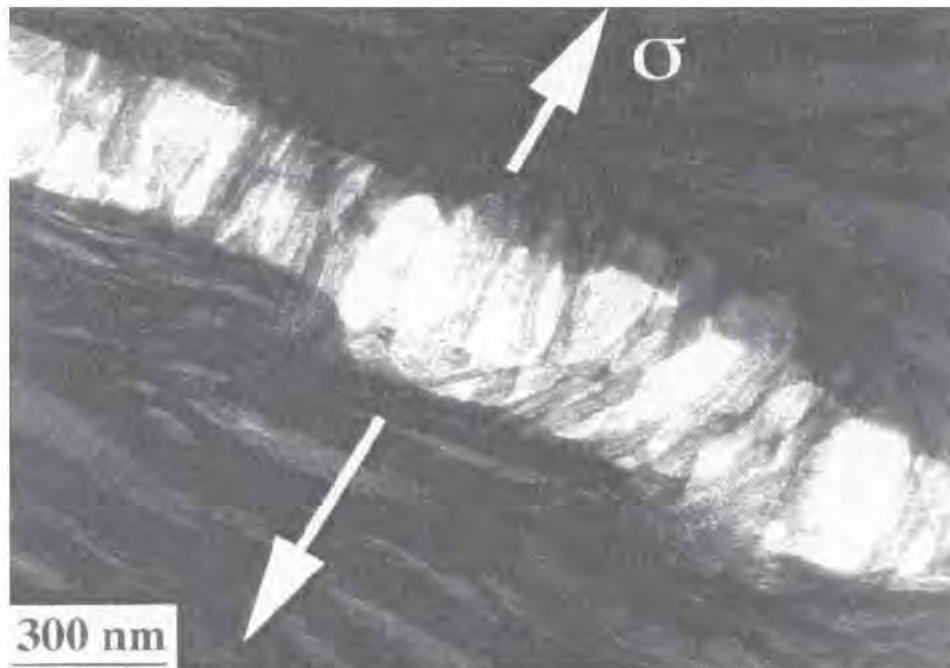
Figure 8 shows part of a typical thin section taken from the periphery of the stress-whitened region surrounding the coarse fibrillar zone at the crack tip in a specimen of POM with  $M_n = 41$  kg/mol, deformed under the conditions of Fig. 4. In spite of the reservations expressed above, the superlamellar structure visible in Fig. 8 was believed to be representative of the original structure of the section, and was typical of that seen in sections taken from the periphery of the damage zone. The craze-like feature visible in Fig. 8 contained fibrils with a diameter of 50 to 100 nm, and whose fine structure suggested them to correspond to single and/or multiple stacked lamellae. Given that the planes of the edge-on lamellae in the surrounding relatively undeformed material were oriented perpendicular to the tensile axis, the fibrils appear to have originated in sections of lamellar stacks that had been torn away from the adjacent lamellar stacks and progressively oriented and stretched parallel

Features such as that shown in Fig. 8 were identified with strongly light scattering, crack-like defects seen in optical sections from deformed tensile test bars, prepared using petrographic methods. These occur predominantly in equatorial regions of spherulites and in regions of columnar growth (where the lamellar orientation is broadly the same as at the spherulite equators). They are also thought to give rise to the intense stress-whitening and hard elastic behavior observed in room temperature tensile tests, where pseudo-brittle failure occurs prior to macroscopic necking.

Fig. 8. TEM micrograph of a craze-like feature observed in the periphery of the stress-whitened region at the tip of a crack propagating in a stable manner at 100°C (the arrows indicate the tensile direction).

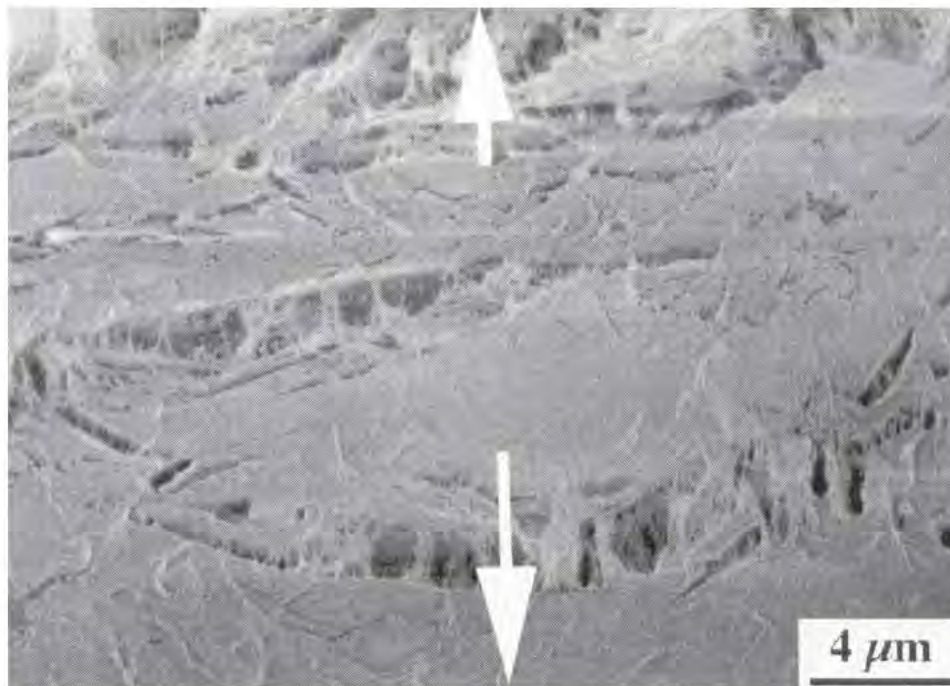
Figure 9 shows part of a freeze fracture surface corresponding to the periphery of the main coarse fibrillar zone at the crack tip. It indicates not only the presence of numerous craze-like features with dimensions consistent with those of the deformation zone in

Fig. 8, but also regions of relatively coarse cavitation/fibrillation. It is apparent from Fig. 9 that the development of the coarser fibrillar zones was not solely a result of continuous widening of pre-existing defects in the direction of the tensile axis, but also proceeded by deformation of the intervening matrix ligaments. These rotated towards the tensile axis, forming "macrofibrils," much as described for the transformation of lamellar stacks into the fibrils in Fig. 8 (albeit on a different length scale). A TEM micrograph taken from close to the main coarse fibrillar zone is shown in Fig. 10. This part of the specimen had been well impregnated with the embedding epoxy resin, and the section appears in reverse contrast with respect to the voids, owing to mass loss from the POM. Traces of the original lamellar texture can still be seen in relatively undeformed regions of the matrix in Fig. 10, again indicating the lamellar trajectories to be locally perpendicular to the deformation axis. The fibrils spanning the deformation zones had undergone considerable drawing compared with those in Fig. 8, and the deformation zone boundaries were irregular, with islands

Fig. 9. SEM micrograph of a specimen freeze fractured perpendicular to the crack plane after a stable crack propagation at 100°C, showing deformation in the stress-whitened region and at the periphery of the coarse fibrillar zone (the arrows indicate the tensile direction).

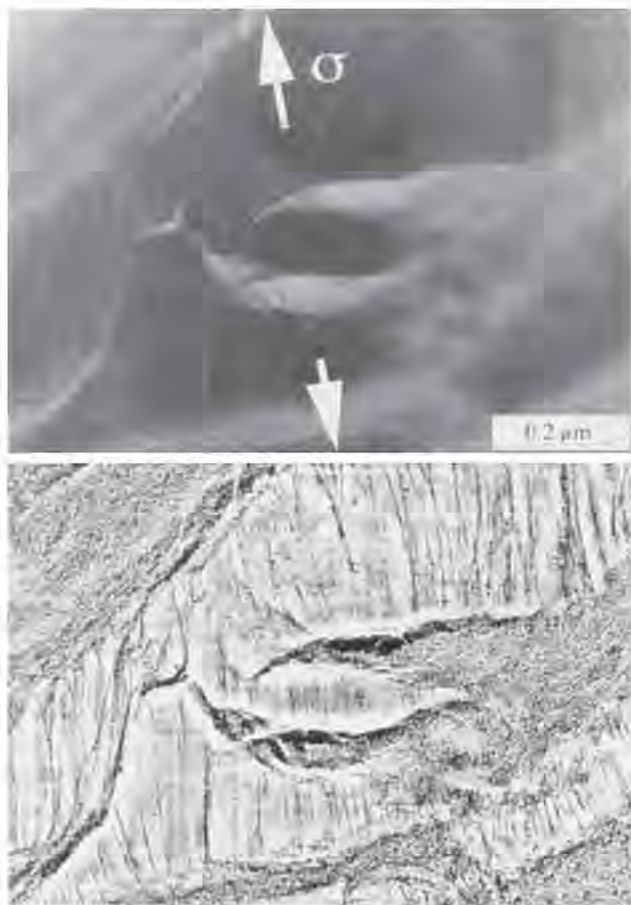
Fig. 10. TEM micrograph of microdeformation close to the edge of the coarse fibrillar zone at the tip of a crack propagating in a stable manner at 100°C. The bottom image is the same micrograph after application of a high pass filter, contrast enhancement and inversion, which makes the fibrils easier to see.

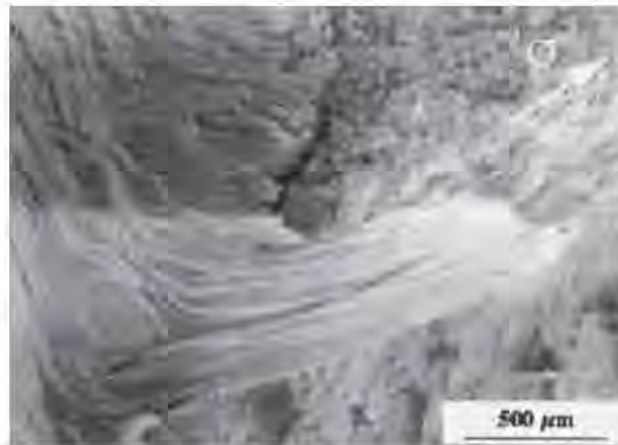
Since some of the coarser fibrils in the main fibrillar zone were up to 100 μm or more in diameter, they incorporated many of the smaller fibrillar zones initially present in the stress-whitened region. These also rotated through about 90° so that their final trajectories were parallel to the stress axis, as may be seen in Fig. 11, which shows the structure of a macrofibril. Continued drawing of the macrofibrils resulted in collapse of the localized fibrillar zones, giving rise to a characteristic fibrous texture, similar to that in macroscopic necks in tensile test bars drawn at close to melting point. (Indeed, given that the formation of macroscopic necks is also mediated by stress-whitening/ cavitation there appears every justification for assuming macro-fibrils and macroscopic necks to be analogous, as implicit in certain approaches to SCG in PE (12, 13).) A further illustration of this is given in Fig. 12, which shows deformation at the base of a macrofibril in more detail. The resulting sponge-like network of drawn matrix and voids with characteristic dimensions of the order of 100 nm (although there is

Fig. 11. SEM micrograph of a detail of a macrofibril within the coarse fibrillar zone.

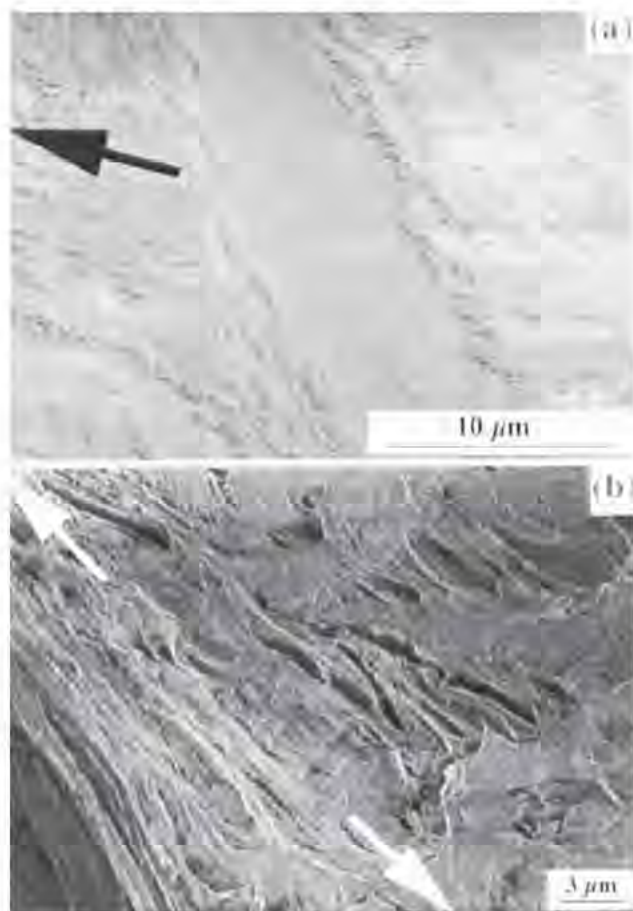
Fig. 12. (a) SEM micrograph of deformation at the edge of the coarse fibrillar zone (the arrow indicates the local tensile direction); (b) detail of the interior of the coarse fibrillar zone close to the crack tip (the arrows indicate the local tensile direction).

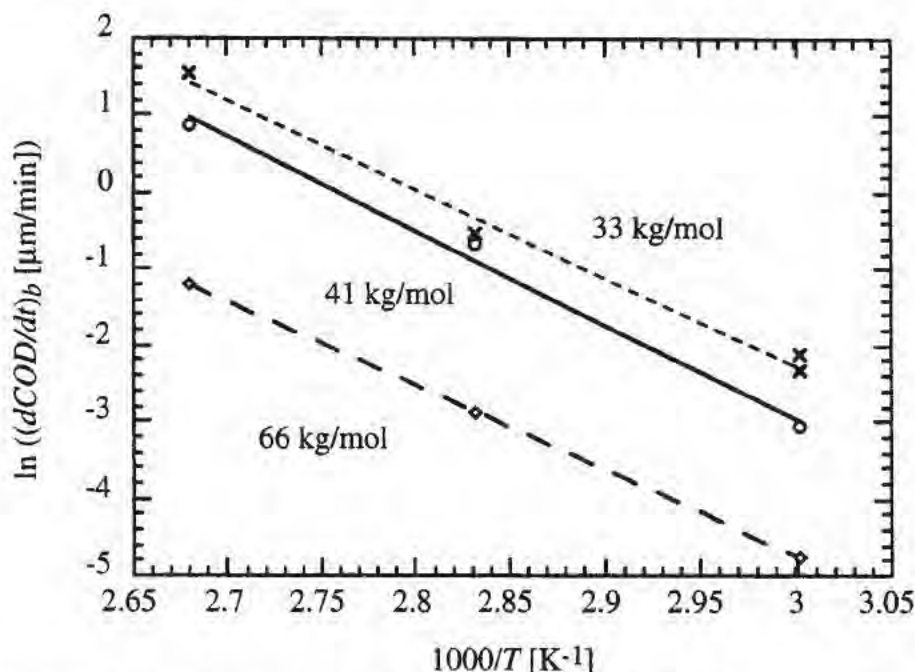
Fig. 14. The influence of temperature on  $(dCOD/dt)_b$  for different  $M_n$  and  $K_{app} = 1.67 \text{ MPa}\cdot\text{m}^{1/2}$ .

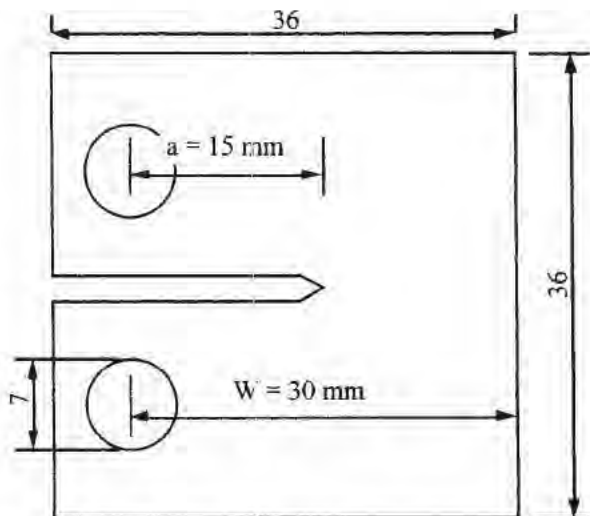
Fig. 1. The compact tension specimen geometry used for the present study. The specimen thickness  $B = 10 \text{ mm}$ .

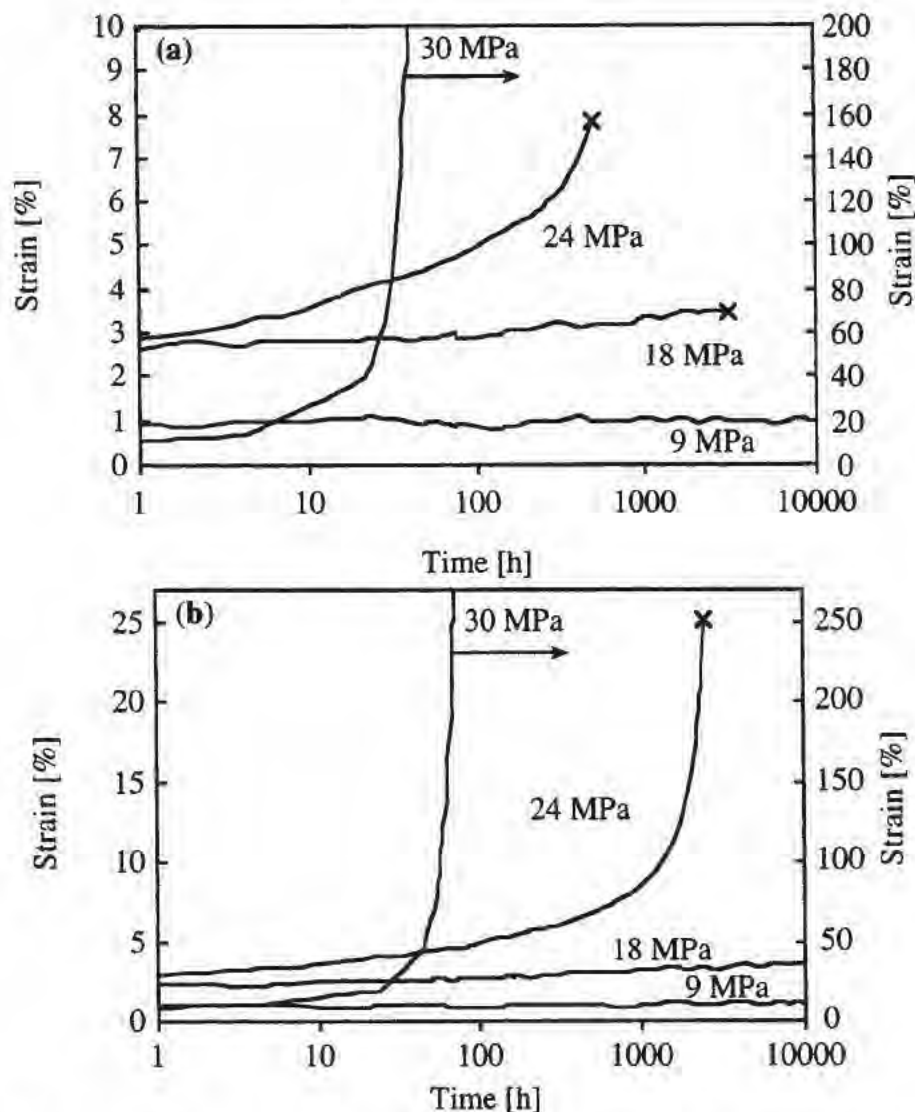
Figure 2 shows the nominal strain in specimens with  $M_n = 41 \text{ kg/mol}$  and  $66 \text{ kg/mol}$  as a function of time in creep tests at  $60^\circ\text{C}$  at different constant nominal stresses, illustrating the behavior described in the introduction. At 30 MPa, all the specimens showed fully ductile behavior and stable plastic necking up to at least 250% strain (that is, the upper limit of the extensometer). At 24 MPa, however, specimens with  $M_n = 41 \text{ kg/mol}$  failed at a strain of 8% after about 500 h. This compares with a failure time of 2500 h and a failure strain of 25% for  $M_n = 66 \text{ kg/mol}$  at the same stress. The failure strain for  $M_n = 41 \text{ kg/mol}$  dropped further to 3% when the stress was decreased to 18

Fig. 2. Tensile creep for (a)  $M_n = 41$  kg/mol and (b)  $M_n = 66$  kg/mol at  $60^\circ\text{C}$  at various stresses (the arrows indicate those curves that should be referred to the right-hand strain axis).

MPa, although the time to failure (3000 h) was considerably longer than at 24 MPa. Indeed, specimens with  $M_n = 41$  kg/mol tested at 9 MPa, and specimens with  $M_n = 66$  kg/mol tested at 18 MPa and 9 MPa remained load bearing up to the maximum test time of 10,000 h. Similar behavior has also been observed in specimens tested at higher temperatures, with failure occurring at about 5% strain for  $M_n = 41$  kg/mol loaded at 15 MPa at  $80^\circ\text{C}$ , whereas fully ductile behavior was seen in specimens loaded at 25 MPa (7).

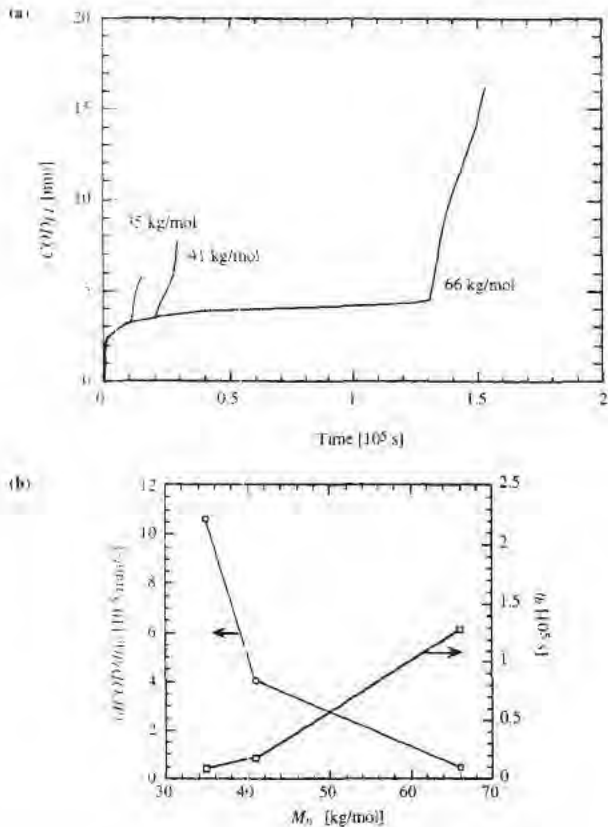
Figure 5a compares the crack opening behavior of specimens with different molar masses under the test conditions of Fig. 4. The initial evolution of  $COD_{LL}$  was similar for all the  $M_n$ , but there was a clear monotonic increase in  $t_b$  with increasing  $M_n$  as shown in Fig. 5b. Also plotted in Fig. 5b are critical crack opening rates  $(dCOD/dt)_b$ , defined as the minimum slope of  $COD_{LL}(t)$ . The transition to rapid crack advance in Stage II occurred at progressively lower values of  $(dCOD/dt)_b$  as  $M_n$  increased.

Fig. 5. (a) The evolution of  $COD_b$  in CT specimens with different molar masses ( $M_n = 35, 41,$  and  $66$  kg/mol) at  $100^\circ\text{C}$  and  $K_{app} = 1.67 \text{ MPa}\cdot\text{m}^{1/2}$ ; (b) the corresponding evolution in  $t_b$  and  $(dCOD/dt)_b$  with  $M_n$ .

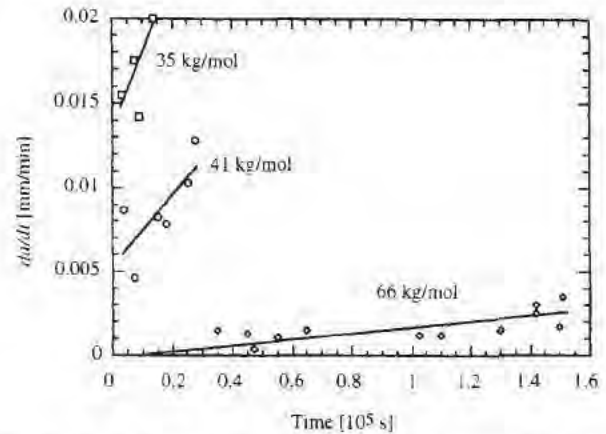
Figure 6 shows the rate of advance of the tip of the fibrillar deformation zone,  $da/dt$ , as a function of time for the different  $M_n$  ( $a$  is the distance between the deformation zone tip and the initial position of the notch tip, and does not include the stress-whitened region ahead of the fibrillar zone).  $da/dt$  was substantially reduced at high  $M_n$ , which suggests an increase in the stability of the stress-whitened region with respect to advance of the fibrillar zone.

Fig. 6. The influence of  $M_n$  on the rate of advance of the tip of the fibrillar deformation zone,  $da/dt$ , at  $100^\circ\text{C}$  with  $K_{app} = 1.67 \text{ MPa}\cdot\text{m}^{1/2}$ .

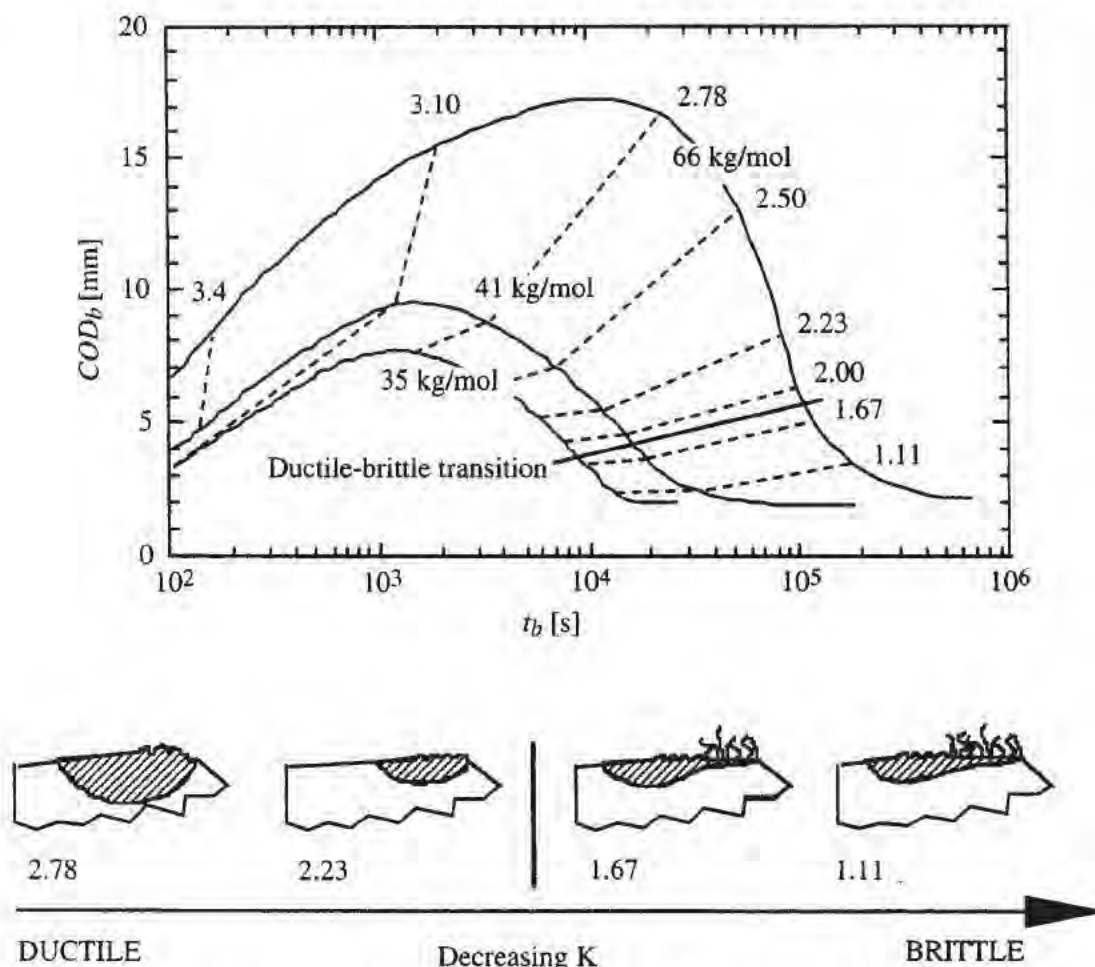
discussed. This value was sufficiently low to ensure stable crack growth via the formation of a fibrillar damage zone for all values of  $M_n$  at  $100^\circ\text{C}$ , while not being so low as to result in prohibitively long test times. In Fig. 7,  $COD_b$  has been plotted against  $t_b$  for a range of  $K_{app}$  and all the  $M_n$ , using data from tests carried out at  $100^\circ\text{C}$ , permitting an overview of the behavior and the establishment of a window for stable crack growth. The data points for the highest  $K_{app}$  ( $3.34 \text{ MPa}\cdot\text{m}^{1/2}$ ) corresponded to unstable failure, and indeed this  $K_{app}$  value

As the applied load was reduced both  $COD_b$  and  $t_b$  initially increased. This behavior was associated with the formation of a large stress-whitened region at the crack tip, but subsequent failure continued to intervene in an unstable manner, without the formation of a fibrillar deformation zone. For  $K_{app}$  less than about  $2.8 \text{ MPa}\cdot\text{m}^{1/2}$ ,  $COD_b$  began to decrease. It was only when  $K_{app}$  reached  $1.67 \text{ MPa}\cdot\text{m}^{1/2}$  that stable growth and fibrillar deformation were observed, as shown in Fig. 7b. This was true of all the grades regardless of  $M_n$ , although  $M_n$  clearly influenced  $COD_b$  over the full range of  $K_{app}$  investigated at this temperature.

Fig. 7. (a)  $COD_b$  vs  $t_b$  for the different values of  $K_{app}$ , indicated at  $100^\circ\text{C}$  and for different  $M_n$  (the dotted lines represent lines of constant  $K_{app}$ ); (b) SEM images of the fracture surfaces corresponding to  $M_n = 41$  kg/mol and various  $K_{app}$ .

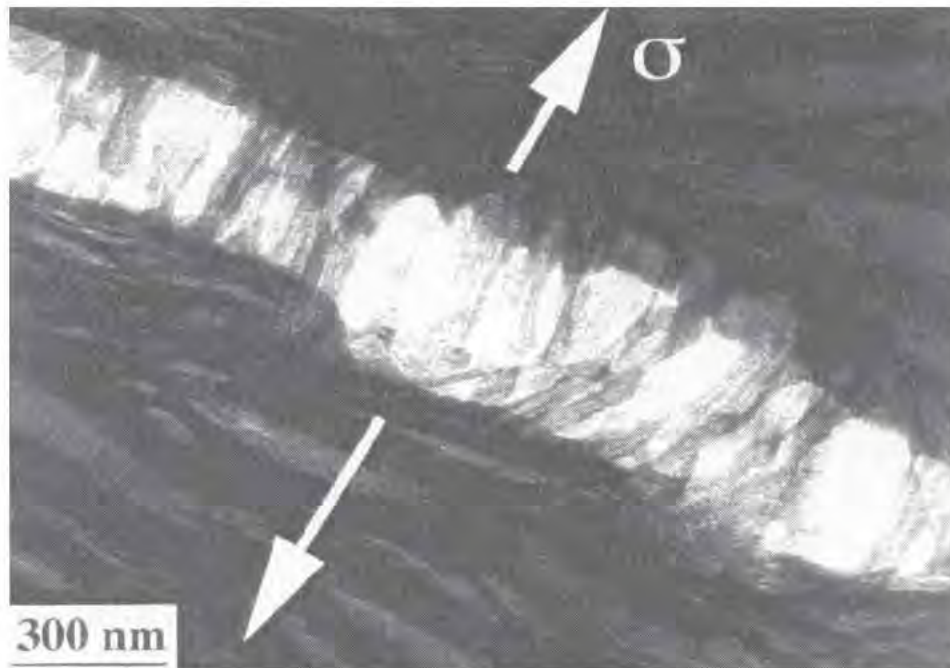
Figure 8 shows part of a typical thin section taken from the periphery of the stress-whitened region surrounding the coarse fibrillar zone at the crack tip in a specimen of POM with  $M_n = 41$  kg/mol, deformed under the conditions of Fig. 4. In spite of the reservations expressed above, the superlamellar structure visible in Fig. 8 was believed to be representative of the original structure of the section, and was typical of that seen in sections taken from the periphery of the damage zone. The craze-like feature visible in Fig. 8 contained fibrils with a diameter of 50 to 100 nm, and whose fine structure suggested them to correspond to single and/or multiple stacked lamellae. Given that the planes of the edge-on lamellae in the surrounding relatively undeformed material were oriented perpendicular to the tensile axis, the fibrils appear to have originated in sections of lamellar stacks that had been torn away from the adjacent lamellar stacks and progressively oriented and stretched parallel

Features such as that shown in Fig. 8 were identified with strongly light scattering, crack-like defects seen in optical sections from deformed tensile test bars, prepared using petrographic methods. These occur predominantly in equatorial regions of spherulites and in regions of columnar growth (where the lamellar orientation is broadly the same as at the spherulite equators). They are also thought to give rise to the intense stress-whitening and hard elastic behavior observed in room temperature tensile tests, where pseudo-brittle failure occurs prior to macroscopic necking.

Fig. 8. TEM micrograph of a craze-like feature observed in the periphery of the stress-whitened region at the tip of a crack propagating in a stable manner at 100°C (the arrows indicate the tensile direction).

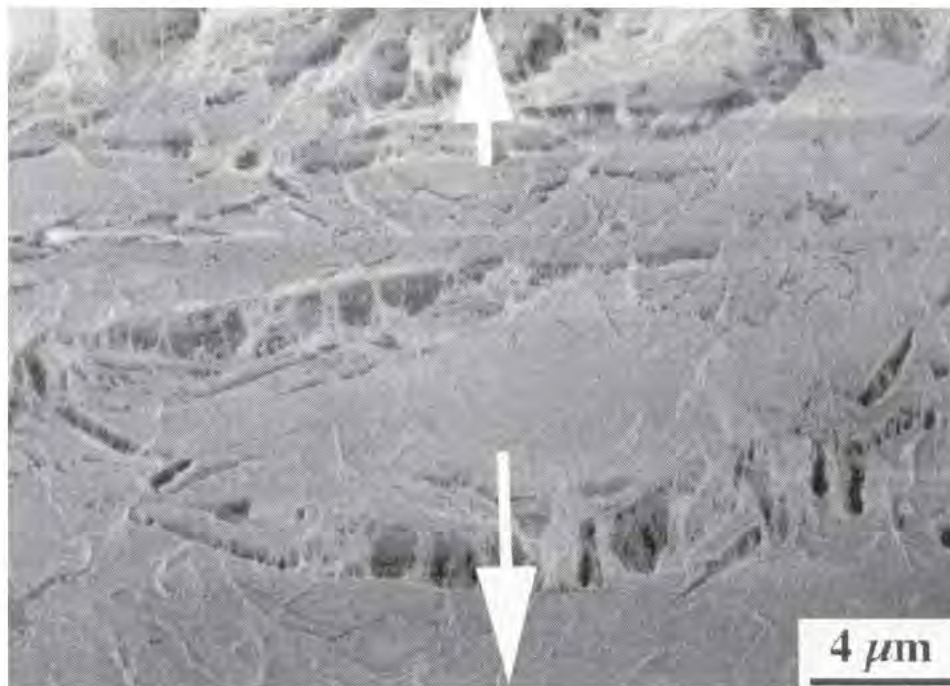
Figure 9 shows part of a freeze fracture surface corresponding to the periphery of the main coarse fibrillar zone at the crack tip. It indicates not only the presence of numerous craze-like features with dimensions consistent with those of the deformation zone in

Fig. 8, but also regions of relatively coarse cavitation/fibrillation. It is apparent from Fig. 9 that the development of the coarser fibrillar zones was not solely a result of continuous widening of pre-existing defects in the direction of the tensile axis, but also proceeded by deformation of the intervening matrix ligaments. These rotated towards the tensile axis, forming "macrofibrils," much as described for the transformation of lamellar stacks into the fibrils in Fig. 8 (albeit on a different length scale). A TEM micrograph taken from close to the main coarse fibrillar zone is shown in Fig. 10. This part of the specimen had been well impregnated with the embedding epoxy resin, and the section appears in reverse contrast with respect to the voids, owing to mass loss from the POM. Traces of the original lamellar texture can still be seen in relatively undeformed regions of the matrix in Fig. 10, again indicating the lamellar trajectories to be locally perpendicular to the deformation axis. The fibrils spanning the deformation zones had undergone considerable drawing compared with those in Fig. 8, and the deformation zone boundaries were irregular, with islands

Fig. 9. SEM micrograph of a specimen freeze fractured perpendicular to the crack plane after a stable crack propagation at 100°C, showing deformation in the stress-whitened region and at the periphery of the coarse fibrillar zone (the arrows indicate the tensile direction).

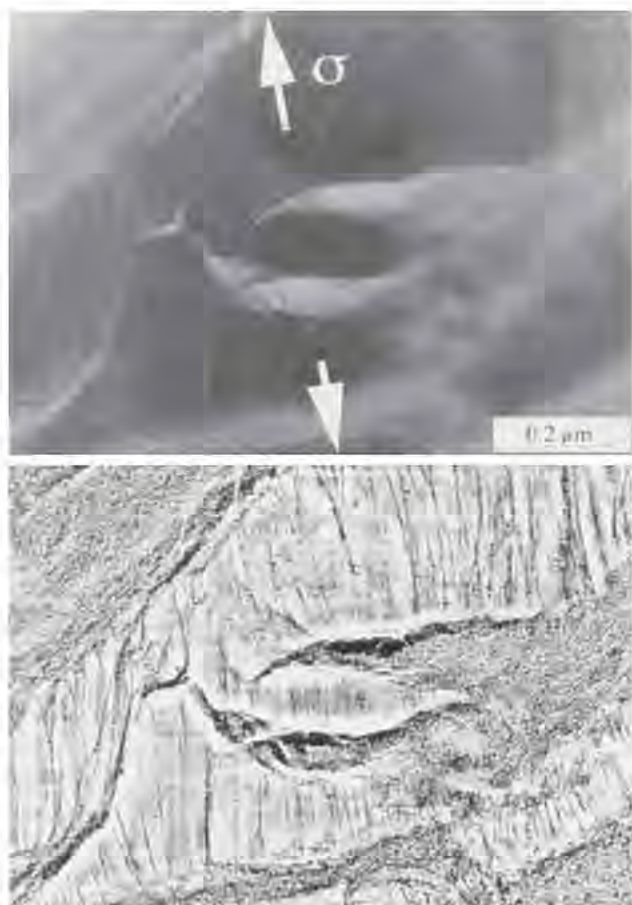
Fig. 10. TEM micrograph of microdeformation close to the edge of the coarse fibrillar zone at the tip of a crack propagating in a stable manner at 100°C. The bottom image is the same micrograph after application of a high pass filter, contrast enhancement and inversion, which makes the fibrils easier to see.

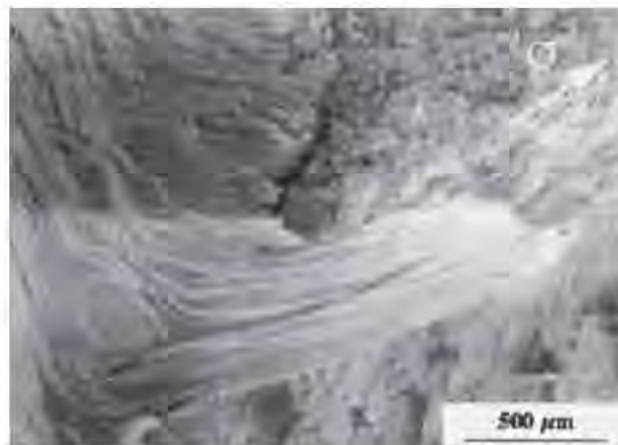
Since some of the coarser fibrils in the main fibrillar zone were up to 100 μm or more in diameter, they incorporated many of the smaller fibrillar zones initially present in the stress-whitened region. These also rotated through about 90° so that their final trajectories were parallel to the stress axis, as may be seen in Fig. 11, which shows the structure of a macrofibril. Continued drawing of the macrofibrils resulted in collapse of the localized fibrillar zones, giving rise to a characteristic fibrous texture, similar to that in macroscopic necks in tensile test bars drawn at close to melting point. (Indeed, given that the formation of macroscopic necks is also mediated by stress-whitening/cavitation there appears every justification for assuming macro-fibrils and macroscopic necks to be analogous, as implicit in certain approaches to SCG in PE (12, 13).) A further illustration of this is given in Fig. 12, which shows deformation at the base of a macrofibril in more detail. The resulting sponge-like network of drawn matrix and voids with characteristic dimensions of the order of 100 nm (although there is

Fig. 11. SEM micrograph of a detail of a macrofibril within the coarse fibrillar zone.

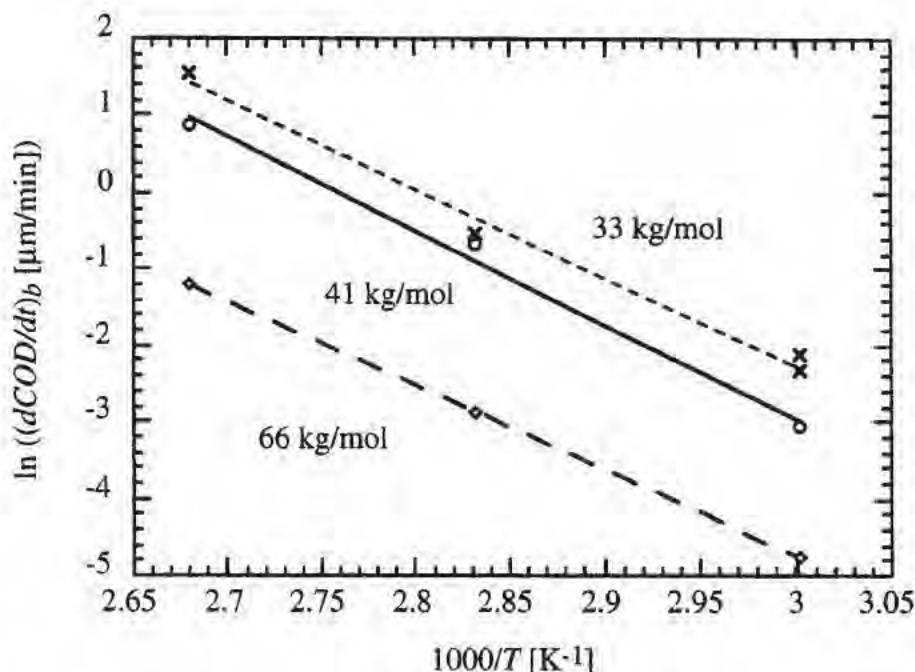
Fig. 14. The influence of temperature on  $(dCOD/dt)_b$  for different  $M_n$  and  $K_{app} = 1.67 \text{ MPa}\cdot\text{m}^{1/2}$ .

where  $Q$  is an activation energy characteristic of the fibril viscosity (15) (although the viscosity is not the only temperature dependent term in Eq 3). In the present case  $d\delta/dt$  was identified with  $(dCOD/dt)_b$ . However, insufficient data were available to confirm the  $K_f^2$  dependence of  $(dCOD/dt)_b$ . Neither is it clear that a true steady state crack opening rate was achieved at any time during the tests, particularly for the lower molar masses. An attempt was nevertheless made to derive an activation energy using Eq 4. Figure 14 shows  $\ln((dCOD/dt)_b)$  at  $K_{app} = 1.67 \text{ MPa}\cdot\text{m}^{1/2}$  plotted against reciprocal temperature for each  $M_n$ . The apparent activation energy  $Q \approx 120 \text{ kJ/mol}$  was similar to values obtained in the same way for SCG in PE (15). The mechanisms of deformation also remained
