PE14-030

FORD

APPENDIX I

Engineering Review

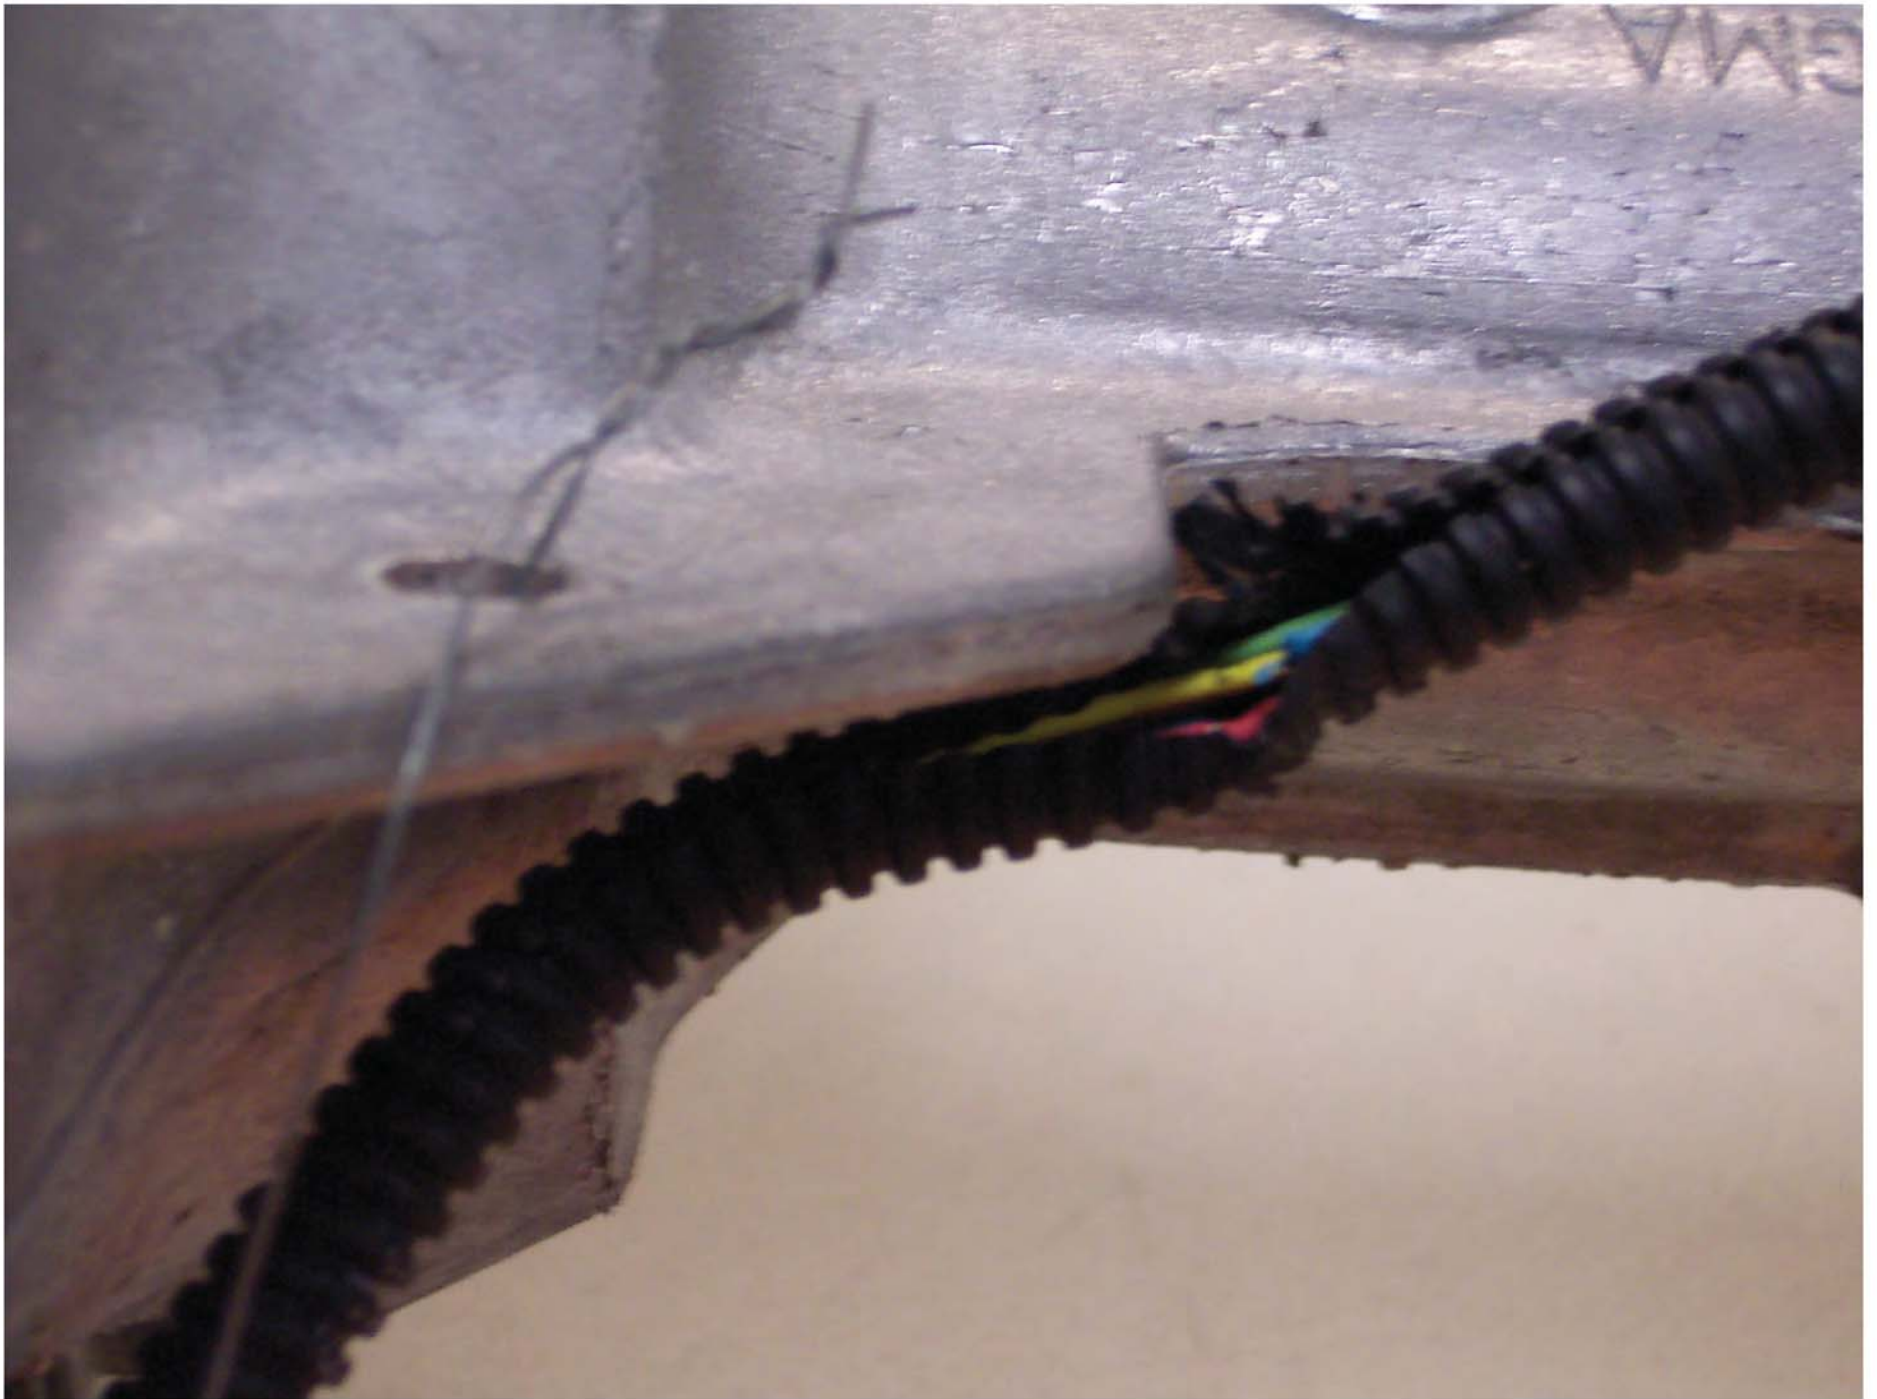
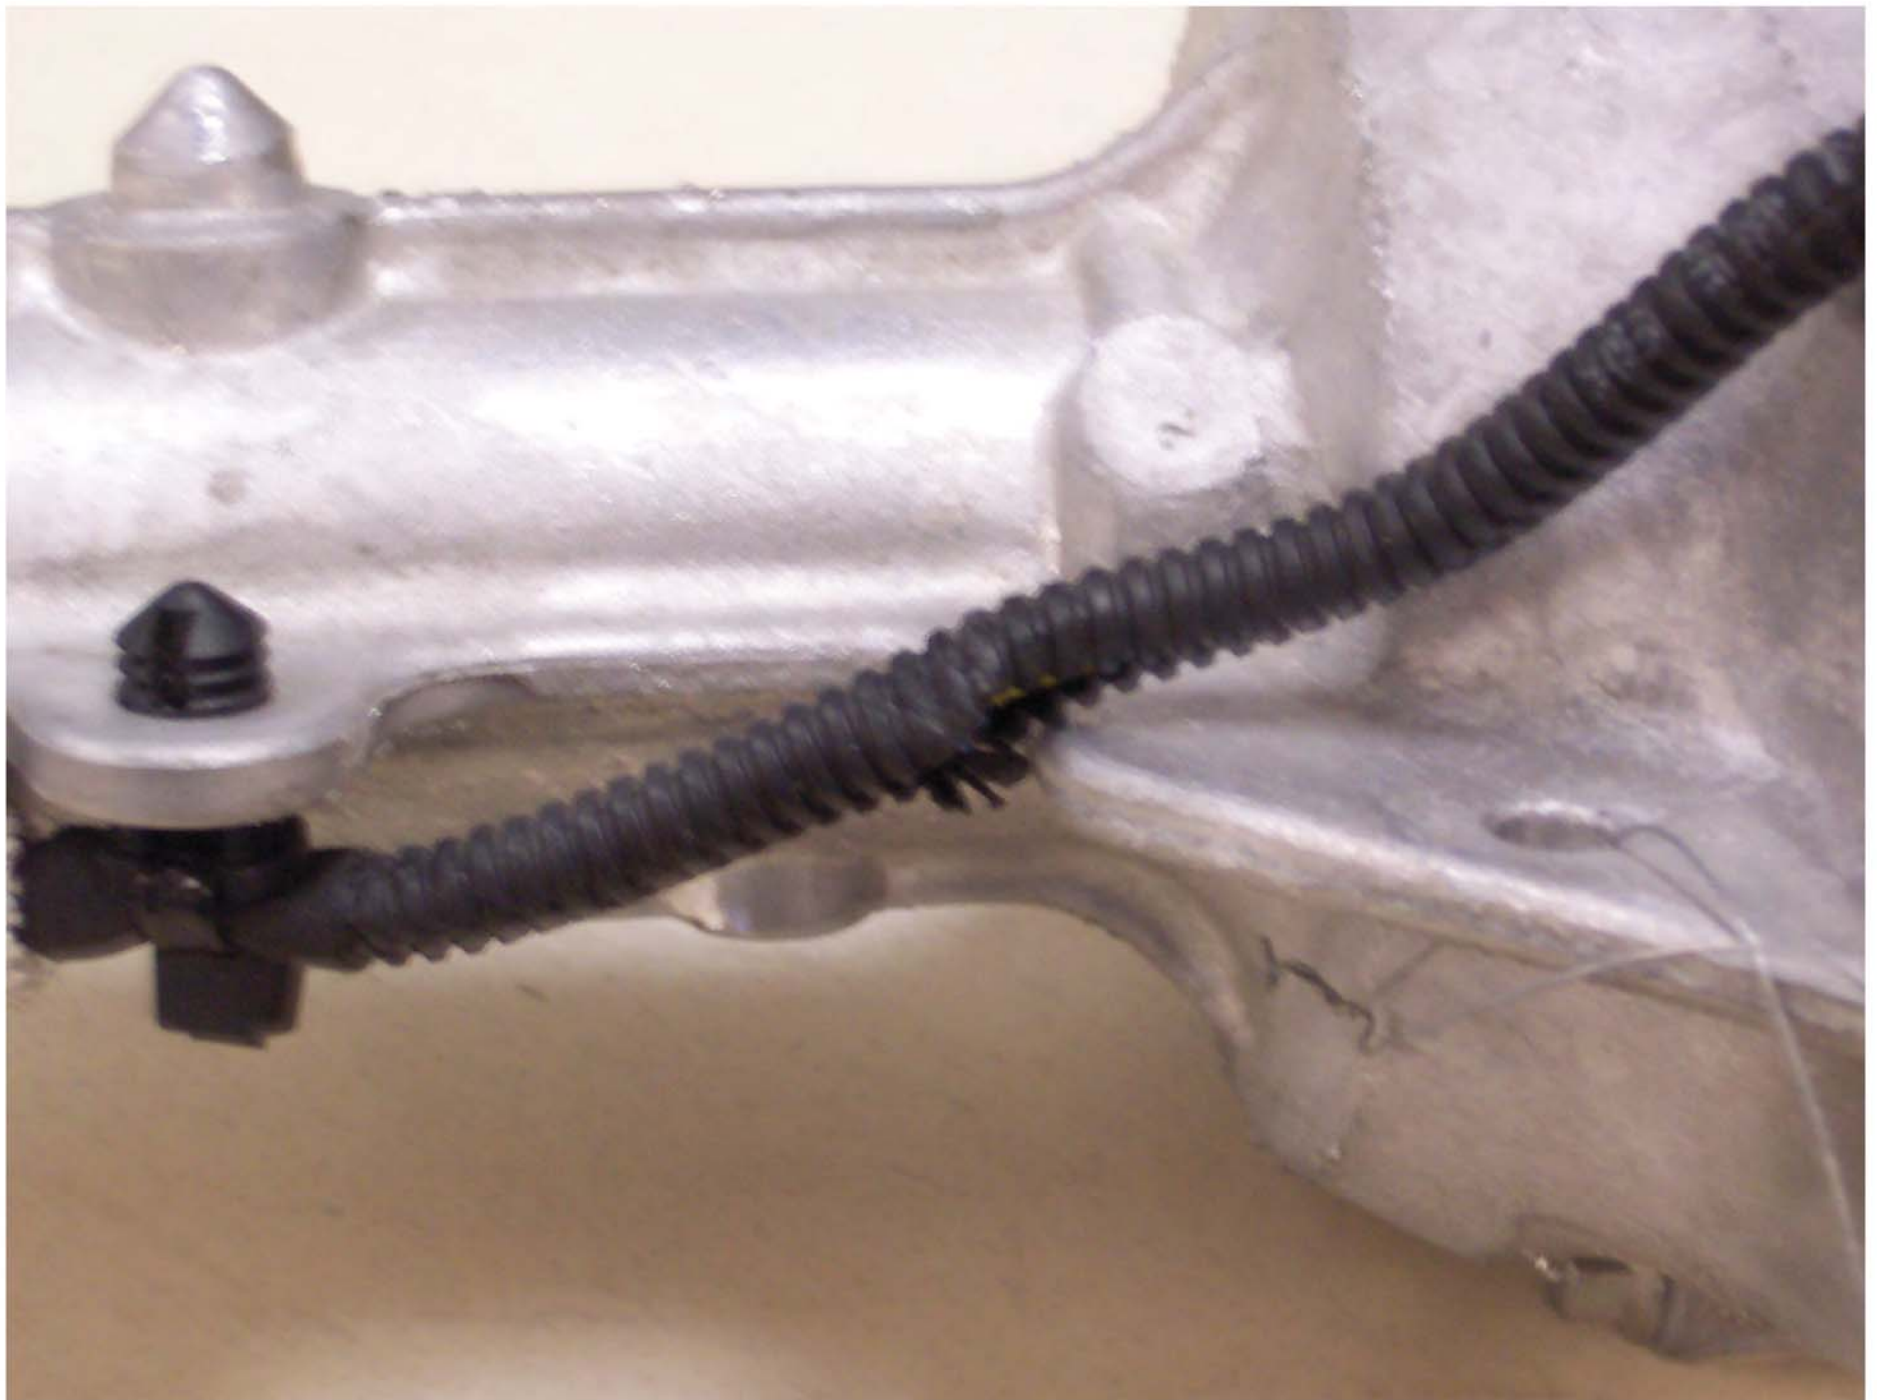
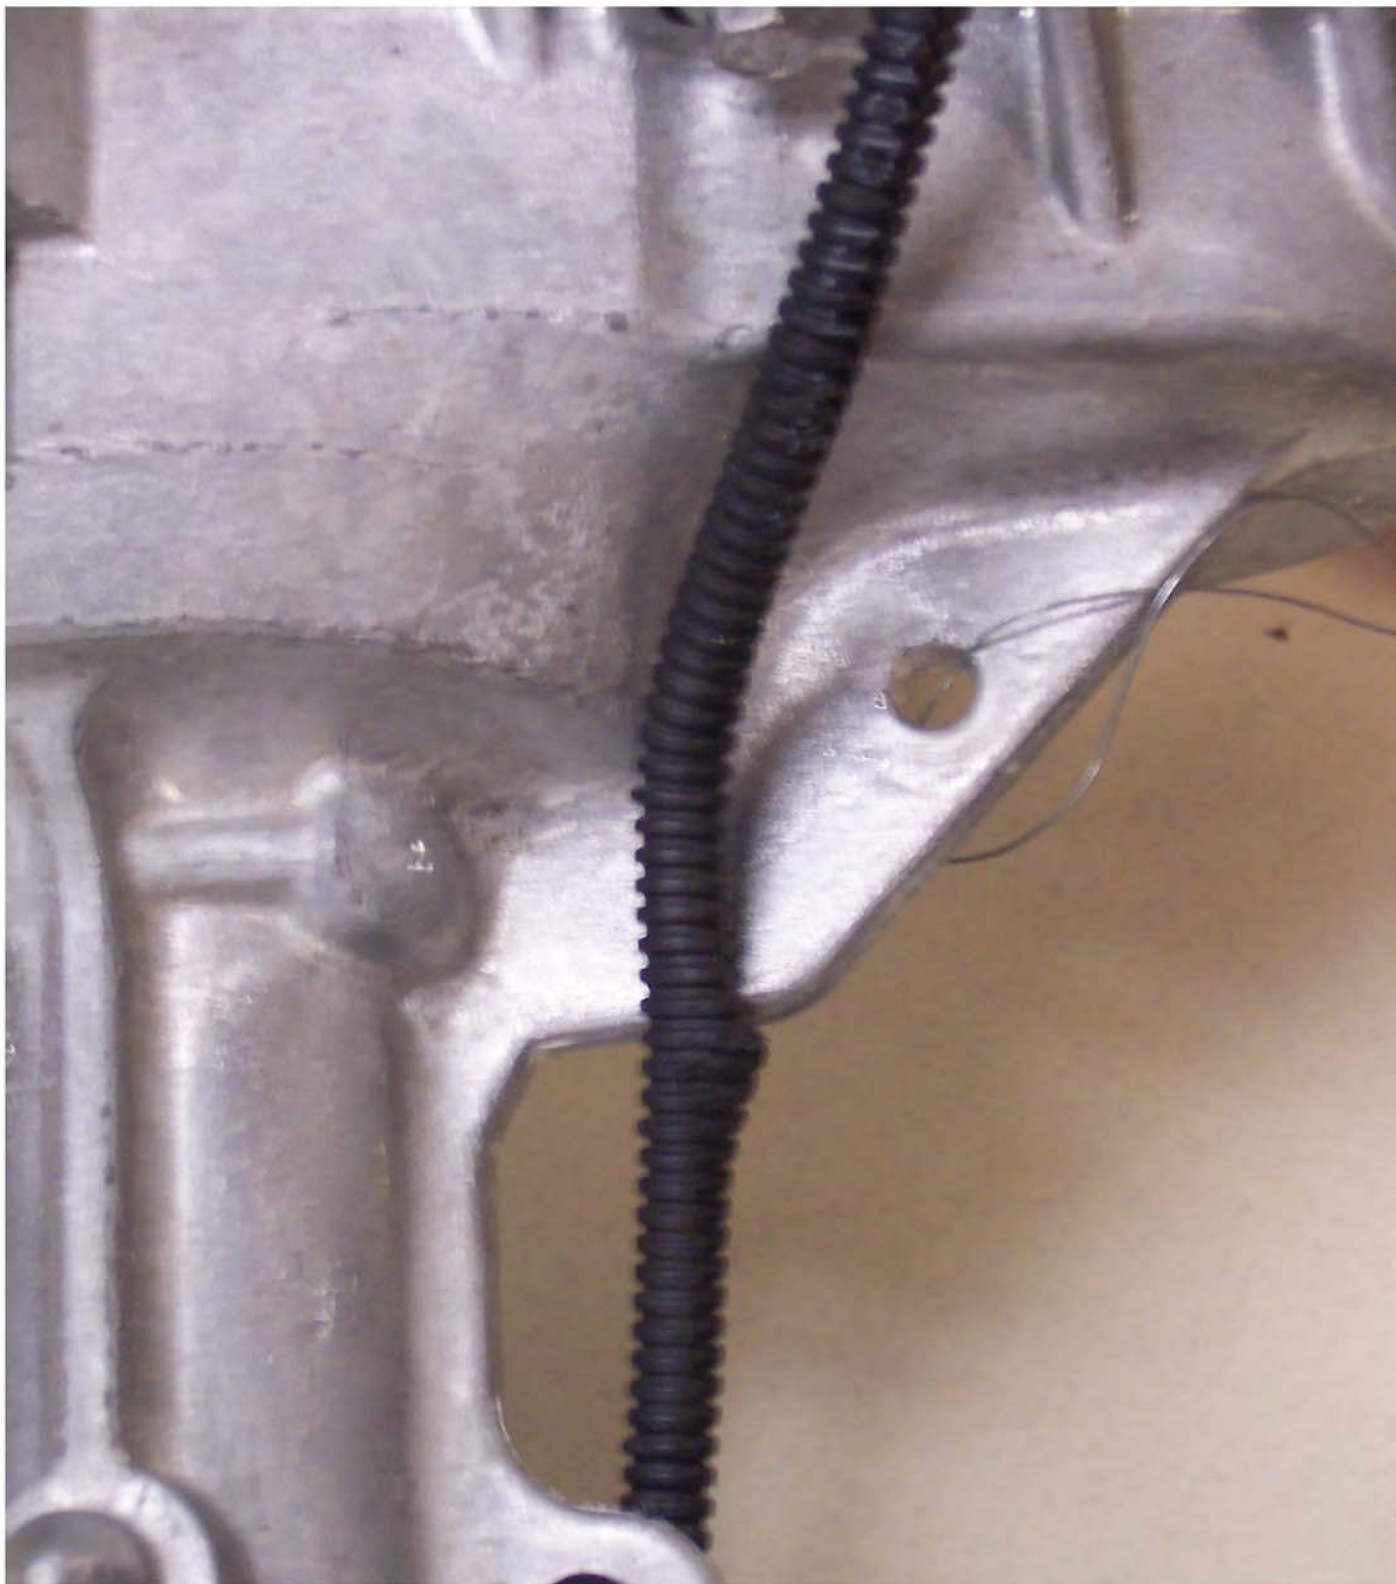
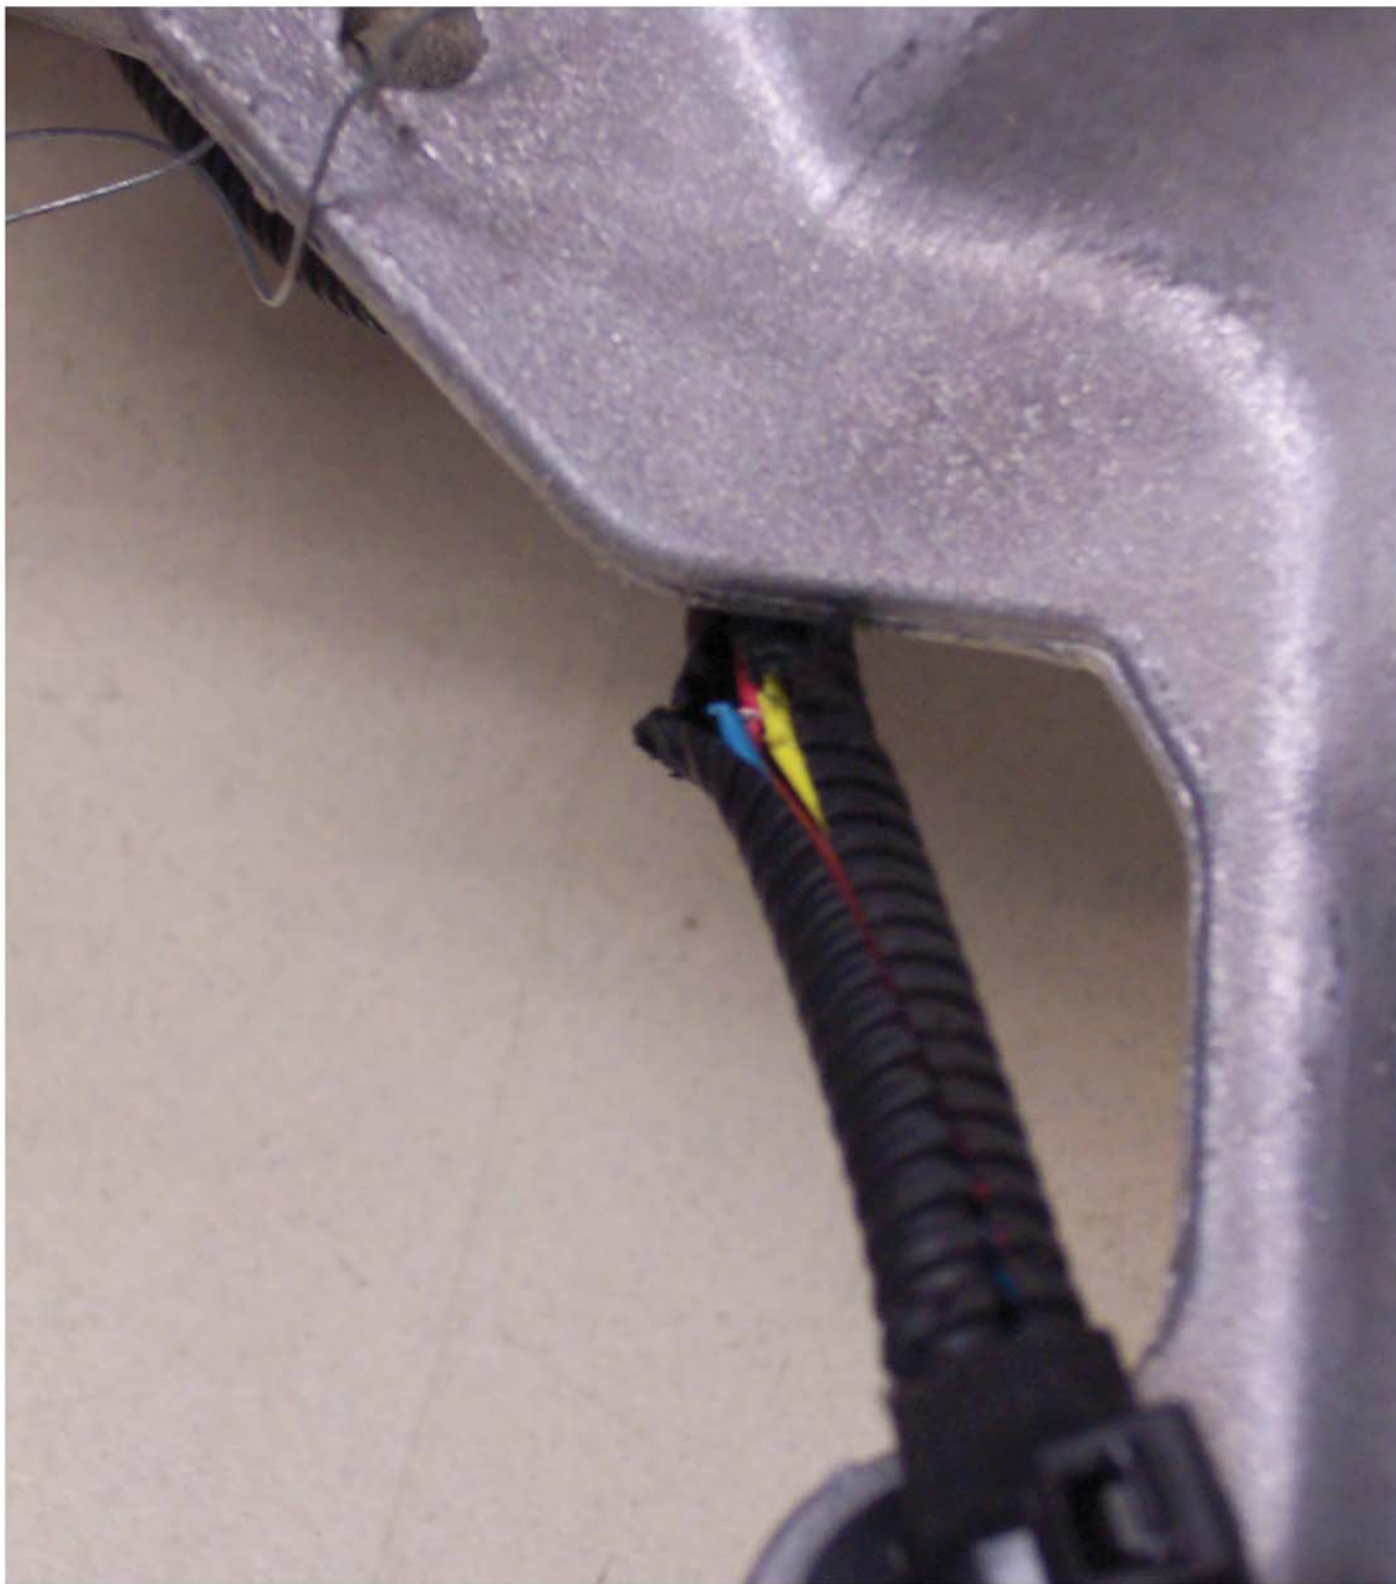
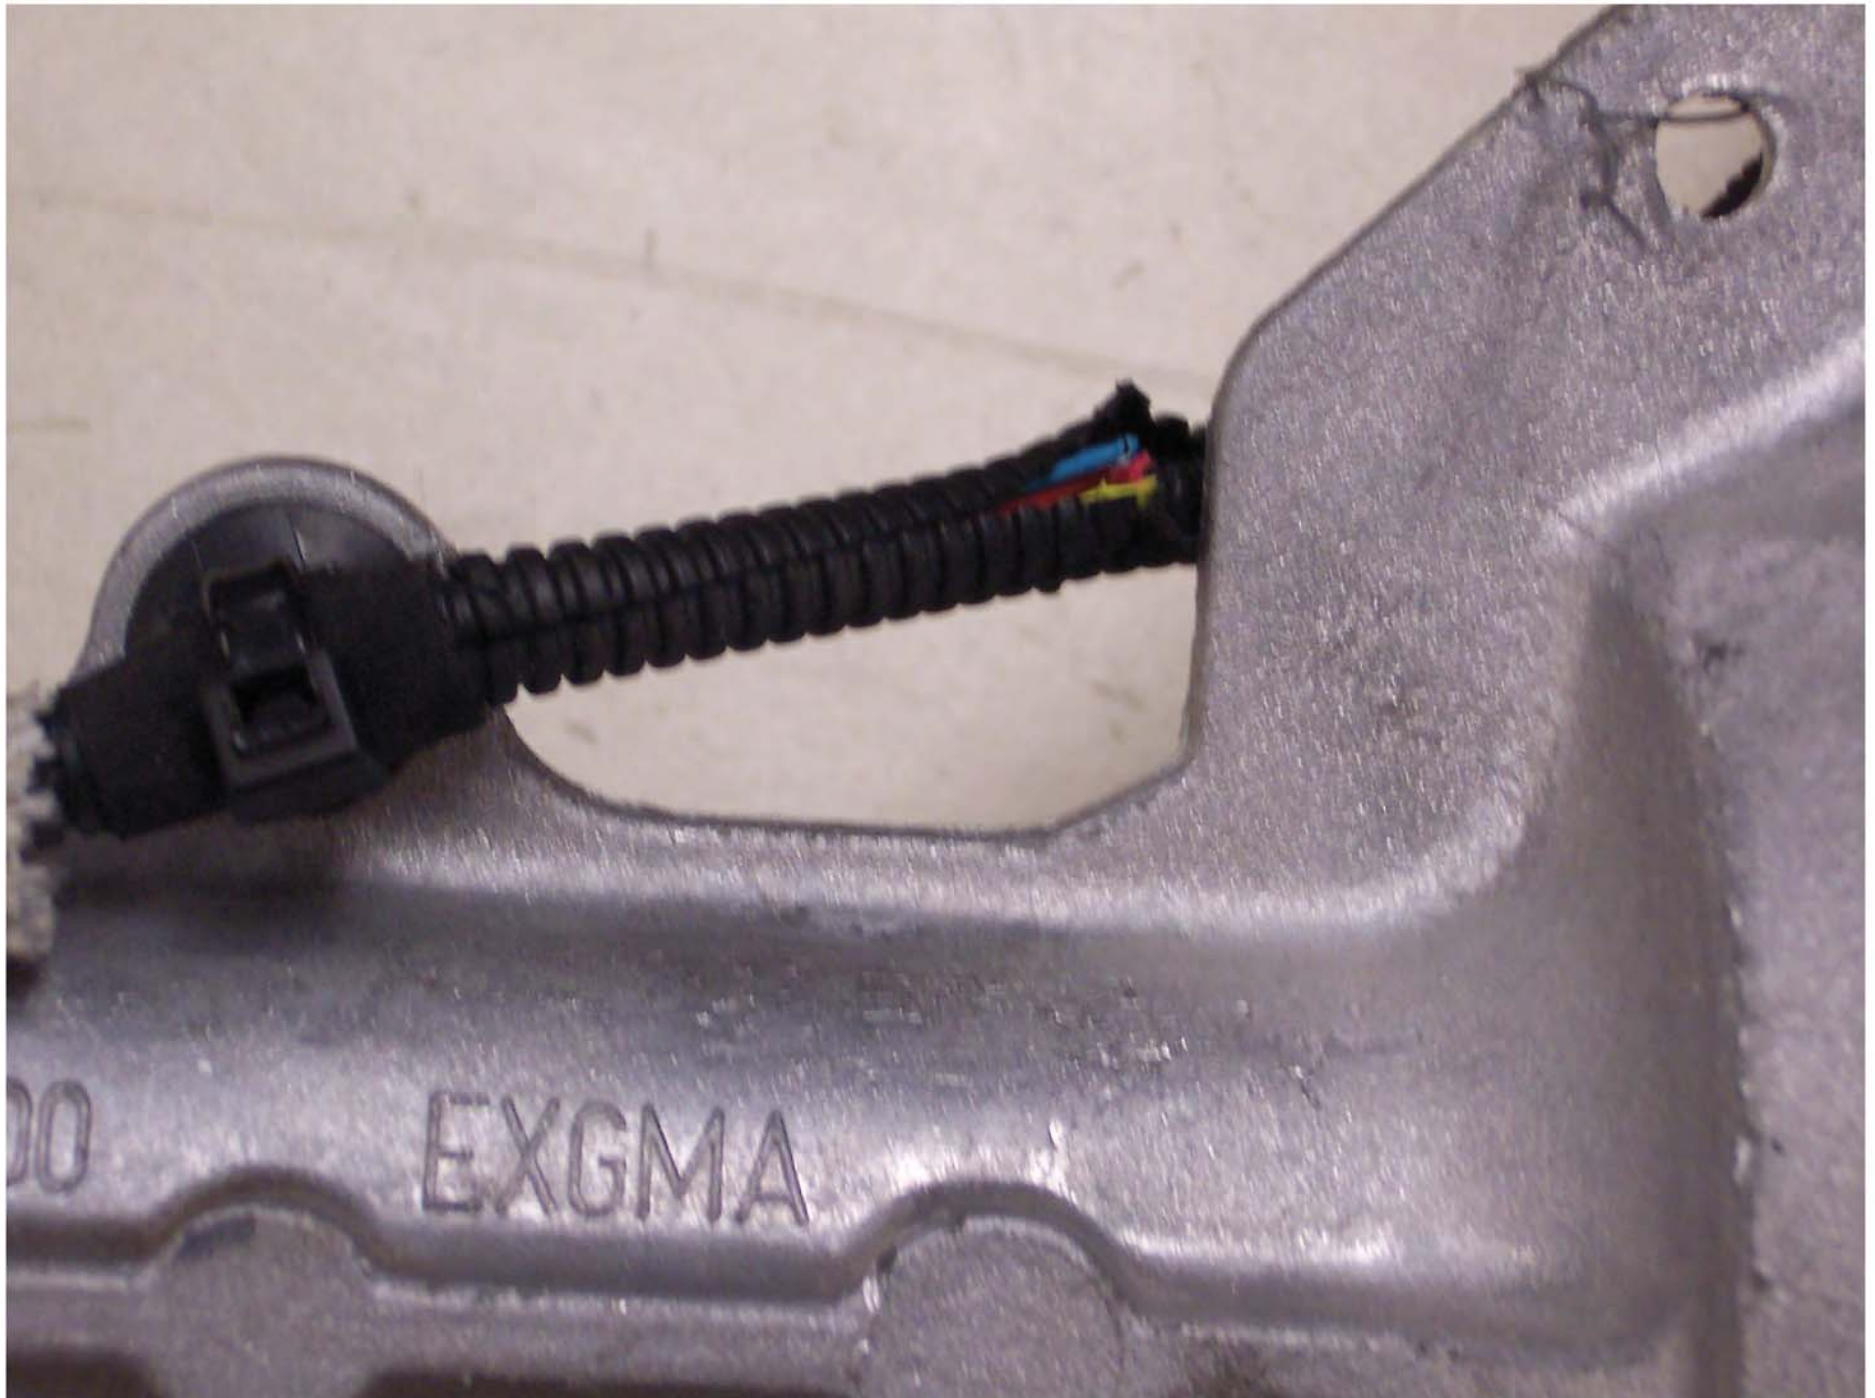
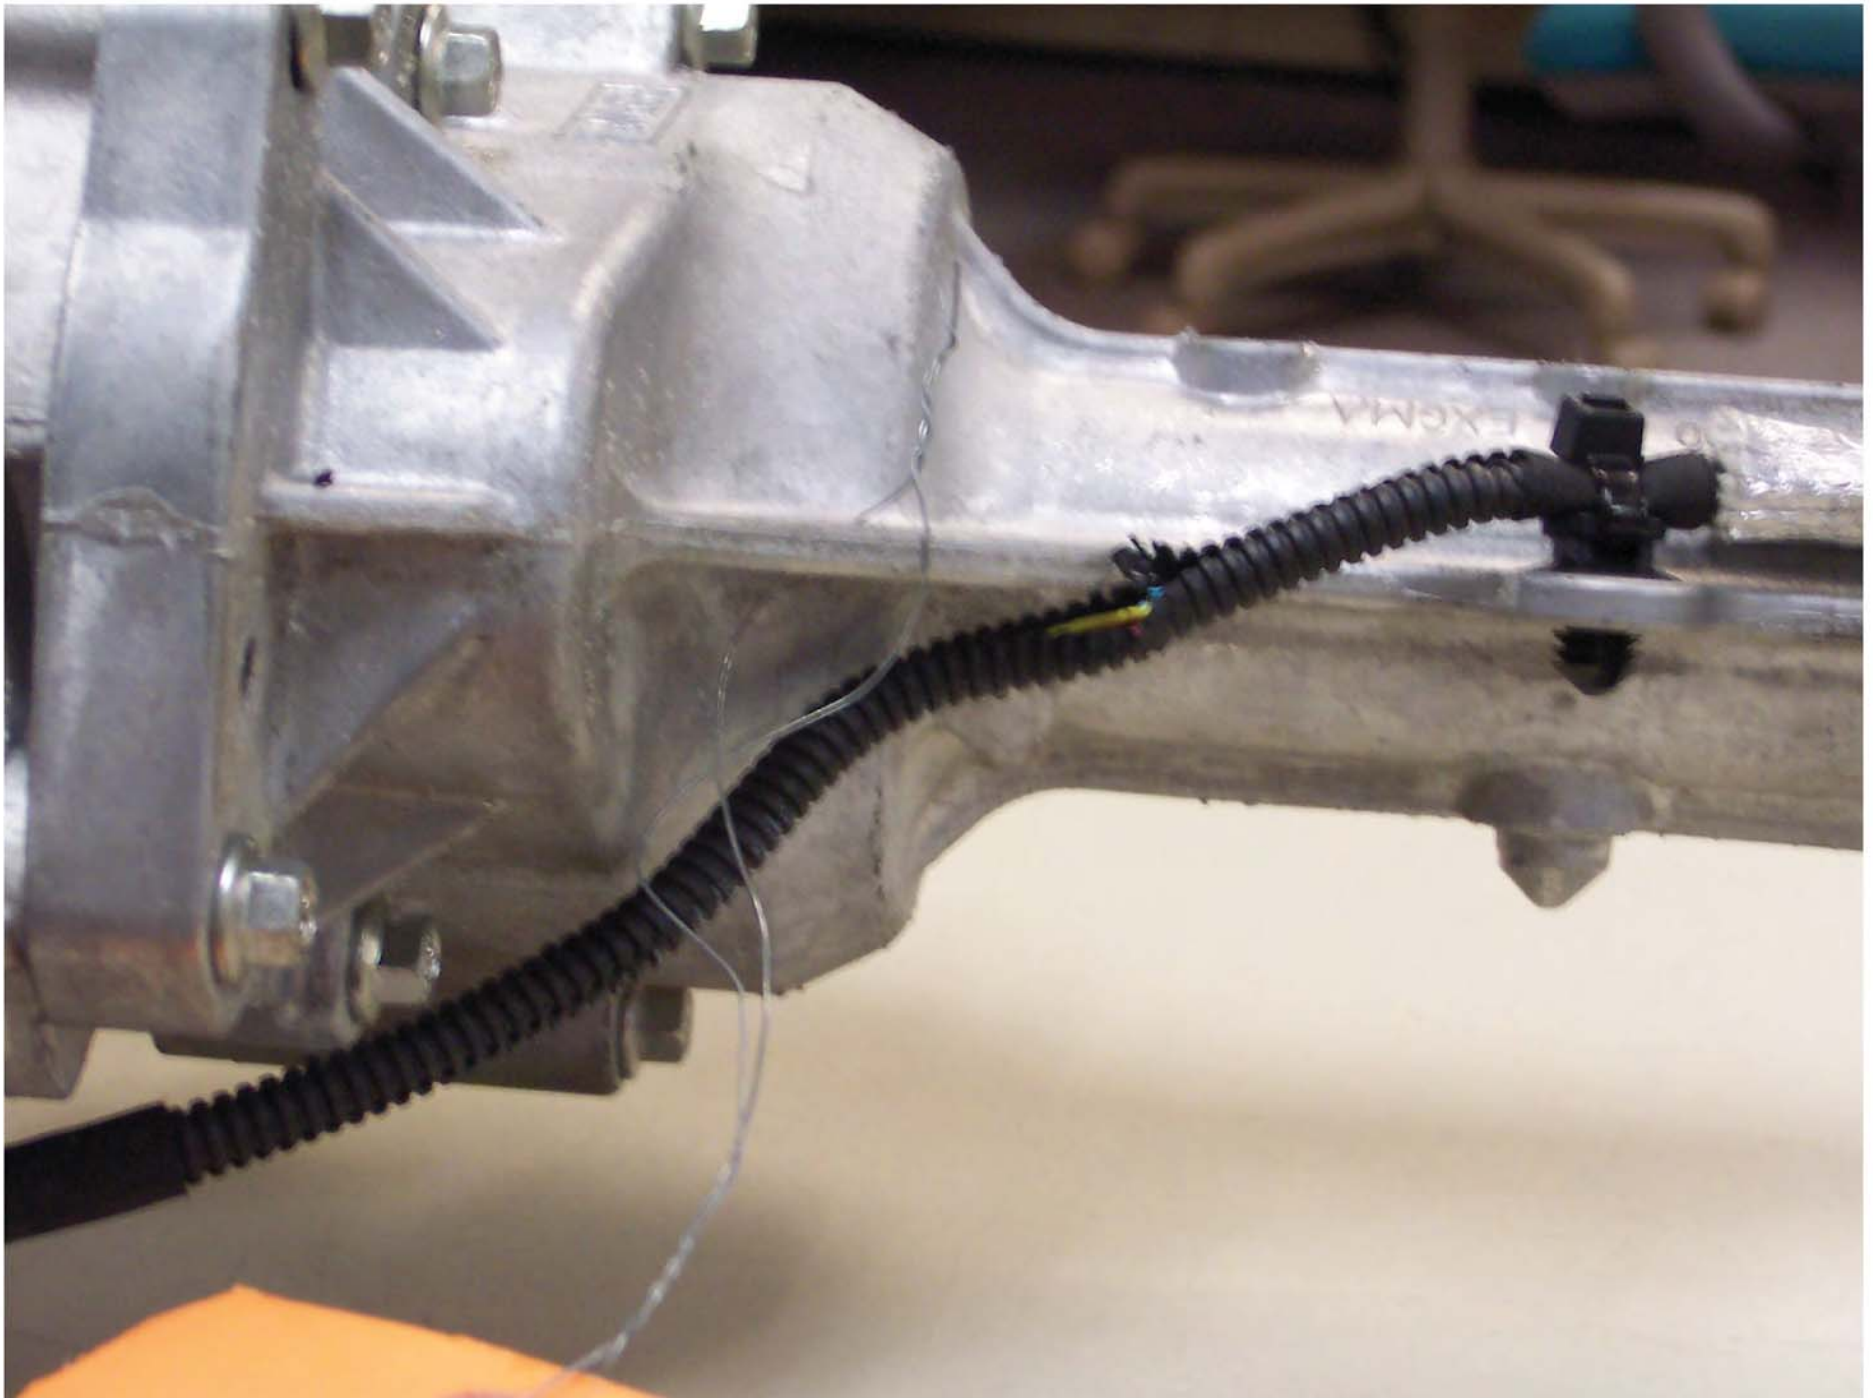
From: Estes, Eric (E.E.)
Sent: Thursday, January 28, 2010 7:45 PM
To: Bahena, Miguel (Mike.); Snider, Tim (T.O.); Diez, Timothy (T.P.); Mrozek, Robert (R.M.)
Subject: FR0123 TS damage
Attachments: FR0123 - Damaged TS harness.pdf; EPAS Gear 001.jpg; EPAS Gear 002.jpg; EPAS Gear 003.jpg; EPAS Gear 004.jpg; EPAS Gear 005.jpg; EPAS Gear 006.jpg

This is one we did not have time for in yesterday's TS meeting but not sure if we can close this out since the dealer cut-out the evidence of a damaged TS harness. See attachments for pics & the interactive diagnosis. Vehicle was not in a wreck or had other repairs only came in for this complaint and the vehicle has 22k miles so unsure how this TS harness was damaged.
