PE14-032

HNDA

12-19-2014

Title: CBR250 Insufficient valve clearance causes engine to cut out with clutch disengaged
(Valve clearance adjust NG)

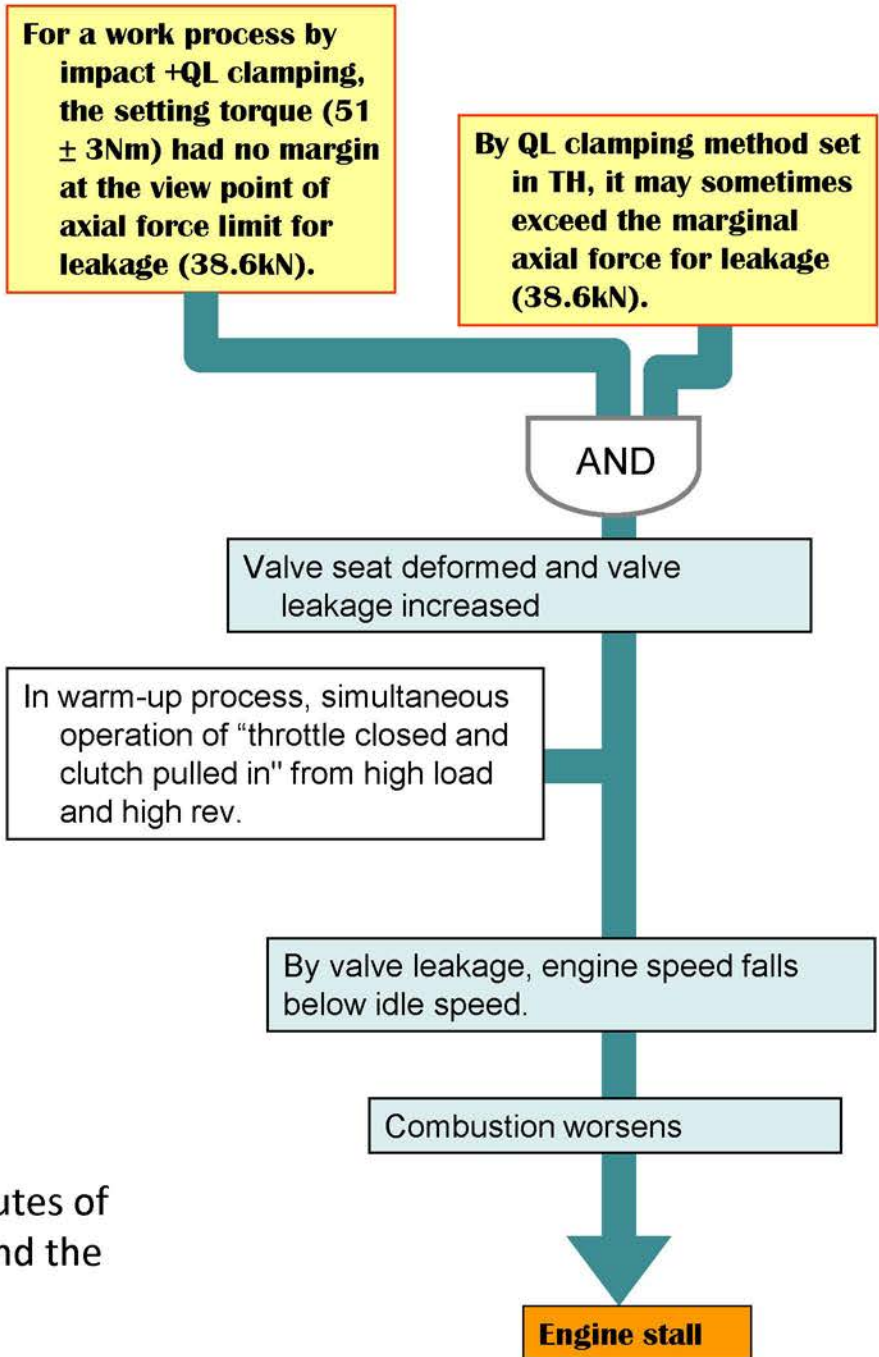
- The tightening torque of the cylinder Head ($51 \pm 3\text{Nm}$) had no margin for limit axial force before leak occurs (38.6kN). Thus, depending on manufacturing variation in tightening the cylinder head at the manufacturing plant, there are instances in which axial force may exceed the leak limit (38.6kN).

- The failure may happen intermittently within 10 minutes of engine start-up while riding between 3000-8000rpm and the clutch is disengaged for an extended period of time.

- The failure occurs during warm-up immediately after an engine start. Even if the engine stalls, rapid deceleration or irregular vehicle behavior will not occur, and there will be no change in deceleration feeling. The engine can be started by operating the starter switch and engaging the clutch.

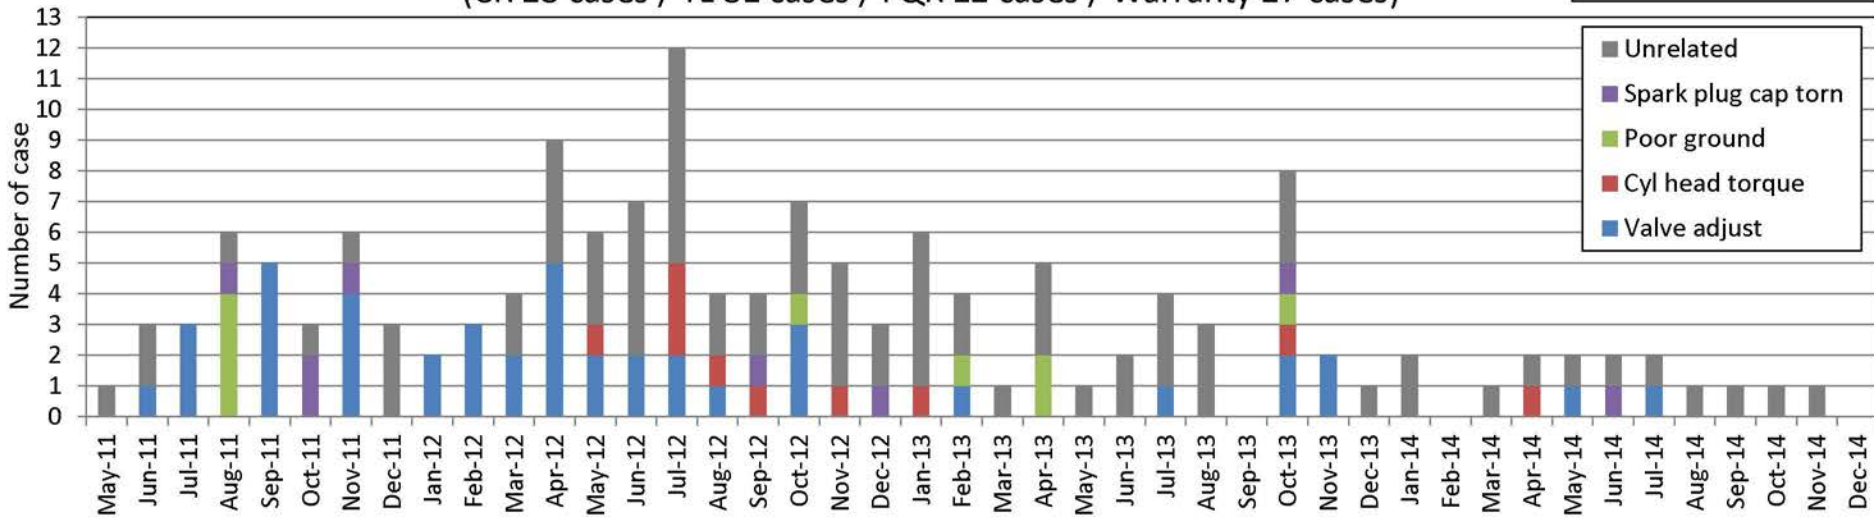
All engine stall cases while the vehicle is under way (CR 28 cases / TL 81 cases / FQR 12 cases / Warranty 27 cases)

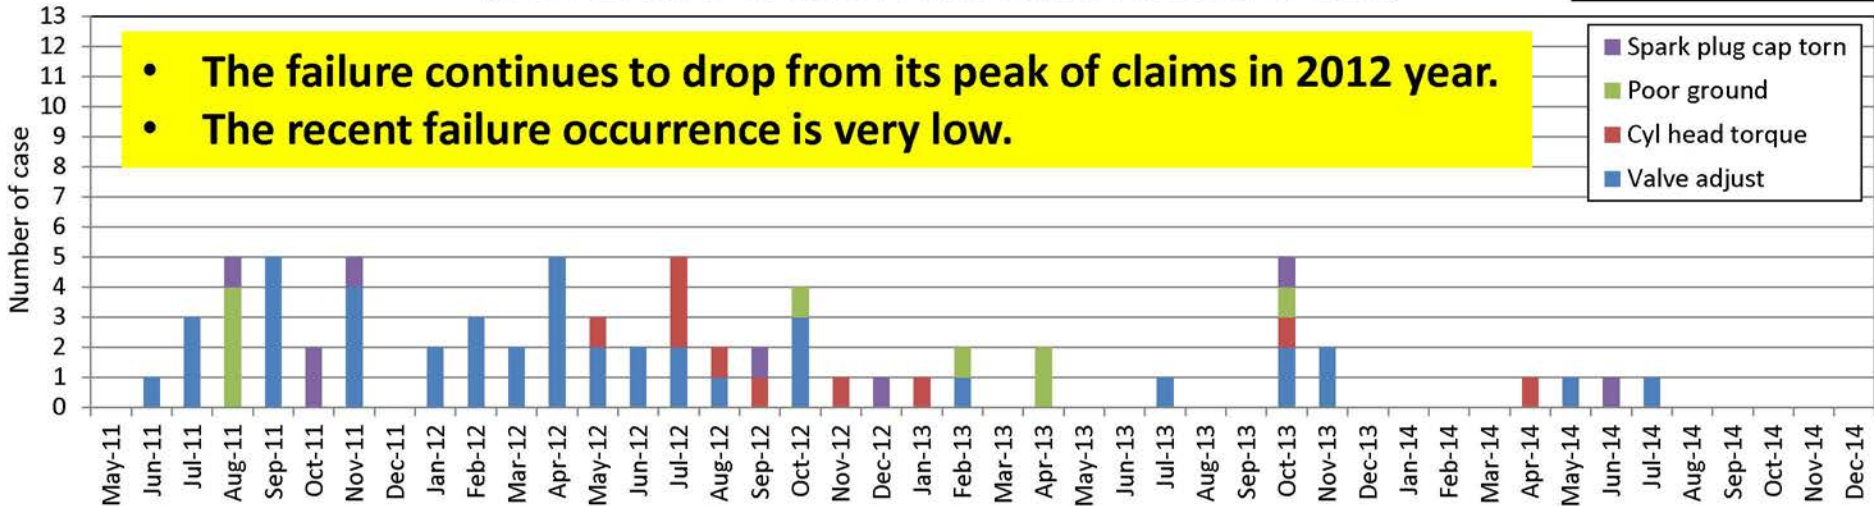
Unrelated cause is excluded

Engine stall cases while the vehicle is under way on 4 causes (CR 11 cases / TL 35 cases / FQR 8 cases / Warranty 16 cases)

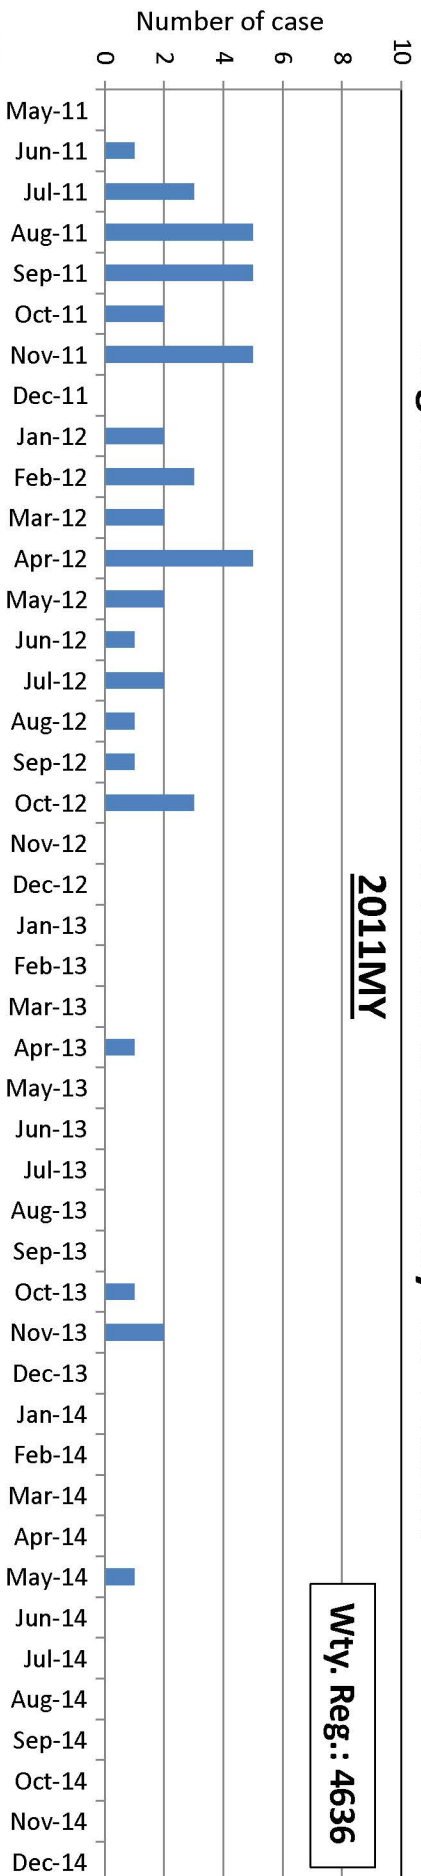
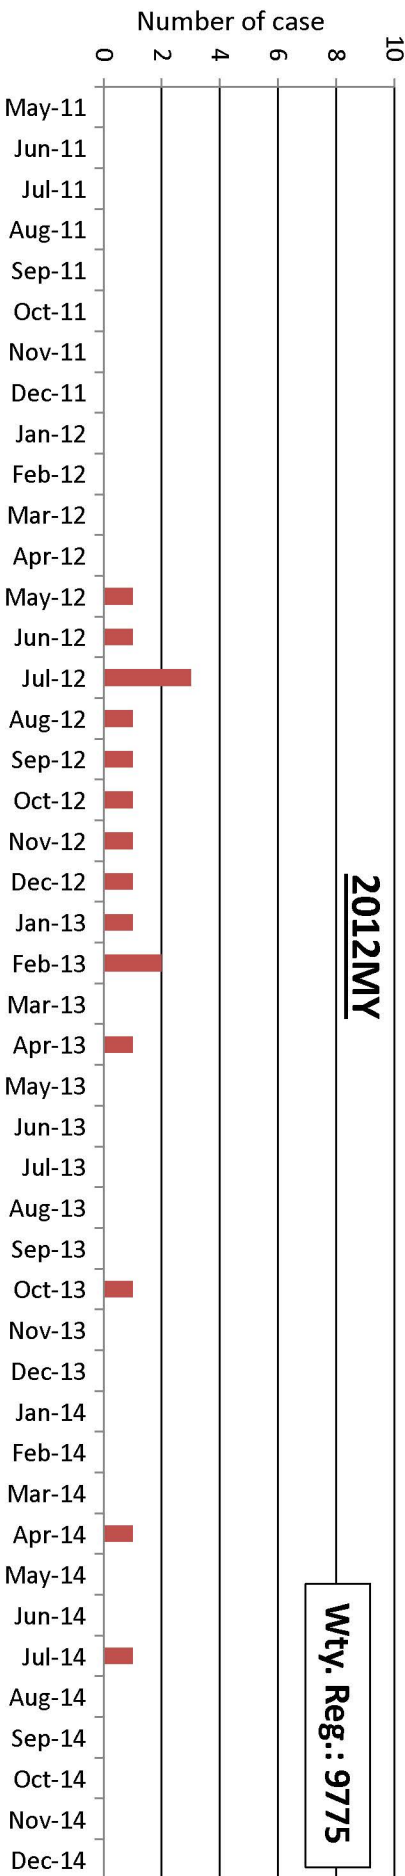
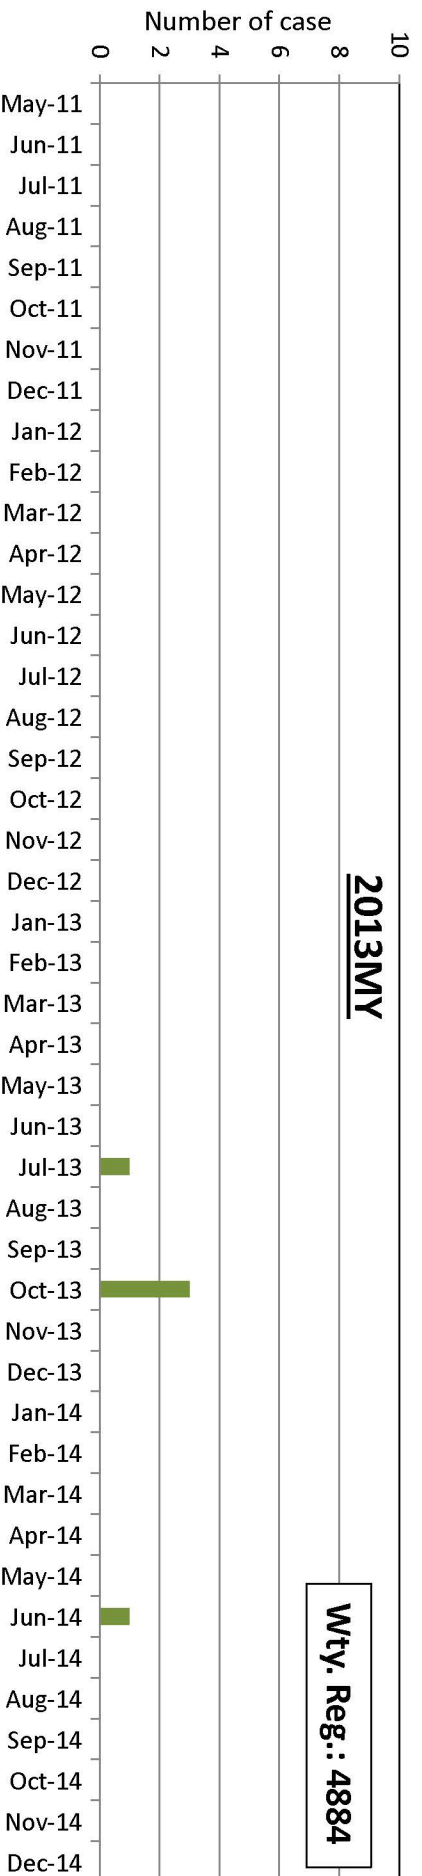
Occurrence trend by vehicle model year

Engine stall cases while the vehicle is under way on 4 causes

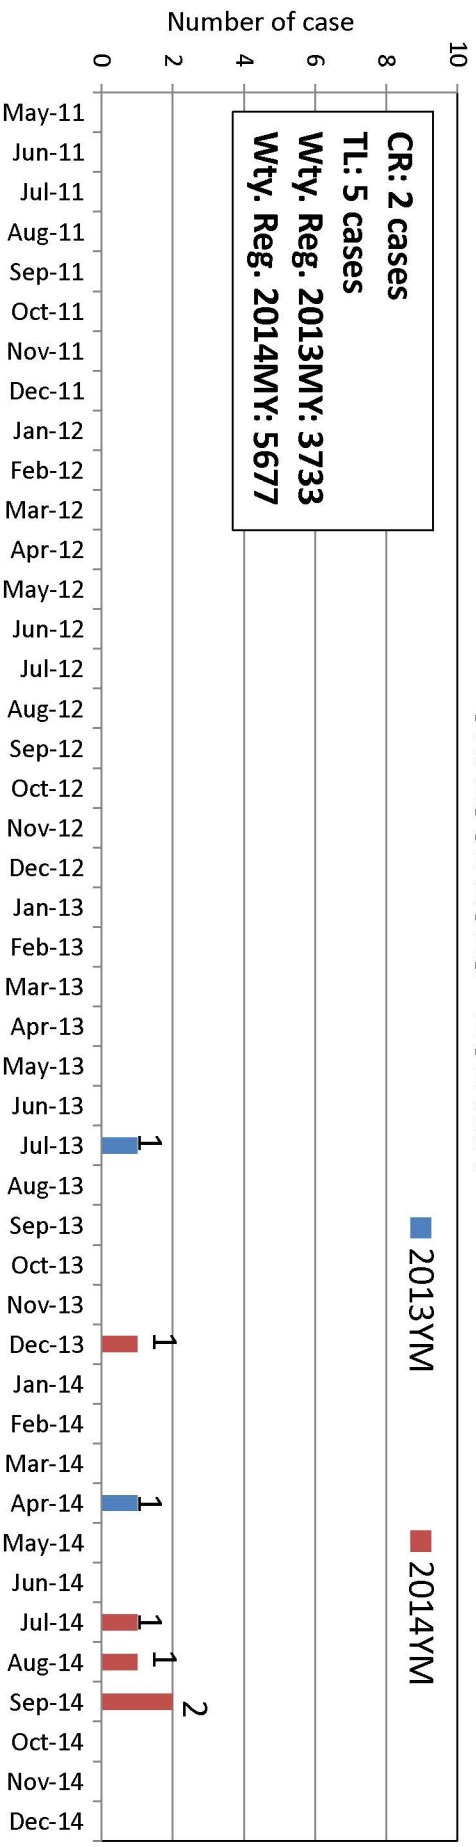
CRF250L 2013 - 2014MY

All engine stall cases while the vehicle is underway

Compared to similar motorcycle Honda CRF250L, engine stall case is same level, which indicates that recent occurrence is quite low level.
