PE14-032

HNDA

ACTUAL PLACE VISIT
REPORT REDACTED PG 38

GQM REDQACTED PAGE 58

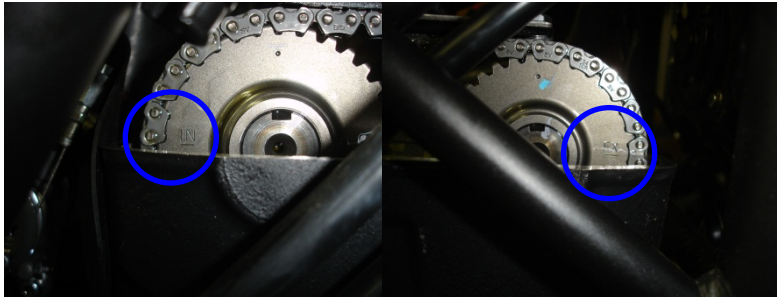
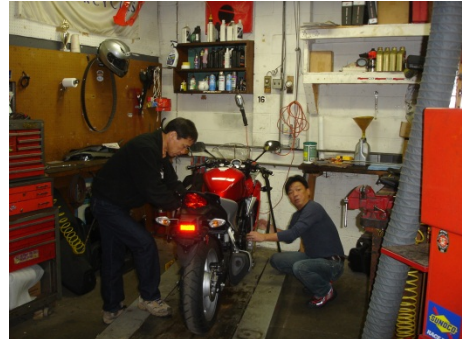
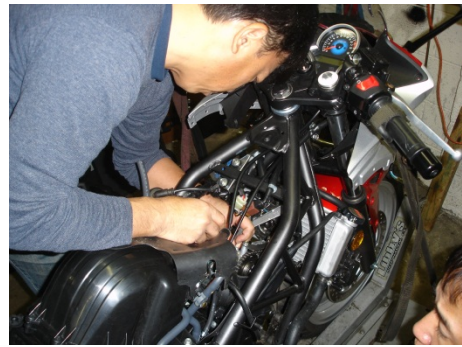
▪ Valve Timing was normal

▪ Plug Cap did not have any cracks or damage

▪ grounding wire condition was normal

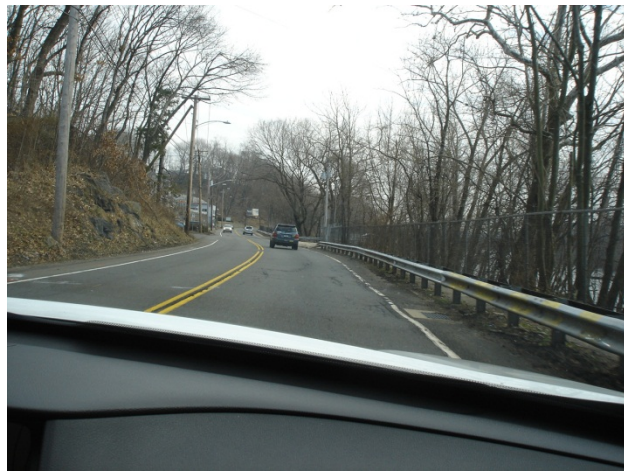
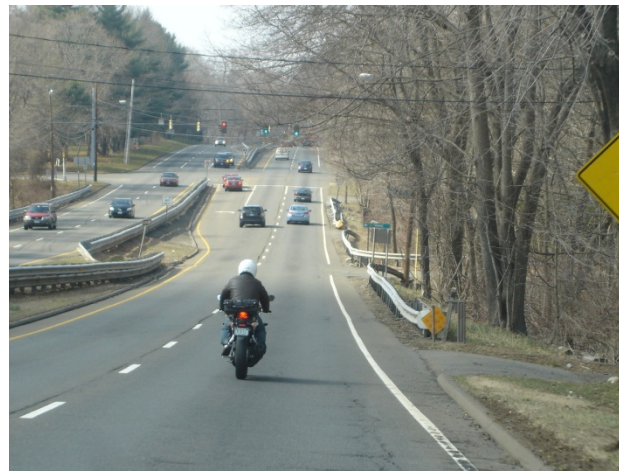
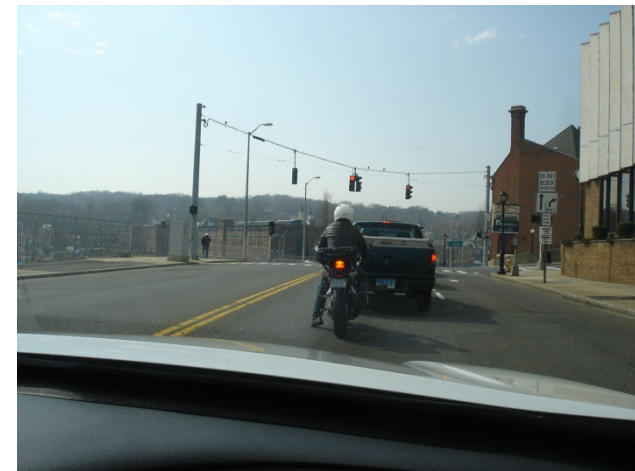
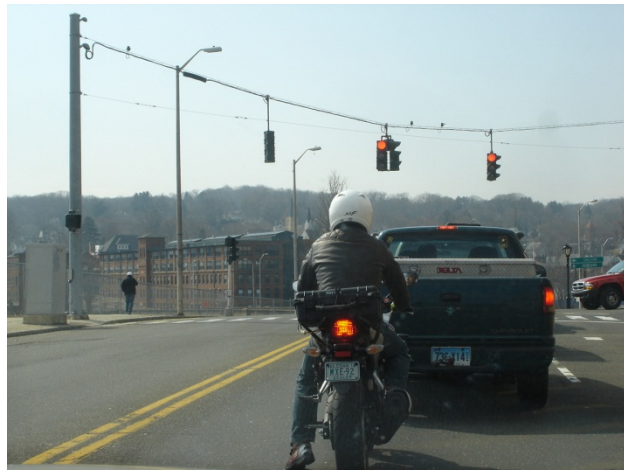
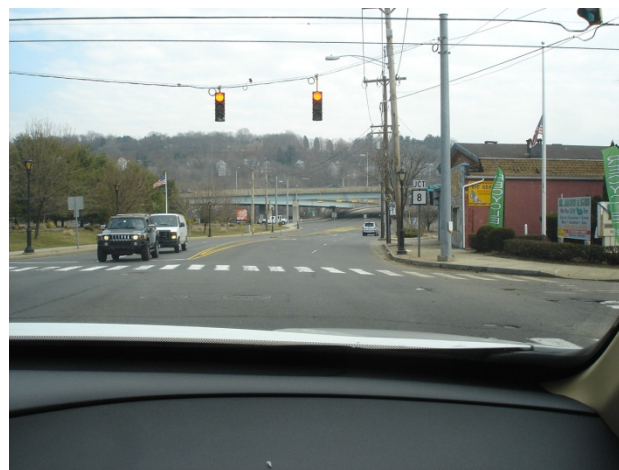
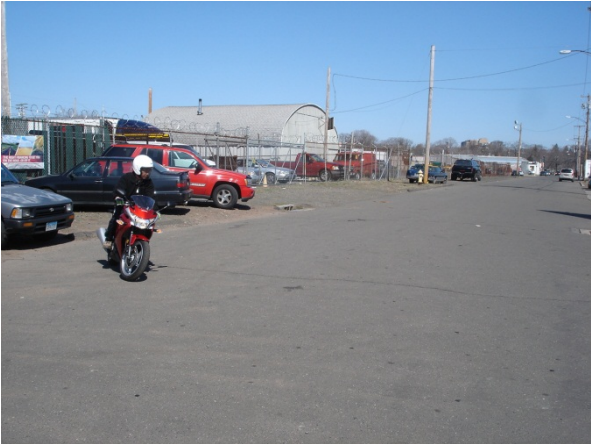
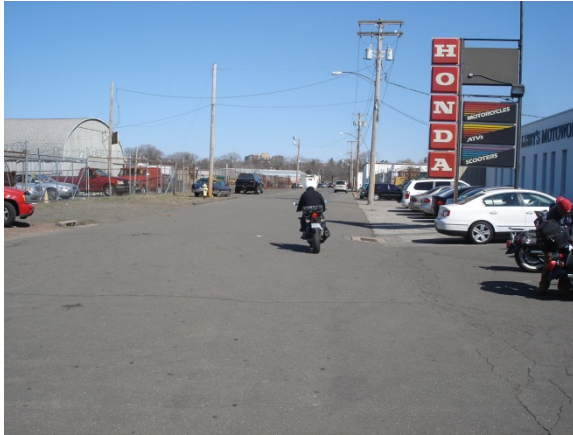
A running test was performed on the same road as the complaint. The outside temp. is about 58F~64F, with a distance of about 5.2miles up and downhill with traffic lights. The running test was performed with about 60 miles following the same steps as described in the allegation. The engine stall was not able to be recreated.

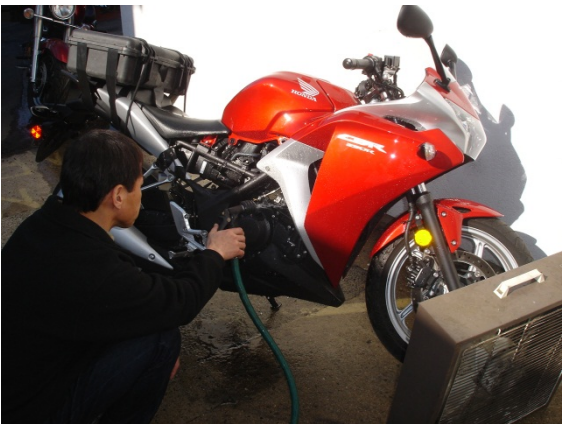
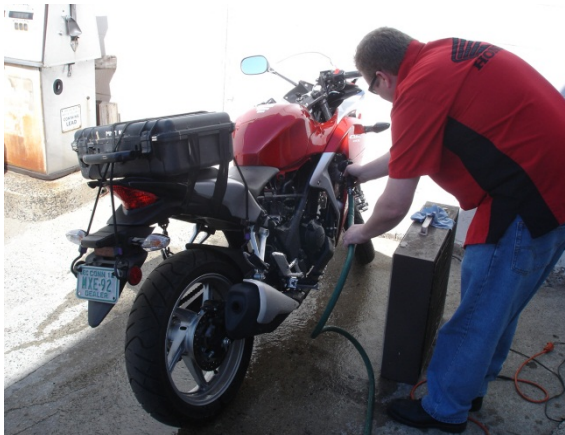
Test Place : Hardfolk
Test in front of the dealers
shop , clear, dry
Outside temp. 14°C~17°C

Not to able get the distance between the actual place and the customer's home, and because of the need to keep the engine cool, decided to perform a running test on a private road near the dealer.

Engine Stall – Not Found

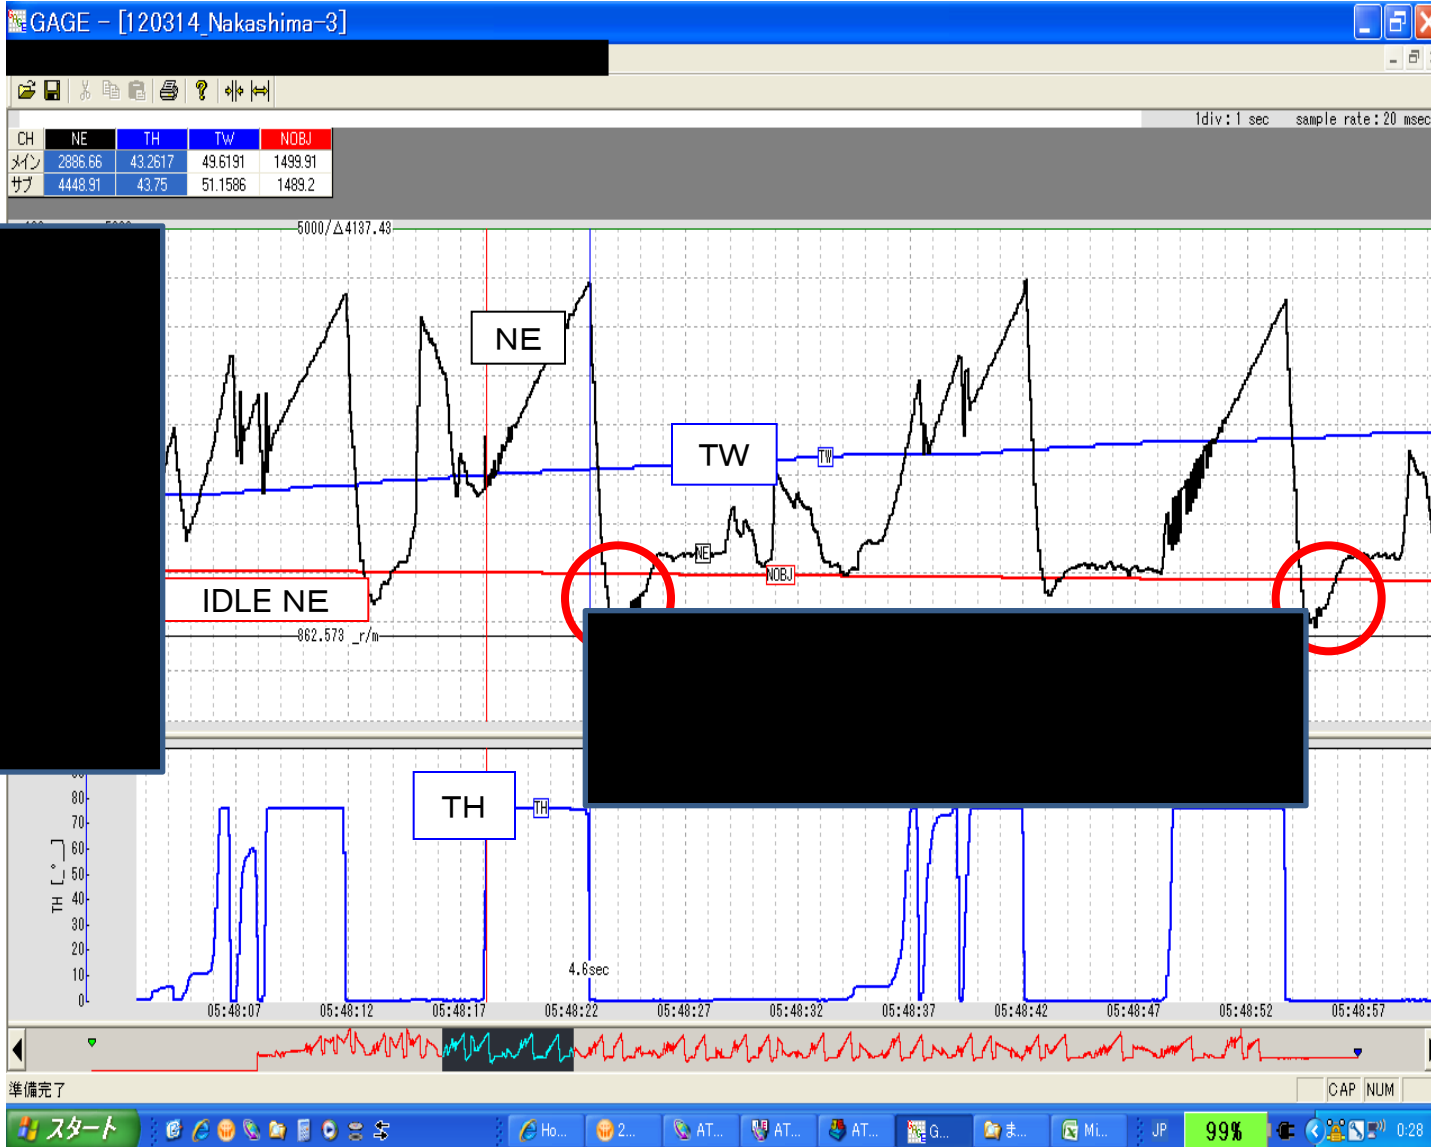
Perform test with the same condition – 3 times.

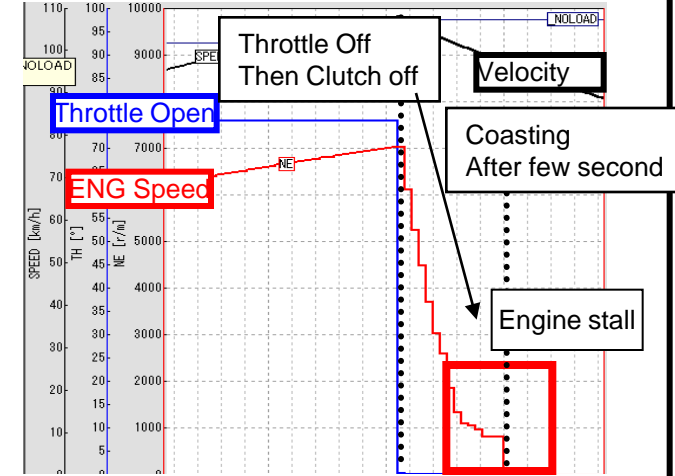
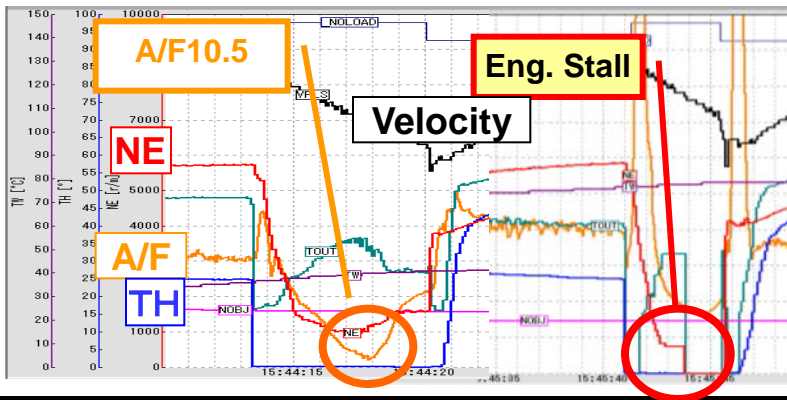
TW:23~85°C
 Gear Position : 6th
 Clutch disengage
 at 70~90km/h
 (7,000r/min)
 Temperature: 10°C
 0.5sec/div

T.Water : less than 40°C, T.Oil : less than 25°C	T.Water : 40~82°C, T. Oil : 25~60°C	T.Water : Over 85°C, T.Oil : Over 60°C
Eng Stall	No	Yes	No
A/F	10.5	unkown (may be less than 10.5)	13

CBR Engine Stall occurs both at the same time the clutch disengage to coasting with the throttle fully closed from the Engine high speed range.

- The idling Speed drops below 1450r / min in the warm-up process, A/F becomes rich, occur engine Speed drop and engine stall.
- Engine stall has occurred in the Range in the middle of completion of the warm-up of the Oil Temperature 25 ~ 60 °C.

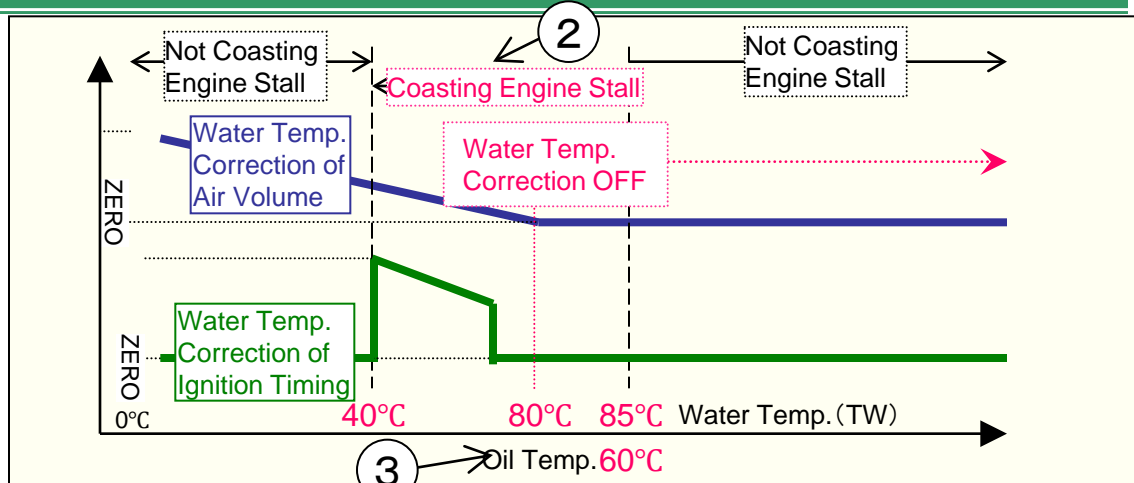
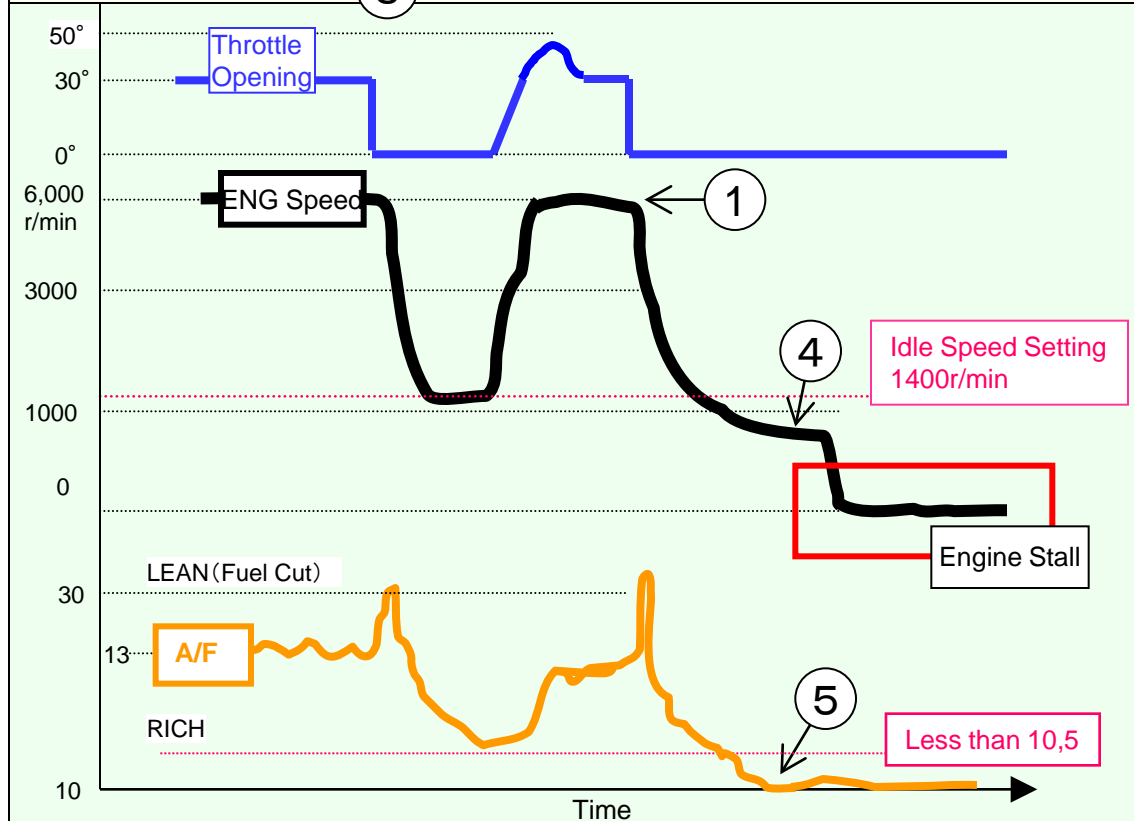
⑤ Worsening Combustion by Over Rich (A/F less than 10.5)

Coasting Engine Stall

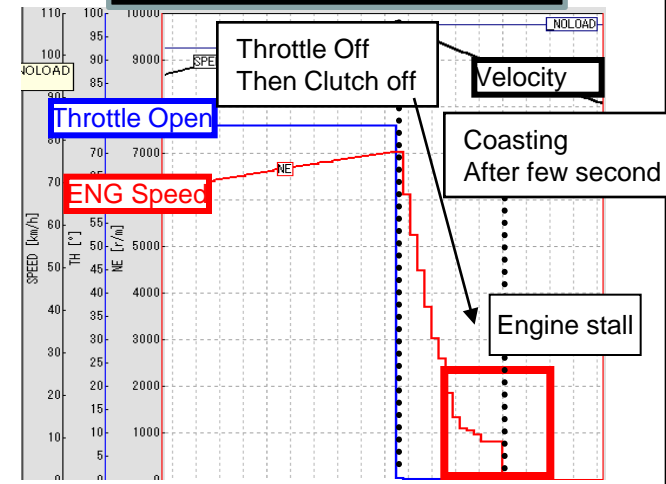
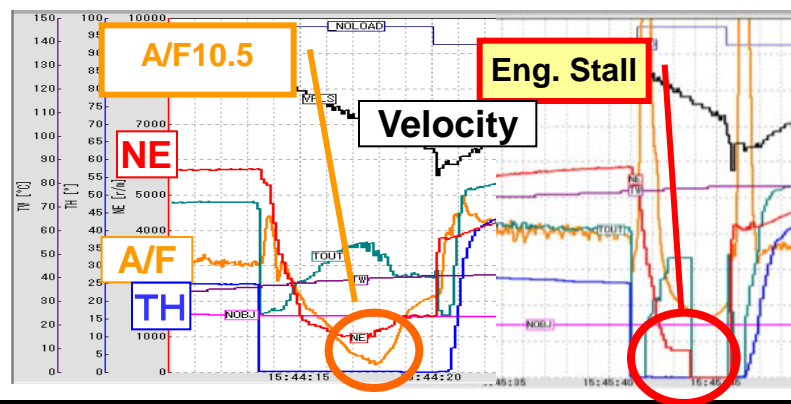
CBR250R (MC41)

TW:23~85°C
 Gear Position : 6th
 Speed : Clutch disengage at 70~90km/h (7,000r/min)
 Temperature : 10°C
 0.5sec/div

T.Water: less than 40°C, T.Oil: less than 25°C	T.Water: 40~82°C, T. Oil: 25~60°C	T.Water: Over 85°C, T.Oil: Over 60°C
Eng Stall	No	Yes	No
A/F	10.5	unkown (may be less than 10.5)	13

- Engine Stall occurs at the same time the clutch disengage to coasting with the throttle fully closed from the Engine high speed range.
- No occurrence of engine stall in a state the clutch engage.
- Restart after engine stall is easy.
- The idling Speed drops below 1450r / min in the warm-up process, A/F becomes rich, occur engine Speed drop and engine stall.
- Engine stall has occurred in the middle of completion of the warm-up of in the Range the Oil Temperature 25 ~ 60 °C.

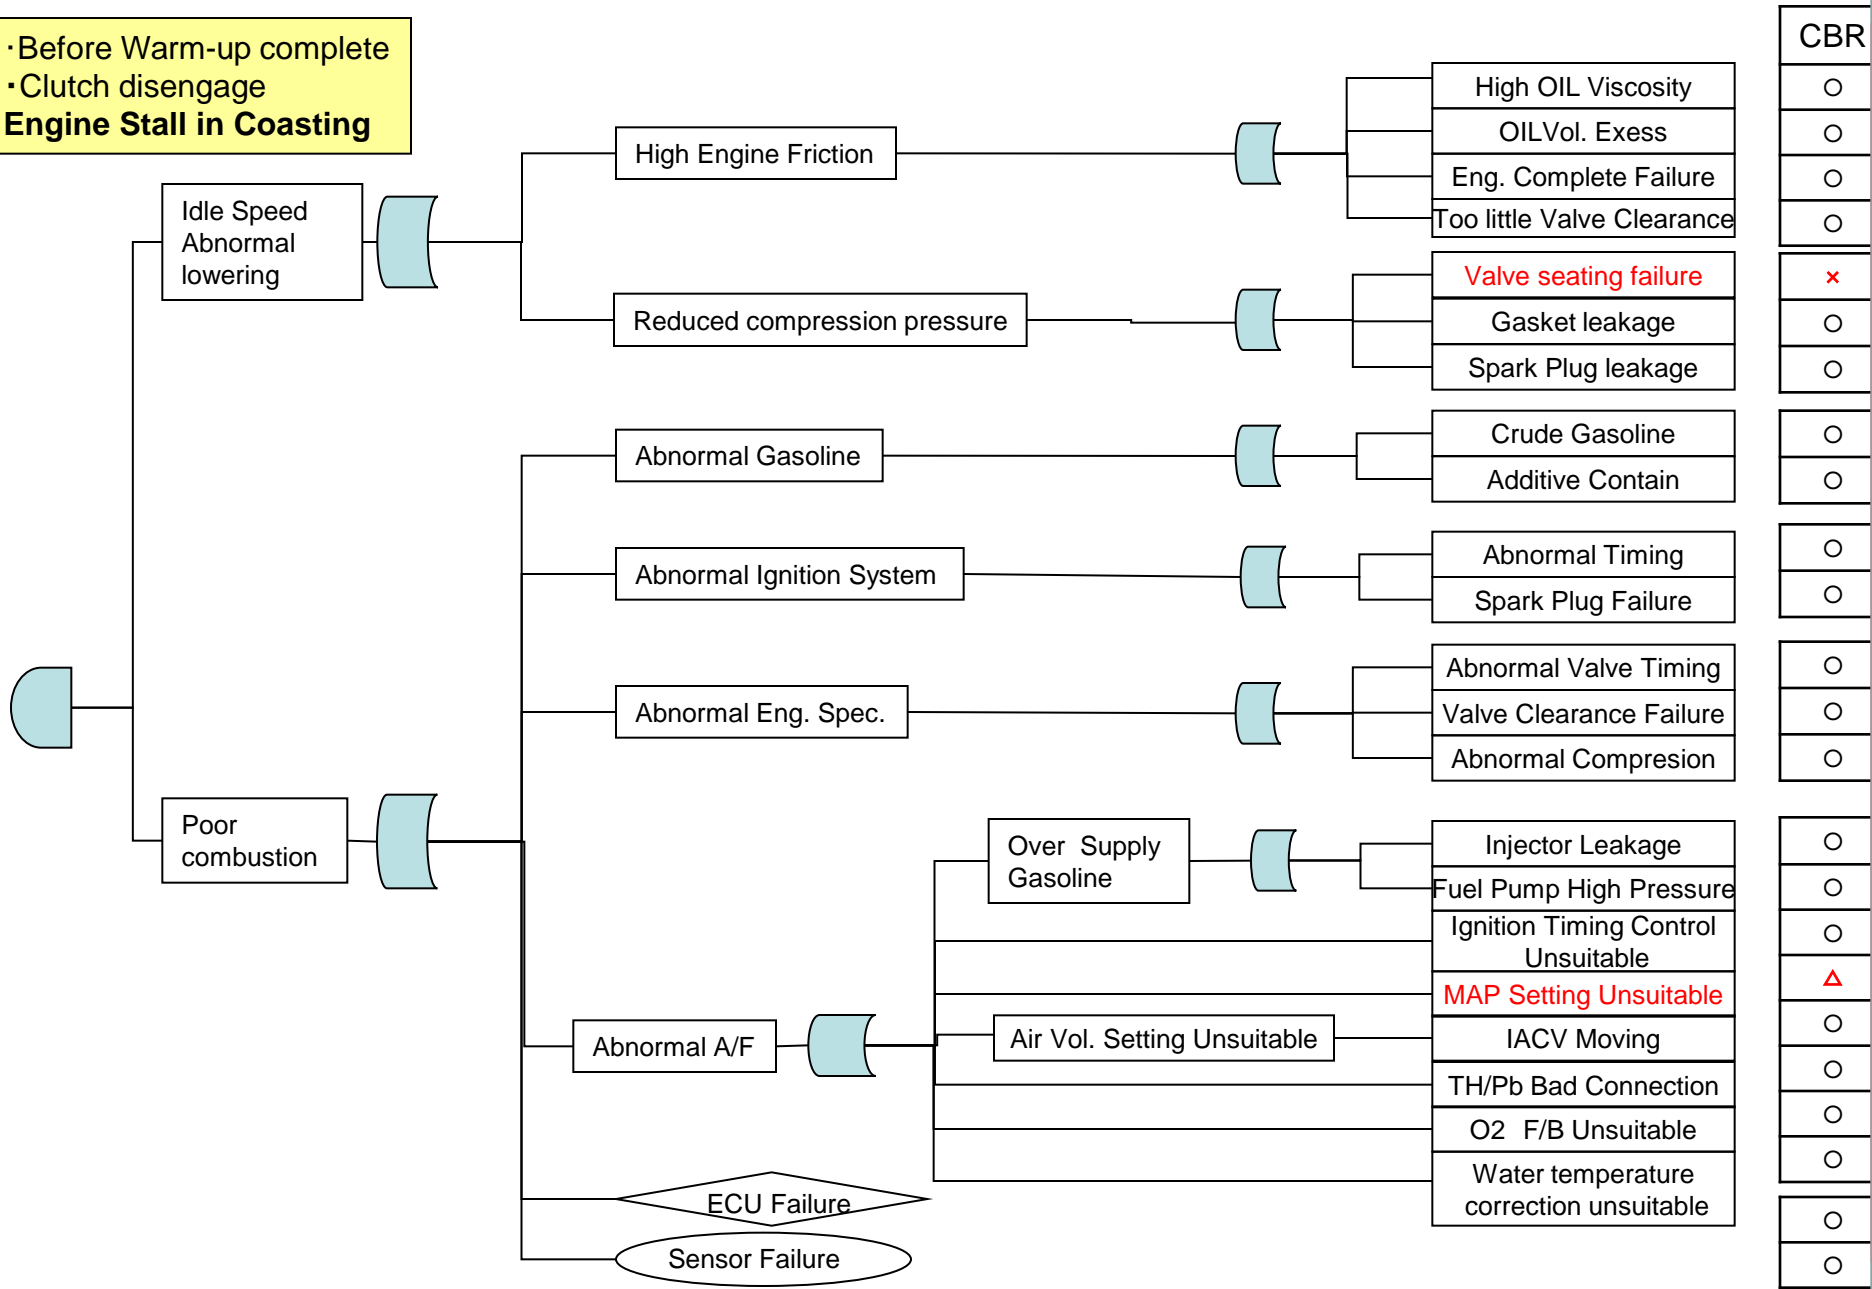
FTA

· Before Warm-up complete
· Clutch disengage
Engine Stall in Coasting

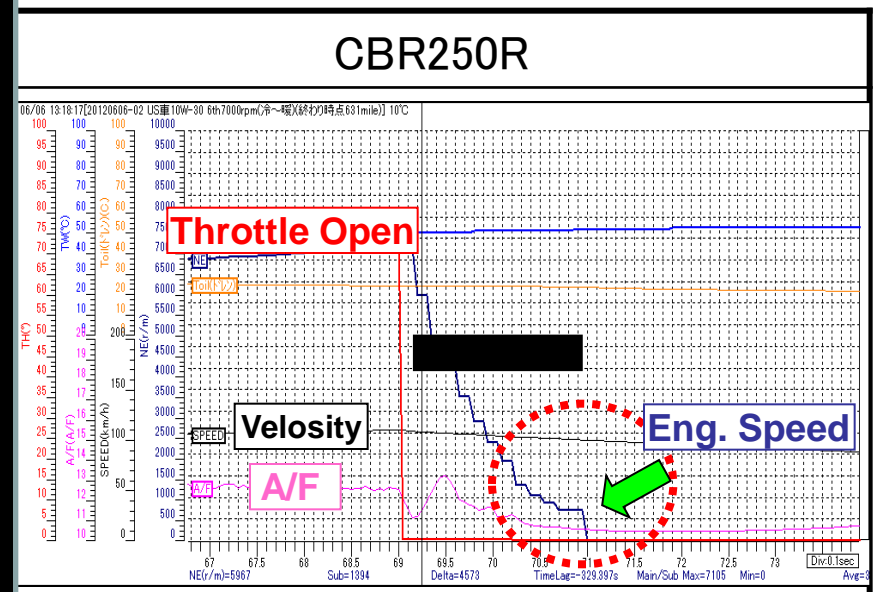
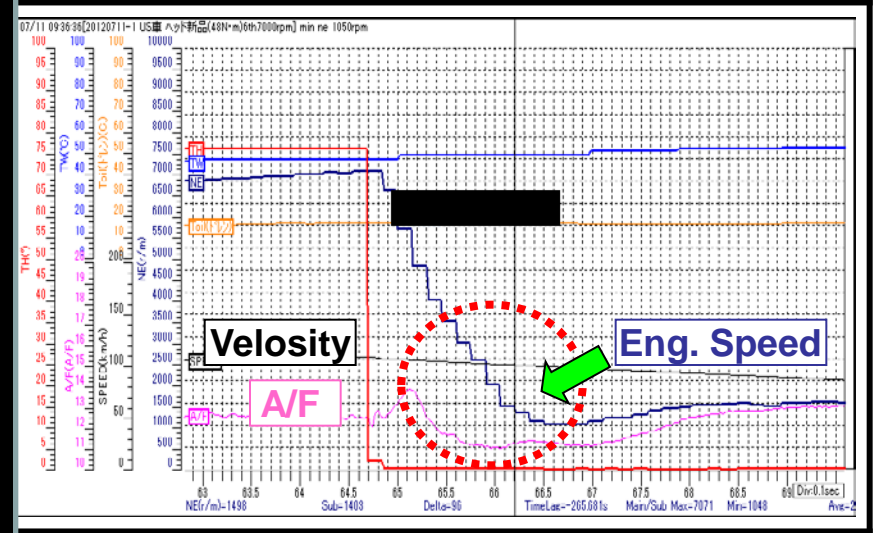
Content		CBR250R		
ENG		Change	Content	Effect
Parts and Tightening Torque Change		①Cylinder Head ②Stud Bolt ③、④Cylinder/Head Gasket ⑤Nut ⑥Washer ⑦Tightening Torque	New ↑ ↑ ↑ ↑ 51N·m →48N·m	Improve distortion of cylinder Head and Eng. Assy. Leakage by Tightening Torque Excessive
		/

Both [redacted] and CBR, the introduction of countermeasure specification, is no longer the occurrence of engine stall

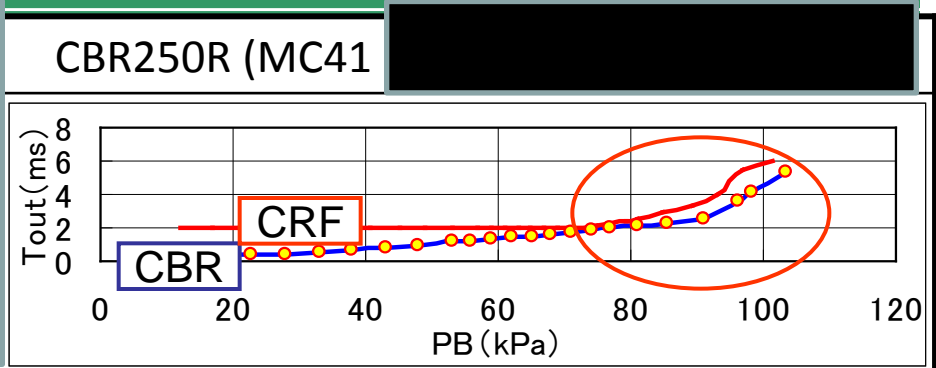
4. Analysis Result Fuel setting lean/ Comparison Head tightening torque

Eng. Stall	BuyBack	No ○	—	Yes ×	—	Yes ×
	New	—	No ○	—	No ○	No ○
Eng. Speed	BuyBack	900r/min 11.1	—	980r/min 11.2	—	970r/min 11.2
er dropping	New	—	1,050r/min 11.2	—	1,230r/min 11.8	1,160r/min 11.8
leakage volume (m ³ /min @20kPa)	BuyBack	236	—	434	—	1,700
	New	—	79	—	580	610
Head tightening torque		40N·m	48N·m	51N·m	54N·m	60.5N·m (Ave.)
						EX 58.7 61.1
						IN 69.3 52.8
	Ref.		Under Tolerance	Setting	Upper Tolerance	Buy Back

- CBR250R leak amount is reduced and not stall occurs Lowering the tightening torque of the head attached clamping by Overspecified.
- CBR250R is stalling does not occur in the exchange to the new head.

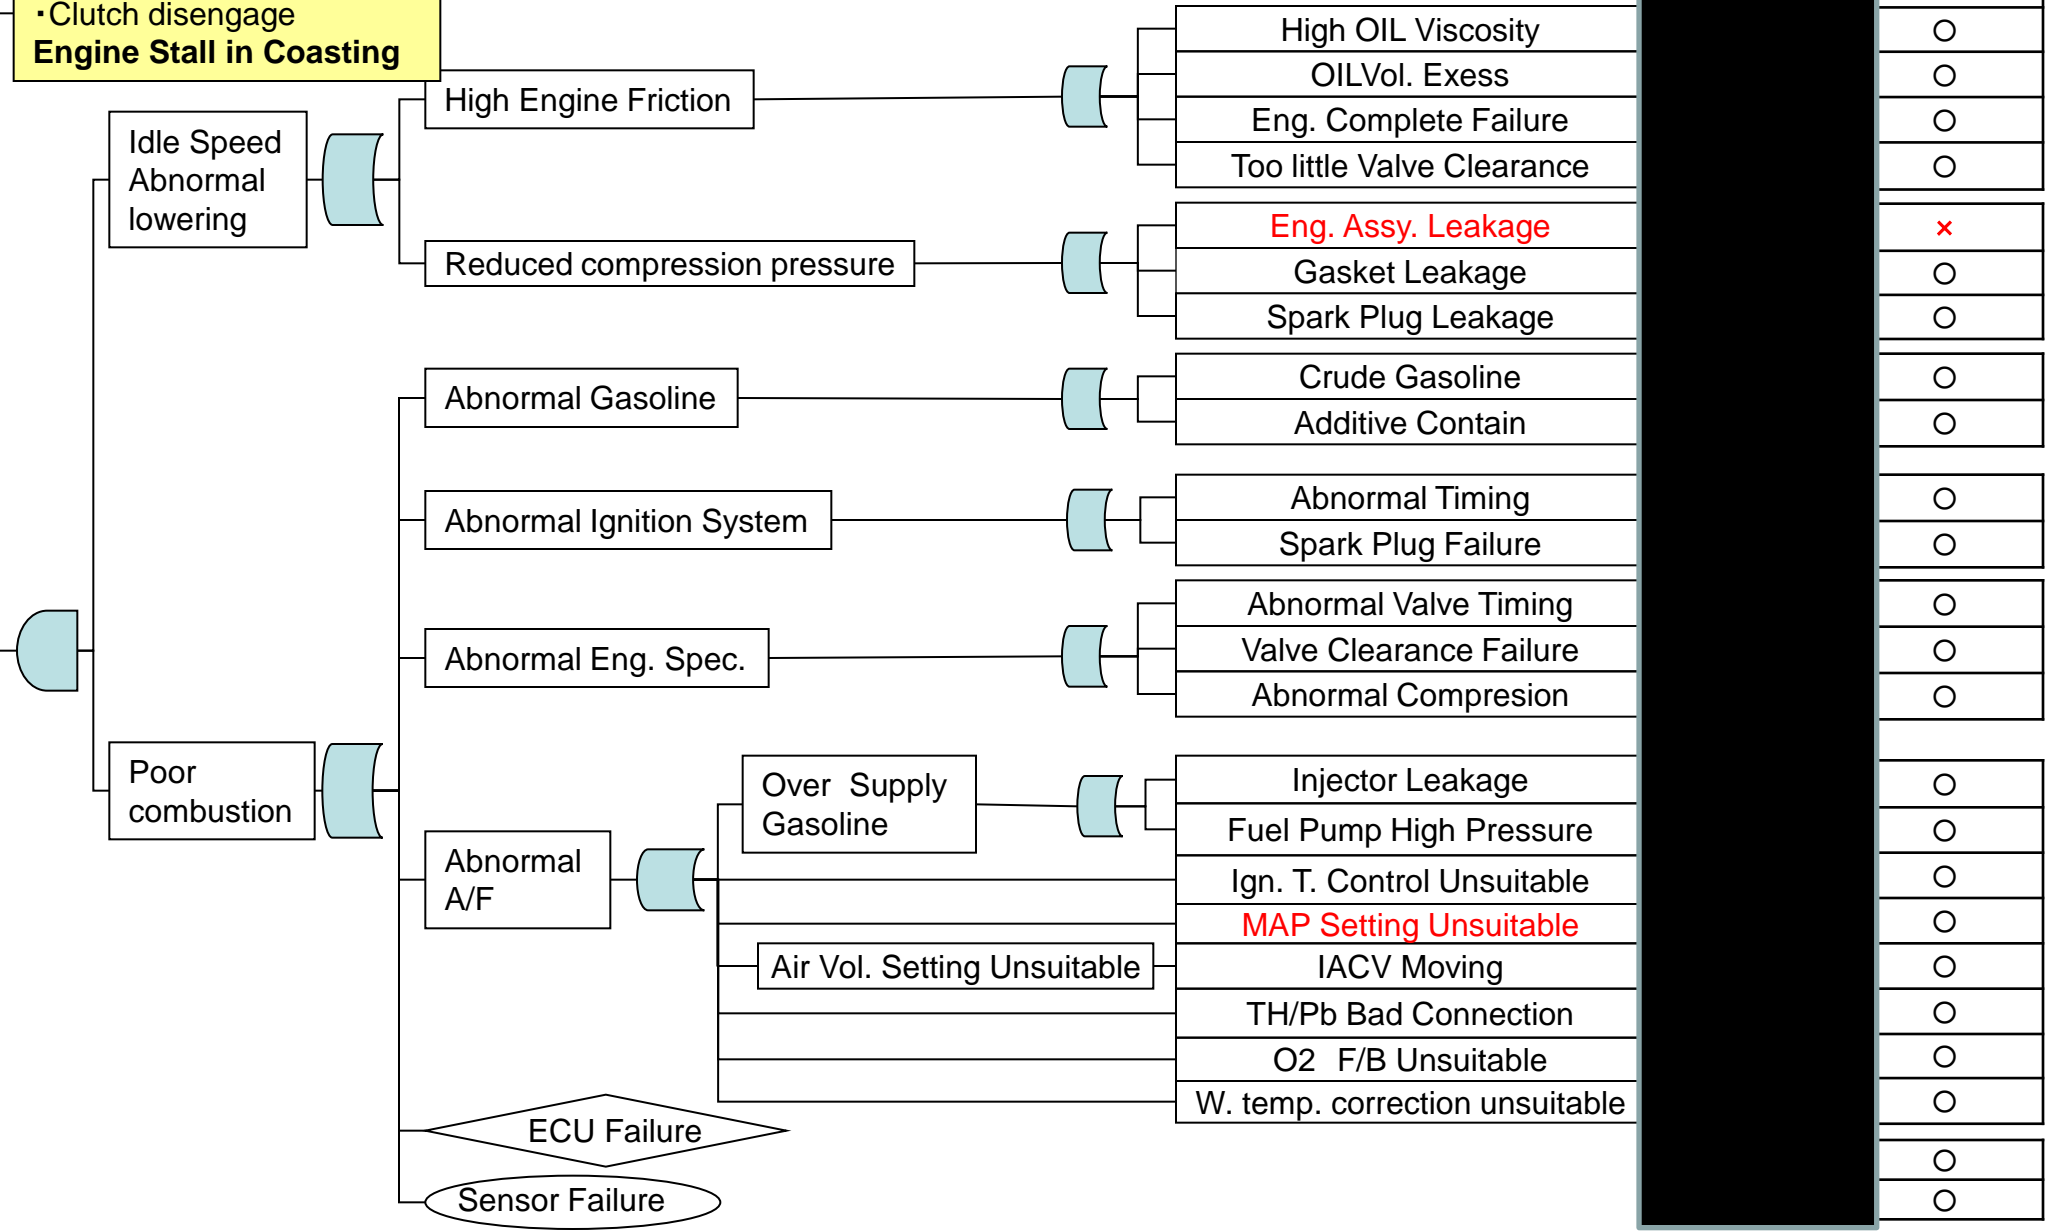
· Before Warm-up complete
· Clutch disengage
Engine Stall in Coasting

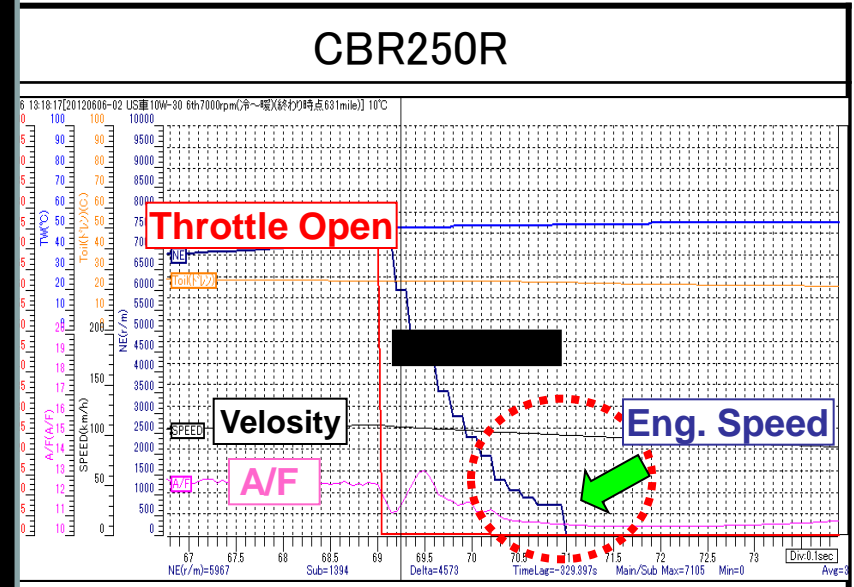
Before

Content	[Redacted]	CBR250R		
[Redacted]		[Redacted]		
[Redacted]				
ENG Parts and Tightening Torque Change	[Redacted]	Change	Content	Effect
	[Redacted]	①Cylinder Head ②Stud Bolt ③、④Cylinder/Head Gasket ⑤Nut ⑥Washer ⑦Tightening Torque	New ↑ ↑ ↑ ↑ 51N·m →48N·m	Improve distortion of cylinder Head and Eng. Assy. Leakage by Tightening Torque Excessive

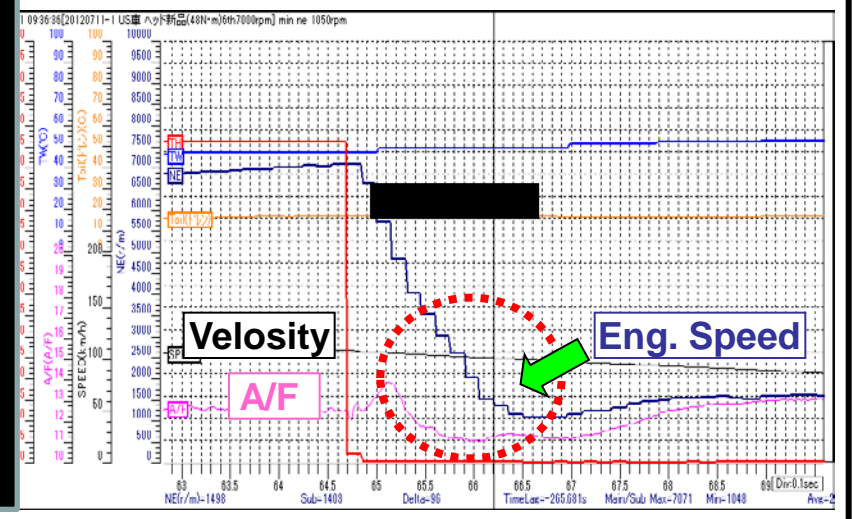
After

Both [redacted] and CBR, the introduction of countermeasure specification, is no longer the occurrence of engine stall

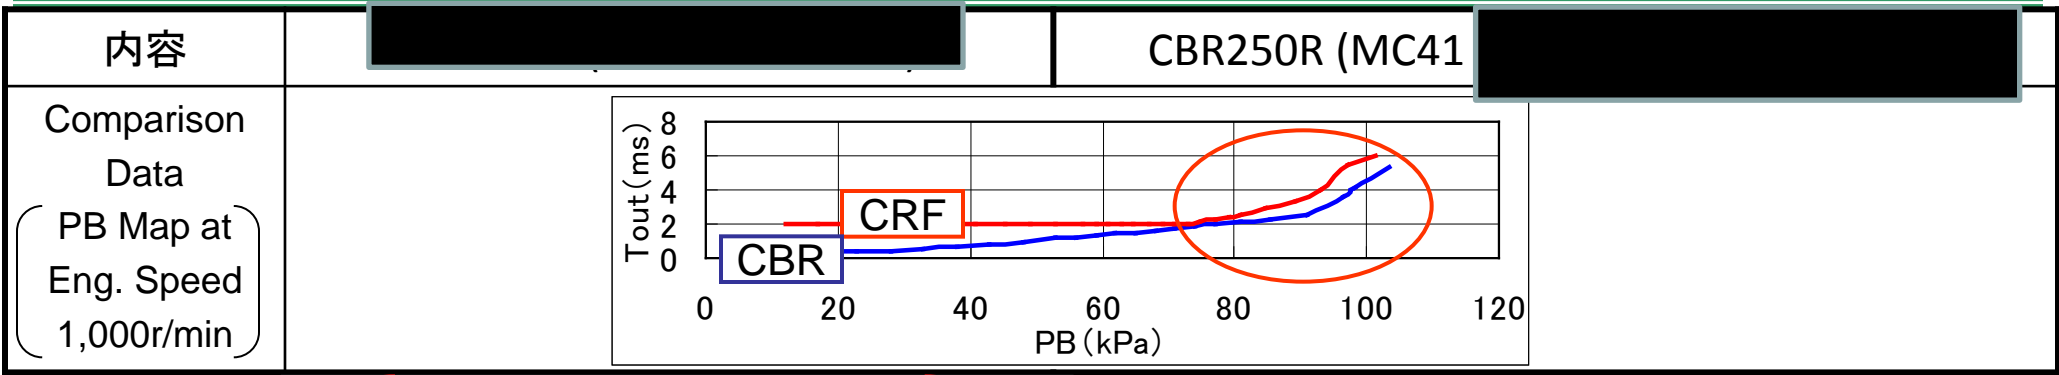
4. Analysis Result Fuel adjustment lean/ Comparison Head tightening torque

BuyBack	No	—	Yes	—	Yes									
	Eng. Stall	○	—	×	—	×									
	New	—	○	—	○	○									
	BuyBack	900r/min 11.1	—	980r/min 11.2	—	970r/min 11.2									
	New	—	1,050r/min 11.2	—	1,230r/min 11.8	1,160r/min 11.8									
	A/F	—	—	—	—	—									
CBR250R Changing Head tightening torque (Right)	BuyBack	236	—	434	—	1,700									
	New	—	79	—	580	610									
	Ref.	40N·m	Under Tolerance	Setting	Upper Tolerance	Buy Back									
	Head tightening torque	40N·m	48N·m	51N·m	54N·m	60.5N·m (Ave.)

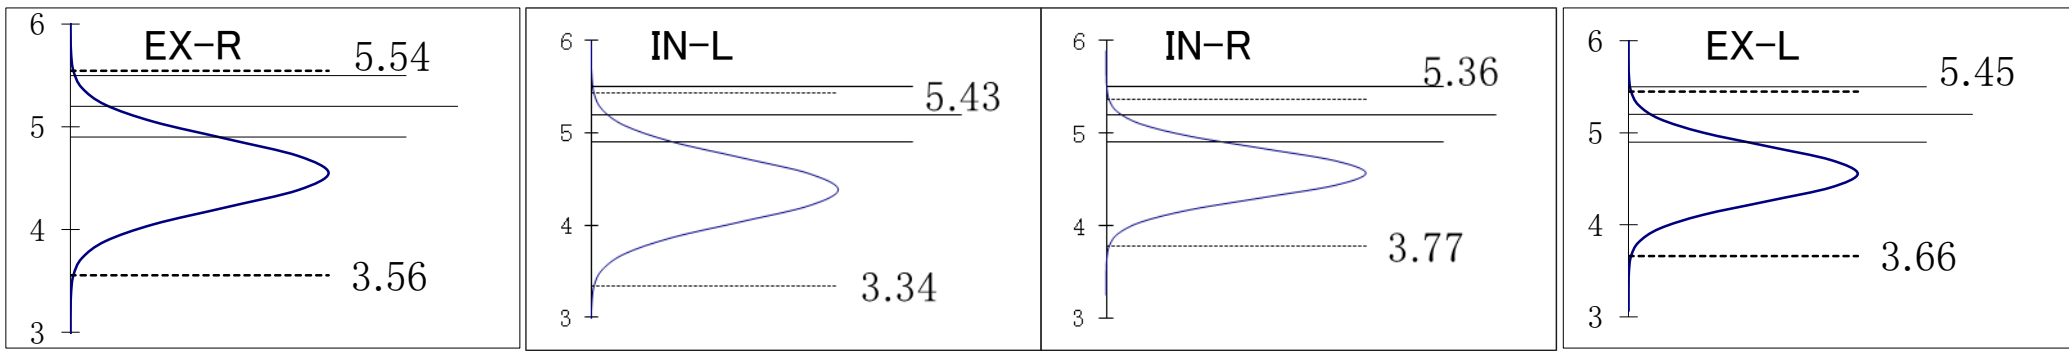
After with oil pulse wrench tighten (n=20 Unit)

4. Analysis Result CBR250R Factory line Tightening Torque Check Result

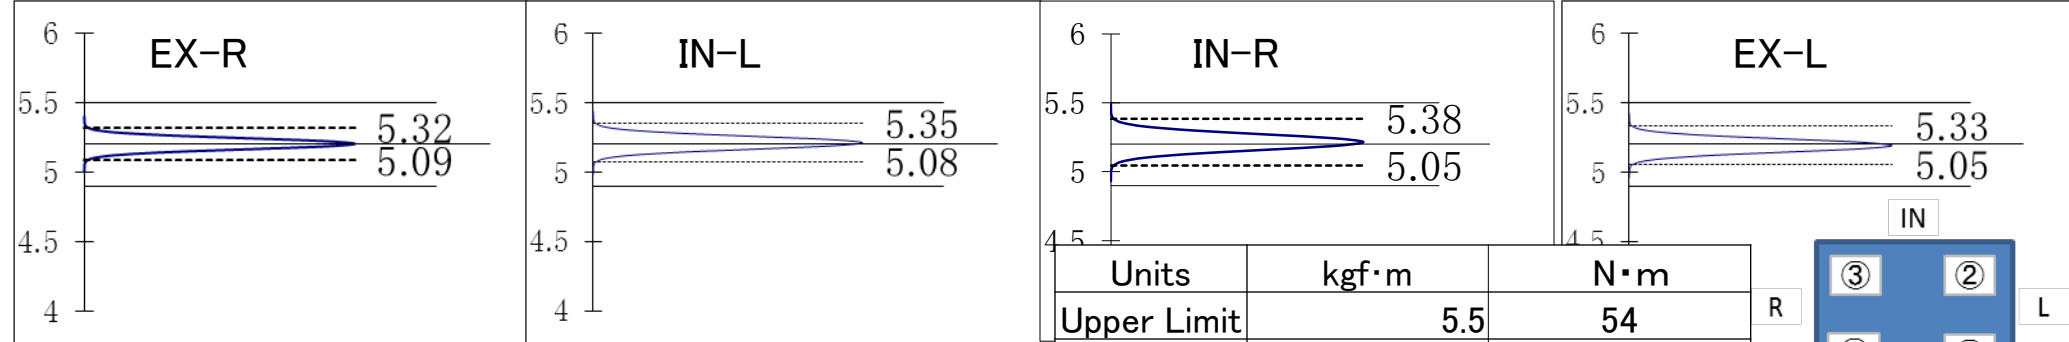
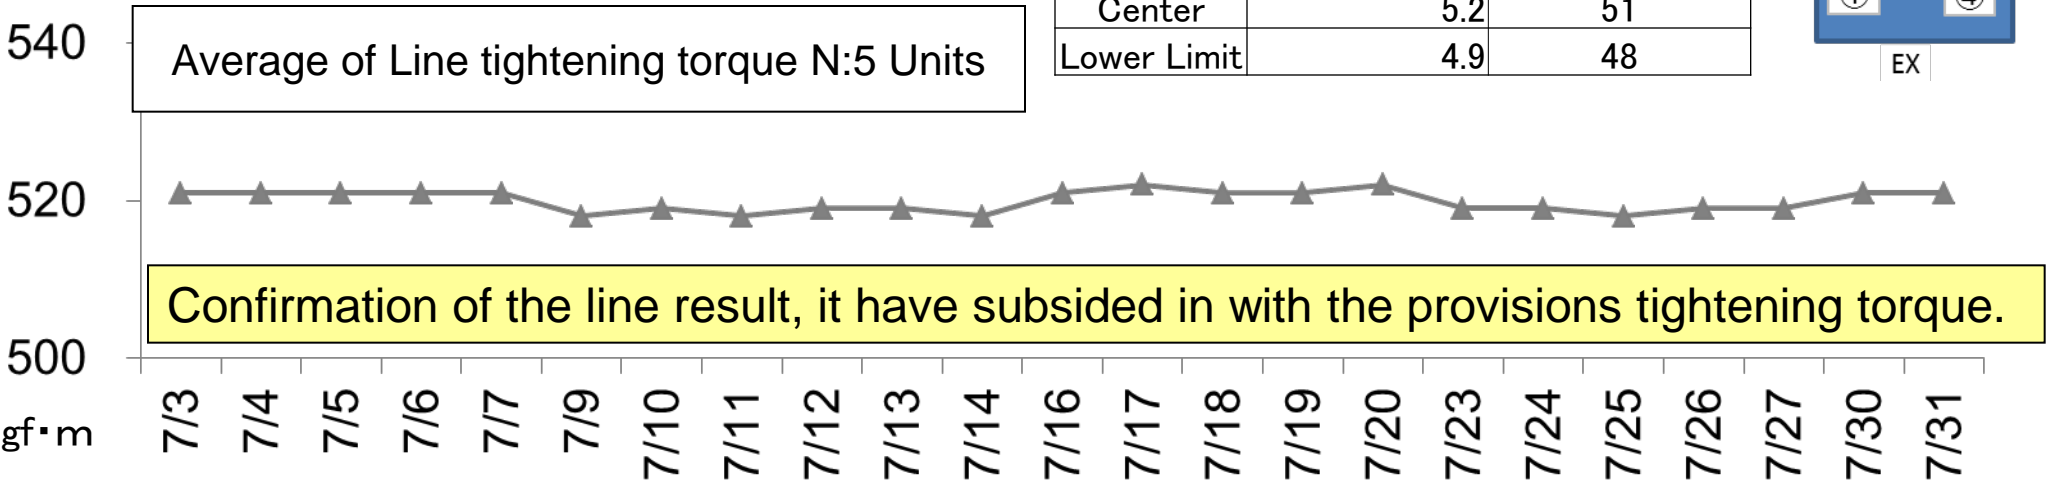
After with QL Wrench tighten (n=20 Unit)

- The axial power which does not cause engine stall is under 38.6 kN.
- Clamping of TH(Impact & QL) may surpass axial power limit for leakage.
 - Variation of axial power by impact wrench clamping.
 - Overstroke by QL wrench clamping

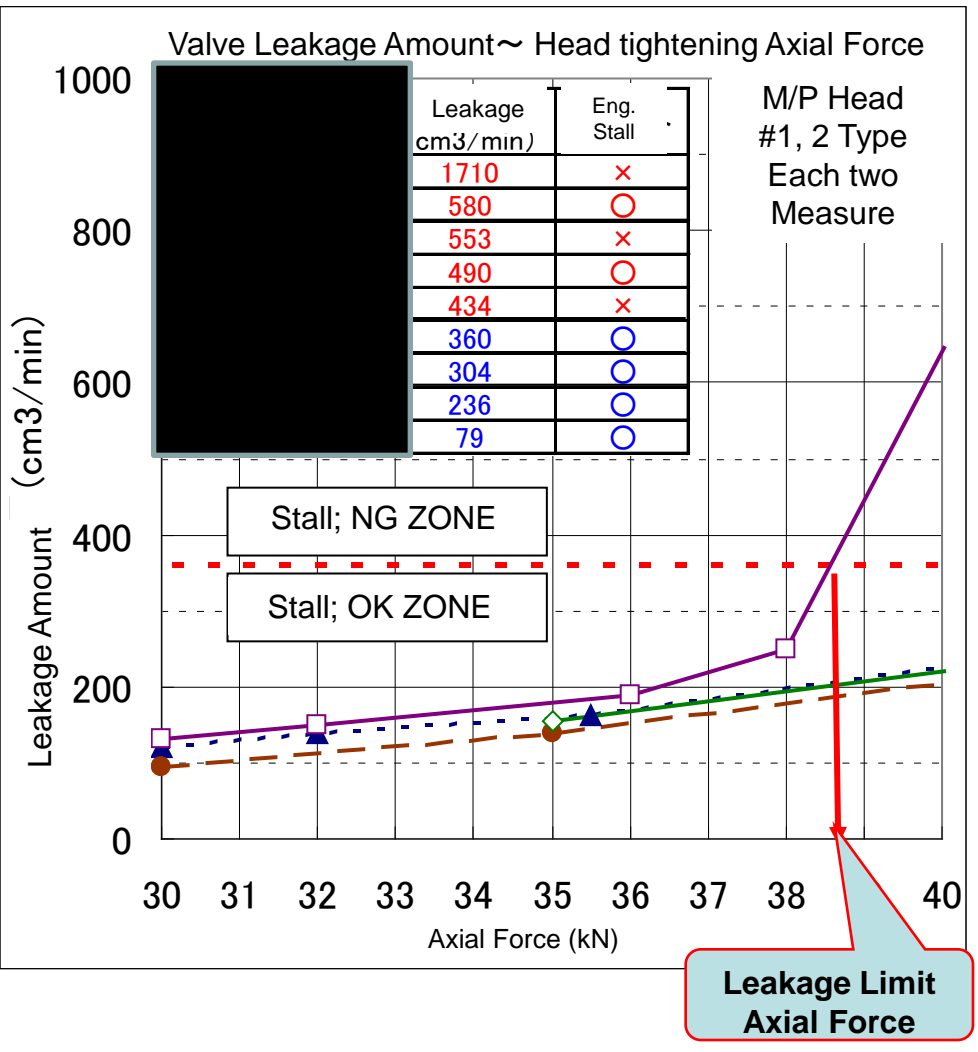
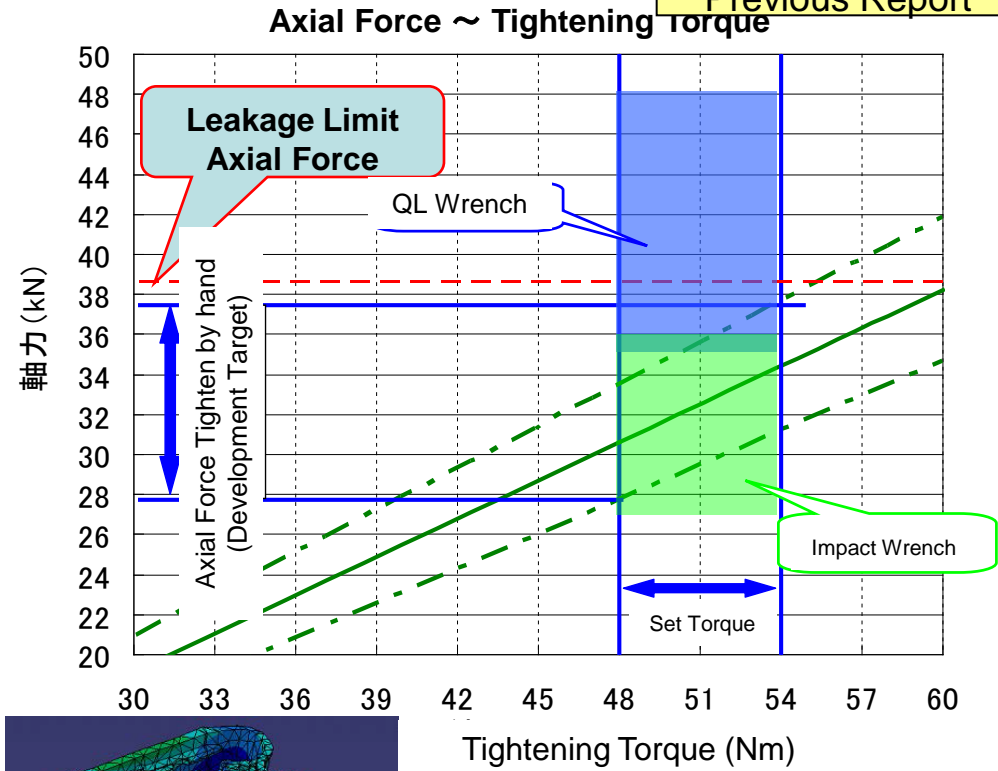
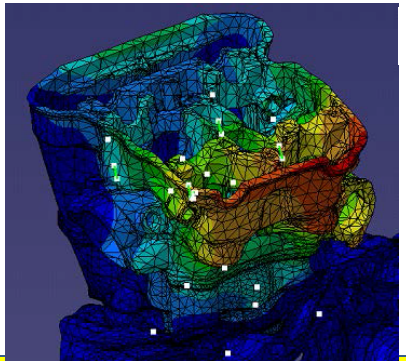
4. Analysis Result Valve Leakage amount ~ Head tightening Axial Force

CAE analysis results
Valve Seat Leakage occurs deformed by with Head Tightening Axial Force

CAE Conditions: Axial Force 37.7kN
