PE14-032

HNDA

ACTUAL PLACE VISIT
REPORT REDACTED PG 38

GQM REDQACTED PAGE 58

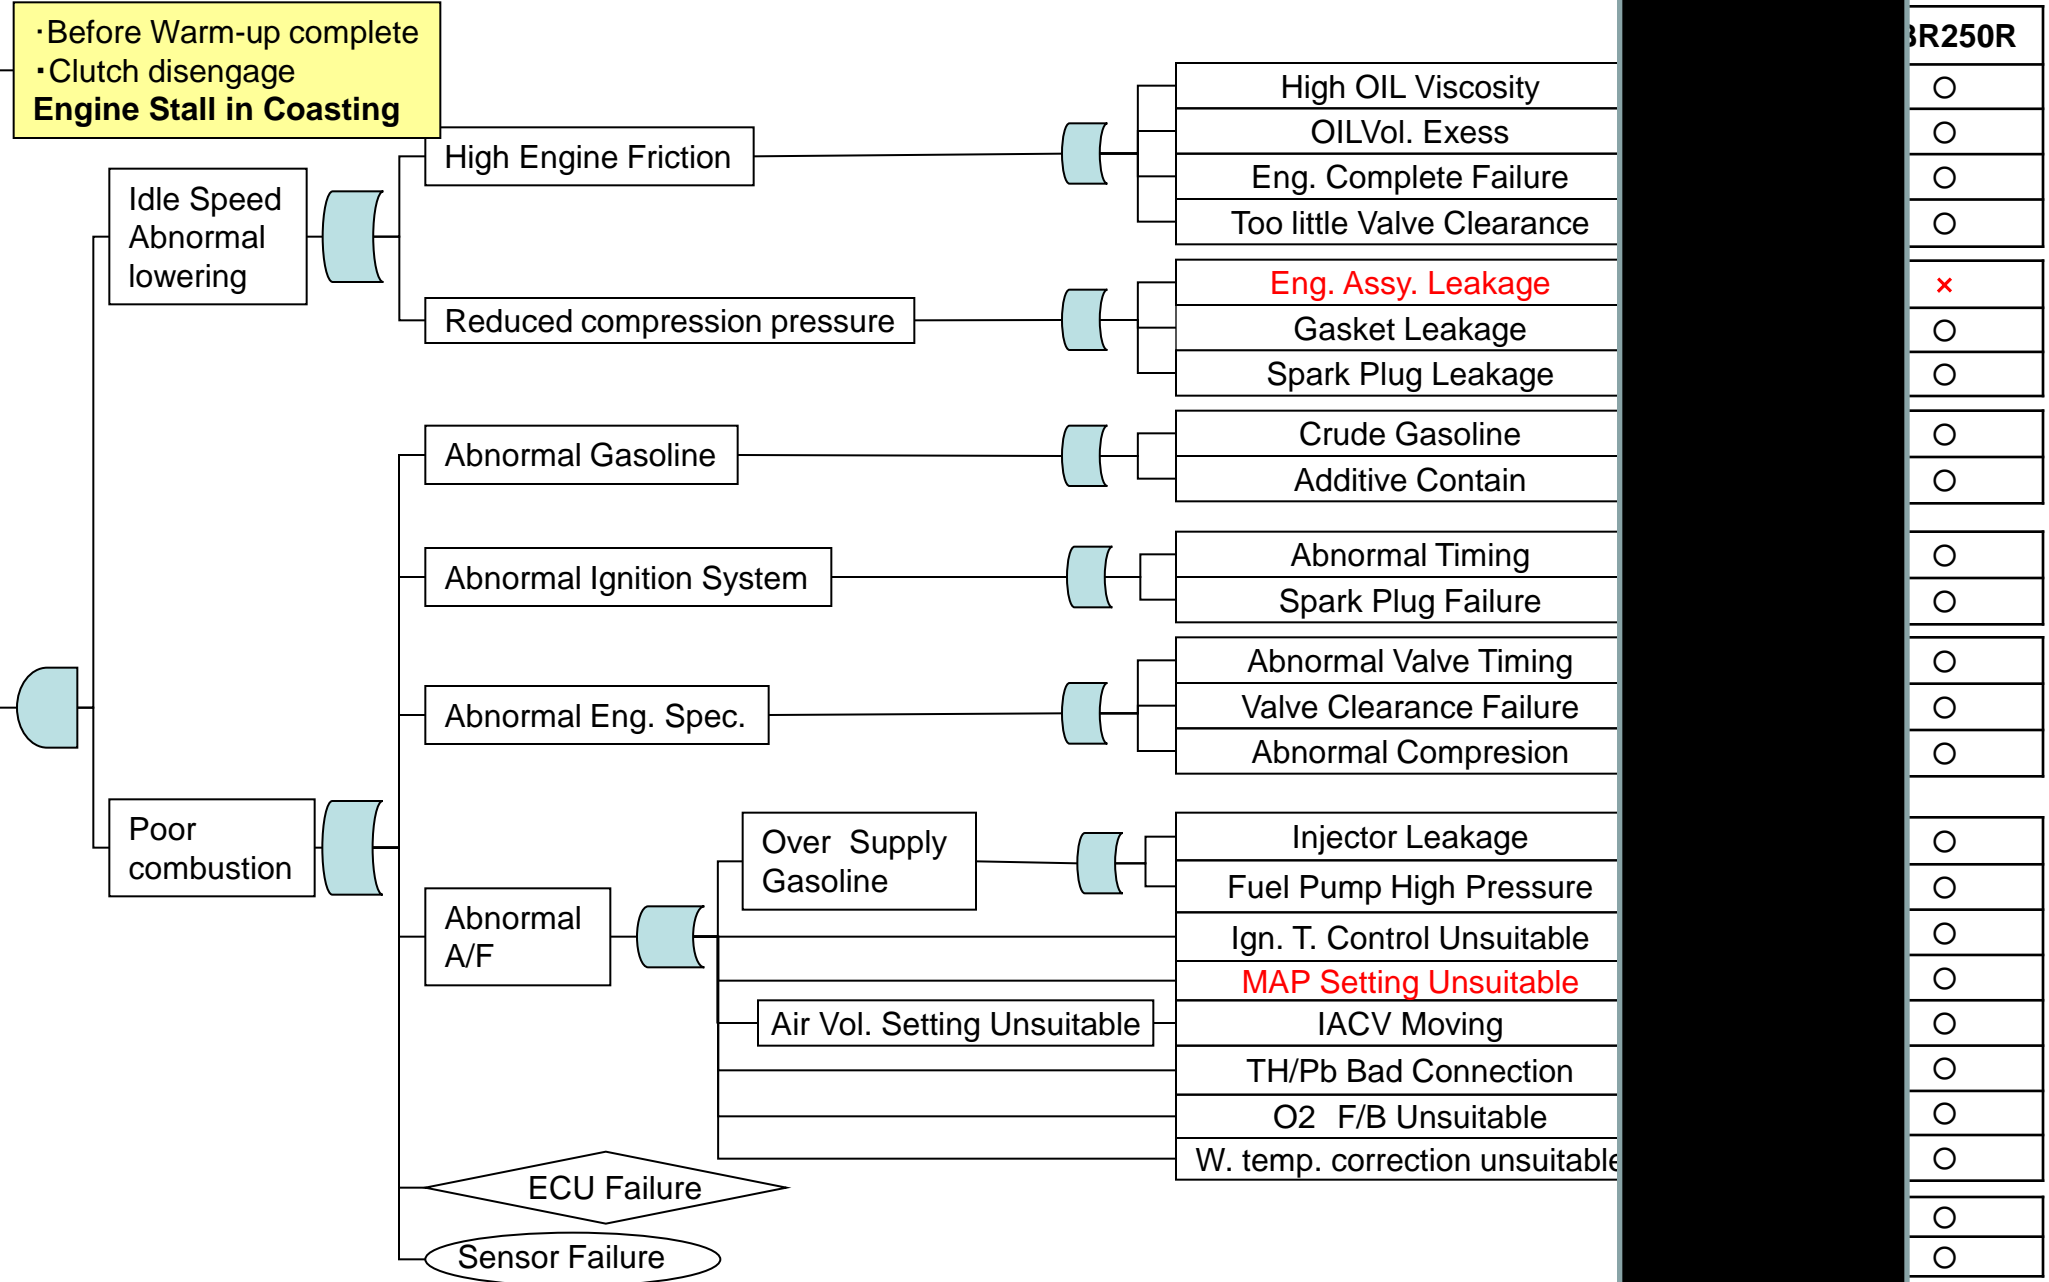
· Before Warm-up complete
· Clutch disengage
Engine Stall in Coasting

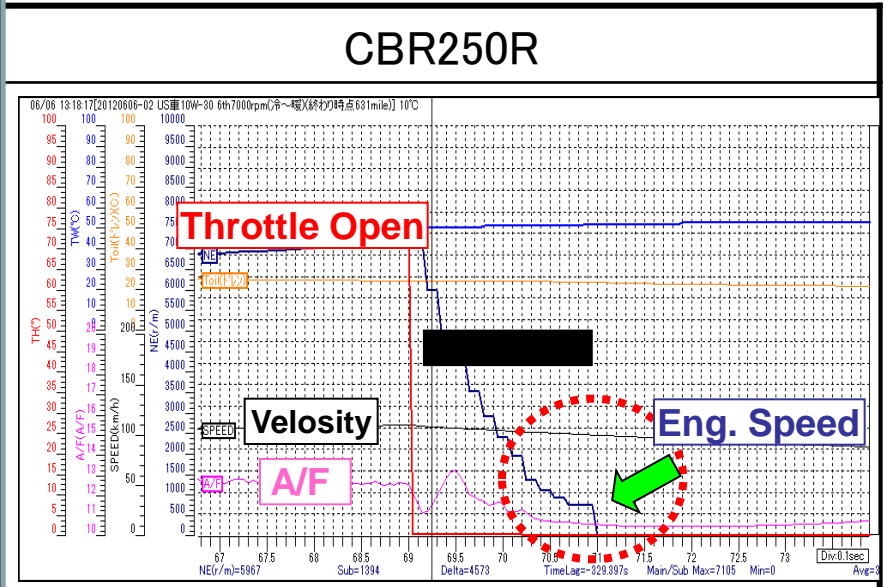
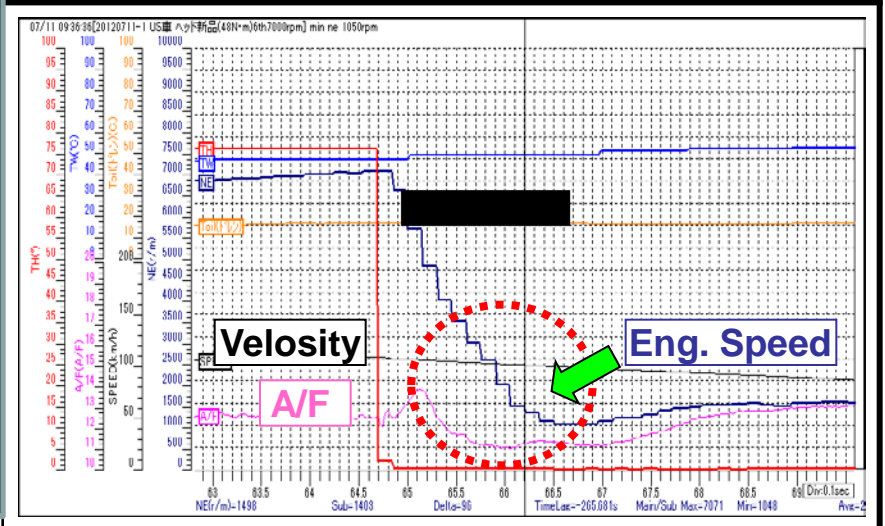
Both [redacted] and CBR, the introduction of countermeasure specification, is no longer the occurrence of engine stall.

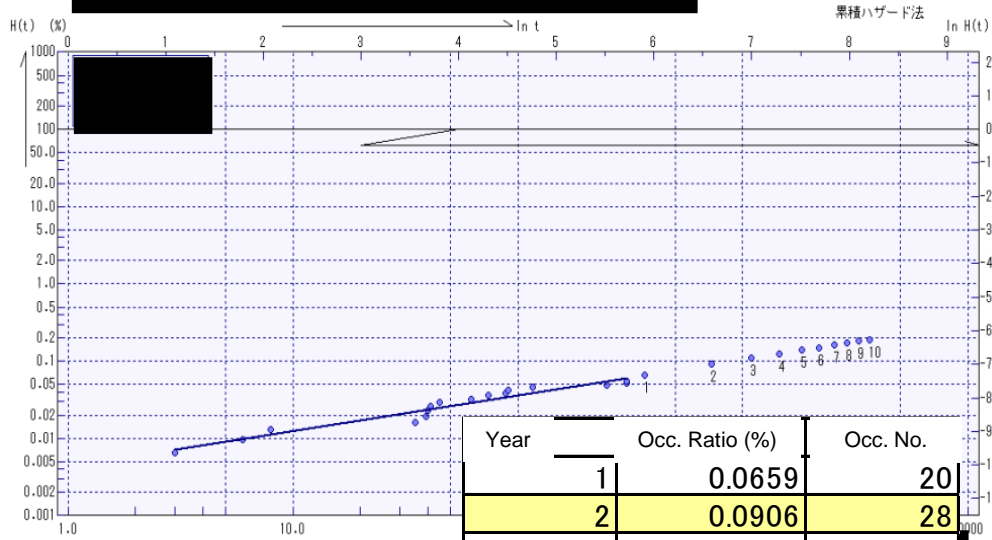
■ Weibull: user (N = 17) released one year 9 months

• M = 0.4596
Early Type

• CBR250R : Incidence of after two years is 0.09%, and the occurrence number expected to be 28 units.

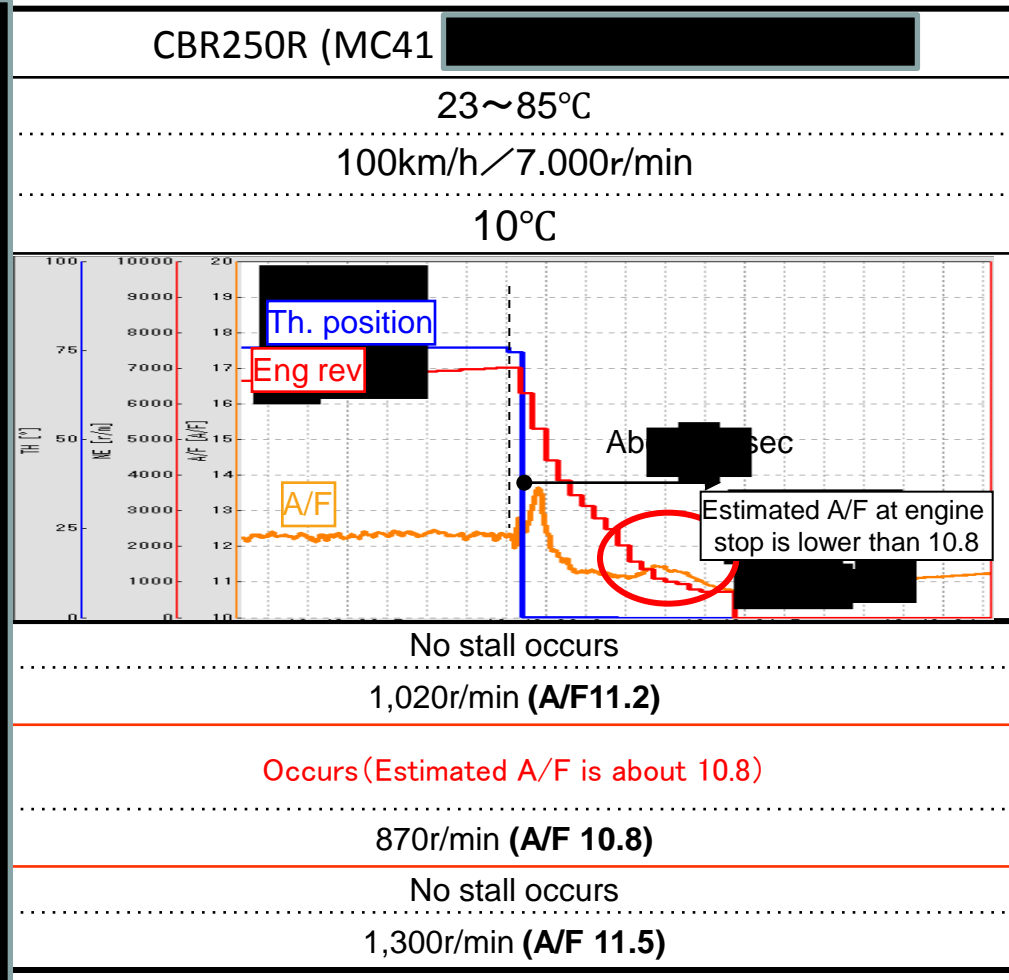
Temp. range of occur.

- Engine stop occurs during inertia run 2-3 seconds after clutch is pulled in with throttle fully closed from a high engine rev situation.
- Engine stop doesn't occur under the situation with clutch engaged. Even if the engine stop occurs, it is easy to restart engine.
- Engine rev decreases less than setting idol rev in warm-up process (oil temp is 25~65°C), and A/F becomes rich, and engine stall occurs.

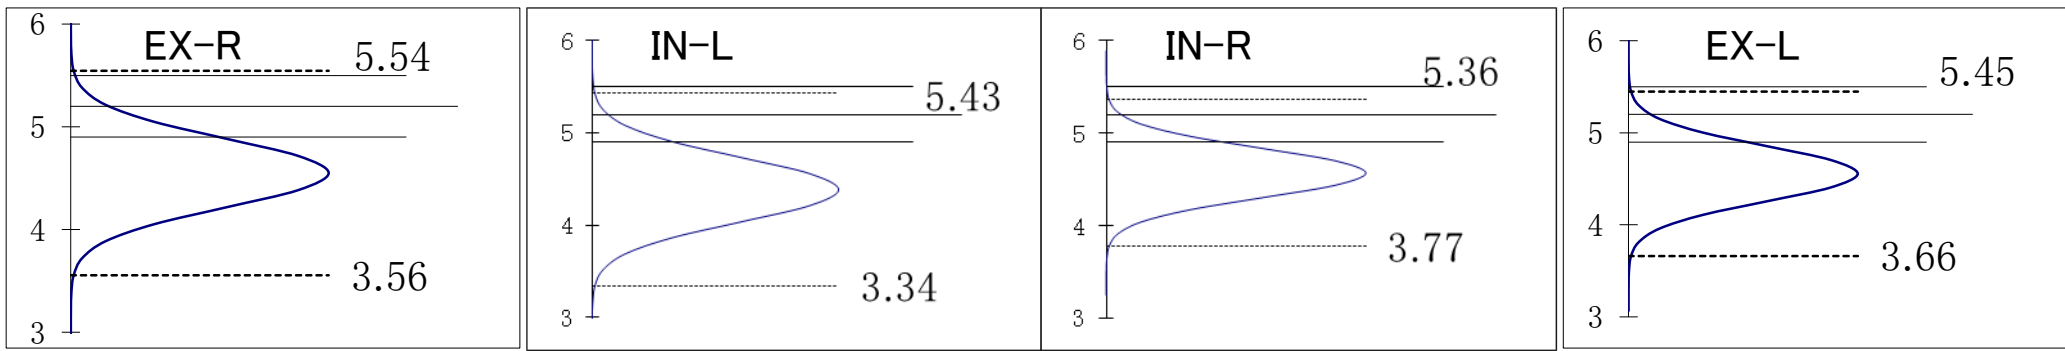
After clamping with oil pulse wrench (n=20units)

Actual line verification shows that clamping torque data are all in standard.

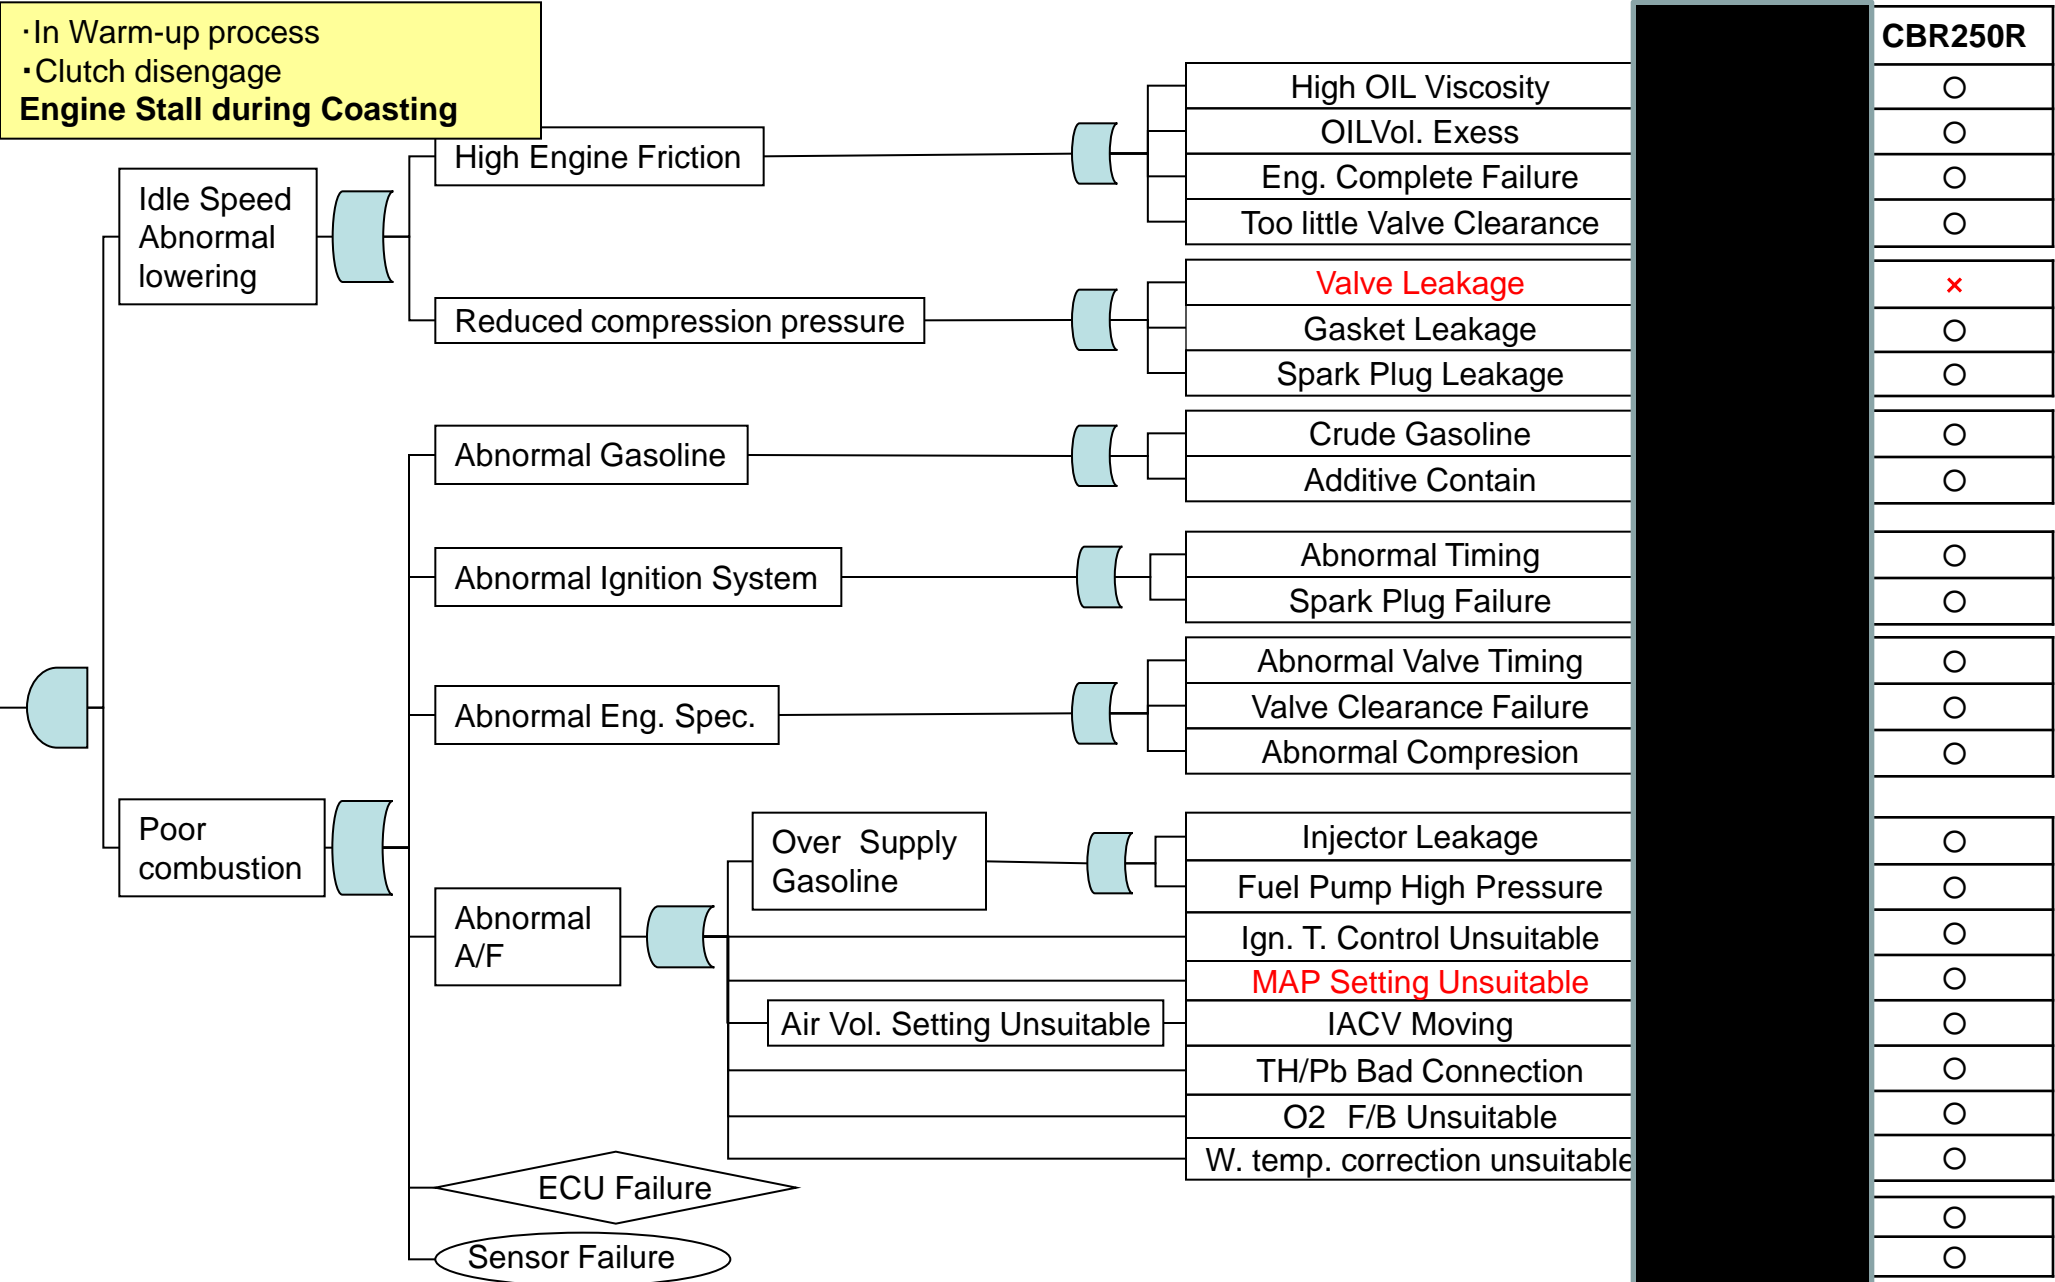
FTA

· In Warm-up process
· Clutch disengage
Engine Stall during Coasting

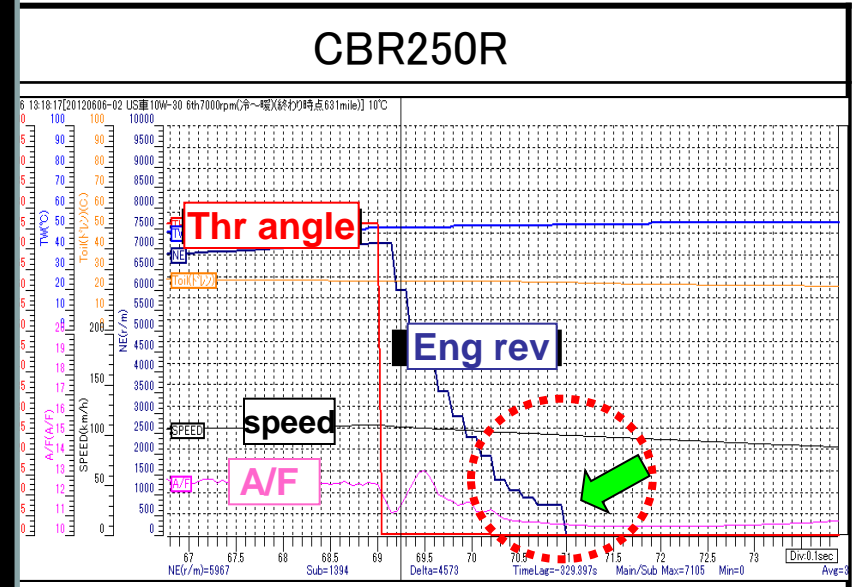
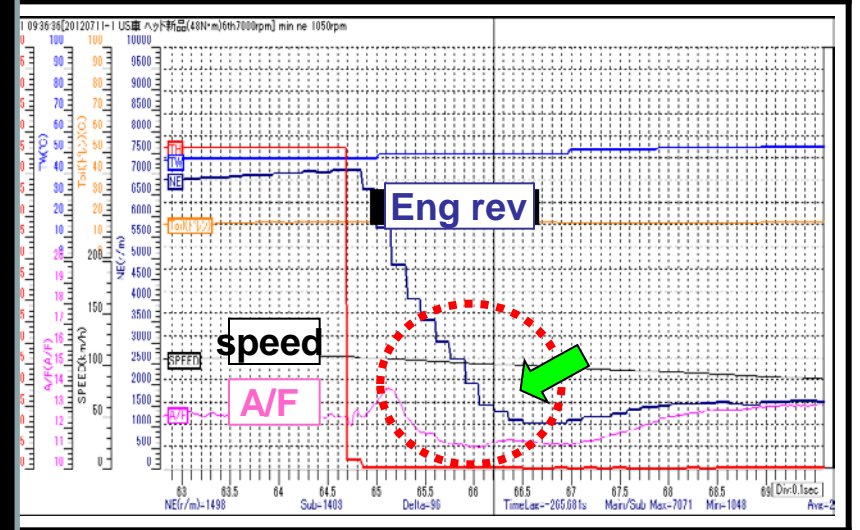
No engine stall occurs by means of countermeasures for both [redacted] and CBR250R.

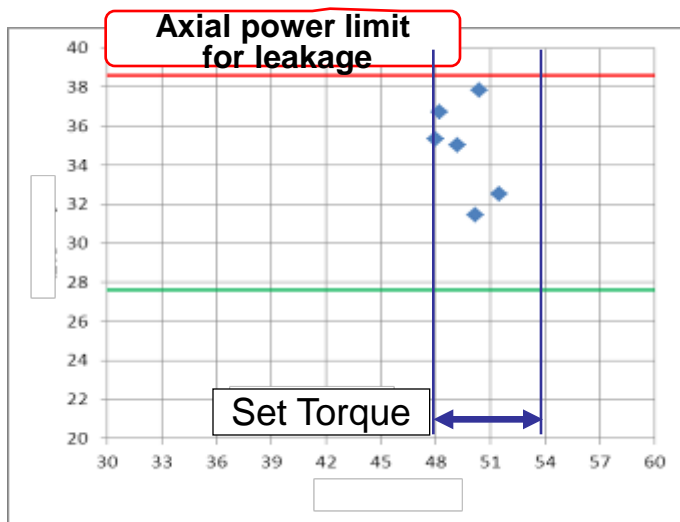
Head comp clamping in TH line

It was confirmed that axial power comes in target range by changing the setting

Change the set torque for impact wrench: 51 → 33 N·m
 Change a QL wrench: adopt a over less type wrench (set torque is 51 N·m, no change)

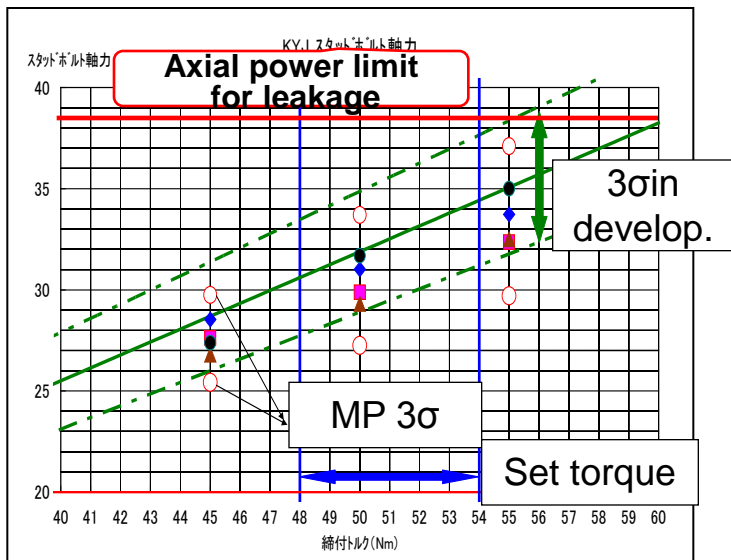
Head comp clamping in measures

It was confirmed that no engine stall occurs at the upper limit torque by hand clamping.

Impact wrench is not available.
 Set torque is 51 N·m instructed in Service Manual. No change.

- Impossible to use impact wrench because of its variation.
- Wearout parts, such as stud bolt, washer, nut, Cylinder gasket, and head gasket, will be replaced to new one.

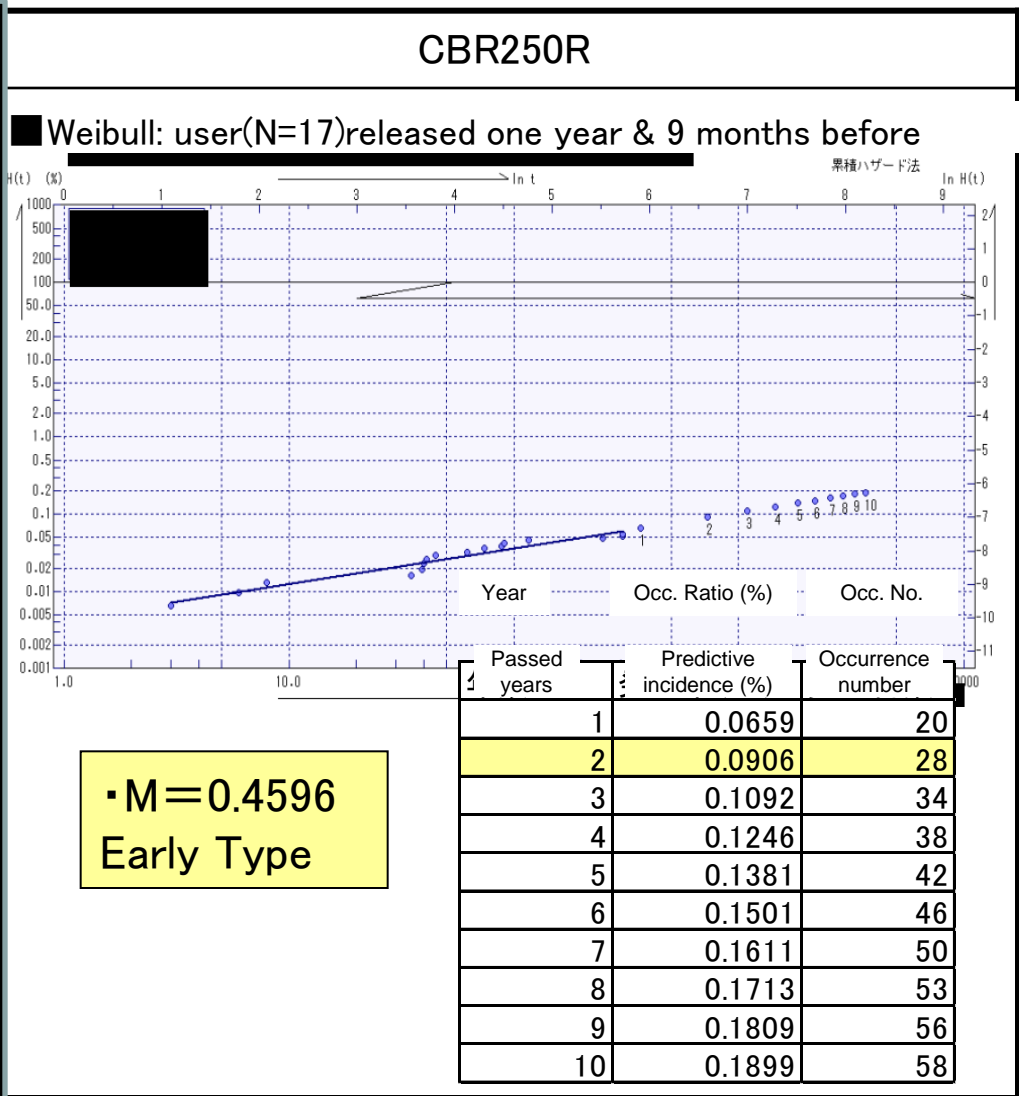
Occurrence Prediction

• CBR250R : Incidence of after two years is 0.09%, and the occurrence number expected to be 28 units.

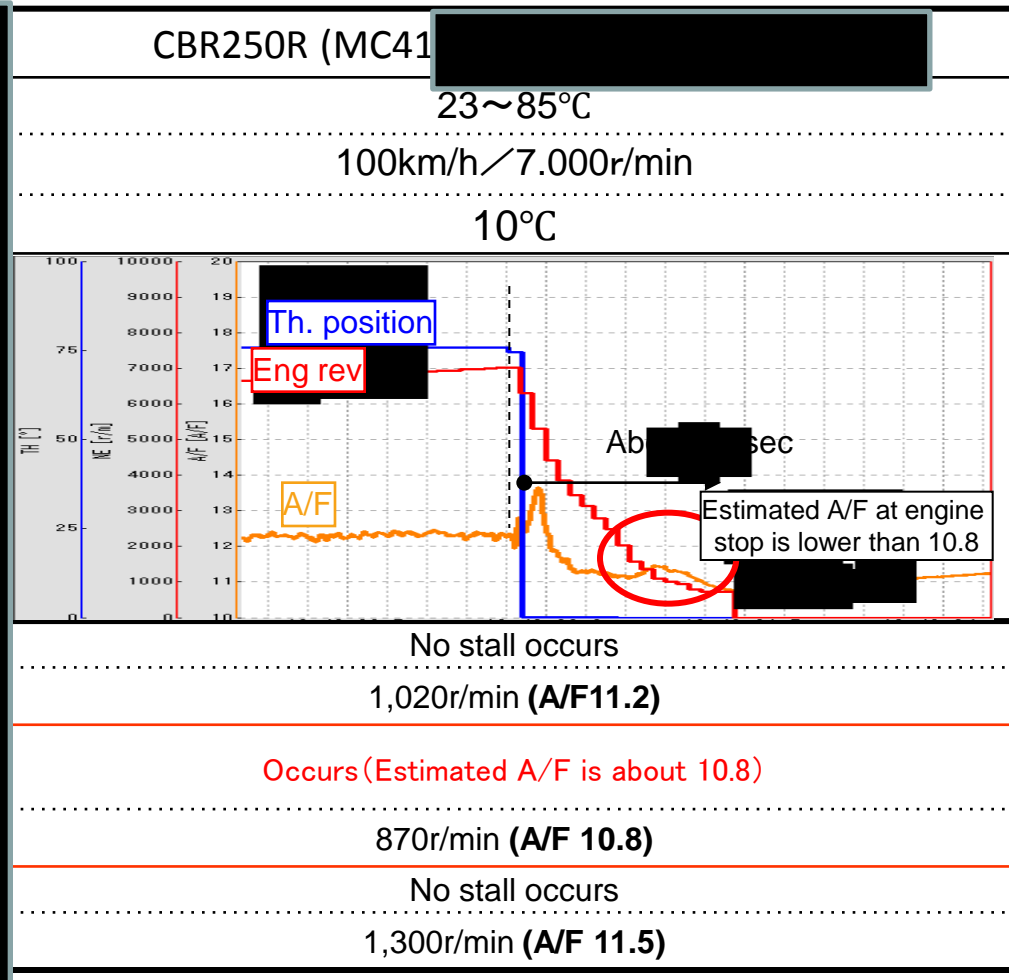
Temp. range of occur.

- Engine stop occurs during inertia run 2-3 seconds after clutch is pulled in with throttle fully closed from a high engine rev situation.
- Engine stop doesn't occur under the situation with clutch engaged. Even if the engine stop occurs, it is easy to restart engine.
- Engine rev decreases less than setting idol rev in warm-up process (oil temp is 25~65°C), and A/F becomes rich, and engine stall occurs.

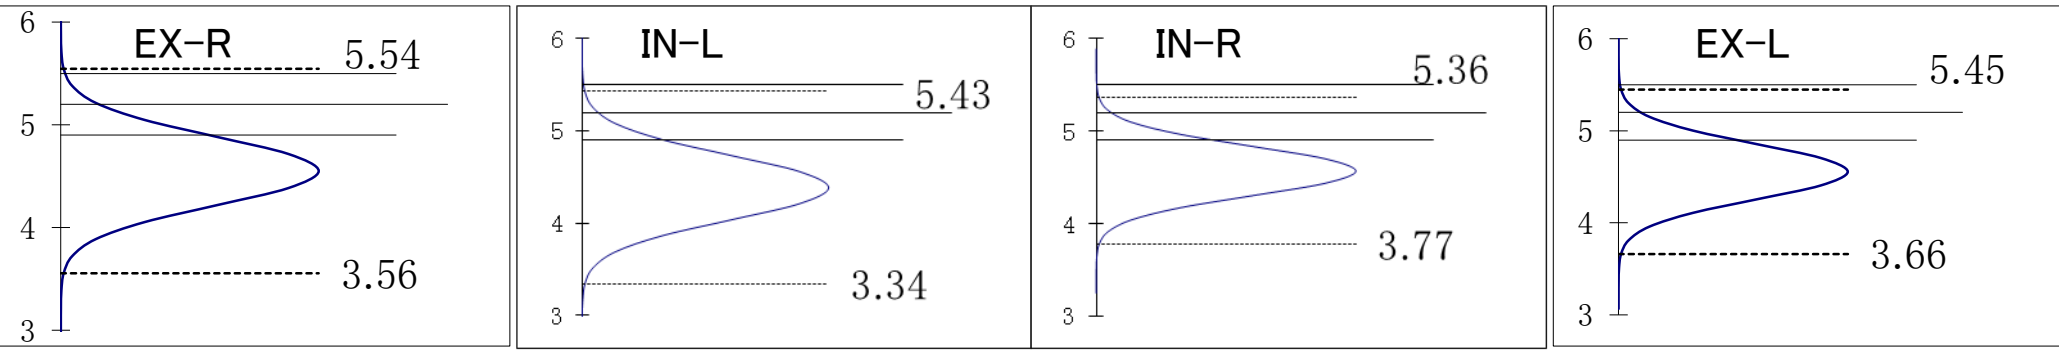
After clamping with oil pulse wrench (n=20units)

Actual line verification shows that clamping torque data are all in standard.

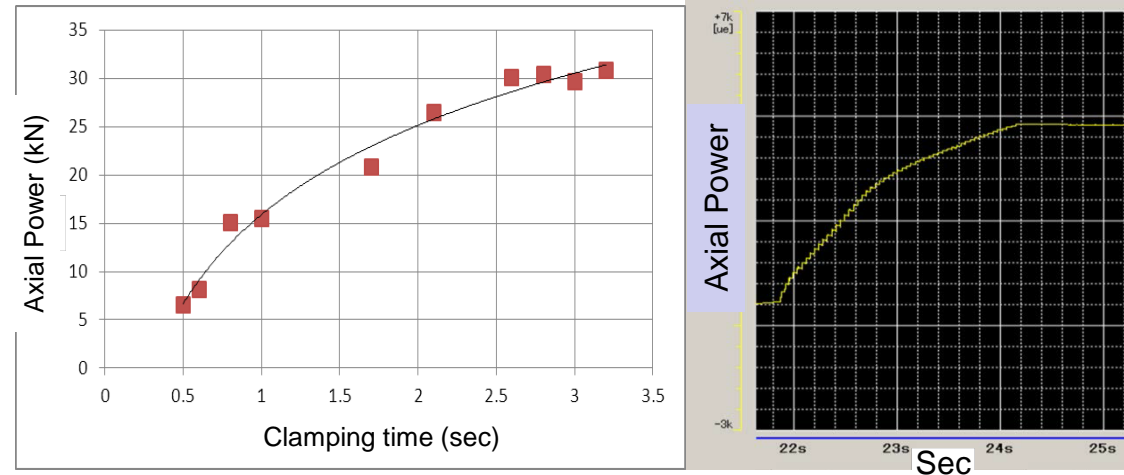
Clamping time by impact wrench(51N·m) ~ Axial power

Because of unevenness of oil pulse wrench, Clamping stroke by QL wrench became Unstable. And it may cause some defective clamping such as overstroke.

QL clamping time is 0.5~3.3sec, and it is faster than that of development whose time was 5~10sec (corresponding to QL clamping), so coefficient of friction decreases, and unevenness spreads in the high axial power side. (refer to the diagraph of clamping torque/axial power of previous page)

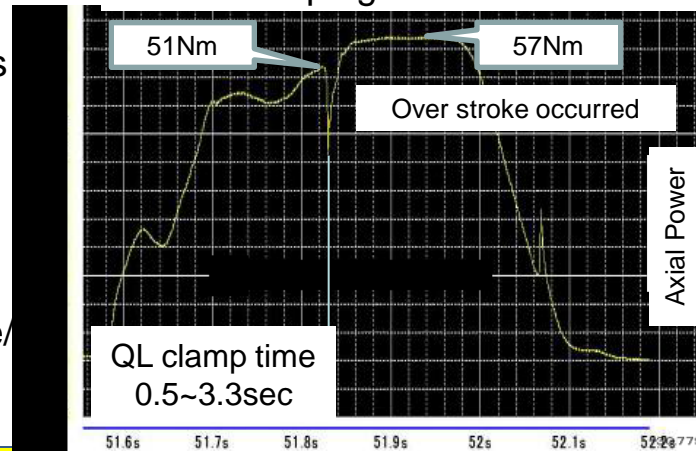
CL clamping of MP line in TH

- By the method of MP clamping (impact and QL) in TH, it may sometimes exceed the marginal axial power for leakage.
- Instability of clamping by QL wrench and overstroke, caused by unevenness of clamping time at the time of impact clamping.
- Decrease of coefficient of friction, caused by the clamping speed.

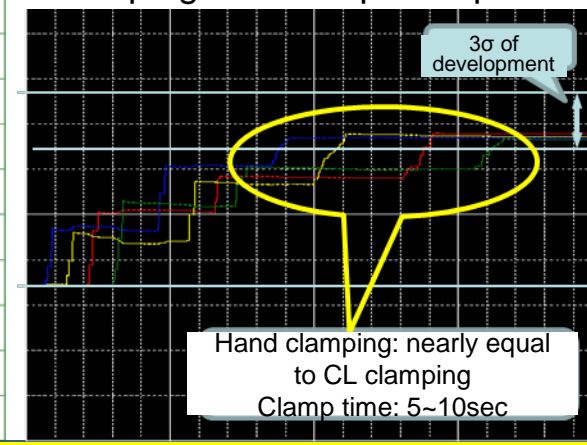
Clamping of development process

- The axial power which does not cause engine stall is under 38.6 kN.
- Compared to the axial power upper limit set in development, margins of axial power limit for leakage was small.
- Compared to the axial power set in development, MP clamping axial power has a big unevenness in the high axial power side.

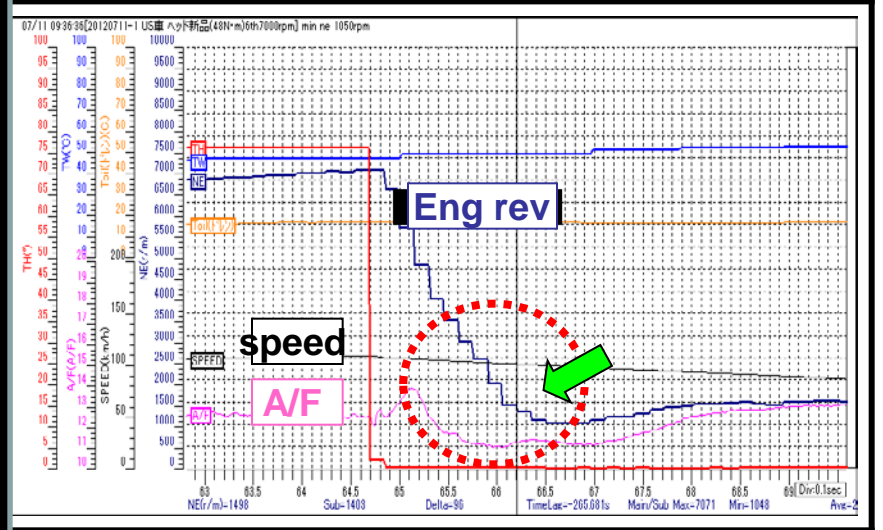
After
C/M

No engine stall occurs by means of countermeasures for both [redacted] and CBR250R.

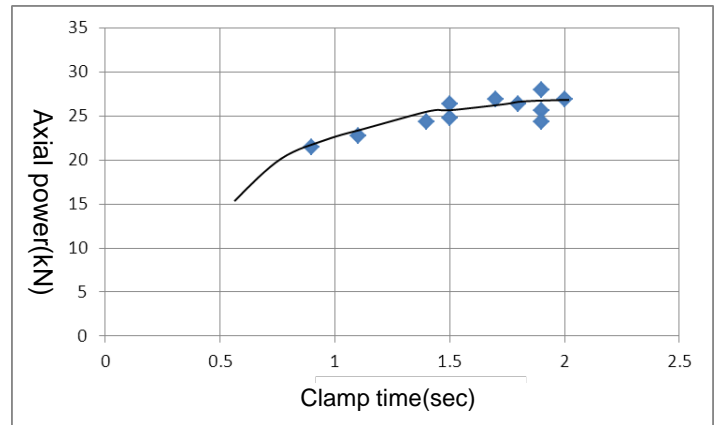
Impact (33N·m) clamp time ~ Axial power

By reducing setting torque of oil pulse wrench, clamping time before relief is shorten and axial power becomes stable.

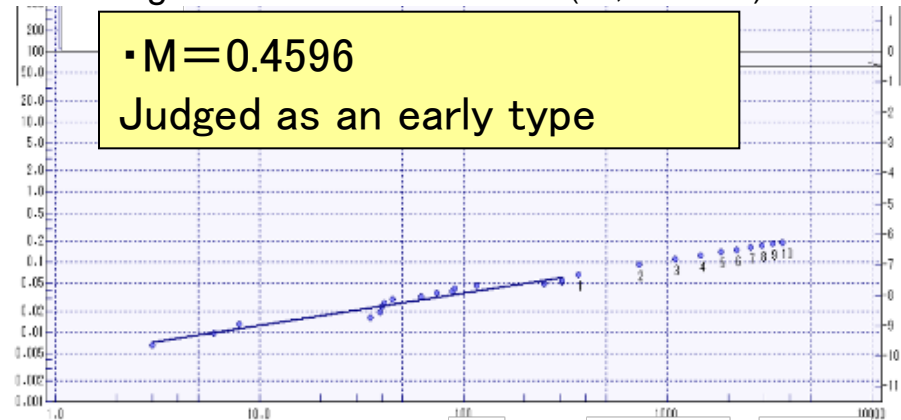
From register date to occurrence (30,777 units)

Passed years	Predictive incidence (%)	Occurrence no.
1	0.0659	20
2	0.0906	28
3	0.1092	34
4	0.1246	38
5	0.1381	42
6	0.1501	46
7	0.1611	50
8	0.1713	53
9	0.1809	56
10	0.1899	58

Predictive occurrence after 2 years is 28 units

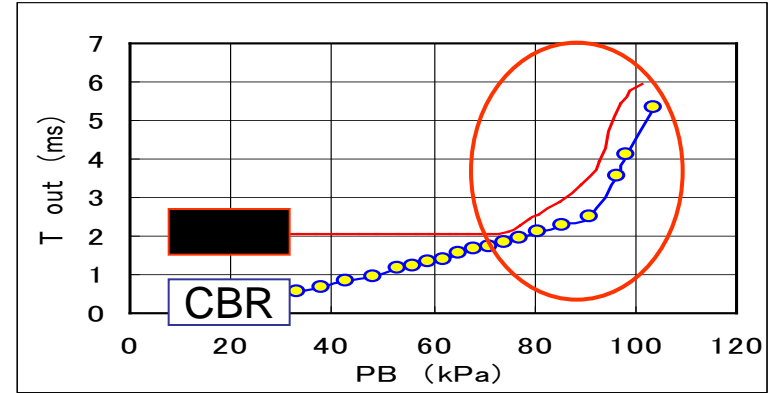
CBR250R (MC41

Engine stall	Actual Unit	Not occur	—	Occur	—	Occur						
	New Unit	—	Not occur	—	Not occur	Not occur						
rpm at stall	Actual Unit	900r/min 11.1	—	980r/min 11.2	—	970r/min 11.2						
A/F	New Unit	—	1,050r/min 11.2	—	1,230r/min 11.8	1,160r/min 11.8						
leak amount as engine Assy	Actual Unit	236	—	434	—	1,700						
cm ³ /min at 20kPa)	New unit	—	79	—	580	610						
Tightening torque	For reference	40N·m	lower limit tolerance 48N·m	Set value 51N·m	Upper limit tolerance 54N·m	Outcome of Actual Unit 60.5N·m (Ave.)

- CBR250R will not occur engine stall after the tightening torque of Actual unit is released to 40N·m.
- CBR250R will not occur engine stall after the engine head is replaced to new one.

○	い ○	る ×		×
	900r/min	1,050r/min	980r/min	定)	970r/min
A/F	11.1	11.2	11.2		11.2
cm3/min (20kPa時)	236	79	434	1,564	1,700
	40N・m	48N・m	51N・m	35KN ⇒56N・m	60.5N・m
					EX 58.7 61.1 69.3 52.8

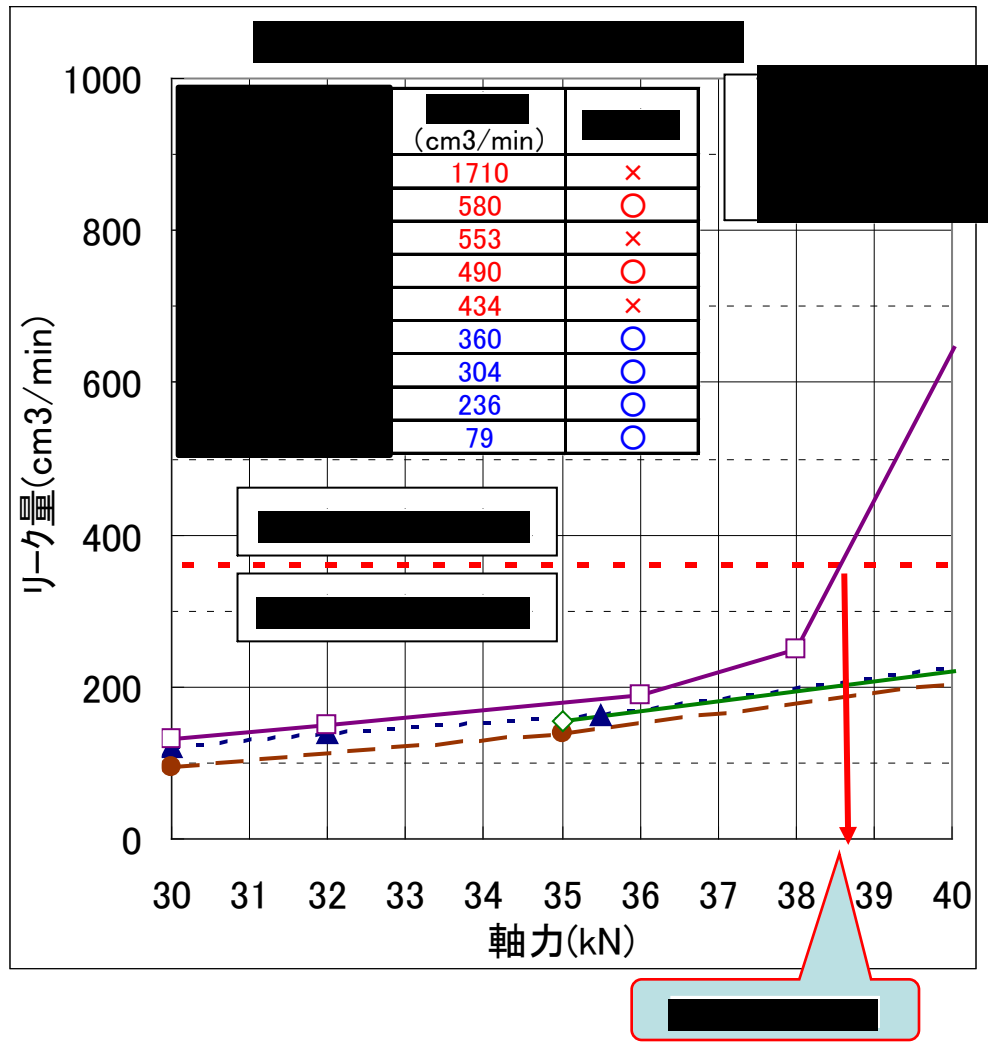
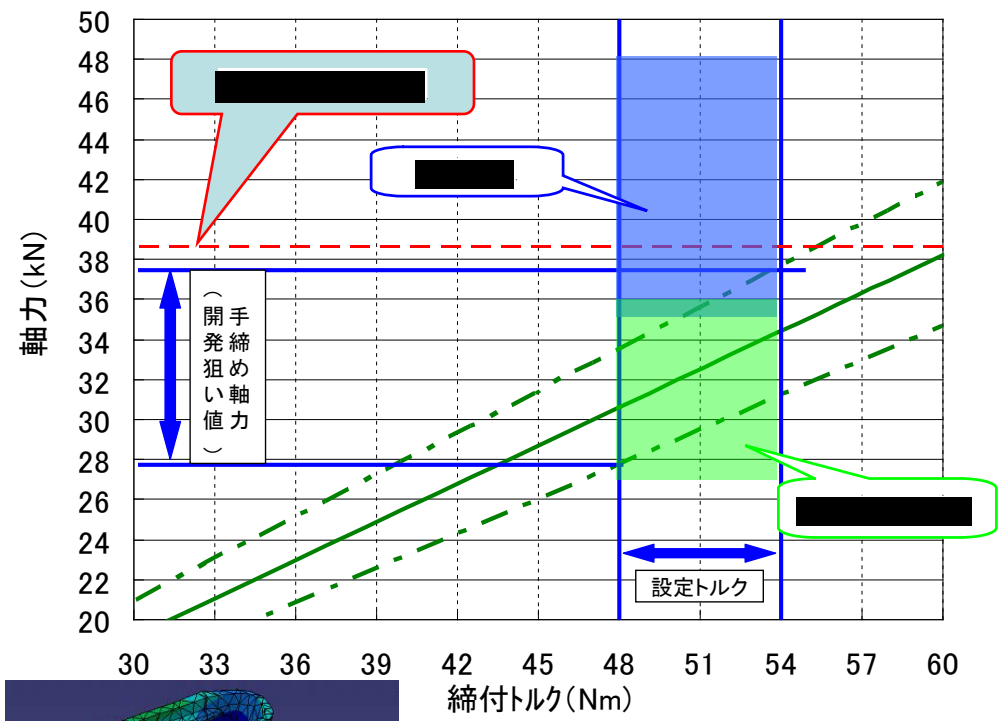
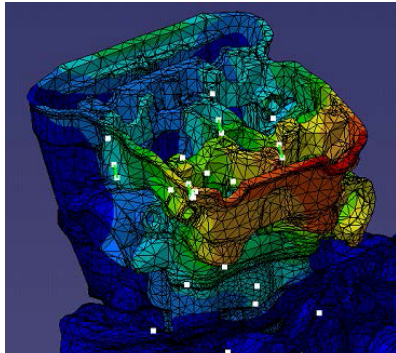
CAE [Redacted] 37.7kN

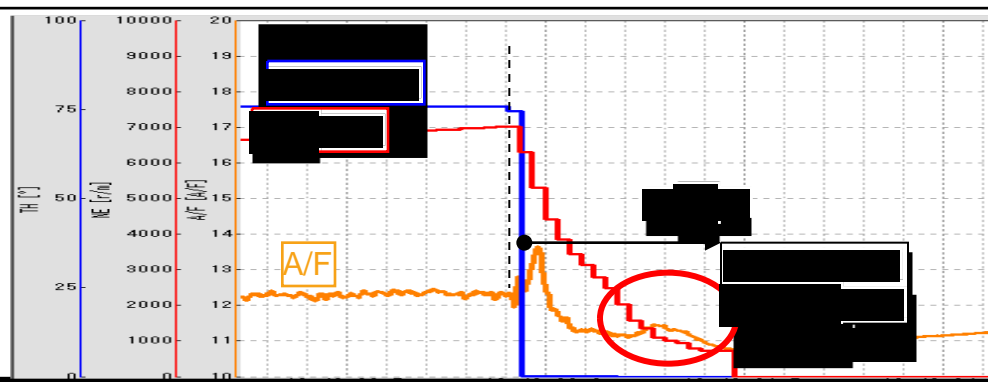
1,020r/min (A/F11.2)

870r/min (A/F 10.8)

1,300r/min (A/F 11.5)
