PE14-032

HNDA

CBR250R (US) : Visiting an actual place Result : Customer feedback information

10. Engine stall when riding CBR250R(KYJA)

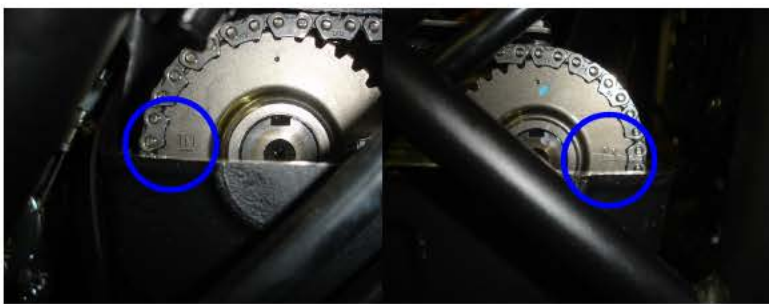
- Valve Timing was normal

・バルブタイミング=問題なし

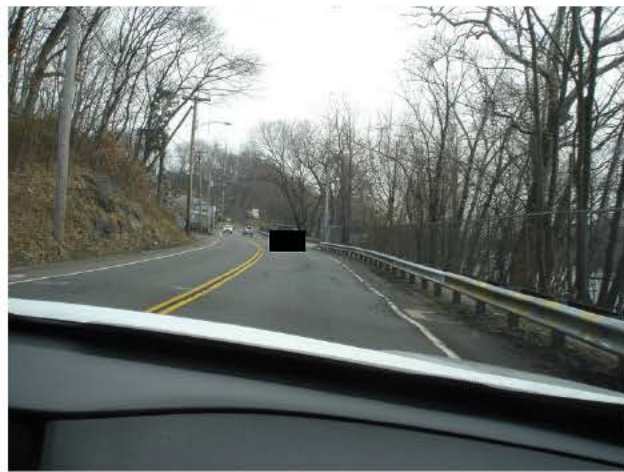
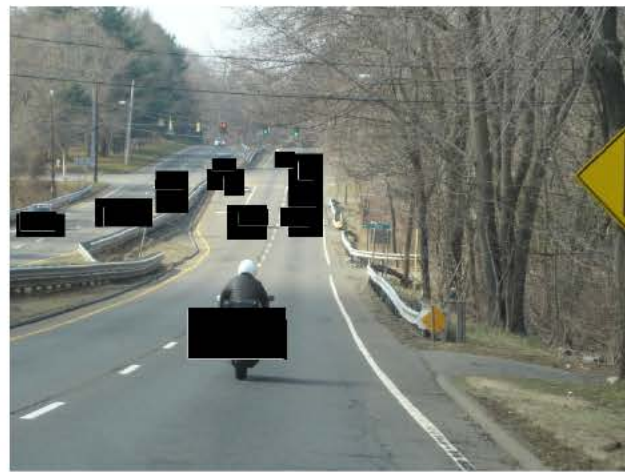
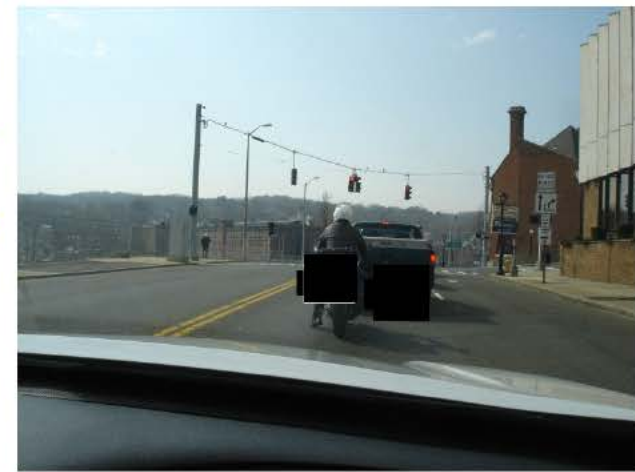
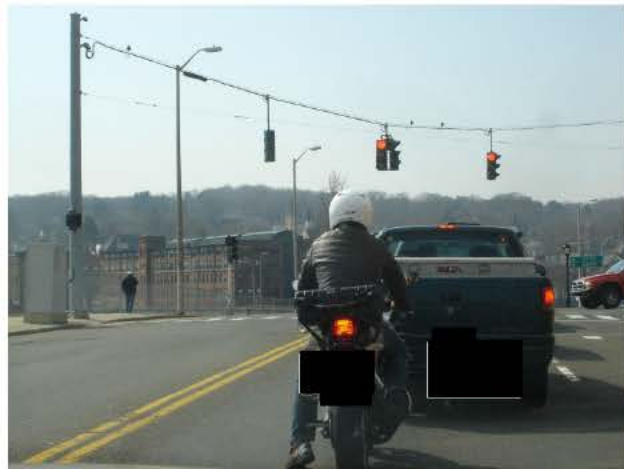
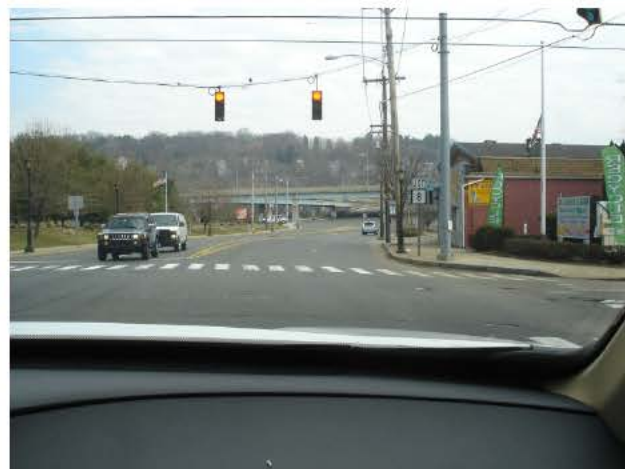
A running test was performed on the same road as the complaint. The outside temp. is about 58F~64F, with a distance of about 5.2miles up and downhill with traffic lights. The running test was performed with about 60 miles following the same steps as described in the allegation. The engine stall was not able to be recreated.

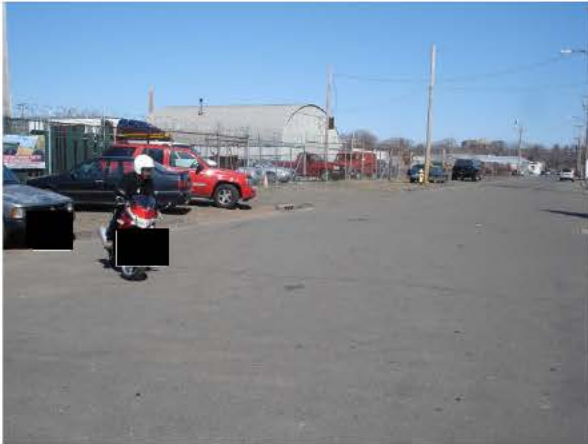
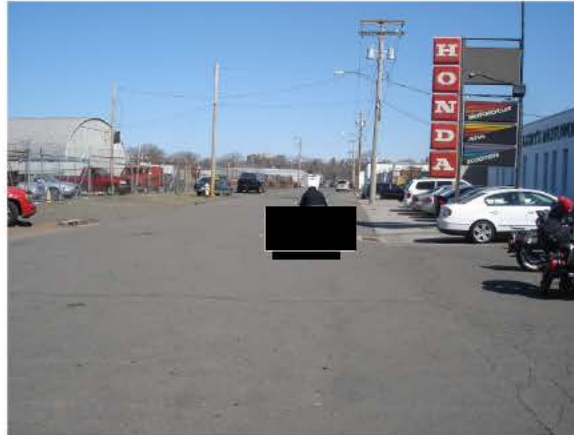
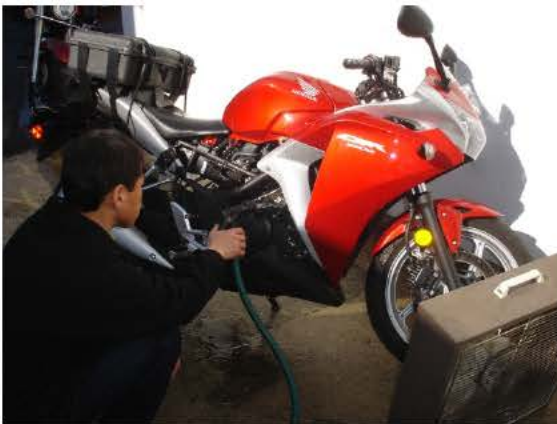
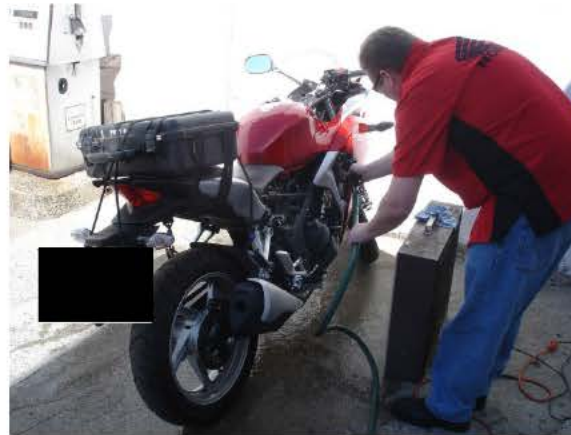
CBR250R Actual place (US) visit Result : Simulation test 2

Test Place : Hardfolk
Test in front of the dealers
shop , clear, dry
Outside temp. 14°C~17°C

Not to able get the distance between the actual place and the customer' s home, and because of the need to keep the engine cool, decided to perform a running test on a private road near the dealer.

Engine Stall – Not Found

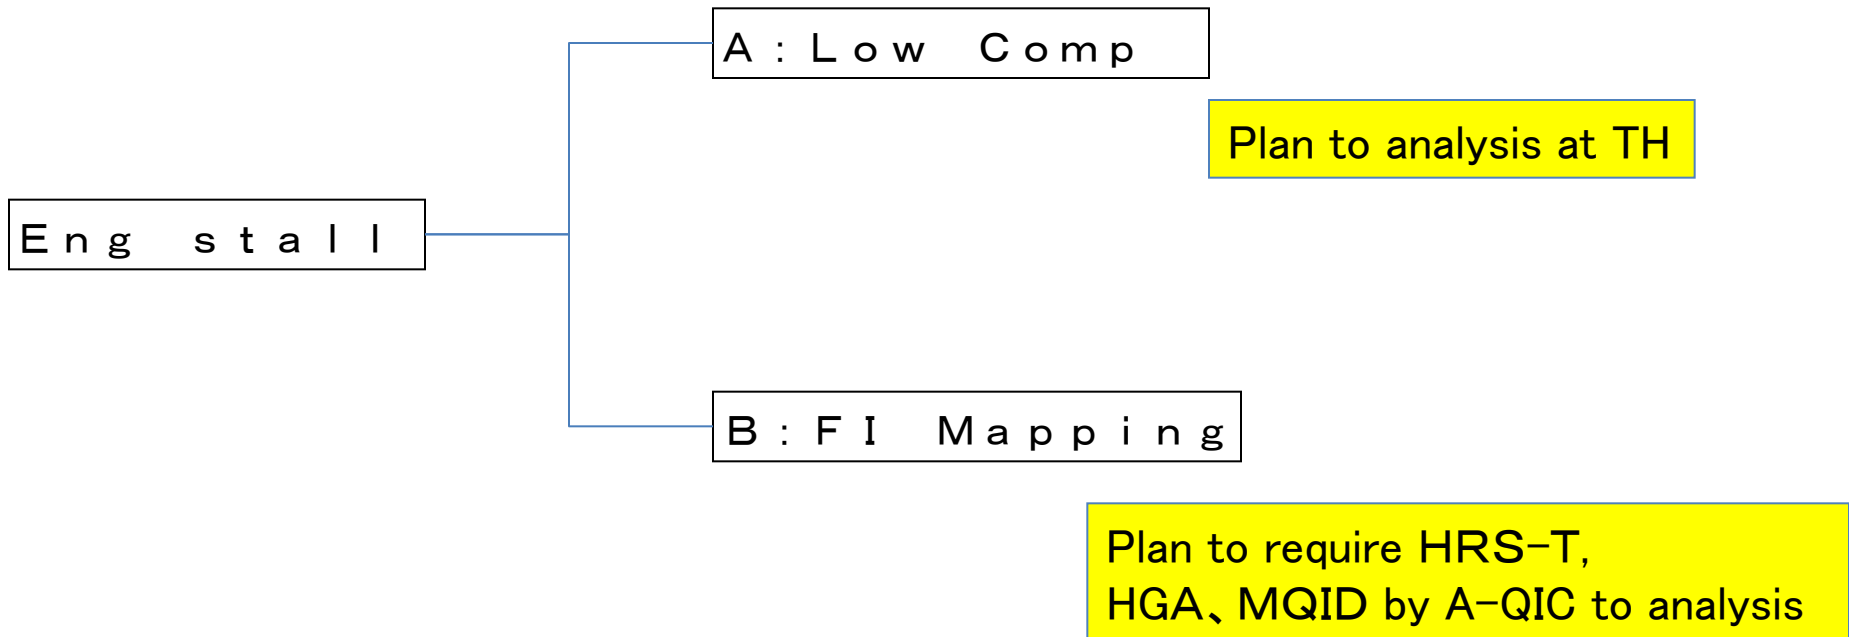
Team estimated the causes of engine stall to be from 2 reasons. However, the team can't judge if the cause of problem occurred from individual or several problems. After this, Thai Honda will analyze the cause of low compression pressure in the engine head. In addition to lower idle, it will be compared with the mass prod. of other models. A-QIC will be the one who requests HRS-T, HGA, MQID to analyze the cause of this problem

- Used motorcycle will be sent to Thai Honda

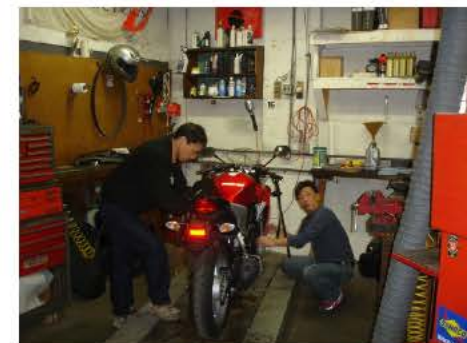
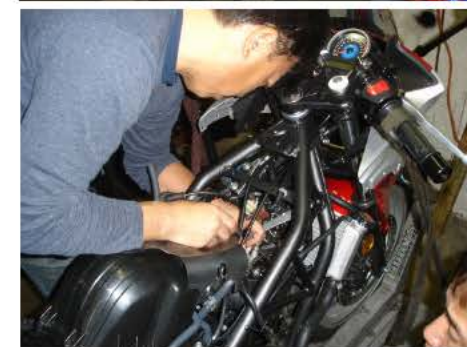
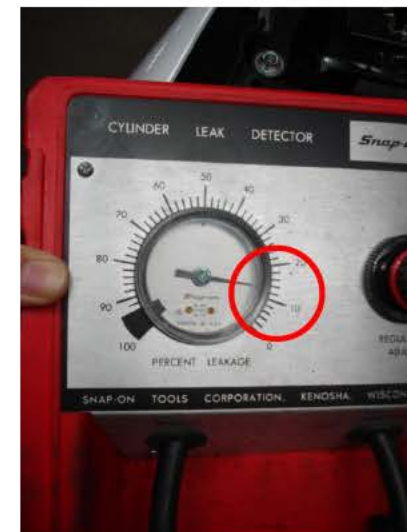
・プラグキャップ 亀裂等ダメージなし。

・アース締結 問題なし

・リークテスト 測定結果 (14% (通常は10%)前後との事)

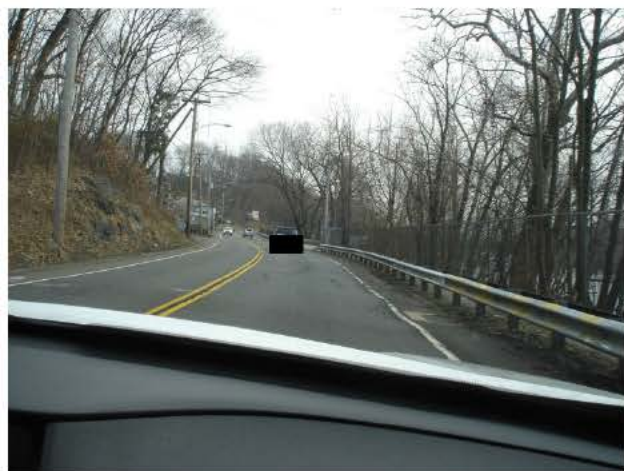
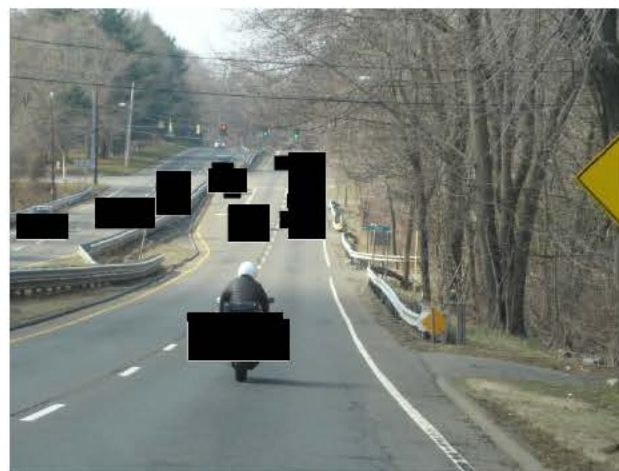
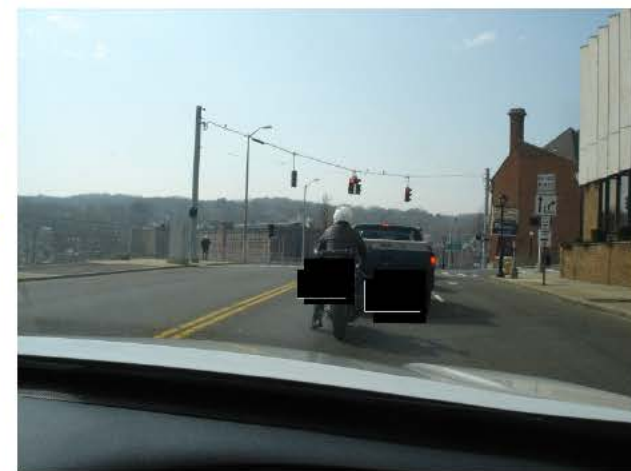
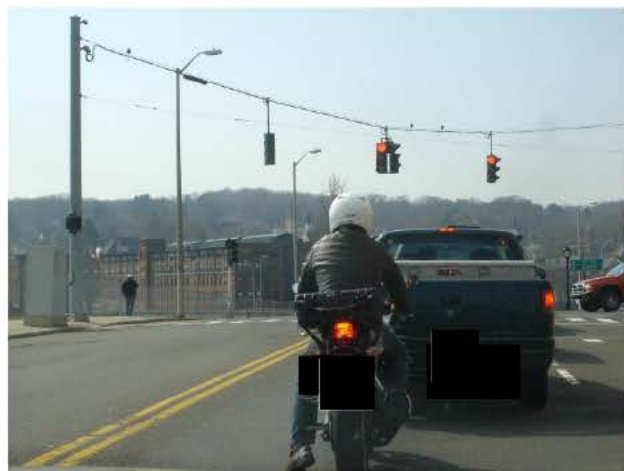
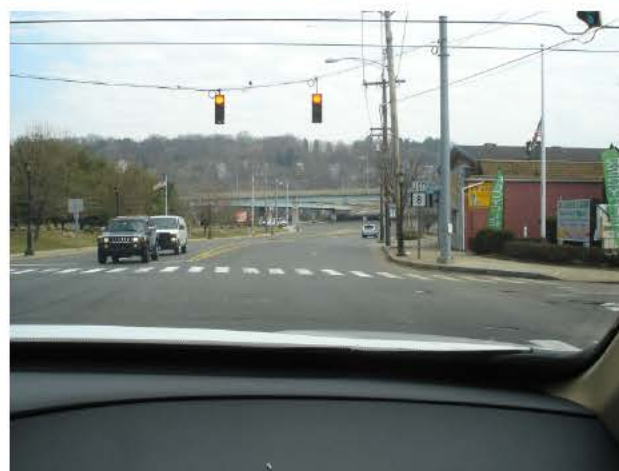
お客様が頻繁に事象を確認したコースへ出向き走行テスト実施。 外気温58F~64F
片道5.2マイルのなだらかな上り下りがあるコース。 お客様が頻繁に発生したと教えて頂いた箇所に
信号機あり。

コースには特に珍しいと思われるような特長はなく、ごく一般的な市外路。

およそ60マイル同じ場所を行き来し、お客様のいわれる手順、またそれ以外の操作で事象発生を試み
たがエンスト事象発生せず。

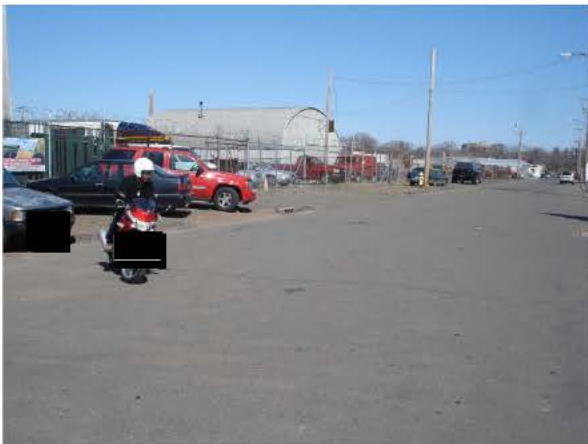
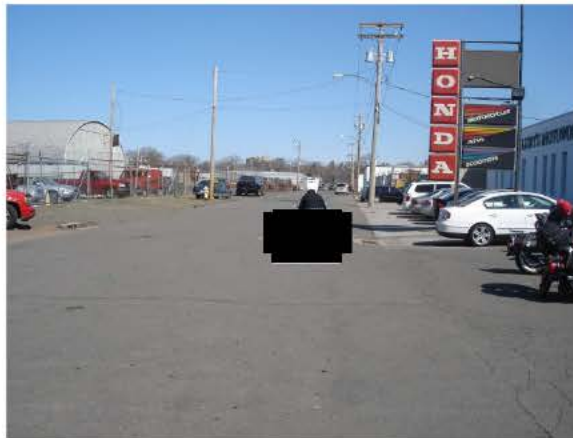
テスト地: ハートフォード
ディーラーの前の道路、晴れ、
ドライ、外気温14°C~17°C

お客様が最も事象を経験した場所と顧客宅との距離関係より、冷機時に絞り再現テストと計測を実施。
冷機状態を保つため、DLR前の私道にて繰り返し実施した。

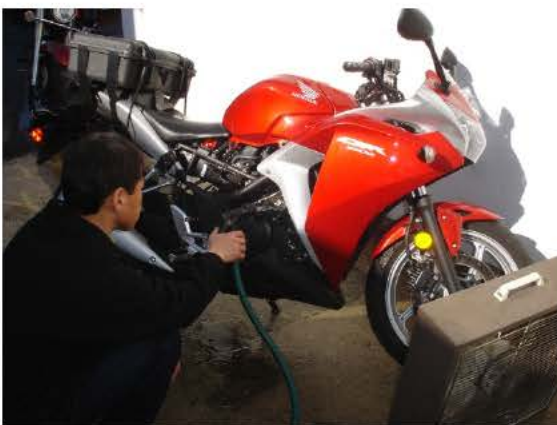
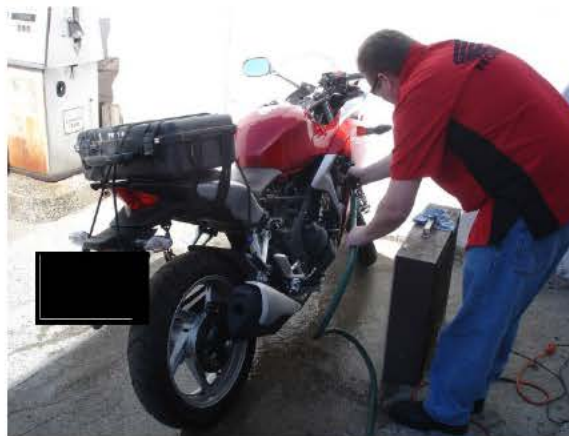
・エンスト事象再現せず。

・しかし、ある一定のモードで、Eng. Ne 低下が確認できた。

ファーストアイドル終了前後の、水温50~70°C付近が弱そう。

ほぼ同一条件でのテスト確認を3回実施し、再現性のあることが確認できた。

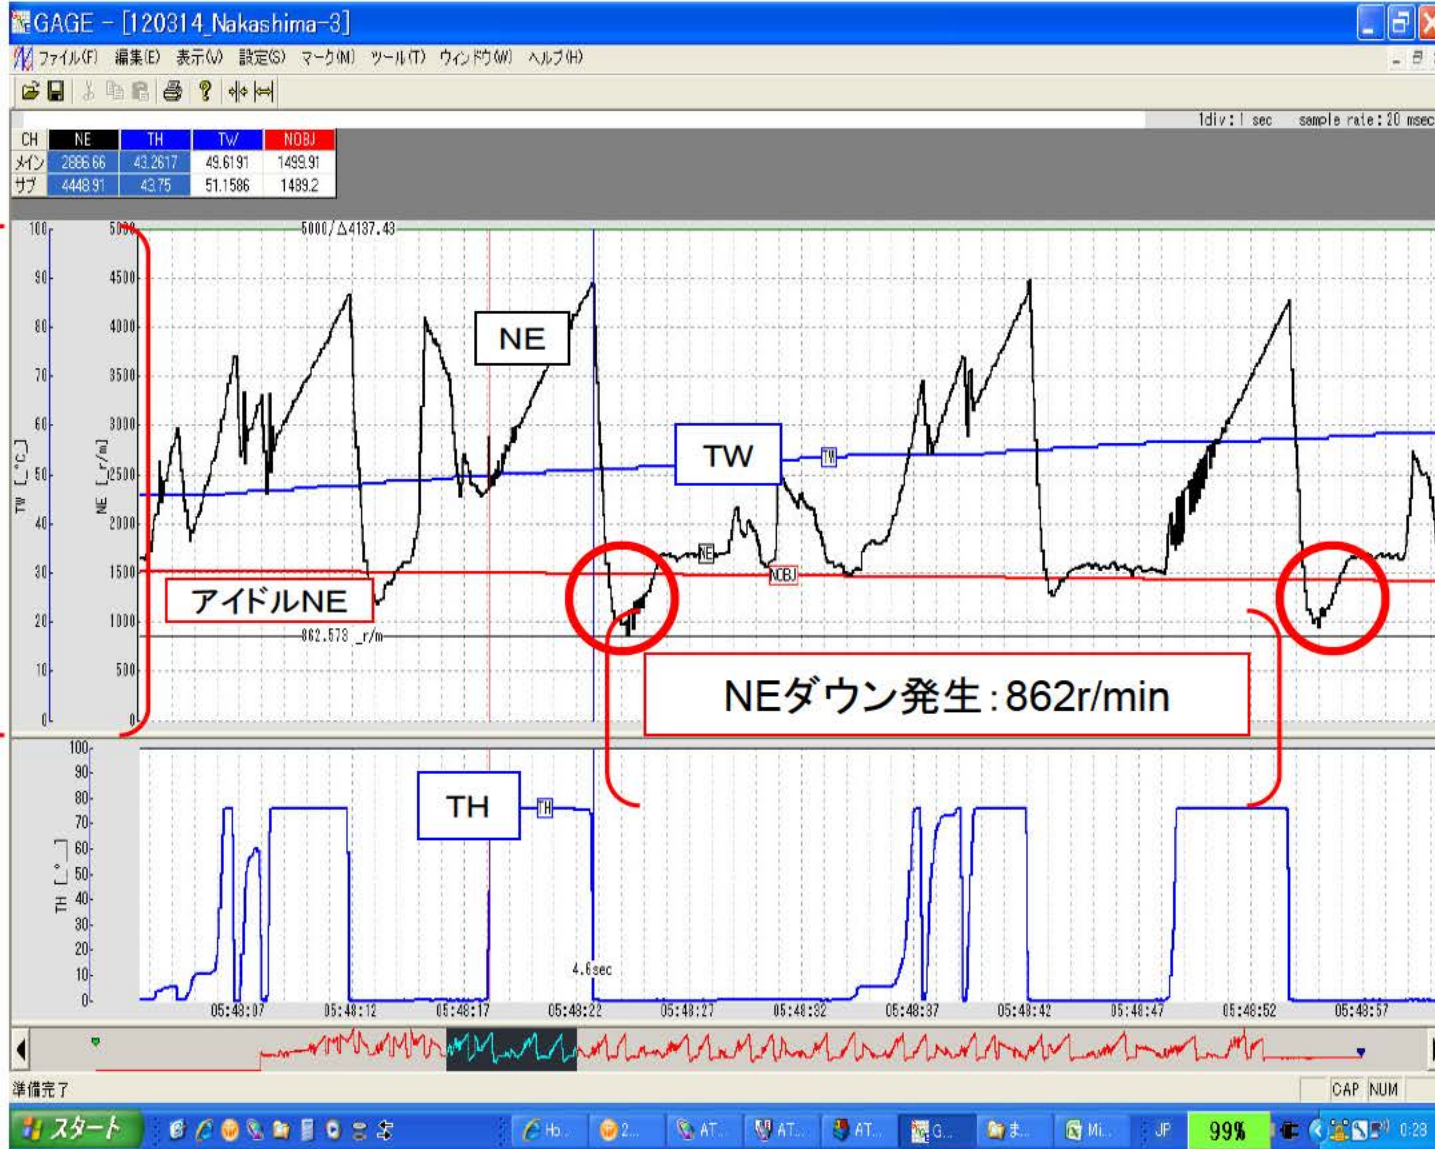
*別途詳細データ有り

チームとしては現在のエンスト推定原因は2つと推定している。
但し事象発生が単独問題で発生しているのか、複合で発生しているのか現時点では特定できない。よって今後、ヘッドの圧縮圧が低いについてはTHで原因解析を実施。
NE低下事象については他量産車御確認を含めA-QICより、HRS-T、HGA、MQIDに依頼し、原因解析を実施して頂く。

・現車はTHへ発送する。

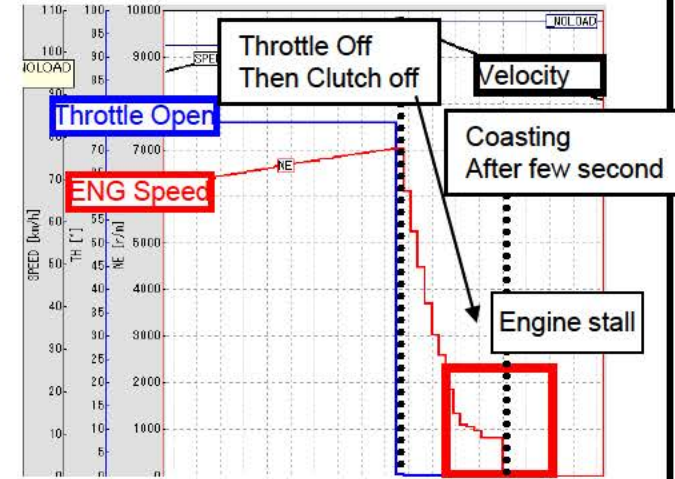
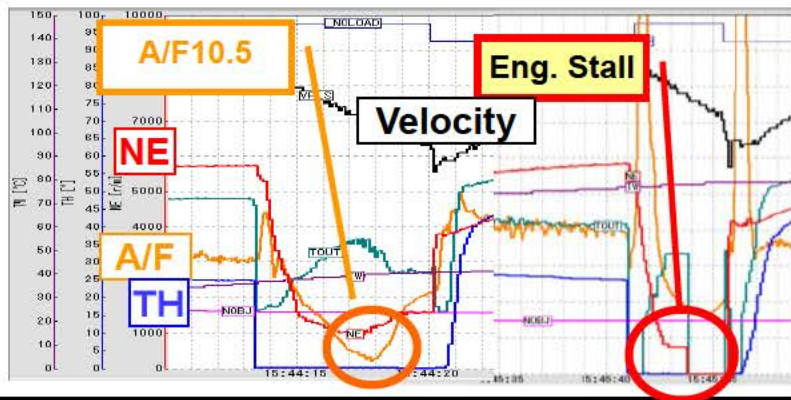
CBR250R (MC41

TW:23~85°C
 Gear Position : 6th
 Clutch disengage
 at 70~90km/h
 (7,000r/min)
 Temperature : 10°C
 0.5sec/div

T.Water: less than 40°C, T.Oil: less than 25°C	T.Water: 40~82°C, T. Oil: 25~60°C	T.Water: Over 85°C, T.Oil: Over 60°C
Eng Stall	No	Yes	No
A/F	10.5	unkown (may be less than 10.5)	13

CBR Engine Stall occurs both at the same time the clutch disengage to coasting with the throttle fully closed from the Engine high speed range.

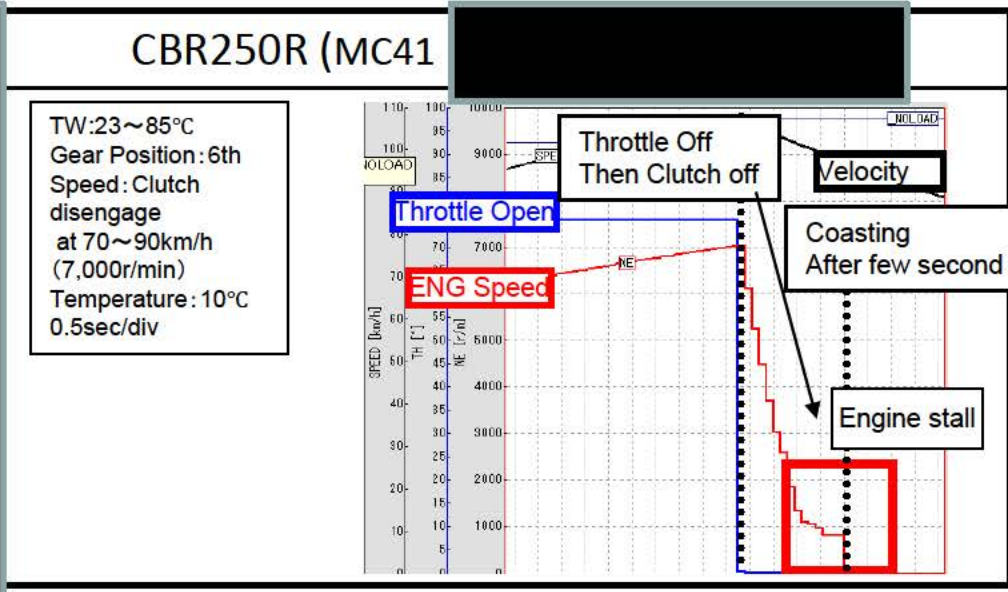
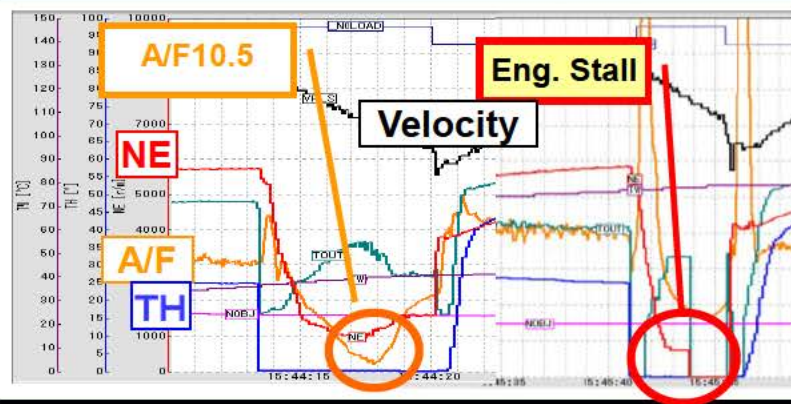
4. Analysis Result Problem Vehicle (Reproduction, Engine Stall Temp. Range) 5/10

T.Water: less than 40°C, T.Oil: less than 25°C	T.Water: 40~82°C, T. Oil: 25~60°C	T.Water: Over 85°C, T.Oil: Over 60°C
Eng Stall	No	Yes	No
A/F	10.5	unkown (may be less than 10.5)	13

- Engine Stall occurs at the same time the clutch disengage to coasting with the throttle fully closed from the Engine high speed range.
- No occurrence of engine stall in a state the clutch enage.
- Restart after engine stall is easy.
- The idling Speed drops below 1450r / min in the warm-up process, A/F becomes rich, occur engine Speed drop and engine stall.
- Engine stall has occurred in the middle of completion of the warm-up of in the Range the Oil Temperature 25 ~ 60 °C.

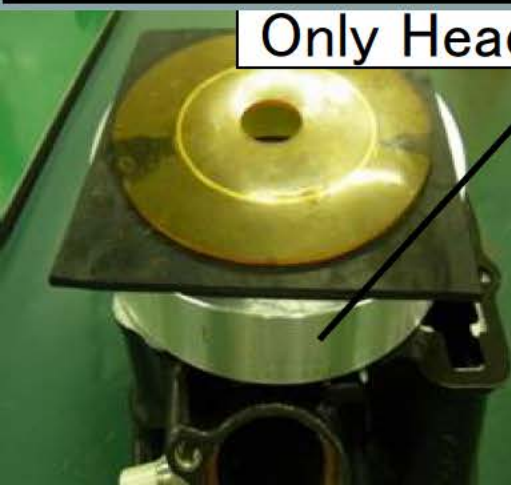
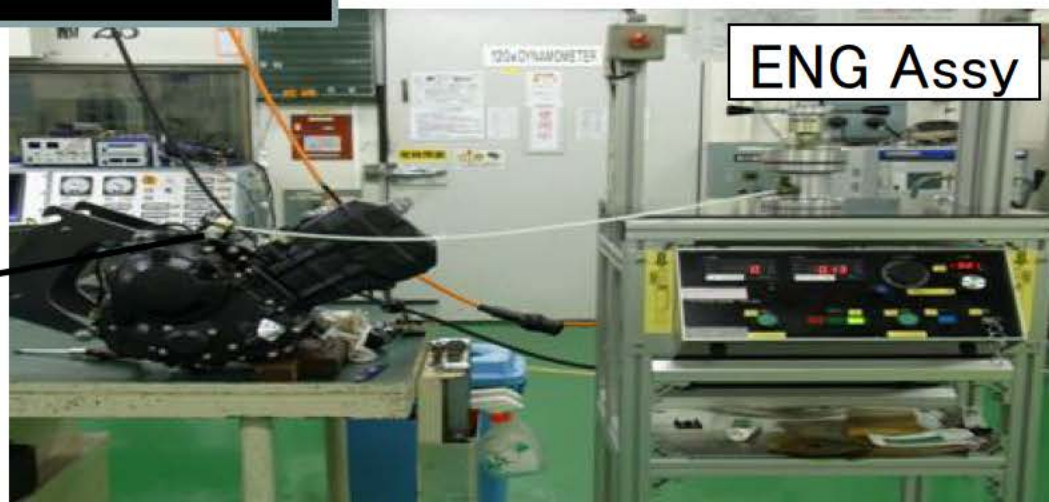
ENG Assy

• Development (sand mold) head is bad alone leakage quantity, leakage quantity is reduced by tightening.

• US Buy Back and Fukui vehicles (M/P) head leak amount is increasing by tightening.

Head leak amount difference need further analysis.

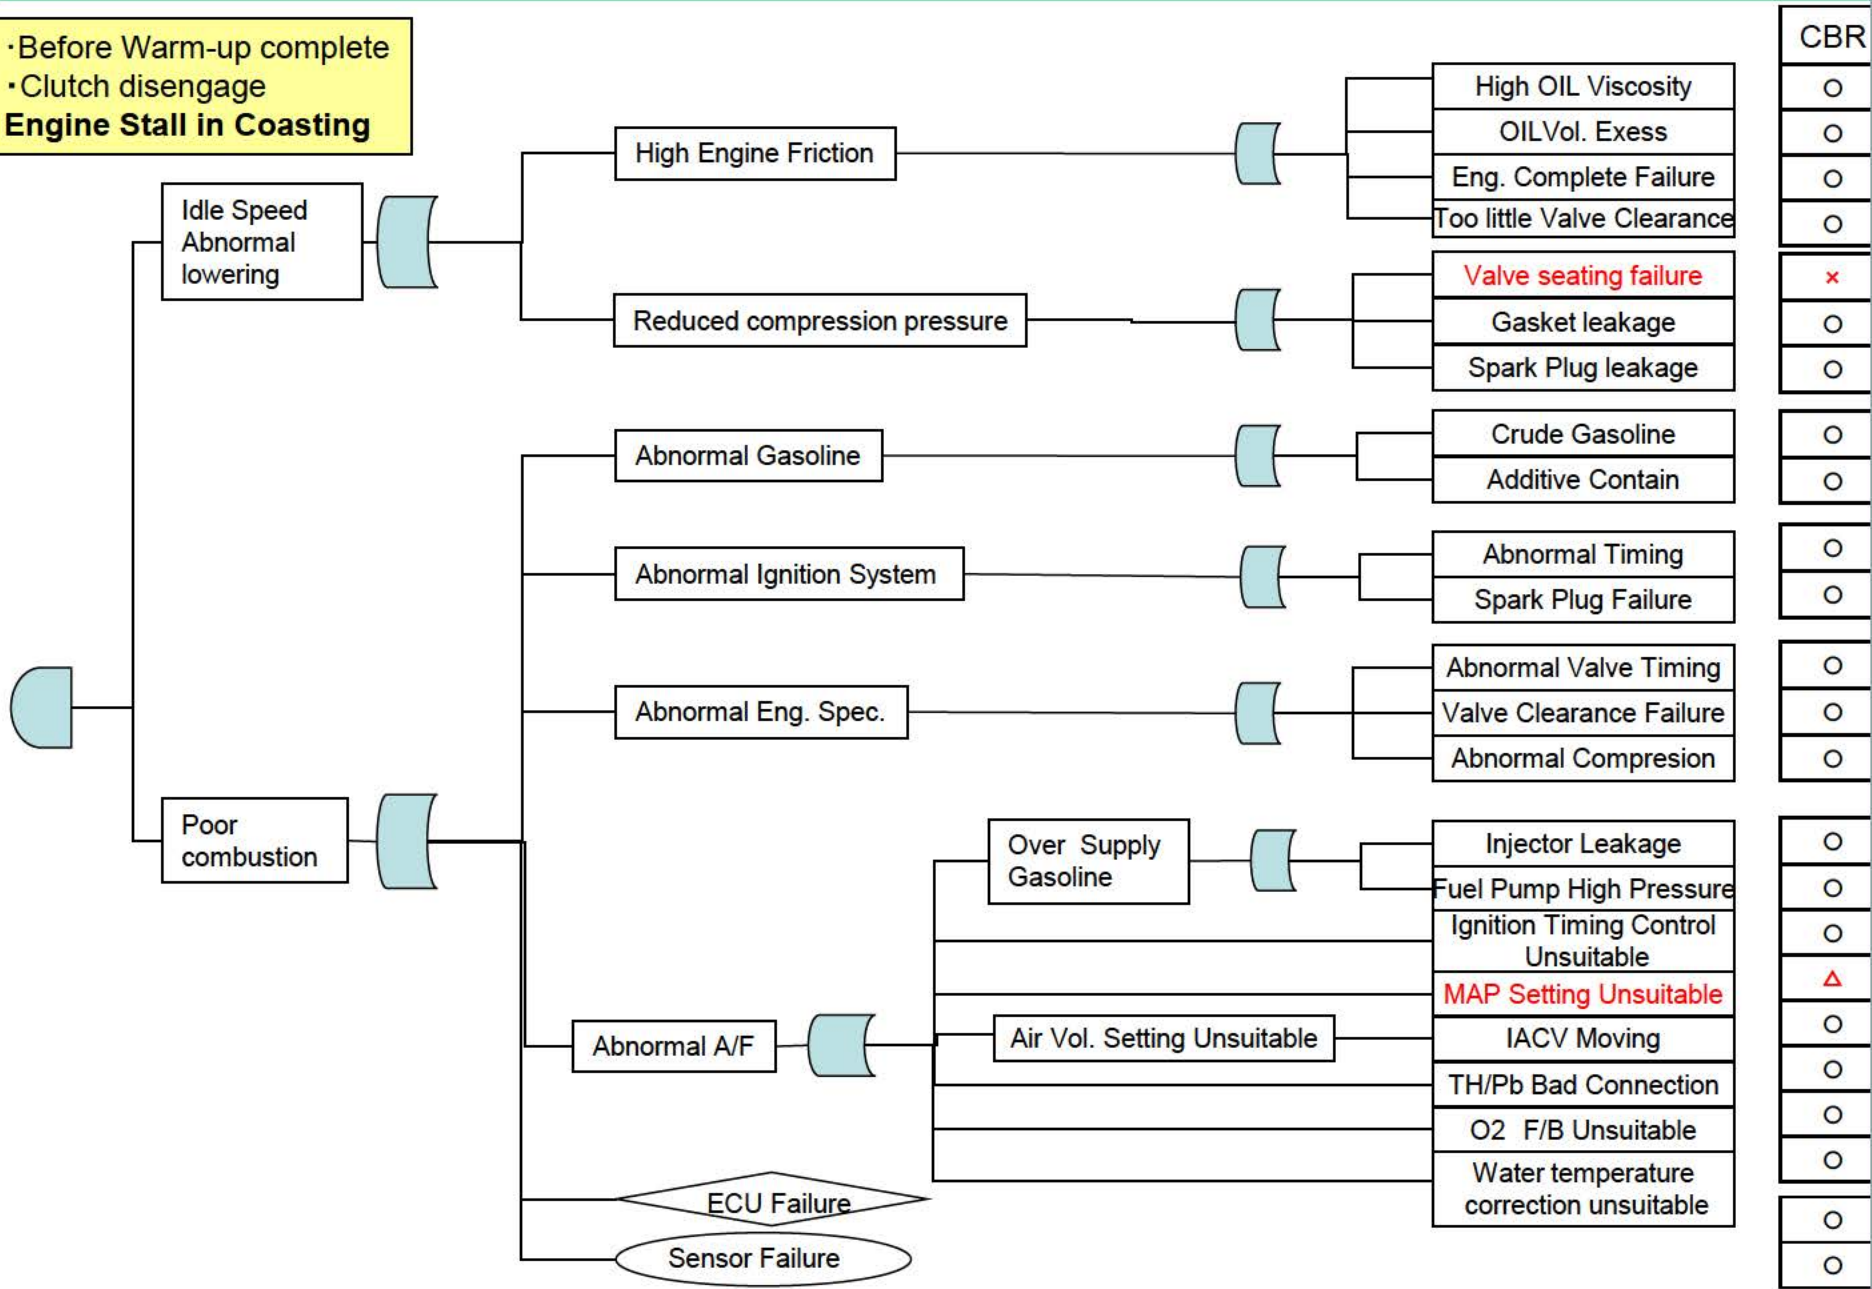
FTA

·Before Warm-up complete
·Clutch disengage
Engine Stall in Coasting

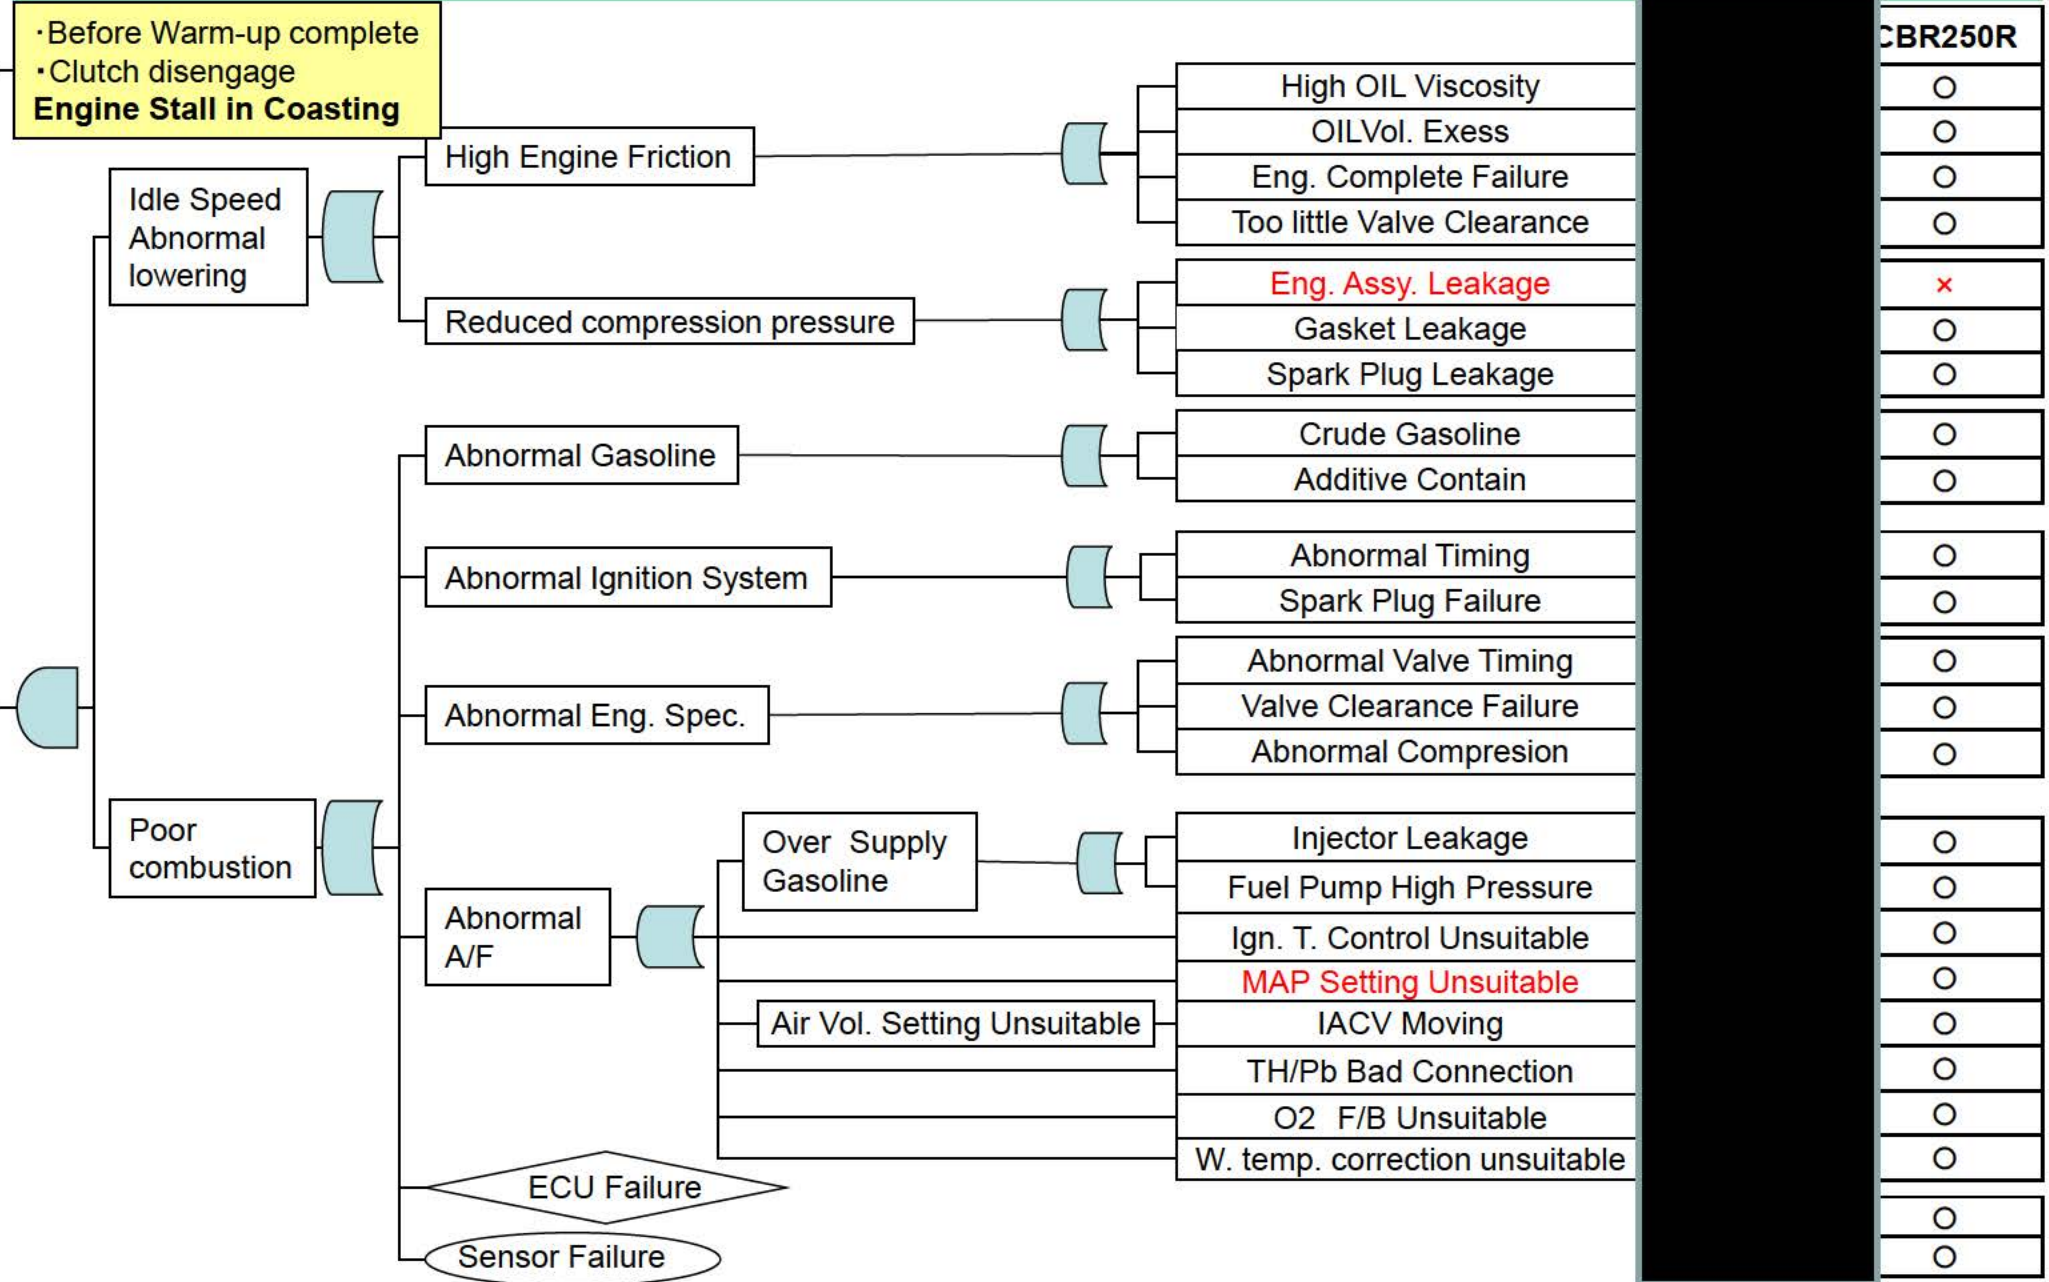
FTA

· Before Warm-up complete
· Clutch disengage
Engine Stall in Coasting

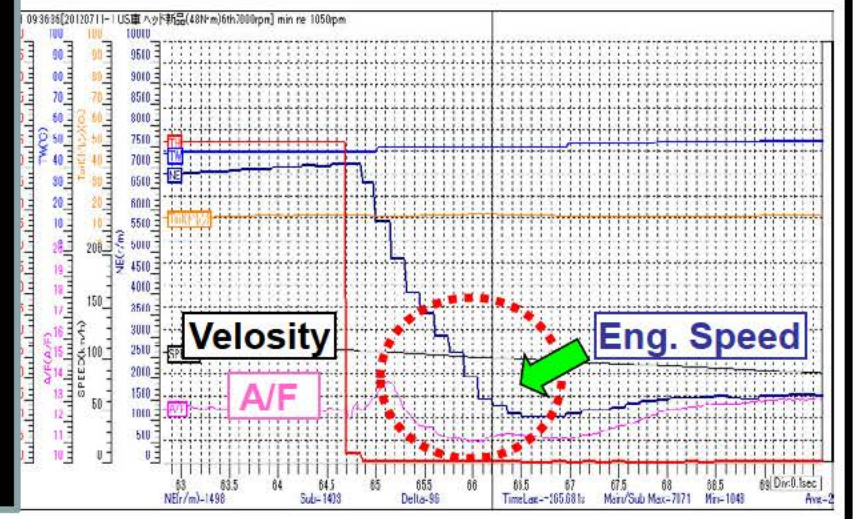
After

Both [redacted] and CBR, the introduction of countermeasure specification, is no longer the occurrence of engine stall

Change	Content	Effect	①Cylinder Head	New	Improve distortion of cylinder Head and Eng. Assy. Leakage by Tightening Torque Excessive	②Stud Bolt	↑	③、④Cylinder/Head Gasket	↑	⑤Nut	↑	⑥Washer	↑	⑦Tightening Torque	51N·m →48N·m
Change	Content	Effect																	
①Cylinder Head	New	Improve distortion of cylinder Head and Eng. Assy. Leakage by Tightening Torque Excessive																	
②Stud Bolt	↑																		
③、④Cylinder/Head Gasket	↑																		
⑤Nut	↑																		
⑥Washer	↑																		
⑦Tightening Torque	51N·m →48N·m																		
ENG Parts and Tightening Torque Change

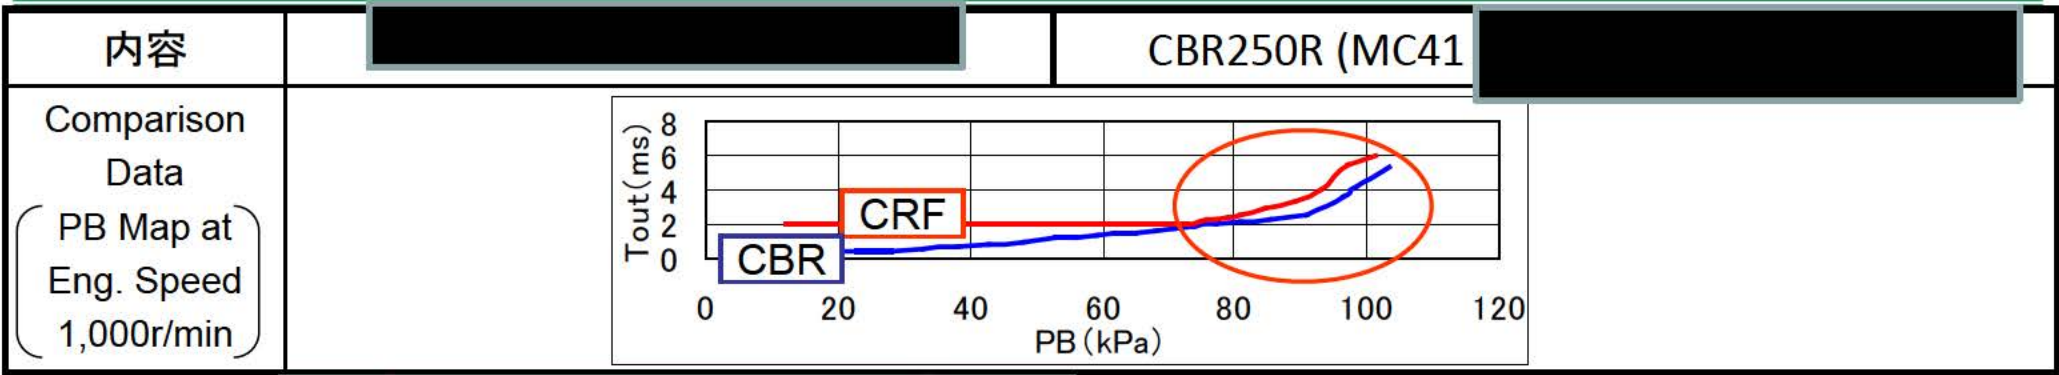
4. Analysis Result Fuel adjustment lean/ Comparison Head tightening torque

- CBR250R leak amount is reduced and not stall occurs Lowering the tightening torque of the head attached clamping by Overspecified.
- CBR250R is stalling does not occur in the exchange to the new head.

Eng. Stall	BuyBack	No <input type="radio"/>	—	Yes <input checked="" type="checkbox"/>	—	Yes <input checked="" type="checkbox"/>									
		New	—	No <input type="radio"/>	—	No <input type="radio"/>	No <input type="radio"/>										
		Eng. Speed after dropping	BuyBack	900r/min 11.1	—	980r/min 11.2	—	970r/min 11.2									
		New	—	1,050r/min 11.2	—	1,230r/min 11.8	1,160r/min 11.8										
		A/F	—	—	—	—	—										
		leakage volume (m3/min @20kPa)	BuyBack	236	—	434	—	1,700									
		New	—	79	—	580	610										
		Head tightening torque	Ref.	40N·m	Under Tolerance	Setting	Upper Tolerance	Buy Back									
							60.5N·m (Ave.)

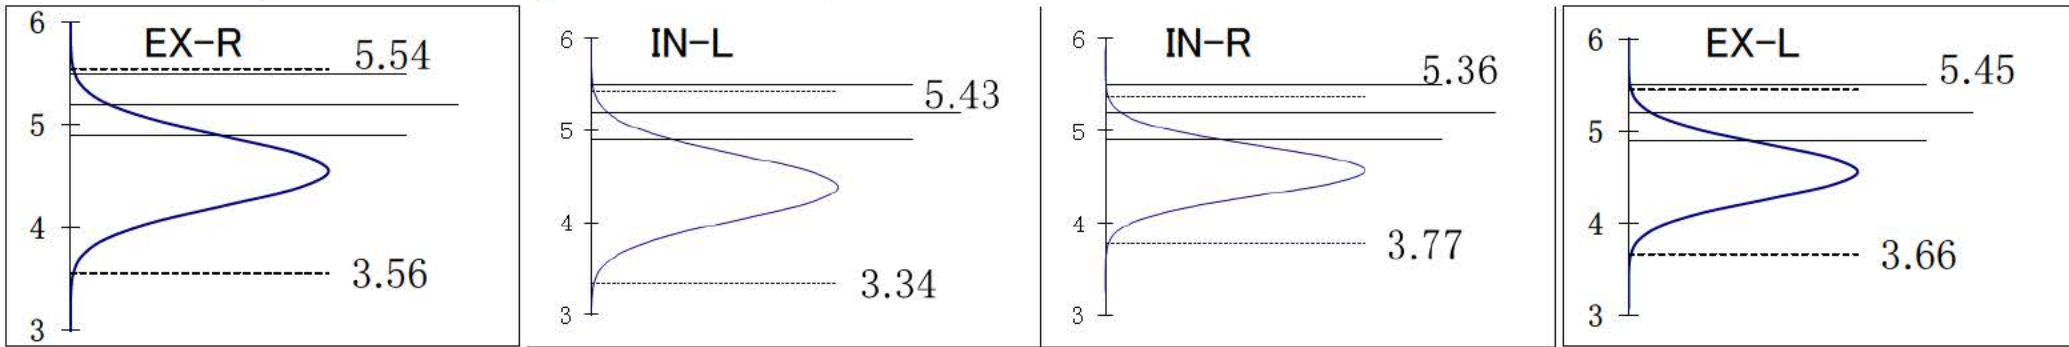
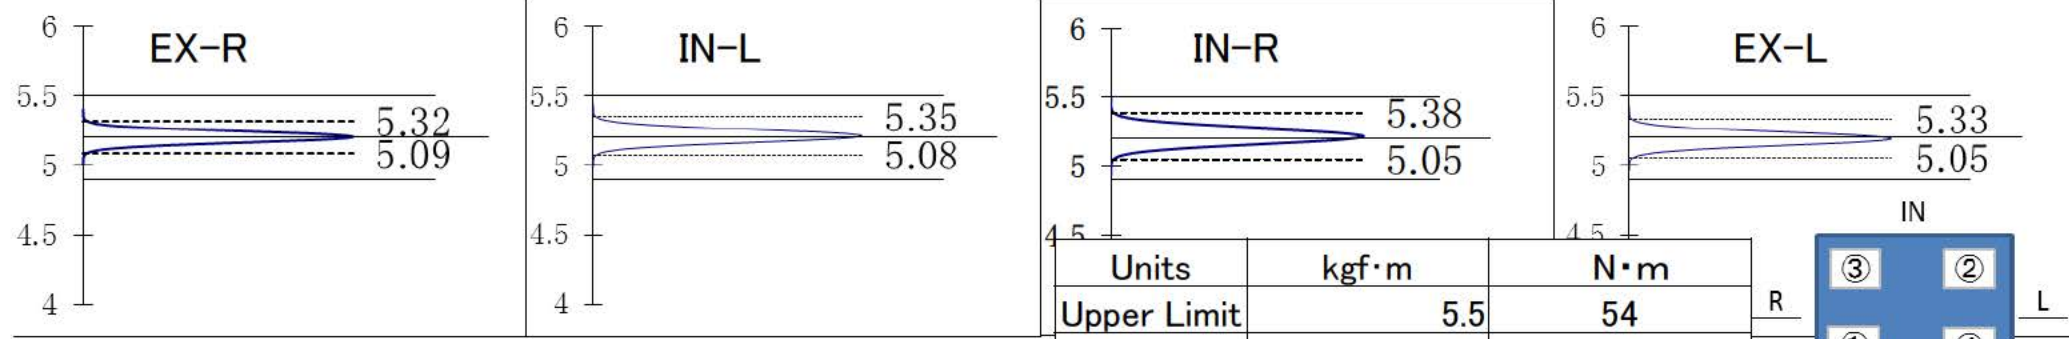
4. Analysis Result CBR250R Factory line Tightening Torque Check Result

After with oil pulse wrench tighten (n=20 Unit)

After with QL Wrench tighten (n=20 Unit)

Units	kgf·m	N·m
Upper Limit	5.5	54
Center	5.2	51
Lower Limit	4.9	48

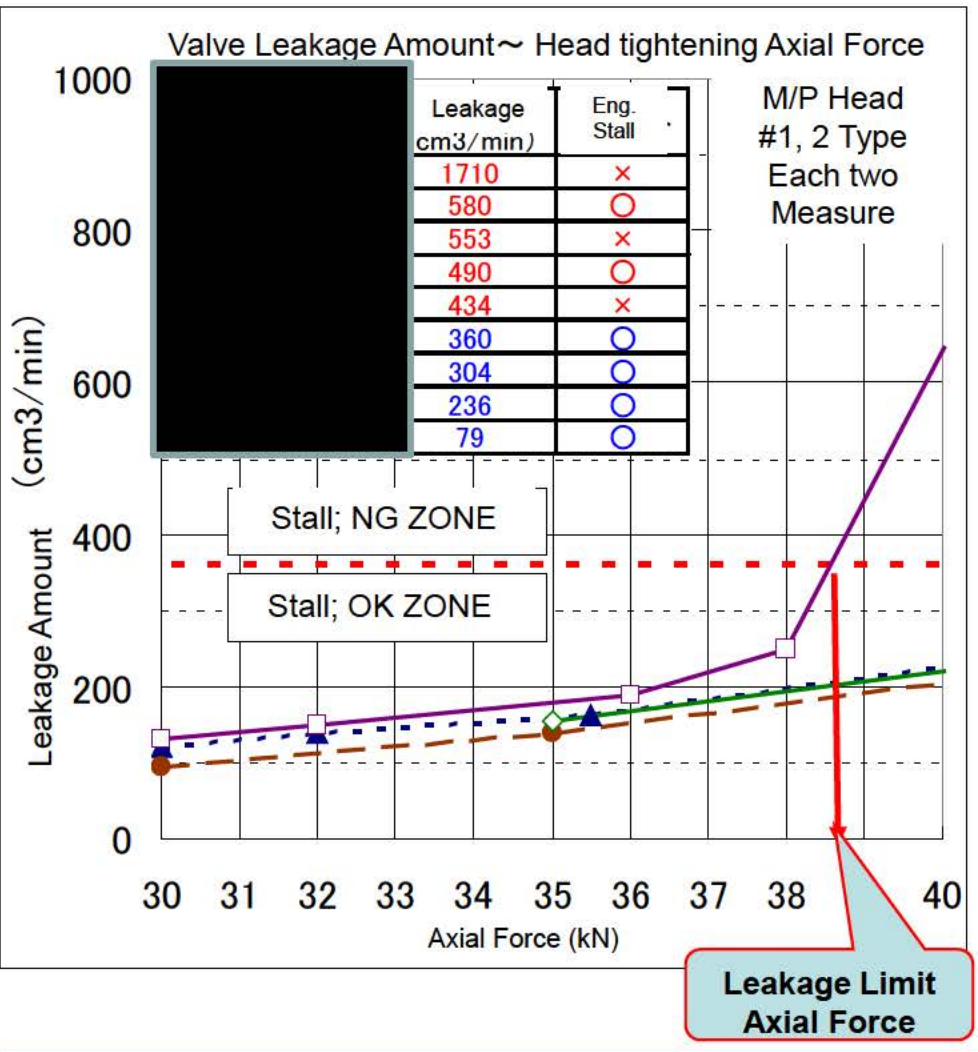
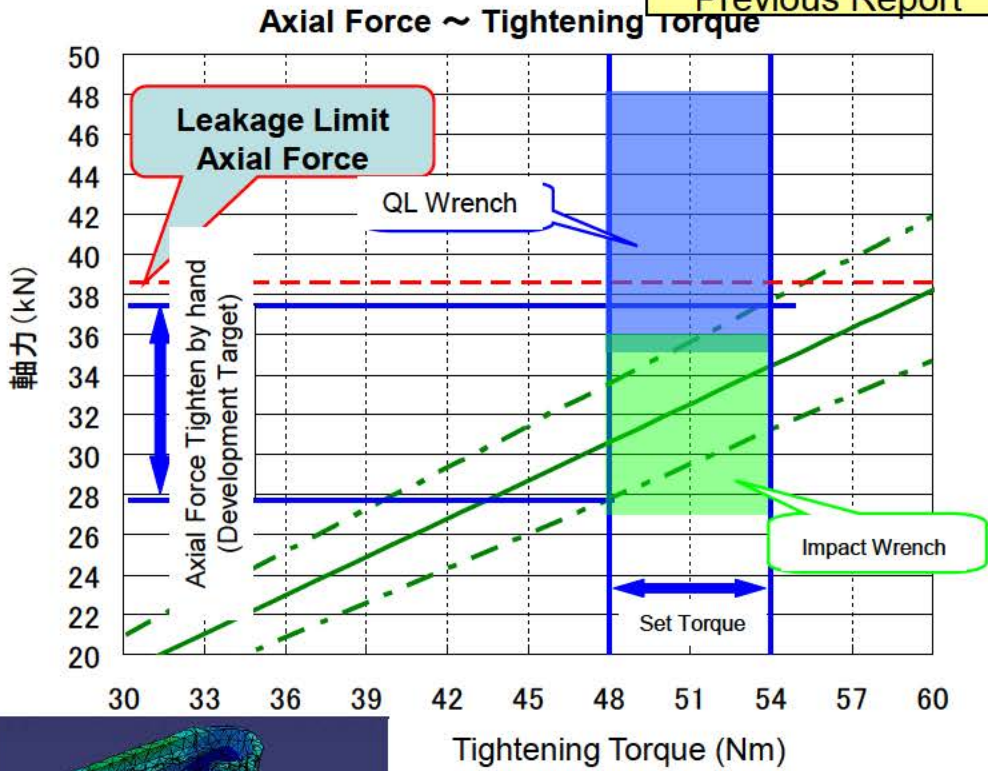
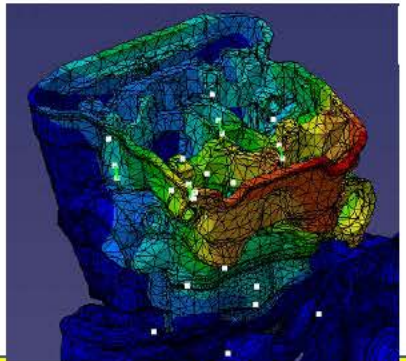
4. Analysis Result Valve Leakage amount ~ Head tightening Axial Force

CAE analysis results
Valve Seat Leakage occurs deformed by with Head Tightening Axial Force

CAE Conditions: Axial Force 37.7kN

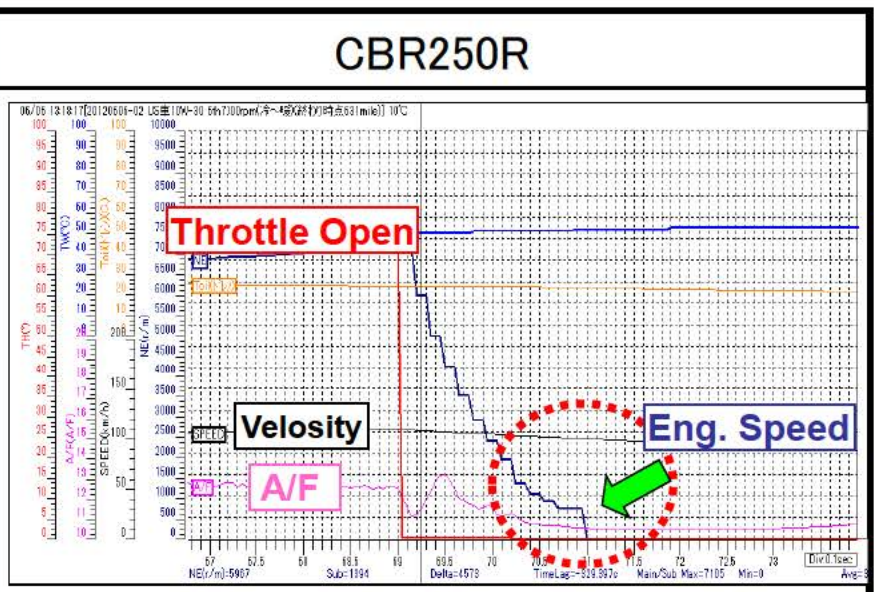
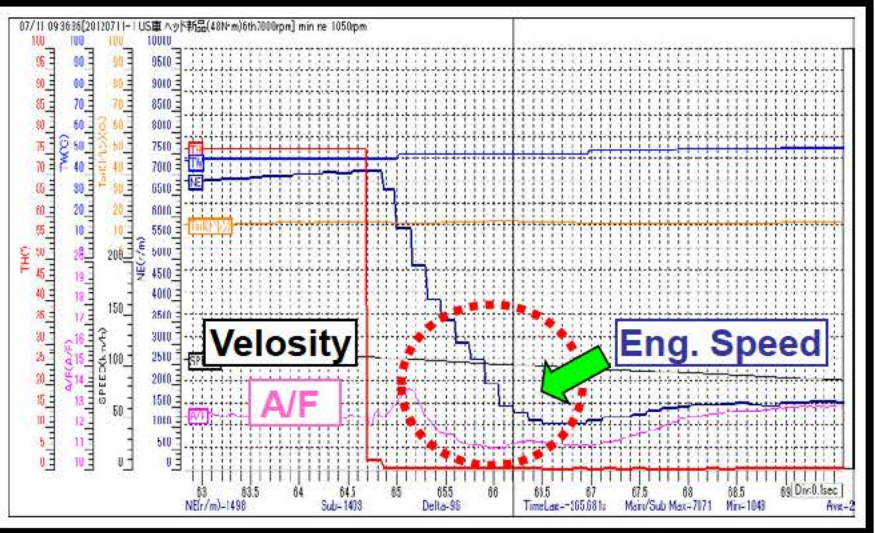
Effect of countermeasure

Both [redacted] and CBR, the introduction of countermeasure specification, is no longer the occurrence of engine stall.
