PE14-032

HNDA

CBR250R (US) : Visiting an actual place Result : Customer feedback information

10. Engine stall when riding CBR250R(KYJA)

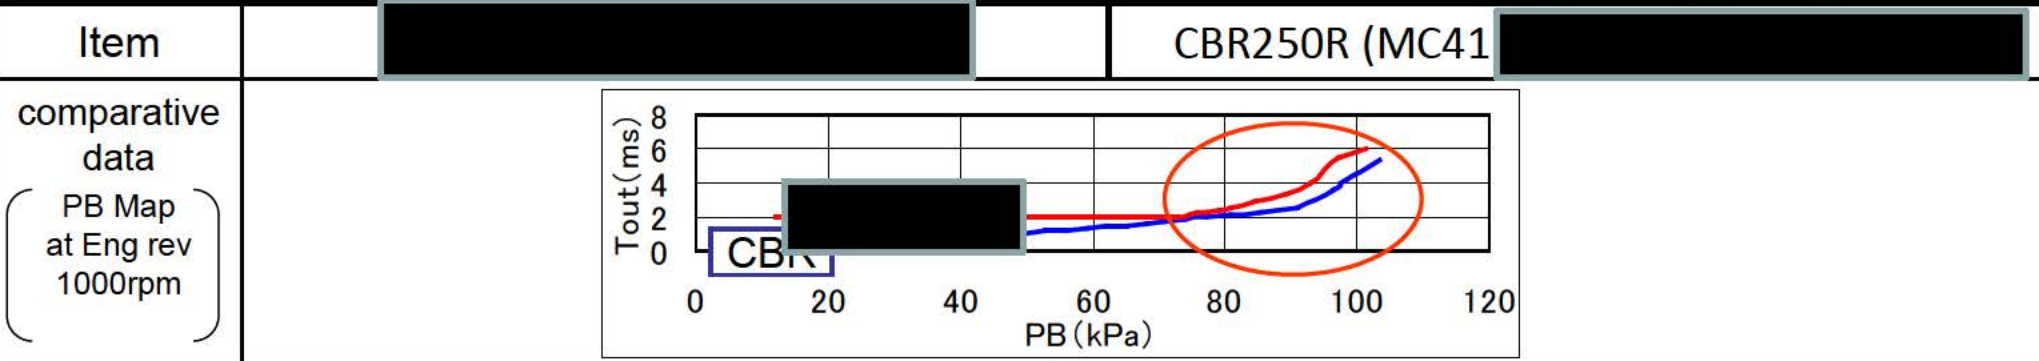
Comparison for A/F ratio lean control and Head comp tightening Torque

CBR250R Tightening Torque changing (Right table)	Engine stall	Actual Unit	Not occur ○	—	Occur ×	—	Occur ×					
		New Unit	—	Not occur ○	—	Not occur ○	Not occur ○					
rpm at stall	Actual Unit	900r/min 11.1	—	980r/min 11.2	—	970r/min 11.2						
	New Unit	—	1,050r/min 11.2	—	1,230r/min 11.8	1,160r/min 11.8						
Tightening torque	Actual Unit	236	—	434	—	1,700						
	New unit	—	79	—	580	610						
		For reference 40N·m	lower limit tolerance 48N·m	Set value 51N·m	Upper limit tolerance 54N·m	Outcome of Actual Unit 60.5N·m (Ave.)

·CBR250R will not occur engine stall after the engine head is replaced to new one.

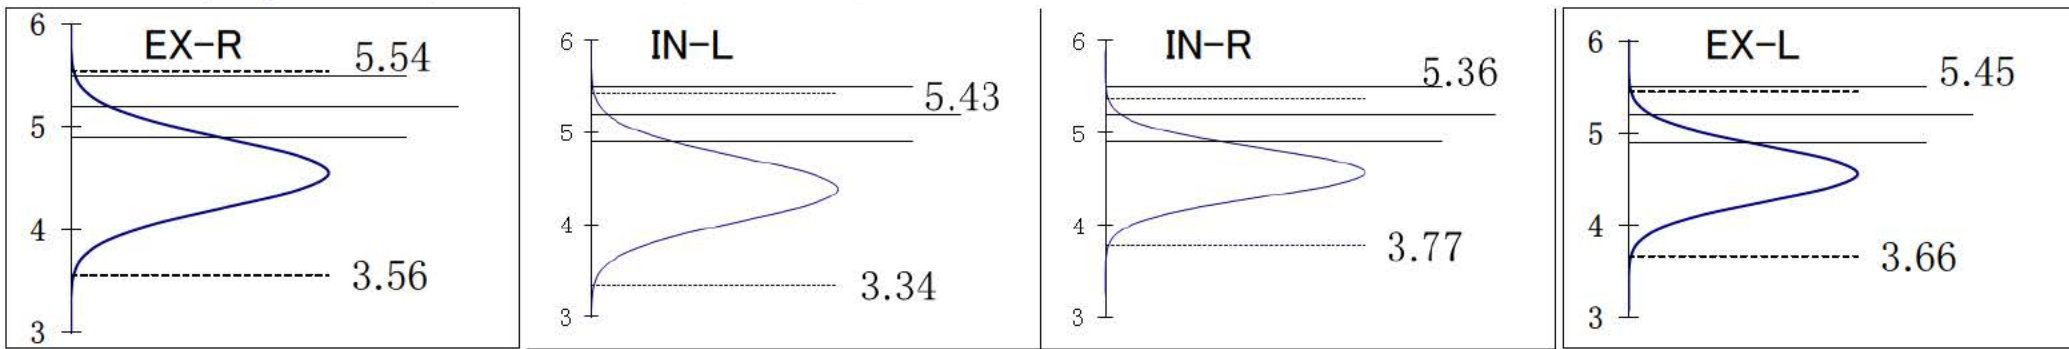
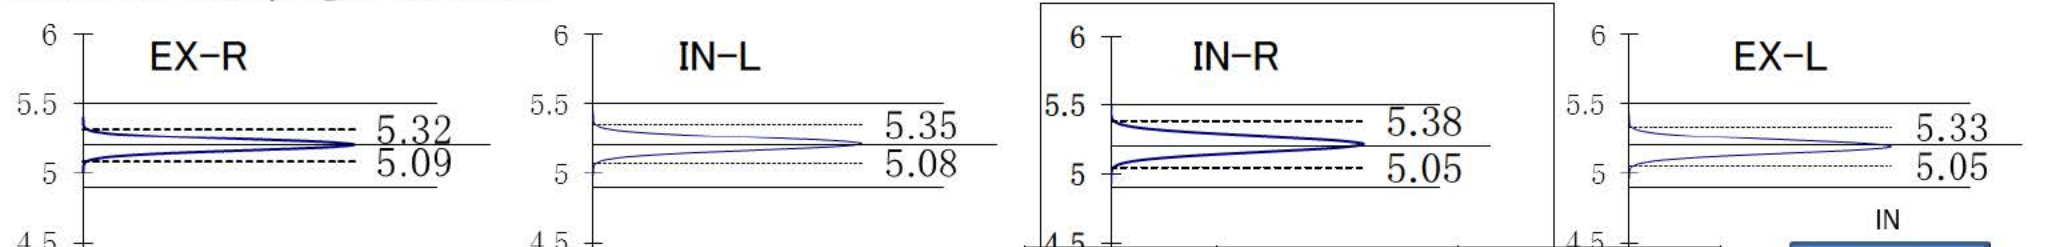
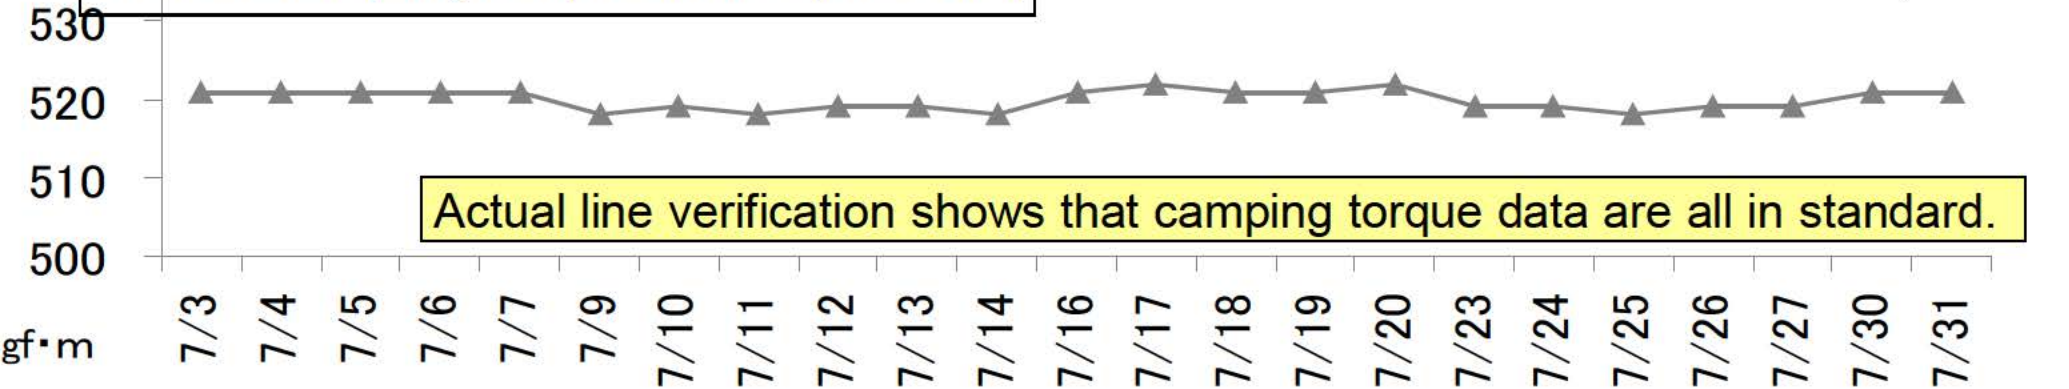
CBR250R Verification results of clamping torque in factory line.

Actual line verification shows that clamping torque data are all in standard.

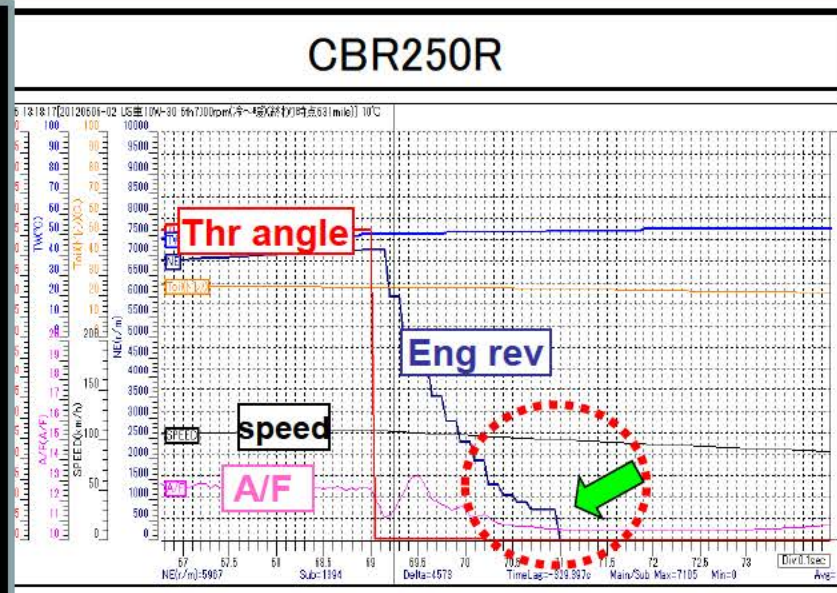
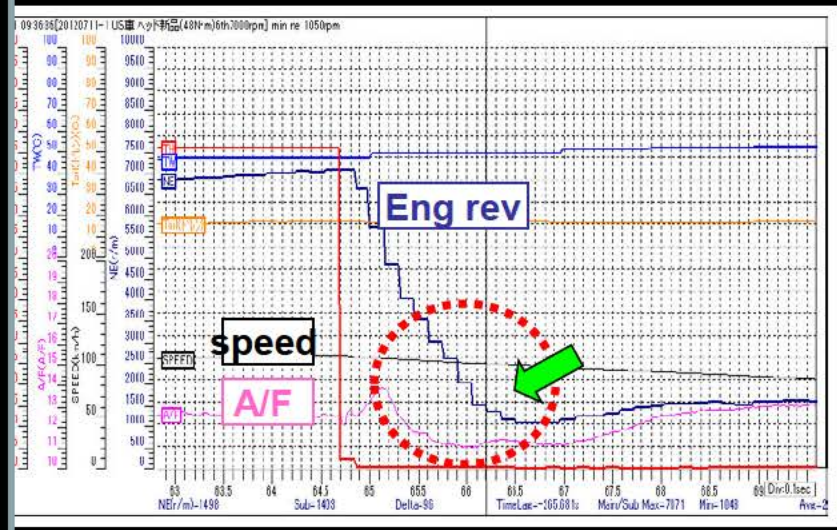
Proposed market action, Confirmation of the measures effect

No engine stall occurs by means of countermeasures for both [redacted] and CBR250R.

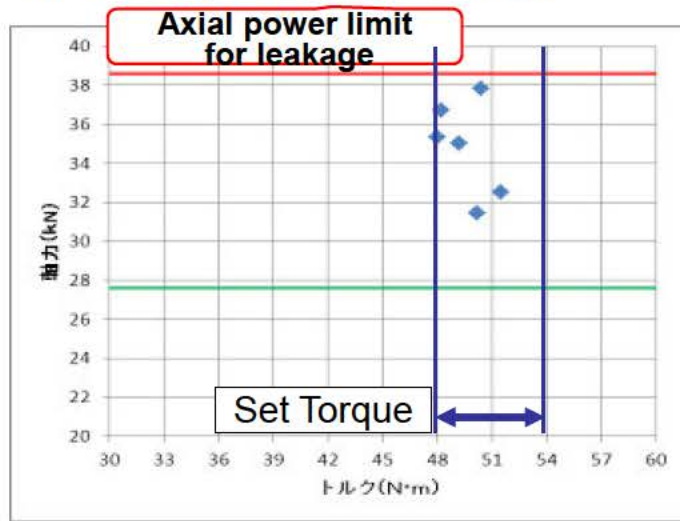
Head comp clamping in TH line

It was confirmed that axial power comes in target range by changing the setting

Change the set torque for impact wrench: 51 → 33 N·m
 Change a QL wrench: adopt a over less type wrench (set torque is 51 N·m, no change)

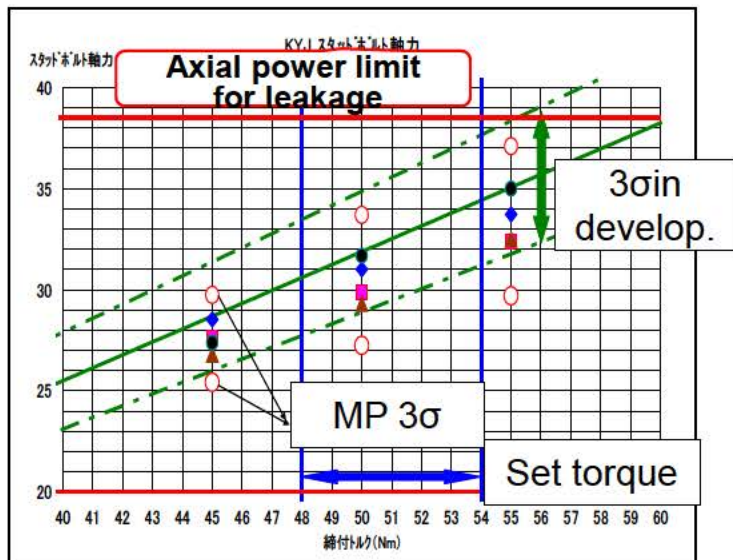
Head comp clamping in measures

It was confirmed that no engine stall occurs at the upper limit torque by hand clamping.

Impact wrench is not available.
 Set torque is 51 N·m instructed in Service Manual. No change.

- Impossible to use impact wrench because of its variation.
- Wearout parts, such as stud bolt, washer, nut, Cylinder gasket, and head gasket, will be replaced to new one.

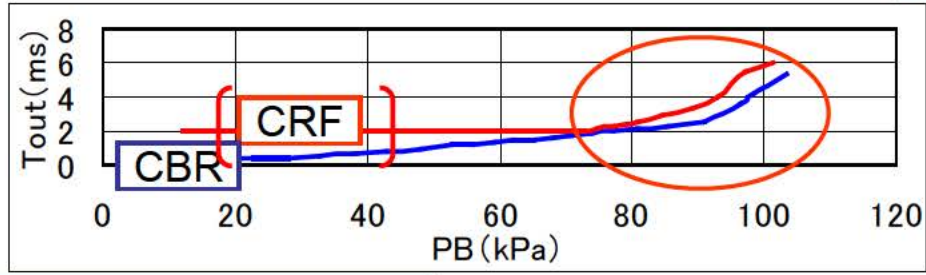
Comparison for A/F ratio lean control and Head comp tightening Torque

Engine stall	Actual Unit	Not occur	—	Occur	—	Occur
	New Unit	—	Not occur	—	Not occur	Not occur
rpm at stall	Actual Unit	900r/min 11.1	—	980r/min 11.2	—	970r/min 11.2
A/F	New Unit	—	1,050r/min 11.2	—	1,230r/min 11.8	1,160r/min 11.8
Peak amount of engine Assy	Actual Unit	236	—	434	—	1,700
3m3/min at 20kPa)	New unit	—	79	—	580	610
Tightening torque	For reference	40N·m	lower limit tolerance 48N·m	Set value 51N·m	Upper limit tolerance 54N·m	Outcome of Actual Unit 60.5N·m (Ave.)
						L R
						EX 58.7 61.1
						IN 69.3 52.8

- CBR250R will not occur engine stall after the tightening torque of Actual unit is released to 40N·m.
- CBR250R will not occur engine stall after the engine head is replaced to new one.

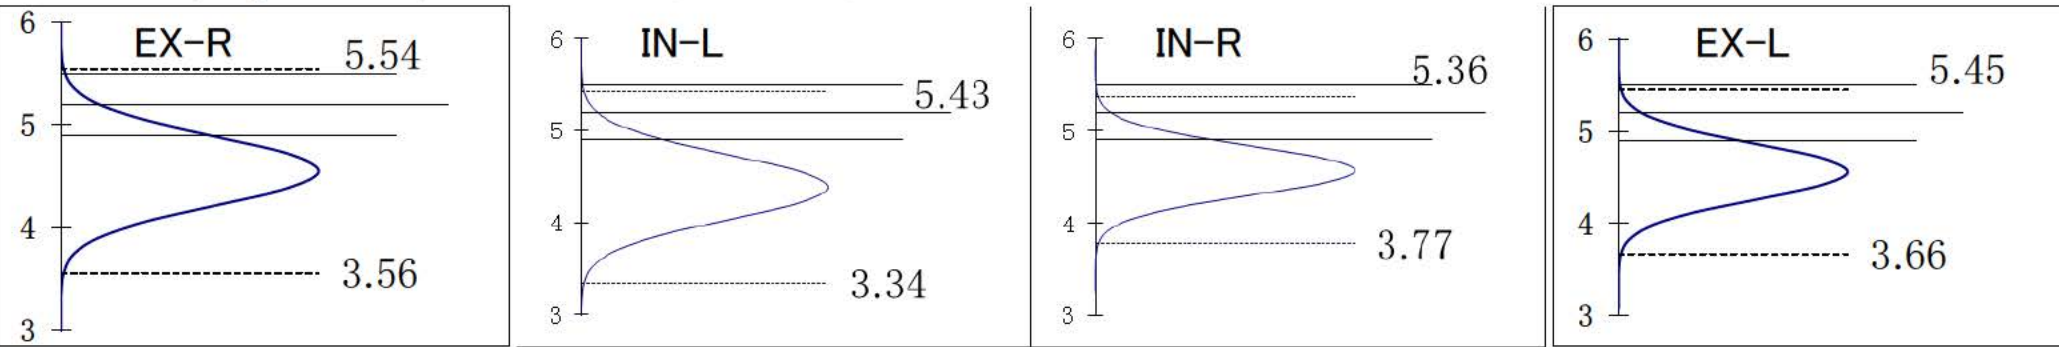
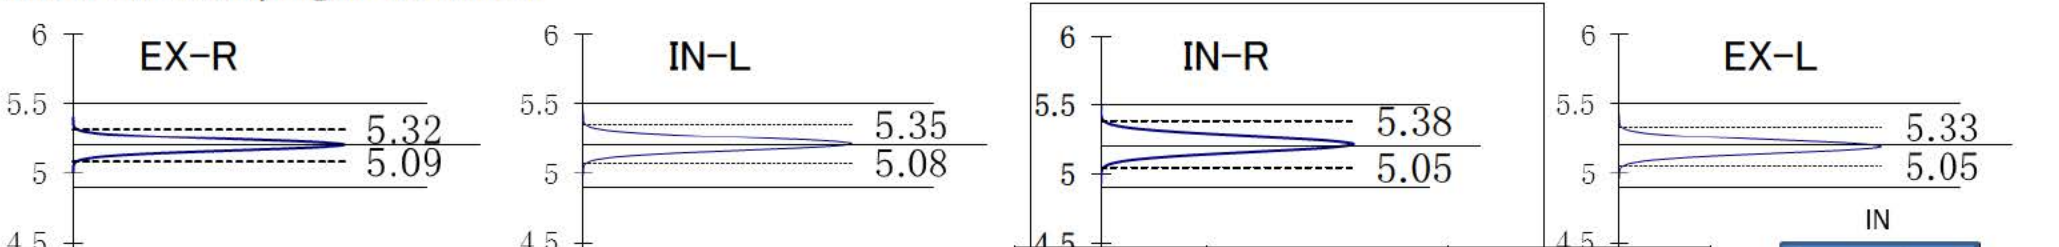
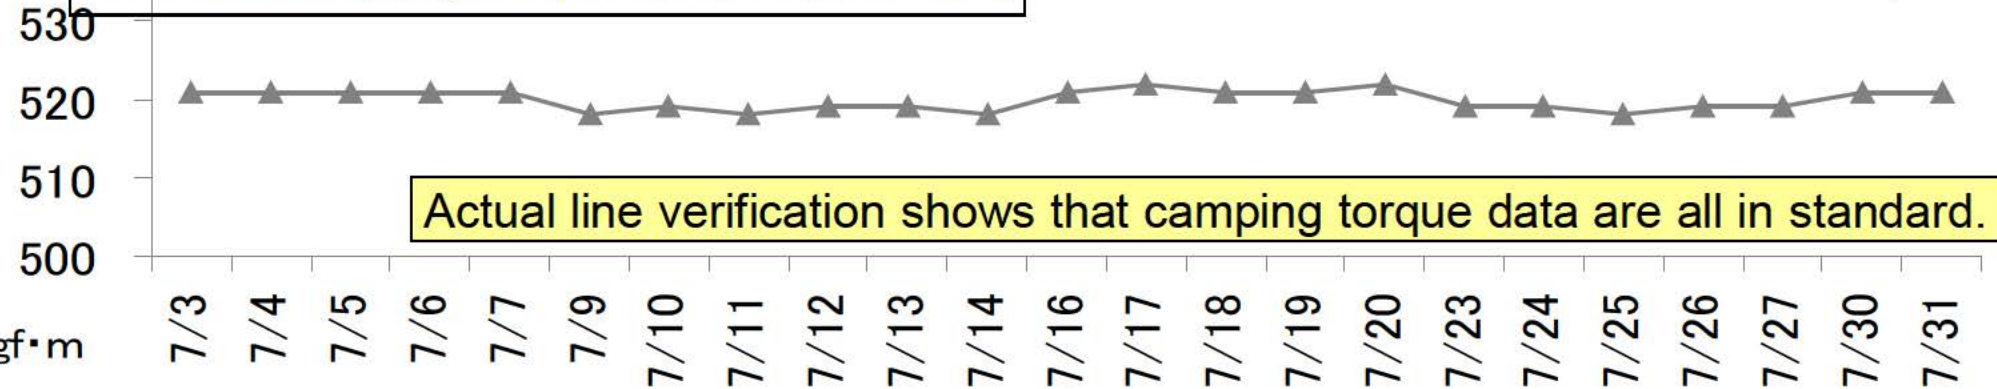
CBR250R Verification results of clamping torque in factory line.

Actual line verification shows that clamping torque data are all in standard.

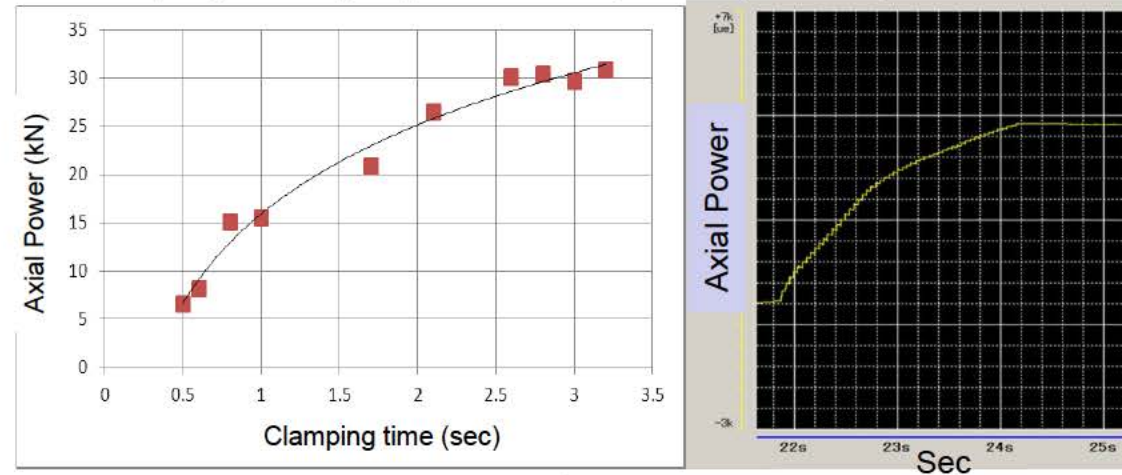
Clamping time by impact wrench(51N·m) ~ Axial power

Because of unevenness of oil pulse wrench, Clamping stroke by QL wrench became Unstable. And it may cause some defective clamping such as overstroke.

QL clamping time is 0.5~3.3sec, and it is faster than that of development whose time was 5~10sec (corresponding to QL clamping), so coefficient of friction decreases, and unevenness spreads in the high axial power side.
(refer to the diagraph of clamping torque/ axial power of previous page)

- By the method of MP clamping (impact and QL) in TH, it may sometimes exceed the marginal axial power for leakage.
- Instability of clamping by QL wrench and overstroke, caused by unevenness of clamping time at the time of impact clamping.
- Decrease of coefficient of friction, caused by the clamping speed.

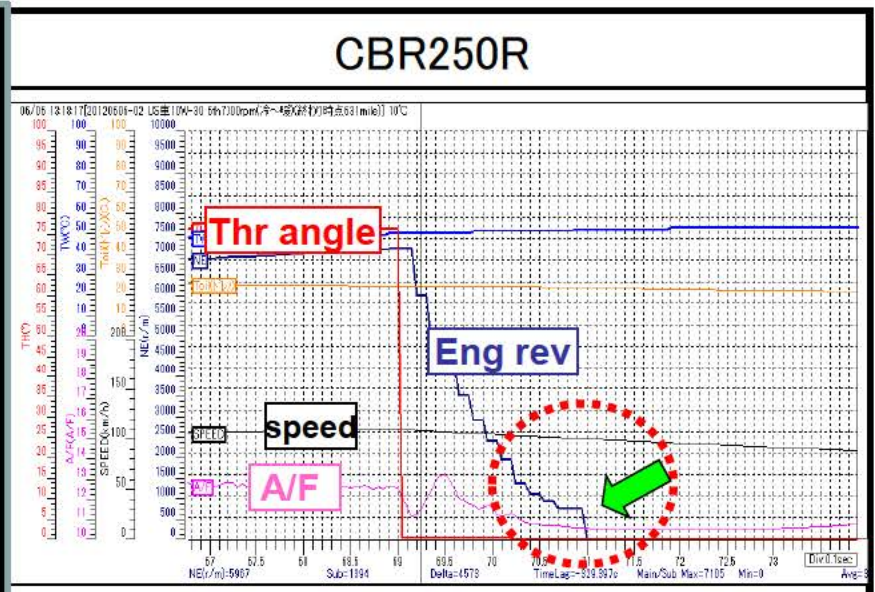
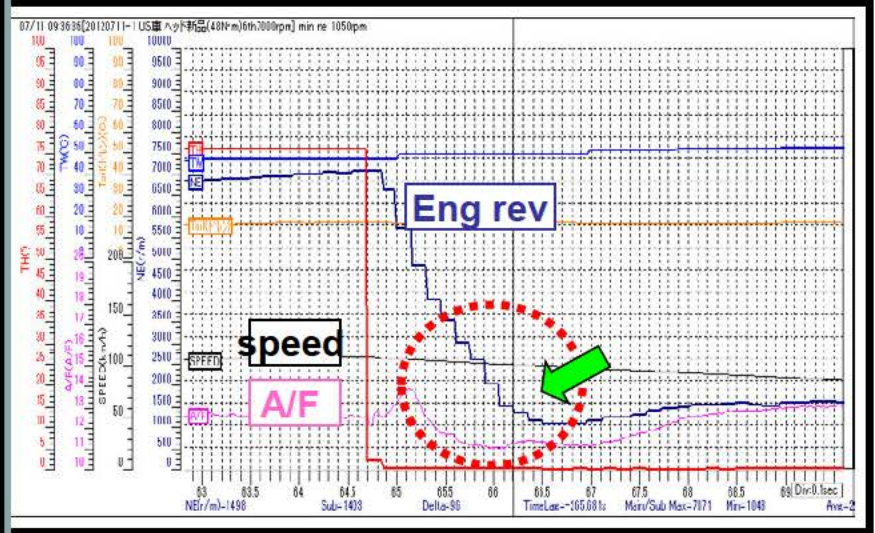
No engine stall occurs by means of countermeasures for both [redacted] and CBR250R.

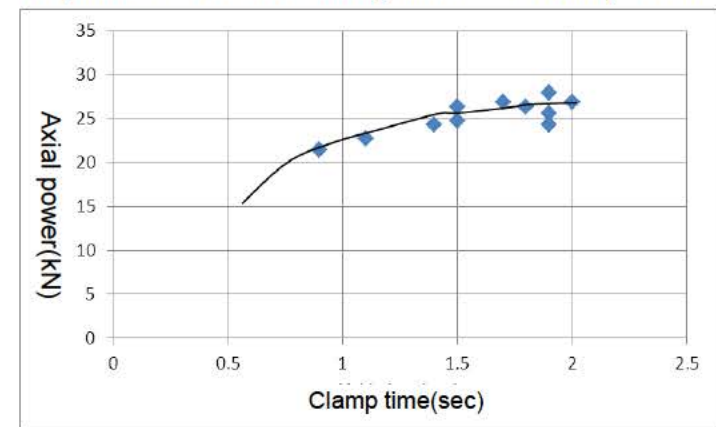
Impact (33N·m) clamp time ~ Axial power

By reducing setting torque of oil pulse wrench, clamping time before relief is shorten and axial power becomes stable.

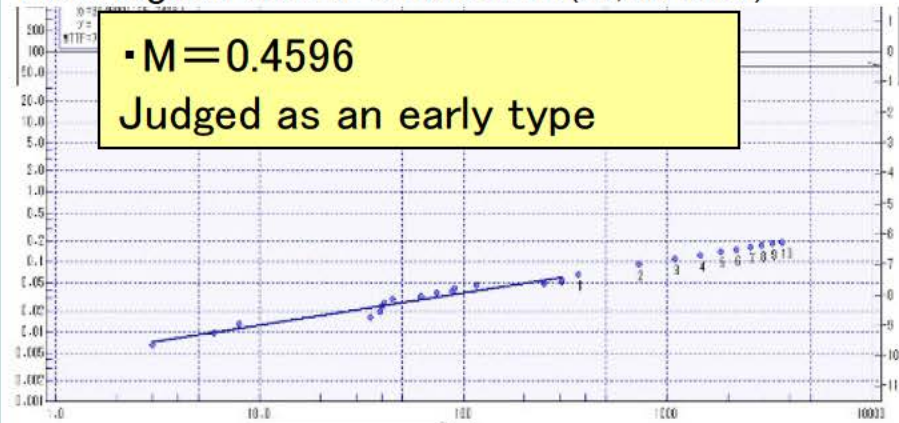
From register date to occurrence (30,777 units)

Passed years	Predictive incidence (%)	Occurrence no.
1	0.0659	20
2	0.0906	28
3	0.1092	34
4	0.1246	38
5	0.1381	42
6	0.1501	46
7	0.1611	50
8	0.1713	53
9	0.1809	56
10	0.1899	58

Predictive occurrence after 2 years is 28 units

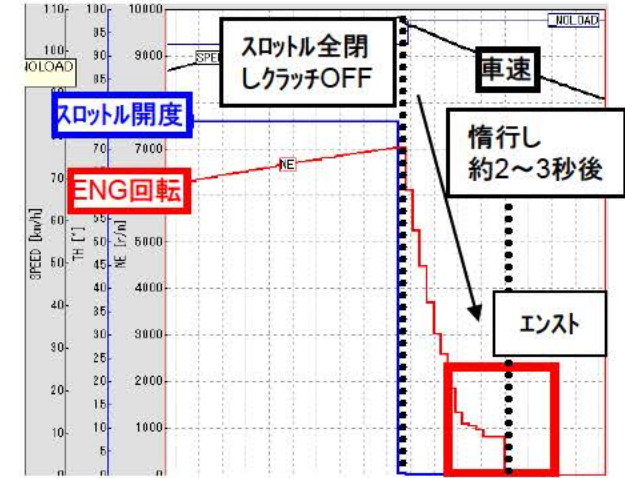
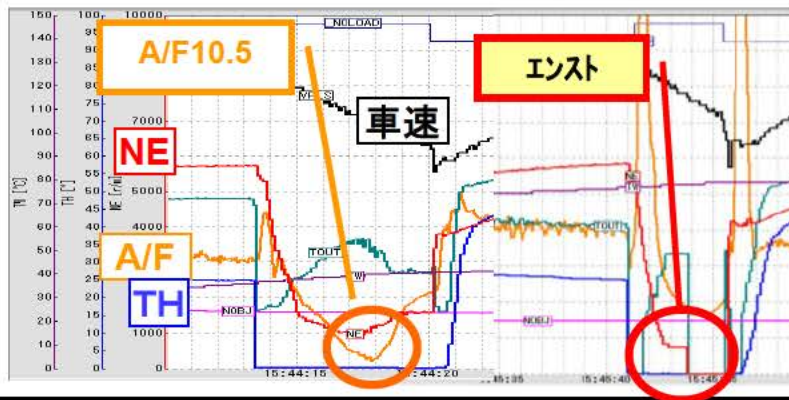
CBR250R (MC41

TW:23~85°C
 使用ギヤ:6速
 車速:70~90km/h
 (7,000r/min)
 からクラッチOFF
 外気温:10°C
 1目盛:0.5秒

TW:40°C以下、油温: 25°C以下	TW:40~82°C、油温: 25~60°C	TW:85°C以上、油温: 60°C以上
エンスト	無	有	無
A/F	10.5	エンストA/F不明(10.5以下 下推測)	13

- CBR ■ 高回転域からスロットル全閉と同時にクラッチOFFし惰行走行でエンストが発生する
- ・暖機過程でのアイドル回転1450r/min以下に低下し、A/Fはリッチとなり回転落ちやエンスト
 - ・油温25~60°Cの暖機完了途中での領域でエンストが発生している。

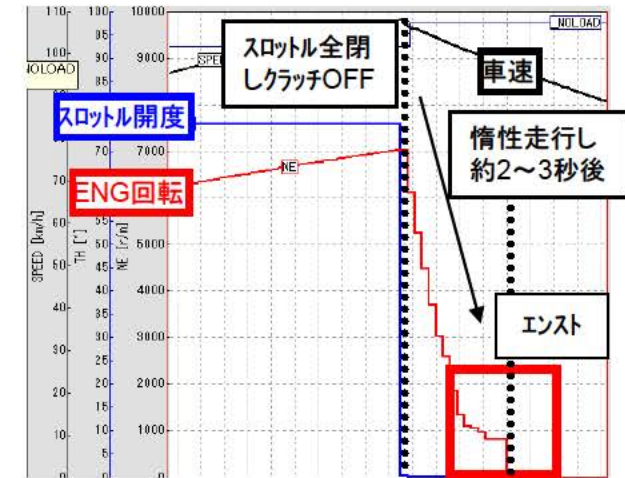
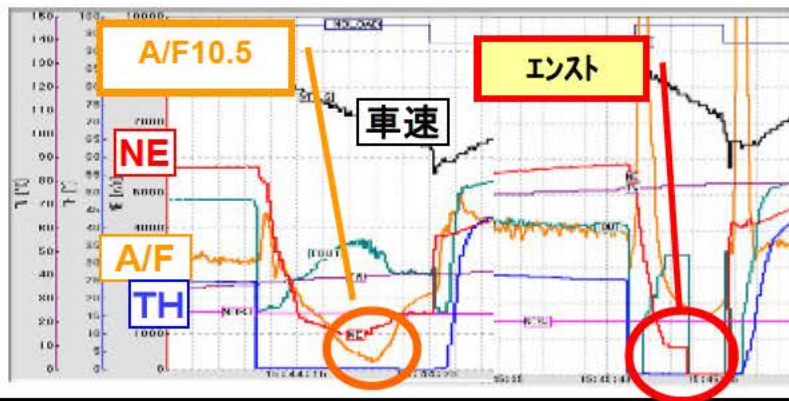
CBR250R (MC41)

TW:23~85℃
 使用ギヤ:6速
 車速:70~90km/h
 (7,000r/min)
 からクラッチOFF
 外気温:10℃
 1目盛:0.5秒

TW:40℃以下、油温: 25℃以下	TW:40~82℃、油温: 25~60℃	TW:85℃以上、油温: 60℃以上
エンスト	無	有	無
A/F	10.5	エンストA/F不明(10.5以下 下推測)	13

- /CBR共 高回転域からスロットル全閉と同時にクラッチOFFし惰性走行でエンストが発生する
- ・クラッチを切らない状態ではエンストの発生はない
- ・エンスト後の再始動は容易である
- ・暖機過程でアイドル回転1450r/min以下に低下し、A/Fがリッチとなり回転落ちやエンストが発生する
- ・油温25~60℃の暖機完了途中での領域でエンストが発生している。

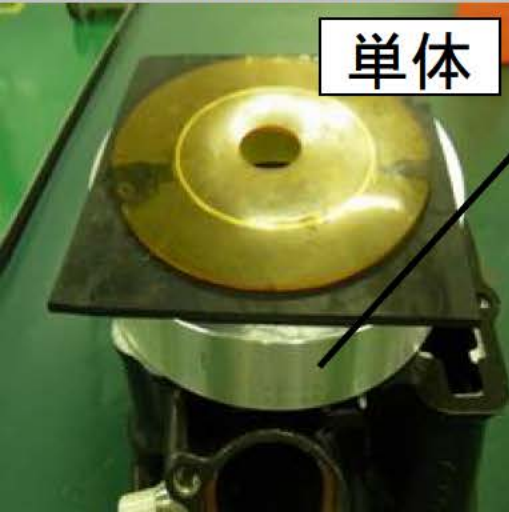
単体

ヘッドリーク量差は継続解析必要。

・定常流治具を取りつけてのリーク量測定。

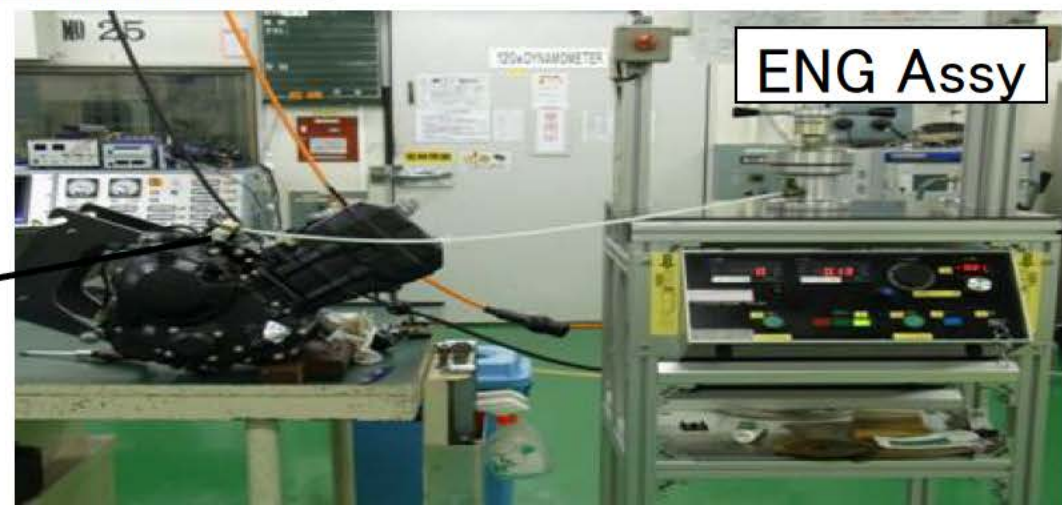
ENG Assy

・ENG Assy状態でのリーク量測定。

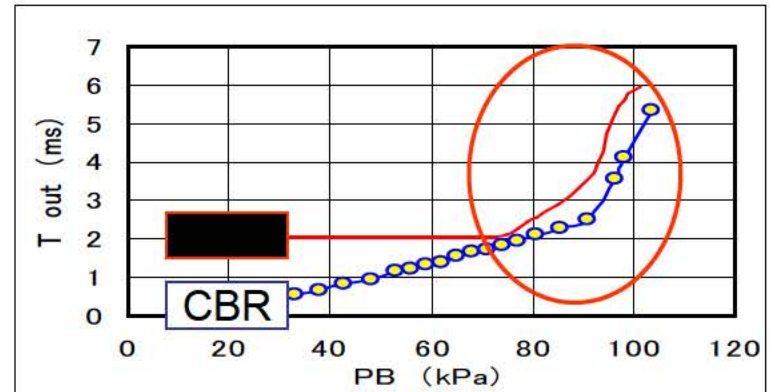
CBR250R (MC41)

エンスト	しない ○	しない ○	する ×	未確認 (測定予定)	する ×
回転落ち時 回転数	900r/min	1,050r/min	980r/min		970r/min
A/F	11.1	11.2	11.2		11.2
エンジンAssy リーク量 cm ³ /min (20kPa時)	236	79(新品ヘッド)	434	1,564	1,700
ヘッド締付け トルク	40N・m 参考	48N・m 公差下限	51N・m 設定値	35KN (軸力) ⇒56N・m	60.5N・m(平均) 現車 成行き EX 58.7 61.1 69.3 52.8

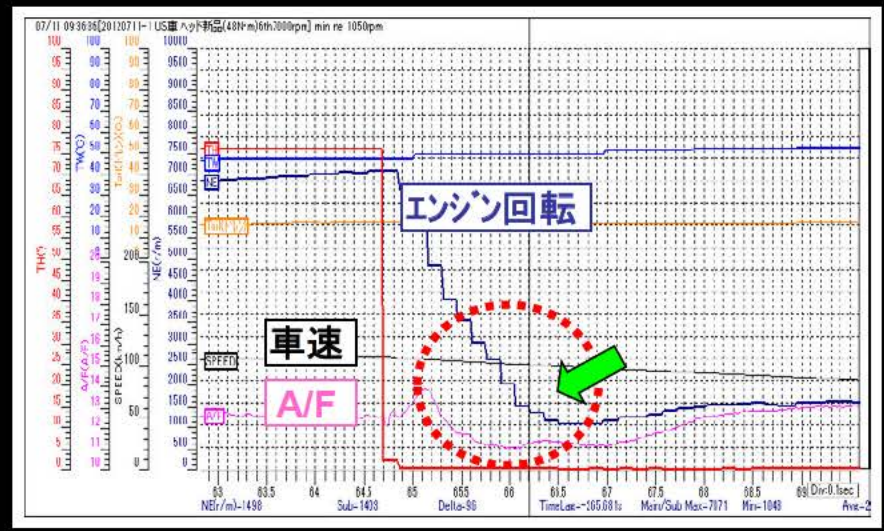
対策後

CBR 対策仕様の投入により、インストの発生はなくなった

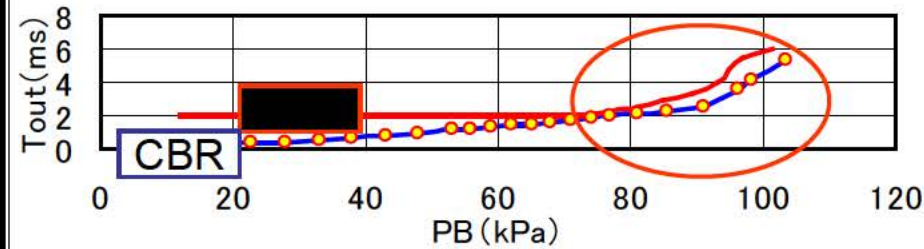
CBR250R
締付トルク
変更
(右)

エンスト	現車	しない ○	—	する ×	—	する ×
	新品	—	しない ○	—	しない ○	しない ○
回転落ち 時回転数	現車	900r/min 11.1	—	980r/min 11.2	—	970r/min 11.2
	A/F 新品	—	1,050r/min 11.2	—	1,230r/min 11.8	1,160r/min 11.8
エンジンAssy リーク量 cm ³ /min (20kPa時)	現車	236	—	434	—	1,700
	新品	—	79	—	580	610
締付トルク		40N・m	48N・m	51N・m	54N・m	60.5N・m(平均) EX 58.7 61.1 IN 69.3 52.8
		参考	公差下限	設定値	公差上限	現車 成行き

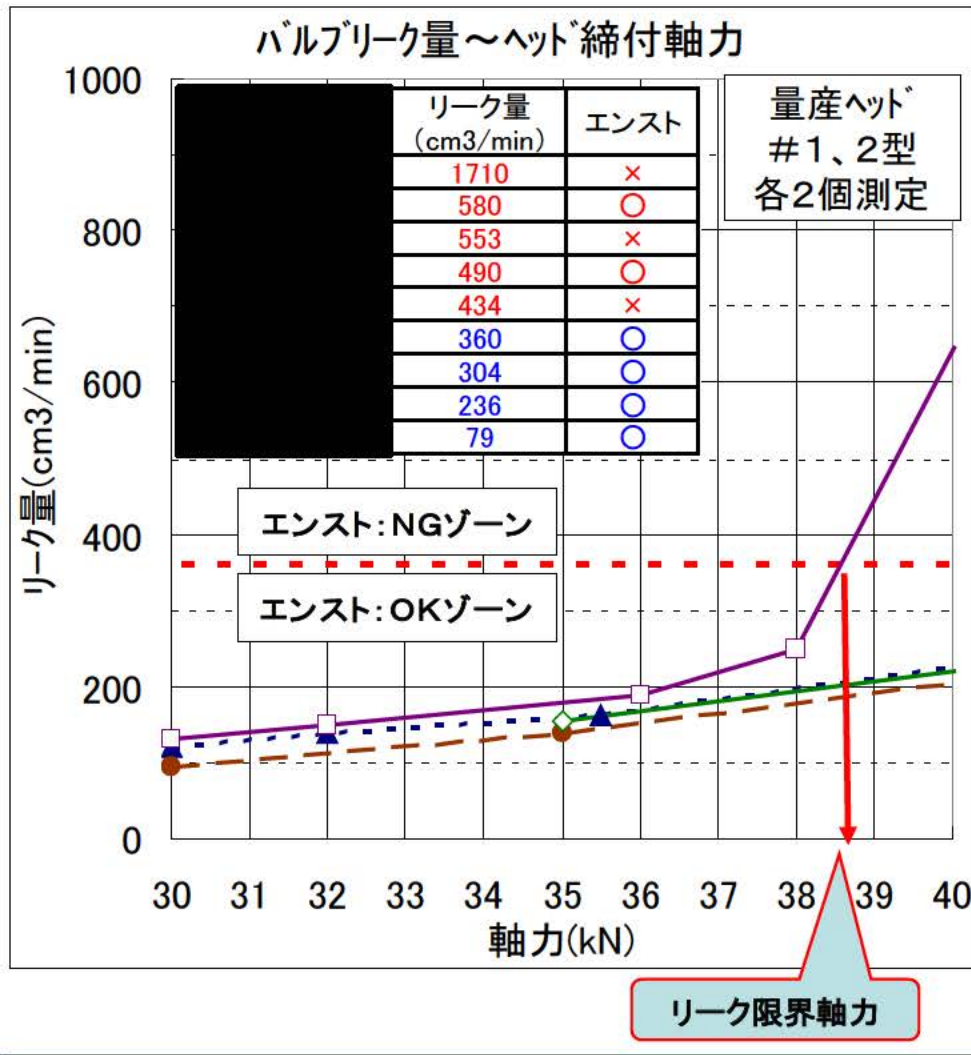
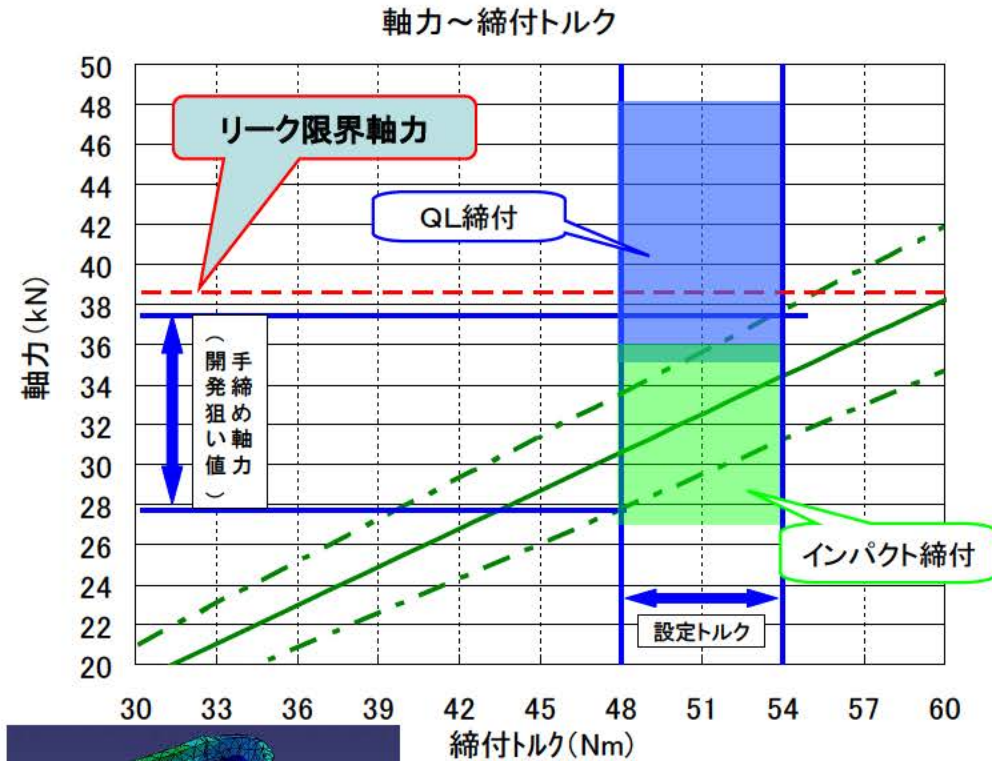
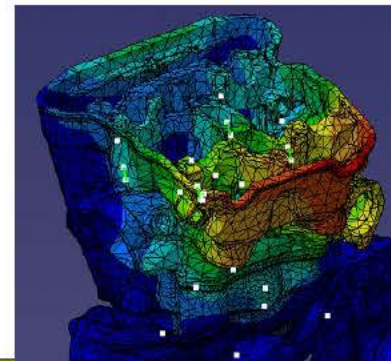
バルブリーク量～ヘッド締付け軸力影響

CAE解析結果
ヘッド締付け軸力により
バルブシートが変形し
リークが発生する

CAE計算条件: 締付け軸力 37.7kN

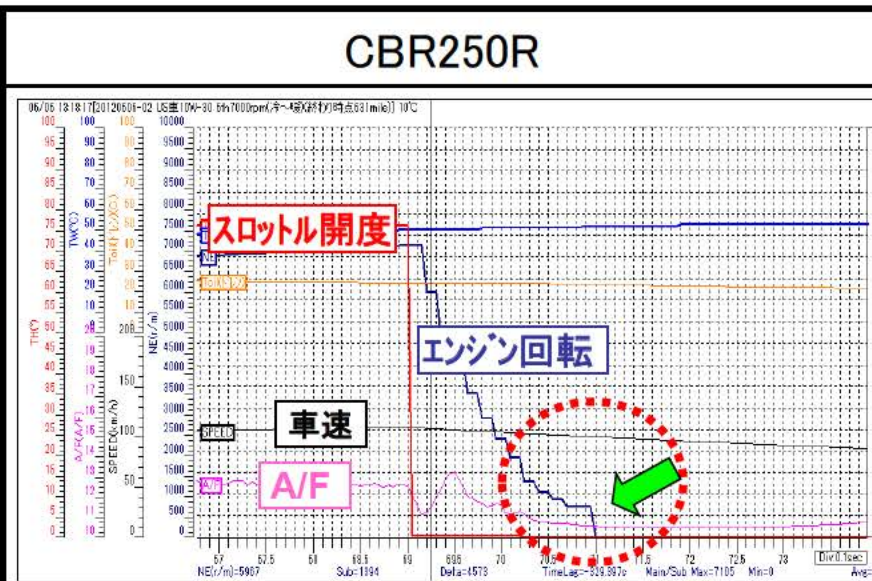
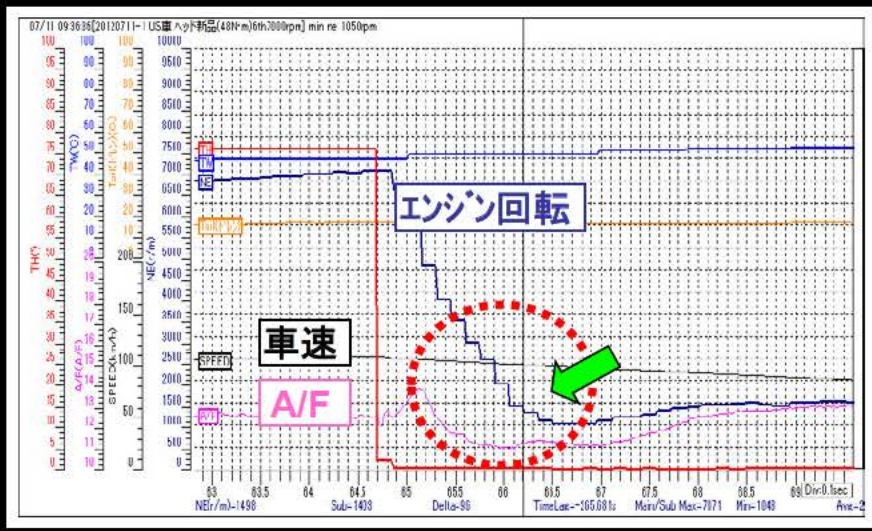
5. 対策内容

、CBR250R 対策仕様の投入により、インストの発生はなくなった

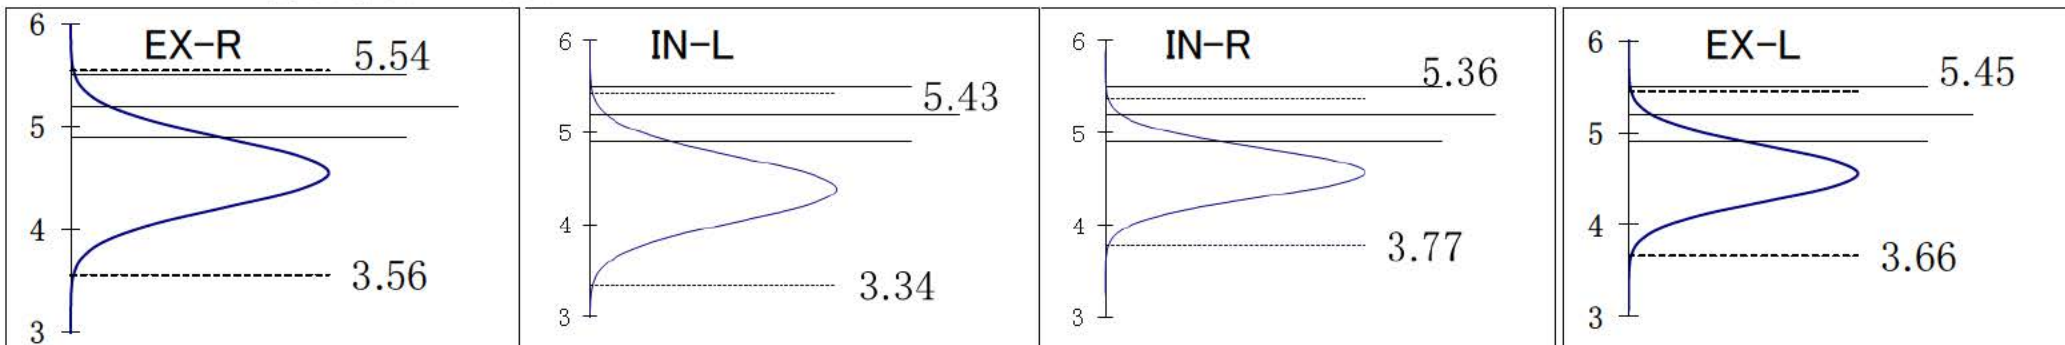
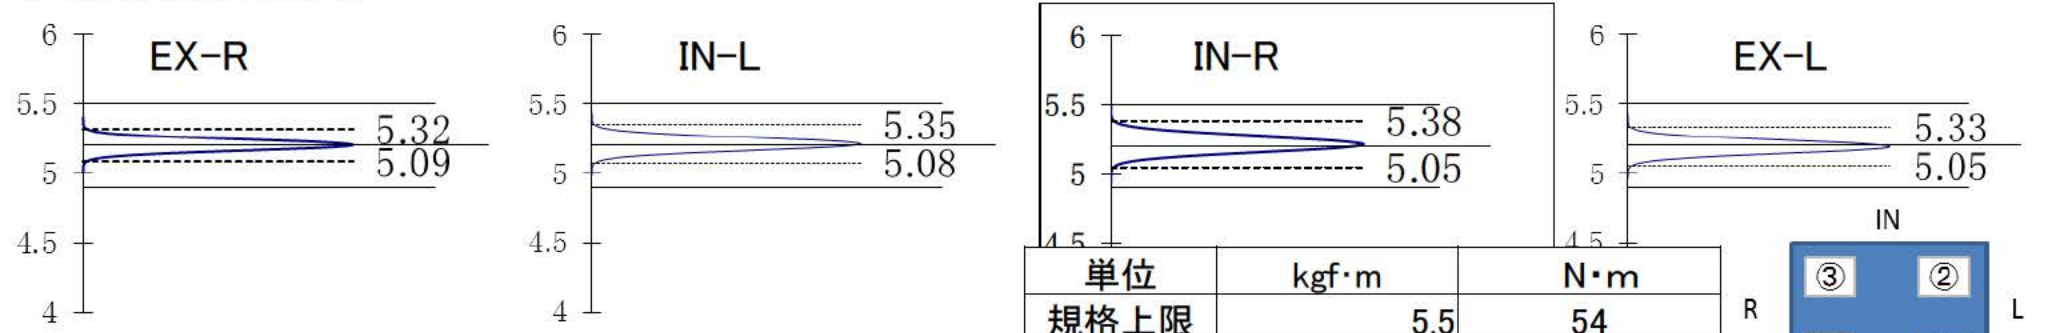
CBR250R 工場ライン締付トルク確認結果

オイルパルスレンチ締付後 (n=20台)

QL締付後 (n=20台)

単位	kgf·m	N·m
規格上限	5.5	54
規格中央	5.2	51
規格下限	4.9	48

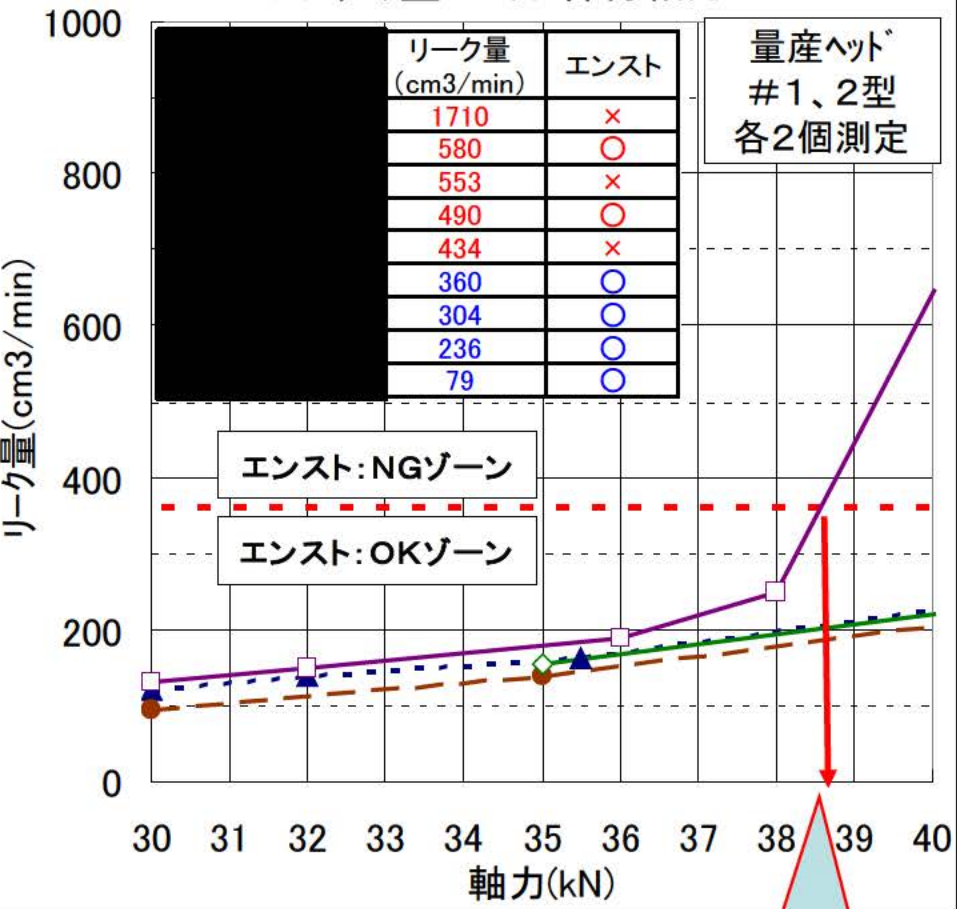
バルブリーク量～ヘッド締付け軸力

リーク限界軸力

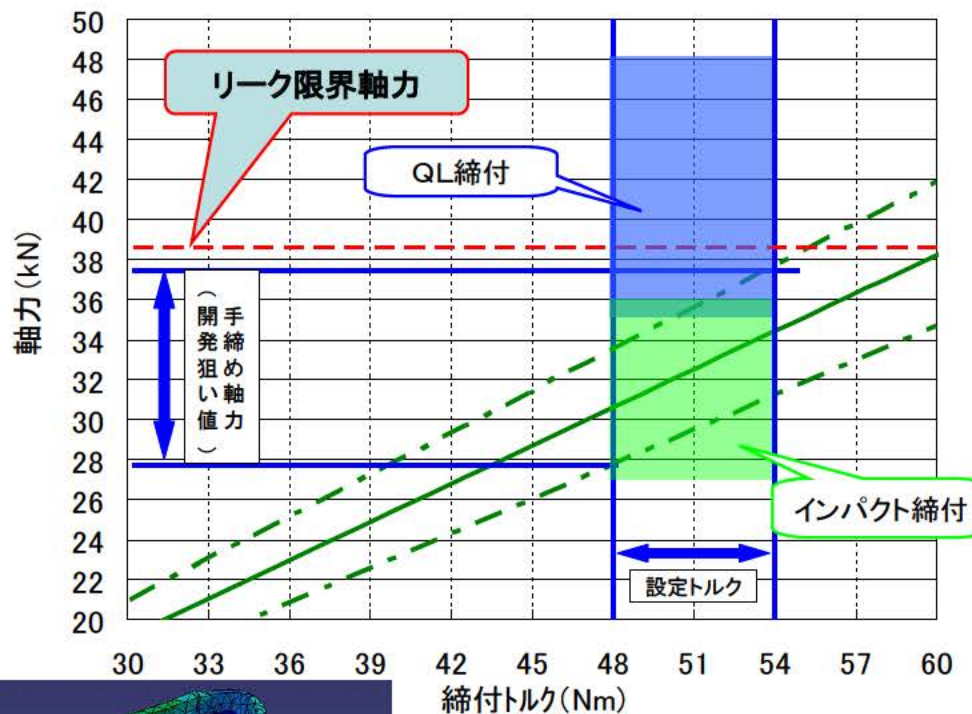
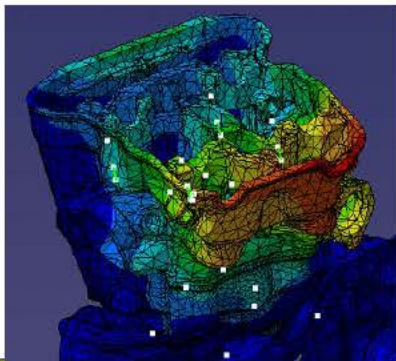
軸力～締付トルク

CAE解析結果
ヘッド締付け軸力により
バルブシートが変形し
リークが発生する

CAE計算条件: 締付け軸力 37.7kN

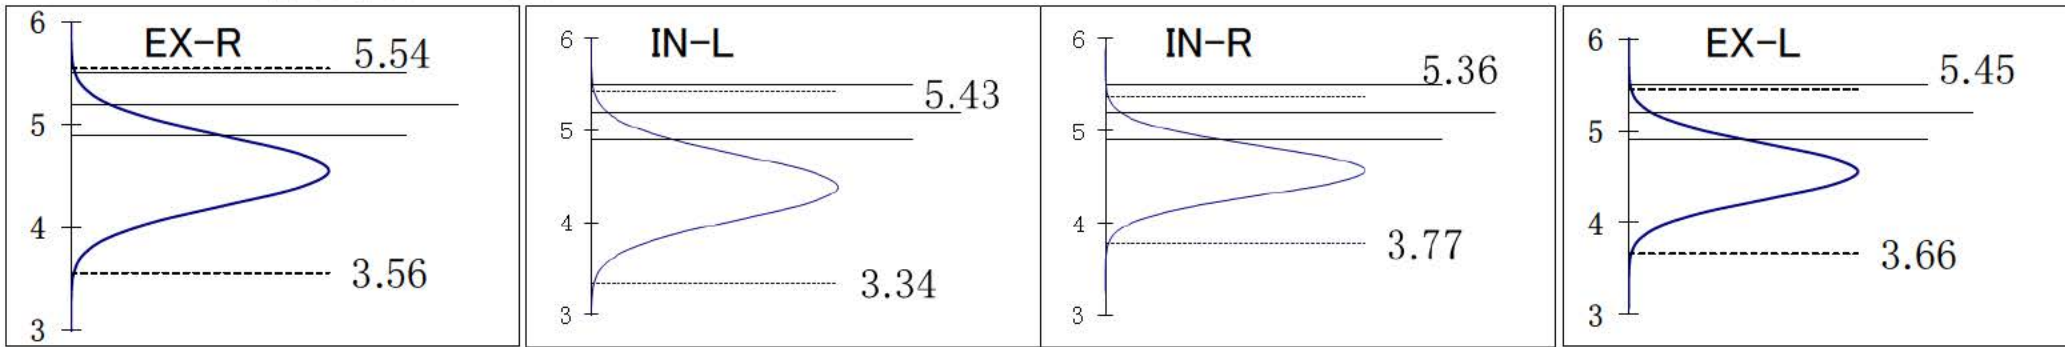
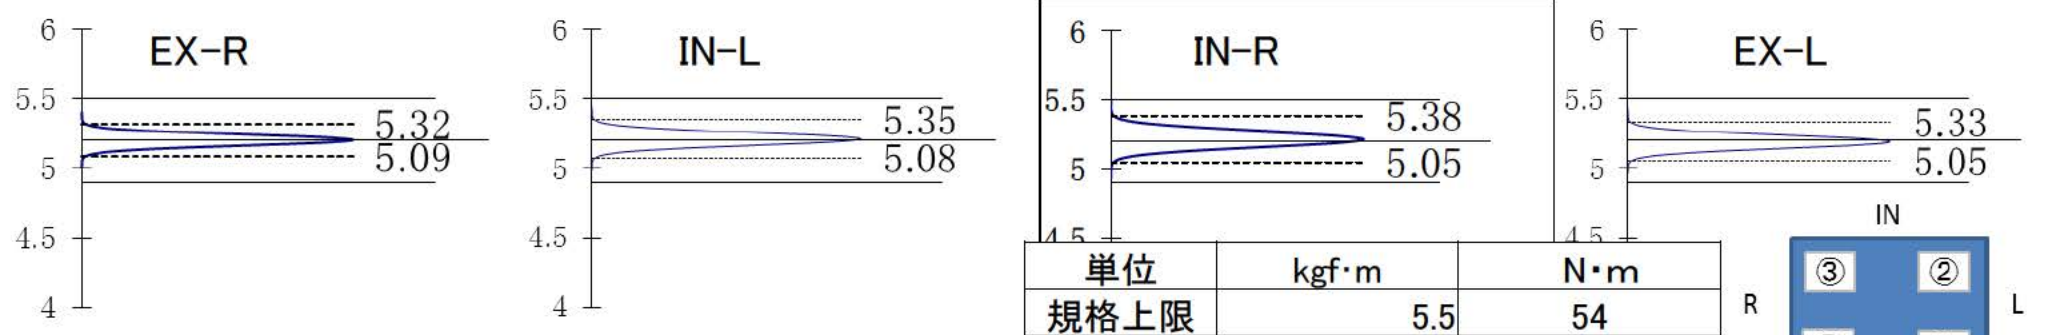
オイルパルスレンチ締付後 (n=20台)

QL締付後 (n=20台)

現行ラインの確認結果、規定締付トルクに収まっている

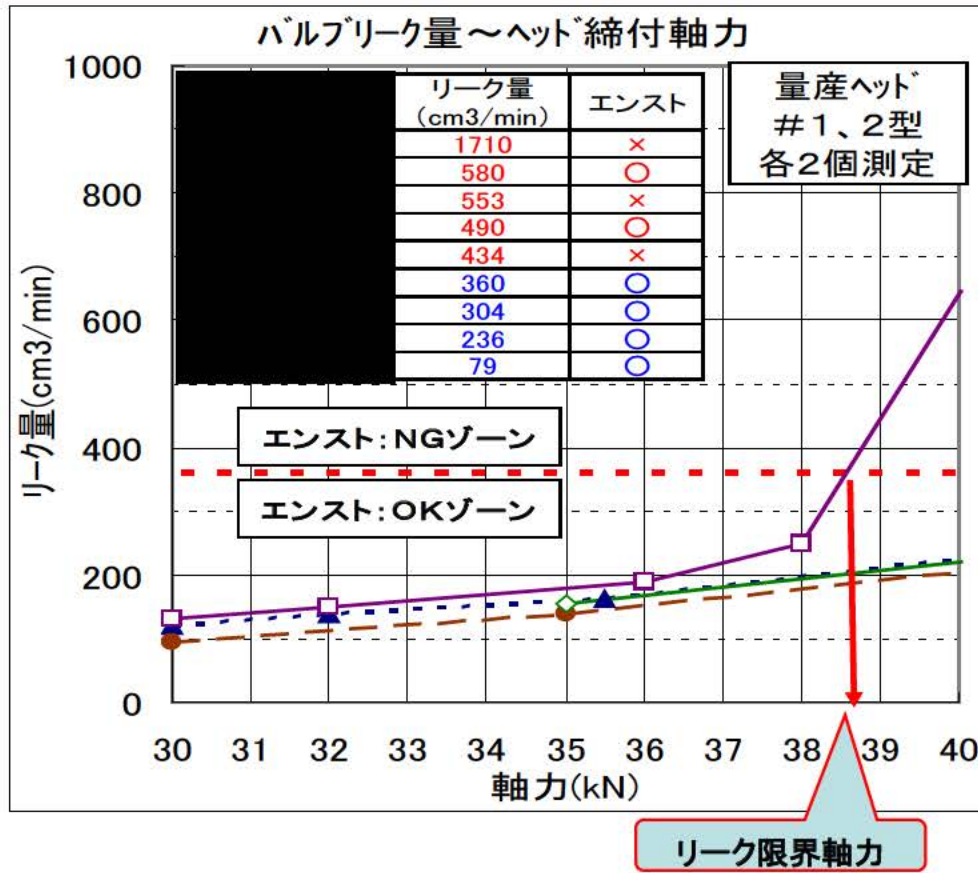
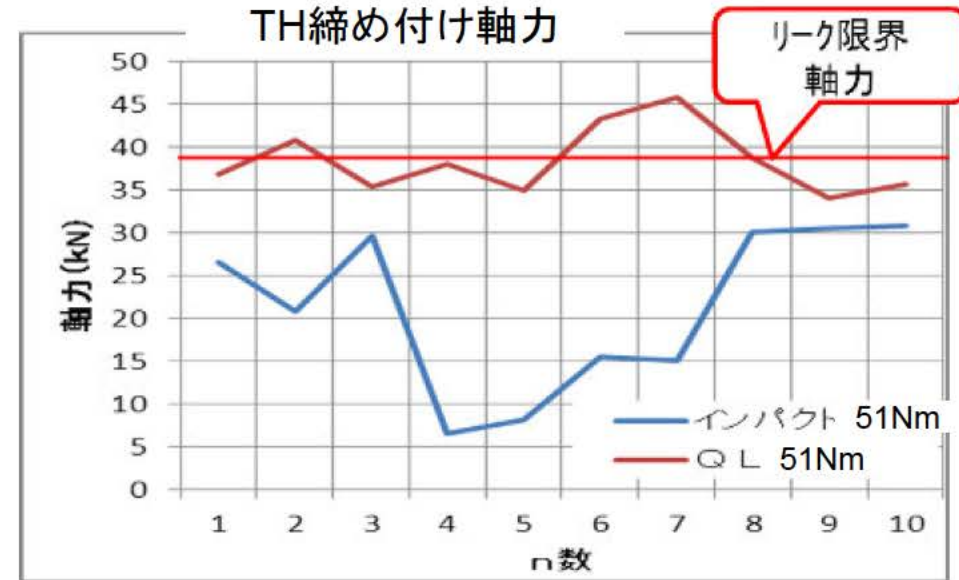
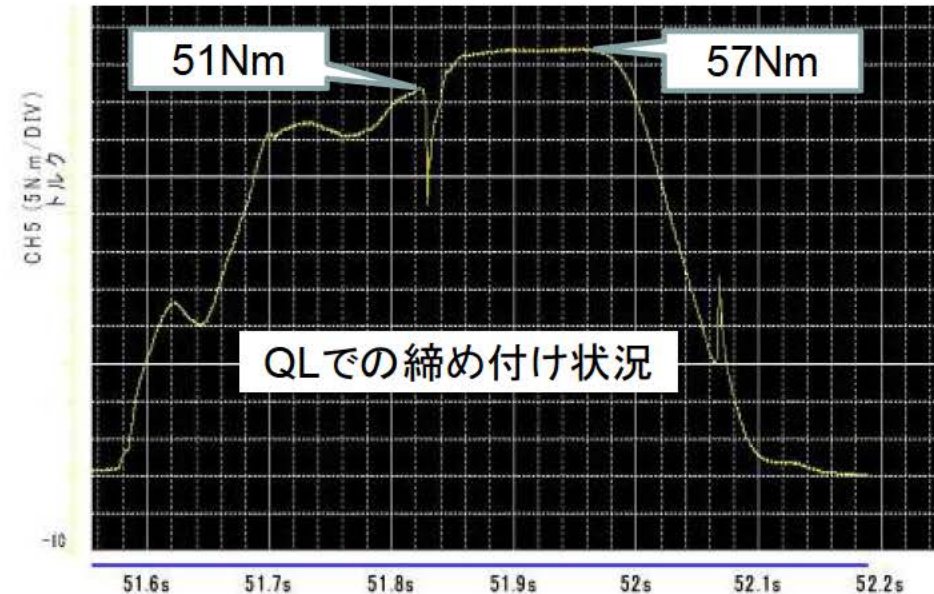
バルブリーク量～ヘッド締め付け軸力

- ・エンストを発生させない軸力は、38.6kN以下である。
- ・TH締め付け(インパクト&QL)は、リーク限界軸力を超えてしまう事がある。
 - ・インパクト締め付け時の軸力バラつき
 - ・QLレンチ締め付け時のオーバーストローク

インパクト+QL締付での作業工程に対し、設定トルク(51±3Nm)はリーク限界軸力(38.6kN)観点で、余裕がなかった。
