PE14-032

HNDA

CBR250R (US) : Visiting an actual place Result : Customer feedback information

10. Engine stall when riding CBR250R(KYJA)

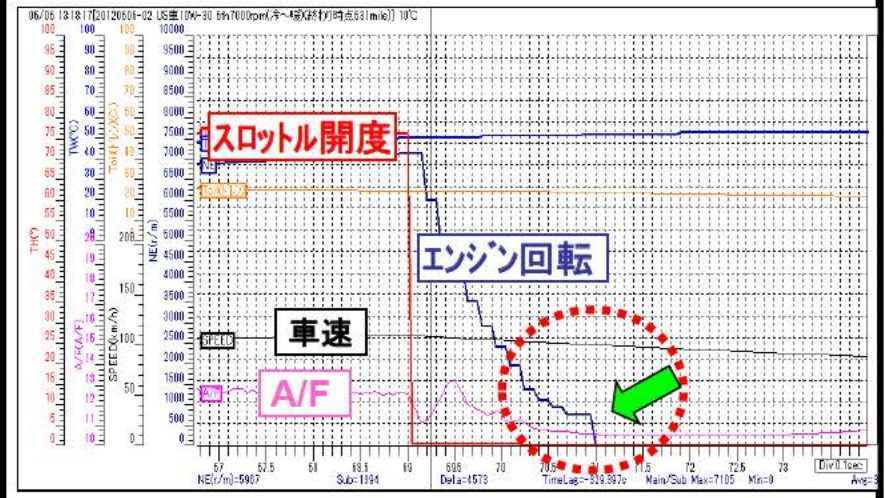
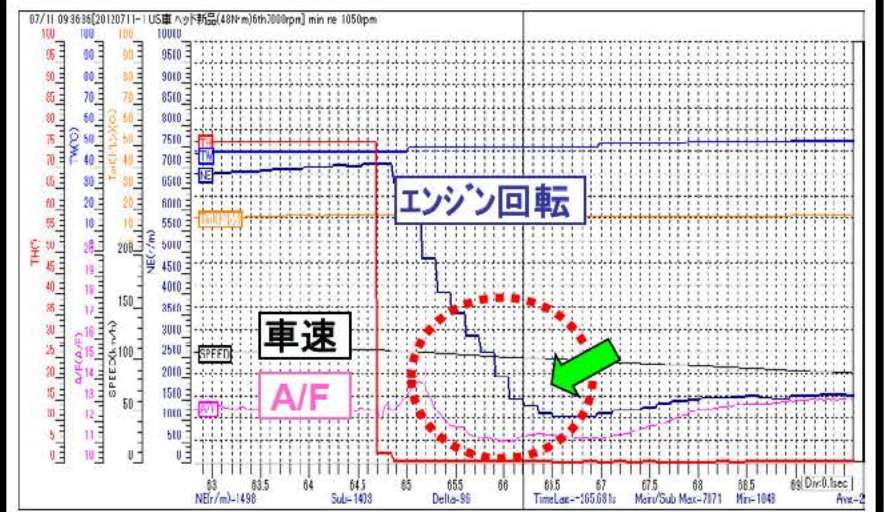
CBR250R 対策仕様の投入により、エンストの発生はなくなった

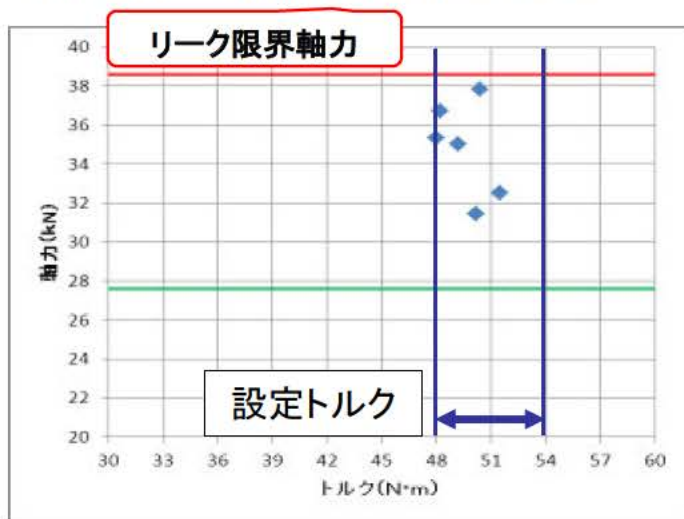
THでのヘッド締め付けについて

設定変更で狙いの軸力に収まる事が確認できた

インパクト設定トルク変更: 51 → 33 N・m

QLレンチ変更: オーバーレスType採用 (設定トルクは51 N・mで変更なし)

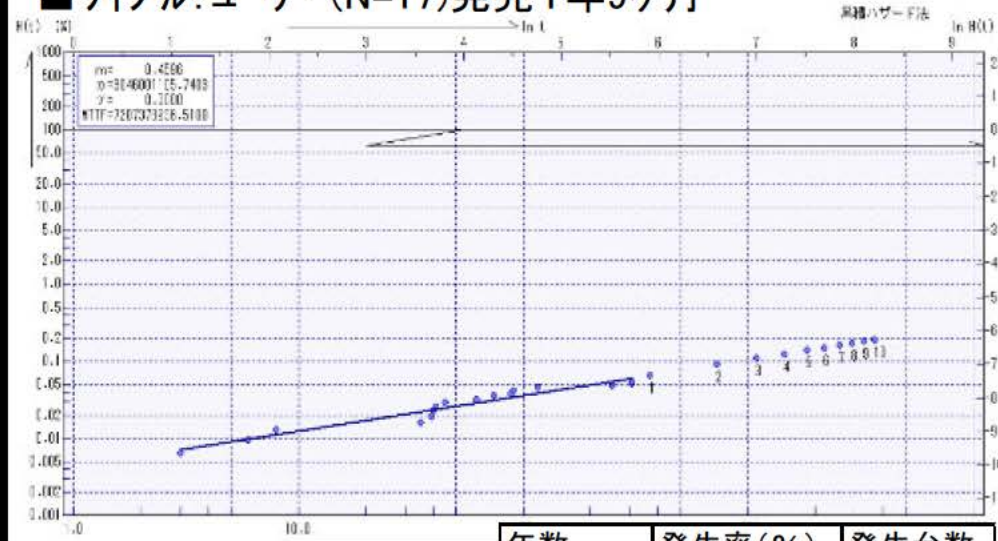
■ワイブル:ユーザー(N=17)発売1年9ヶ月

・M=0.4596
初期型

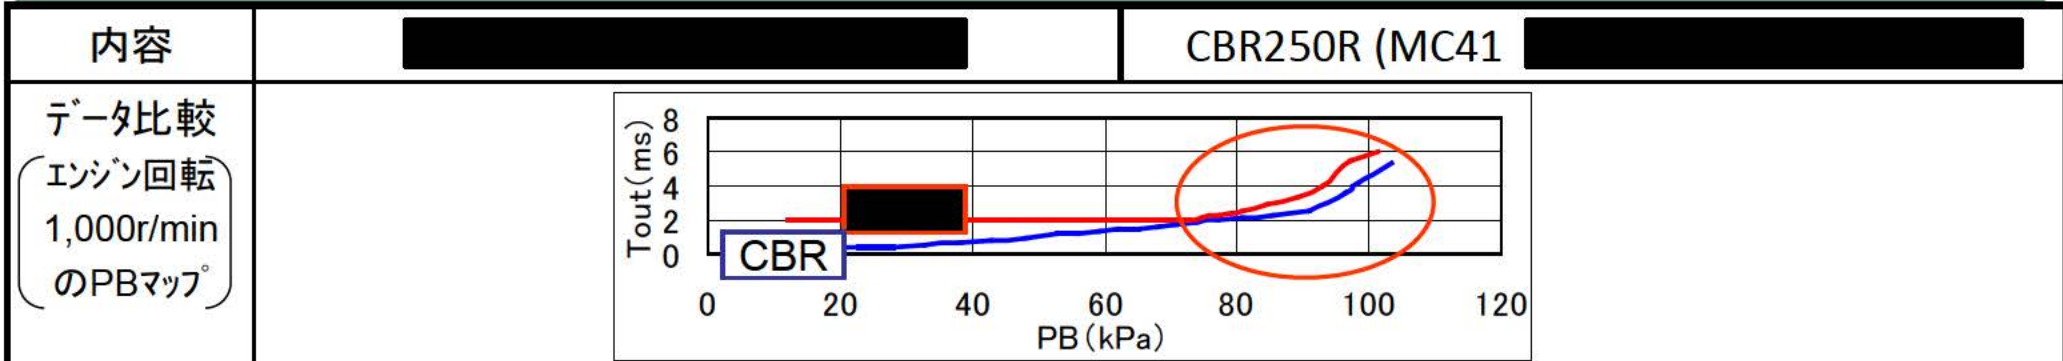
燃調リーン化、ヘッド締付けトルク比較

CBR250R 締付トルク 変更(右)	エンスト	現車	しない ○	—	する ×	—	する ×
	新品	—	しない ○	—	しない ○	—	しない ○
回転落ち 時回転数	現車	900r/min 11.1	—	980r/min 11.2	—	970r/min 11.2	—
	A/F 新品	—	1,050r/min 11.2	—	1,230r/min 11.8	—	1,160r/min 11.8
エンジンAssy リーク量 cm3/min (20kPa時)	現車	236	—	434	—	1,700	—
	新品	—	79	—	580	610	—
締付トルク	参考	40N・m	公差下限 48N・m	設定値 51N・m	公差上限 54N・m	現車 成行き 60.5N・m(平均)	
						L	R
						EX 58.7	61.1
						IN 69.3	52.8

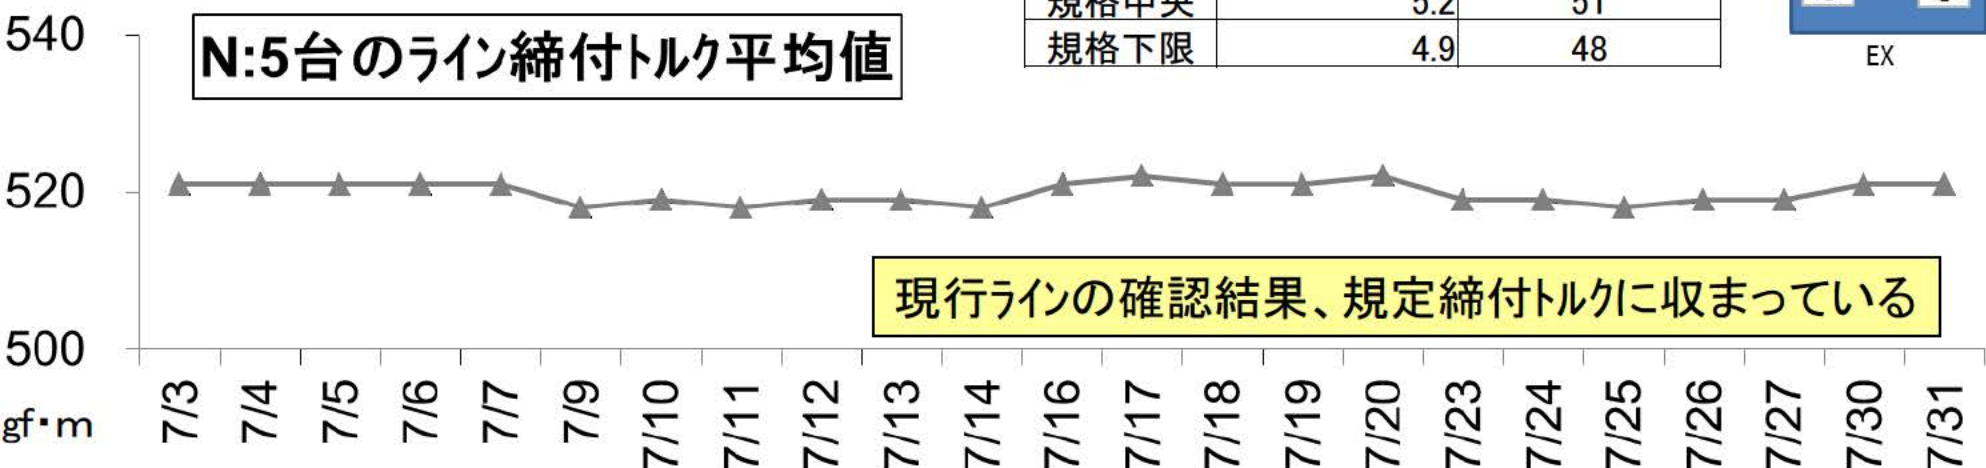
N:5台のライン締付トルク平均値

現行ラインの確認結果、規定締付トルクに収まっている

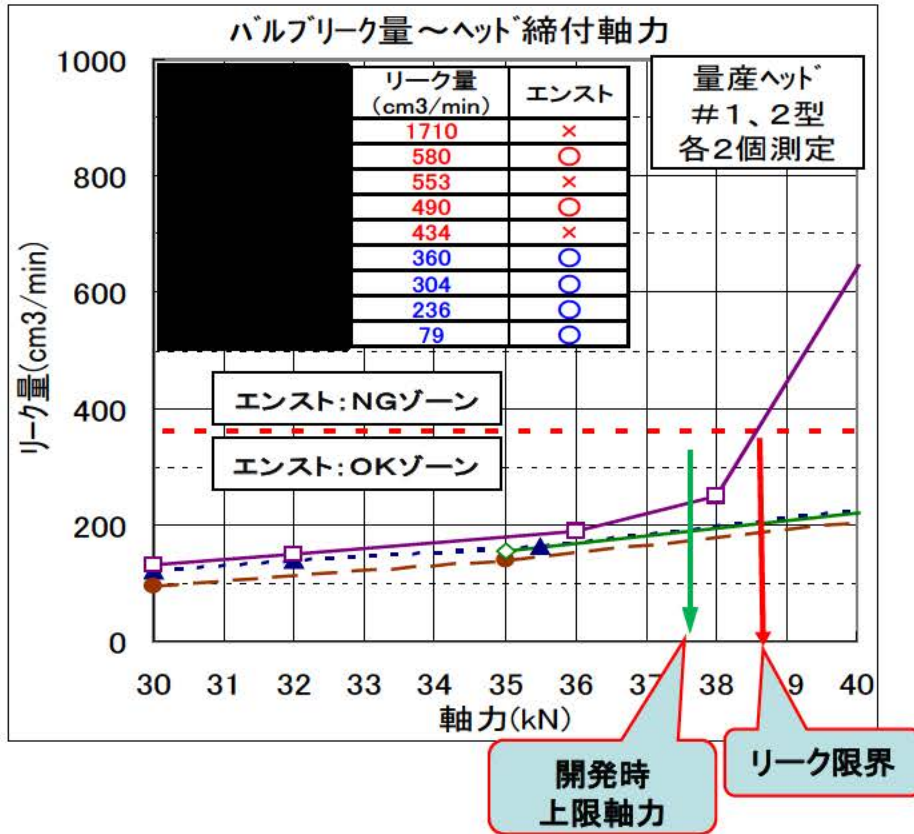
バルブリーク量と締付軸力

リーク量とヘッド締付け軸力、トルク相関

- ・エンストを発生させない軸力は、38.6kN以下。
開発時上限軸力に対し、リーク限界軸力の余裕が少なかった。
- ・開発時軸力に対し、量産締付の軸力は、高軸力側にばらつきが大きくなっている。

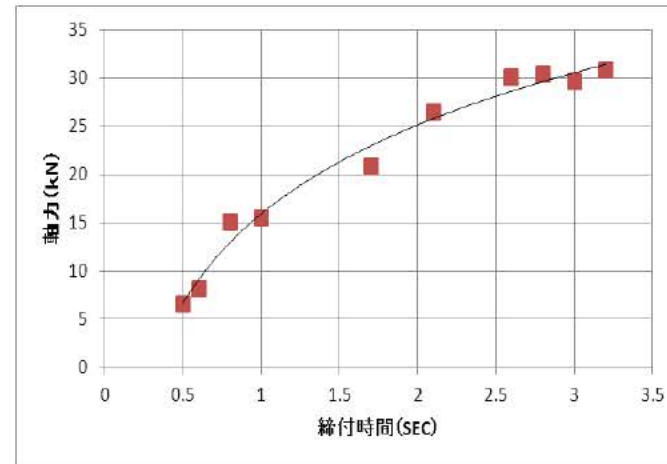
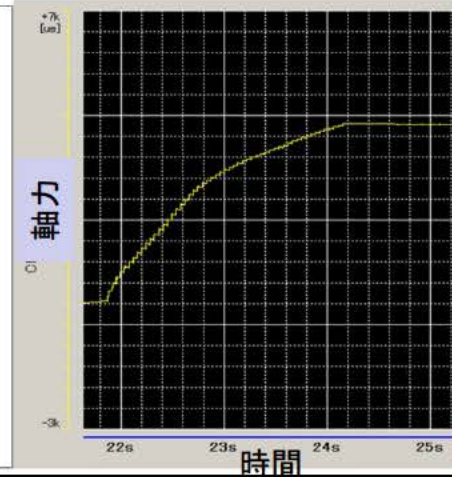
インパクト(51N・m)締付時間～軸力

- ・TH量産締付(インパクト&QL)は、リーク限界軸力を超えてしまう事がある。
- ・インパクト締付時の締付時間バラつきによるQLレンチ締付不安定、オーバーストローク
- ・締付速度による摩擦係数の低下

インパクト+QL締付での作業工程に対し、設定トルク(51±3Nm)はリーク限界軸力(38.6kN)観点で、余裕がなかった

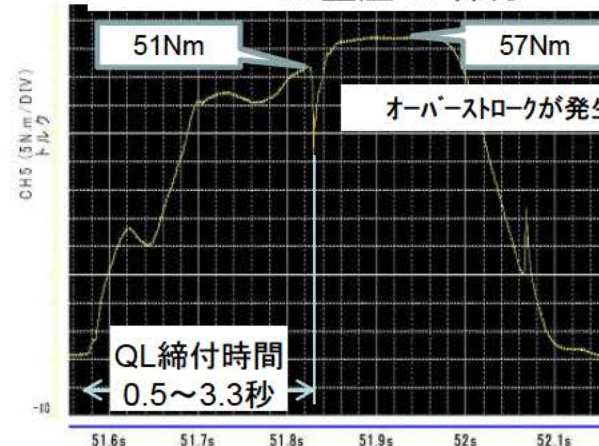
TH量産QL締付

QL締付速度は、0.5~3.3秒で、
 開発時締付(QL締付相当)の
 5~10秒に対し早いため、
 摩擦係数が低下し、高軸力側に
 ばらつきが拡大している。
 (前頁トルクと軸力グラフ参照)

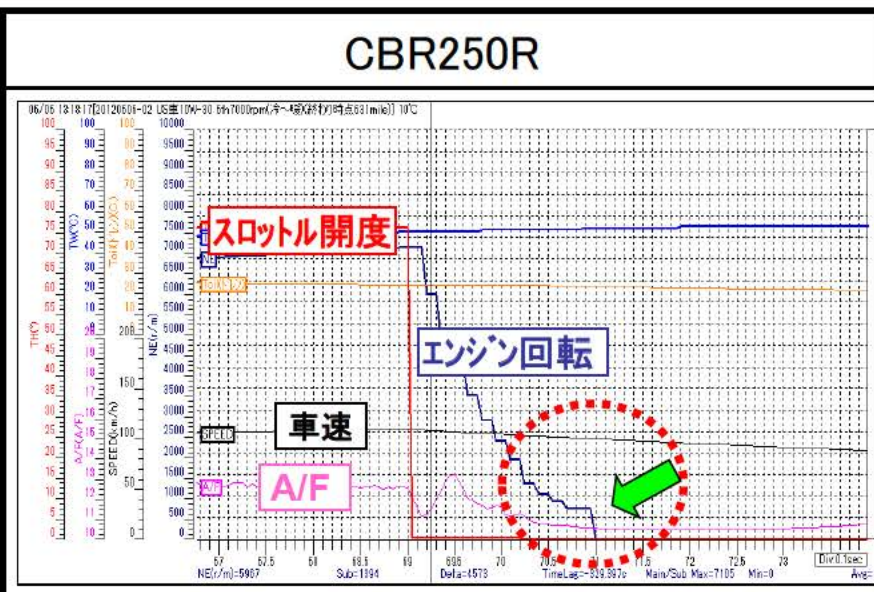
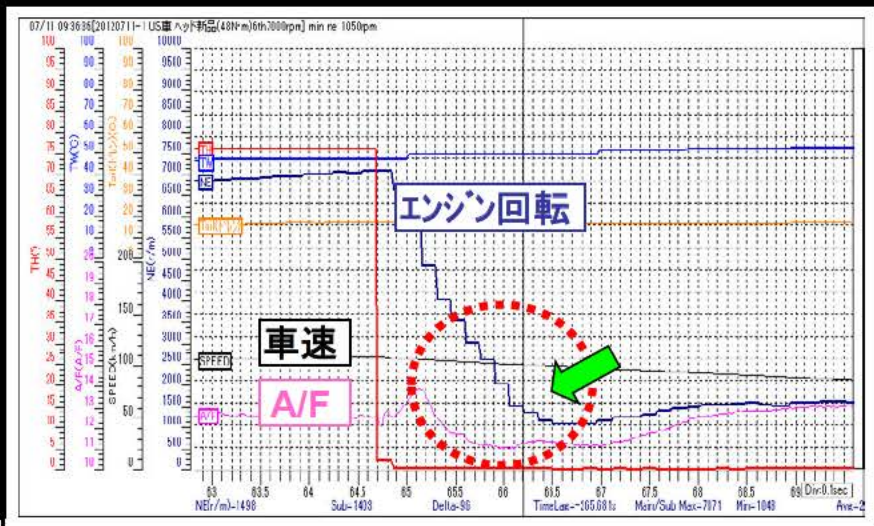
、CBR250R 対策仕様の投入により、エンストの発生はなくなった

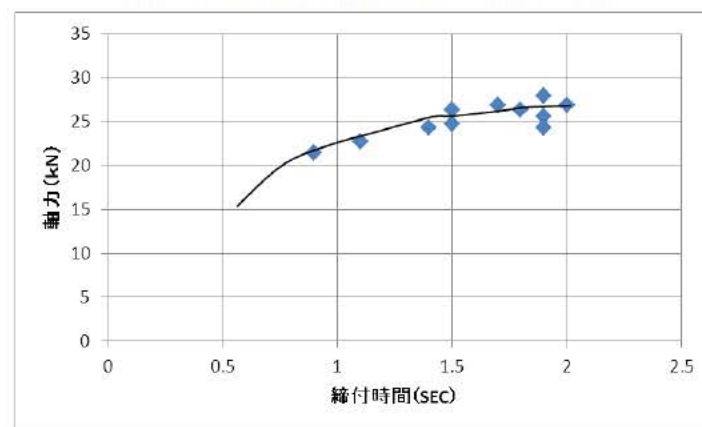
インパ外(33N・m)締付時間～軸力

オイルパルスレンチ設定トルクを下げることにより、リーフするまでの締付時間が短縮し、軸力も安定した。

設定変更で狙いの軸力に収まる。
設定トルクは他機種同等。
但し、下限軸力のネガ確認が必要で
確認を実施。(後の頁で説明)

QL設定トルク変更: 45 ± 3 N・m

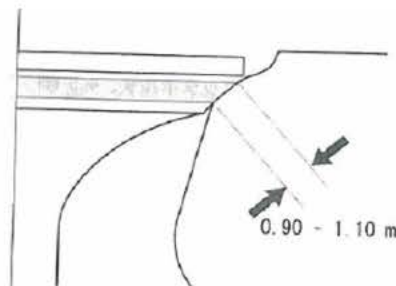
～2. シートカッタによる効果確認

サービスマニュアルに則り、擦り合わせを当たり確認まで実施。
均一な当たりが得られ、単体リーク量も50cm³/min以下。
実機確認結果、インスト発生なく、OK。

シートカッター(32°、60°)を使用して、シート面を規定幅に修正する。
バルブシート当たり幅:0.9～1.1mm
その後、摺合せ実施し、光明丹で当たり確認。
当たりの状況に応じ、バルブ交換。

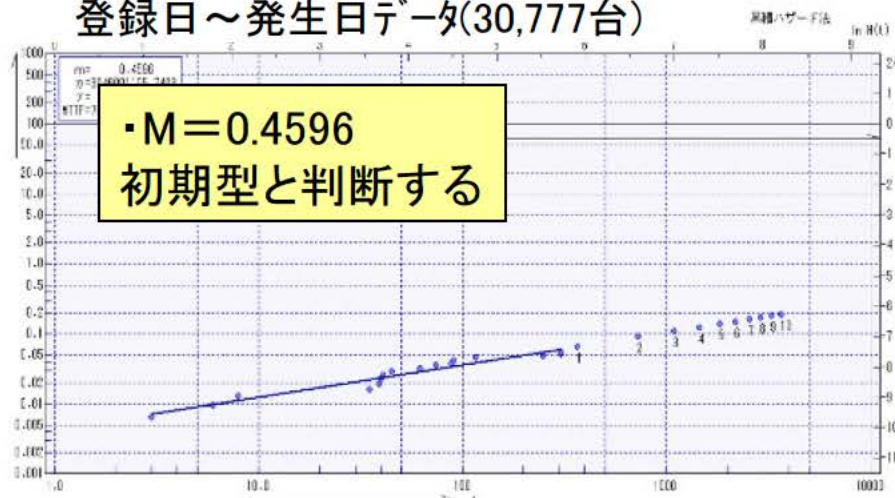
■ワイブル:ユーザー(N=17)発売1年9ヶ月
登録日～発生日データ(30,777台)

2年後の発生台数は28台と予測
