RQ14-005

Appendix H

Field Communications

## 6.4L DIESEL—LACKS POWER, MIL ON WITH DTCS P20E2, P20E3, P20E4, P2080, P2084, P242A, P242B, P0544 OR P2031

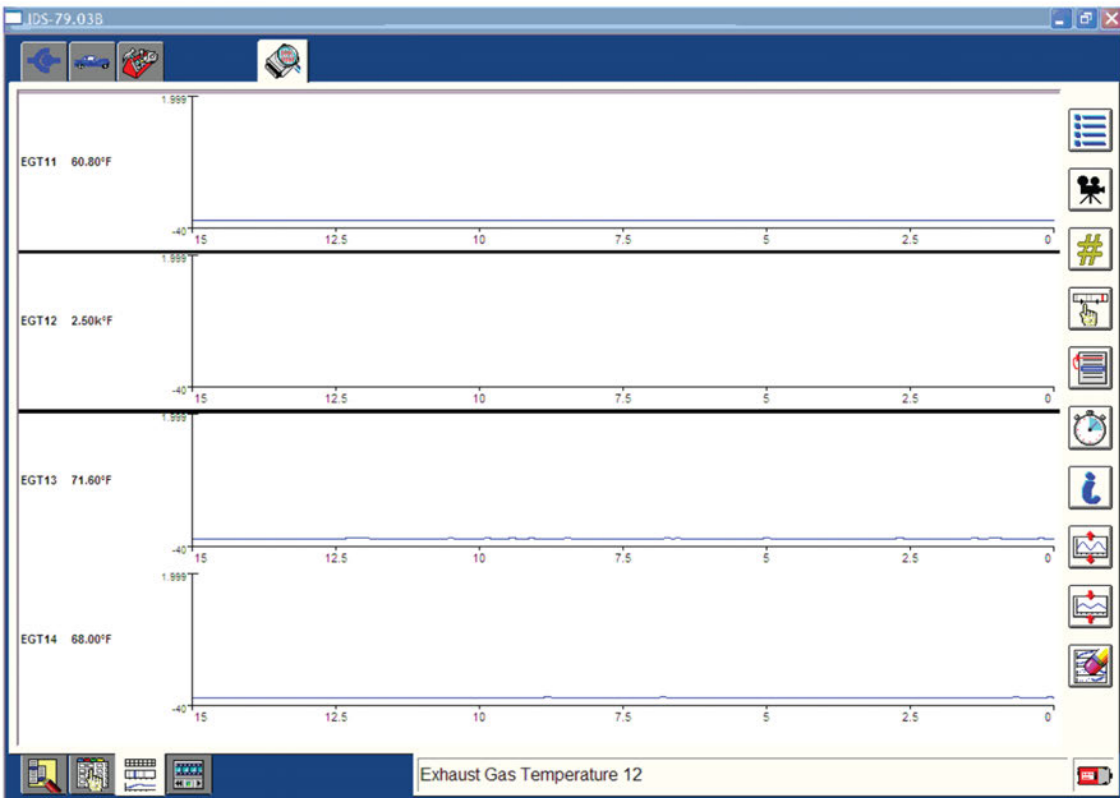
Figure 1 - Article 12-7-1

1. Using the Integrated Diagnostic System (IDS) or equivalent scan tool, retrieve all continuous memory DTCs. Are DTCs P200E and P200C present with or without DTCs P2471, P2479, P242D and P247B?
  - a. No - this article does not apply. Refer to the Powertrain Control/Emissions Diagnosis (PC/ED) manual for normal diagnosis.
  - b. Yes - proceed to Step 2.
2. Obtain the exhaust gas temperature (EGT) readings from freeze frame data when DTCs P200E or P200C were set. (Figure 1)
  - a. If one EGT sensor is reading 850 °C (1562 °F) or higher, replace that sensor. Refer to Workshop Manual, Section 303-14B.
  - b. If two or more EGT sensors are reading 850 °C (1562 °F) or higher, this article does not apply. Refer to PC/ED manual pinpoint test RC to diagnose the concern. EGT locations are different for chassis cab (narrow frame and pickup truck (wide frame). (Figure 2)

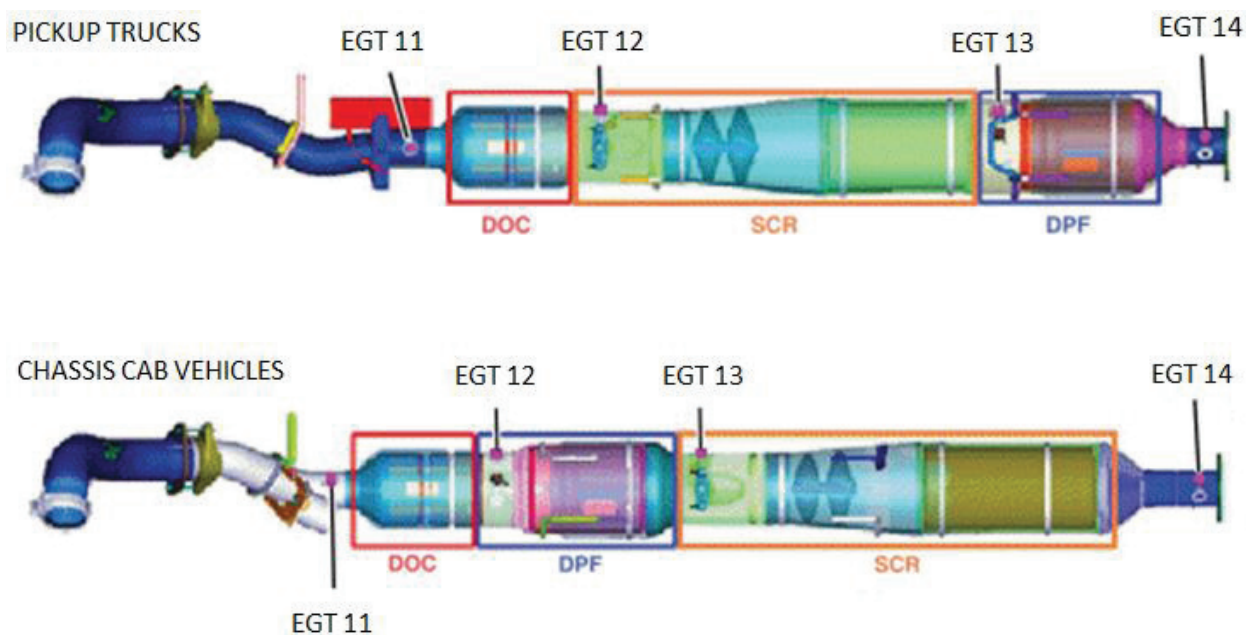
#### Pickup and Chassis Cab EGT Locations

The EGT sensors on both Pickup Truck and the Chassis Cab vehicles are now in order of exhaust flow from engine to tailpipe. See figure below

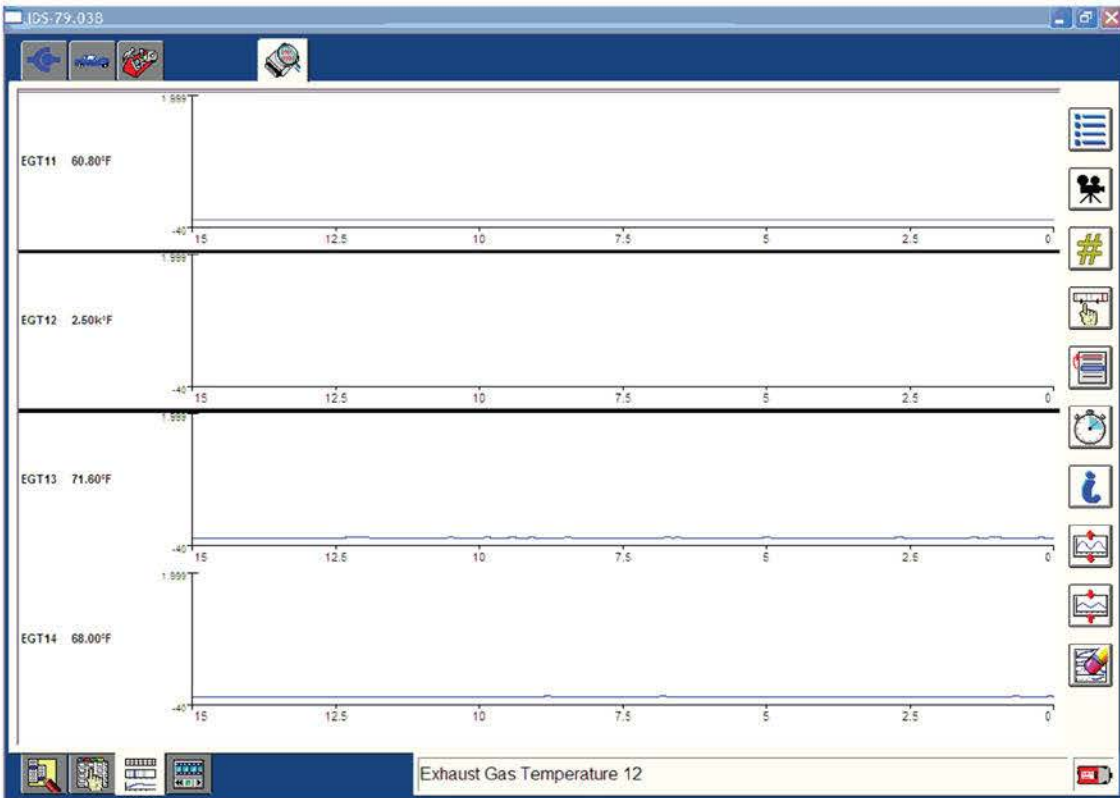
Figure 1 - Article 13-10-2

1. Using the Integrated Diagnostic System (IDS) or equivalent scan tool, retrieve all continuous memory DTCs. Are DTCs P200E and P200C present?
  - a. No - this article does not apply. Refer to the Powertrain Control/Emissions Diagnosis (PC/ED) manual for normal diagnosis.
  - b. Yes - proceed to Step 2.
2. Obtain the exhaust gas temperature (EGT) readings from freeze frame data when DTCs P200E or P200C were set. (Figure 1)
  - a. If only one EGT sensor is reading 850 °C (1562 °F) or higher, replace that sensor. Refer to Workshop Manual, Section 303-14B.
  - b. If two or more EGT sensors are reading 850 °C (1562 °F) or higher, this article does not apply. Refer to PC/ED manual pinpoint test RC to diagnose the concern. EGT locations are different for chassis cab (narrow frame) and pickup truck (wide frame). (Figure 2)

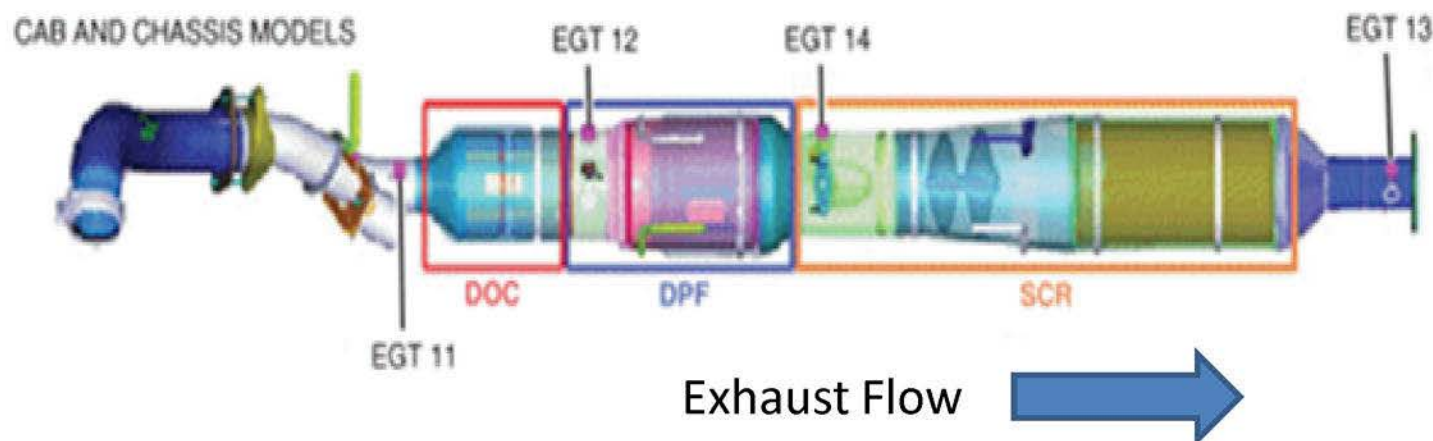
# 2011MY, 2012MY, 2013MY (R10) P473 6.7L Dyno Cert – Exhaust Gas Temperature (EGT) Layout

| OBD DTC | Repair Procedure |
|---|---|
| <b>EGT14 DTC</b><br>P246E - Exhaust Gas Temperature Sensor Circuit (Bank 1 Sensor 4)<br>P246F - Exhaust Gas Temperature Sensor Circuit Range/Performance (Bank 1 Sensor 4)<br>P2470 - Exhaust Gas Temperature Sensor Circuit Low (Bank 1 Sensor 4)<br>P2471 - Exhaust Gas Temperature Sensor Circuit High (Bank 1 Sensor 4)<br>P200C/P200E | Disconnect EGT13, confirm that PID EGT13_V sensor voltage is reading 5V.<br>If 5V then replace EGT13 sensor |

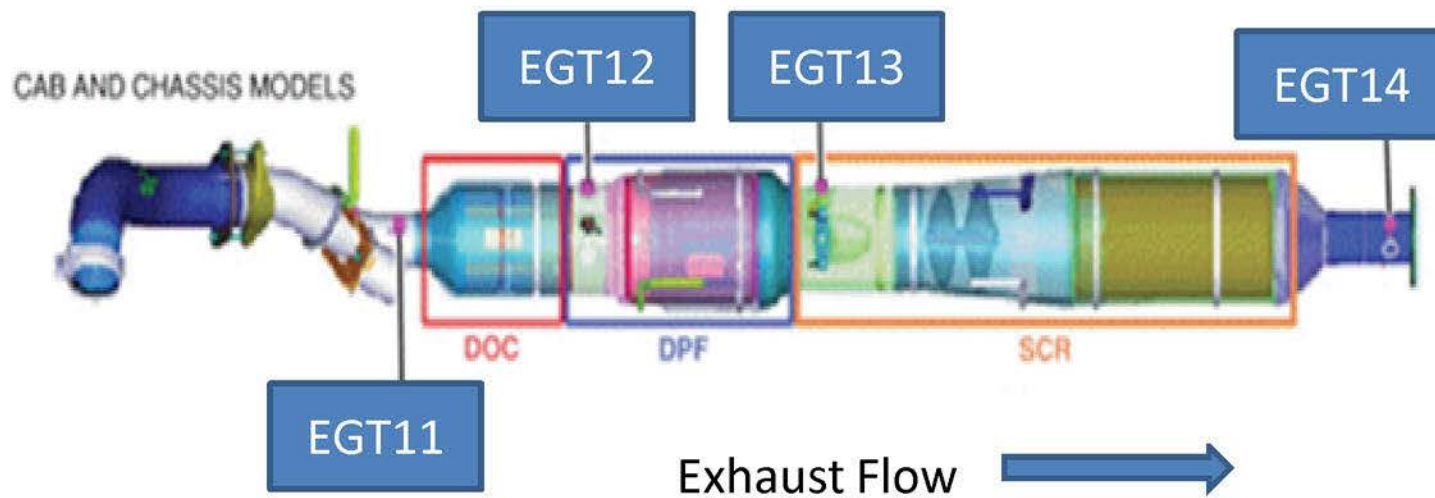
## 2013 MY P473 6.7L (Post J1) Dyno Cert – Exhaust Gas Temperature (EGT) Layout

**2013/ F350-550 Super-Duty Chassis Cab (Narrow Frame) vehicles built after dd/mm/12 and equipped with 6.7L diesel engines set the following DTCs:**

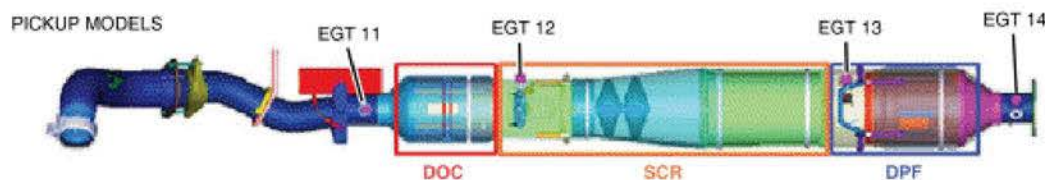
### **Pickup EGT Locations**

The EGT sensors on the Pickup Trucks are in order of exhaust flow from the engine to the tailpipe. See figure below

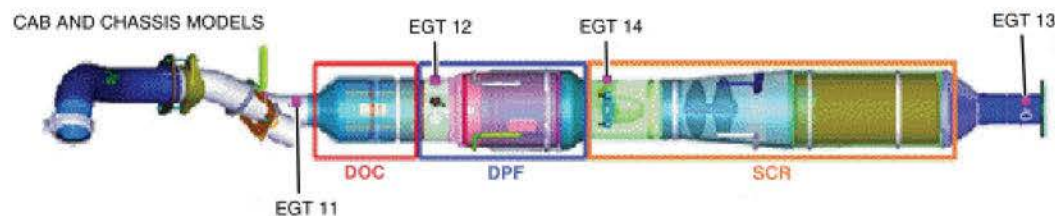
### **Chassis Cab EGT Locations**

The EGT sensors on the Chassis Cabs are in order of the exhaust components vs. exhaust flow from the engine to the tailpipe. See figure below
