| Title: | National Highway Traffic Safety Administration Toyota Unintended Acceleration Investigation | Page #: 1 of 177 |

Technical Support to the National Highway Traffic Safety Administration (NHTSA) on the Reported Toyota Motor Corporation (TMC) Unintended Acceleration (UA) Investigation

January 18, 2011

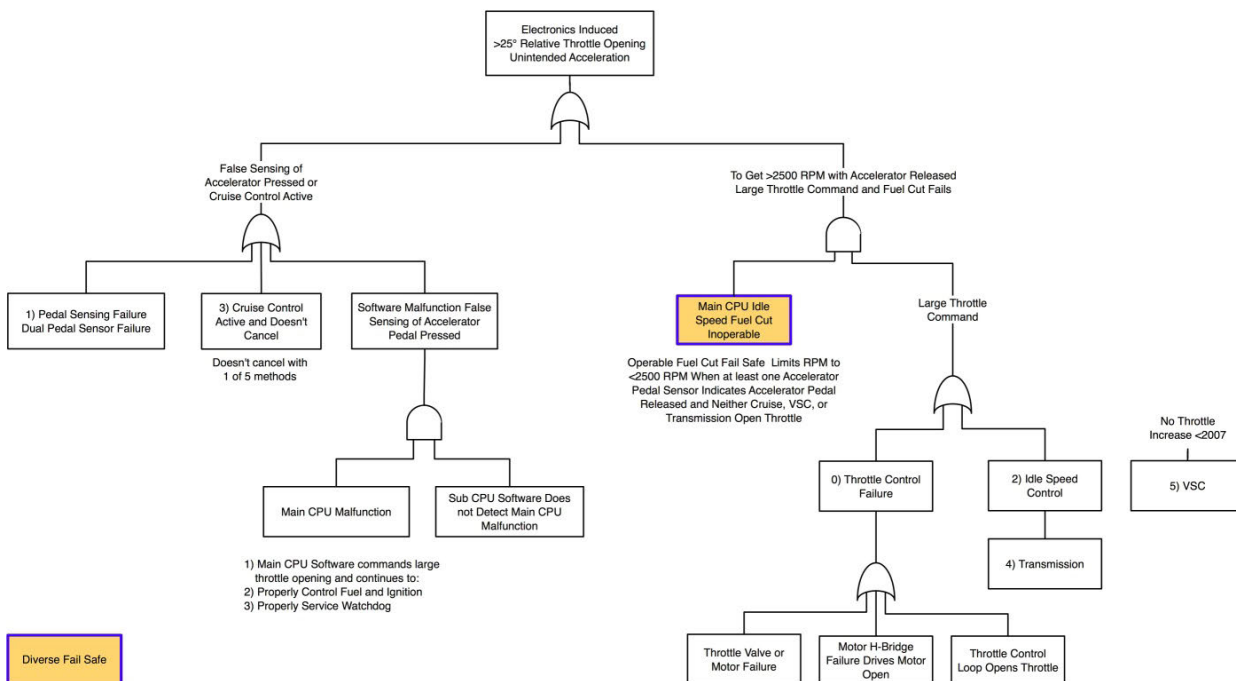
Figure 6.5.2.1-1. High Level Functional Fault Tree

The High Level Functional Fault Tree shown in Figure 6.5.2.1-1 shows the combinatorial logic and the system level fail-safe features that must fail for an electronics failure to unintentionally open the throttle a significant amount.

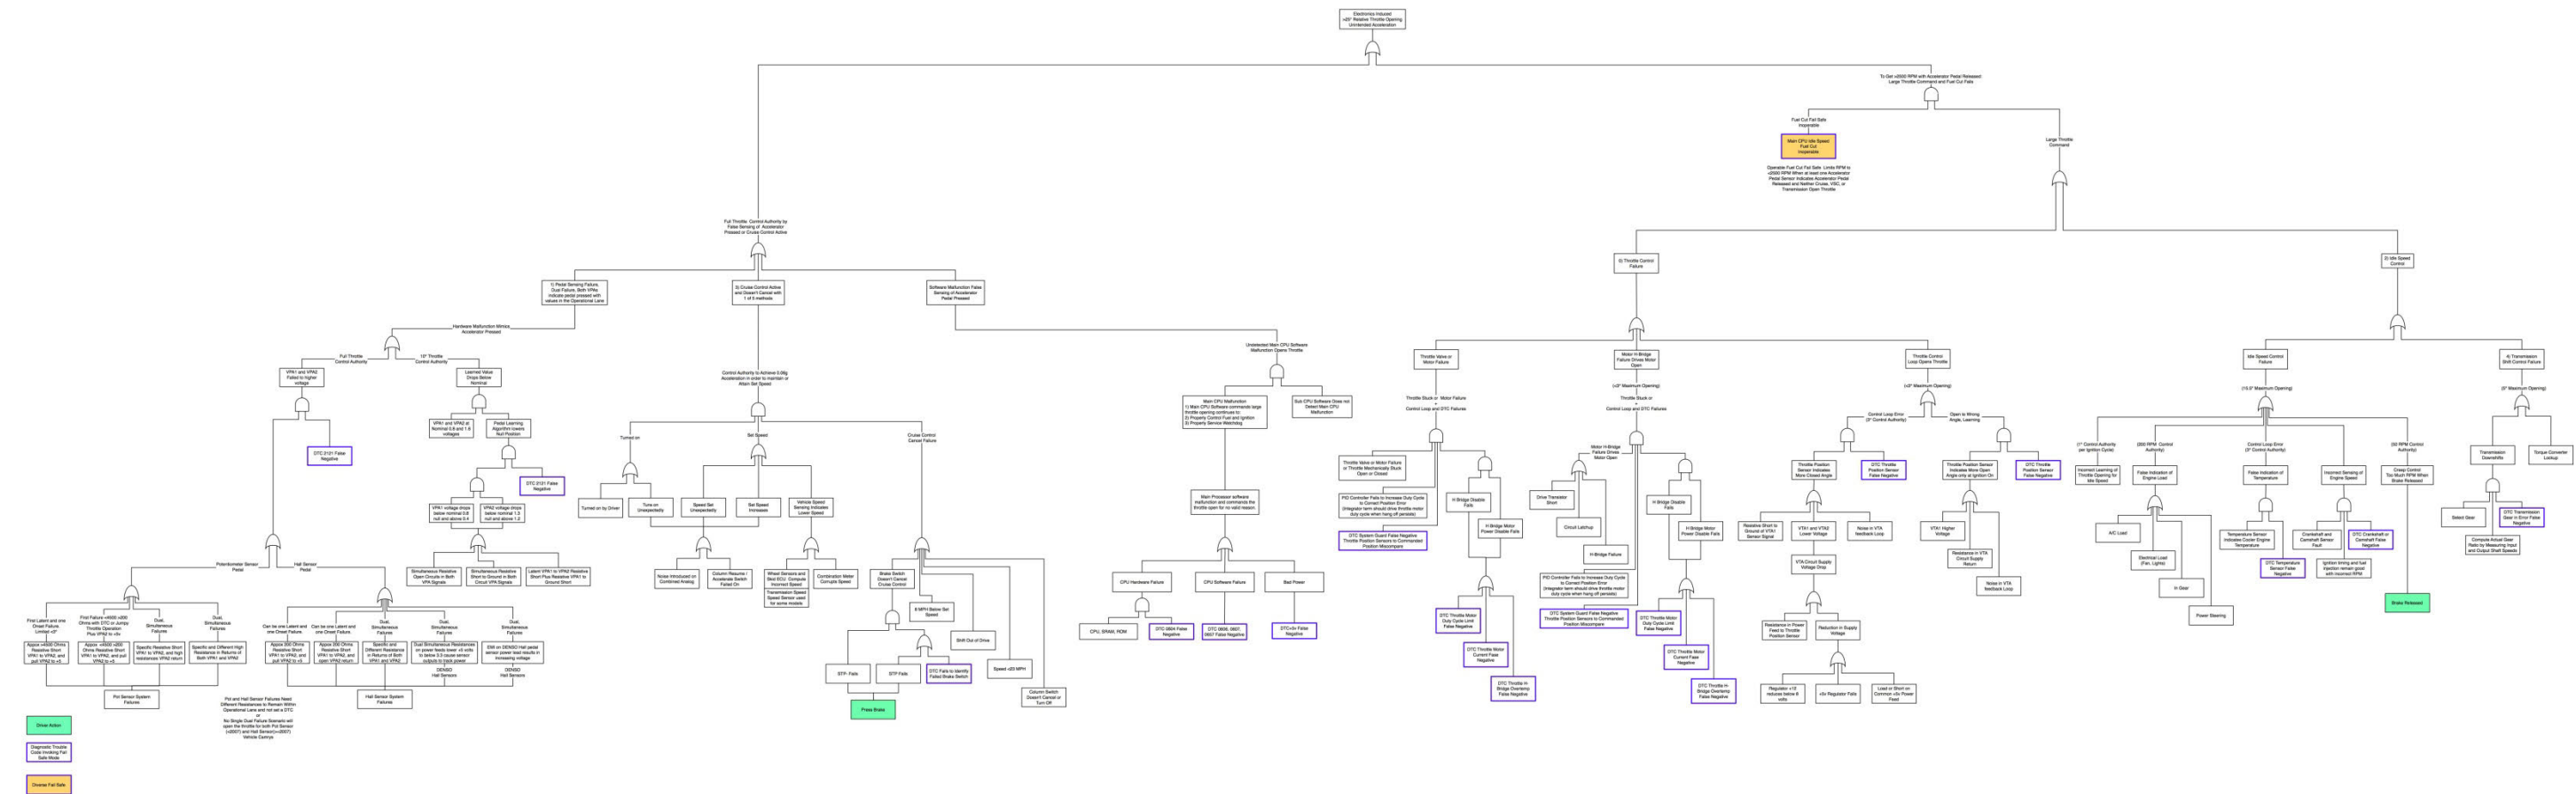
Figure 6.5.2.2-2. System Level Functional Fault Tree

The Functional Fault Tree, Figure 6.5.2.2-2, shows how functional failures and failure causes, captured in the Failure fishbone Appendix B, can combine and result in unintended throttle openings. Hardware and software failure modes and potential environmental causes are captured on the fishbone chart described in Section 6.6. The fishbone organizes failure causes along a functional hierarchy, but without the combinatorial logic necessary to create a UA.

The right hand side of Figure 6.5.2.2-2 captures conditions where the system level fuel cut fail-safe mode protects the vehicle when the accelerator pedal is released. The "and" gate combines a large anomalous throttle command that escaped detection with the non functioning idle speed fuel cut fail-safe in order to create an event with engine speed higher than 2500 rpm. Barring a software fault described below, the Main CPU will cut the fuel at engine speeds of 2500 rpm regardless what created the throttle command. This fuel cut strategy can protect the vehicle from mechanical throttle valve failures as shown on the left input to the Function 0 "or" gate selecting anomalous throttle commands. Even if the throttle butterfly valve would lose its shape and allow a large amount of air to flow, engine speed would be controlled. As shown in Figure 6.5.2.2-2, Idle Speed Fuel Cut Fail-Safe Mode, can also control electronics failures escaping detection by

Failures appearing as a valid pedal sensor signal to the Main CPU indicate the accelerator pedal is off idle or is pressed. These kind of functional failures are shown as the left branch of the functional fault tree on the left side of Figure 6.5.2.2-2.

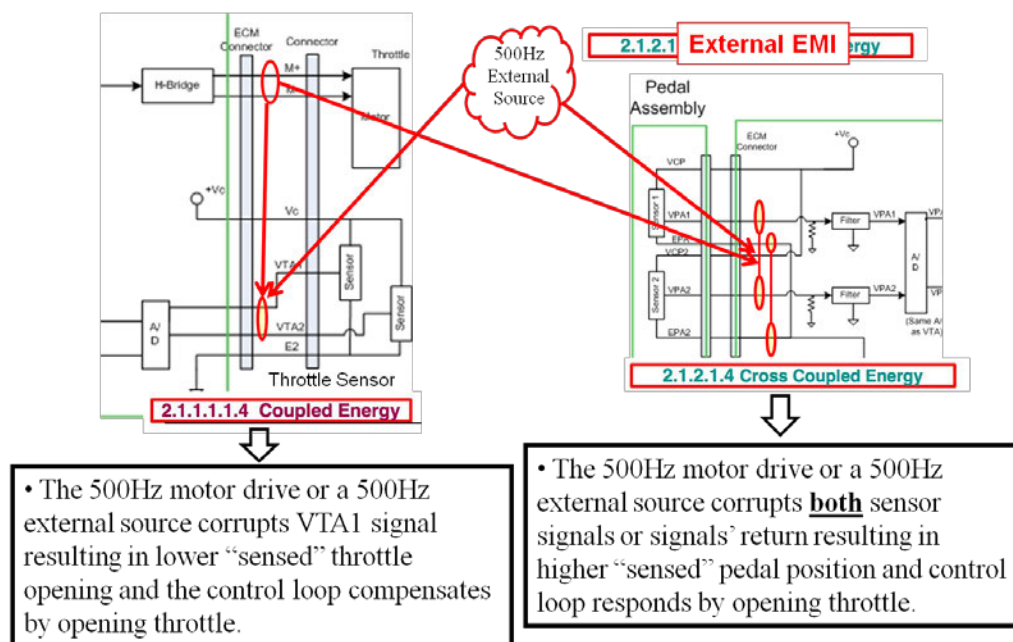
Figure 6.6.1.2-2. Summary of Postulated EMI Faults Identified from Fishbone Analysis

Figure 6.6.1.2-2 indicates the postulated EMI faults as identified from the fishbone analysis. Three different tests uncovered a 500 Hz sensitivity; the noise injection common to both VPA signals, noise injection on VTA1 signal, and the vehicle level conductive EMC testing.

On a simulator, a signal was injected in both VPA signals between their return lines (EPA1 & EPA2) and the ECM common ground. The results indicated a decreasing system response as the frequency was increased. However, as the (0.4Vpp) noise source on VPA signal return was increased to a frequency of 500 Hz, a 2 Hz signal (beat frequency with the internal 500Hz A/D sampling) of 0.2Vpp was observed on VTA as shown in Figure 6.6.1.2-3. Note the results shown are for a simulator without air flowing through the throttle body and are intended to describe the electrical response and not intended to describe an actual vehicle response.

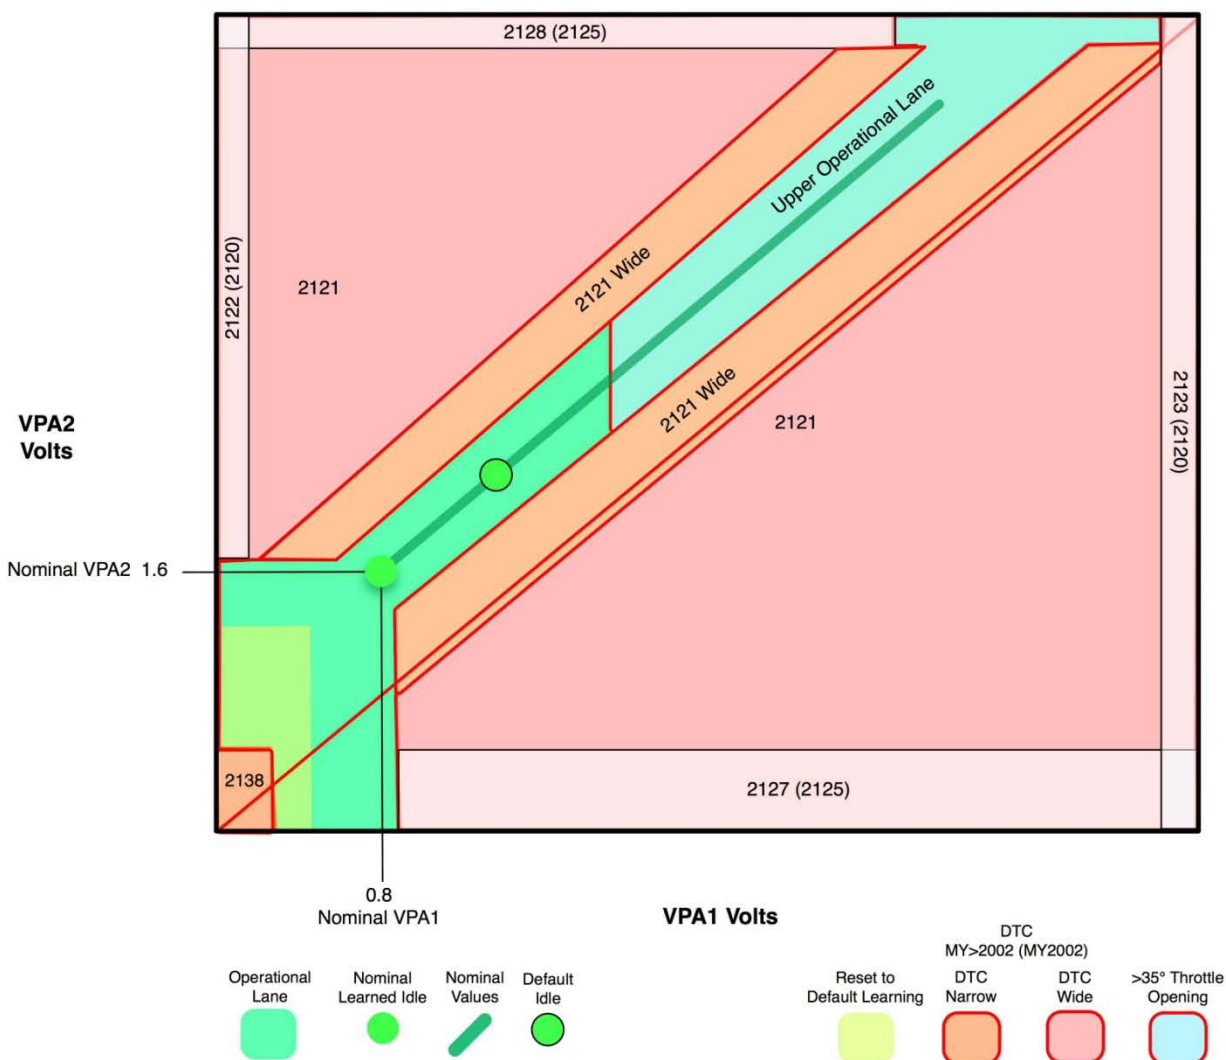
Figure 6.6.2.1-4. Notional Pedal DTC Map, 07 Camry V6, red is P2121 wide limit

Expanded thresholds for acceptable pedal values can occur whenever the battery voltage has been removed and restored, during certain pedal learning failures, and when the DTC P2121 has been detected. These expanded thresholds, or DTC wide thresholds, allow a wider range of pedal voltages to be accepted as operational. Nominally, after the foot-off-pedal position has been successfully learned, the operational lane of acceptable sensor values becomes reduced in width. A notional DTC map is shown in Figure 6.6.2.1-4. The wide allowable operating lane for signal voltages is shown in red.

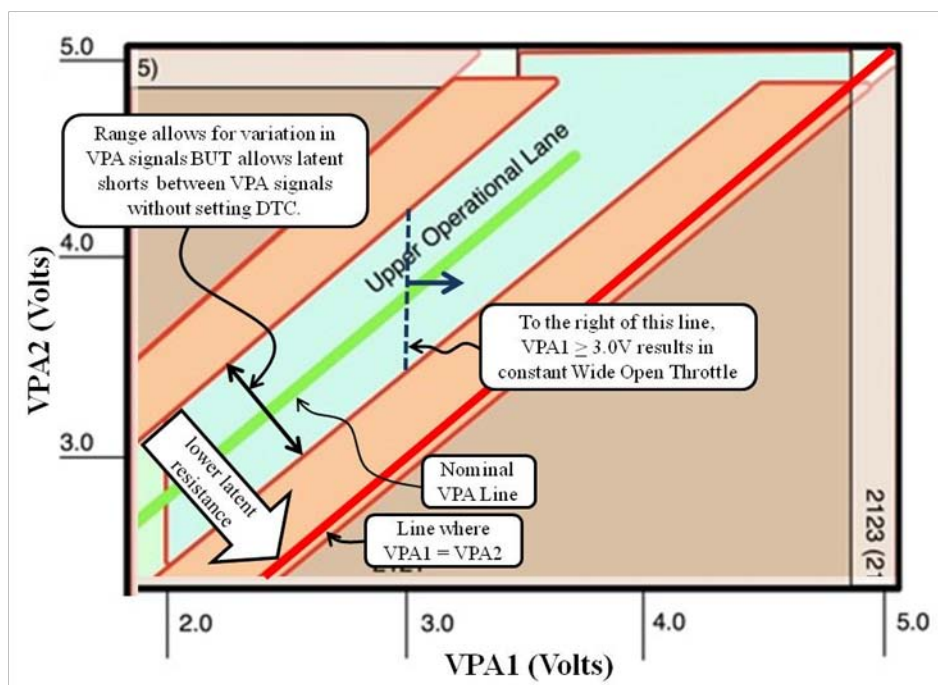
Figure 6.6.2.2-2. The upper operational lane with the latent fault influence and WOT location.

VPA signals if it were to occur can decrease the nominal line in the downward and right direction approaching the $VPA1 = VPA2$ line. In order to avoid generating a DTC, such a latent resistance must not result in the VPA signals going outside the operational lane. That is, a latent resistance can move the VPA signal from the current line position to the edge of the operational lane. For a Hall Effect sensor and nominal VPA signals (green line), the minimum latent resistance is approximately 200 ohms (to stay in the operational lane if a secondary VPA2 short to +V supply occurs). However, if the VPA signals were closer to the lower operational lane limit, then the minimum latent resistance would be greater, and conversely if the actual VPA signals were closer to the upper operational lane limit, then the minimum latent resistance would be lower.

The other key point of Figure 6.6.2.2-2 is the relationship between VPA1 and the throttle position. For nominal VPA signal voltages, VPA1 greater than or equal to 3.0V corresponds to WOT or 90 degree throttle opening. For VPA1 voltages greater than 3.0V, the throttle position maintains a constant WOT. This condition is true only for nominal idle voltages of VPA1 equal 0.8V and VPA2 equals 1.6V. For default learning where $VPA1=1.4V$, then the WOT VPA1 voltage would be 0.6V higher or VPA1 equal or greater than 3.6V.

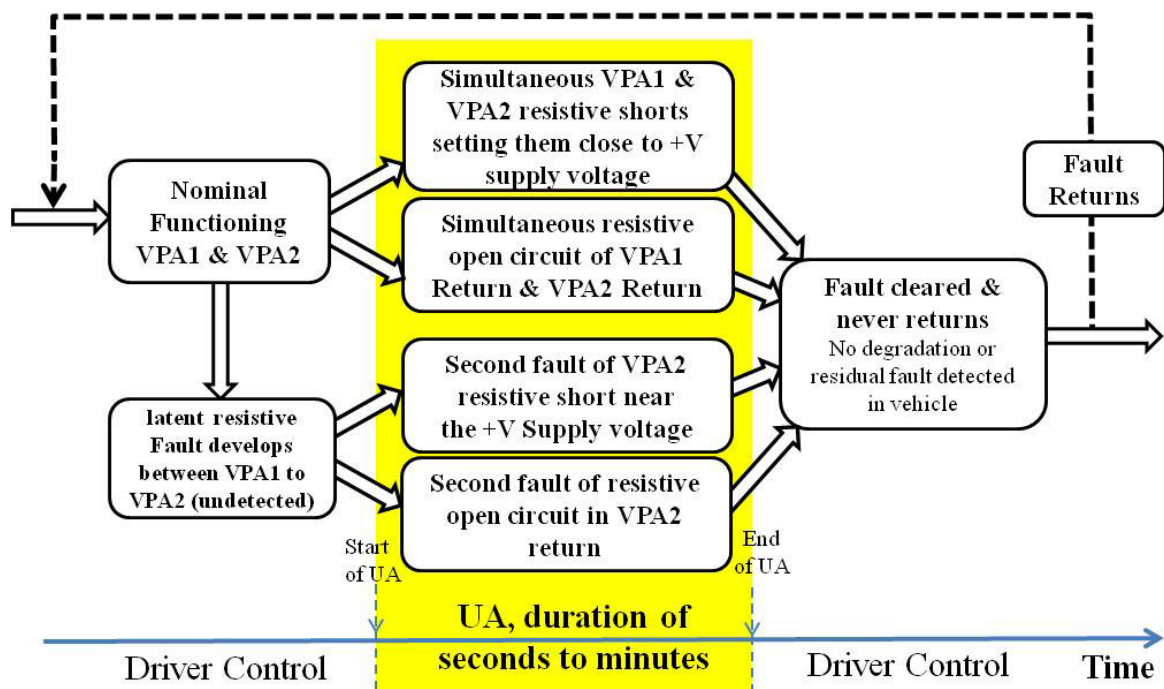
Figure 6.6.2.2-3. Chronological steps of a dual fault in the upper operational lane

due to two anomalous resistive current paths placing VPA1 and VPA2 in the upper operational lane which may last from seconds to minutes followed by the fault clearing allowing driver control again with the fault condition never occurring again in most cases and to not be detected when taken for service in all cases. In VOQ cases analyzed, this type of UA has been reported although in the majority of incidents it was experienced only once. In no known cases (VOQ or otherwise) have the large throttle opening UA conditions been predictably repeated under normally occurring conditions except during NESC tests. Figure 6.6.2.2-3 also includes the possible postulated fault steps in which a UA can occur; either from a latent fault that resides in the design for a period of time then later the second fault condition occurs or also for two faults that occur simultaneously (both within 0.5 seconds time period).

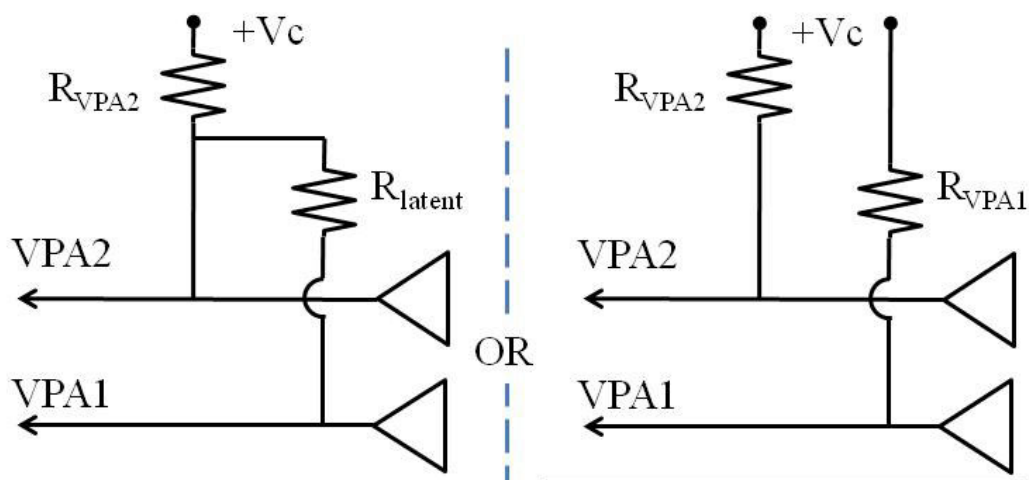
Figure 6.6.2.2-4. Fault resistance locations for the postulated double fault of shorts to the +V supply

sensors may not. Figure 6.6.2.2-4 indicates the location of the latent fault in relationship to the VPA signals and the relation of the latent resistance to the resistances for the dual fault to the +V supply.

A latent fault could exist between the two VPA signals and go undetected (in Hall Effect sensors) within a limited range of resistance values and at some later time the second fault to VPA2 could occur placing the two signals in the upper operational lane. The low output impedance of the Hall Effect sensor amplifier allows the latent resistance to be present yet not impact the circuit performance. As will be shown later, the potentiometer sensor has a much higher output resistance and latent faults of the same resistance (as Hall Effect latent resistance) will result in the signals going outside the operational lane and generating a DTC for most, but not all conditions.

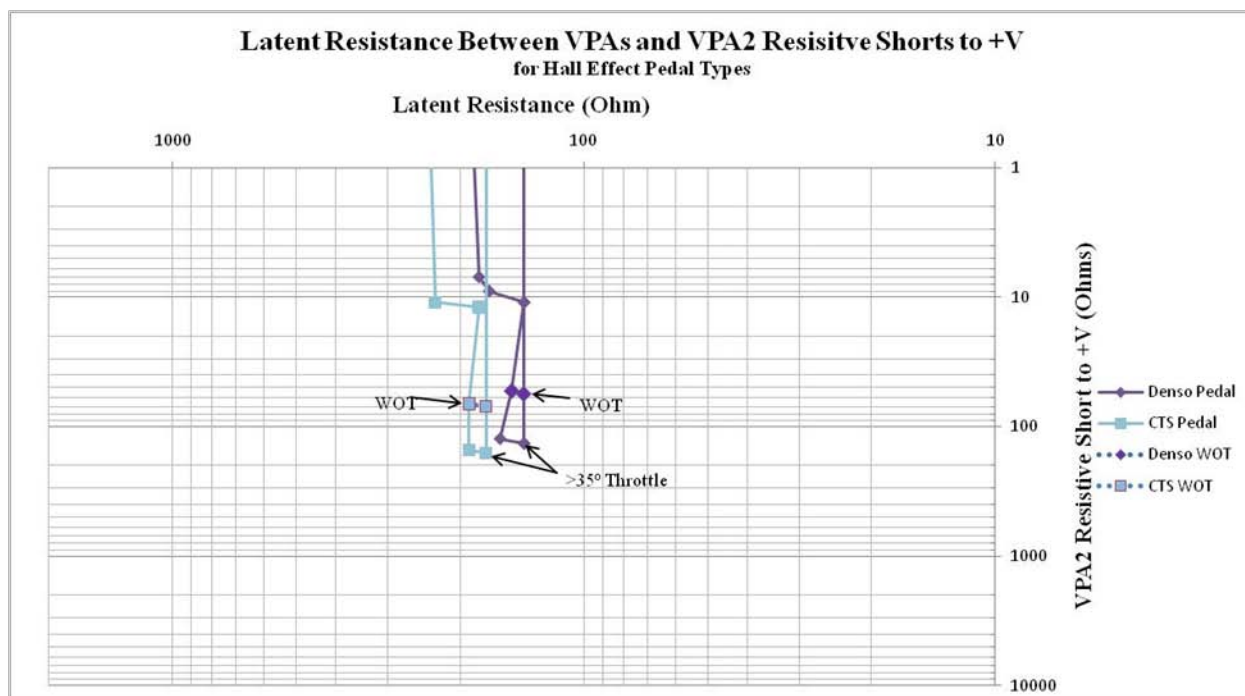
Figure 6.6.2.2-5. For Hall Effect type pedals, resistance range required for latent fault between VPA signals and second fault of VPA2 resistive shorted to +V

The other failure mode identified is a latent fault between the VPA signals with the second fault being a resistive open circuit on the VPA2 return line. The NESC team studied this effect (see Appendix C). For the CTS pedal tested, there was not a resistance range, but rather a single resistance of approximately 1700Ω between the VPA signals which placed them in the upper operational lane with a VPA2 return line open circuit of 8kΩ or greater (and not generate a DTC). Since the fault was at the edge of the operational lane, due to natural variances other CTS pedals may have a narrow resistance range allowing this fault to occur and not generate a DTC for the full range of pedal stroke.

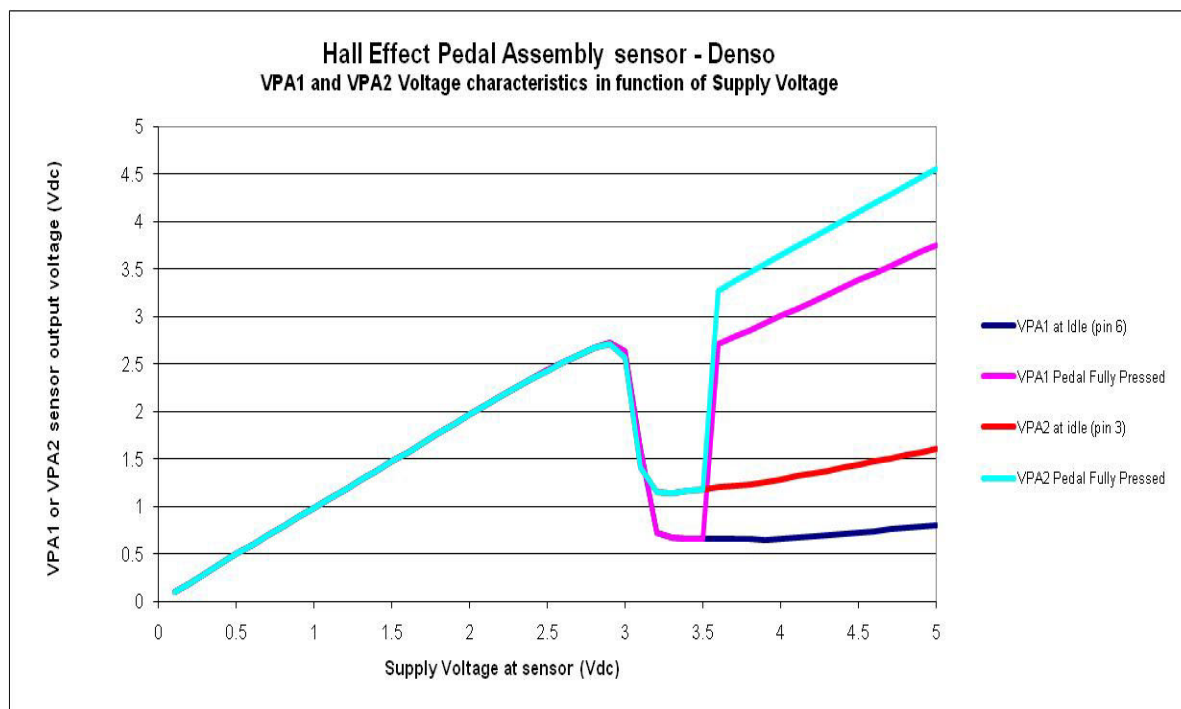
Figure 6.6.2.2-7. Denso Hall Effect sensor outputs as a function of the lower supply voltage

Before relating these Hall Effect sensor responses to the operational lane, a design characteristic of the Denso pedal will be described. This design characteristic is unique to the Denso Hall Effect sensor pedals where the signal outputs are affected in a unique manner by the reduction of the sensor +V supply voltage, which was demonstrated by introducing resistance in the supply lines.

As shown in Figure 6.6.2.2-7, for the Denso pedal, as the supply voltages drop the output voltages also drop concurrently, however, at approximately 3V range sensor output then jumps to the supply voltage and follows the supply voltage linearly to zero. If the VPA signals converge as shown (within <0.4V) then a DTC is generated. However, depending on the fault conditions, there are voltage combinations which may put the VPA signals in the operational lane and not set a DTC. For these conditions, the Denso pedal would be subject to simultaneous dual resistive open circuit in the +V supply faults similar to the other postulated faults. However, the peak VPA signal voltage is approximately 2.7V. If VPA2 was at the maximum 2.7V, then to stay in the operational lane, then VPA1 can be no more than 2.2V or just inside the upper operational lane. This fault is similar to the postulated simultaneous resistive faults conditions in the return, but the maximum throttle opening is significantly less. Since the consequence is significantly less (just inside the upper operational lane) determining the exact resistance ranges was not explored for this unique case.

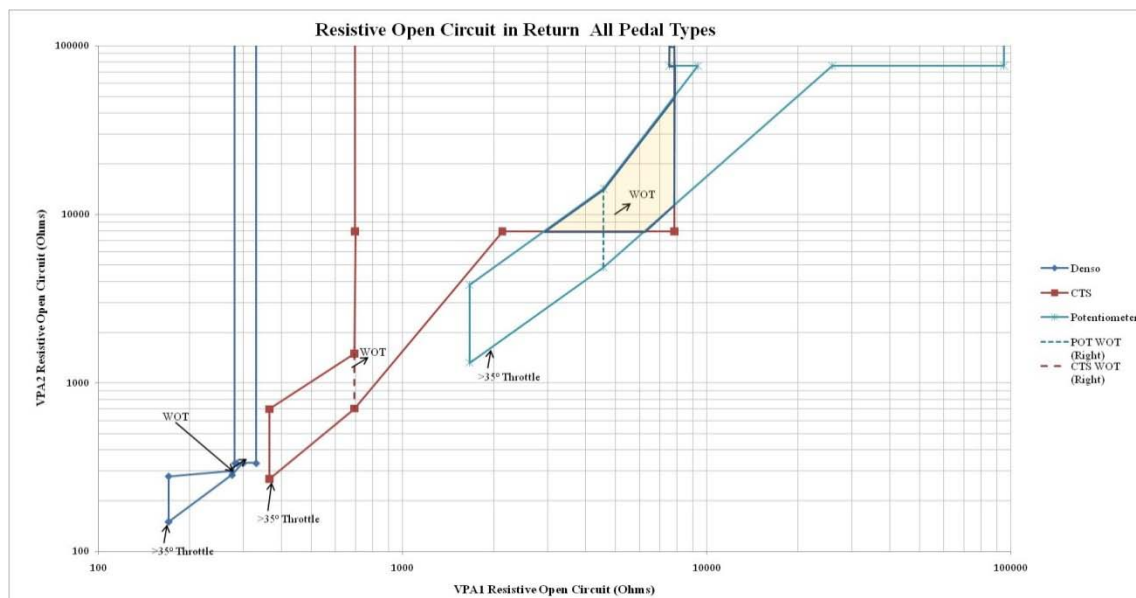
Figure 6.6.2.2-8. Resistance range required for simultaneous resistive open circuit in the VPA return line for all three pedal types

Again, assuming the pedal is at the physical idle position, Figure 6.6.2.2-8 shows the necessary resistance range required for resistive open circuits in the VPA signal return for all three pedal types to not generate a DTC. Note that resistance ranges do not overlap and therefore there is not one set of conditions common to all pedal types which could cause a large throttle opening UA. This implies that if this postulated fault was occurring, then the conditions in addition to the other restrictions previously described would need to be uniquely tailored for each pedal type rather than common across all pedal types to avoid generating DTCs.

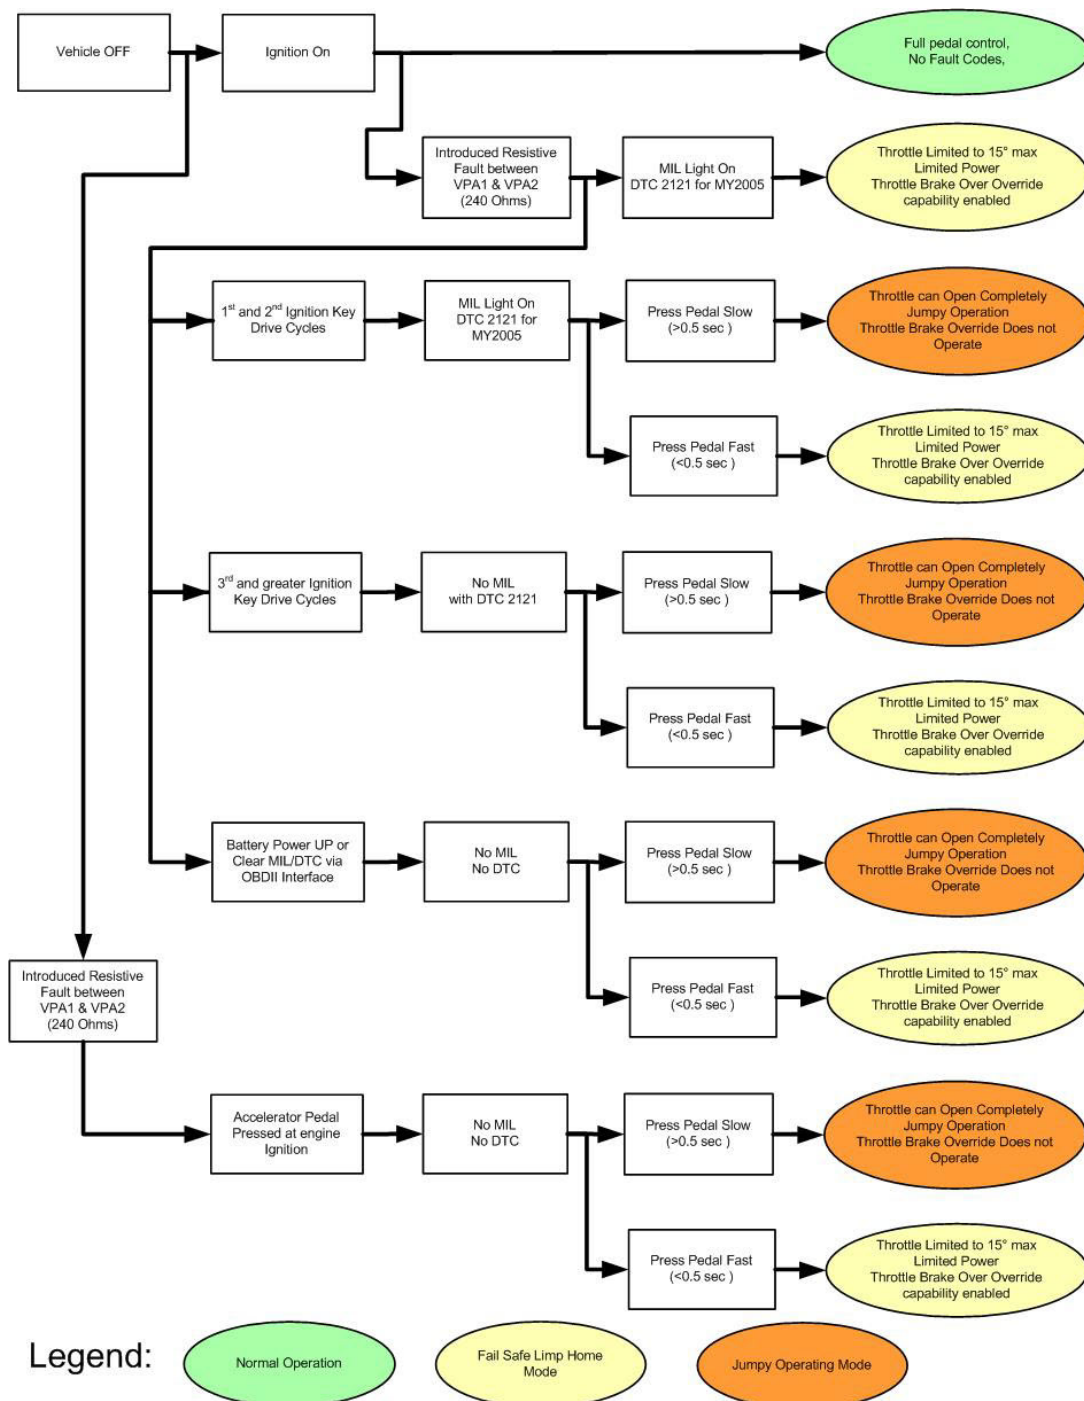
Figure 6.6.2.3-2. Pedal Resistive Fault Event Sequence Diagram

Testing with a simulated defective pedal on both the V6 MY 2006 and L4 MY 2005 ETC simulators showed different responses depending on when the failure was introduced, and the number of ignition and drive cycles. The event sequence diagram, shown in Figure 6.6.2.3-2, illustrates the various responses to different operational sequences.

The first path of the event sequence diagram introduces the resistive short while driving, a DTC is declared along with a MIL, and fail-safe limp home mode is active including throttle brake override capability irrespective of the accelerator pedal position.

The second path shows after an ignition key cycle the DTC and MIL remain; however, the vehicle responds differently depending on how the accelerator is pressed. When the accelerator is pushed slowly, the vehicle has a jumpy response, and is capable of full throttle without throttle brake override. When the accelerator pedal is pushed quickly, the fail-safe limp home mode is active including brake override.

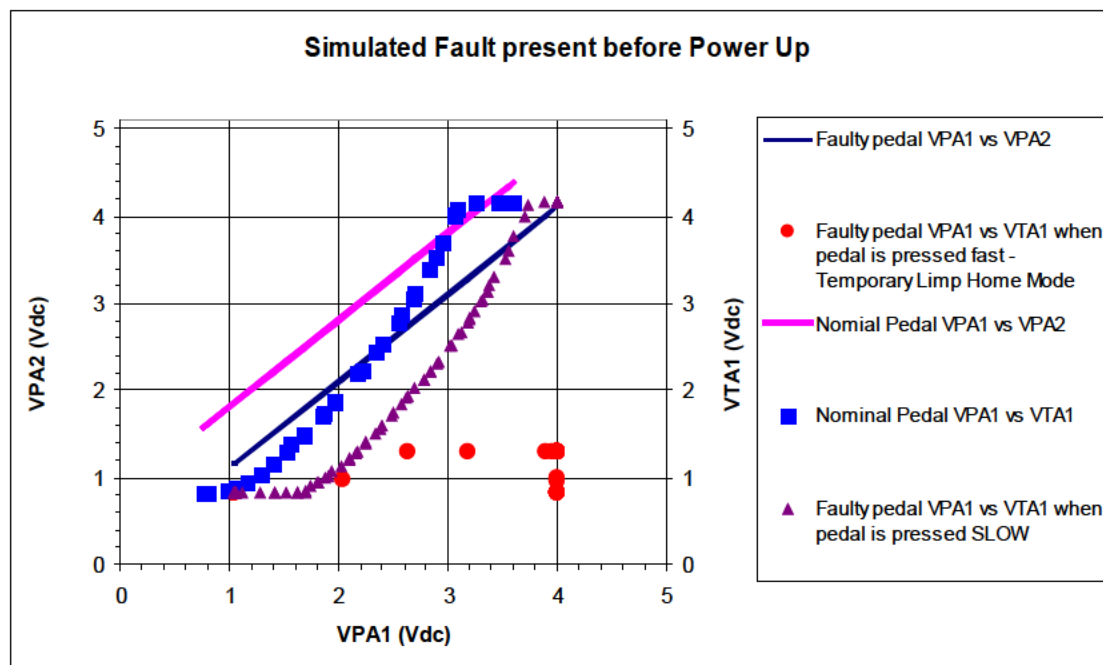
Figure 6.6.2.3-3. Simulated Pedal Fault Behavior

The following plot, Figure 6.6.2.3-3., was generated from tests performed on the MY 2006 V6 ETC simulator. A short of 248 ohms was introduced between VPA1 and VPA2.

The nominal pedal relationship between VPA1 and VPA2 is depicted in pink. The pedal relationship with the 248 ohm short is offset below and to the right in dark blue.

If the 248 ohms fault occurs after the system is powered up, a limp home mode will govern the throttle operation, thus limiting the throttle opening as described by the red dot curve of Figure 6.6.2.3-3. The throttle opens smoothly and is limited to approximately 15 degrees above idle. Also noted is the throttle closing as the throttle brake override activates when the brake pedal was applied after the pedal reached its fully pressed position.

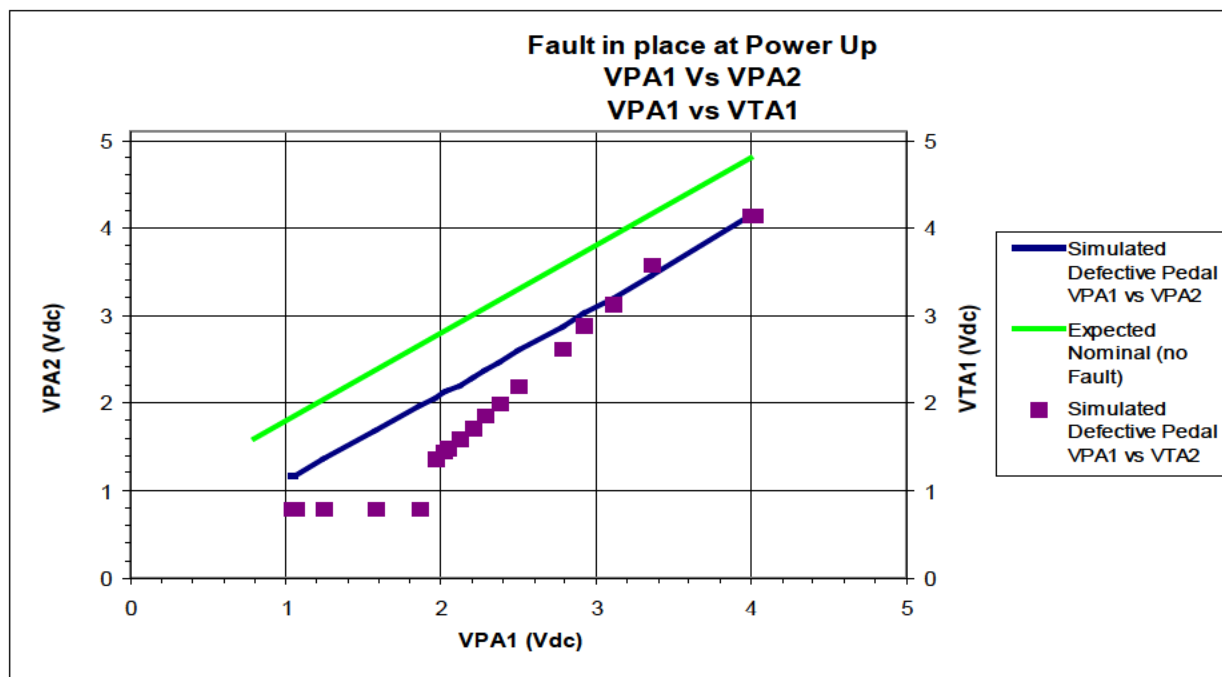
Figure 6.6.2.3-4. Fault in Place at Power Up

The following plot, Figure 6.6.2.3-4, was generated from tests performed on the 2005 L4 ETC simulator. A short of 248 ohms was introduced between VPA1 and VPA2.

The nominal pedal relationship between VPA1 and VPA2 is depicted in green. The pedal relationship with the 248 ohm short is offset below and to the right in dark blue.

When the pedal is pressed slowly, more than 0.5 seconds through the first 0.5 inches of pedal travel, no throttle opening occurs during the initial pedal travel. Then a sharp increase in throttle valve opening occurs. After this sharp increase, the throttle valve can be controlled by the pedal input up to the maximum throttle valve opening, where it limits and no longer increases. This is illustrated by the purple squares. Throttle brake override capability is not available under this condition.

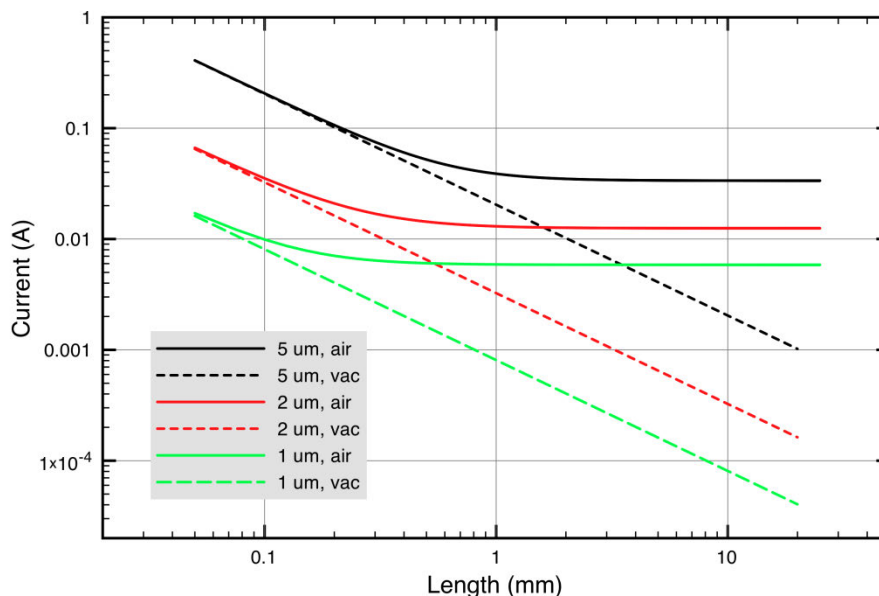
Figure 6.6.2.3-7. The current to bring a tin whisker to its melting temperature versus the length of the tin whisker¹⁹

This bridging whisker’s thickness is calculated to be approximately 1.7 μm , based on its length (1.9 mm), its electrical resistance (240 ohms), and the electrical properties of tin.

The electrical current needed to melt a whisker of this length and thickness in air is approximately 5 mA, as shown in Figure 6.6.2.3-7. This current raises the temperature to the melting point of tin, 232 C, and increases the resistance of this metal whisker to about 410 ohms. The electrical characteristics of the dual potentiometer circuit cannot place such a large current through this whisker, bridging VPA1 and VPA2; thus, its survival (i.e., non-melting during the operation of the car) is expected. Electrical analysis by the NESC team determined that less than 1 mA will typically flow in a fault between VPA1 and VPA2 and a second similar fault to Vc, if it were to occur, would result in a higher current, approximately 5 ma, through that fault, but not enough to ensure melting.

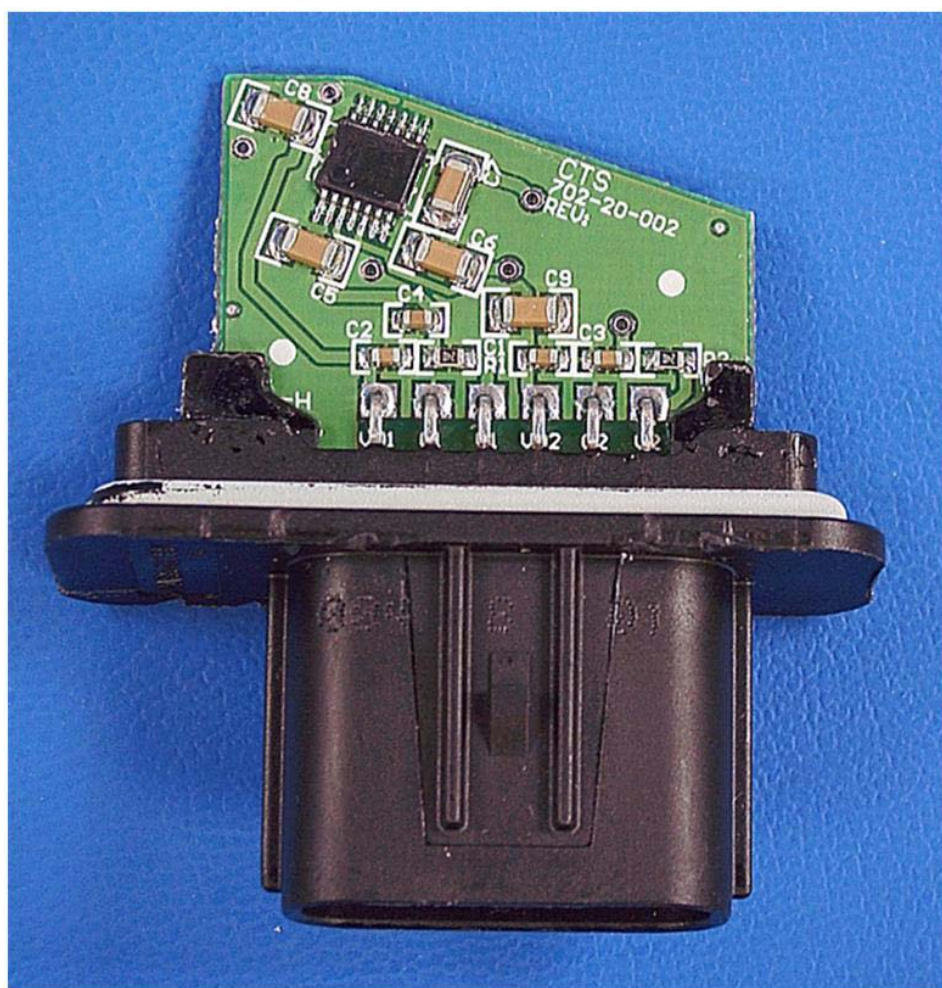
Figure 6.6.2.3-9. CTS Hall Effect Pedal Assembly Connector and Circuit Card

Destructive physical analysis of a CTS pedal assembly showed that the circuit card that contains the Hall Effect sensors is directly mounted to the connector as shown in Figure 6.6.2.3-9.

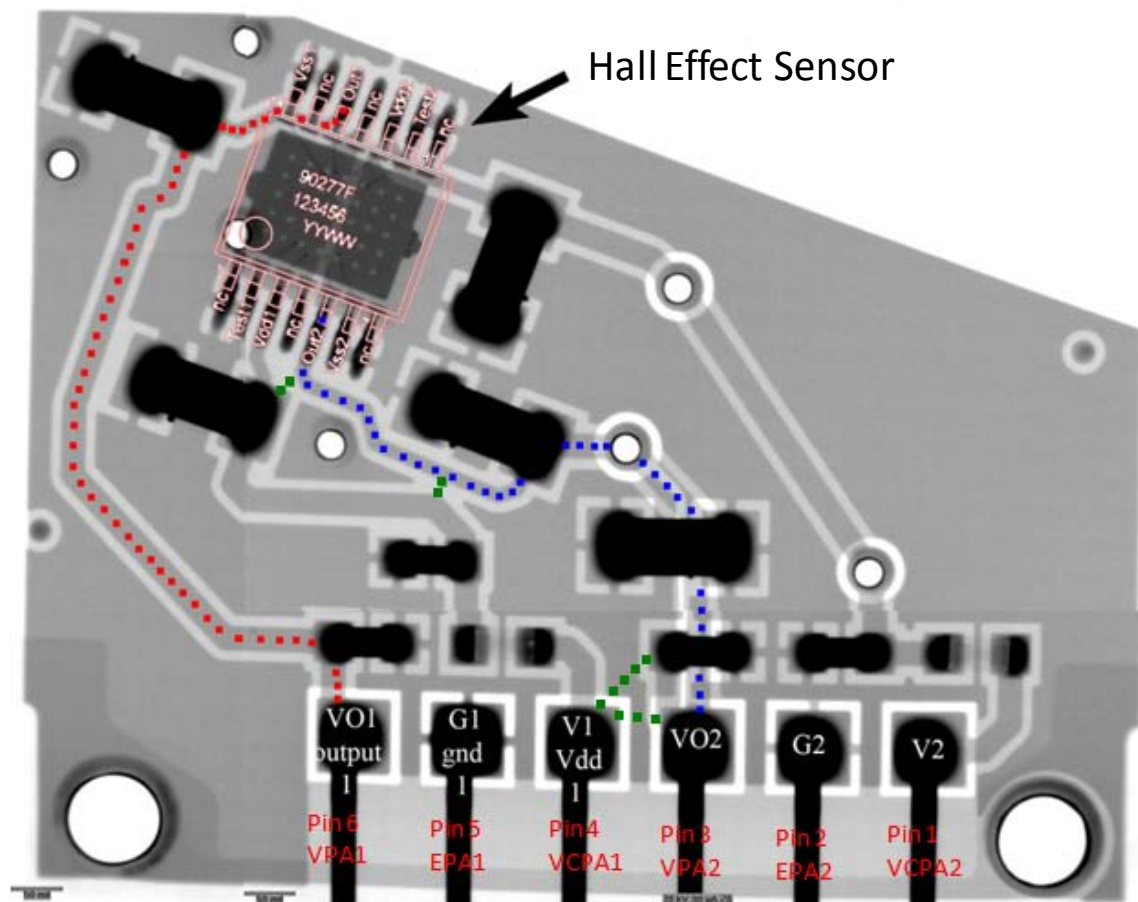
Figure 6.6.2.3-10. CTS Pedal Assembly Circuit Board X-ray Detail

Figure 6.6.2.3-10 shows the CTS pedal assembly connector contact board attachment points and signal traces for VPA1 (red dots) and VPA2 (blue dots), which are physically separated. Also, the VPA1 circuit trace appears to have ground potential traces on both sides of its length. VPA2

has ground potential traces along most of its length, but there are four identified regions (green dots) where VPA2 is in proximity to +5V (VCPA1). Two of these have capacitors with tin plated end caps. A survey of solder joints showed them to be a lead/tin alloy, which is resistant to tin whisker formation. Also the circuit card has an insulating protective conformal coating over it and the parts, although some gaps in the coating were detected. The connections between the circuit card and the connector pins at the bottom of Figure 6.6.2.3-9 has pure tin, but as previously noted the VPA1 and VPA2 signals have wide separation. This configuration appears to be more robust against undesirable tin whisker shorts (particularly those between VPA1 and VPA2) than the potentiometer configuration, previously shown, where VPA1 and VPA2 pin and signal conductors are next to each other and +5V (VCPA1) is next to VPA2 with no conformal coating (see Figure 6.6.2.3-10).

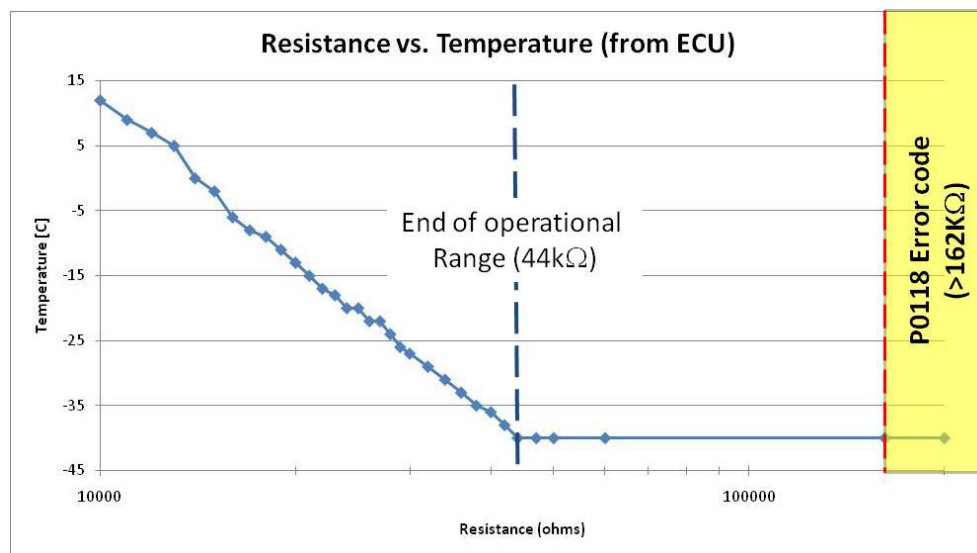
Figure 6.6.3.7-2. Upper resistance range of the Coolant Temperature Sensor including the DTC error range

For the coolant temperature sensor, the ECM software look-up table increases the target rpm directly proportional to the temperature reaching a maximum at -40C. When tested on a vehicle, the vehicle would not start when the engine was warm. Additionally, as the engine warmed the vehicle did not run smoothly, therefore the driver would have other indication the vehicle was not operating properly. These symptoms were not seen in the VOQs and there is no incidence of DTCs or repairs, therefore this postulated failure is not supported by the available data.
