**Rear-End Collision and Subsequent Vehicle Intrusion
Into Pedestrian Space at Certified Farmers' Market
Santa Monica, California
July 16, 2003**

Highway Accident Report

NTSB/HAR-04/04

**NTSB/HAR-04/04
PB2004-916204
Notation 7649B
Adopted August 3, 2004**

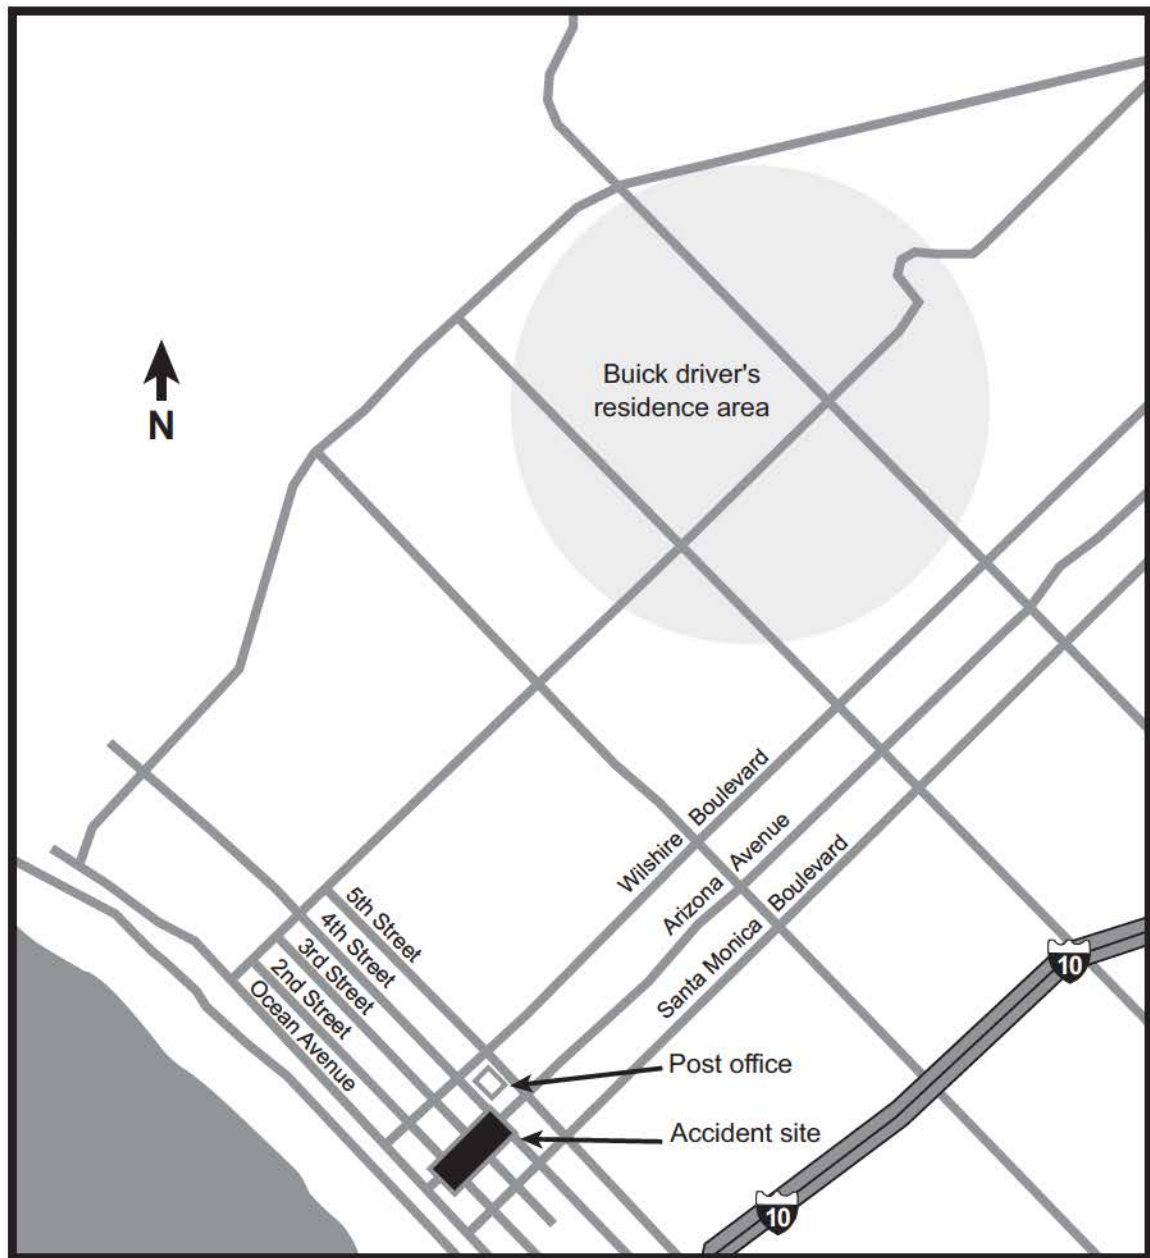
Figure 1. Accident area.

The accident occurred moments after the Buick driver had departed the Santa Monica Main Post Office on Fifth Street. The Buick driver told police investigators that he could see the farmers' market as he turned from Fifth Street onto Arizona Avenue. According to witnesses, the Buick approached the Fourth Street intersection; the Mercedes had stopped at the red light, had begun to proceed after the light turned green, and had again stopped to allow pedestrians in the crosswalk to cross Fourth Street. The Buick then struck the stopped Mercedes in the left rear, pushing it into the intersection. Witnesses stated that the Buick continued on Arizona Avenue, where it maneuvered past an orange ROAD CLOSED AHEAD sign on the yellow centerline of the roadway, through barricades, and into the area where the Santa Monica Certified Farmers' Market (SMCFM) had been set up. (See figures 1 and 2.)

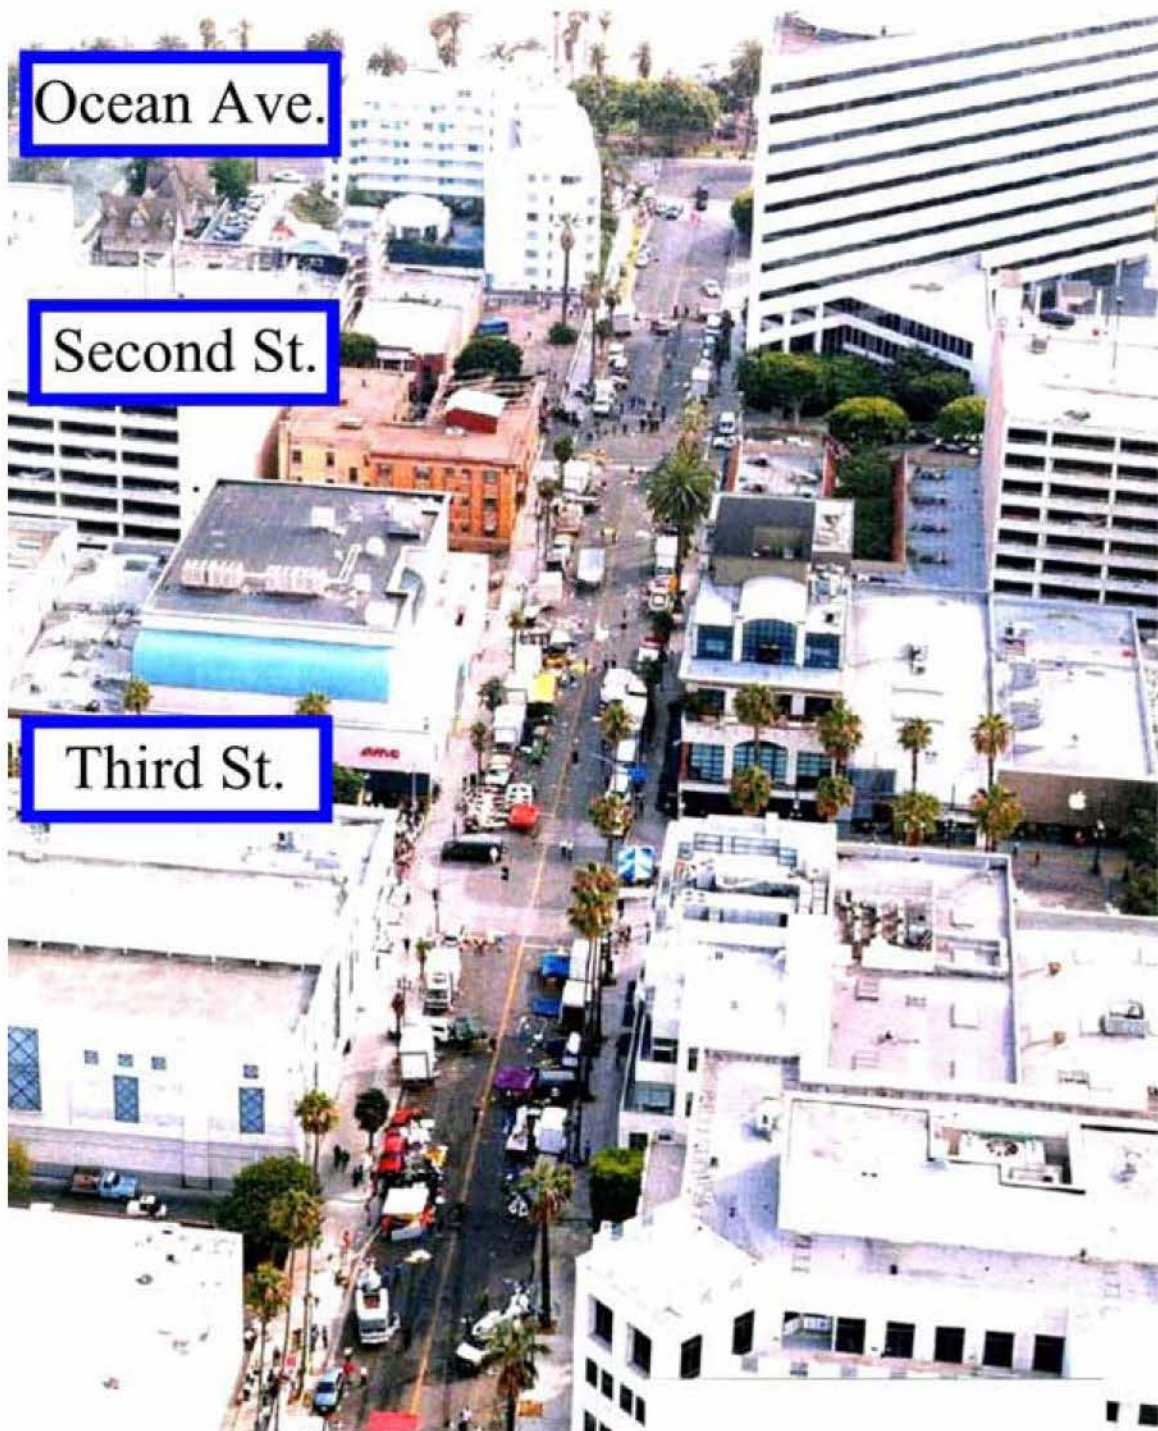
Figure 2. Aerial view of accident site.

The Buick proceeded through the farmers' market for approximately 2 1/2 blocks (750 feet) and came to rest on Arizona Avenue near the alley east of the intersection of Ocean and Arizona Avenues. As a result of the accident, 10 people were fatally injured, and 63 people sustained injuries ranging from minor to serious. The Buick driver and both Mercedes occupants were uninjured.

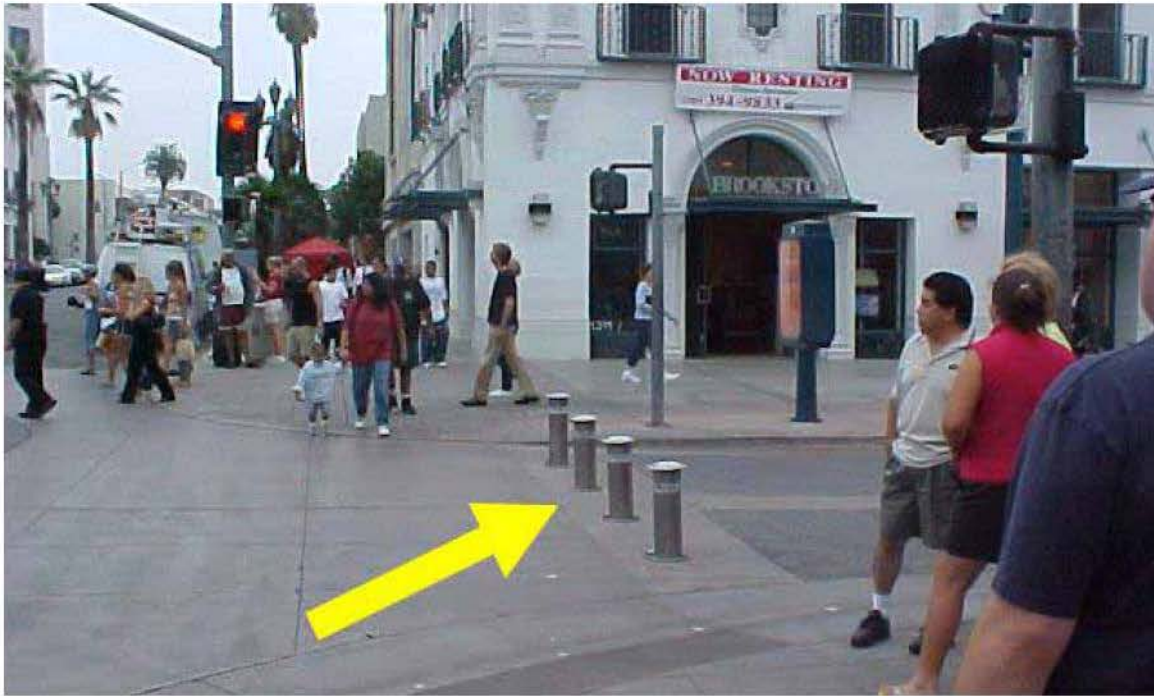
Figure 10. Bollards in place at the Third Street pedestrian promenade.

The Third Street promenade intersects Arizona Avenue midway in the SMC FM. It is a dedicated pedestrian mall that is permanently closed to vehicular traffic. Metal bollards¹¹ are positioned at the entrances to the mall at Arizona Avenue, Colorado Avenue, and Wilshire Boulevard. According to the city, “the bollards are intended to keep vehicles off the Third Street promenade on a full-time, permanent basis.” Four bollards are embedded into the Third Street roadway at each intersection, and they extend approximately 24 inches above the ground. (See figure 10.) They are locked into place with a padlock and can be lowered into the ground to allow access by emergency vehicles. Emergency response personnel have keys to the padlocks.

According to city officials, the metal bollards were installed at the mall entrances because the promenade was designated a permanent pedestrian mall. Officials indicated that bollards were not considered for the SMC FM entrances because the market does not operate on a full-time basis, necessitating permanent closure of Arizona Avenue.

Santa Monica recognized the need for and value of positive, rigid barriers to protect pedestrians when the city installed removable bollards on the Third Street pedestrian promenade (see figure 10). Metal bollards at the entrances along Arizona Avenue protect the Third Street promenade, a dedicated pedestrian mall that was once a through street. The bollards, while designed to be permanently placed in the roadway, can also be lowered to allow passage of traffic, if necessary. By providing a rigid, positive separation between vehicles and pedestrians, bollards reduce the likelihood of vehicular incursion into pedestrian traffic areas.

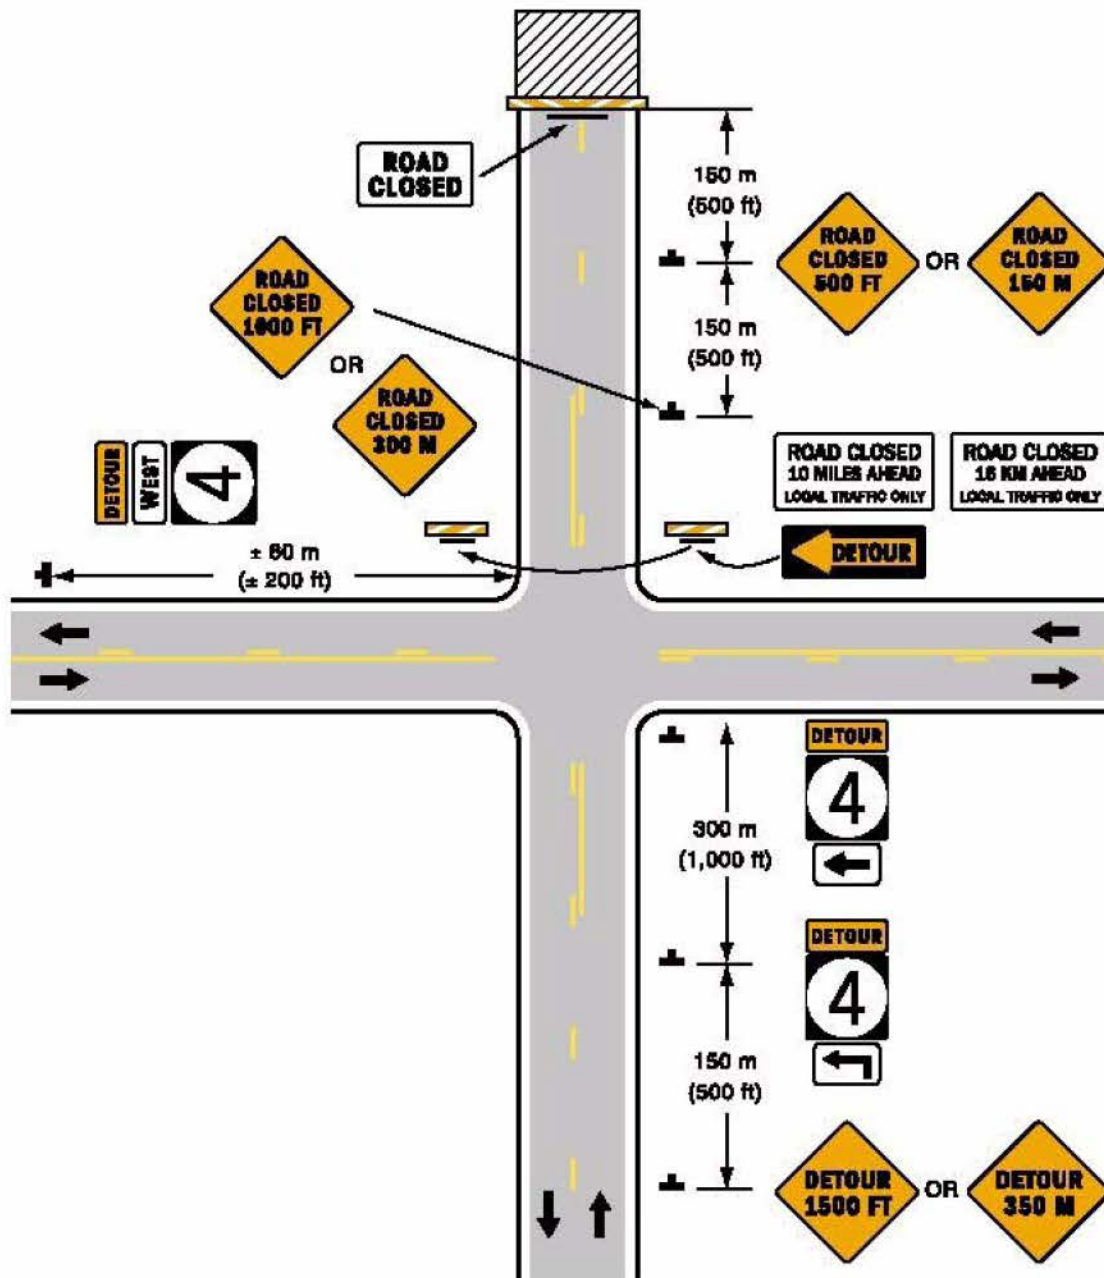
Figure 11. TA-8, the model application for road closures with off-site detour.

The model application for road closures with off-site detour is model TA-8 (see figure 11). It states that a ROAD CLOSED¹⁹ sign mounted on type III barricades (see figure 12) may be located at the edge of a roadway that is not being closed to all traffic.²⁰ If the road is closed a short distance beyond the intersection and a few origin or destination points are also beyond the intersection (for example, a few residences), the ROAD CLOSED sign may be placed on a type III barricade²¹ placed in the center of the roadway.

Section 6G.04 of the MUTCD, “Modifications to Fulfill Special Needs,” provides guidance on adding supplemental devices to temporary traffic control applications. According to section 6G.04, “When conditions are more complex, typical applications should be modified by incorporating appropriate devices and practices from the following list,” which includes temporary traffic barriers (#8) and crash cushions (#9).
