U.S. Department
Of Transportation

National Highway
Traffic Safety
Administration

Technical Assessment of Toyota Electronic Throttle Control (ETC) Systems

February 2011

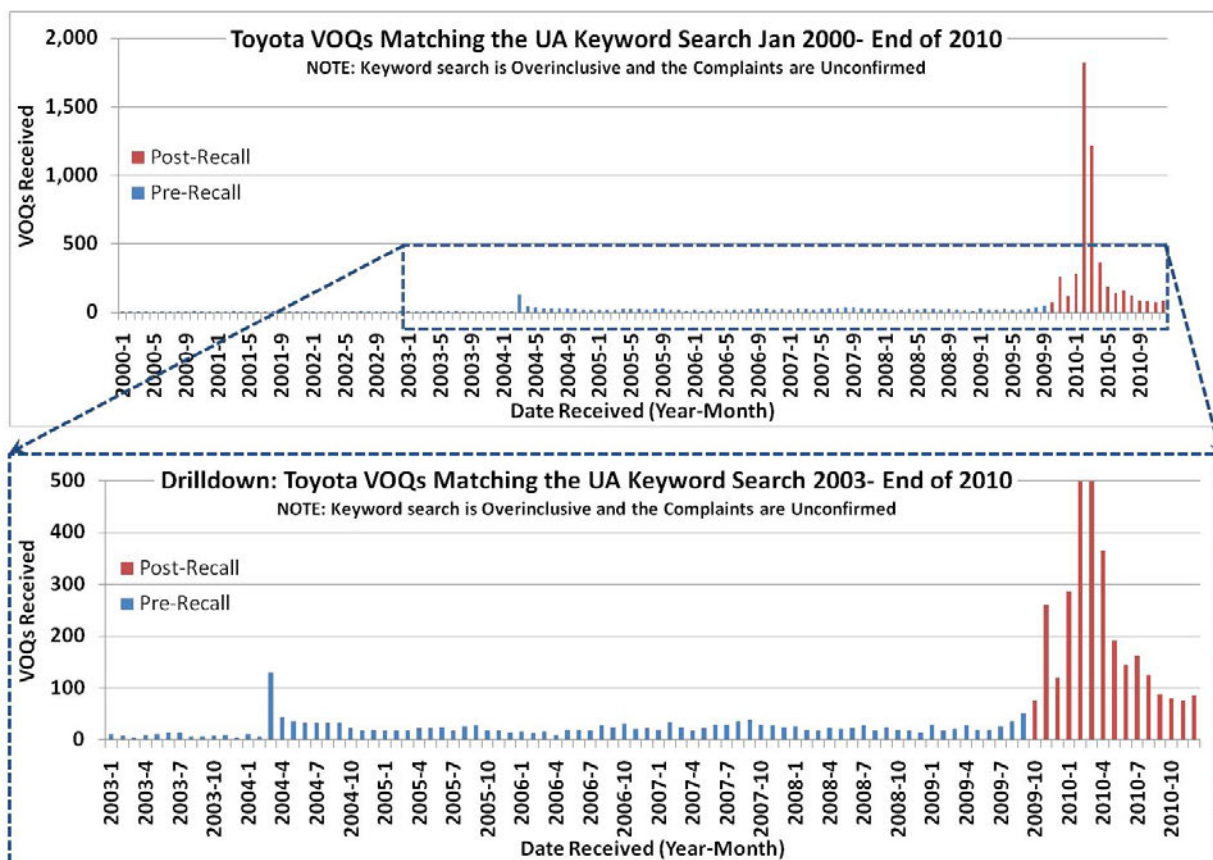
For example, NHTSA's complaint volume spiked in March 2004, (after four months of pre-investigative screening of the problem) when NHTSA opened an investigation (PE04-021) of electronic throttle control concerns in the 2002-2003 Camry, Solara, and ES300 (Figure 1). However, it is unlikely that this spike was caused by a sudden increase of the in-field failures at that time. Rather, the spike was likely related to publicity surrounding the opening of the investigation. Complaints also ramped up starting in September 2009, through the end of March 2010. Publicized events during this time period included the fatal ES350 crash near San Diego, California in late August of 2009, announcement of a safety recall involving the accelerator pedal being entrapped by out of position floor mats (Safety Recall 09V388) in early October, an expansion of the October recall and announcement of a new recall for a "sticky pedal" defect in January 2010, and the early 2010 Congressional hearings. A majority (71%) of the complaints presented in Figure 1 were reported after the announcement of the pedal entrapment recall in October 2009, with almost half (43%) received in the months of February and March 2010.³⁹

Figure 1: Consumer Complaints to NHTSA Alleging Unintended Acceleration in MY 1998-2010 Toyota Vehicles

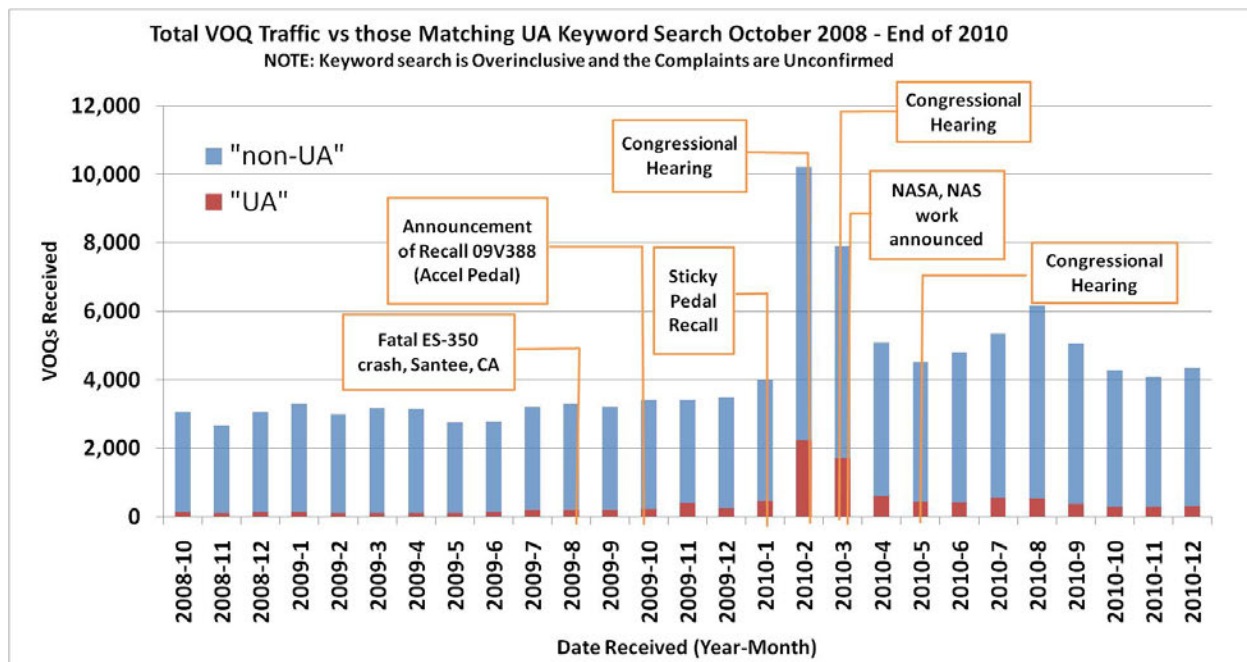
Although the proportion of complaints concerning UA allegations rose considerably, the publicity surrounding certain events substantially increased the flow of complaints to NHTSA in all categories, not just UA, as Figure 2 illustrates. Although Toyota vehicles accounted for a disproportionate share of the influx of complaints, complaint volumes on vehicles of all major manufacturers were affected.

Figure 2: Recent VOQ Traffic to NHTSA – UA vs. Non-UA

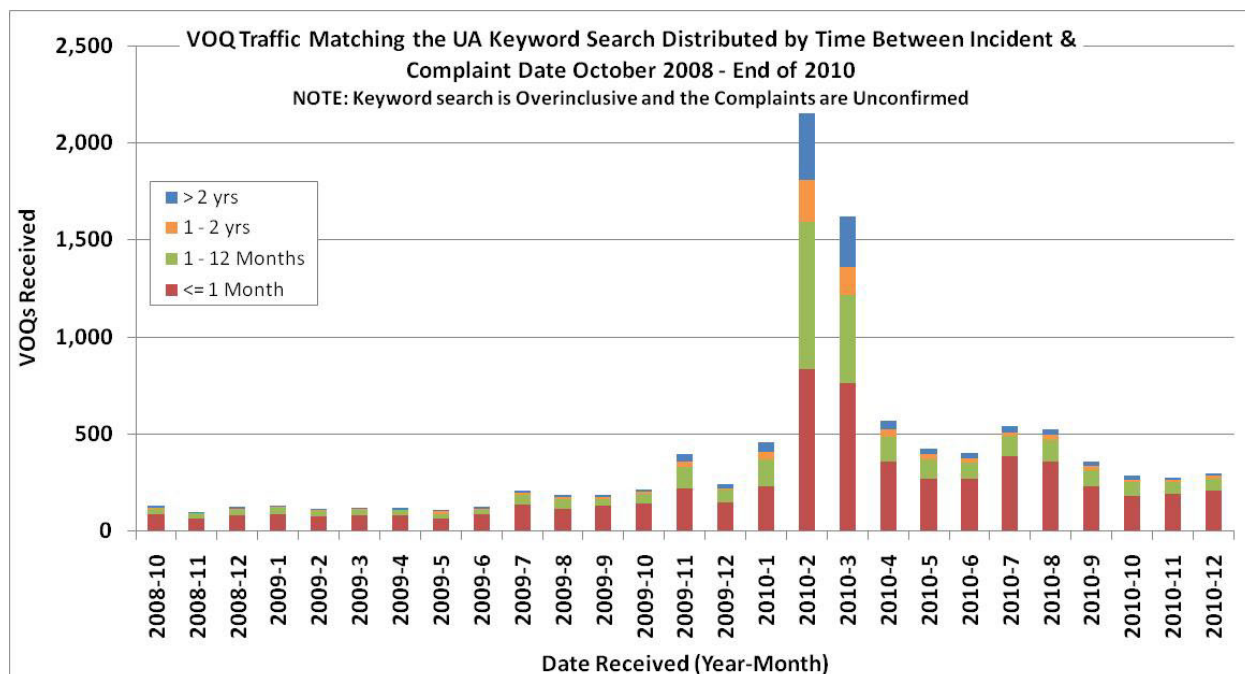
The time lag between incidents and complaints about them is also affected by publicity. Throughout the past decade, a majority (64%) of complaints (UA and non-UA) were filed within a month of the incident's occurrence. In contrast, during the heightened publicity in early 2010, complaints pertaining to recent UA incidents were less than half of the total (42%), and a quarter (26%) of UA complaints filed pertained to incidents over a year old. This time lag suggests that a major portion of the increased complaints was the reporting of older incidents rather than an uptick in new incidents (Figure 3).

Figure 3: Recent UA VOQ Traffic to NHTSA – Older Incidents vs. New Incidents

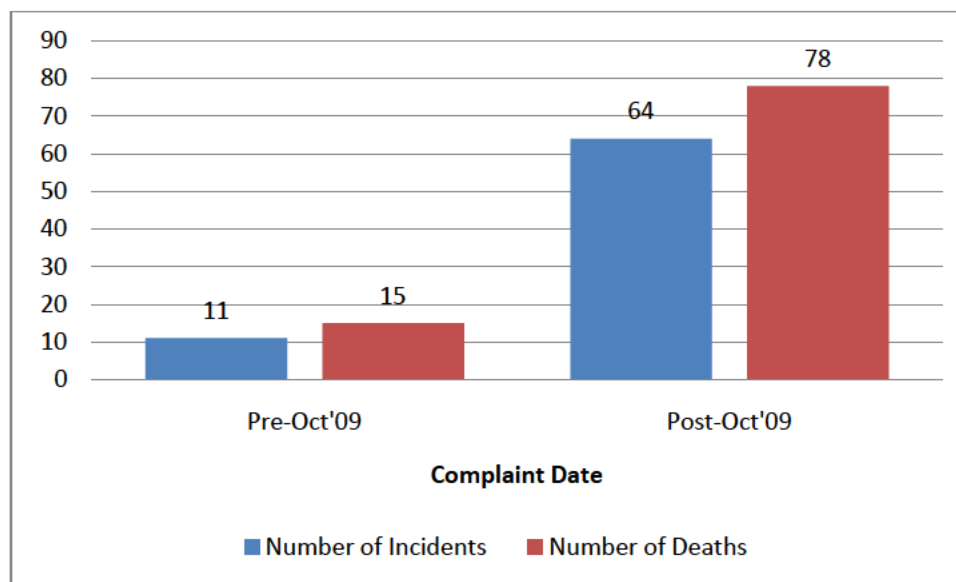
Publicity has affected the reporting of these incidents to NHTSA. The Toyota pedal entrapment recall was announced in October 2009, which provides a useful point of reference. Figure 6 shows fatal incidents by complaint date. Eighty-five percent of the incidents (64 out of 75) have been reported to NHTSA since October 2009. In fact, 58 of the incidents (77%) have been

reported just since the “sticky pedal” recall in late January 2010, which intensified public interest. The most incidents were reported in February and March of 2010, with 22 and 24 respectively. The latest incident was reported in June 2010. Although a significant time lag between an incident and the submission of a complaint does not diminish the complaint’s credibility, these numbers strongly suggest that publicity played a major role in the reporting of these incidents. Of the 11 incidents that were reported before October 2009, 10 involved vehicles with ETC. Of those 10, half (5) were reported during the 3-month publicity spike after the original investigation of ETC was opened early in 2004.

Figure 6: Fatal Incidents by Complaint Date

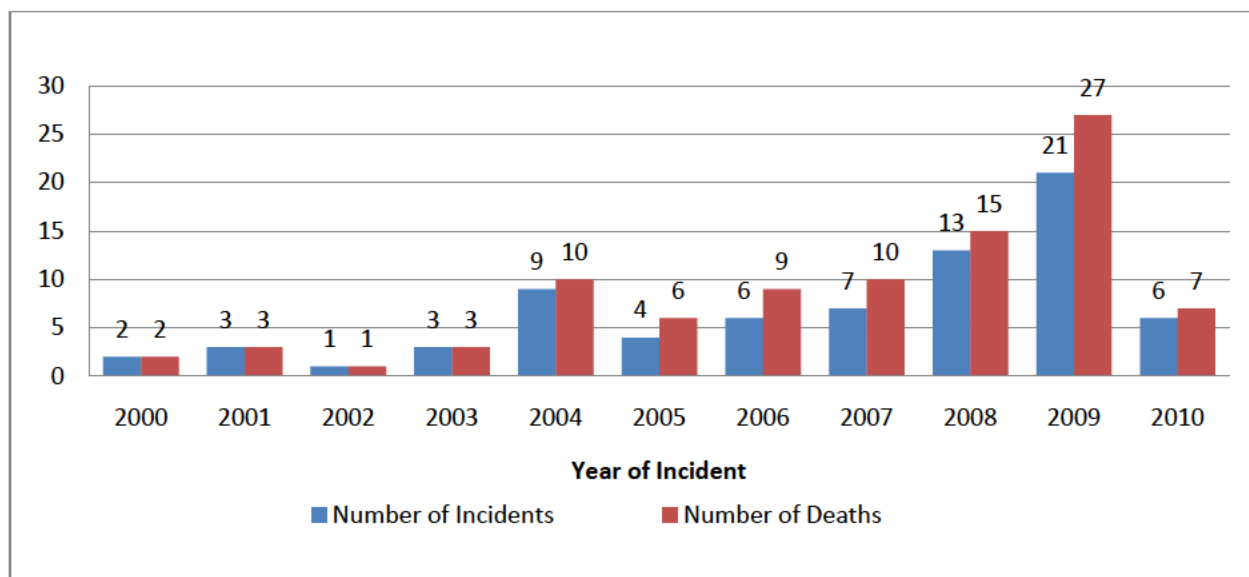
Even though most of these incidents were reported to NHTSA in 2010, very few of them actually occurred in 2010. Only six of the reported incidents (involving seven deaths) have occurred in 2010. Many of the occurrences were in 2009, but some of the recently received reports involve incidents dating back several years. Figure 7 shows fatal incidents by year of incident.

Figure 7: Fatal Incidents by Incident Date
