**National Highway  
Traffic Safety  
Administration**

**Investigation:** EA 15-005

**Subject:** Front Brake Hose Failure

**Products:** 2013 - 2015 Ford Explorer Police Interceptor

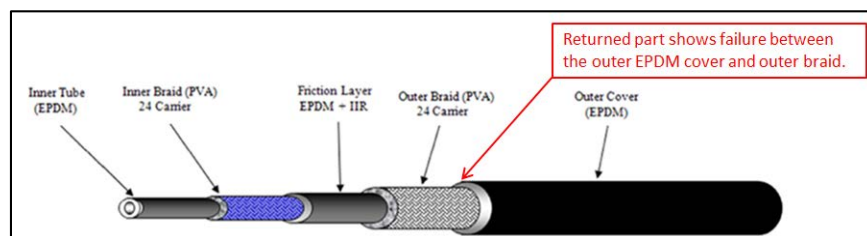
**Figure 2. Subject Hose Construction.**

**Subject brake hose.** The brake hose construction for both the subject hose assembly and the 2016 hose assembly consists of five layers (Figure 2): 1) Inner Tube – carries the brake fluid; 2) Inner Braid – provides structure to hold internal pressure; 3) Friction Layer – separates two braids; 4) Outer Braid – provides additional structure to hold internal pressure; and 5) Outer Cover – protects the Outer Braid from the elements. The maximum design operating temperature for the subject brake hose and subject caliper crimp joint is 120°C (248°F).

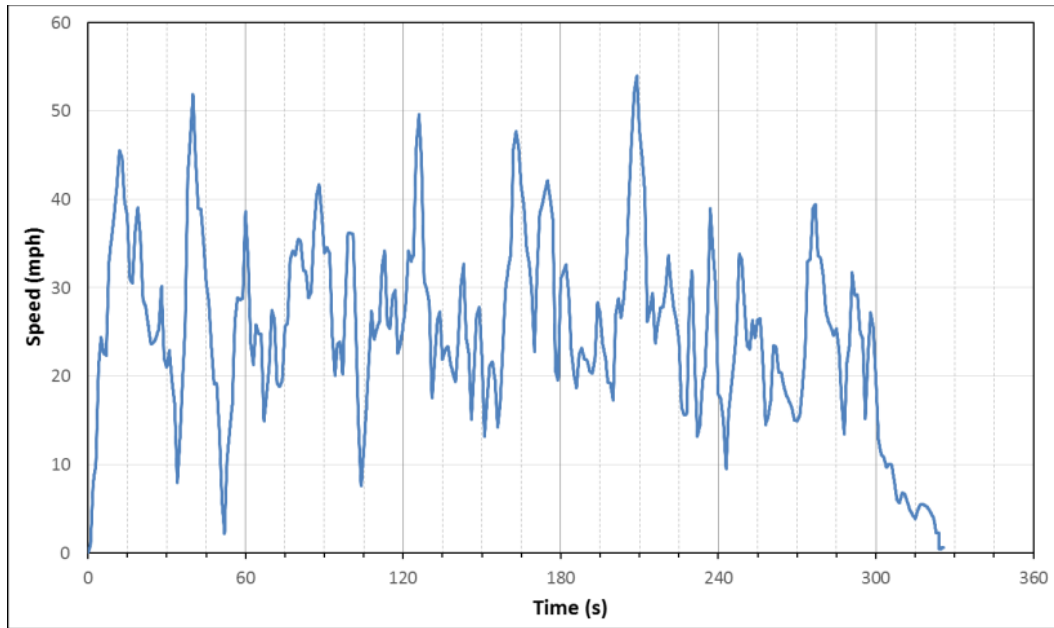
The EVOC driving involves three different exercises: 1) Controlled Braking; 2) Collision Avoidance; and 3) City Street Hazard Complex Exercise (Pursuit Driving). The course is a multiple-option turn points course that could be zig-zagged at multiple intersections and run in any direction. During the EVOC driving cycle, vehicles are subjected to repeated and continual hard throttle and brake applications with virtually no operation at steady, cruising speeds (Figure 8). This results in substantial heat build-up in the brake rotors by the end of each training run (Figure 9), as heat is generated in rotors faster than it can be dissipated and there are no periods between the hard accelerations and braking during which the ventilated brake rotors would be able to dissipate heat most efficiently by forced convection.<sup>1</sup>

Figure 8. Typical Sacramento EVOC pursuit training speed profile.

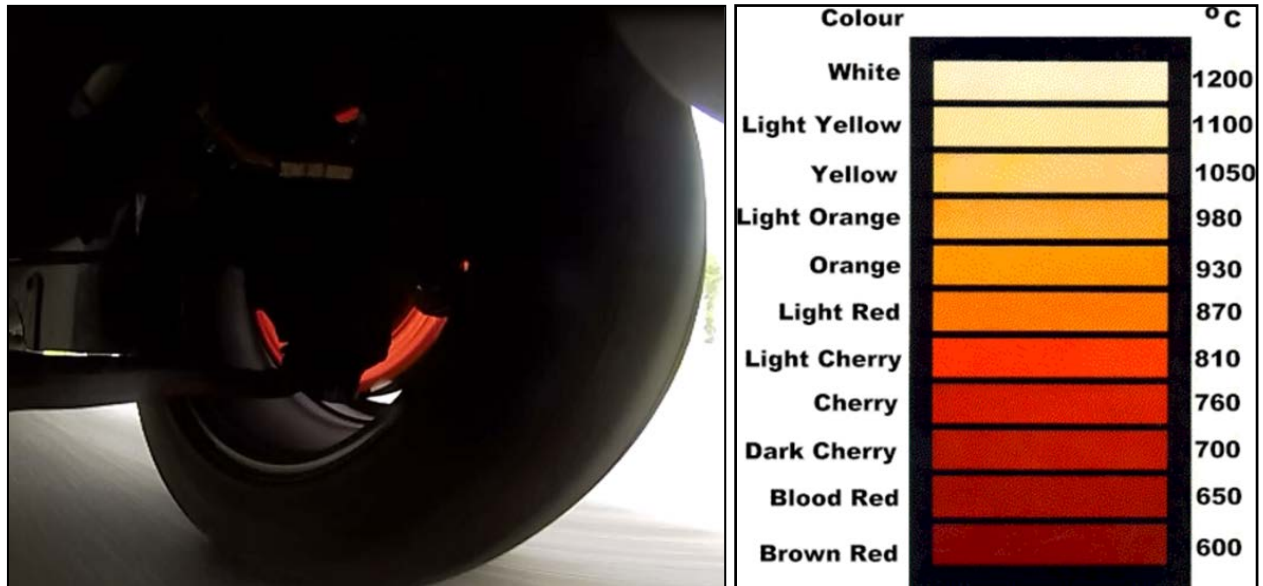
**Ford assessment.** Based on supplier (Hitachi) laboratory inspection of failed parts returned from Sacramento EVOC vehicles, testing of the subject crimp strength at elevated temperatures, and vehicle testing conducted to reproduce EVOC training course operating conditions, Ford concluded that the failures were caused by extreme use and duty cycle conditions unique to the Sacramento EVOC training course:

Figure 9. Brake rotor heating during Ford EVOC reproduction testing.

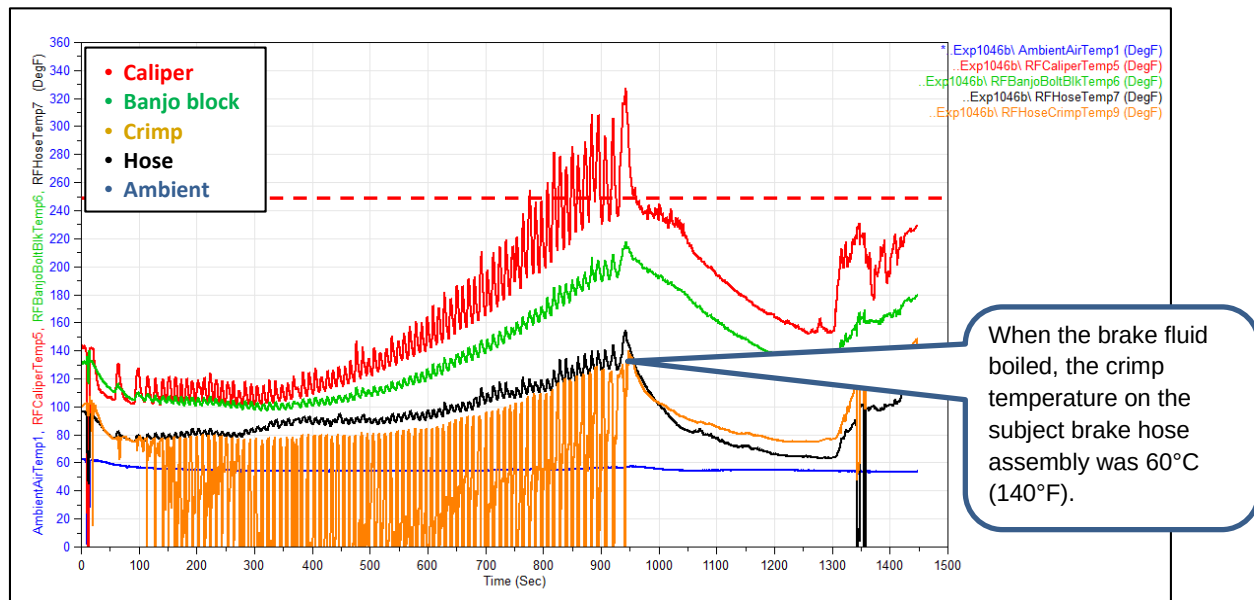
Figure 12. Subject brake hose assembly component temperatures in VRTC brake fade testing, right front wheel.

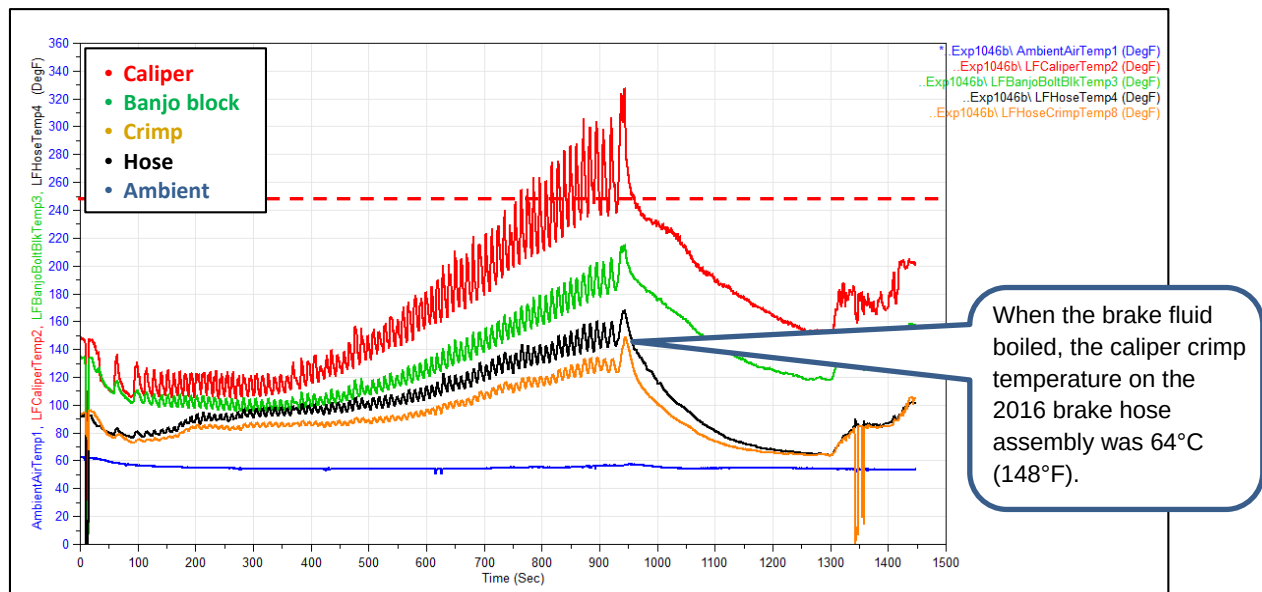
Figure 13. 2016 brake hose assembly component temperatures in VRTC brake fade testing, left front wheel.
