PE16-008

FORD

Appendix G

Field Communications

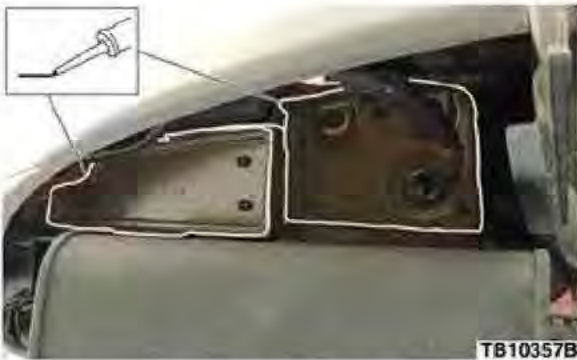
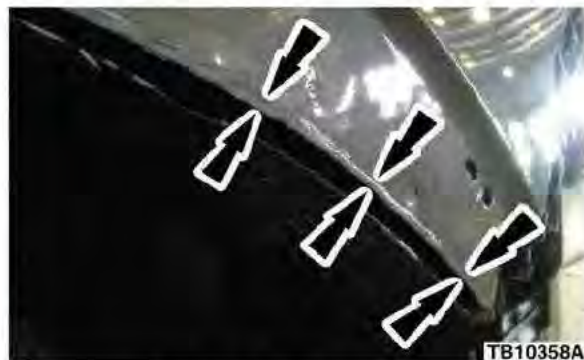
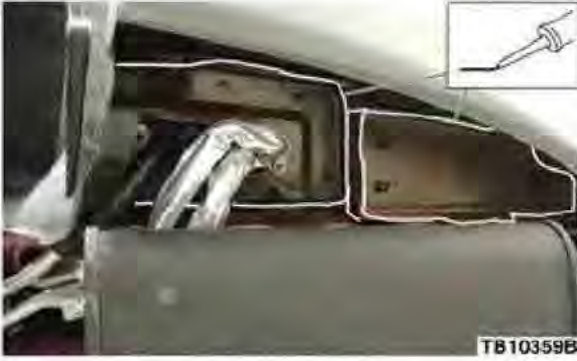
6. Clean areas on underside of vehicle where seam sealer will be applied. (Figures 3-5 below)

7. Cover the exhaust system and auxiliary climate control drain to prevent the seam sealer from getting on these parts or clogging the drain during sealer application.
8. Apply a generous amount of Motorcraft Seam Sealer to rear horizontal sheet metal lap joints on left and right sides of the vehicle, and the rear sheet metal overlap flange across the rear of the vehicle. Make sure the sealant has sealed the openings and remove if any excessive sealant applied. (Figures 3-5 above)
9. Spray generous amount of 3M Rubberized Undercoating around auxiliary air conditioning lines and seam sealer areas. (Figure 6)

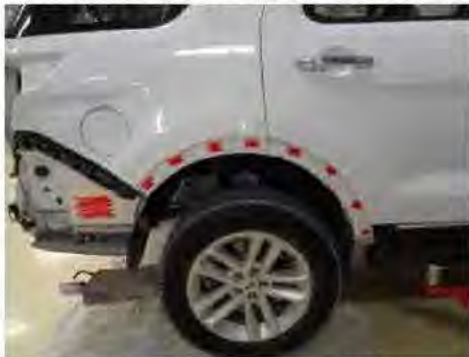
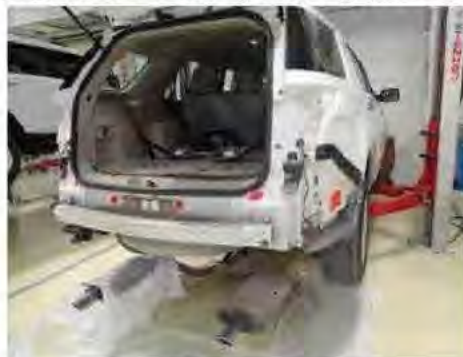
- a. Using masking tape, seal the rear air extractors and areas marked in red. Do not need to mask the rear lip molding for vehicle that do not have the rear lip molding removed (Figure 7-8)

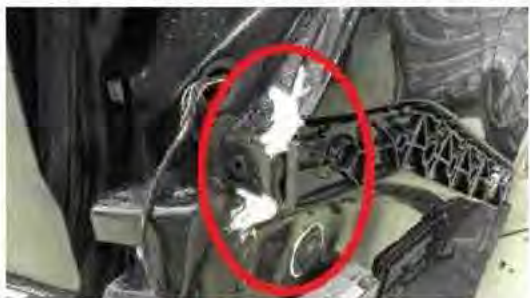
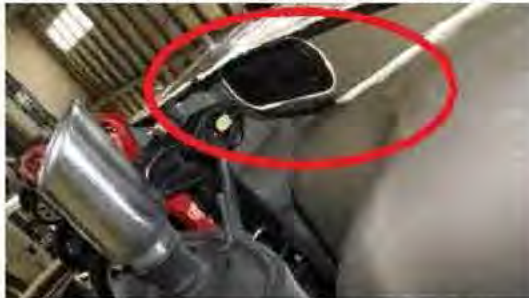
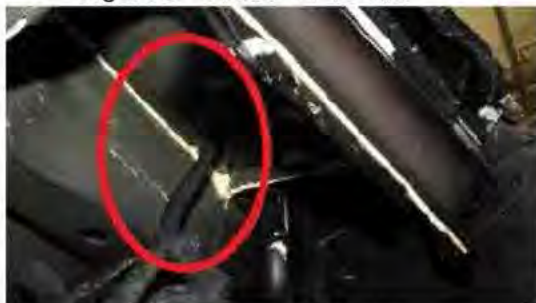
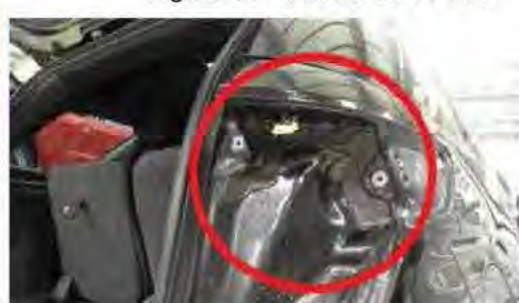
- b. Start vehicle, set A/C to fresh air mode and set blower speed to max.
- c. Close all doors and ensure windows are fully closed.
- d. Use soapy water in a spray bottle to help locate air leaks.
- e. Spray around the following areas:
 - ❖ Under body seams
 - ❖ Underbody rubber grommet (Figure 10)
 - ❖ Rear wheel well seams
 - ❖ Rear tail light seams
 - ❖ Rear deck lid seals
 - ❖ Side panel glass seals
 - ❖ License plate area
- f. Air leaks can be identified by the presence of air bubbles.
- g. Mark all areas identified to have air leaks. Common areas shown below. (Figure 9-12)

- h. Turn off A/C
- i. Turn off vehicle
- j. Clean and dry all areas marked earlier
- k. Seal using Motorcraft seam sealer
- l. Allow sealant to dry and retest (May take up to 20 minutes)
- m. Remove the masking tape used in step (a) of the pressure test

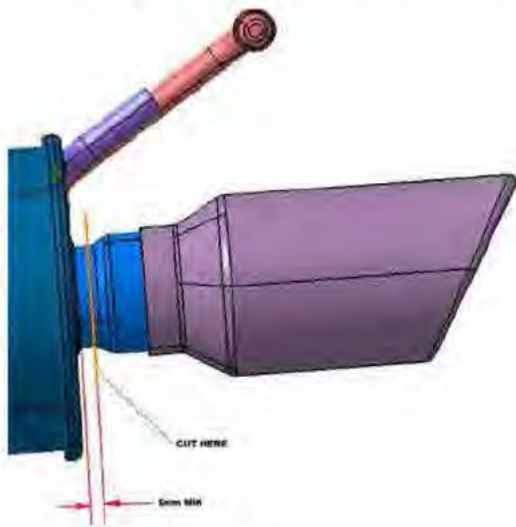
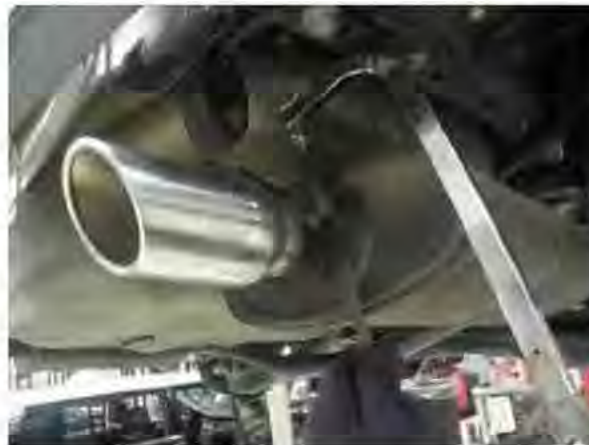
15. Using a suitable exhaust cutting tool, remove the existing tailpipe/tip 5mm (.19 inches) to the rear of the factory weld as shown. Be careful not to cut or damage the exhaust hanger bracket. (Figure 13-14)

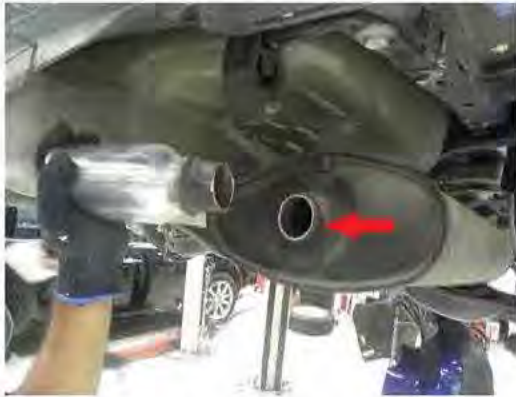
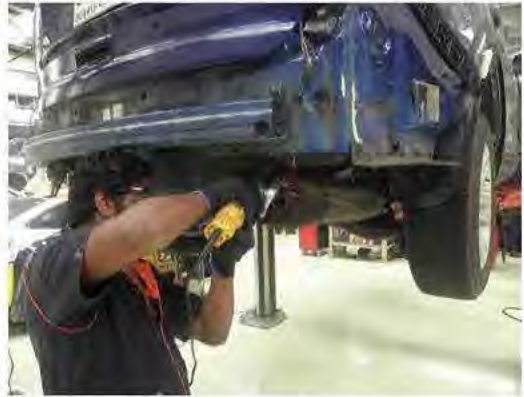
16. Remove the existing exhaust tip. Grind down enough of the original weld to remove the rest of the exhaust tip that was left over in the muffler. Remove any remaining sharp edges and/or burrs produced during the cutting process. (Figure 15-16).

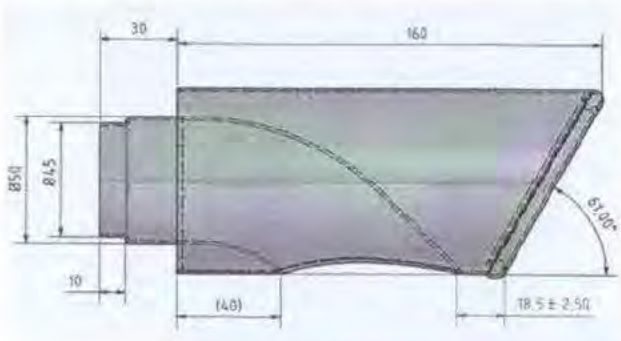
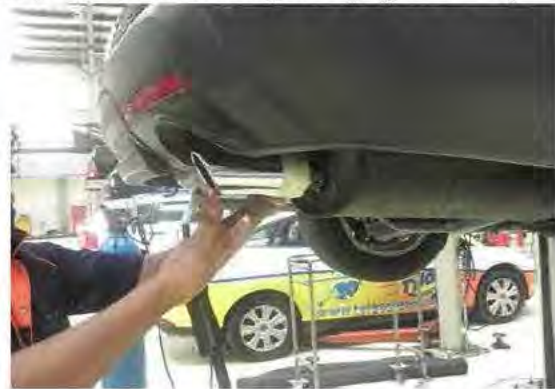
19. Install the new exhaust tip, butt up against the muffler, and tack weld into place. (Figure 17-18)

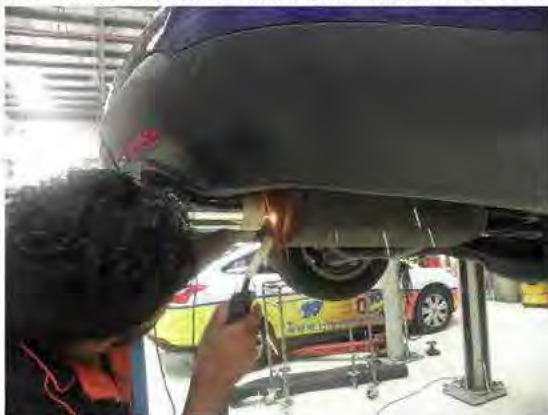
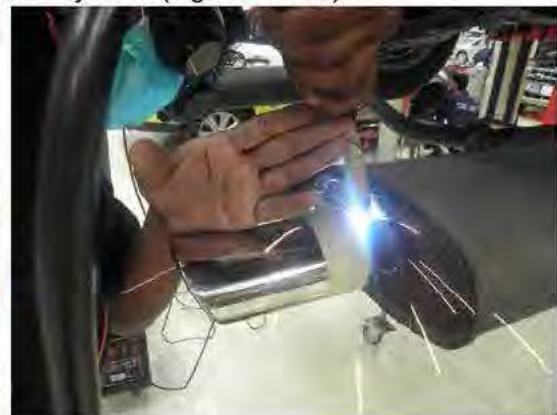
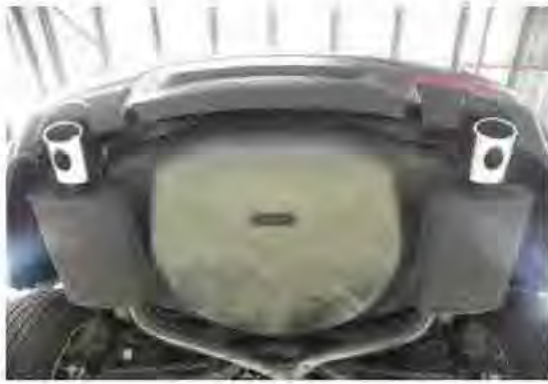
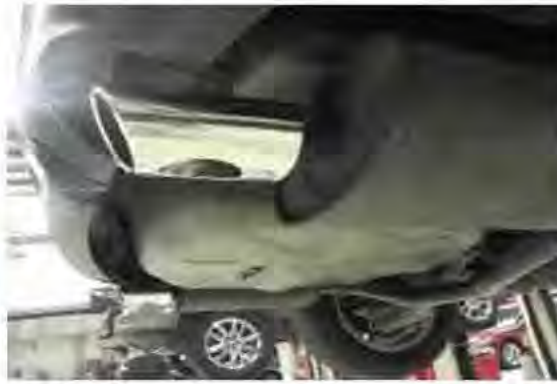
20. Once the tips are located properly, finish welding around the entire exhaust-tip joint, and grind smooth the weld. **NOTE:** It will be necessary to drop the exhaust hanger on each side to completely weld the entire diameter. Reinstall back the rear exhaust system. (Figures 19-22)

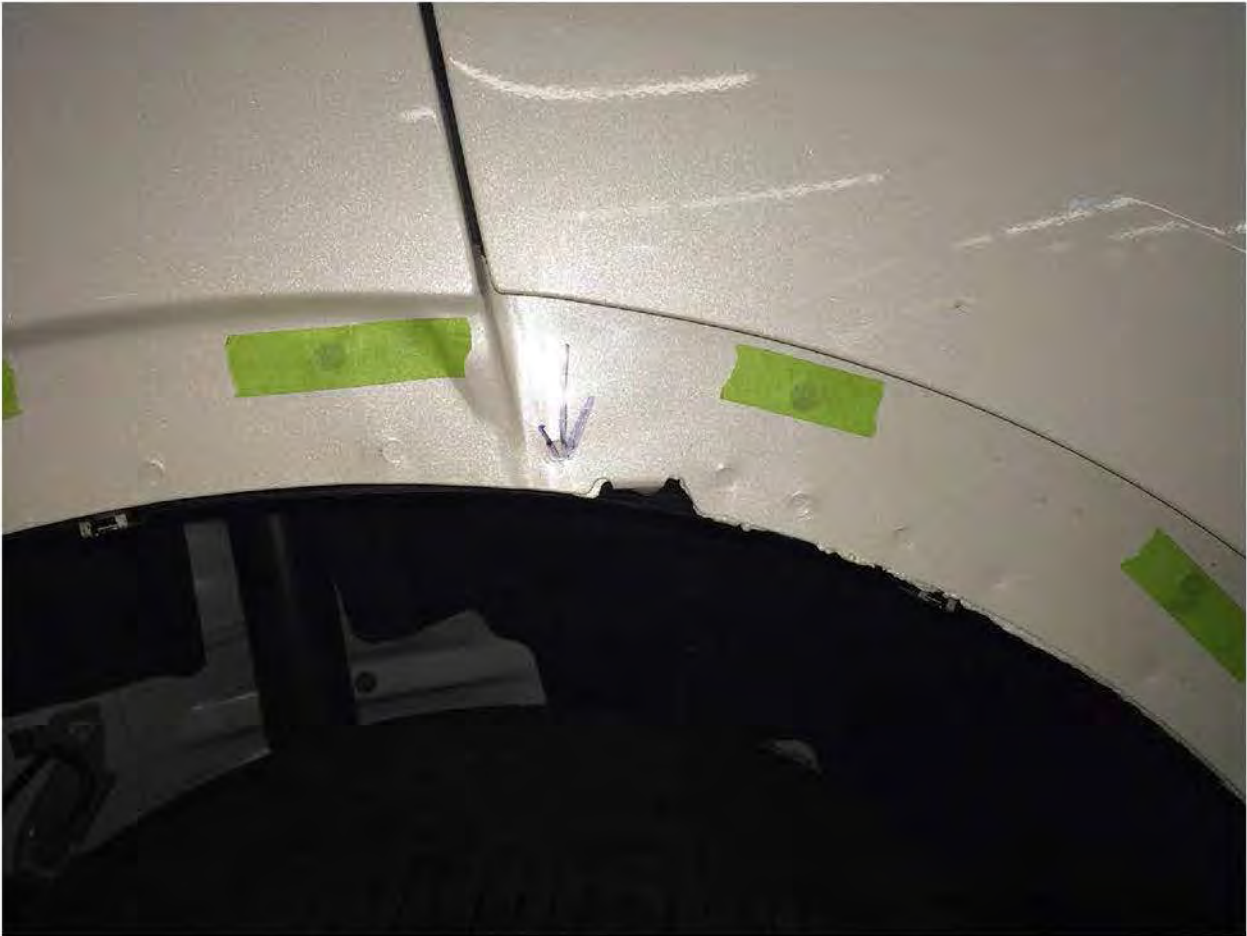
Sealant missing in
gap around various
spots of wheel arch

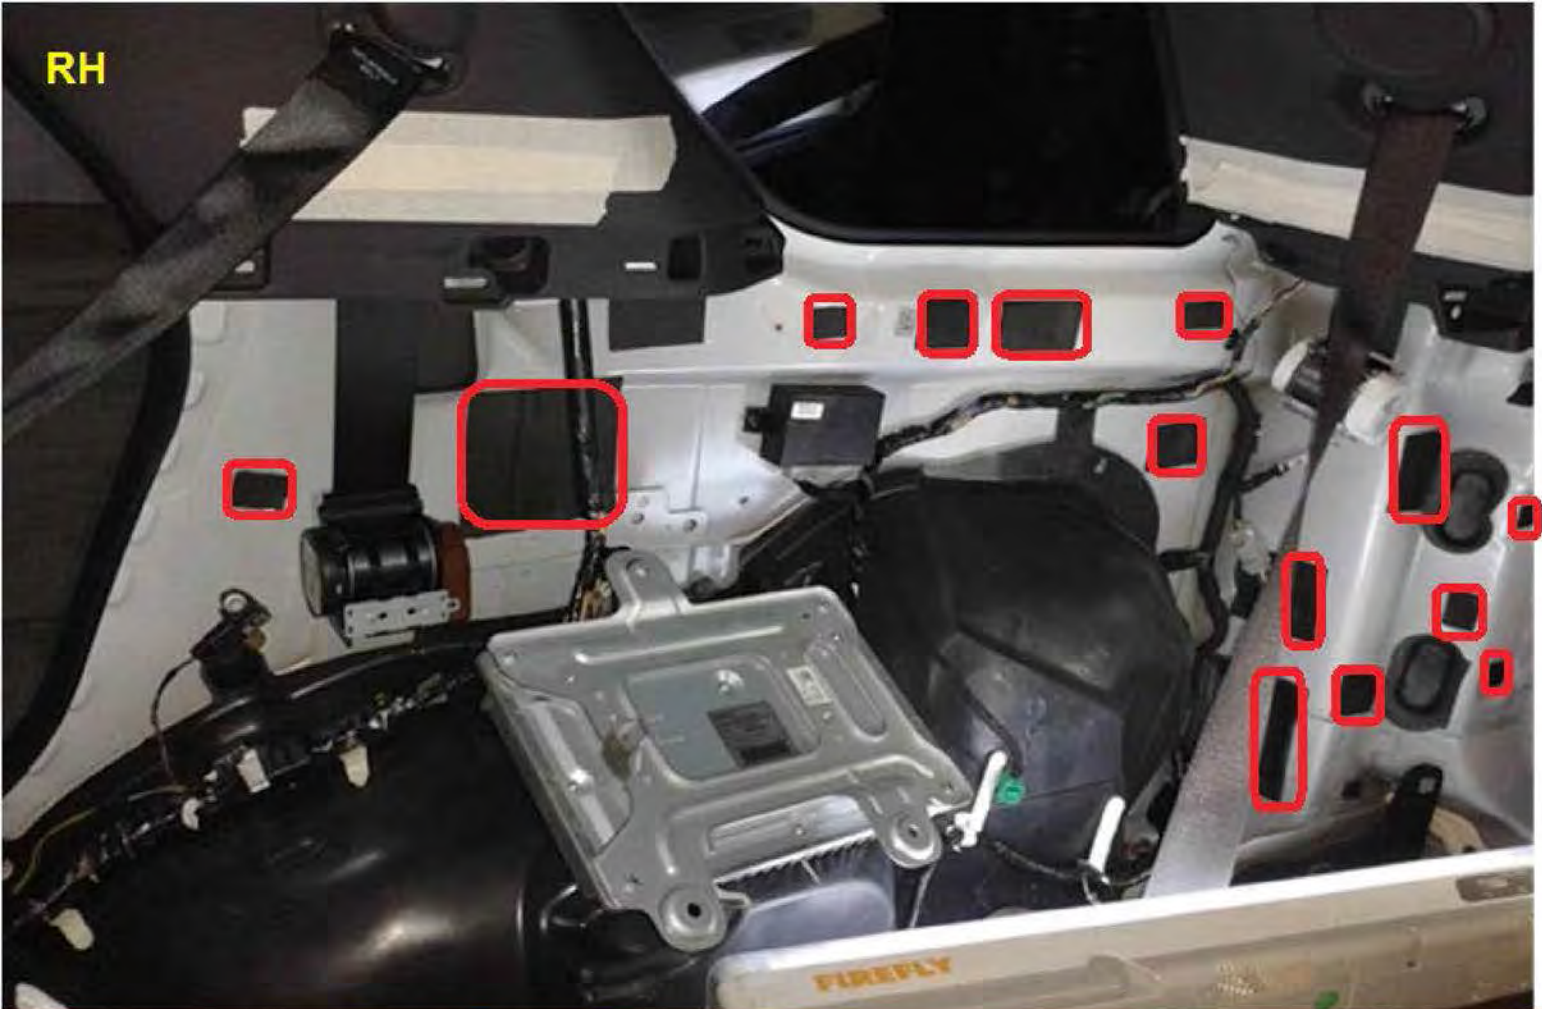
RH

- Remove the third row seat area interior quarter trim panel pieces. Using tape, proceed to tape over all body holes. Locating holes and push-pin holes can be covered but must be cut to allow penetration by the locating pin or push-pin. Gaffer's tape is recommended. It is not recommended to use electrical tape because the adhesion of this type of tape is not sufficient. Do not seal up air extractor holes. Photos attached.
