**Expert Report of  
Dr. Michael E. Cundy**

**[REDACTED] v Ford**

Prepared by:  
Michael E. Cundy, Ph.D., P.E.

December 14, 2015

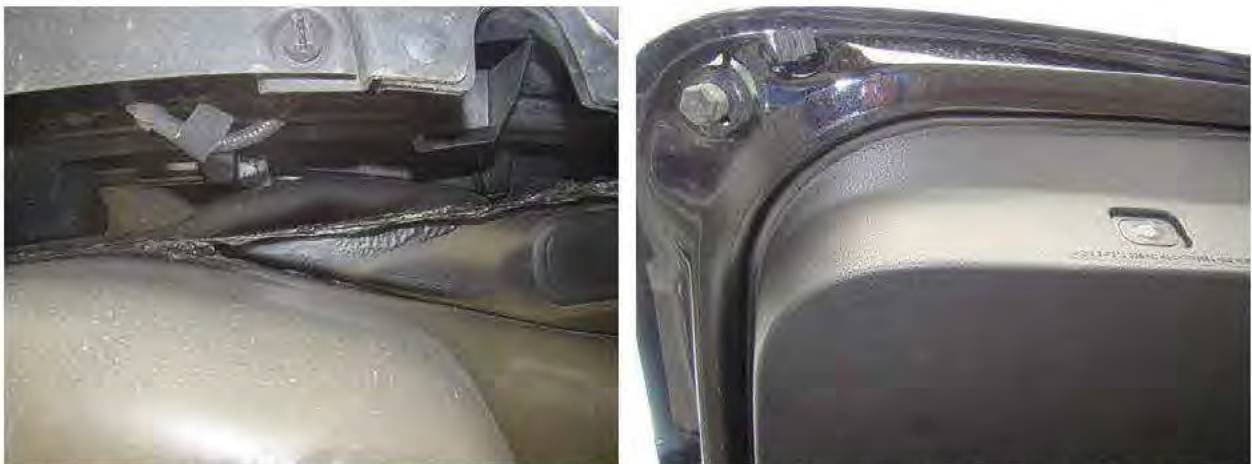
Figure 3. Underbody seam sealant and liftgate valve applied per TSB 14-0130 to 2014 Ford Explorer 3986.

It is noteworthy to mention again that, in addition to the HVAC reprogramming, valves were placed on the condensate drain holes (see Figure 3), an updated air extractor was installed (p/n BB53 B280B63 AB) on the left and right sides, and the rubberized undercoating and seam sealer was used in all locations specified in the TSB.

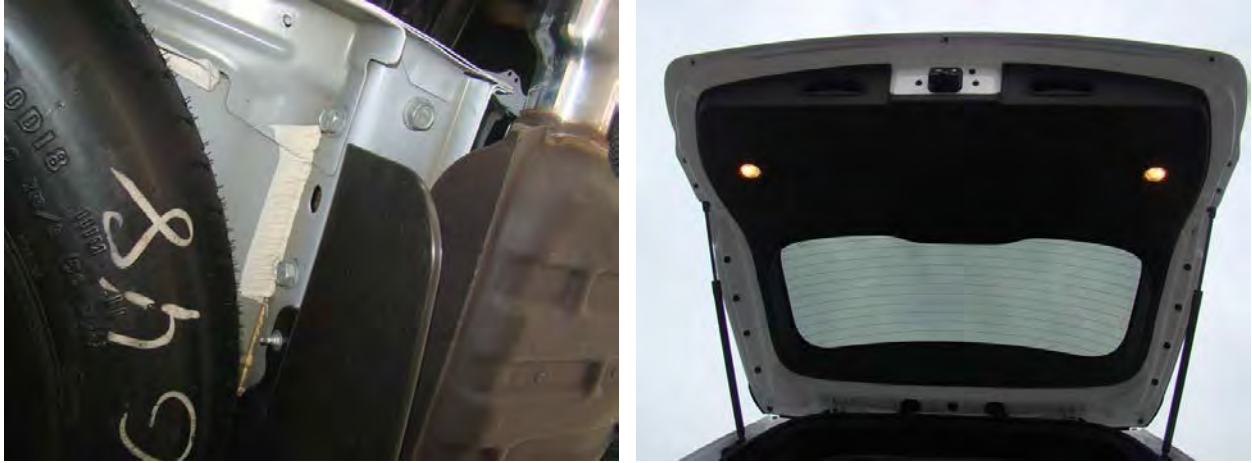
Figure 13. 2015 Dodge Durango [REDACTED]. Intermittent underbody sealant at left. Open drain holes on the left, middle, and right sides at the latch end of the liftgate (top of photo).

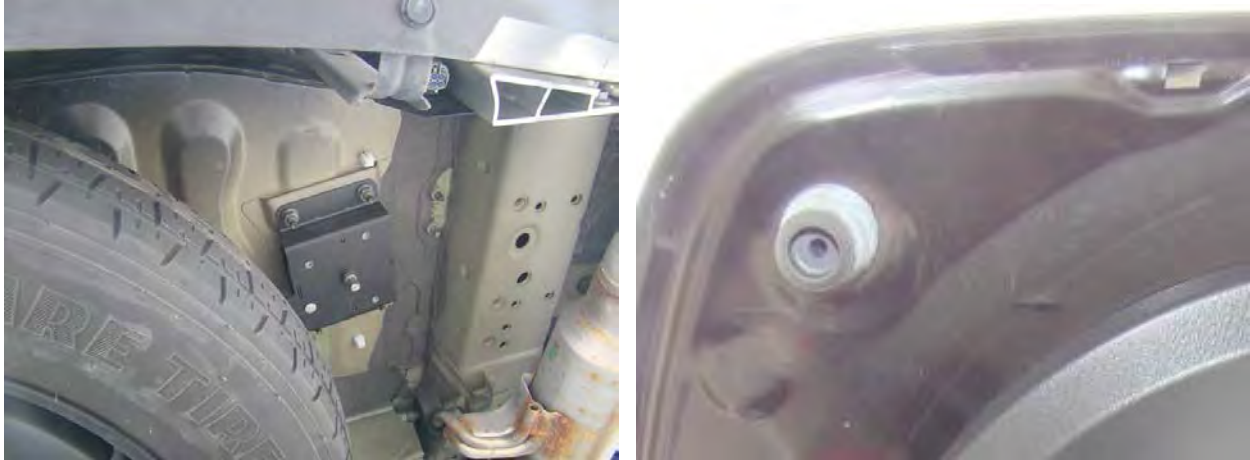
Figure 18. 2015 Nissan Pathfinder 0146. Intermittent underbody sealant at left. Open drain holes at the latch end of the liftgate (right photo, left side drain hole shown).

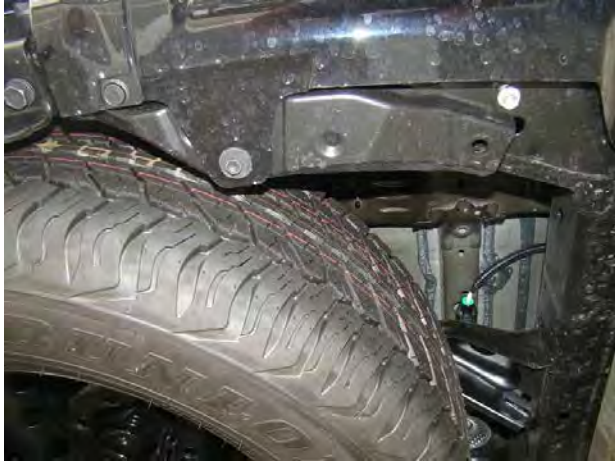
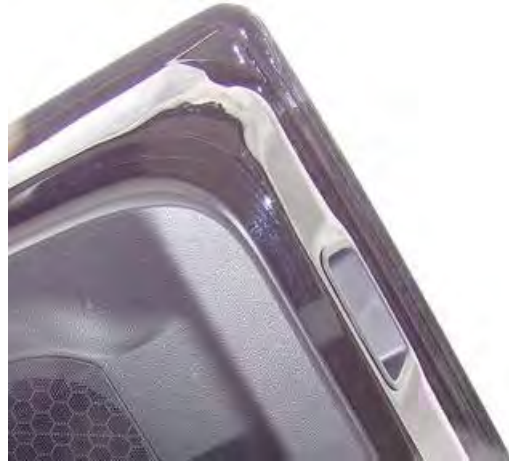
Figure 23. 2016 Toyota 4Runner [REDACTED]. Underbody sealant at left. Plugged drain holes on the left, middle, and right sides at the latch end of the liftgate (top of photo).

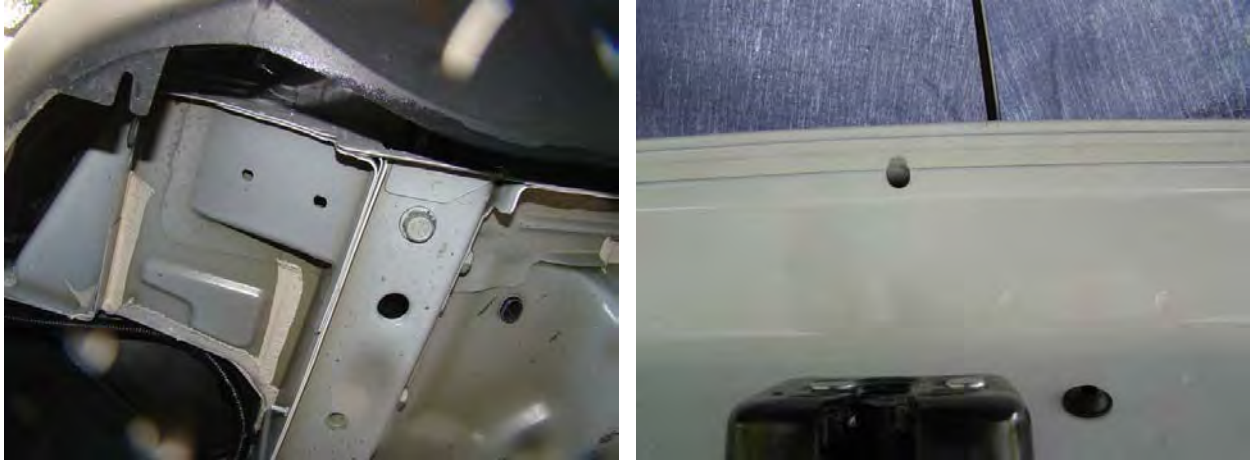
Figure 28. 2015 Jeep Grand Cherokee [REDACTED]. Intermittent underbody sealant at left. Open drain holes on the left, middle, and right sides at the latch end of the liftgate (top of photo).

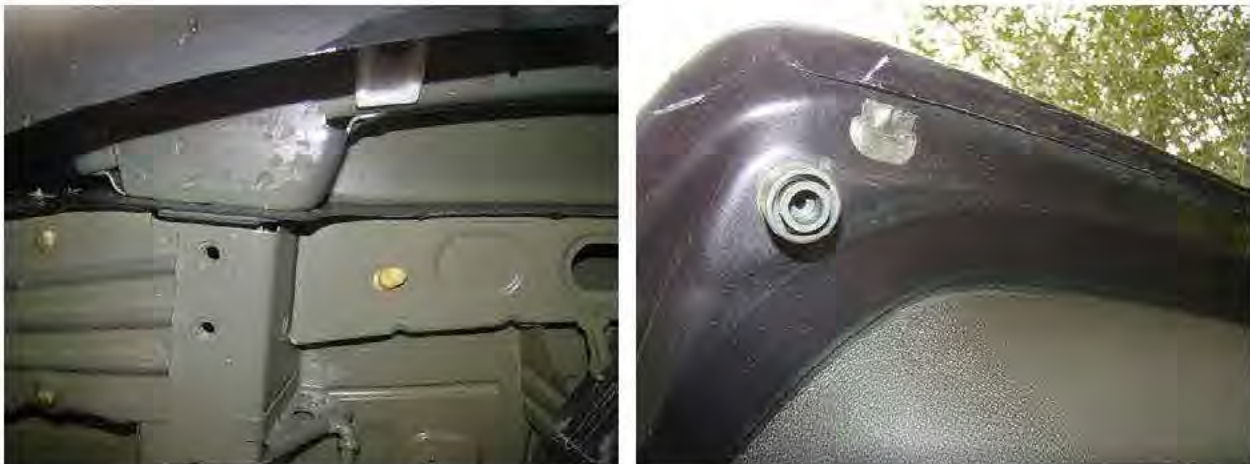
Figure 32. 2016 Chevy Traverse 2347. Intermittent underbody sealant at left. Plugged drain holes on the left, middle, and right sides at the latch end of the liftgate (top of photo).

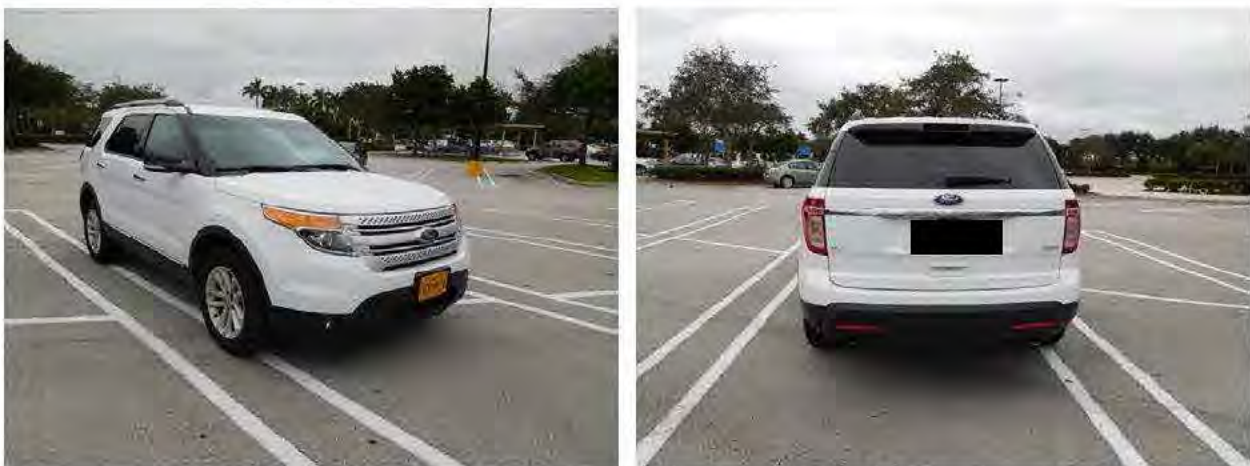
Figure 42. 2013 Ford Explorer XLT VIN 1FM5K8D85D [REDACTED].

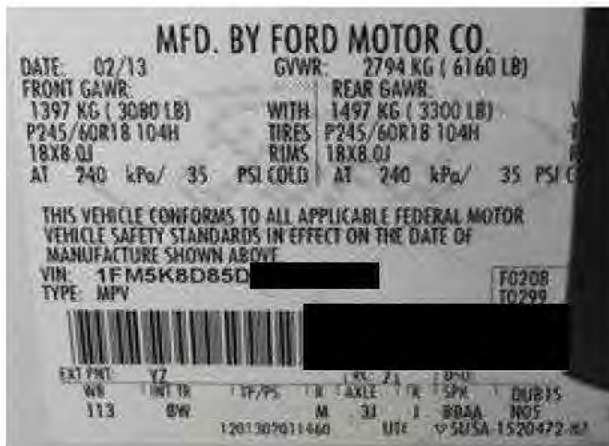
Figure 43. 2013 Ford Explorer [REDACTED] XLT VIN plate.

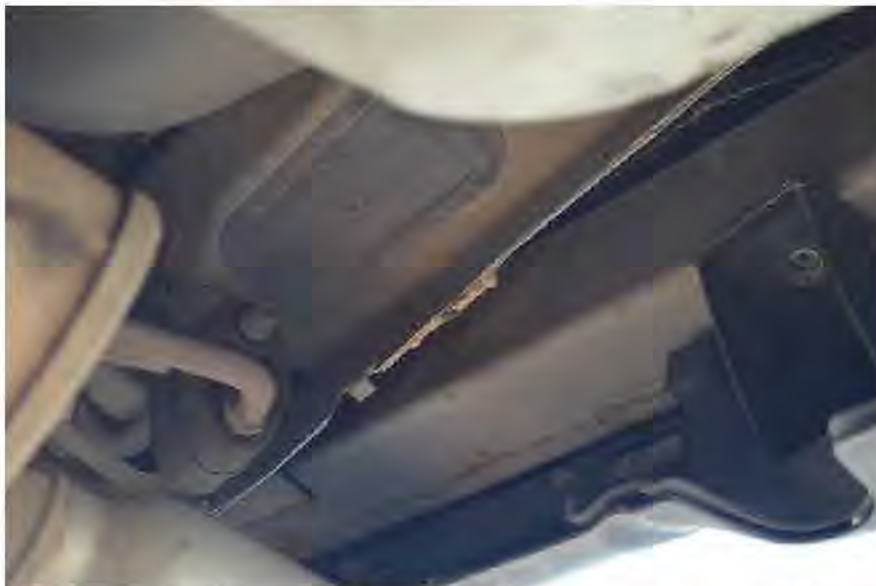
37 The 2013 Ford Explorer XLT with VIN 1FM5K8D85DG [REDACTED] had an odometer reading of 47,098.9 miles at the start of testing (Figure 42). The vehicle was equipped with a V6. It was visually in good operating condition. The Carfax report showed that the vehicle had been involved in a rear end collision with minor damage. No diagnostic trouble codes (DTCs) were found. There were no warranty records associated with odors or the exhaust system in this vehicle. No sealant was observed on the underbody seams forward of the rear bumper (Figure 44).

Figure 44. 2013 Ford Explorer [REDACTED] lack of underbody sealing.

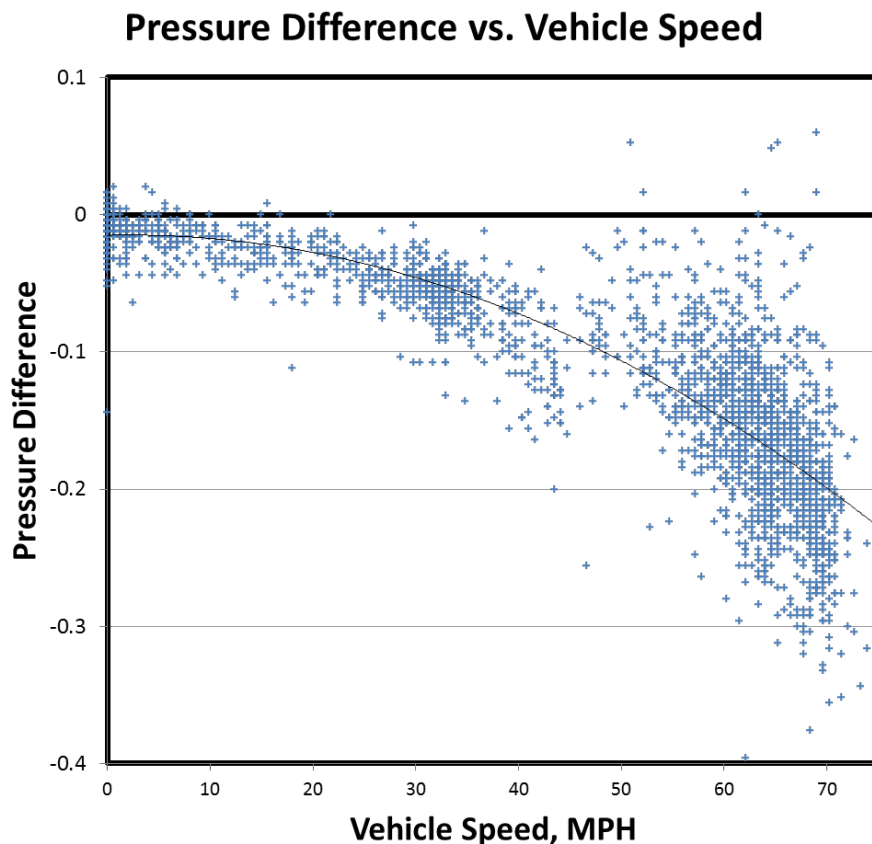
Figure 47 shows a plot of the pressure difference as a function of vehicle speed for the [REDACTED] 2013 Ford Explorer (test ID4). On average, the negative pressure is shown to become greater with increasing vehicle speed. Additional data for all of the tests illustrating this phenomenon can be seen in Appendix C.

The variability in the measurement, which includes some positive pressure readings indicating that the cabin pressure was higher at times, indicates that the wake region behind the vehicles is highly turbulent. This is true of both Explorers and each of the peer SUVs that were tested. Turbulence is characterized using a mean value and a fluctuating component. Given the highly turbulent nature of the flow behind moving vehicles, it is desirable to electronically measure the flow characteristic of interest (pressure difference, in this case) at a suitable sampling rate in order to understand the mean value and fluctuating component. If an improper pressure gage or measurement method is used, then the pressure outside the liftgate, including whether it is positive or negative, cannot be adequately analyzed. Dr. Renfroe’s complete failure to measure negative pressures on any of the peer vehicles he tested is a reflection of an inadequate measurement methodology.

For the [REDACTED] 2013 Ford Explorer test (ID4) in Figure 47, at 70 mph, the average pressure difference appears to be approximately -0.2 inches of H<sub>2</sub>O (in H<sub>2</sub>O), and the bulk of the measurements fall between -0.1 and -0.3 in H<sub>2</sub>O.

Figure 47: Plot showing the pressure difference between the vehicle cabin and the exterior rear hatch area as a function of vehicle speed in the [REDACTED] Ford Explorer 1363 (test ID4).

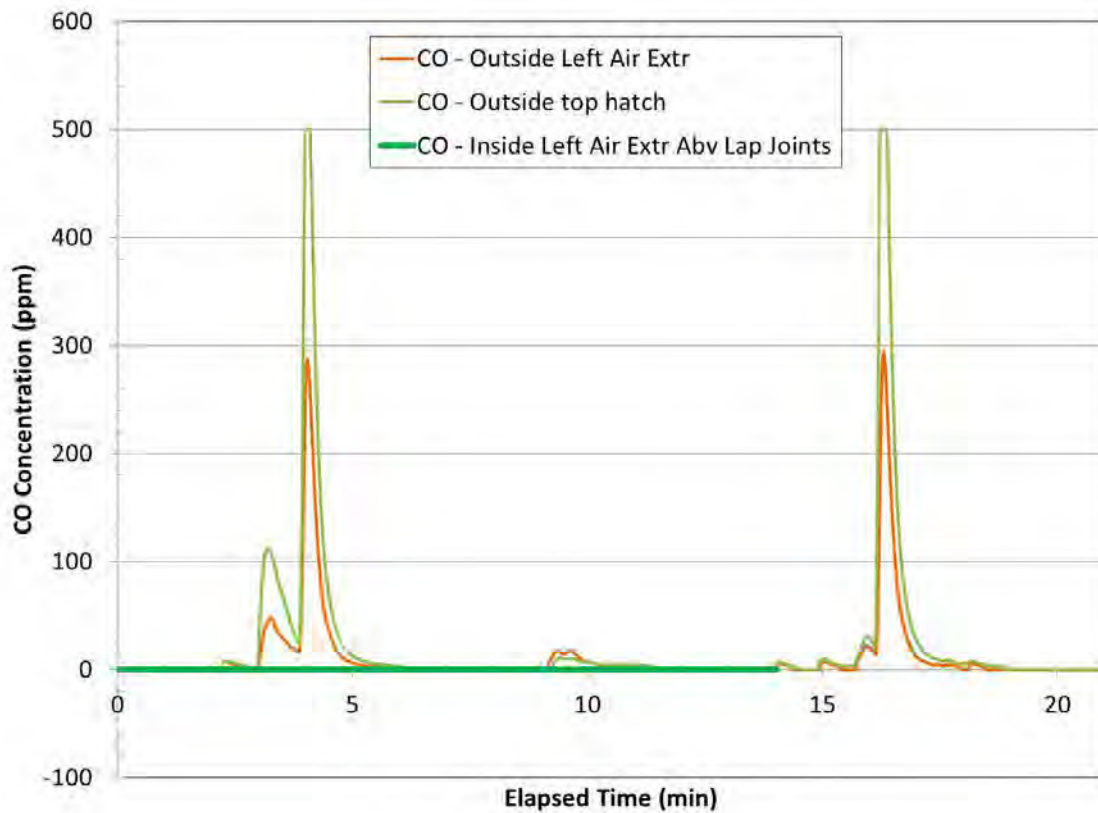
The CO concentrations measured from the locations on the outside of the passenger cabin were plotted against the CO concentrations measured on the inside side of the driver's air extractor (which is also in the area above the underbody lap joints that are sealed on this vehicle; see Figure 52). Although the CO concentration reached 286 ppm outside of the air extractor, zero CO was measured inches away on the interior side of the left air extractor.<sup>8</sup>

Figure 52: Comparison of CO concentrations measured on the outside of the left air extractor, and on the inside of the same air extractor, which is also the area above the underbody lap joints which are sealed in the TSB. CO levels just inside the driver’s side air extractor were below the detection limits. Complaint 2014 Ford Explorer [REDACTED].

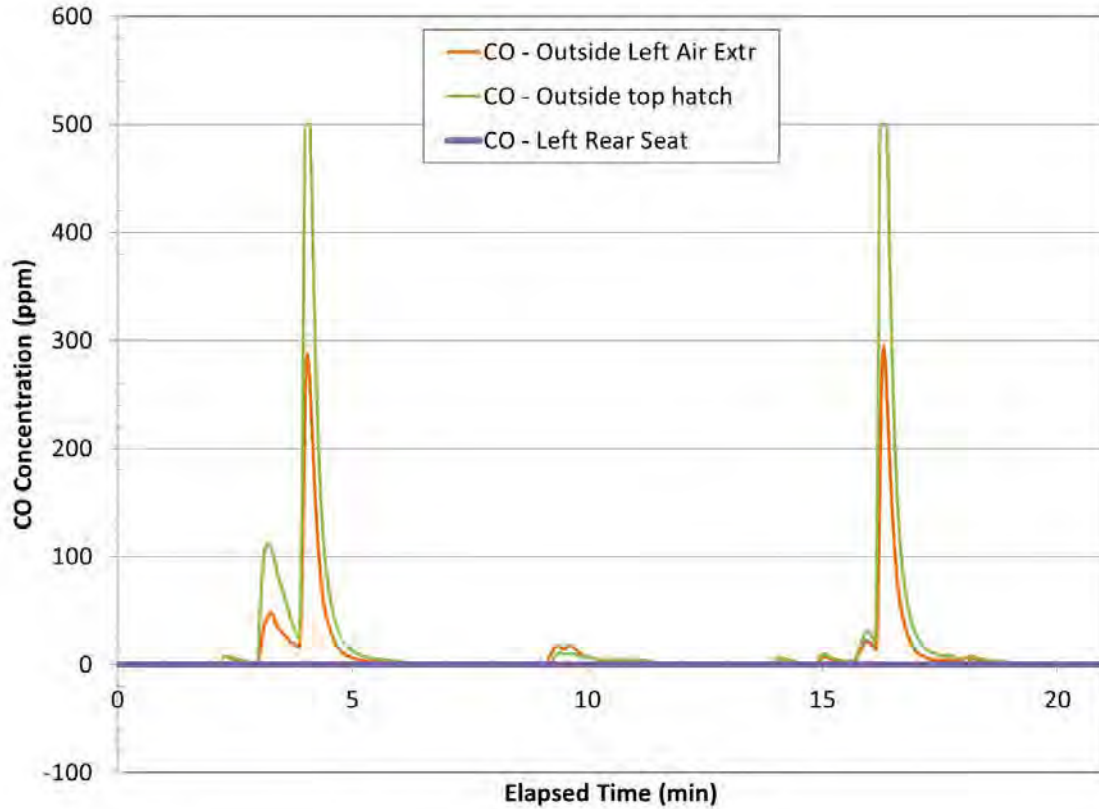
The exterior two CO concentration profiles are then plotted against the CO concentration measured at the left rear seat location (see Figure 53). Again, the CO concentrations at the rear seat was below the level of detection.

Figure 53: Comparison of CO concentrations measured on the outside of the left air extractor, and in the area of the left rear seat headrest. Zero CO is measured. Complaint 2014 Ford Explorer [REDACTED].

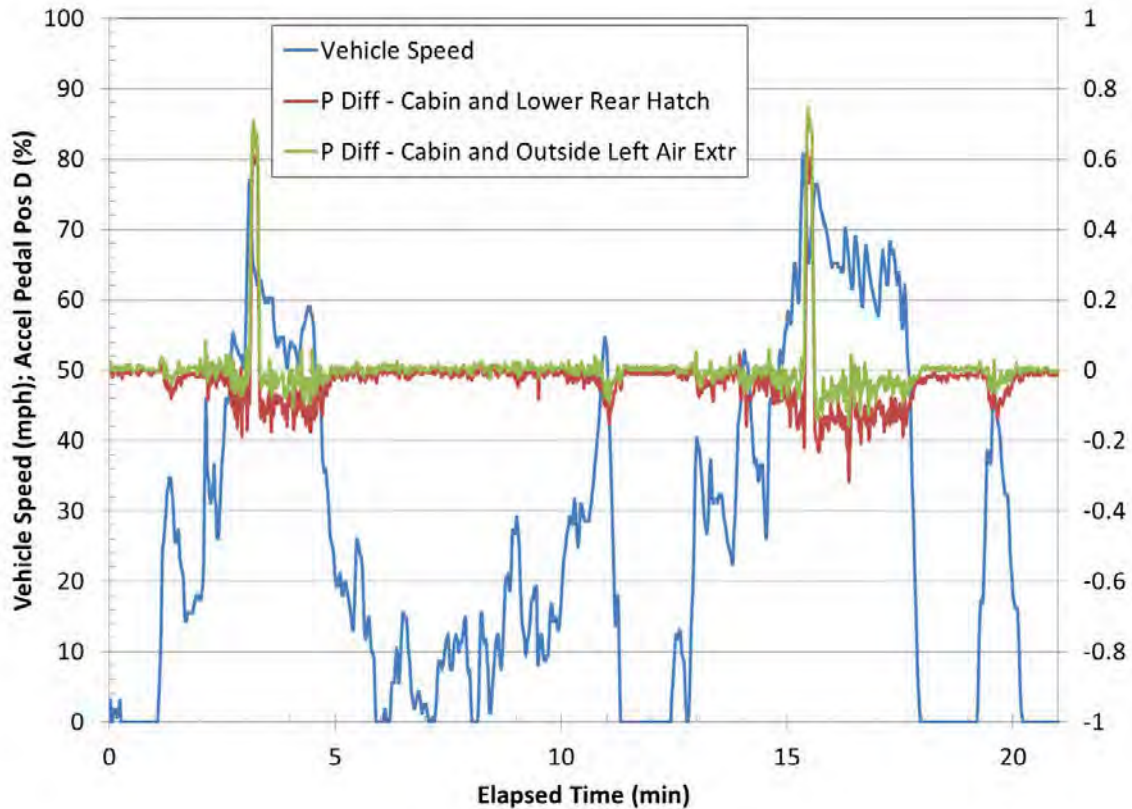
A plot showing the vehicle speed along with pressure differential between the cabin and the lower center outside of the rear hatch, and pressure differential between the cabin and the outside of the left air extractor is shown in Figure 54. Both pressure traces show positive pressure after the two higher speed WOT events, which is consistent with the reprogrammed HVAC module autonomously switching from recirculation mode to fresh air mode. The pressure difference between the cabin and outside of the left air extractor is less than the pressure difference between the cabin and lower rear hatch area.

Figure 54: Plot showing the vehicle speed and pressure differential between the cabin and the lower center outside of the rear hatch, and pressure differential between the cabin and the outside of the left air extractor. Complaint 2014 Ford Explorer [REDACTED].

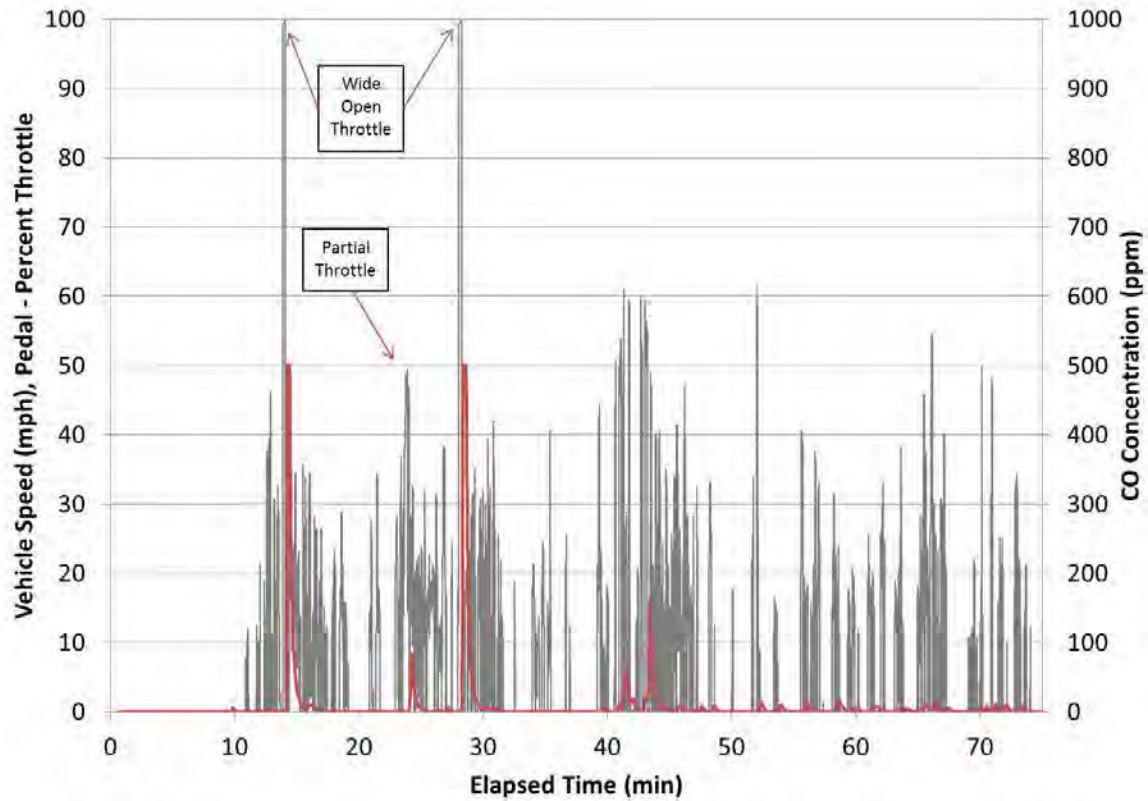
Figure 59 shows a plot with the accelerator pedal position D, along with the CO concentration measured outside of the vehicle near the top of the hatch. The elevated CO concentration peaks correlate with WOT events, with some time lag as discussed before. As with the Complaint 2014 Ford Explorer, the CO concentration outside the vehicle at the top hatch reached above the 500 ppm measurement range of the instrument in this area. For the 50% pedal depression event, a CO peak of only 83 ppm was recorded in the outside top hatch region.

Figure 59: Plot showing the accelerator pedal position with the outside top hatch CO concentration measurements.

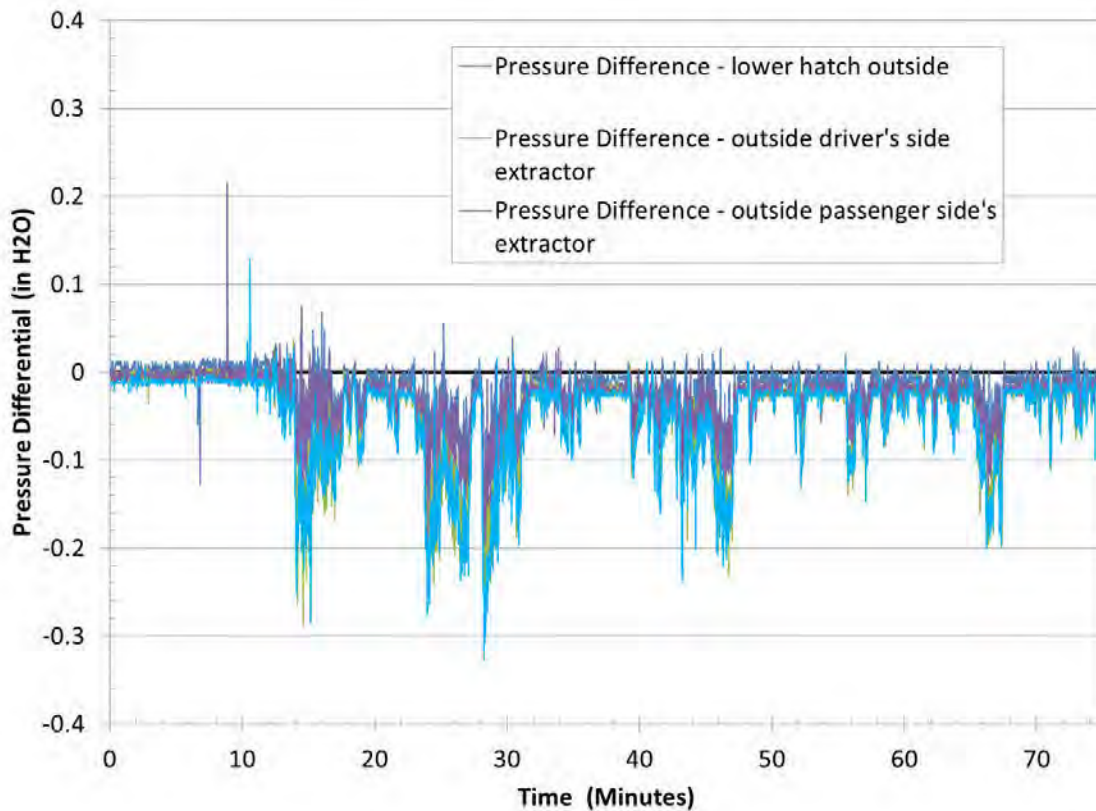
The pressure differentials between the hatch cargo area and four different locations were measured, and are shown in Figure 61. The HVAC system on this vehicle does not evidence the blend door opening associated with WOT that is part of TSB 14-0130 actions. This vehicle does not manifest that control logic.

Figure 61: Pressure differential between the rear cargo area and four different locations outside the vehicle; the outside lower hatch, outside top hatch, outside left air extractor, and outside right air extractor.

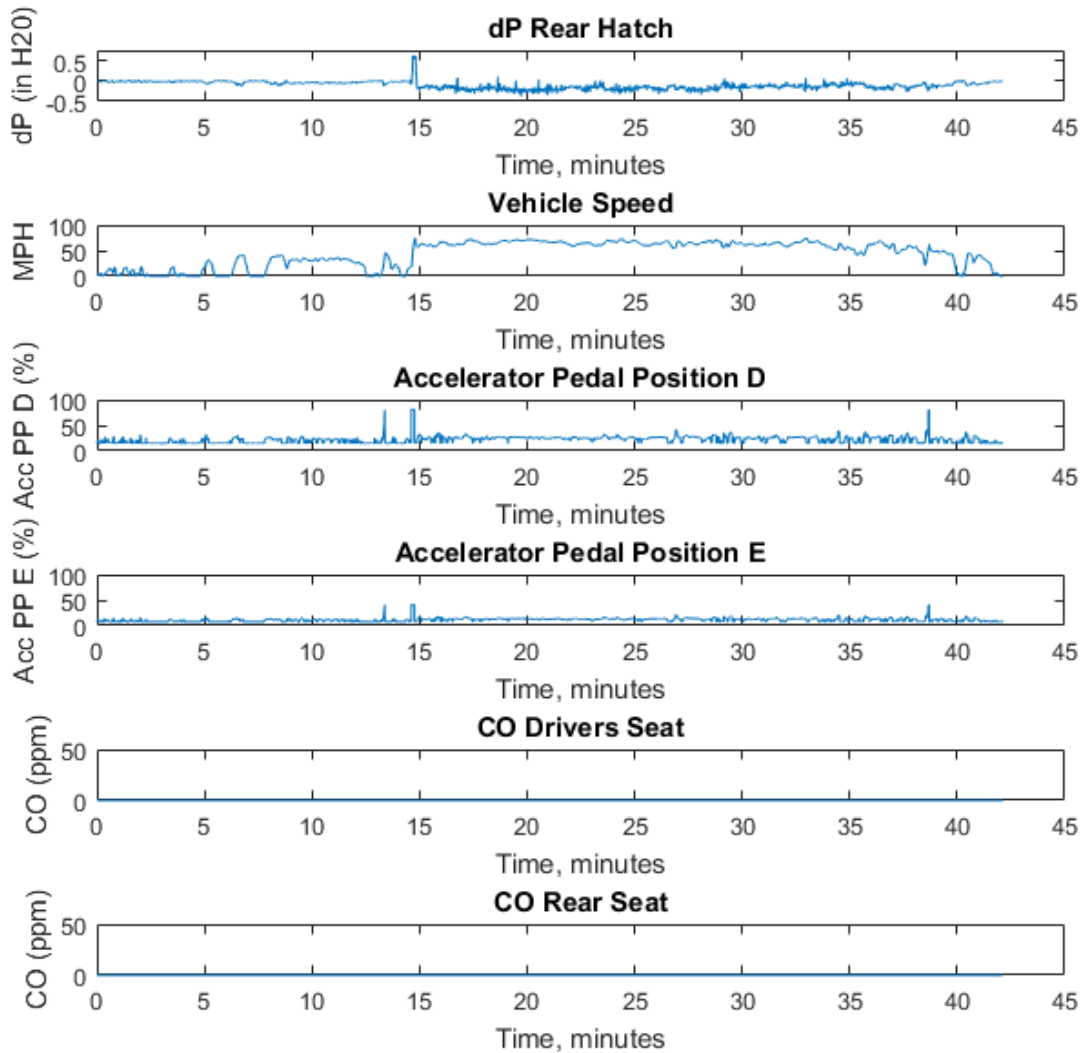
The data captured for test ID3 can be seen in Figure 69. This data was captured simultaneously with test ID4. An odor was detected after WOT on-ramp application. Odor dissipated after approximately 7 seconds.

Figure 69: Complaint 2014 Ford Explorer 3986 test ID3 data.

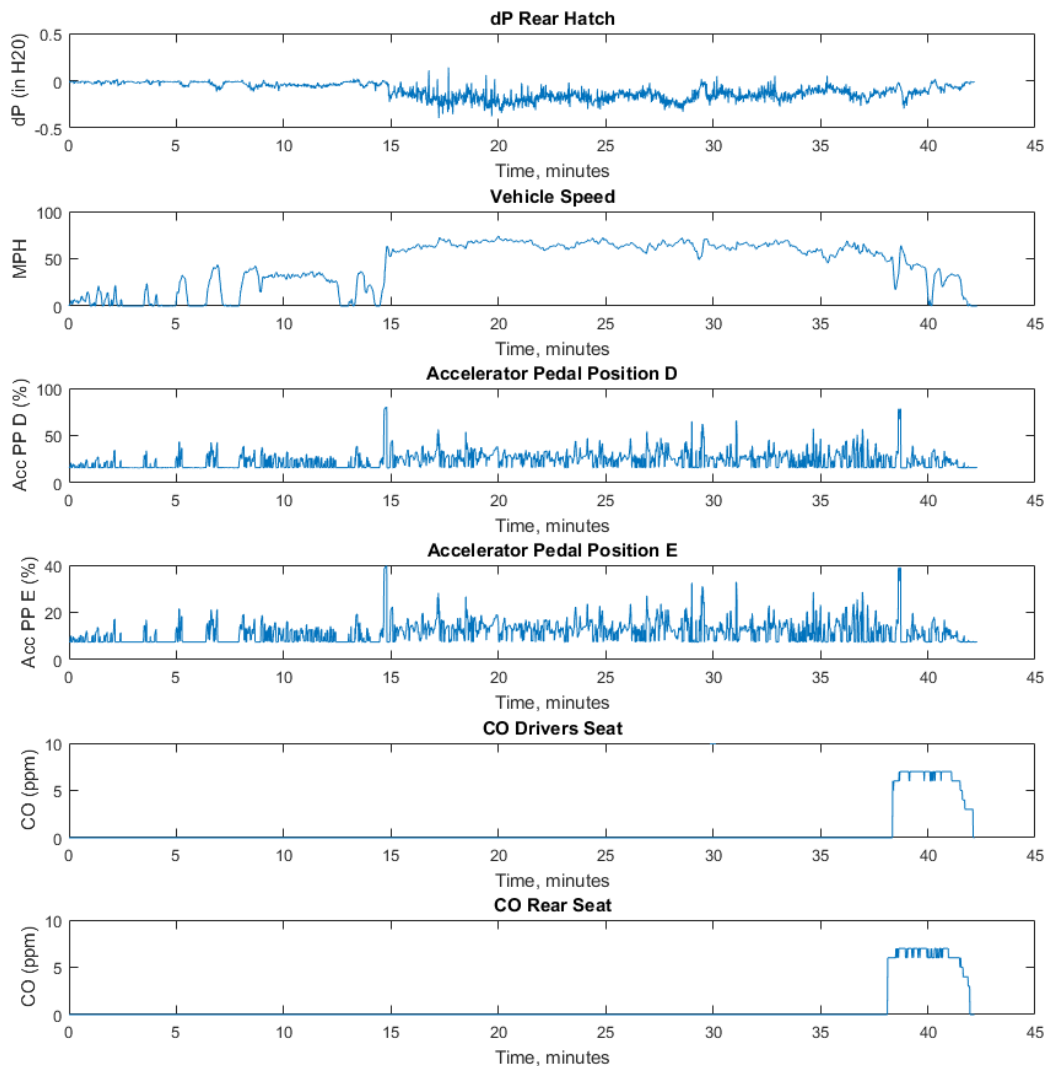
The data captured for test ID4 can be seen in Figure 70. This data was captured simultaneously with test ID3. An odor was detected on three occasions during the test drive. The first odor was detected after the WOT on the onramp to the freeway, and it dissipated after a few minutes. The second odor was experienced in heavy traffic on the freeway. An odor was simultaneously detected by another test engineer nearby on the route, suggesting that the odor could have been associated with other vehicles. An odor was also detected after a WOT on 30<sup>th</sup> Ave., which was faint compared to the first detected odor.

Figure 70: Dixon 2013 Ford Explorer 1363 test ID4 data.

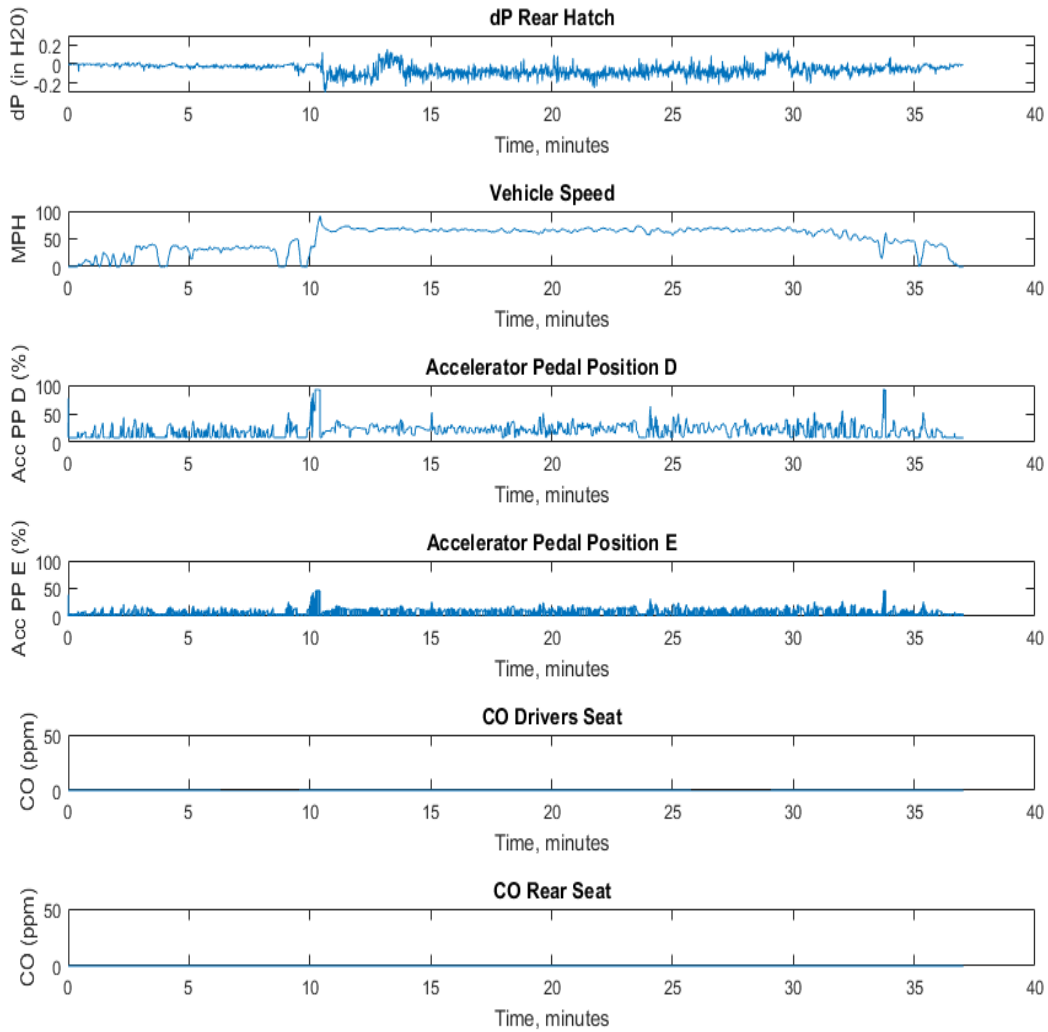
The data captured for test ID9 can be seen in Figure 74. Test ID10 and ID11 were tested simultaneously. CO was registered on the gas monitors prior to the test drive with vehicles idling.

Figure 74: 2015 Jeep Grand Cherokee 6213 test ID9 data.

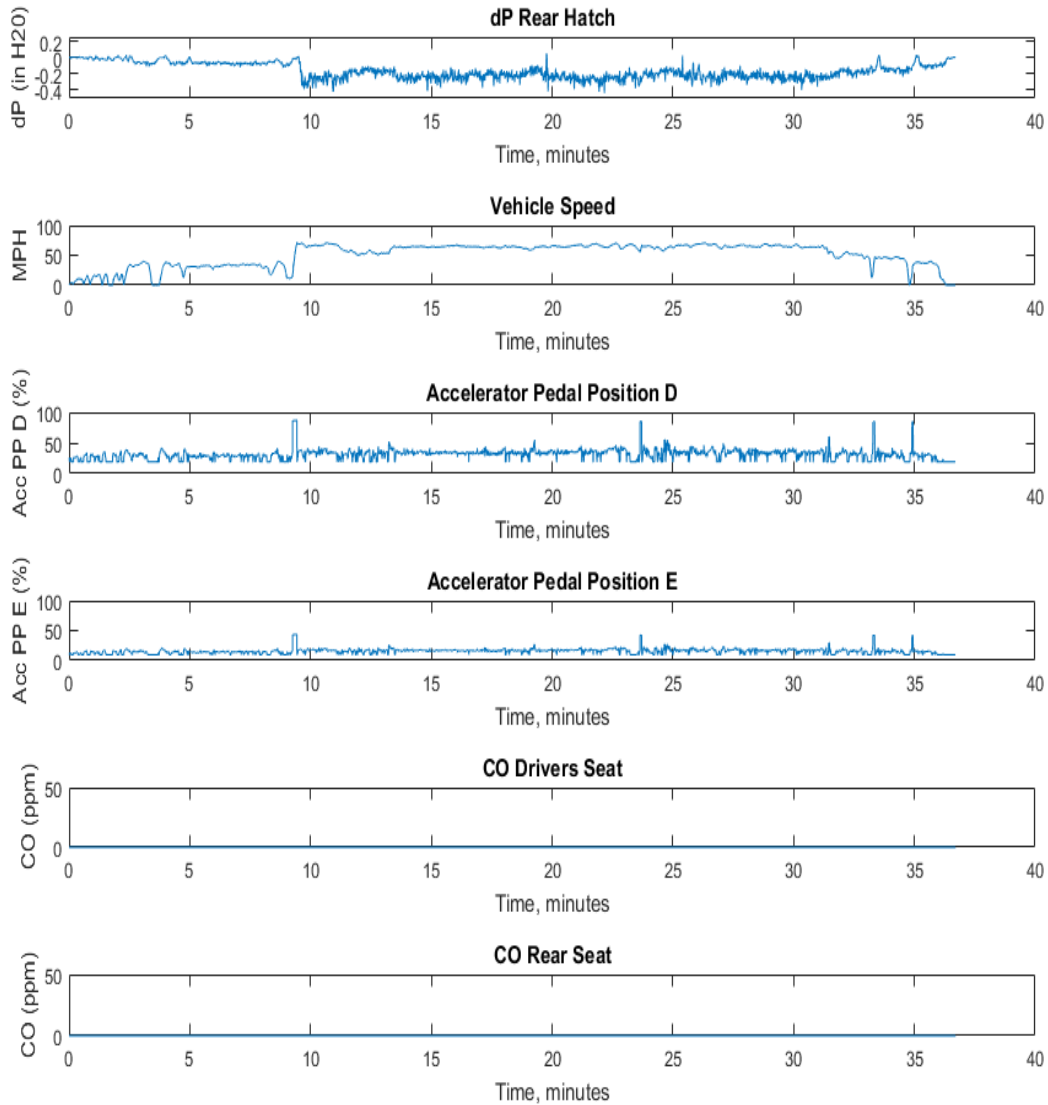
The data captured for test ID10 can be seen in Figure 75. Test ID9 and ID11 were tested simultaneously. An exhaust odor was observed at the conclusion of a WOT on the onramp to the freeway for approximately 10-15 seconds, at which point it dissipated.

Figure 75: 2016 Chevrolet Traverse 2347 test ID10 data.

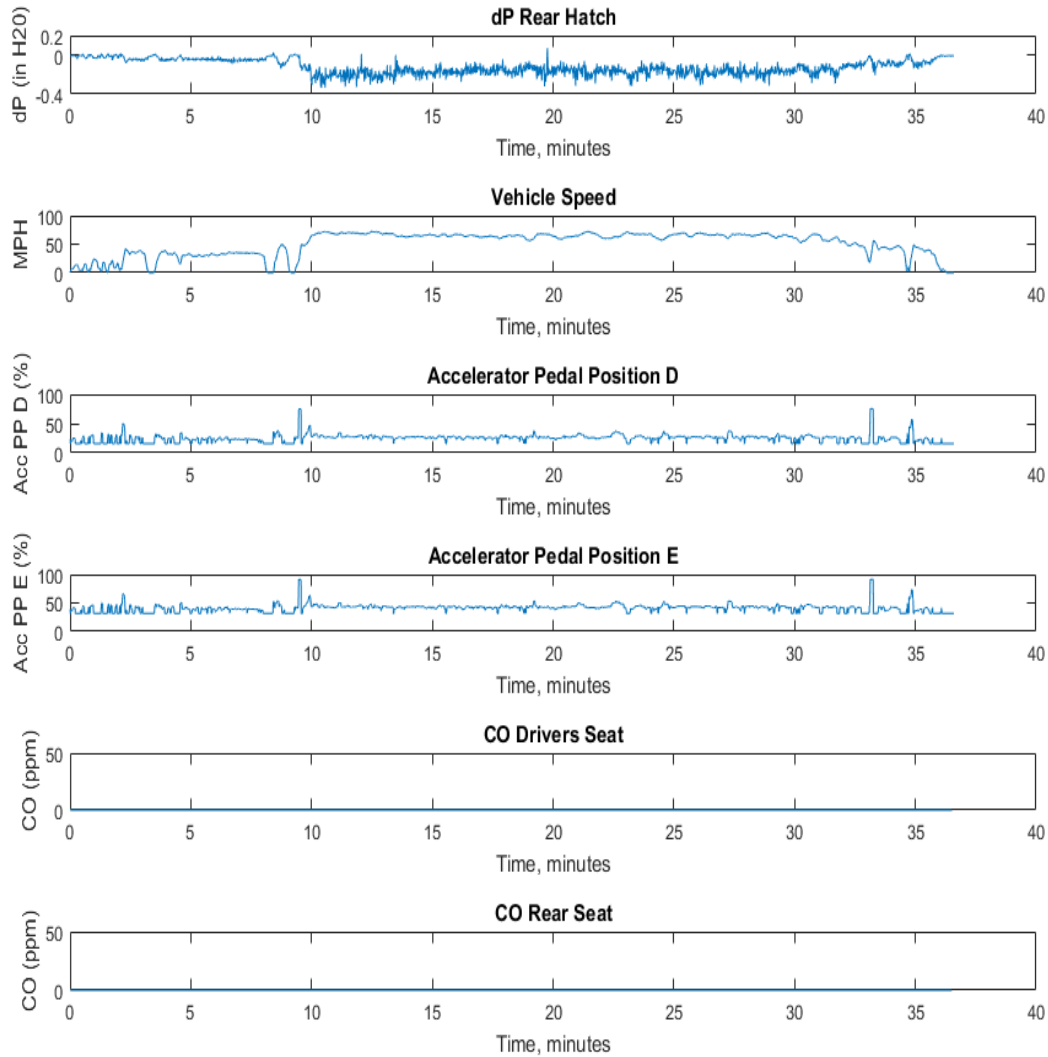
The data captured for test ID11 can be seen in Figure 76. Test ID9 and ID11 were tested simultaneously. An exhaust odor was observed at the conclusion of a WOT on the onramp to the freeway. Also, CO was detected just outside of the left rear door prior to the start of the test, while the vehicle was idling.

Figure 76: 2014 Toyota Highlander 6397 test ID11 data.

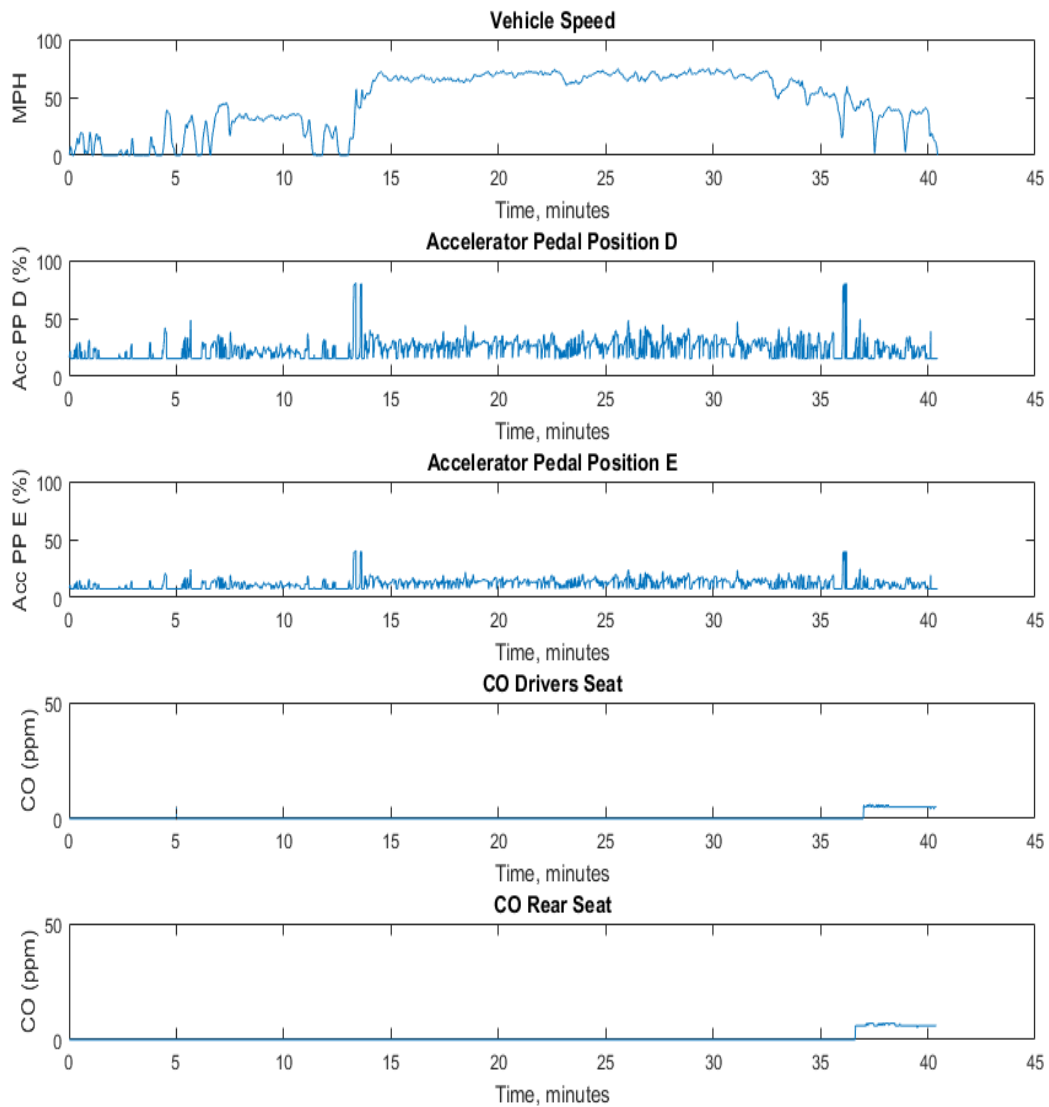
The data captured for test ID14 can be seen in Figure 79. Test ID15 was tested simultaneously. An exhaust odor was observed at the conclusion of a WOT on the onramp to the freeway, which was detected at approximately the same time by the ID15 test engineer. A Diesel truck was ahead of both test vehicles, so it was possible that the exhaust from that vehicle is what the test engineers had smelled (see Figure 80). Even when vehicles are set to “Max AC” mode, with recirculation, some systems are designed to allow outside air into the vehicle.<sup>10</sup> A fog test was performed on an Explorer to confirm that these vehicles do let fresh air in when in recirculation mode. A test was run with windows rolled up, the vehicle in Max AC mode, and fog was directed towards the fresh air inlets at the base of the front windshield, and fog entered the cabin through the vents.

Note that the pressure sensor did not appear to function properly during this test.

Figure 79: 2015 Ford Explorer 9474 test ID14 data.

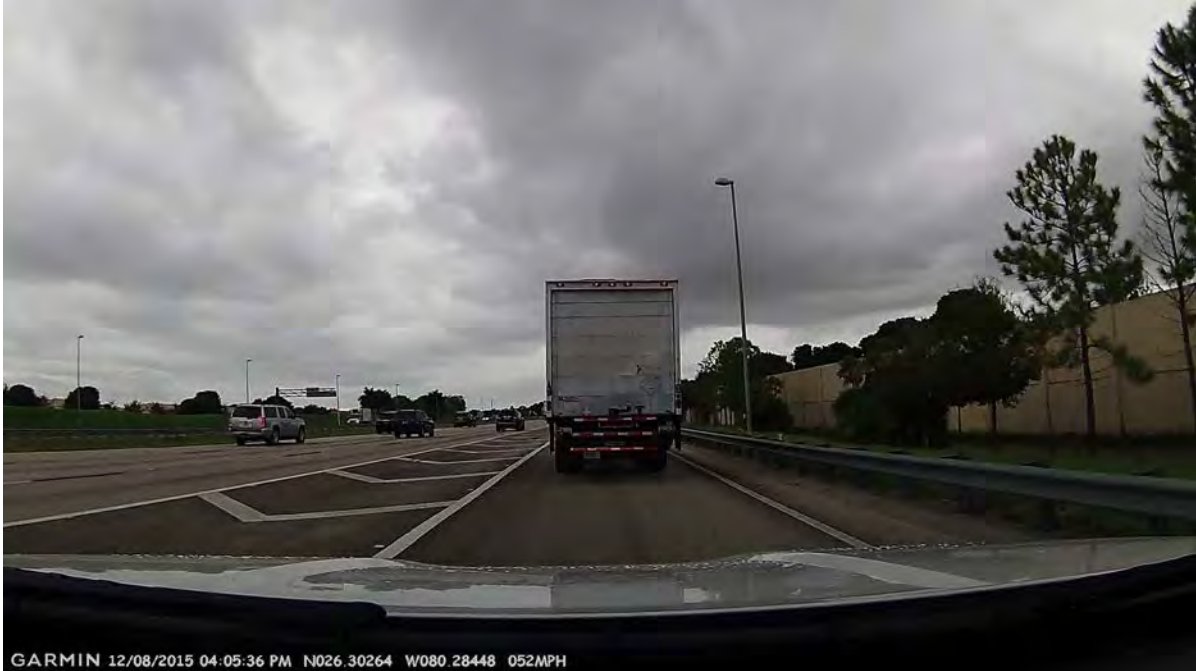
Figure 80: Video screenshot showing the truck on the onramp ahead of the ID14 test vehicle after the WOT.

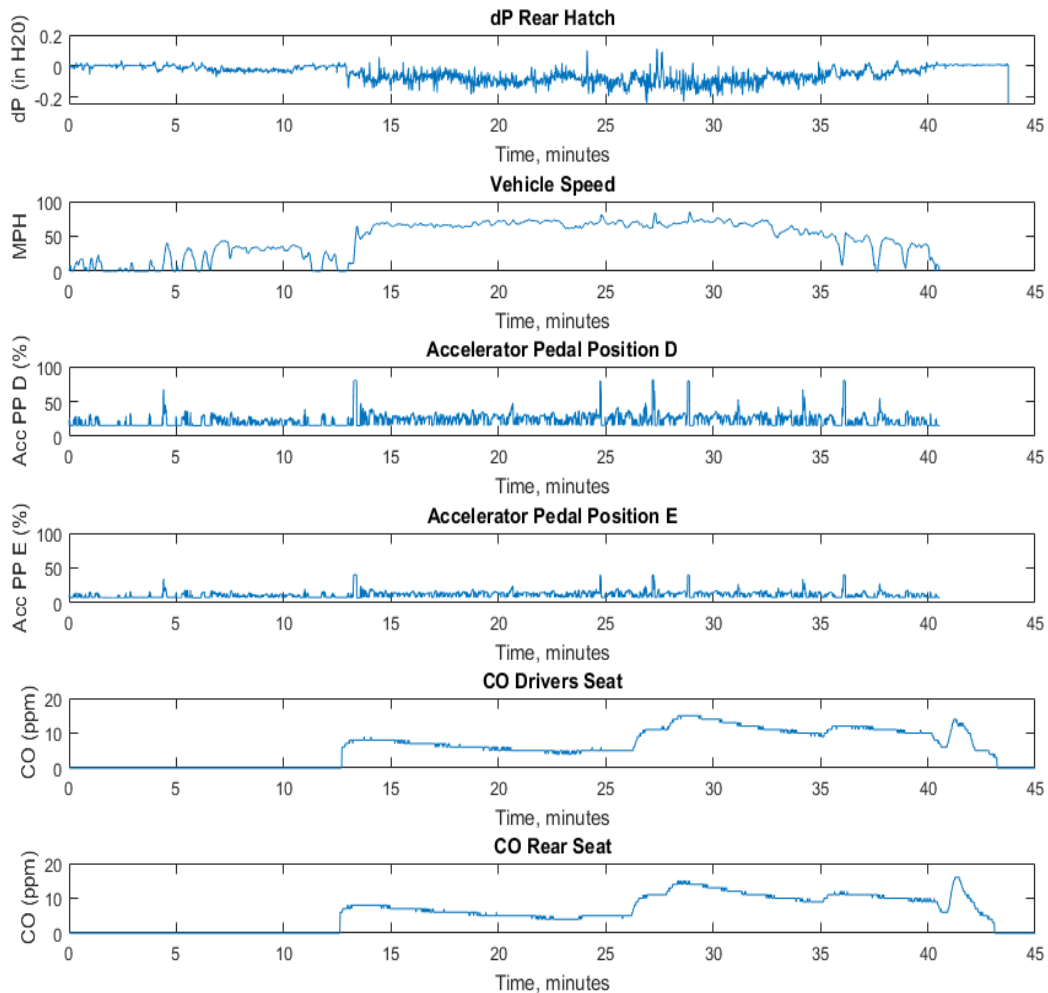
The data captured for test ID15 can be seen in Figure 81. Test ID14 was tested simultaneously. An exhaust odor was observed at the conclusion of a WOT on the onramp to the freeway, which was detected simultaneously by the ID14 test engineer as described before. A Diesel truck was nearby, so it was unclear if the exhaust from that vehicle is what the test engineers had smelled. Alternatively, it is possible that the ID15 test engineer had smelled the exhaust of the ID14 vehicle.

Figure 81: 2013 Ford Explorer [redacted] test ID15 data.

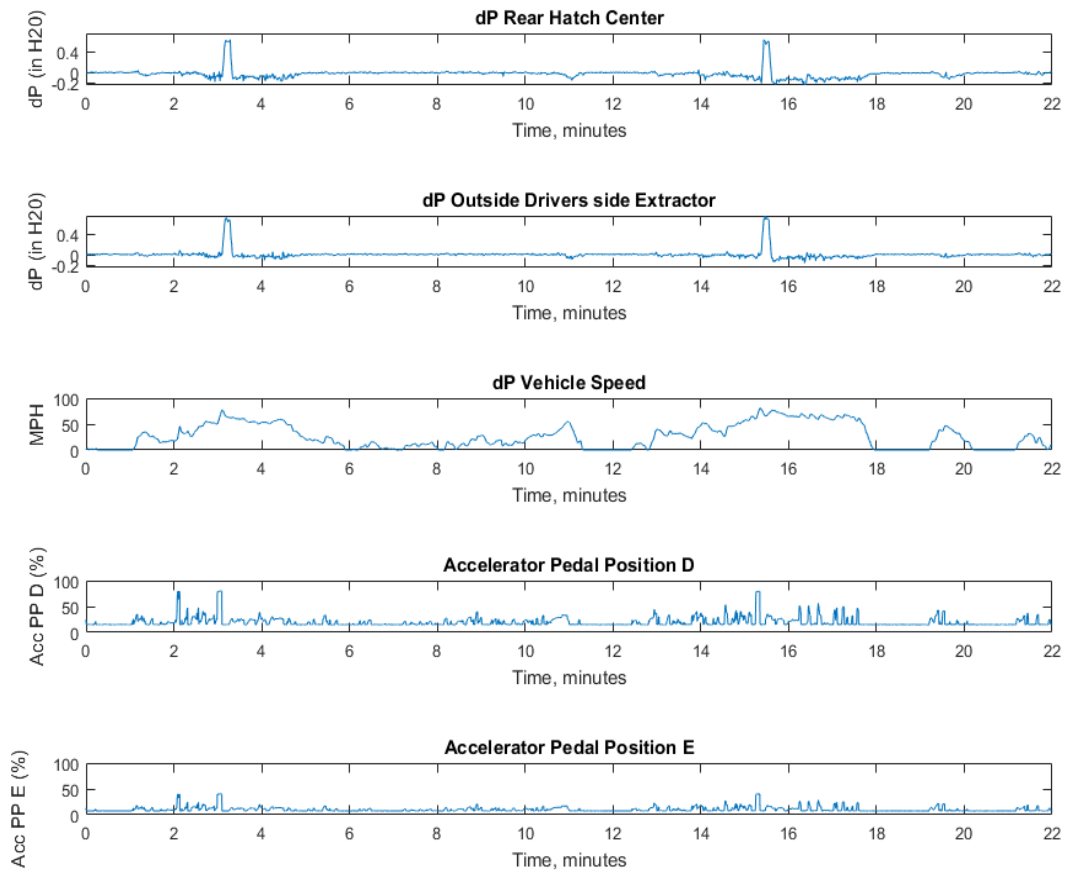
The OBD-II and pressure differential data captured for test ID16 can be seen in Figure 82, and the CO data can be seen in Figure 83. Note that the left air extractor inside, above underbody lap joints CO monitor's battery discharged approximately 14 minutes into the test.

Figure 82: Complaint 2014 Ford Explorer 3986 test ID16 OBD and pressure differential data.
