**Expert Report of  
Dr. Michael E. Cundy**

**[REDACTED] v Ford**

Prepared by:  
Michael E. Cundy, Ph.D., P.E.

December 14, 2015

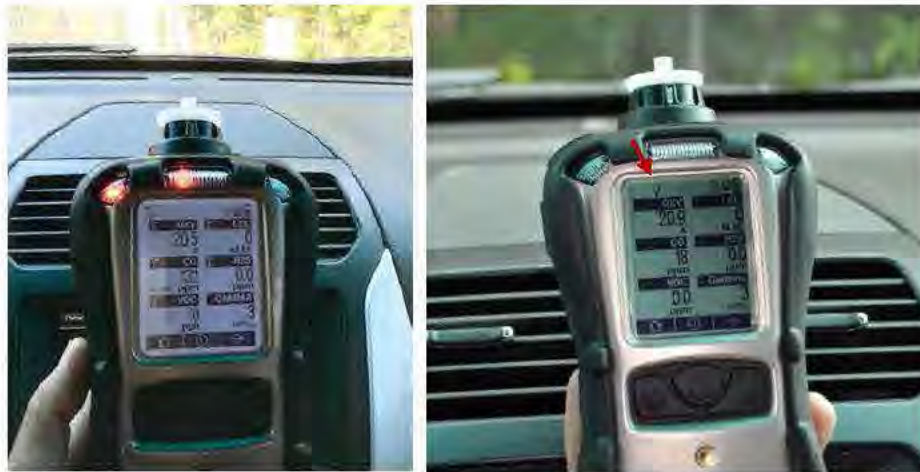
12. Exhibit A to [REDACTED] Declaration shows a photograph of the RAE Systems MultiRAE Pro gas monitor used in the testing described in his deposition. The screen does not show a check mark at the top, which is present only when "all sensors tested and calibrated according to policy."<sup>1</sup> During all Exponent testing, a check mark was present (see Figure 1).

**Figure 1** Photograph from Exhibit A to [REDACTED] Declaration (left) which does not show a check mark, and a photograph taken at the conclusion of an Exponent test with the Subject Vehicle showing a check mark.

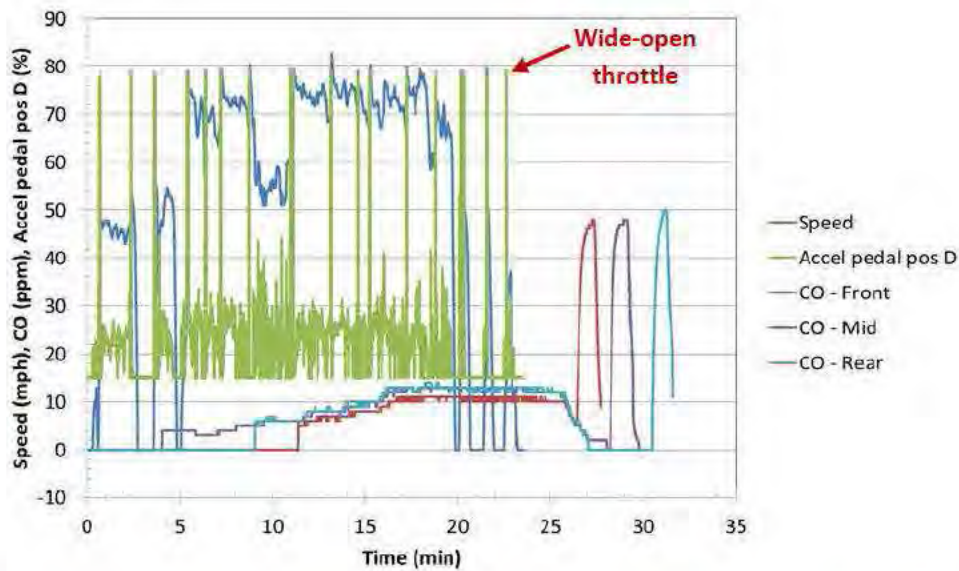
15. I acquired two additional calibrated RAE Systems MultiRAE Pro gas monitors and installed them in the middle row, left seat, and in the rear row, left seat, of the repurchased Explorer, and measured CO concentrations simultaneously with the original meter that was positioned in the front center location. The middle and rear row sensor inlets were positioned a few inches below where the seat back meets the headrest. I tested the repurchased Explorer on Phoenix, Arizona roads with several wide-open throttle accelerations, with “Max AC” on (recirculation on), windows rolled up, and with the rear climate setting at its coldest and highest fan speed. The highest CO concentrations recorded were 11, 13, and 14 ppm in the front center, middle row left seat, and rear row left seat, respectively. Figure 2 shows a plot of the vehicle speed, accelerator pedal position sensor D signal, and the CO concentrations measured at each location. Note that the accelerator pedal position sensor D signal is at idle at

approximately 15% of full scale, and wide-open throttle is approximately 80% of full scale. I repeated the test on the same roads in the opposite direction as I normally drive my personal vehicle, in a manner consistent with current traffic patterns and safe driving habits, and recorded 0 ppm at all three locations for the duration of the test. At the conclusion of each of these two tests, I ran calibration gases through the CO meters to verify their proper operation and calibration, which are the three peaks shown between 27 and 32 minutes.<sup>4</sup>

**Figure 2** Plot showing the vehicle speed, accelerator pedal position sensor D, and CO concentration in the front, near the AC vents, in the middle left seat, and in the rear left seat.

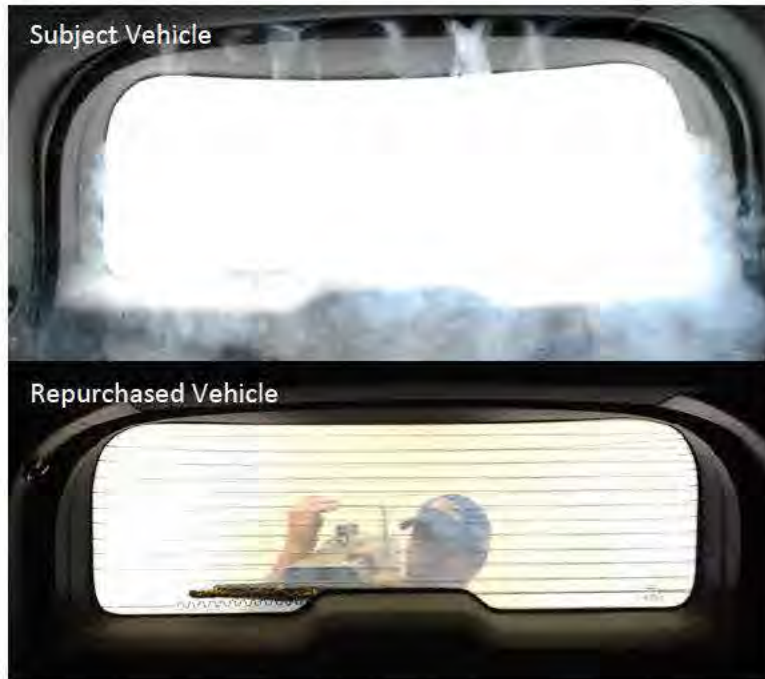
19. A fog test was performed on the repurchased Ford Explorer using the same fog machine and a Ridgid brand 6-gallon shop vacuum with the highest water lift available (model WD06701, 53" H<sub>2</sub>O). Screen-captures from the videos of the Subject Vehicle and repurchased vehicle tests taken approximately 25 seconds into each test are shown in Figure 8. The significant fog intrusion on the Subject Vehicle is consistent with a poorly adjusted rear hatch and/or seal.

**Figure 8** Screen captures taken approximately 30 seconds after the test was started in the Subject Vehicle (top) and in the repurchased vehicle (bottom).

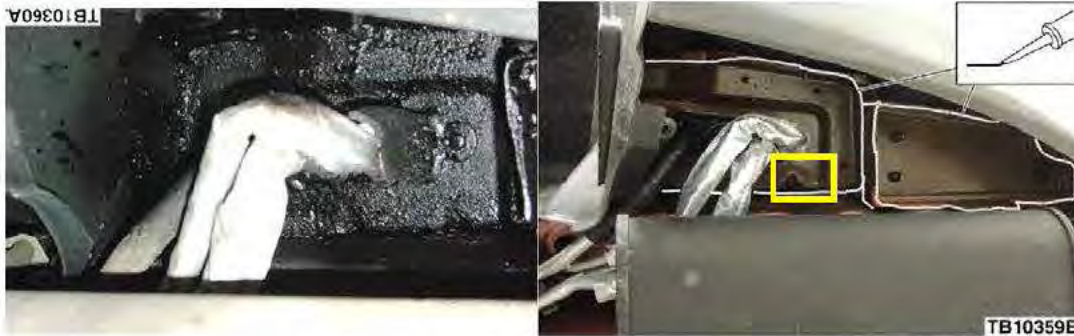
- a. In certain areas, the applied Motorcraft Seam Sealer did not close the gaps in body panels, and the 3M Rubberized Undercoating did not cover the region indicated by the TSB. Figure 9 shows pictures from TSB 12-12-4 indicating proper coverage of the 3M Rubberized Undercoating spray (left picture) and the areas where the Motorcraft Seam Sealer should be applied (right picture) on the driver's side of the vehicle, near the muffler. Incomplete or inadequate application of the spray and seam sealer on the Subject Vehicle are shown in Figure 10. This is in contrast to the repurchased Explorer, which can be seen in Figure 11.

**Figure 9** Photographs from TSB 12-12-4 illustrating areas on the driver’s side which are to be covered with a “generous” amount of 3M Rubberized Undercoating (left picture) and seams to seal with the Motorcraft Seam Sealer (right picture). The yellow box in the right picture shows the field of view for the picture of the Subject Vehicle in Figure 10 and repurchased Explorer in Figure 11.
