**HYUNDAI**NEW THINKING.  
NEW POSSIBILITIES.**Technical Service Bulletin**

**17-01-025**

**Sonata (YF)  
Sonata Hybrid (YF HEV)****SUBJECT:****2011-2014 SONATA (YF) AND 2011-2015 SONATA HYBRID (YF HEV)  
ANCHOR PRETENSIONER INSPECTION (RECALL CAMPAIGN 160)****\* IMPORTANT****\*\*\* Retail Vehicles \*\*\***

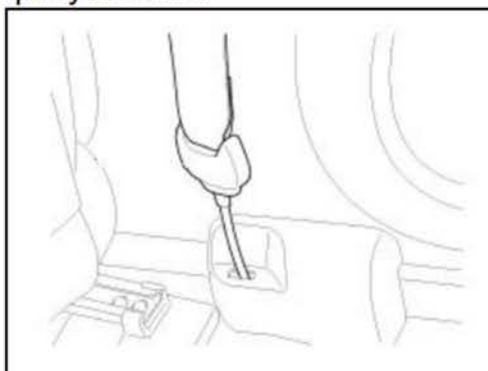
The front seat belt assembly incorporates a seat belt anchor pretensioner fastened to the vehicle's inner sill structure. During vehicle assembly, the anchor pretensioner is fastened to the sill prior to being connected to the seat belt linkage. If, during vehicle assembly, the connector did not fully latch when the linkage was pressed onto the connector, the seat belt can detach from the anchor pretensioner. If the seat belt linkage detaches from the anchor pretensioner in a collision, the risk of injury to the occupant is increased.

This bulletin describes the procedure to inspect the driver's and passenger's anchor pretensioner assemblies to confirm they are properly latched.
