**National Highway
Traffic Safety
Administration**

ODI RESUME

Investigation: EA 17-002
Prompted by: PE16-008, Consumer Reports
Date Opened: 07/27/2017 **Date Closed:** 01/17/2023
Investigator: Brian Smith **Reviewer:** Bruce York-B
Approver: Stephen Ridella
Subject: Exhaust Odor in Passenger Cab

EA17-002 Closing Report

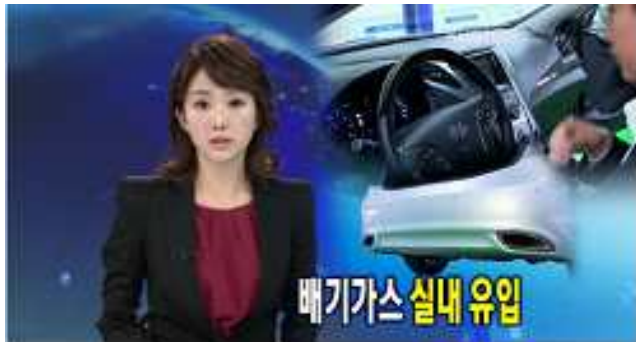
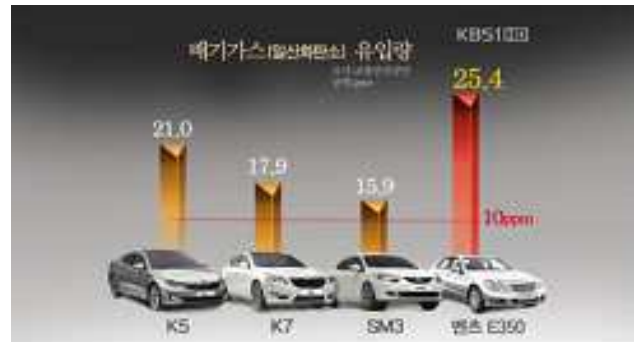
< KBS news regarding “exhaust gas entering into vehicle cabin” >

- ✓ **Consumer complaints “Exhaust gas entering into vehicle cabin”**
- Exhaust smell can disturb driving and raises safety concerns
- ✓ **Ministry of Land, Infrastructure and Transport had launched an investigation into this issue**
- Possible leakage of exhaust fumes and exposure to carbon monoxide inside the vehicle
 - Defect Investigation in 2011 [49 vehicles] and in 2016 [1 vehicle]
 - Free repair service 3 vehicle models in 2012 and 1 model in 2016

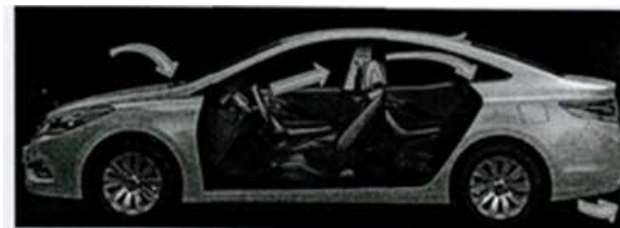
< Fresh air mode >

- ✓ When cars highly accelerate with the condition on internal circulation mode, exhaust gases could enter the passenger compartment due to pressure difference in cabin and vortex flow in back part of the car.

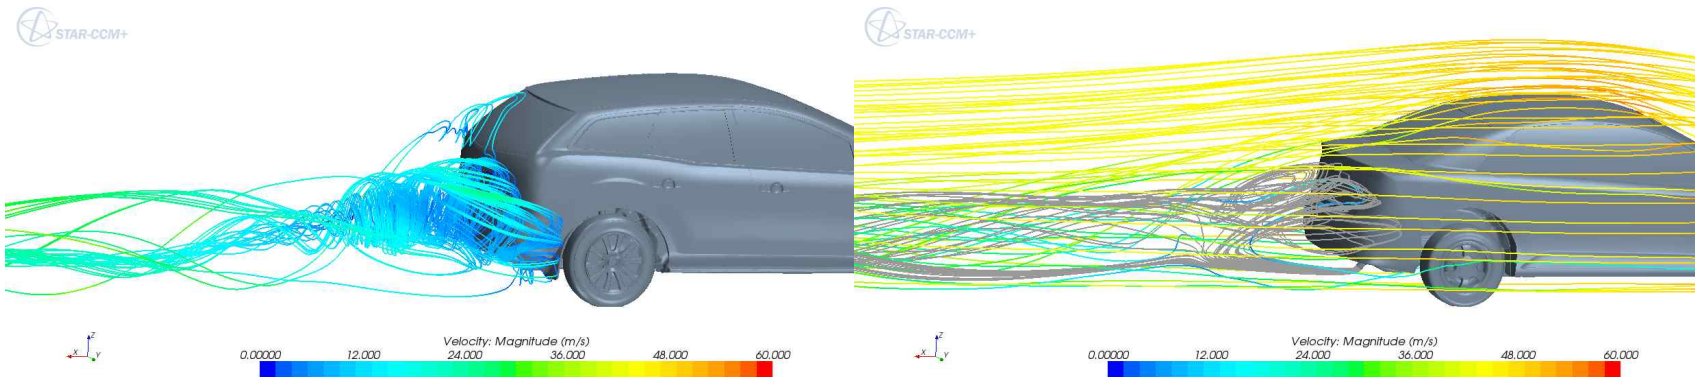
- ✓ The vortex flow occurs in the back part of sedan vehicles depending on vehicle speed

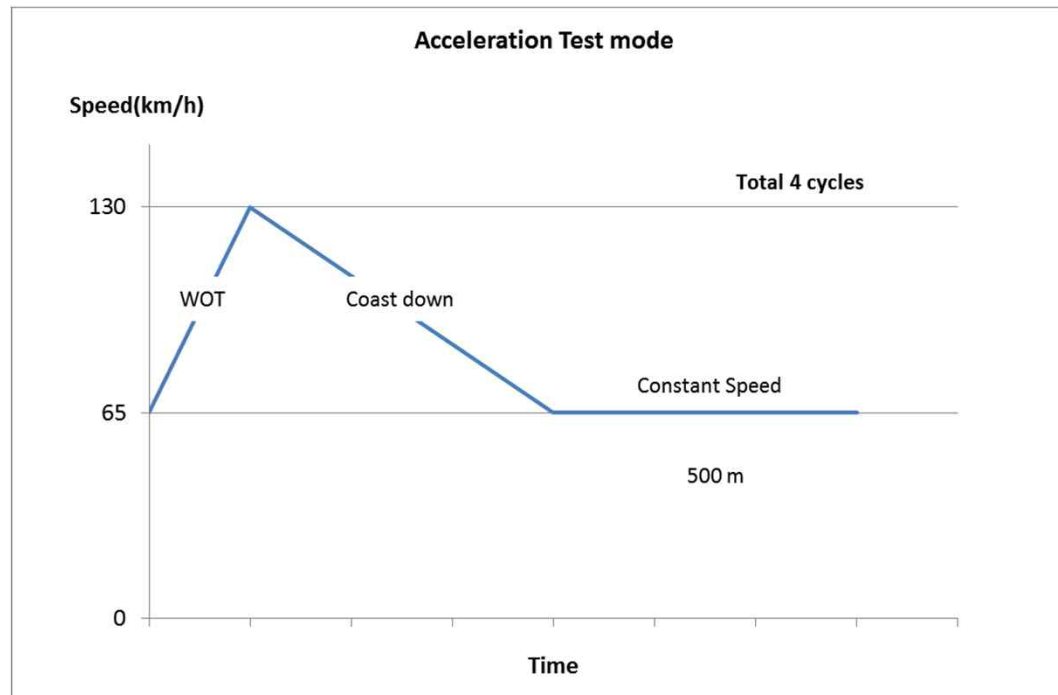
➤ Acceleration mode

- Test cycle : accelerate vehicles from 65 km/h to 130km/h (WOT), right after that coast-down (deceleration) to 65 km/h, cruise drive 500 meter, and then repeat mode
- Total 8 cycle (4 stabilizing cycle, 4 measuring cycle)
