# RQ17-001 Cap Screw Failures

## MY 2016-2017

## RQ17-001 DTNA Cap Screw Failures

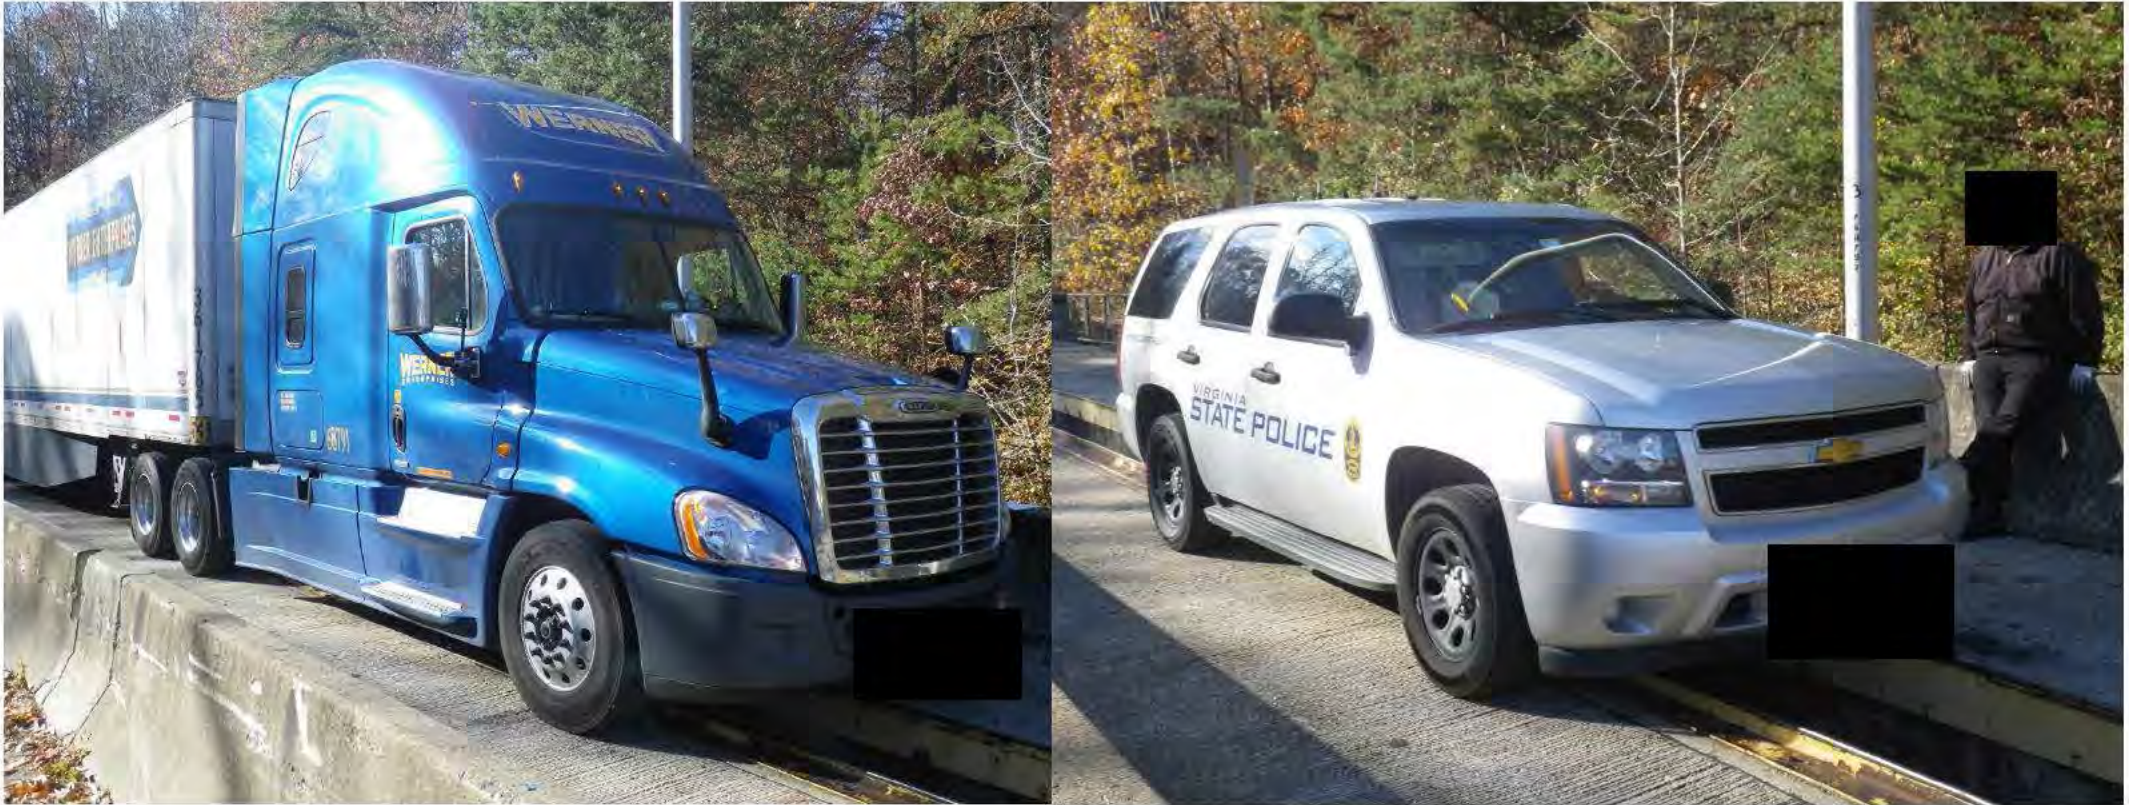
# *Level IV Roadside Inspections with: Virginia State Police, DTNA, & Detroit Axle*

Nov 30 – Dec 1, 2017

I95 Southbound Inspection Station

Dumfries, VA

39 Trucks inspected

156 capscrews

None found to be under torqued
