EA17-002

APPENDIX H

TECHNICAL SERVICE
BULLETINS

**2011-2017 EXPLORER/2013-2017 POLICE INTERCEPTOR UTILITY -
CUSTOMER COMPLAINTS OF CARBON MONOXIDE (CO) AND/OR EXHAUST
ODOR AFTER FSA 17B25 OR 17N03 :**

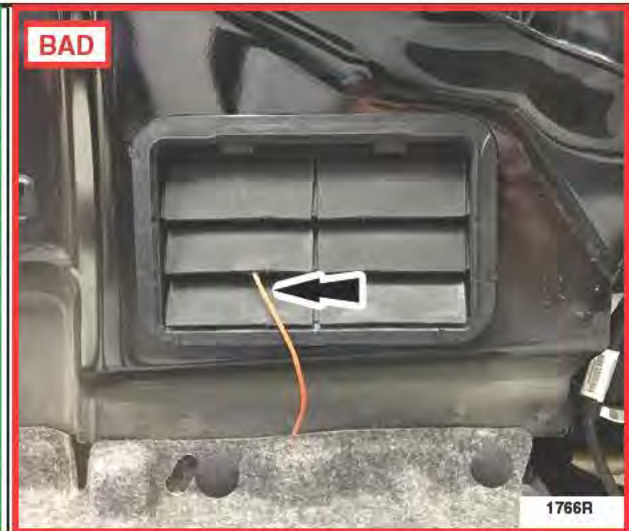
FIGURE 4a

4. Using a telescoping mirror and flashlight, inspect the 4 body plugs and air extractor through the wheelhouse openings on each side of the vehicle to determine if aftermarket wiring has been routed through these components. Reroute aftermarket wiring as needed. See Figures 4a and 4b.

- Replace body plugs or air extractors if any damage is present. Rear bumper cover removal is required to replace the air extractor. Please follow the WSM procedures in Section 501-19.

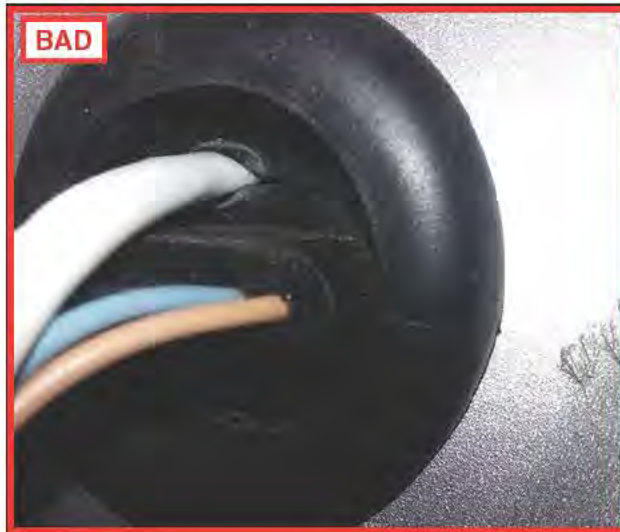
FIGURE 6a

6. Remove the LH and RH rear tail lamp assemblies. Please follow the WSM procedures in Section 417-01.
7. Inspect the sheet metal, wiring harness grommets and factory equipped pass throughs for damage or holes created when installing aftermarket wiring and equipment. See Figure 6a. Seal all holes in the sheet metal and wiring harness grommets with Motorcraft® TA-2 seam sealer or equivalent. See Figure 6b.
