Web Form Data Description of Vehicle Concern: CUST STATES ON HARD ACCELERATION BAD EXHAUST ODOR IN CAB. Please list any diagnostics already performed: CUSTOMERS CONCERN WAS VERIFIED AND TSB 14-0130 WAS PERFORMED. THE VEHICLE HAD CAME BACK MULTIPLE TIMES FOR THIS CONCERN. THE VEHICLE WAS RETESTED PER THE TSB. Parts Replaced: AS LISTED IN THE TSB 14-0130 Your Question: WE HAVE HAD OTHER VEHICLES WITH SIMILAR CONCERN, WE HAVE ADVISED THE CUSTOMER THAT UNDER CERTAIN CONDITIONS SOME EXHAUST SEMLL MAY SEEP INTO THE CABIN AREA. IS THERE ANY UPDATES TO THE CONCERN. THAT WOULD HELP ALLEVIATE THIS CONCERN OF EXHAUST SMELL IN THE CAB ?

Report# :	G6TFM015 NHL	Received:	06/20/2016
CCRG/EPRC:	<input type="text" value="v"/>	Reviewed Status:	Date:
Vehicle:	2015,EXPLORER 4X4 (U502) ,SPORT ,4 DOOR ,MPV ,1FM5K8GT5FGA41945	Build Date:	07/22/2014
Odometer :	25,456 M	Engine:	3.5L-GTDI
Transmission:	6F55	Axle:	A/C: YES
Dealer:	USA 20301 Don Sanderson Ford	Phone#:	623-842-8685
City:	Glendale	State:	Arizona
Originator:	RANDY HANSEN	Country :	USA
Symptom:	4 48 2 39 ST/RN/MV,NOISE,MOVE/DRIVE,INTERMITTENT		
Status:			
VFG:	V49 POWERTRAIN GOOD SOUND AND NVH		
Additional Symptom:	DROAN NOISE		
Fix:	Causal Comp

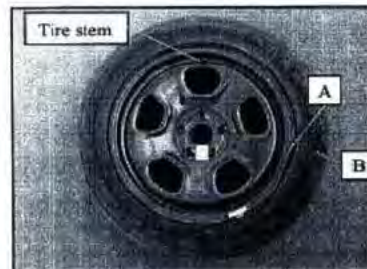
Figure 11. Outboard side of the left-rear tire and wheel.

- Radial collapse of the outboard rim flange at the 4 o'clock position (Figure 11: A).
- A tear in the tire sidewall at the 4 o'clock position (Figure 11: B).

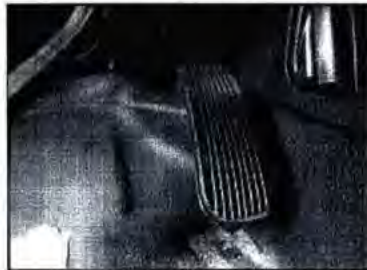
Figure 13. Accelerator pedal.

The throttle system utilized an electronic accelerator pedal assembly. The accelerator pedal assembly was mounted to the bulkhead within the right side of the driver's foot well. The pedal (Figure 13) was manually operated throughout its range of motion with no deficiencies. The pedal assembly was still attached to the control module and return spring (Figure 14). The engine throttle valve utilized an electric motor mounted to the right-side of the throttle body (Figure 15).

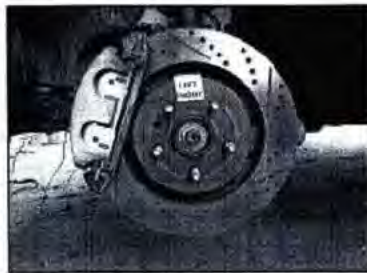
Figure 22. Left-front brake assembly.

Each brake assembly on this axle consisted of a steel brake caliper, brake pads, a brake rotor, and related hardware. Each sliding, dual-piston brake caliper was attached to its caliper mounting bracket with two sliding pins. Each brake caliper support bracket was attached to its respective steering knuckle with two bolts. The aluminum caliper pistons moved freely within their individual bores and their rubber piston dust boots were dry with no indication of fluid contamination. The disc brake hardware and sliding pins were intact. The right-front caliper casting was broken at the lower sliding pin threaded ear (Figure 24: A). The flexible hydraulic brake lines were attached to the rigid lines, and to their respective brake calipers. The right-side rigid brake line to flexible brake line bracket was pulled away from its body attachment position (Figure 24: B).

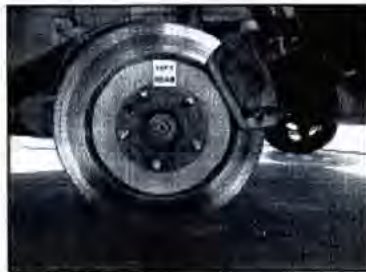
Figure 27. Left-rear brake assembly.

Each brake assembly on this axle consisted of a steel brake caliper with an incorporated parking brake, brake pads, a brake rotor, and related hardware. Each sliding, single-piston brake caliper was attached to its caliper mounting bracket with two sliding pins. Each brake caliper support bracket was attached to its respective steering knuckle with two bolts. The steel caliper pistons turned freely into their parking brake threaded pin within their individual bores and their rubber piston dust boots were dry with no indication of fluid contamination. The disc brake hardware and sliding pins were intact. The flexible hydraulic brake lines were attached to the rigid lines, and to their respective brake calipers.
