STATE OF CALIFORNIA
DEPARTMENT OF CALIFORNIA HIGHWAY PATROL

MULTIDISCIPLINARY ACCIDENT INVESTIGATION TEAM NARRATIVE/DIAGRAM

DATE OF COLLISION (MONTH-DAY-YEAR)	TIME (2400)	NCIC	OFFICER I.D.	NUMBER	MAIT CASE NUMBER	PAGE
05-13-2017	0818	9465	18410			44

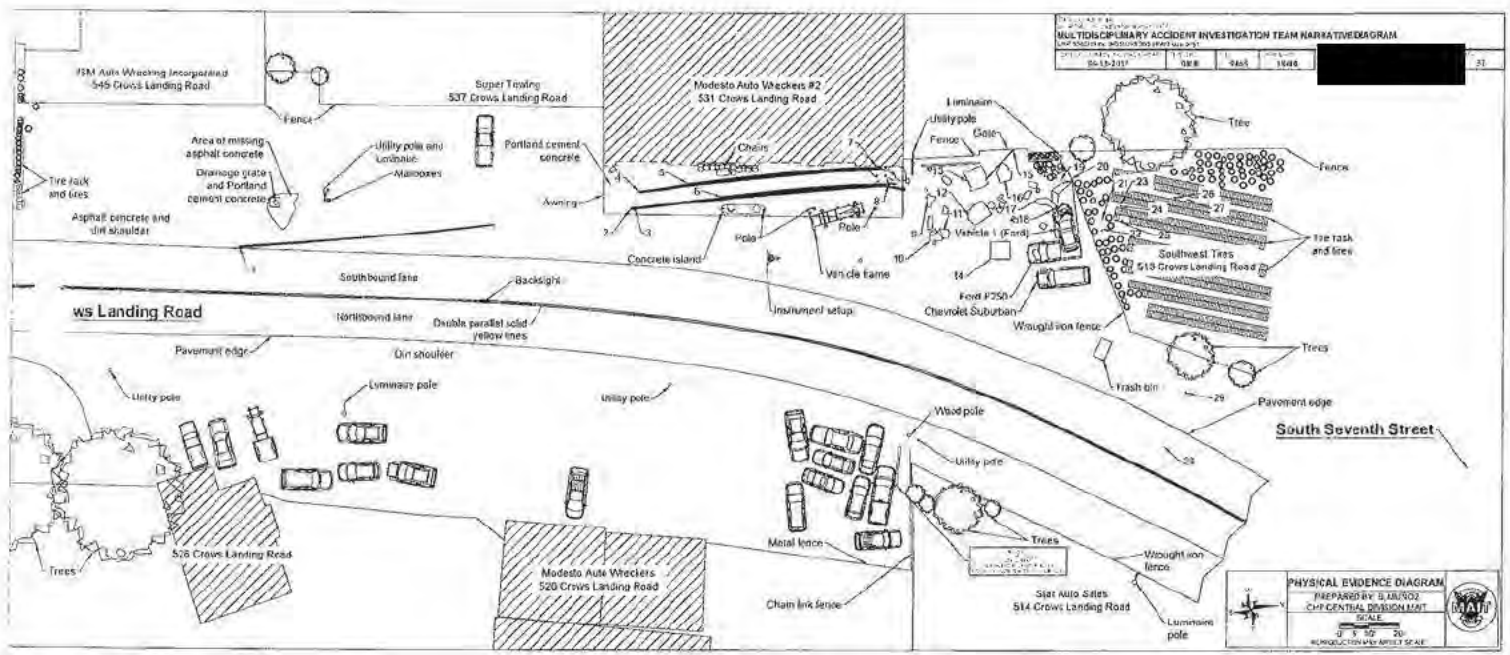
PHYSICAL EVIDENCE DIAGRAM
 PREPARED BY: D. LIL/002
 CHP CENTRAL DIVISION UNIT
 SCALE: 1" = 50'
 REDUCTION MEASUREMENT SCALE

Vehicle 1 (Ford) was located on its wheels resting on top of item 18 (Damaged Roll-Off Container) west of Crows Landing Road south of South Seventh Street, facing in a westerly direction.

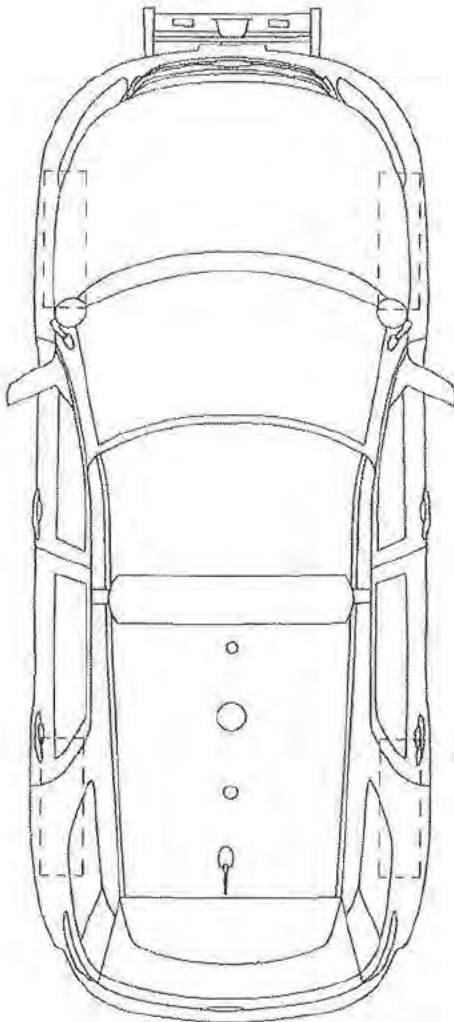
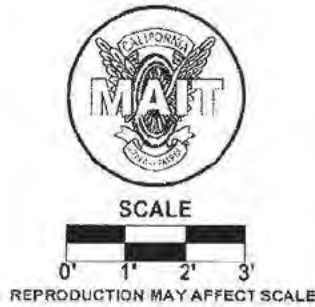
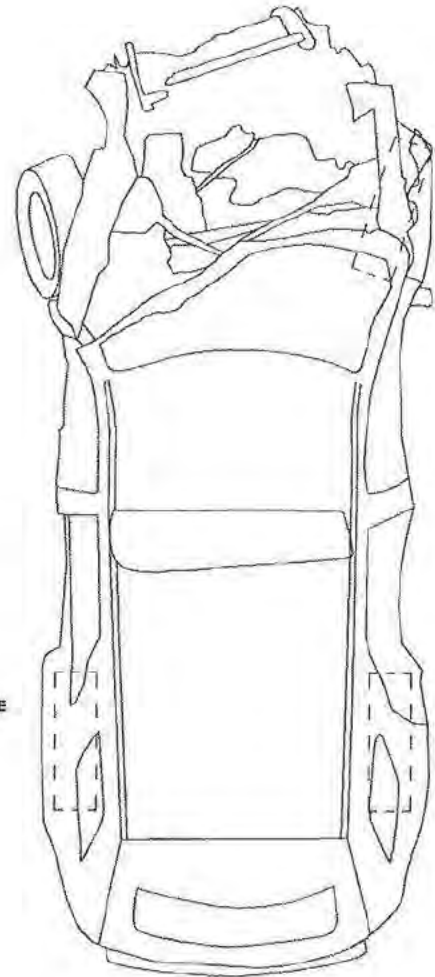
Vehicle Damage Profile

Exemplar 2014 Ford Police Interceptor Utility
Drawn by: Investigator Muñoz

Vehicle 1 (Ford)
Drawn by: Investigator Muñoz

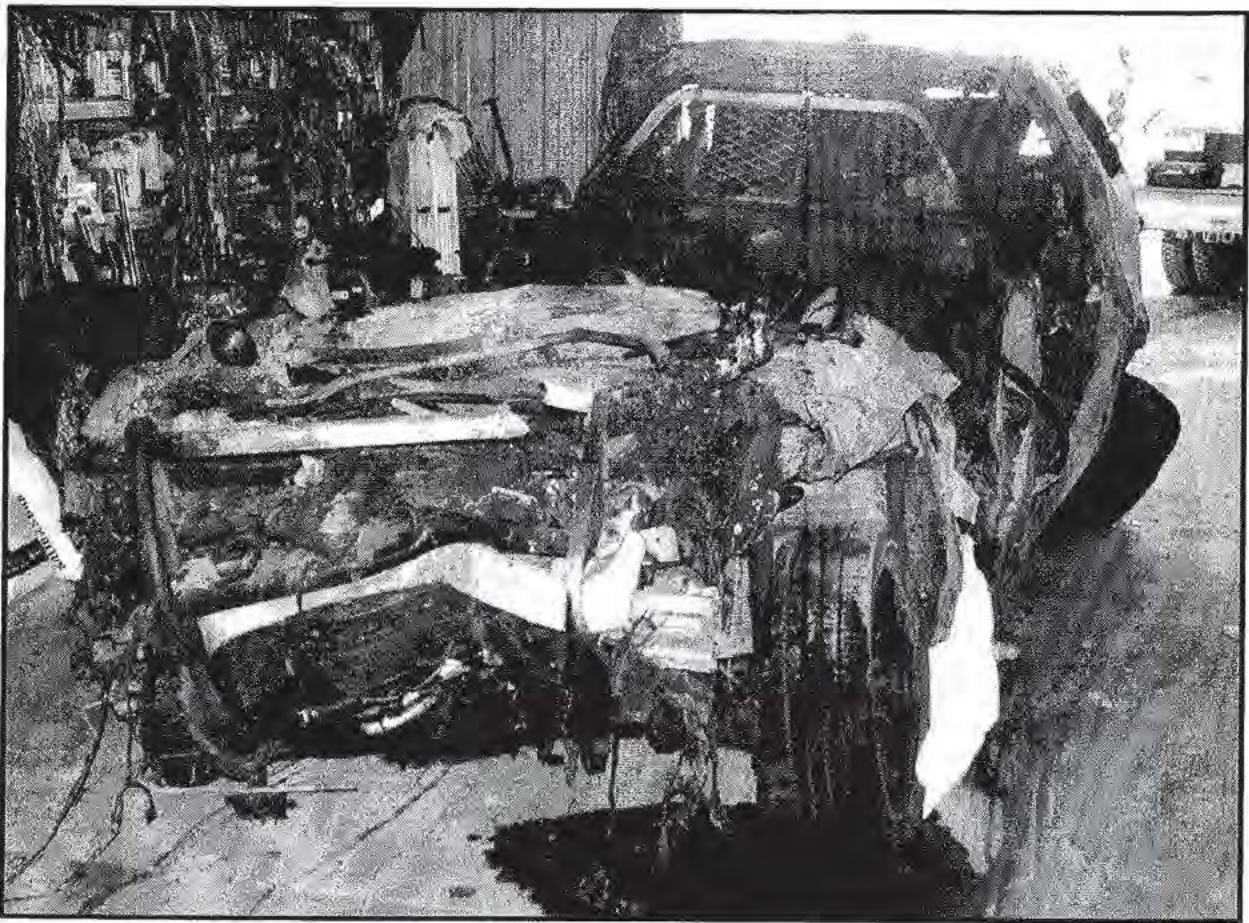
Vehicle 1 (Ford) at E Towing.
CL-012-17 06-06-17 KW (1) cropped, lightened

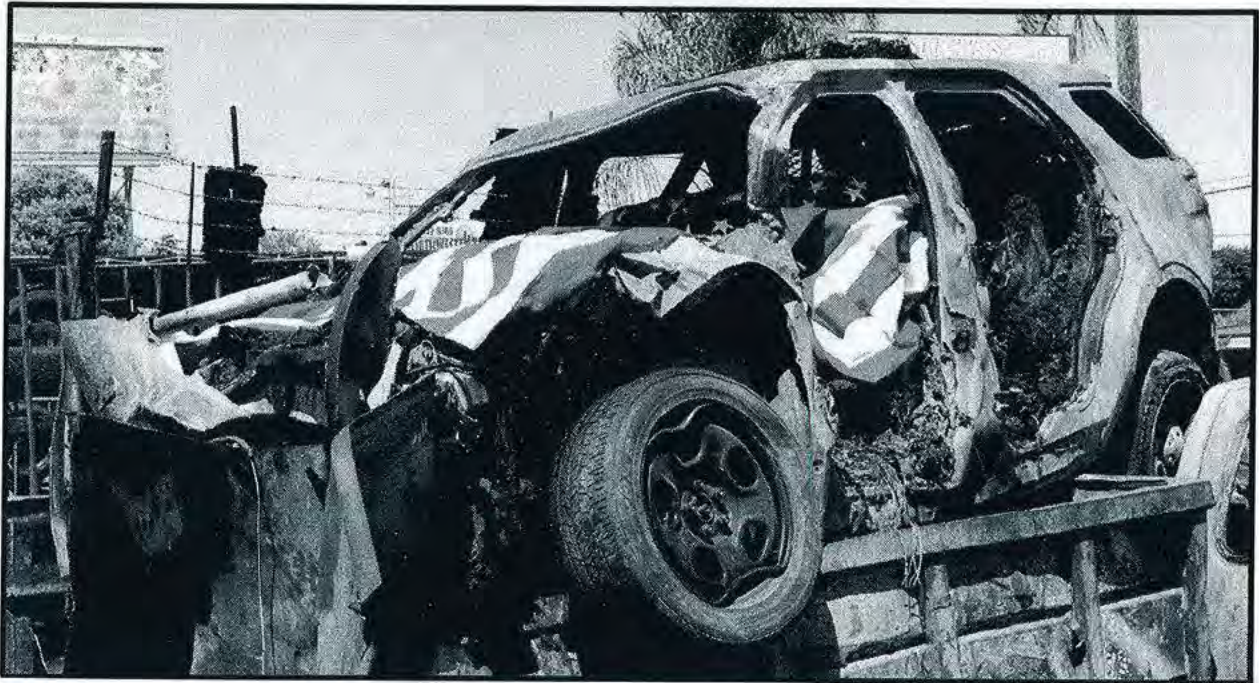
All references to direction are oriented from the driver's seat of the vehicle looking forward through the windshield. Vehicle 1 (Ford) sustained major collision damage to its front end. The PDOF was applied to the front of Vehicle 1 (Ford), and was directed from front to rear.

Vehicle 1 (Ford) at its point of rest at the scene.
CL-012-17 05-13-17 RS-A (223) cropped

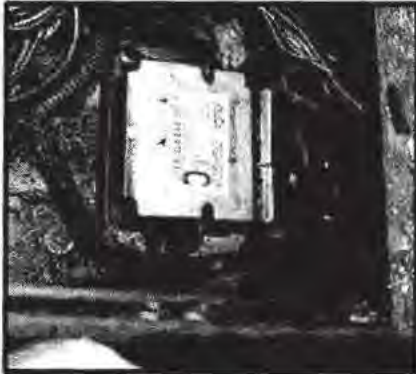
ACM of Vehicle 1 (Ford).
CL-012-17 05-18-17 RS (9) cropped

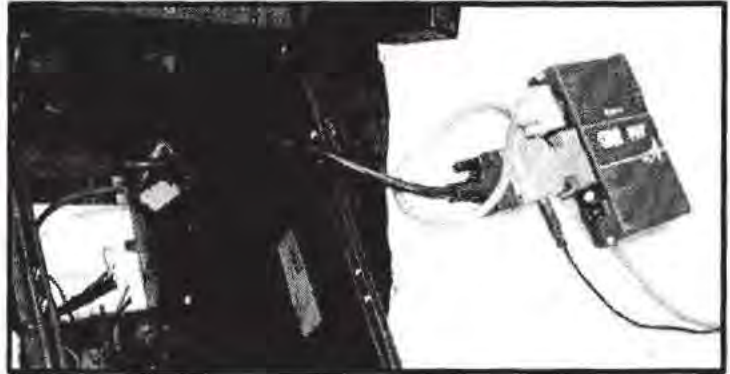
Due to the extensive collision damage and subsequent fire damage to Vehicle 1 (Ford), the CDR system (version 17.3) was connected directly to the ACM utilizing Bosch direct-to-module cable number F-00K-108-783, and adapter F-00K-108-387, in order to conduct a direct-to-module data imaging.

ACM of Vehicle 1 (Ford) connected to CDR equipment.
CL-012-17 05-18-17 RS (13) cropped

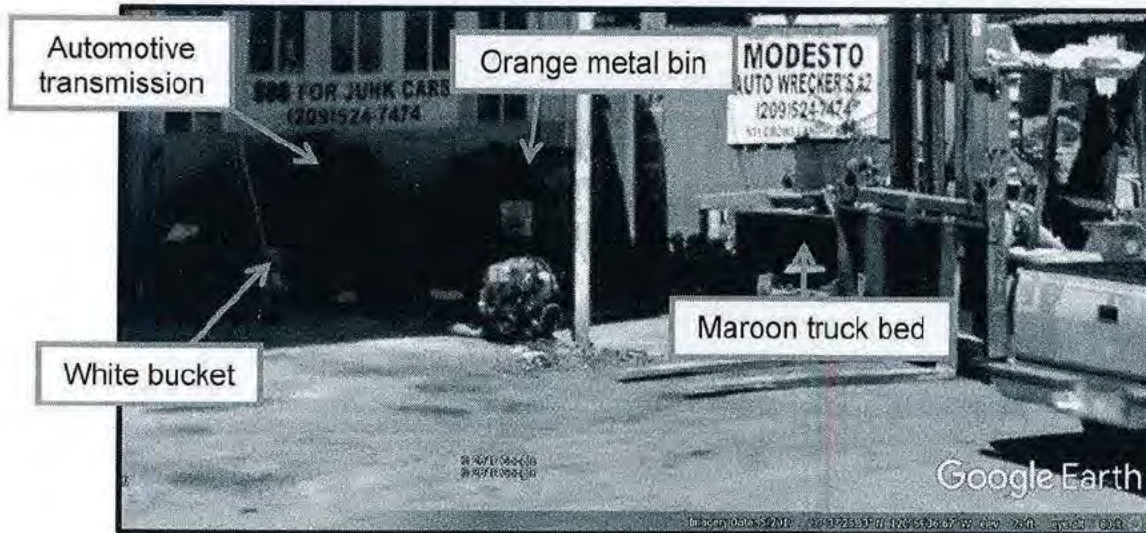
Item 9 Damaged Metal Table

Item 9 was a damaged metal table located on the dirt area west of Crows Landing Road. The owner of the business at 531 Crows Landing Road indicated item 9 contained two miscellaneous automotive automatic transmissions and a torque converter on top of it. There was a hole in the center of the metal table. There was a white bucket underneath the hole to contain the automotive fluids which drained out of the transmissions. The metal table was originally located to the east of item 7 (Damaged Wall). Based on the dynamics analysis and the Google Earth Pro image, this item was determined to have been struck by Vehicle 1 (Ford) and displaced by Vehicle 1 (Ford) during the collision sequence.

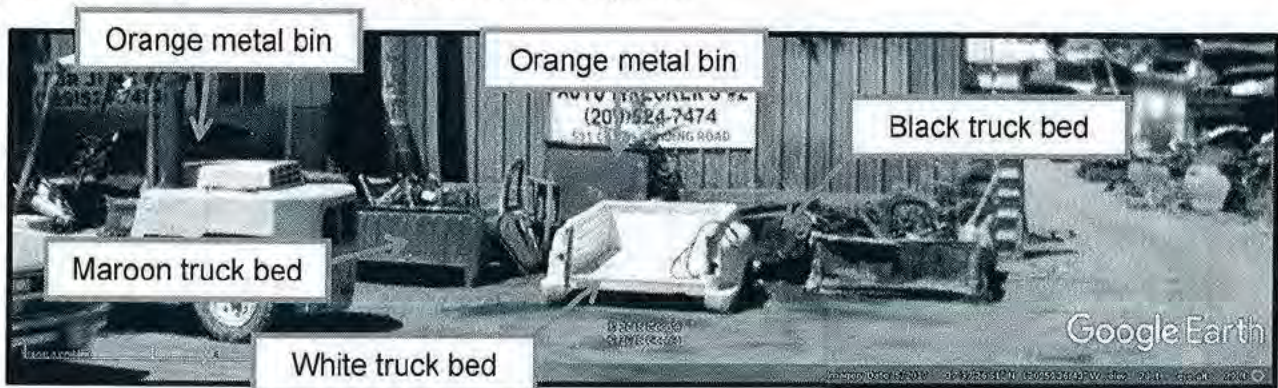
Item 13 Damaged Truck Bed

Item 13 was a damaged truck bed, black in color, located on the dirt area west of Crows Landing Road. The owner of the business at 531 Crows Landing Road indicated item 13 contained miscellaneous automotive parts and was originally located to the northeast of item 7 (Damaged Wall). Based on the dynamics analysis and the Google Earth Pro image, this item was determined to have been struck and displaced by item 16 (Damaged orange metal bin) during the collision sequence.

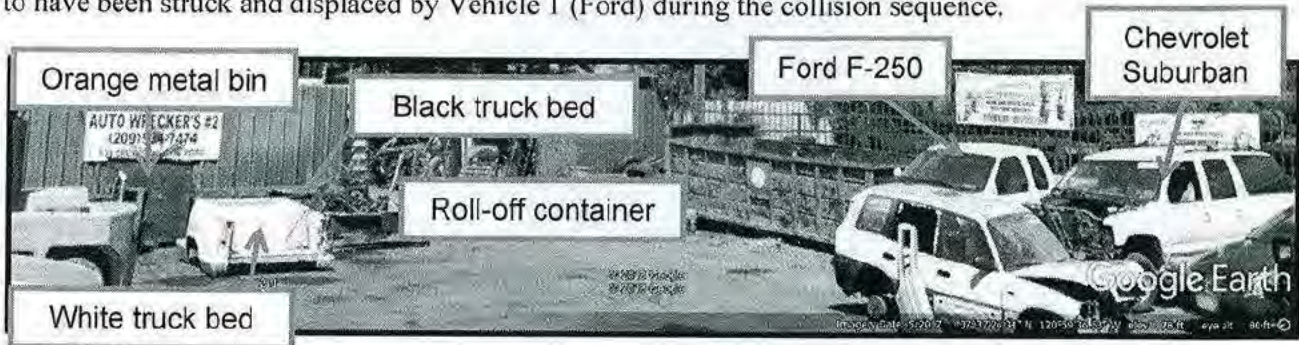
Item 18 Damaged Roll-Off Container

Item 18 was a damaged roll-off container located on the west dirt area of 531 Crows Landing Road. Based on the dynamics analysis and Vehicle 1's (Ford) point of rest, this item was determined to have been struck by Vehicle 1 (Ford). Based on the dynamics analysis and the Google Earth Pro image, this item was determined to have been struck and displaced by Vehicle 1 (Ford) during the collision sequence.
