31 MAY 2013

SECTION: 501-14

Soft Door Close Lock Functionality

Range Rover (LG)

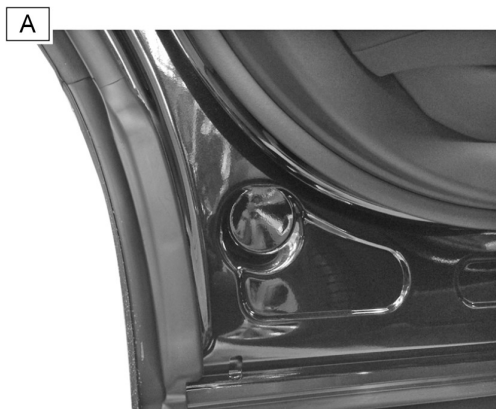
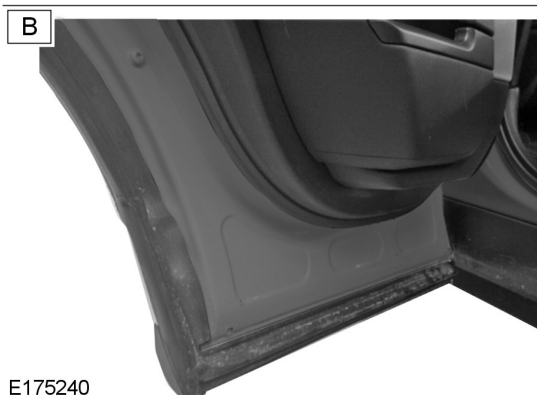
E175240

1. Check the rear door pressing to determine which plunger collar must be used in the following Service Instruction. If the door pressing is as picture 'A', then install the tapered plunger collar (LR066091). If the door pressing is as picture 'B', then install the non-tapered plunger collar (LR066092).

8. **△ NOTE:** install the correct plunger as identified in step 1.

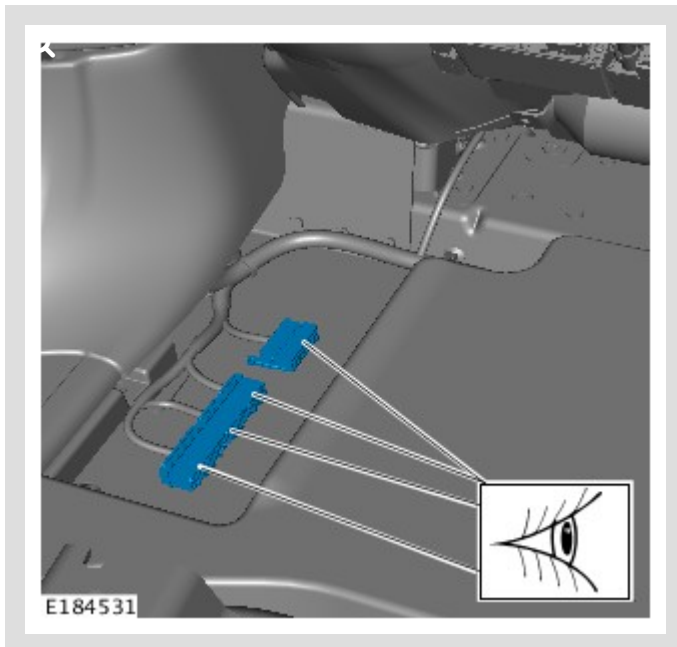
Check the following terminals for signs of corrosion:

- Range Rover Sport - rear left-hand footwell - C3PS186 A/B/C/D
- Range Rover Sport - rear right-hand footwell - C3PS185 A/B/C/D

- Range Rover - rear left-hand footwell - C3PS146 A/B/C/D
- Range Rover - rear right-hand footwell - C3PS145 A/B/C/D.
 - If no corrosion is evident in any connector, continue with normal diagnosis. Use SDD with reference to TOPIx.

Remove the connector block and cut back the corroded wires to a suitable length until corrosion is no longer visible.

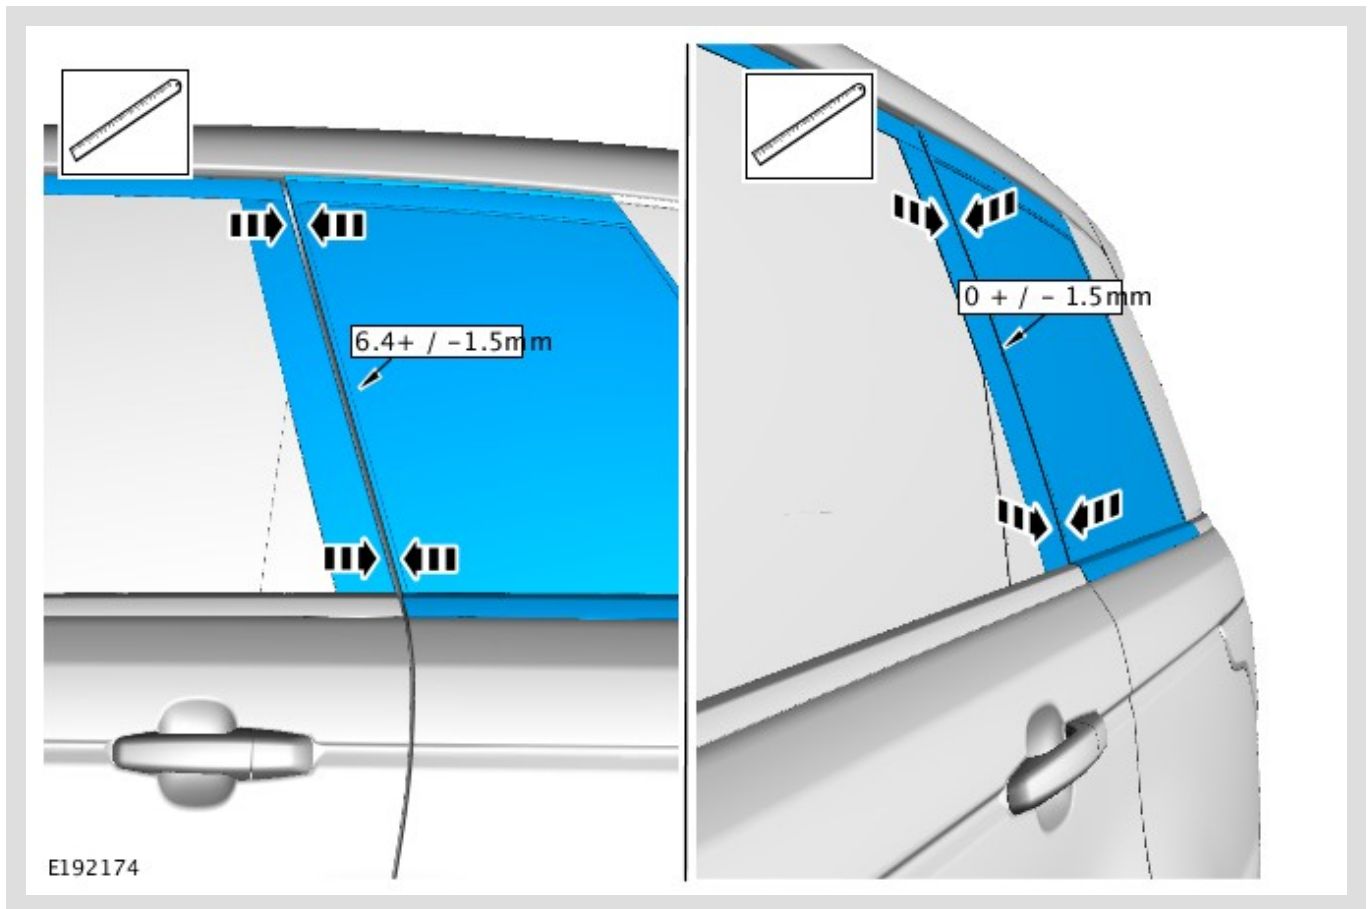
Measure the alignment between the rear door and rear quarter window (record measurement).

- 1 If the alignment does not meet the specifications shown, go to Step 2.
- 2 If the alignment does meet the specifications, apply slip coating (as supplied in the Squeak & Rattle kit) to the margin seal flock coating and front edge of the rear quarter window.
 - Apply 6-8 times, allowing approximately 5 minutes between applications for each coat to dry.

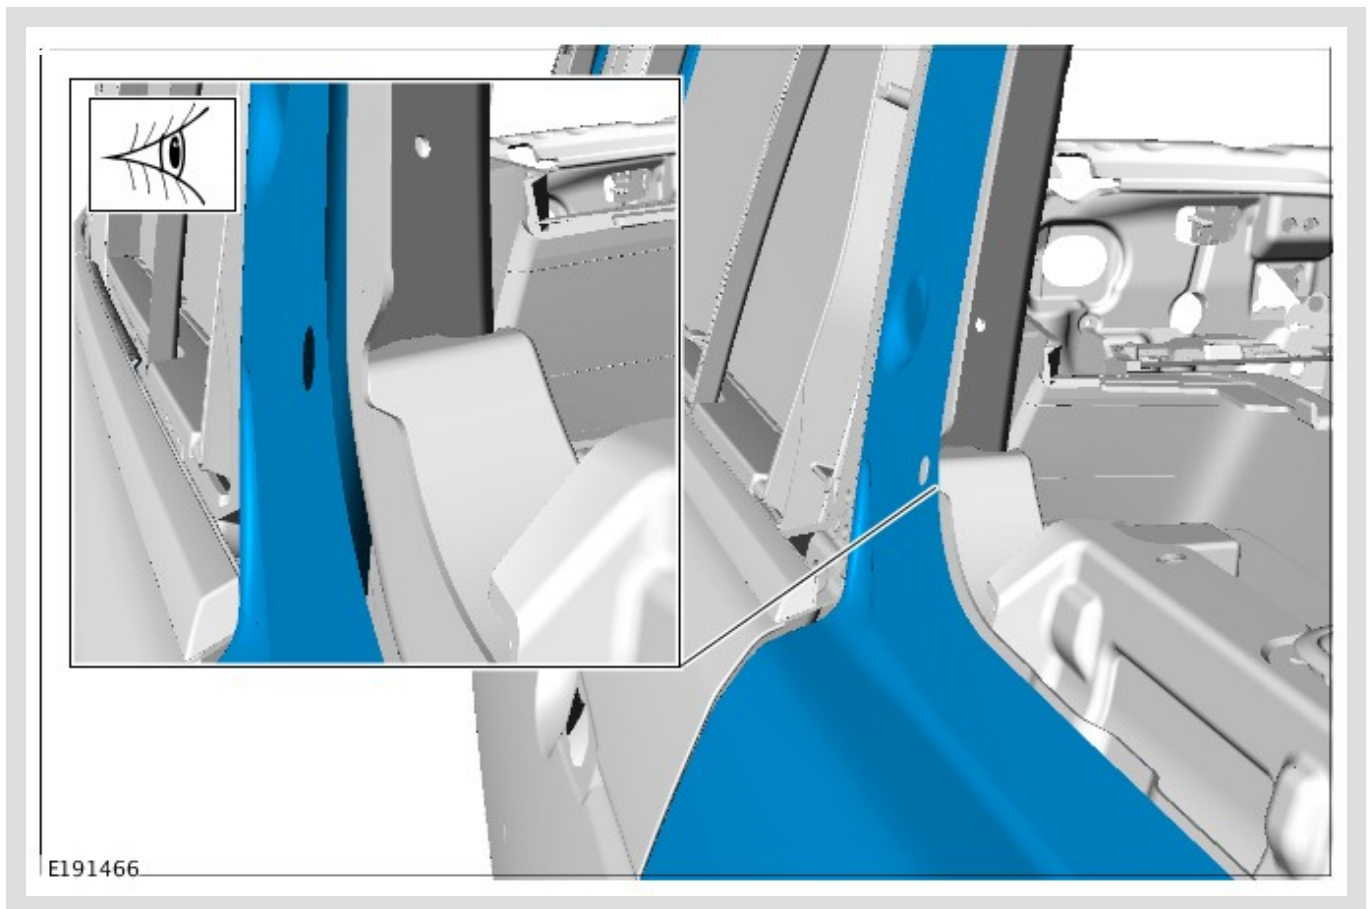
Visually check the body panel.

- 1 If there is a gap between the body panel and reinforcement panel, go to Step 7.
- 2 If there is no gap between the body panel and reinforcement panel, go to Step 8.

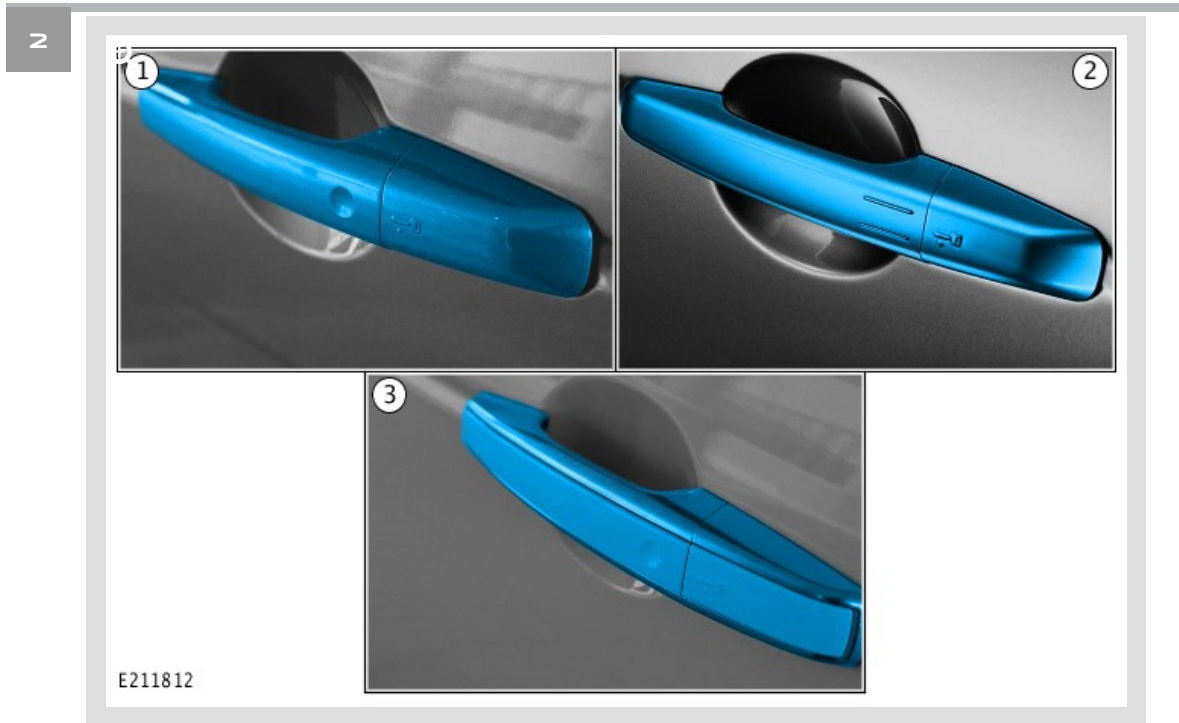
Inspect the type of handle that is to be replaced, to make sure the correct replacement handle is ordered for the vehicle. Refer to the illustration for the different handle types.

- (1) shows the dimple type handle LR061200.
- (2) shows the stripe type handle LR040667.
- (3) shows the chrome type handle supplied by color.

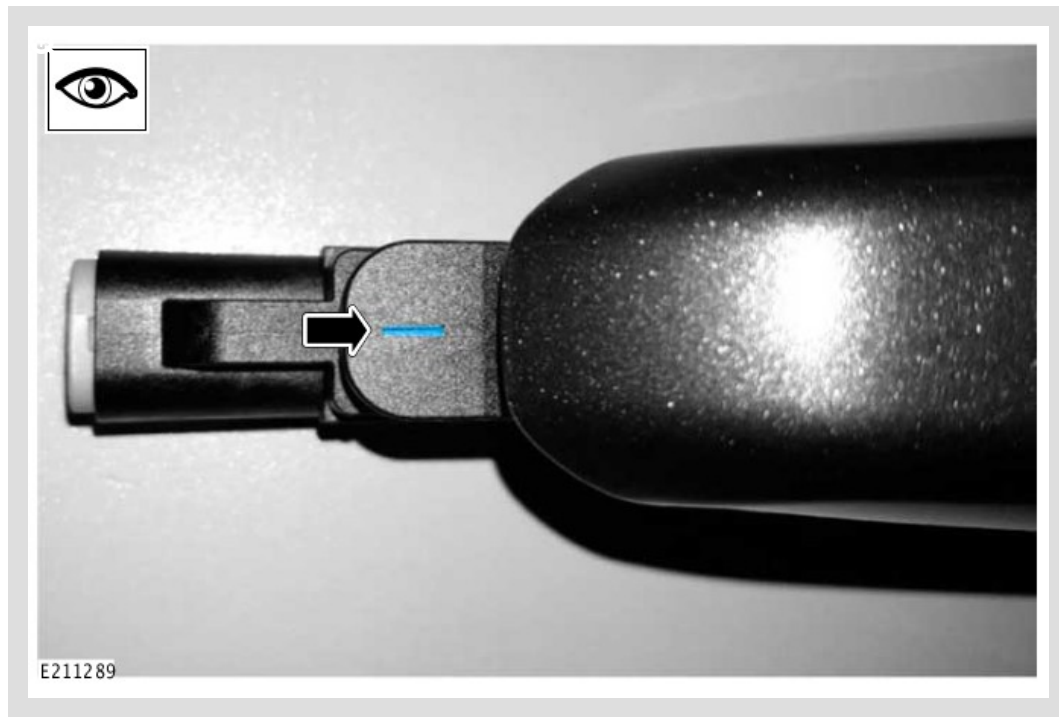
3

Inspect the replacement handle to make sure it is the correct replacement part. Inspect the handle for the correct identification mark as shown in the illustration.

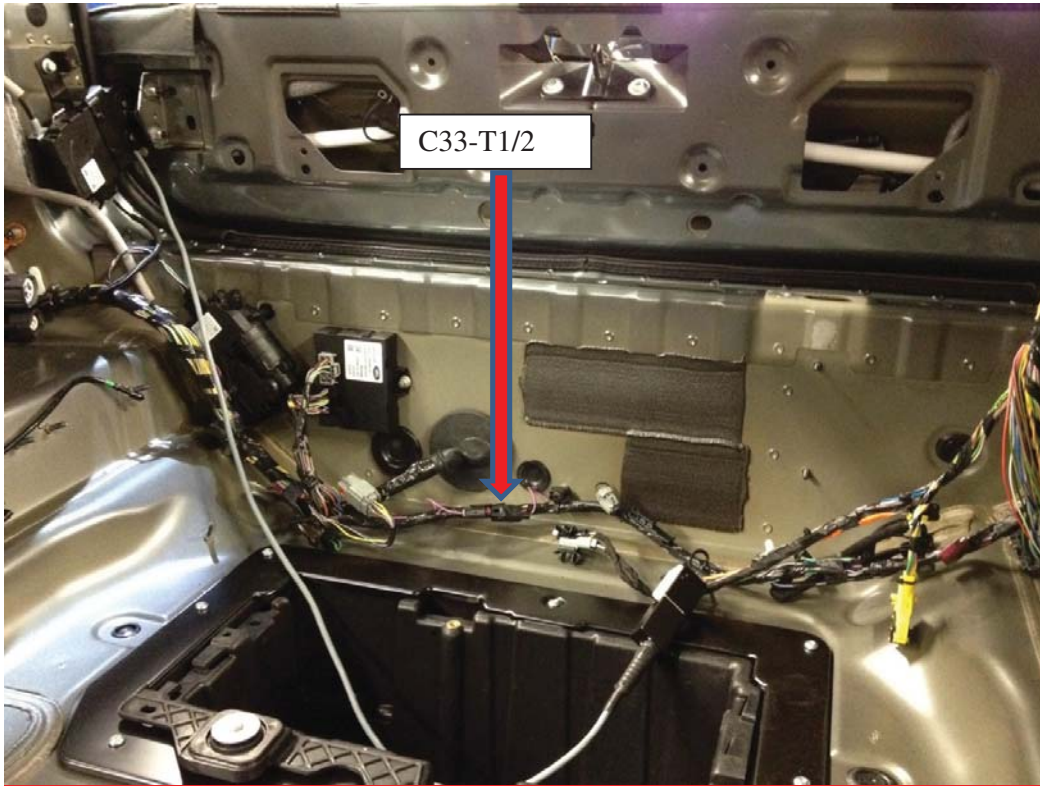
Content :**Issue:** The door soft close feature is found to be inoperative on the driver's door only during Pre Delivery Inspection (PDI).

Cause: At 15MY onwards a new feature is introduced that disables the driver's door soft close cinch motor (where fitted) for transportation purposes. As part of the PDI it will be necessary to reconnect C33-T1/2 (located at the rear of the spare wheel well) to enable the soft close feature.
