RQ17-007

MCI

12-27-2017

TITLE: Exhaust Bellows Failure Investigation

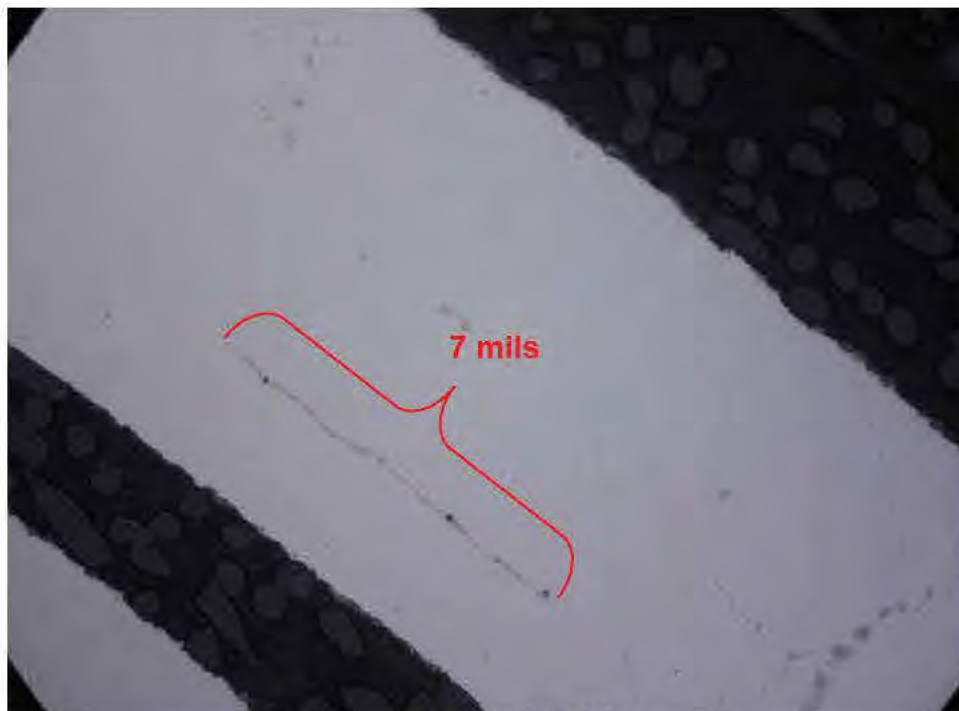
Figure 7 shows cross section micrographs that identify numerous inclusion stringers up to 7.5 mils in length in both Type 321 SS sheets. These stringers were present throughout the sheet thickness. Figure 8 shows Ti(CN) inclusion stringers near the corrugation bend surface that opened up during forming. These stringers produced notches that concentrated service stresses, initiating the fatigue cracking that lead to failure.

As-polished 100x

As-polished 200x

Figure 7 Micrographs showing numerous inclusion stringers up to 7.5 mils in length.

- Modify ordering data to include microstructural requirement to limit inclusion stringers to 2 mils or less, and perform chemistry over check to verify composition.

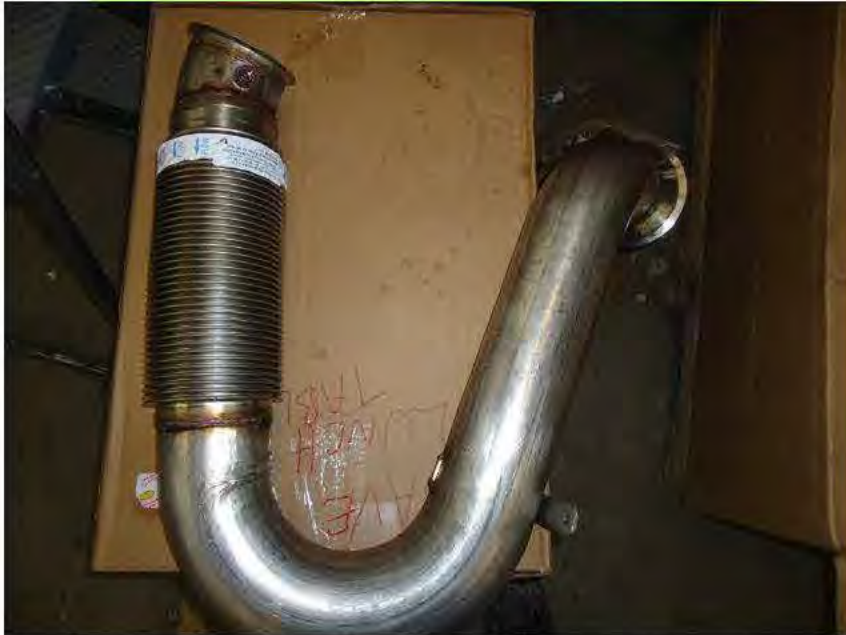
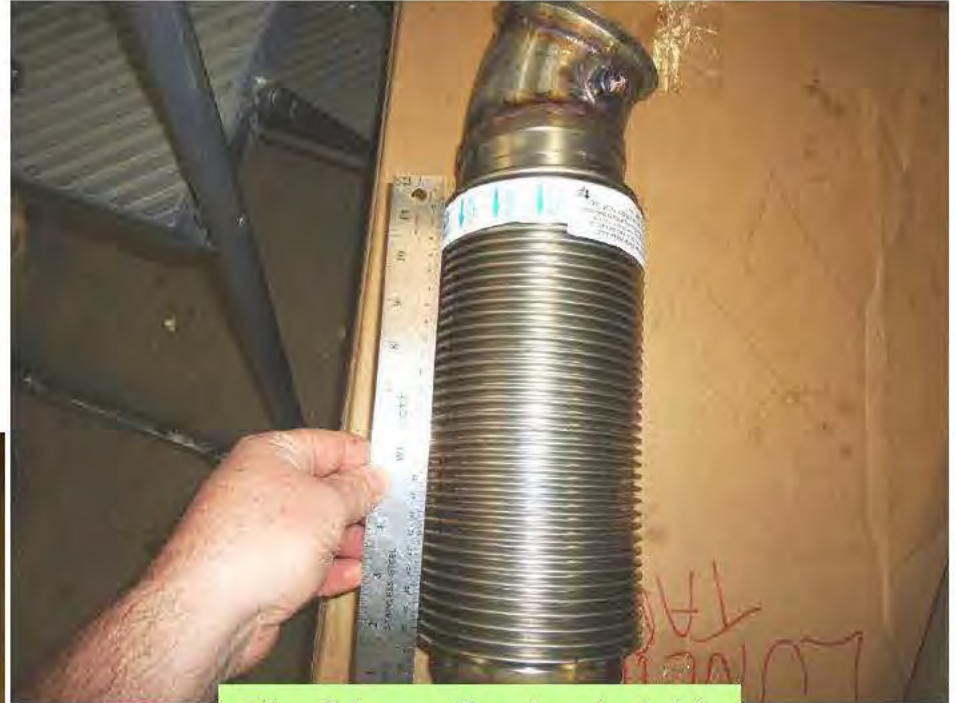
Exhaust as received in Pembina – relaxed state

Flexible portion is straight

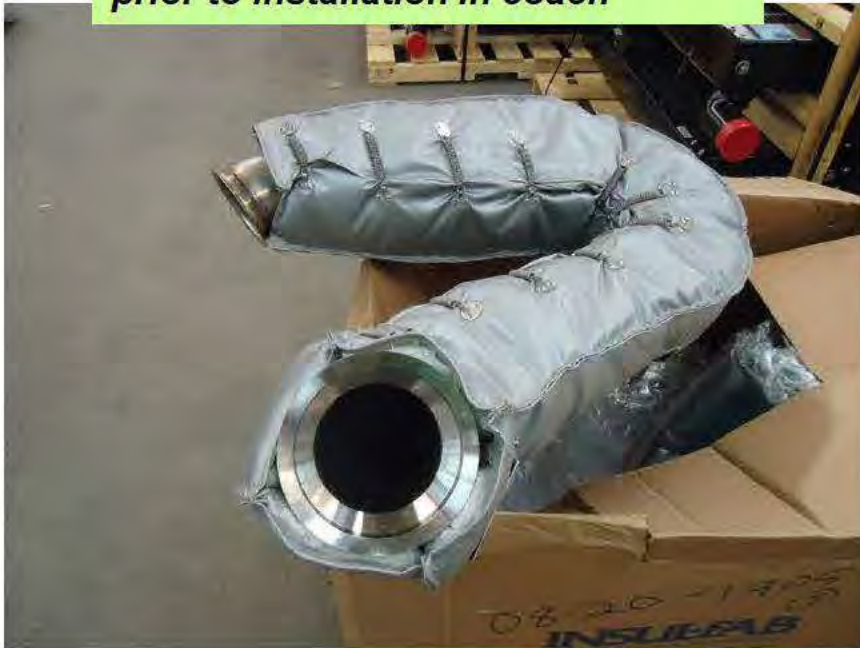
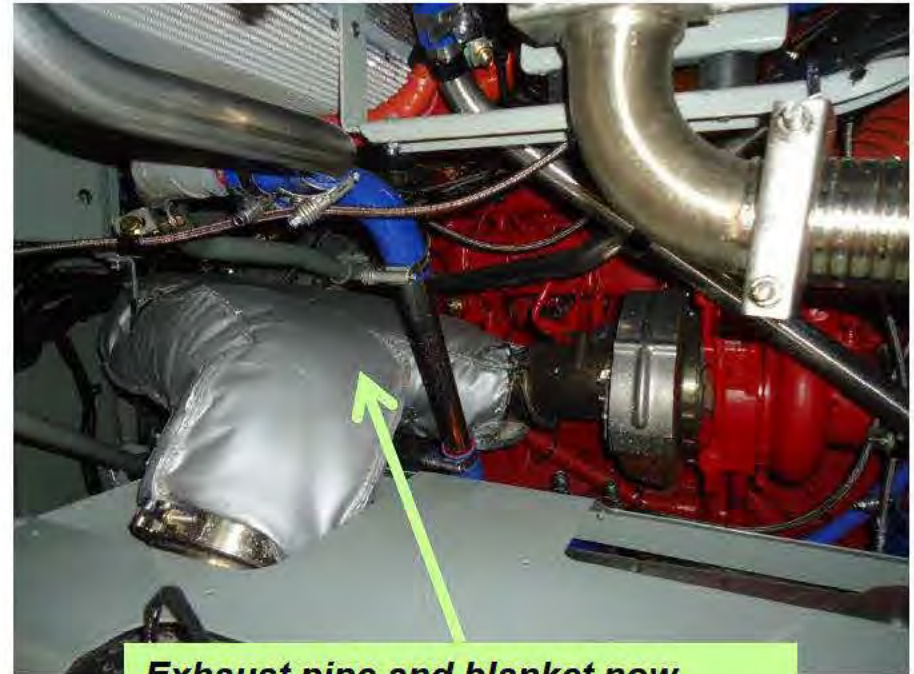
Exhaust blanket is installed on pipe prior to installation in coach

Exhaust pipe and blanket now installed in coach and attached to Cummins ISX engine turbo and DPF muffler

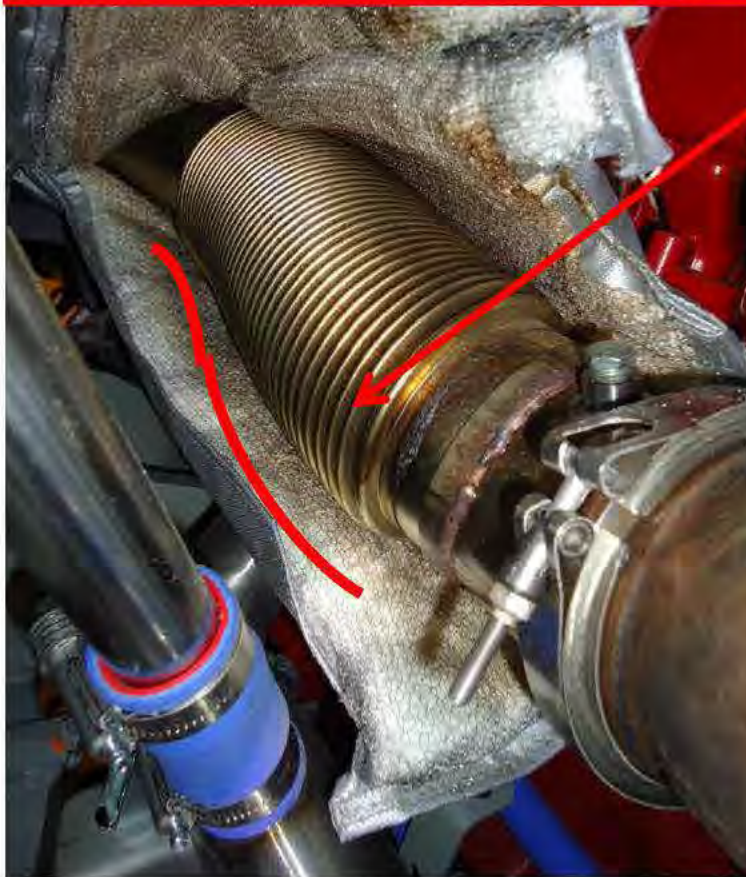
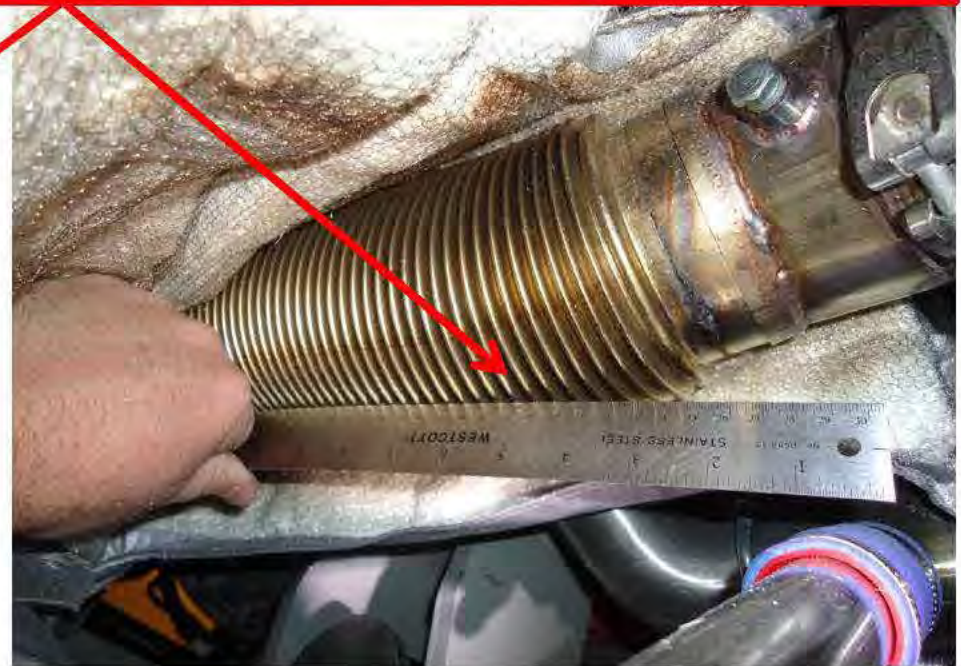
Exhaust pipe as installed in unit 12926 – Coach has been road tested.
Insulation removed to show flexible portion of exhaust.

Flexible portion is no longer straight but has a flexed or slight s-shape and fairly sharp bend at connection point to turbo.

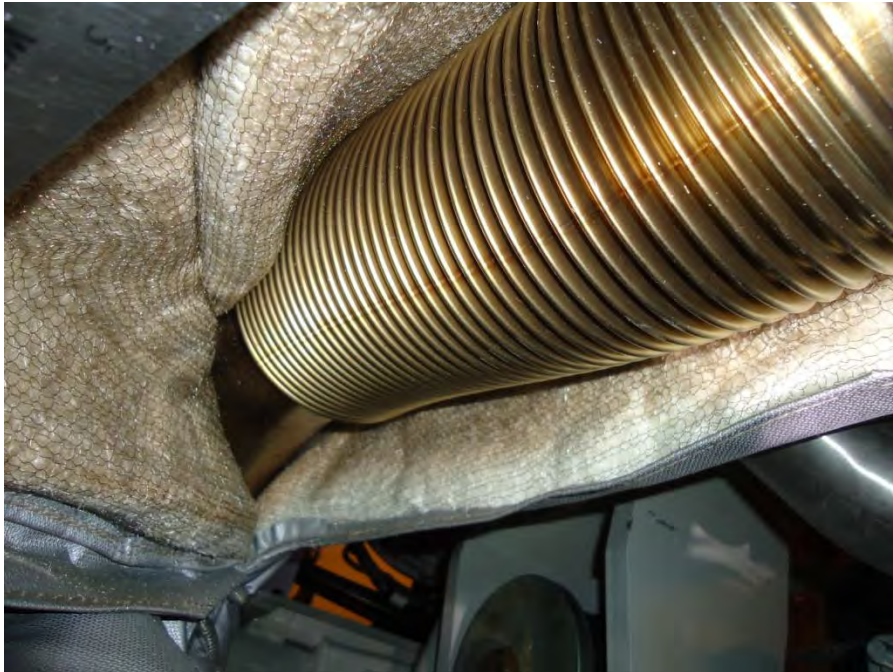
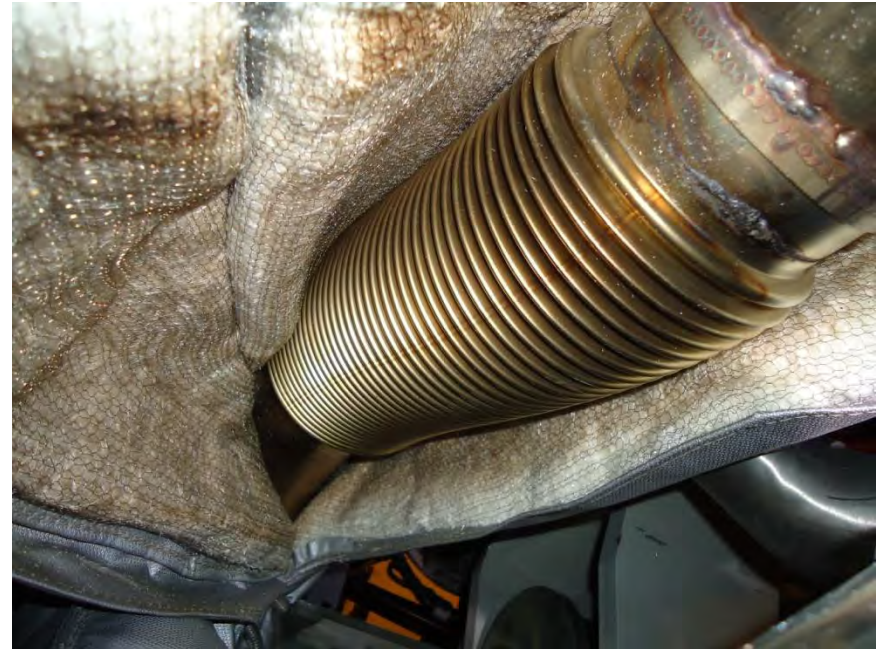
Additional photos of flexible portion of installed exhaust pipe in 12926.

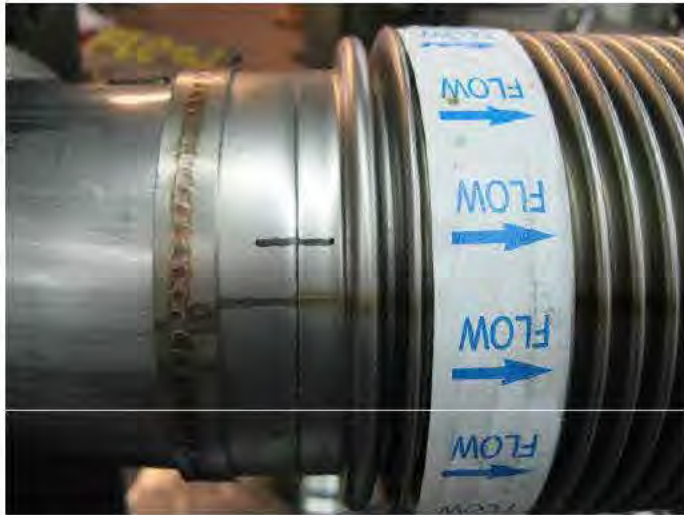
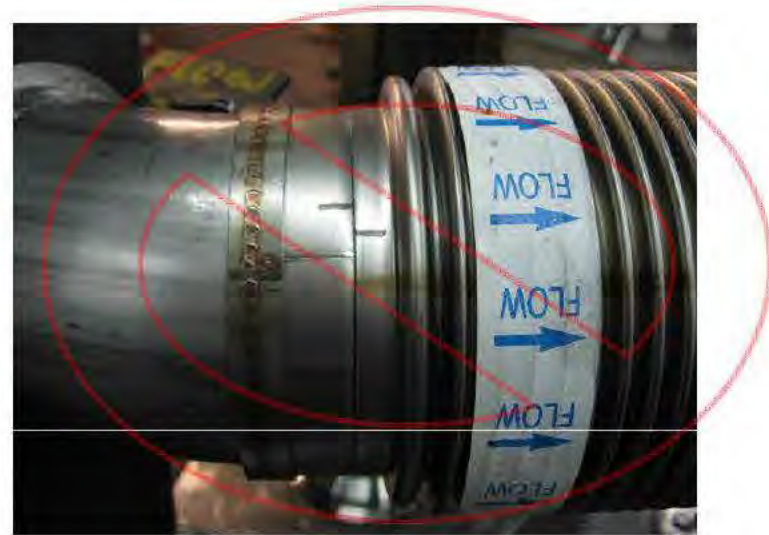
What is causing this deformation?

THIS PART APPEARS TO BE EXPERIENCEING EXCESSIVE MOVEMENT, POSSIBLY CAUSED BY A ROTATION OF INLET FLANGE. IT IS UNCLEAR IF ROTATION HAS OCCURRED DURING INSTALLATION OR DURING OPERATION.

INSTALLATION ALIGNMENT INDICATOR (IAI)

PROPER ALIGNMENT OF THIS MARK WILL ENSURE THAT THE BELLOWS IS IN A
'NEUTRAL/ UNFLEXED' STATE AT INSTALLATION.

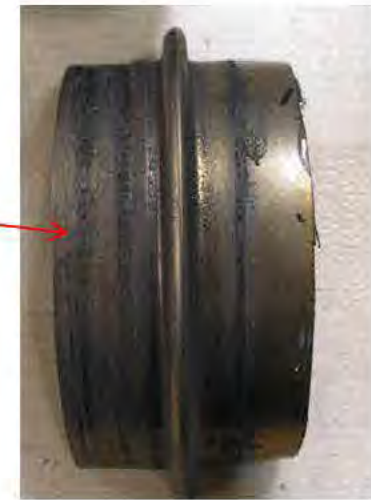
There were no indications of contact
or wear between the torsional sleeve
And the bellows. This is further
indication that the failure was purely
fatigue from misalignment and
motion.

- Both of the returned parts failed from a large amount of installation misalignment. This caused stress on the end corrugations. The failures occurred between the first and second corrugations. This is normal as this is the first point at which the bellows can move. The stress from the misalignment combined with the motion/vibration resulted in premature failure.
- Part # 1 showed more deformation on the outlet end of the bellows. It also appears to have ran for a period of time post-failure and resulted in the crack propagating into the third corrugation as well as wearing on the exhaust tube.
- Part #2 showed more deformation at the inlet end than Part #1 did. This resulted in two cracks between the first and second corrugations. These cracks appear to have started at the inside and the outside of the bend and then propagated around until the nearly met.

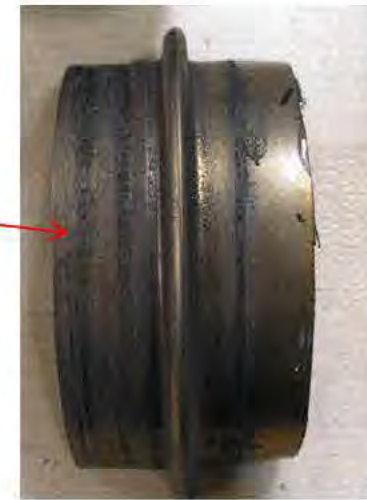
There were no indications of contact
or wear between the torsional sleeve
And the bellows. This is further
indication that the failure was purely
fatigue from misalignment and
motion.

- Both of the returned parts failed from a large amount of installation misalignment. This caused stress on the end corrugations. The failures occurred between the first and second corrugations. This is normal as this is the first point at which the bellows can move. The stress from the misalignment combined with the motion/vibration resulted in premature failure.
- Part # 1 showed more deformation on the outlet end of the bellows. It also appears to have ran for a period of time post-failure and resulted in the crack propagating into the third corrugation as well as wearing on the exhaust tube.
- Part #2 showed more deformation at the inlet end than Part #1 did. This resulted in two cracks between the first and second corrugations. These cracks appear to have started at the inside and the outside of the bend and then propagated around until the nearly met.
