# Safety Recall

## Code: 69L2

| <b>Subject</b> | <b>Steering Wheel Clock Spring</b> |
| <b>Release Date</b> | December 10, 2015 |

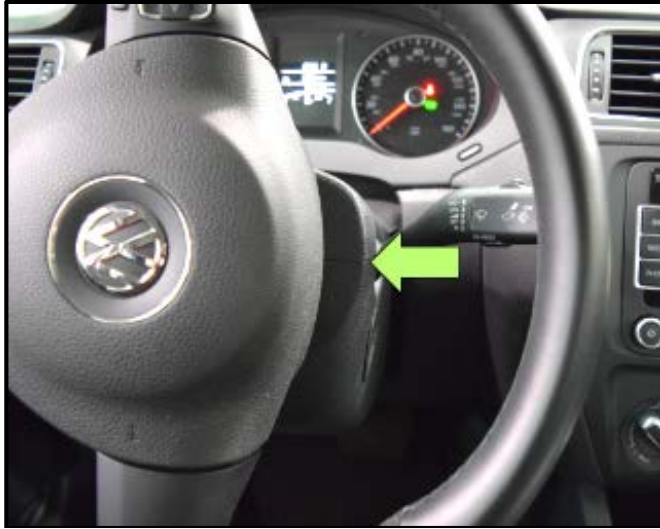
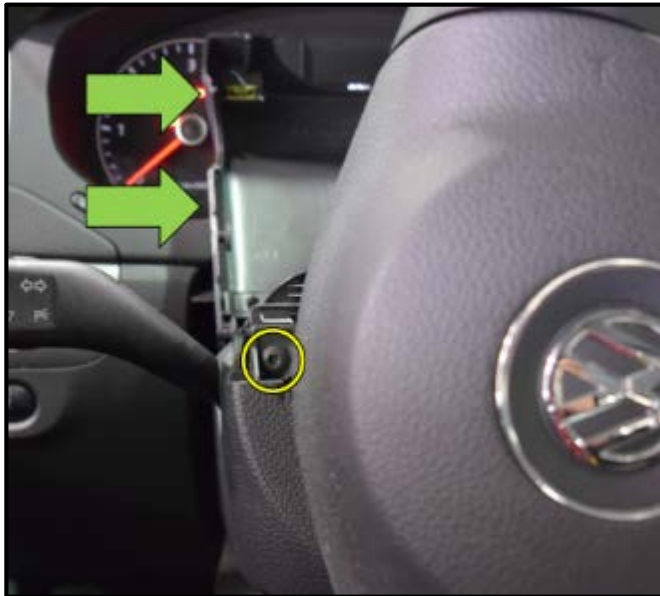
- If the airbag system faults include “Driver airbag igniter Resistance too high (B10001B)” or “Driver side airbag igniter (VAG00588) Upper limit exceeded” <as shown>, the clock spring **MUST** be replaced. Leave the VAS tester connected to the vehicle and **Proceed to Section D – Clock Spring Replacement**

- If the airbag system faults are unrelated to the driver airbag igniter circuit, additional diagnosis is required outside of this action. Clock spring replacement is not necessary. **Proceed to Section C – Clock Spring Cover Installation.**
