Jaguar Land Rover  
Limited  
Suspension Order

**Number:** 2019-004

**Title:** US NHTSA Engineering Analysis EA18-004 - Doors Opening whilst driving

**Model:** Range Rover (L405) and Range Rover Sport (L494)

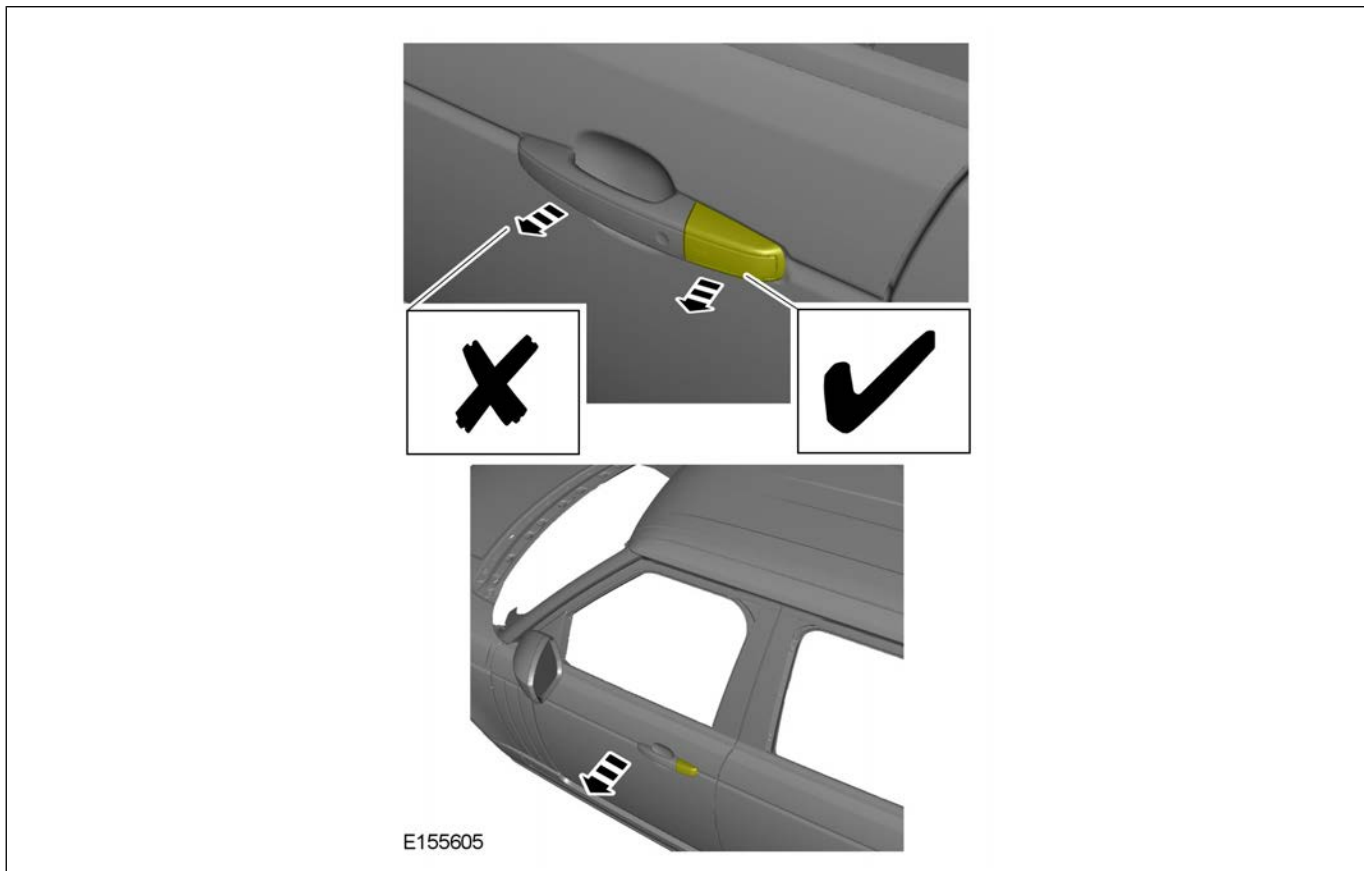
△ NOTE: Make sure that the door is pulled at the 'ticked' position shown. Do not pull on the door handle as this will cause the door to unlatch / open.

- Once the door is in the error state with the soft door close not pulling the door in, gently pull the door away from the vehicle body side by carefully pulling on the key cover.
- If the soft door close function then initiates and pulls the door onto the primary latch position, adjust the striker for the door inboard by 1mm (see step 3).

- Retest soft door close function, and make sure that panel flushness has not been affected by the adjustment.

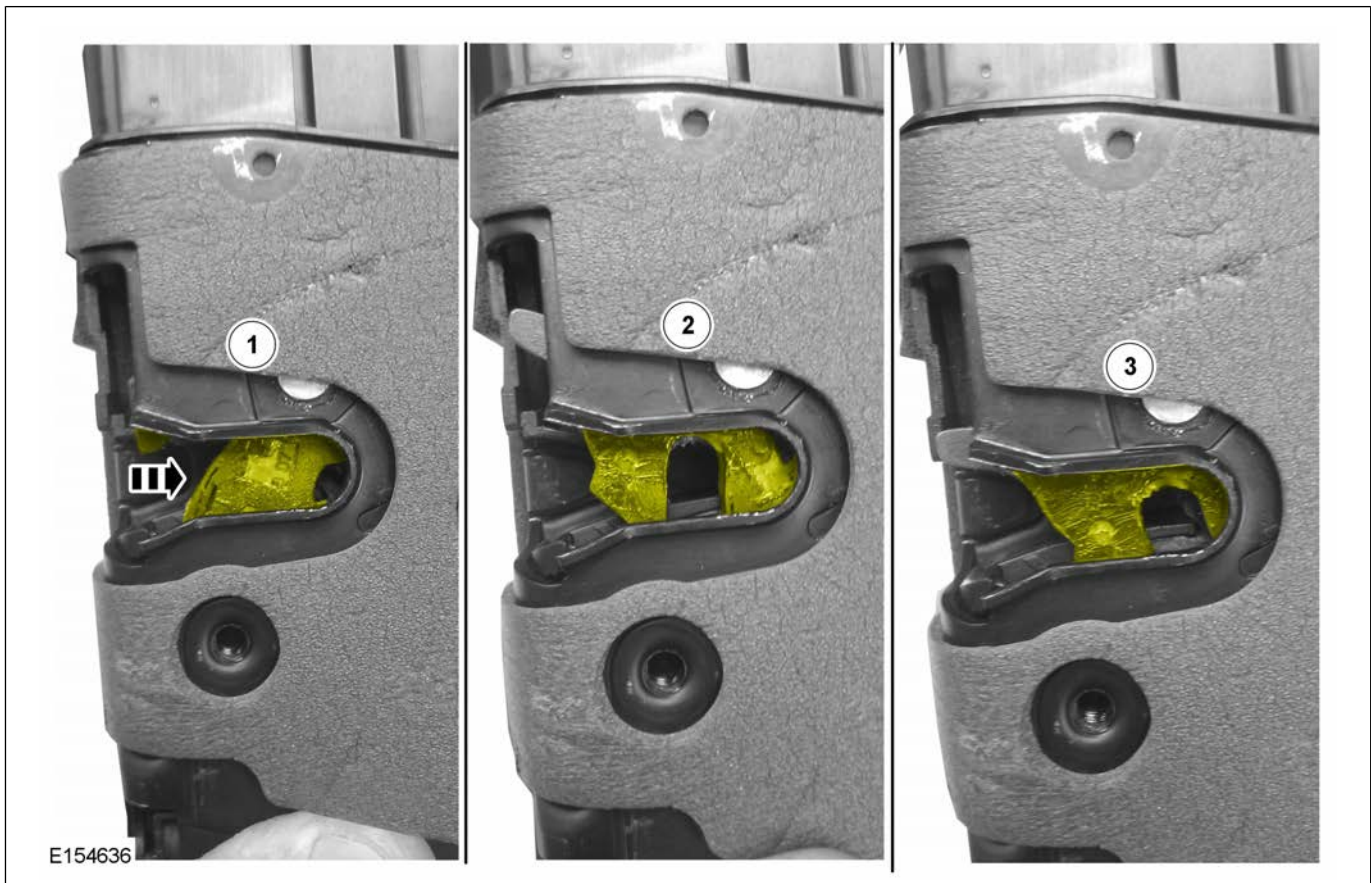
Check the operation of the door latch:

- Open the door.
- Using a suitable tool, carefully move the door latch from position 1 to position 2.
- The latch should automatically move from position 2 to position 3 due to the soft door close function.
- If the latch operates correctly in all three positions, carry on to step 2.
- If the soft door close function moves the door latch to position 3, wait for two (2) seconds. Operate the internal or external door handle and observe the door latch movement. If the door latch is slow to return to position 1 or if it stops at position 2 and then returns to position 3, carry out steps 4-6.
- If the door latch does not automatically move to position 3 **AND** cannot be manually moved to position 3, carry out steps 4-6.

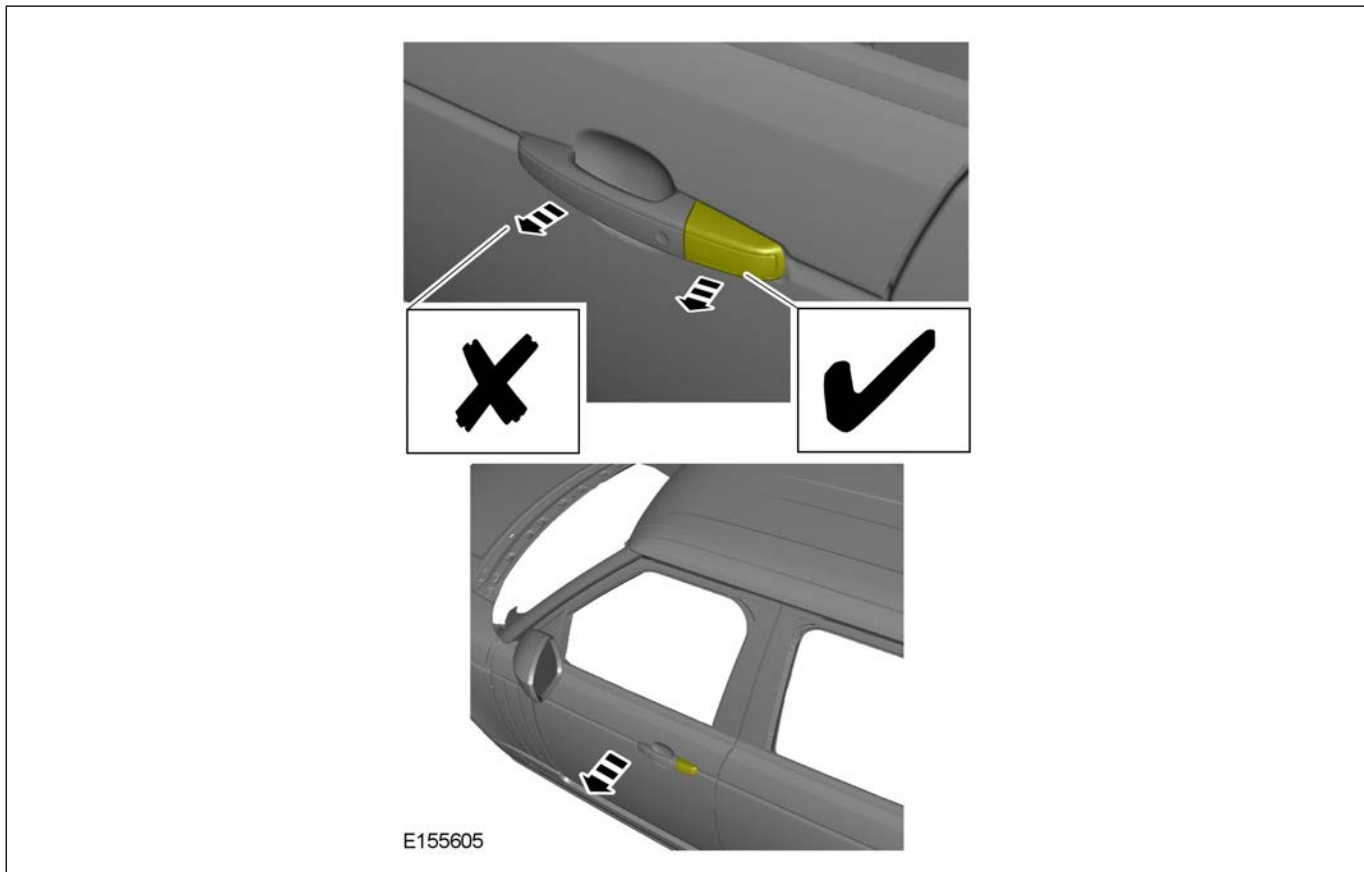
△ **NOTE:** Make sure that the door is pulled at the 'ticked' position shown. Do not pull on the door handle as this will cause the door to unlatch / open.

If the soft door close function is still intermittent, close the door and instigate the error state.

- Once the door is in the error state with the soft door close not pulling the door in, gently pull the door away from the vehicle body side by carefully pulling on the key cover.
- If the soft door close function then initiates and pulls the door onto the primary latch position, adjust the striker for the door inboard by 1mm (see step 3).
- Retest soft door close function, and make sure that panel flushness has not been affected by the adjustment.

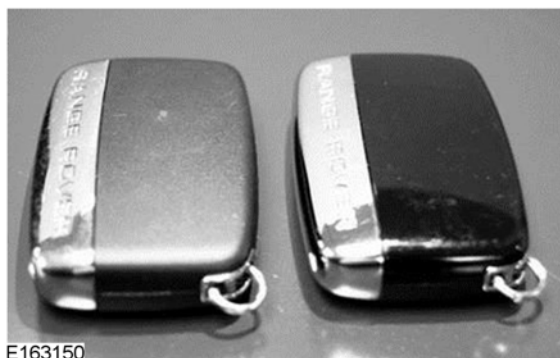
1. Identify the type of compact key handset currently fitted to the vehicle:

- Left = matte finish; continue to step 2.
- Right = gloss finish; a small quantity of Range Rover Evoque, Range Rover Sport, and Range Rover vehicles may have been manufactured gloss-finish compact key handsets. These handsets are no longer available. Should a Range Rover Evoque, Range Rover Sport, and Range Rover customer complain one of their gloss-finish handsets having the above concern, it is recommended to service the customer's remaining gloss-finish handsets as per the Service Instruction outlined below. Contact the customer prior to the repair and request the remaining gloss-finish handsets be present for their Service appointment. All customer handsets should match after the conclusion of the repair. Continue to step 2.

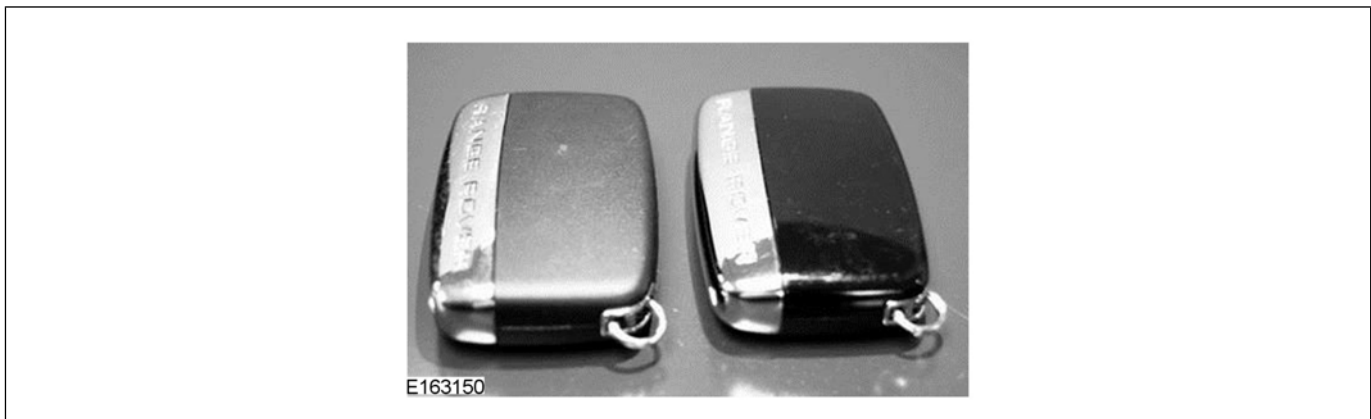
1. Identify the type of compact key handset currently fitted to the vehicle to ensure a like-for-like replacement handset is fitted:
  - Left = matte finish.
  - Right = gloss finish.

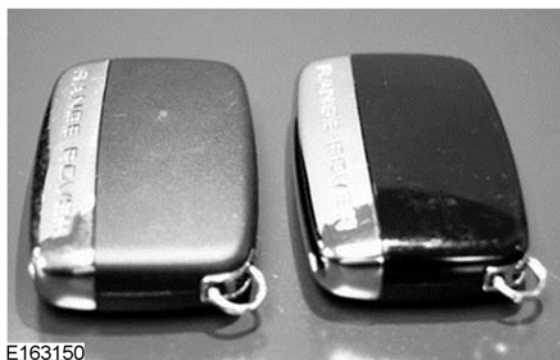
1. Identify the type of compact key handset currently fitted to the vehicle to ensure a like-for-like replacement handset is fitted:

- Left = matte finish.
- Right = gloss finish.

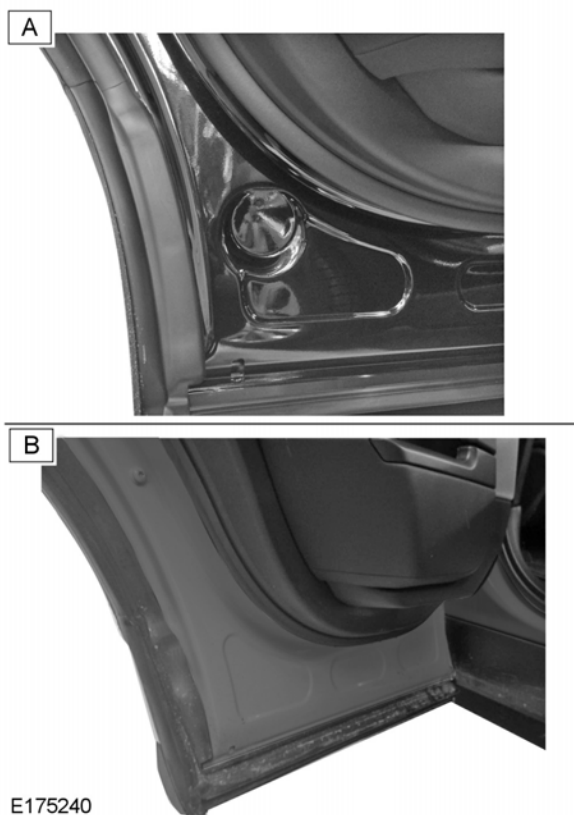
1. Check the rear door pressing to determine which plunger collar must be used in the following Service Instruction. If the door pressing is as picture 'A', then install the tapered plunger collar (LR066091). If the door pressing is as picture 'B', then install the non-tapered plunger collar (LR066092).

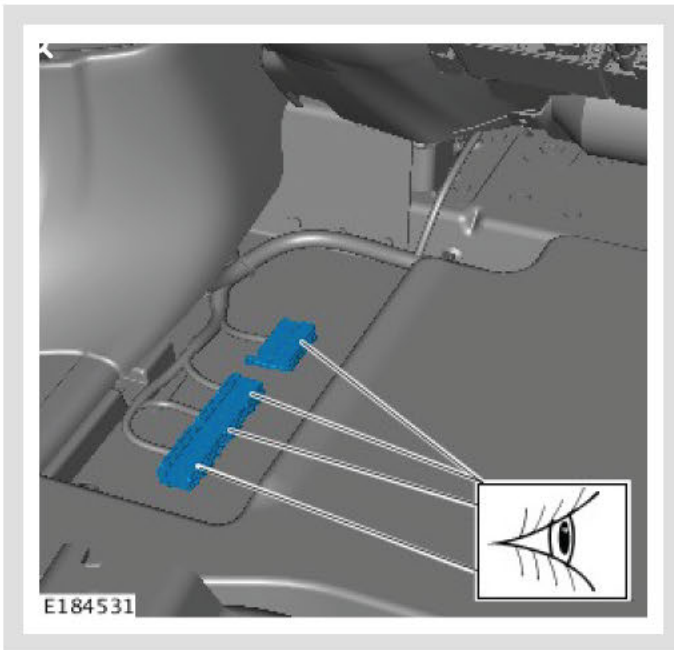
Check the following terminals for signs of corrosion:

- Range Rover Sport - rear left-hand footwell - C3PS186 A/B/C/D
- Range Rover Sport - rear right-hand footwell - C3PS185 A/B/C/D

- Range Rover - rear left-hand footwell - C3PS146 A/B/C/D
- Range Rover - rear right-hand footwell - C3PS145 A/B/C/D.
  - If no corrosion is evident in any connector, continue with normal diagnosis. Use SDD with reference to TOPIx.

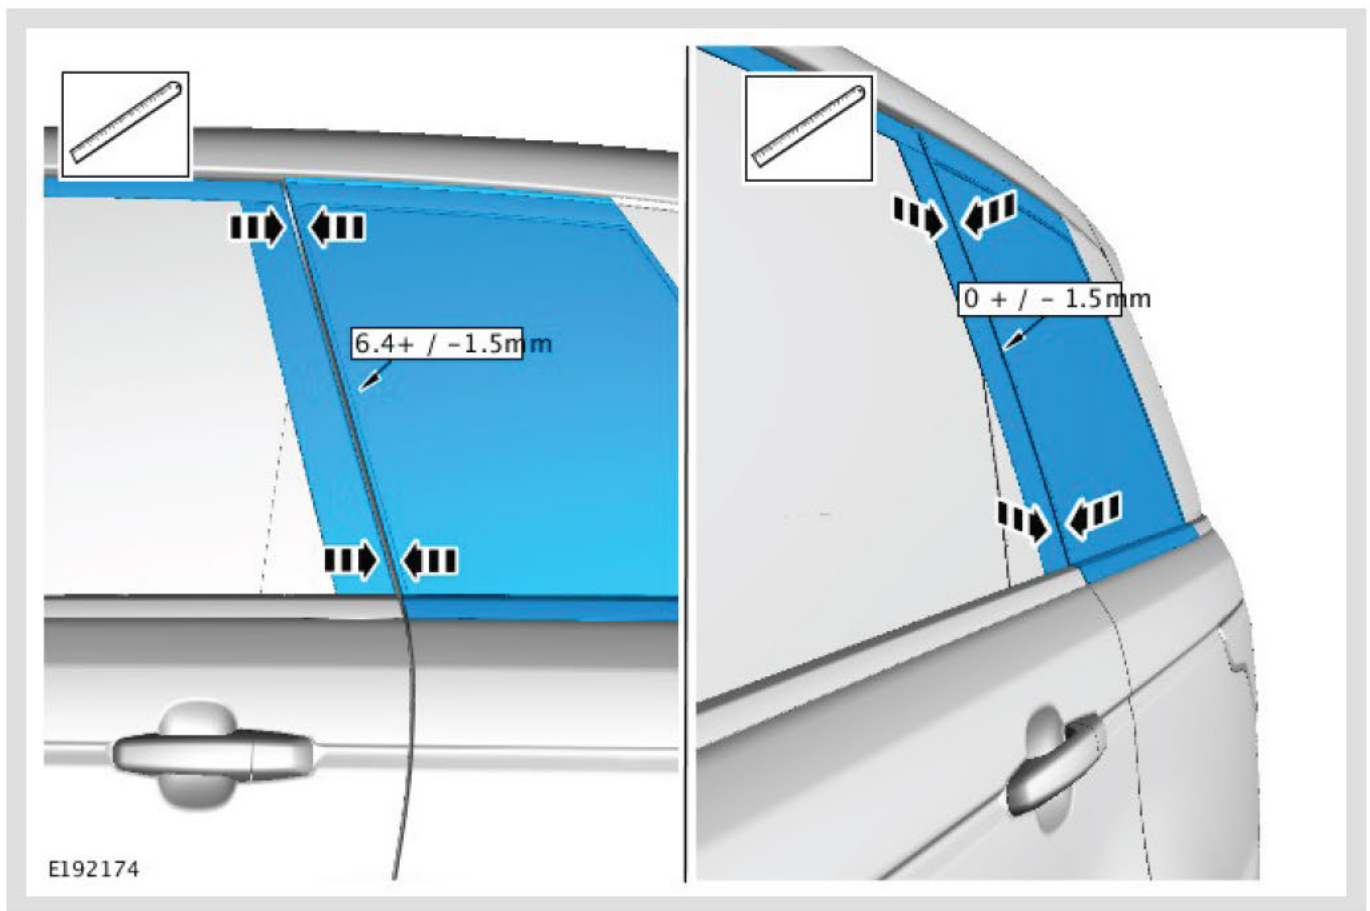
Measure the alignment between the rear door and rear quarter window (record measurement).

- 1 If the alignment does not meet the specifications shown, go to Step 2.
- 2 If the alignment does meet the specifications, apply slip coating (as supplied in the Squeak & Rattle kit) to the margin seal flock coating and front edge of the rear quarter window.
  - Apply 6-8 times, allowing approximately 5 minutes between applications for each coat to dry.

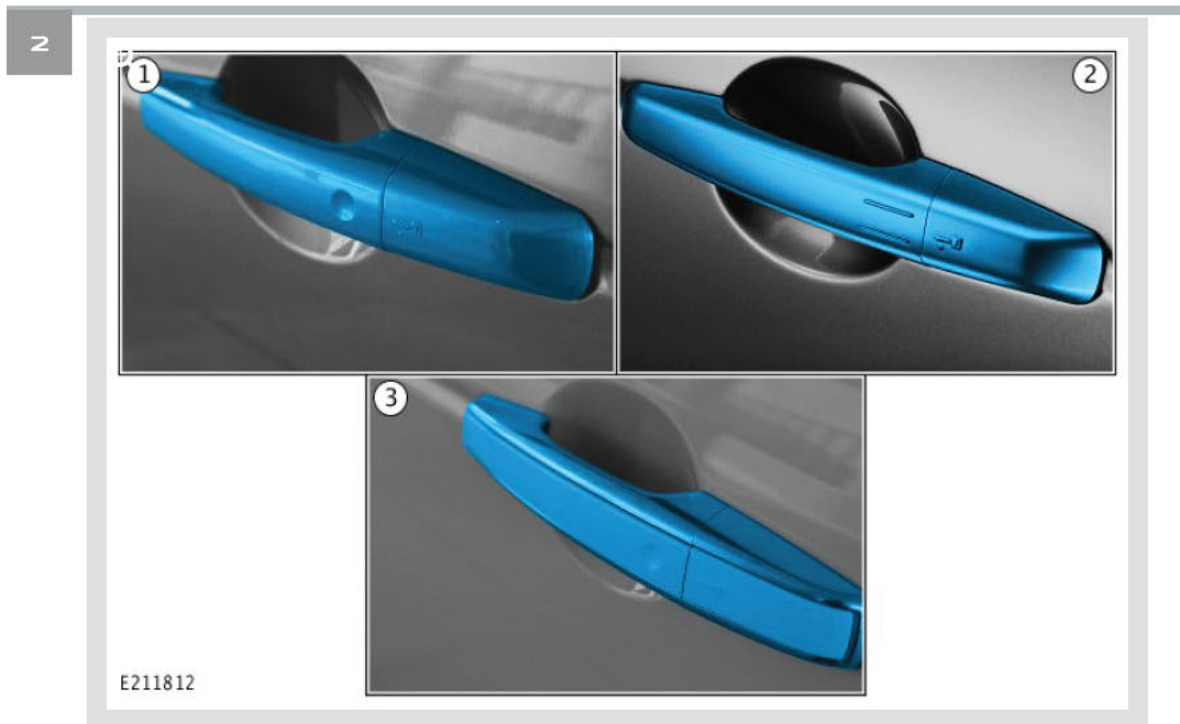
Inspect the type of handle that is to be replaced, to make sure the correct replacement handle is ordered for the vehicle. Refer to the illustration for the different handle types.

- (1) shows the dimple type handle LR061200.
- (2) shows the stripe type handle LR040667.
- (3) shows the chrome type handle supplied by color.

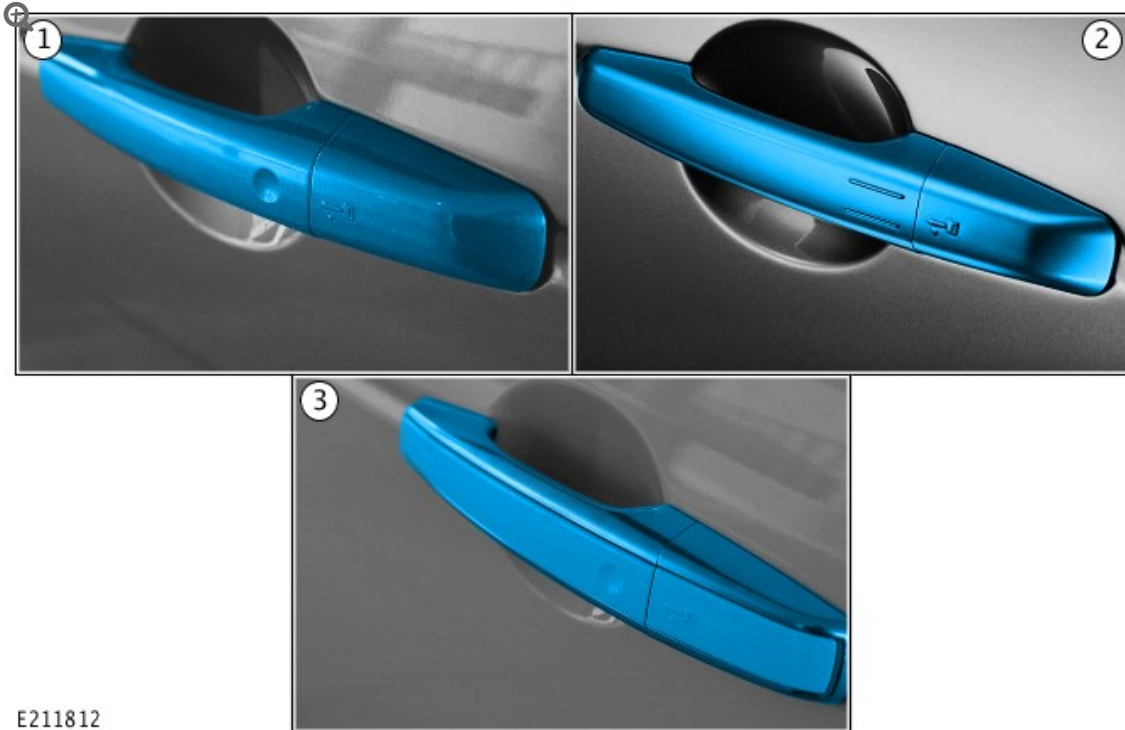
E211812

Identify the existing door exterior handle(s).

- (1) - 'dimple' type handle
- (2) - 'stripe' type handle
- (3) - 'chrome' type handle

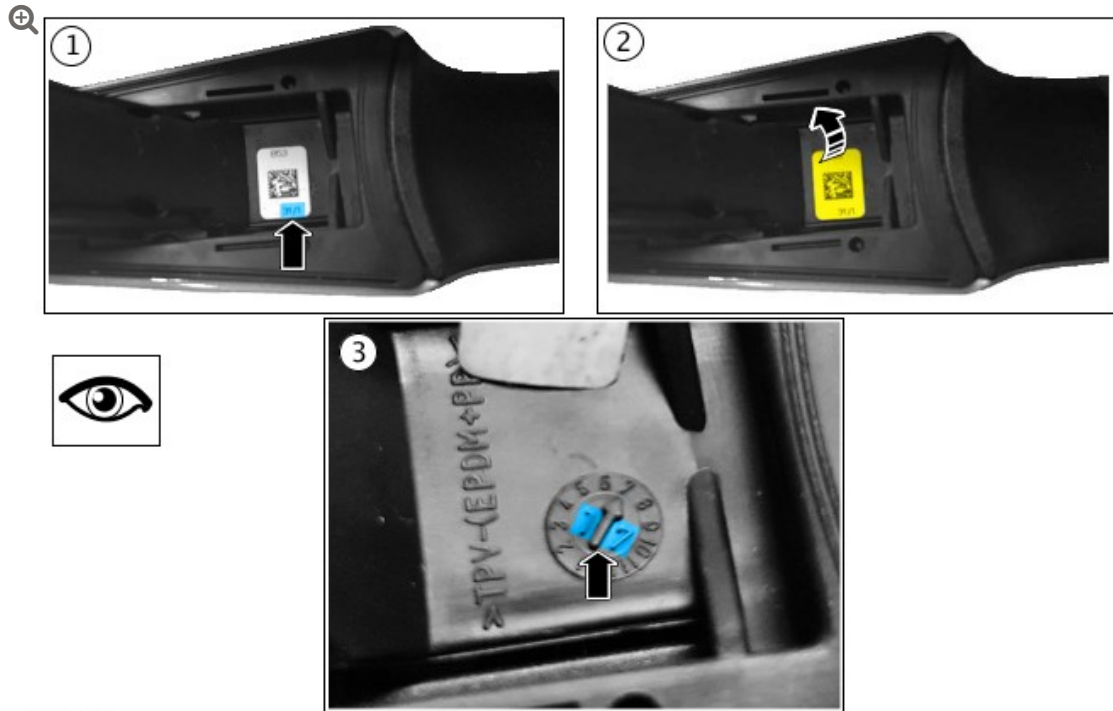
E222292

Record the production date of the NEW door exterior handle(s).

- 1 The label displays the production day and month. ('31/1' = 31 January).
- 2 Peel back the label to display the production year stamp ('17' = 2017).
  - If the production date is 03/08/2017 (03 August 2017) or later, **go to Step 4.**
  - If the production date is 02/08/2017 (02 August 2017) or earlier, **go to Step 3.**

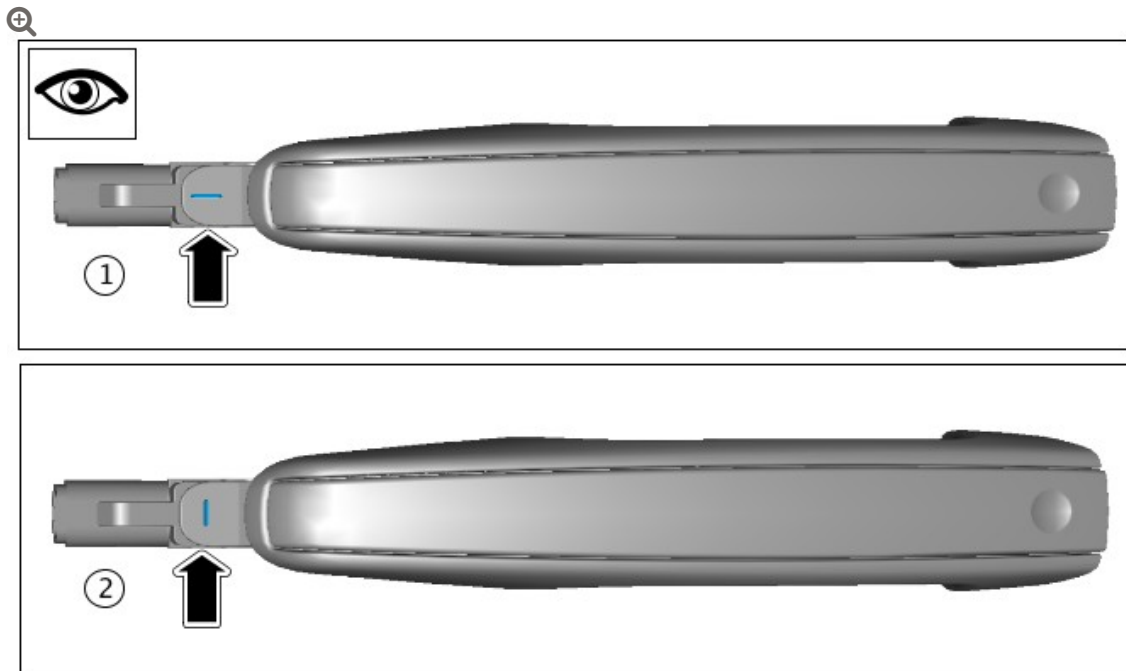
E222286

Inspect the marking(s) on the replacement door exterior handle(s).

- Horizontal marking **(1)** denotes that the handles are supplied pre-assembled. **Go to Step 4.**
- Vertical marking **(2)** denotes that the handles are supplied in kit form. **Go to Step 4.**
- If the new door exterior handle(s) have neither of the above markings and have a production date of 02/08/2017 or earlier, **DO NOT** use these parts. **Return the parts order new replacement door exterior handles and follow the steps above again.**

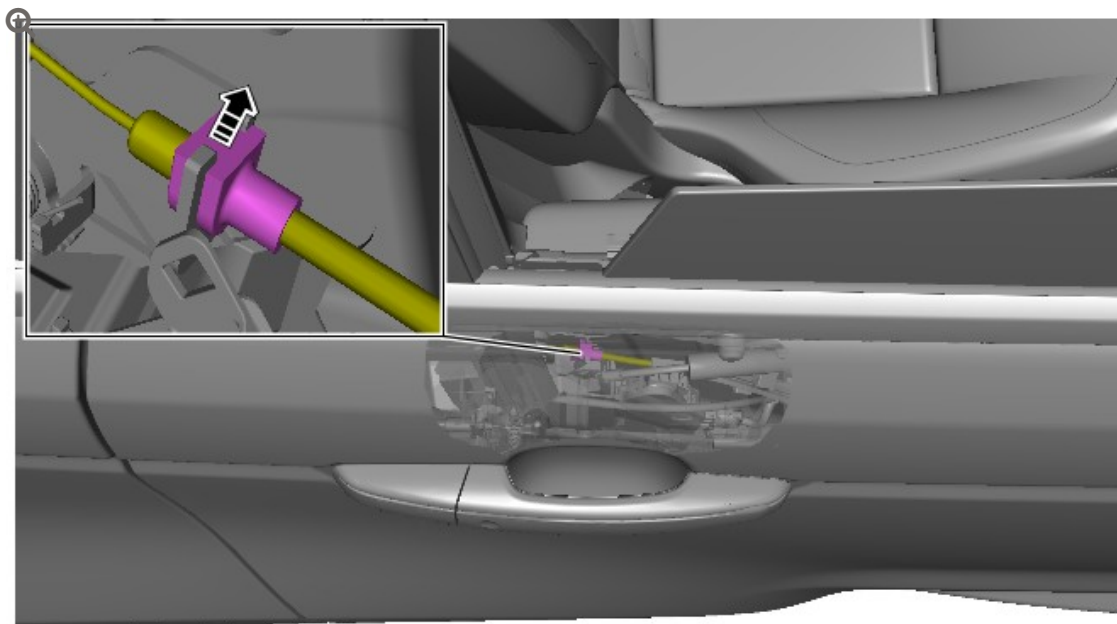
E223621

These may be caused by internal failure of the door closing motor.

Use a suitable piece of wire to remove the door closing motor cable connector from the door latch.

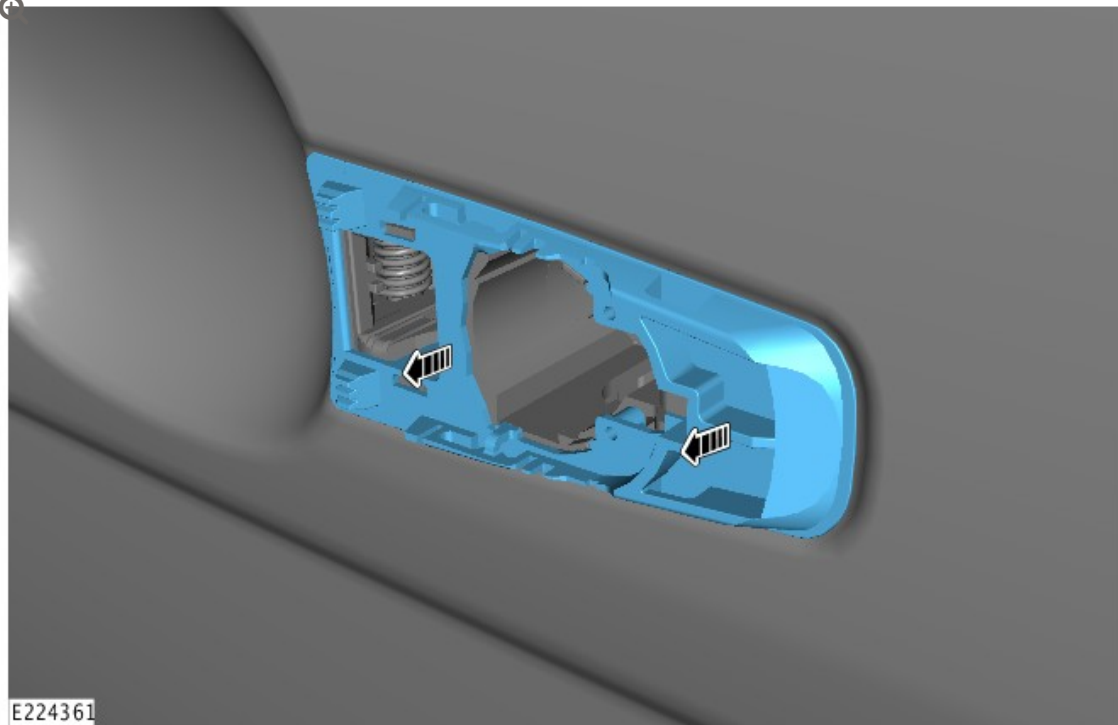
This may be caused by insufficient retaining features on the driver's door exterior handle gasket.

Remove the front left door exterior handle gasket.

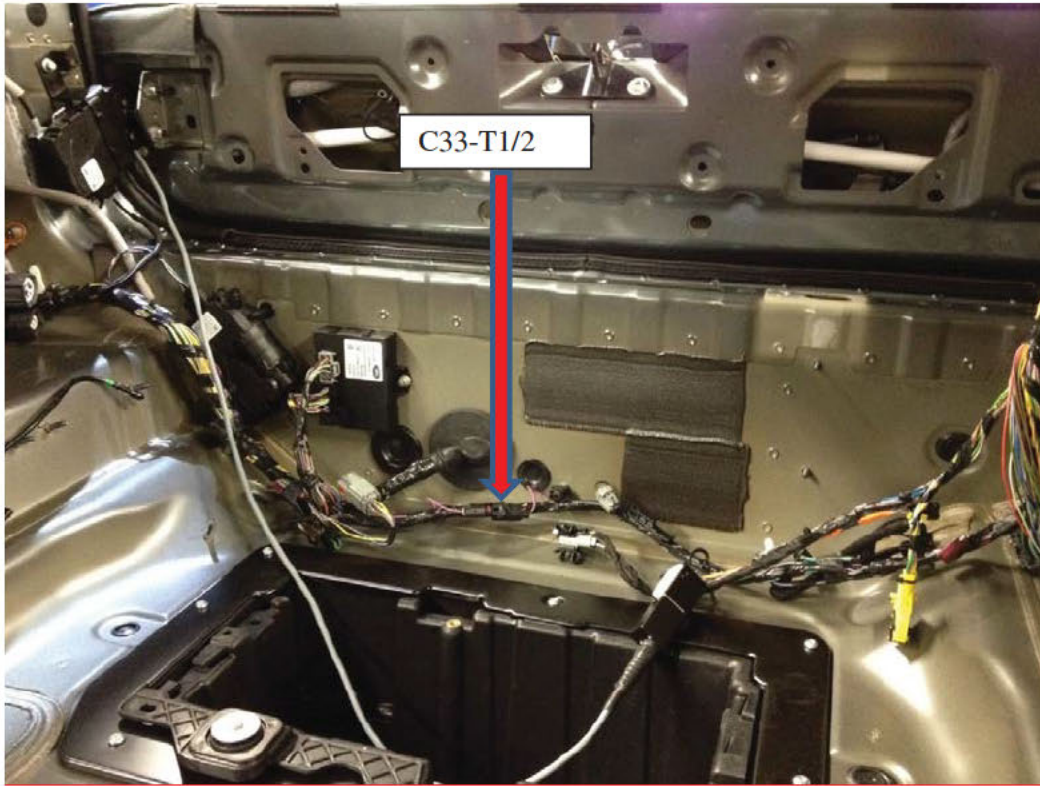
**Content :** **Issue:** The door soft close feature is found to be inoperative on the driver's door only during Pre Delivery Inspection (PDI).

**Cause:** At 15MY onwards a new feature is introduced that disables the driver's door soft close cinch motor (where fitted) for transportation purposes. As part of the PDI it will be necessary to reconnect C33-T1/2 (located at the rear of the spare wheel well) to enable the soft close feature.

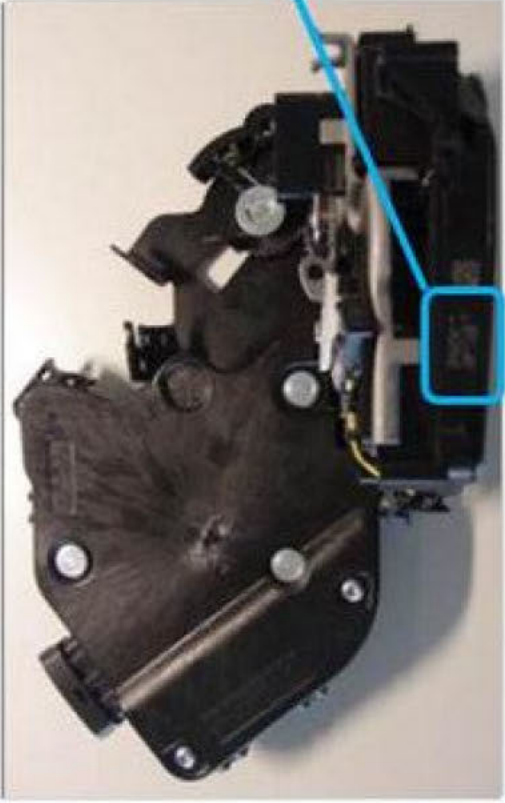
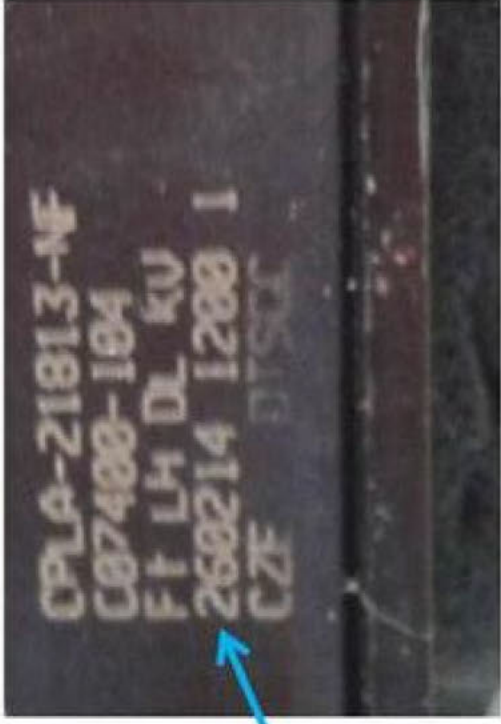
Attached file lists the part numbers affected

If your dealership does not lie within these regions, take note of which door is failing to latch closed and then replace only the affected latch on the vehicle with approved new parts as stated and report this action by submitting an EPQR.
