Jaguar Land Rover
Limited
Suspension Order

Number: 2019-004

Title: US NHTSA Engineering Analysis EA18-004 - Doors Opening whilst driving

Model: Range Rover (L405) and Range Rover Sport (L494)

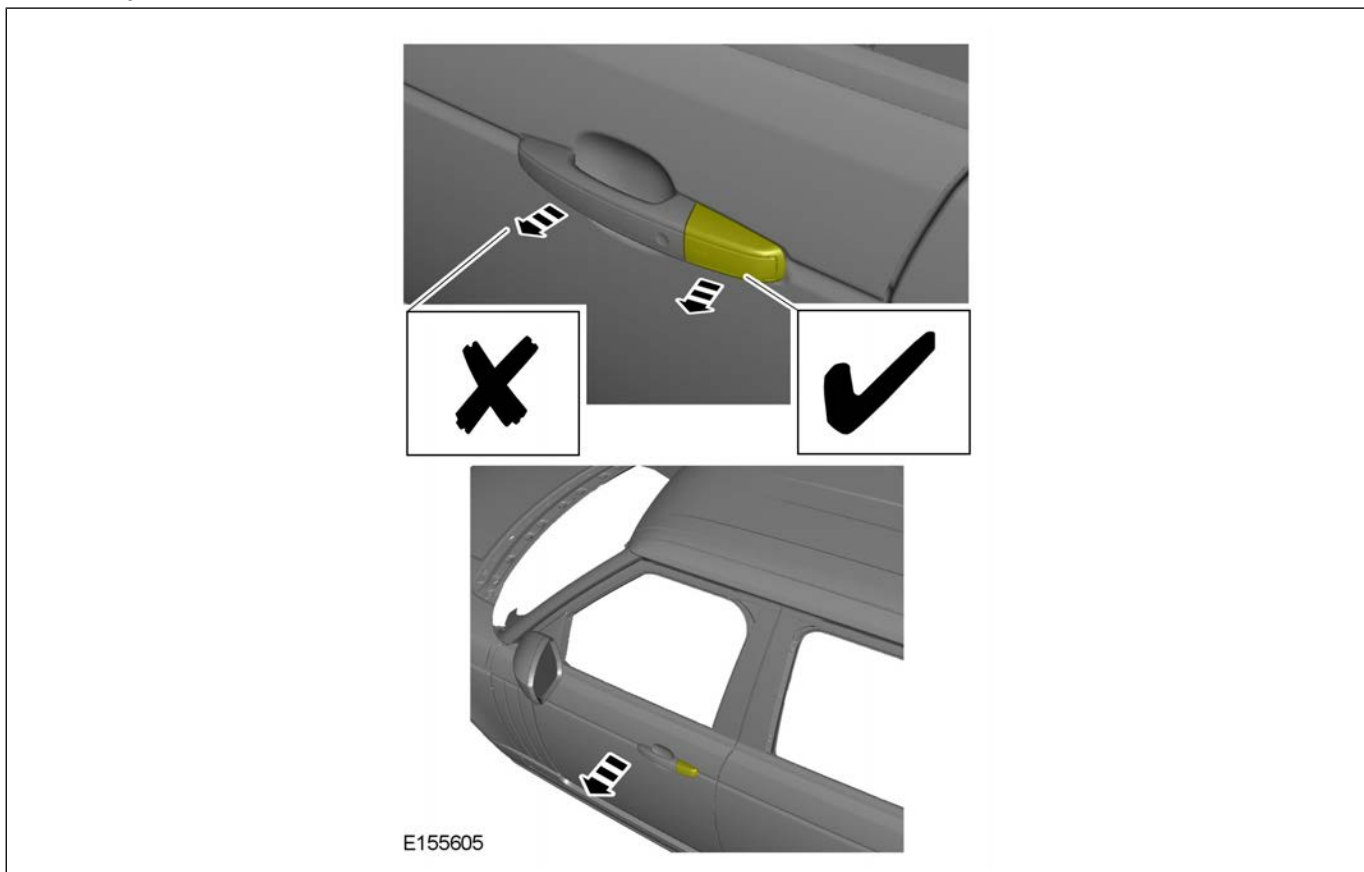
2. △ **NOTE:** Front left shown; others similar.

△ **NOTE:** Make sure that the door is pulled at the 'ticked' position shown. Do not pull on the door handle as this will cause the door to unlatch / open.

If the soft door close function is still intermittent, close the door and instigate the error state.

- Once the door is in the error state with the soft door close not pulling the door in, gently pull the door away from the vehicle body side by carefully pulling on the key cover.
- If the soft door close function then initiates and pulls the door onto the primary latch position, adjust the striker for the door inboard by 1mm (see step 3).
- Retest soft door close function, and make sure that panel flushness has not been affected by the adjustment.

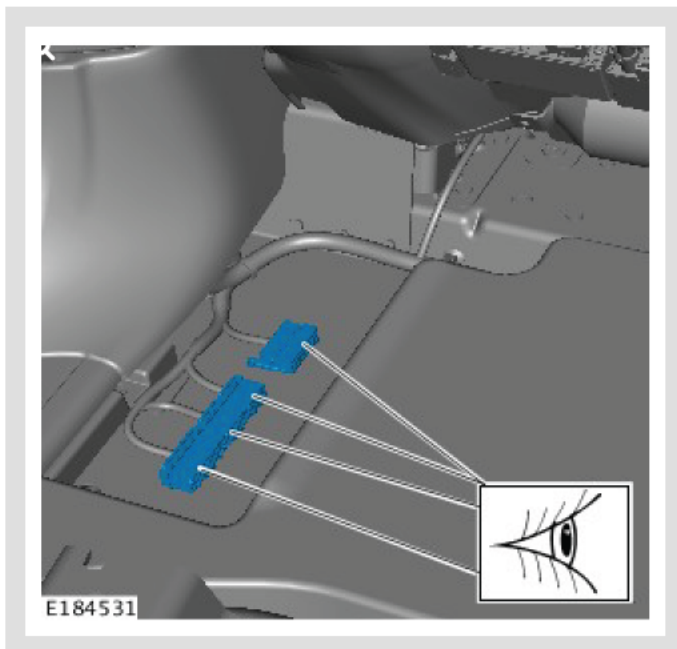
Check the following terminals for signs of corrosion:

- Range Rover Sport - rear left-hand footwell - C3PS186 A/B/C/D
- Range Rover Sport - rear right-hand footwell - C3PS185 A/B/C/D

- Range Rover - rear left-hand footwell - C3PS146 A/B/C/D
- Range Rover - rear right-hand footwell - C3PS145 A/B/C/D.
 - If no corrosion is evident in any connector, continue with normal diagnosis. Use SDD with reference to TOPIx.

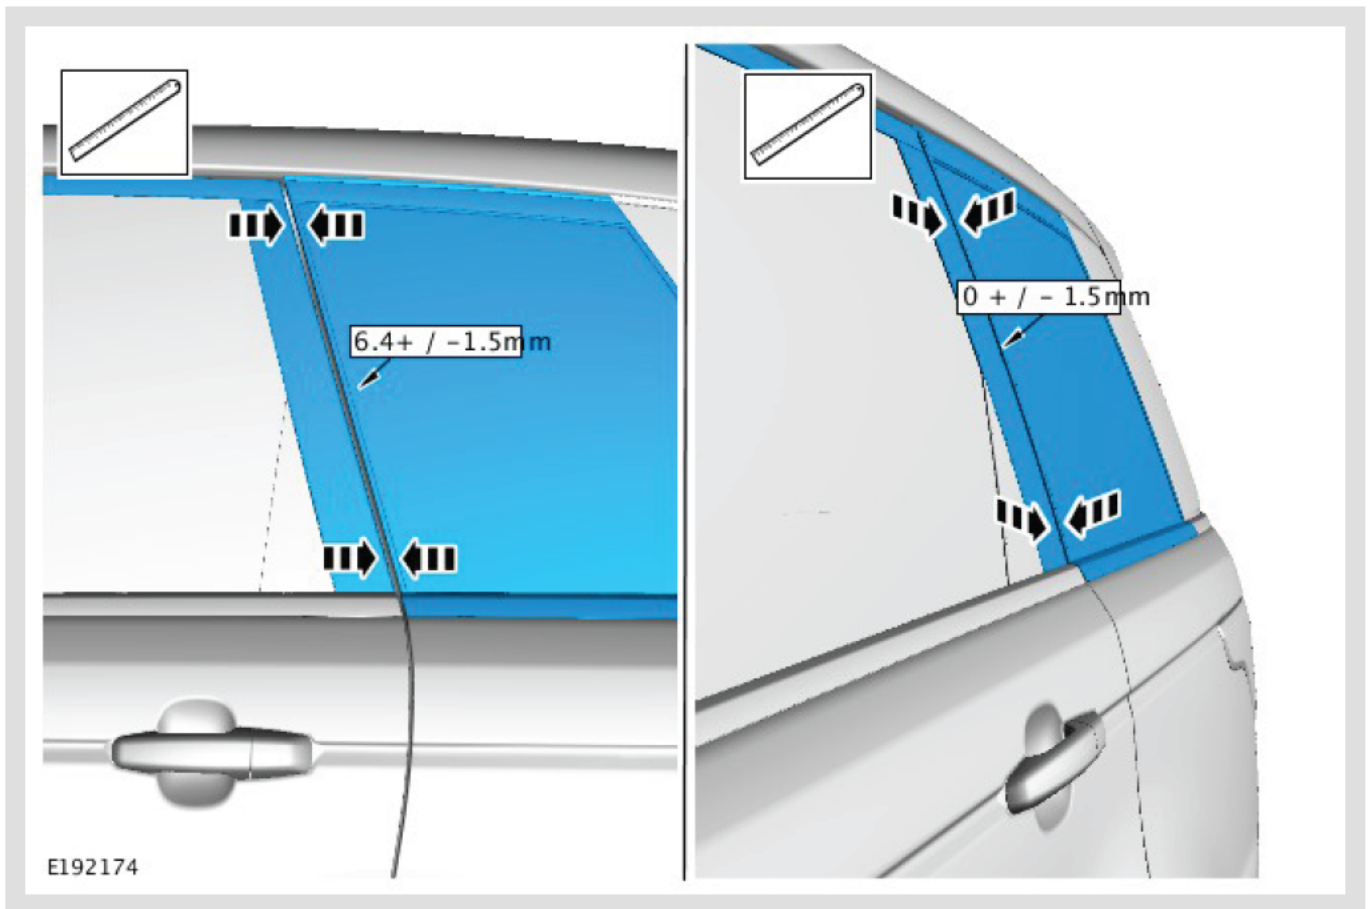
Measure the alignment between the rear door and rear quarter window (record measurement).

- 1 If the alignment does not meet the specifications shown, go to Step 2.
- 2 If the alignment does meet the specifications, apply slip coating (as supplied in the Squeak & Rattle kit) to the margin seal flock coating and front edge of the rear quarter window.
 - Apply 6-8 times, allowing approximately 5 minutes between applications for each coat to dry.

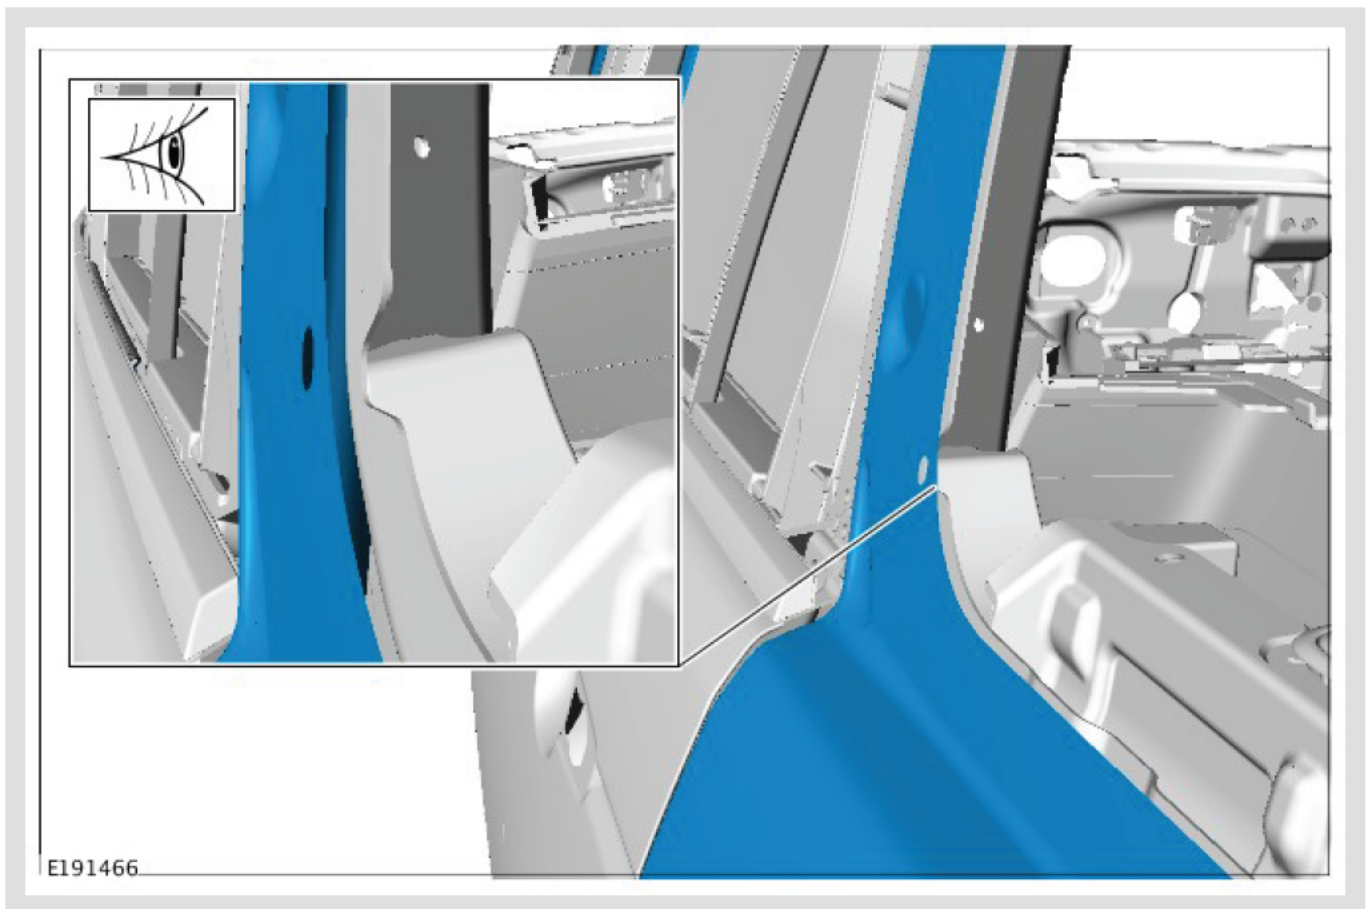
Visually check the body panel.

- 1 If there is a gap between the body panel and reinforcement panel, go to Step 7.
- 2 If there is no gap between the body panel and reinforcement panel, go to Step 8.

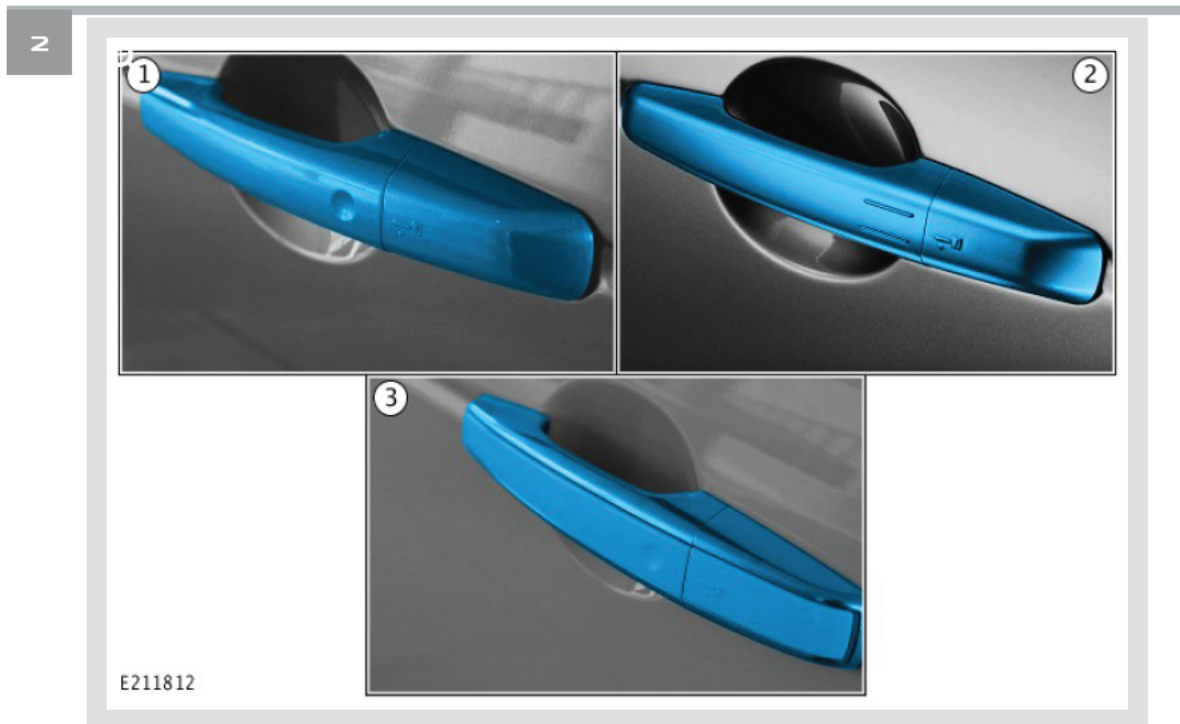
Inspect the type of handle that is to be replaced, to make sure the correct replacement handle is ordered for the vehicle. Refer to the illustration for the different handle types.

- (1) shows the dimple type handle LR061200.
- (2) shows the stripe type handle LR040667.
- (3) shows the chrome type handle supplied by color.

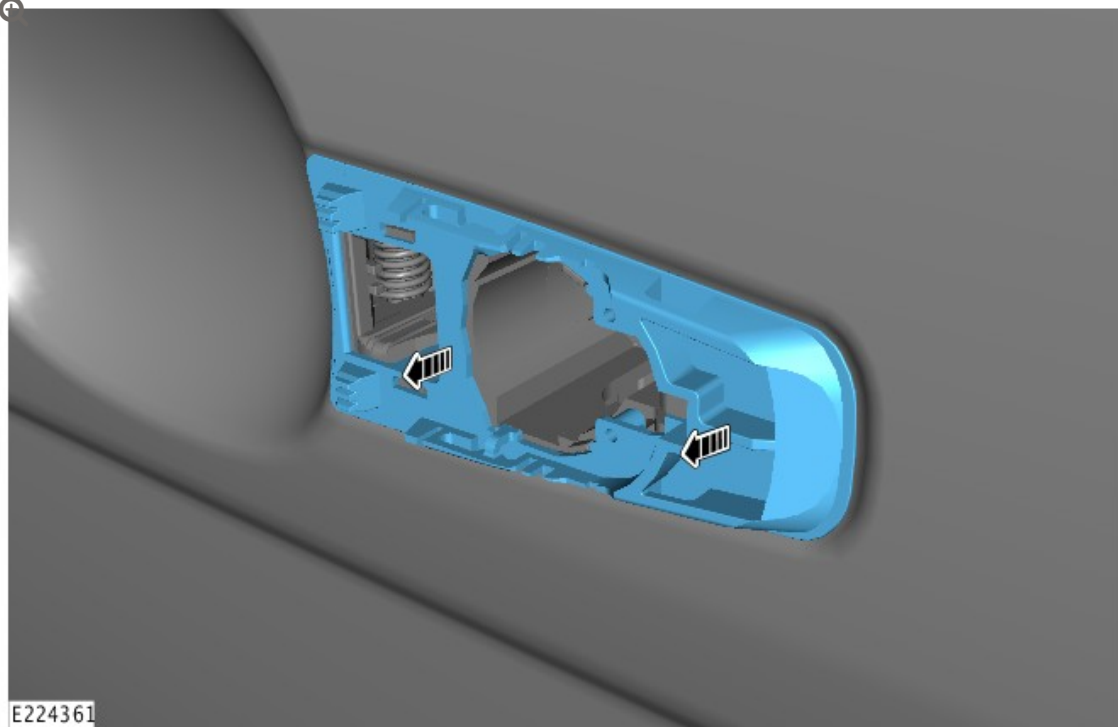
This may be caused by insufficient retaining features on the driver's door exterior handle gasket.

Remove the front left door exterior handle gasket.

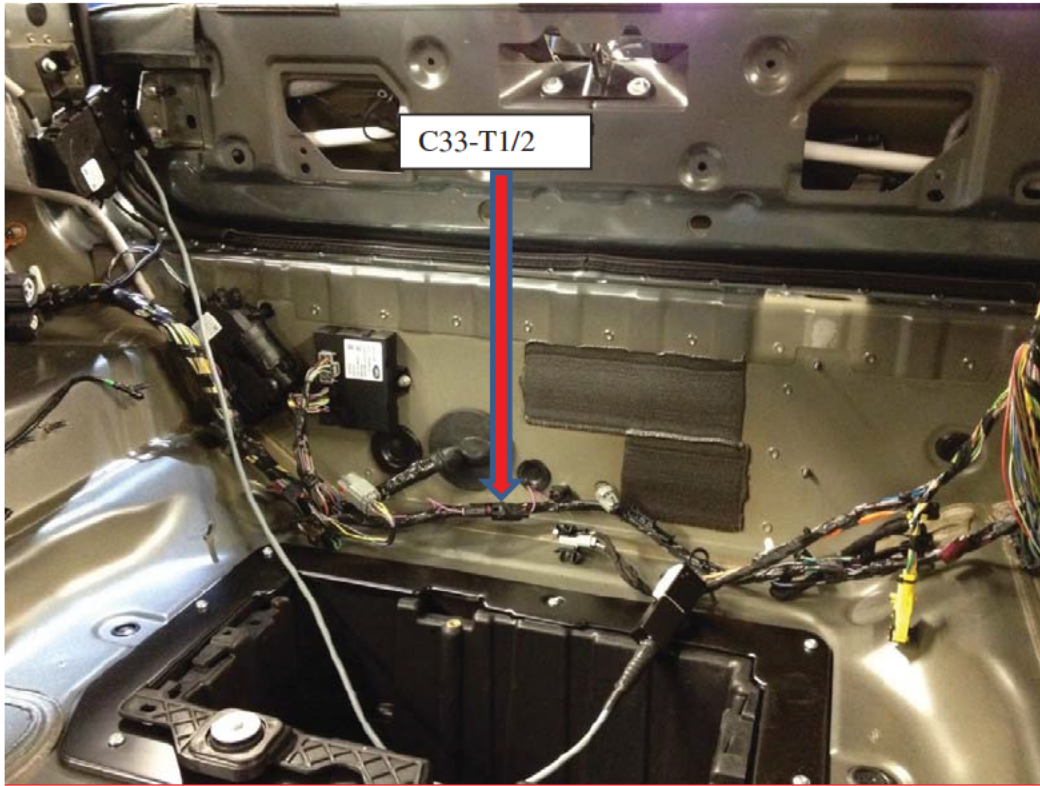
Content : **Issue:** The door soft close feature is found to be inoperative on the driver's door only during Pre Delivery Inspection (PDI).

Cause: At 15MY onwards a new feature is introduced that disables the driver's door soft close cinch motor (where fitted) for transportation purposes. As part of the PDI it will be necessary to reconnect C33-T1/2 (located at the rear of the spare wheel well) to enable the soft close feature.
