Scope and Prioritise Potential Causes

Intermediate result of KV actuator analysis

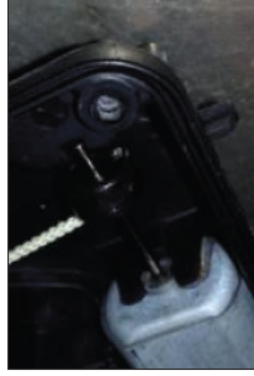
After KV operation at test box with open circuit cord fully unwound
→ OK
