Separation of 6-panel document on the 15th of September 2017 in two parts for better handling:

Scope and Prioritise Potential Causes

Intermediate result of KV actuator analysis

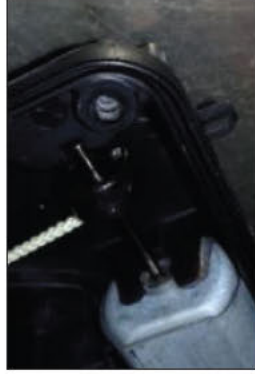
After KV operation at test box with open circuit cord fully unwound
 → OK
