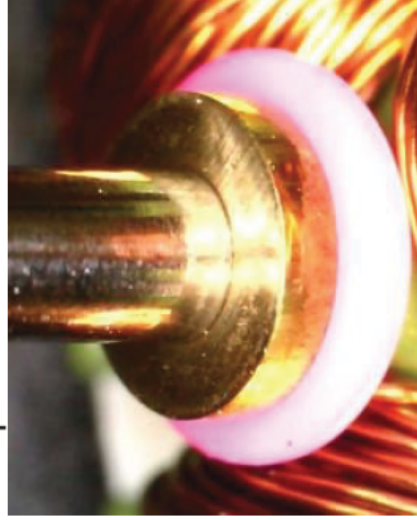
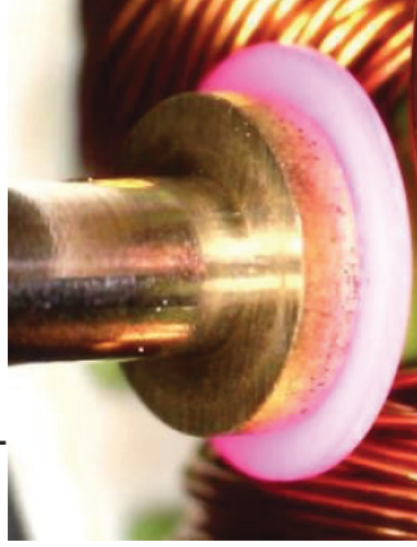
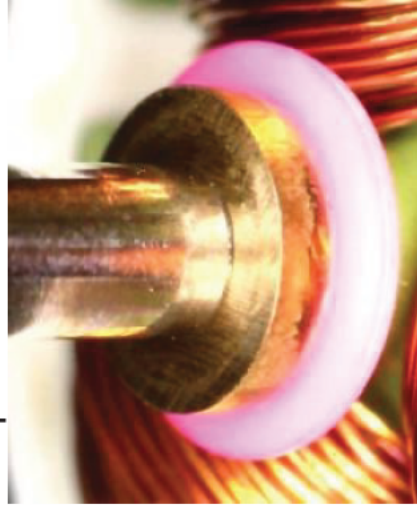
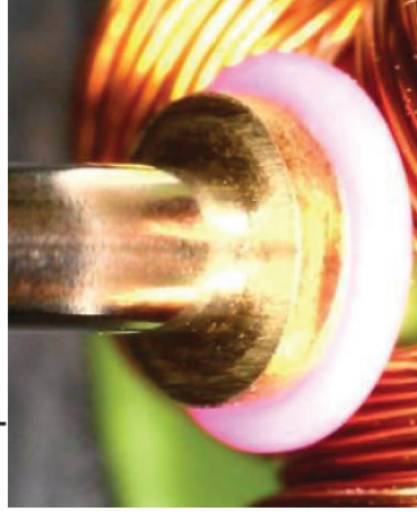
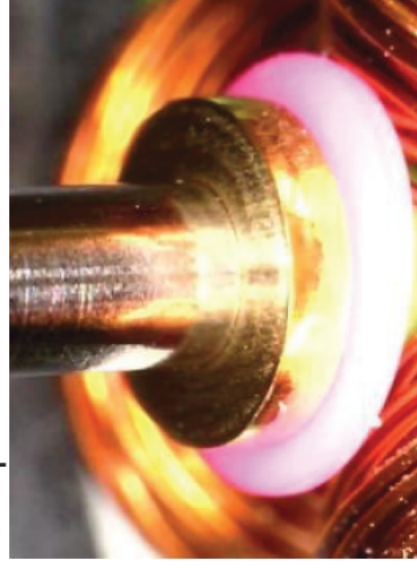
No difference regarding roughness visually detectable on 5 washer surfaces in new condition.

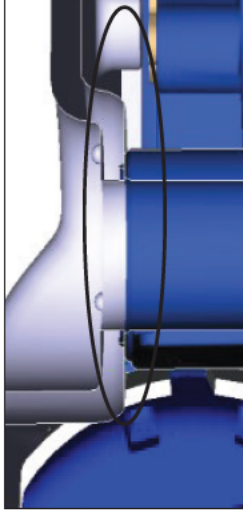
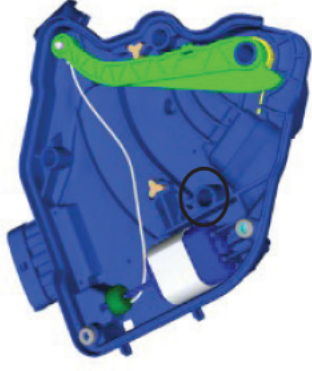
Design proposal to stop leakage path

1. Elimination of edge in KV housing (contact area KV housing to lid), height will be increased
2. Add of sealing contour at KV housing, this will be pressed in KV lid to seal the contact surface

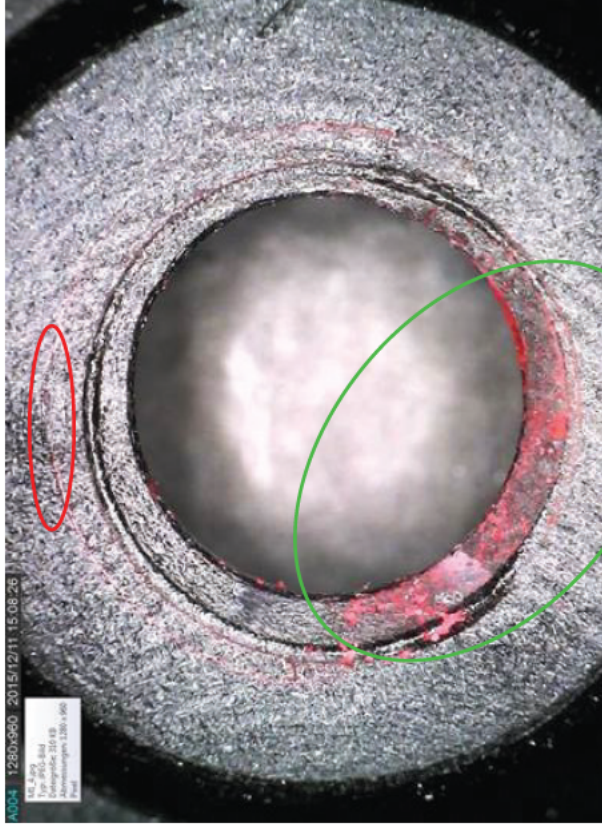
KV housing after testing

Main content of water will be stopped by sealing contour ✓

Slight water traces found inside of the sealing contour ✗

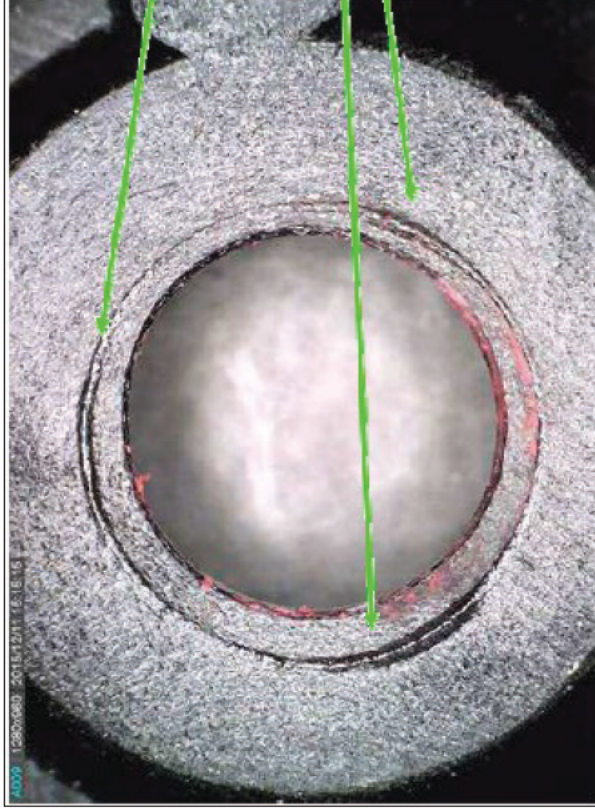
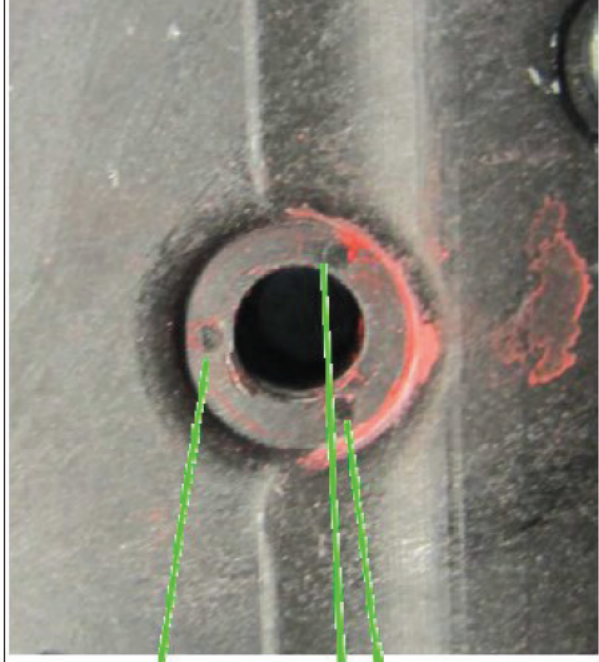
Sealing rib of KV housing is pressed into KV lid sufficiently in the area of the tolerance spots due to higher force during the riveting process. In the area between the tolerance spots the sealing contour is not pressed sufficiently into the KV lid.

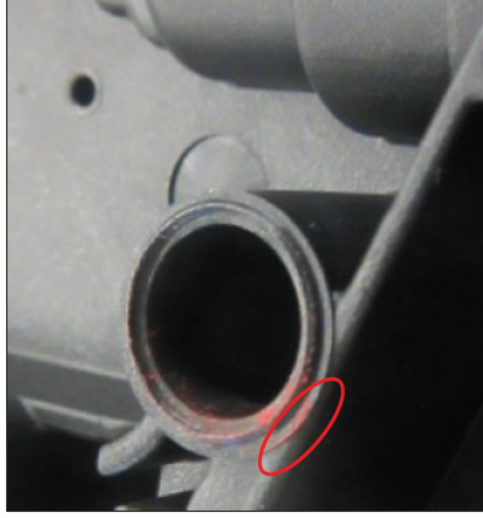
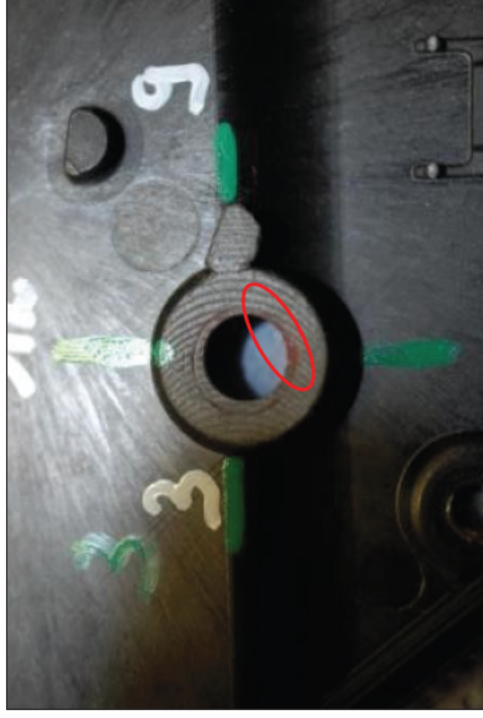
Main content of water will be stopped by sealing contour ✓

Slight water traces found inside of the sealing contour ✗

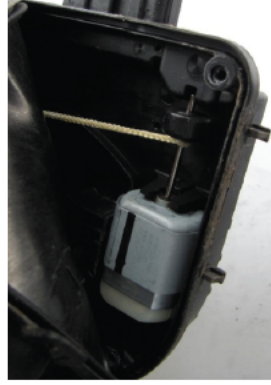
Latch received with 1 winding left on the motorshaft

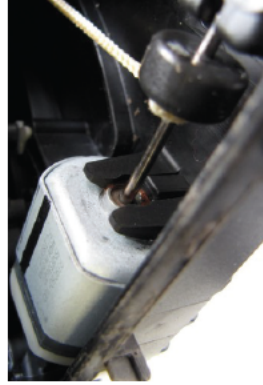
Front sinter bearing red corrosion, corrosion on housing visible, w/o grey sticker.

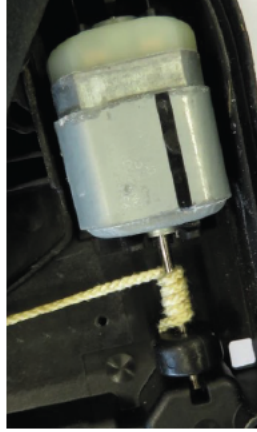
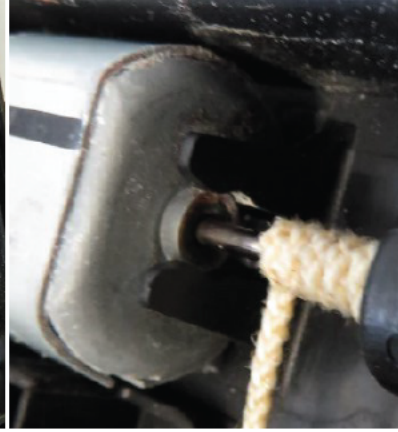
Latch received with 5 windings left on the motor shaft.

Front sinter bearing red, corrosion on housing visible.

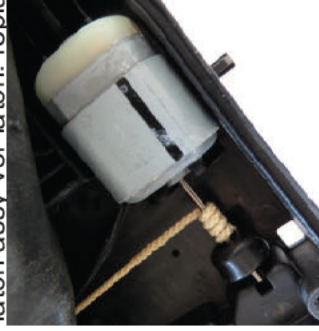
Latch received with 4 windings left on the motor shaft.

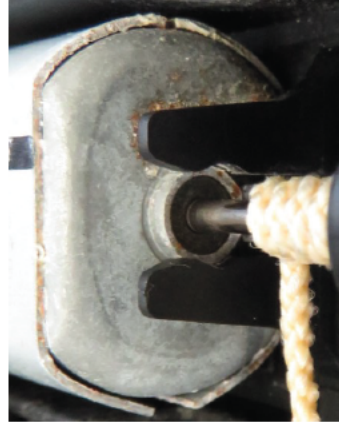
Front sinter bearing grey - corroded, red corrosion on the housing visible.

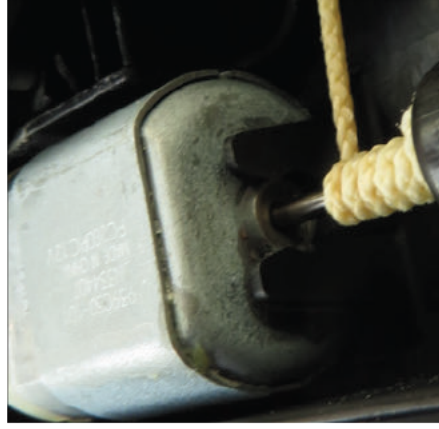
Front sinter bearing corroded and corrosion on the front side of motor found.

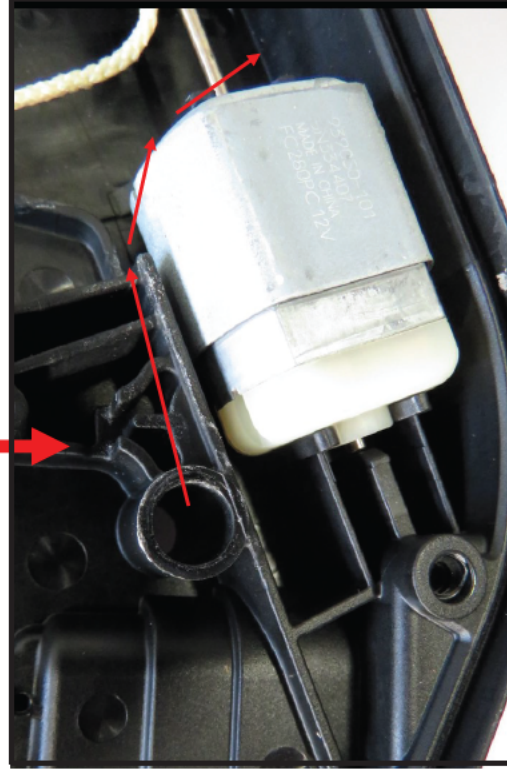
Conclusion: leak path via KV rivet hole found, part prior grey sticker introduction.

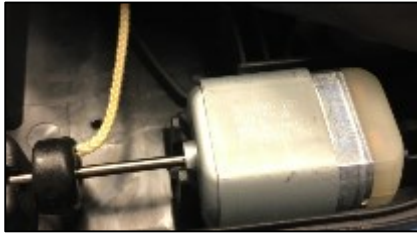
**Latch received completely unwound
– no leakage path visible**

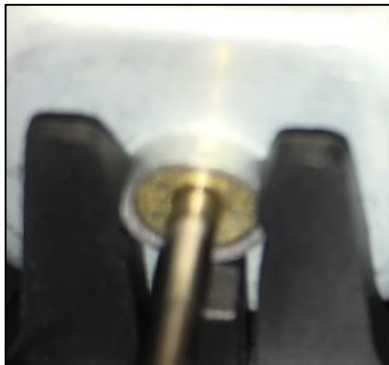
**Sinter bearing shiny, no corrosion on
motor housing visible**

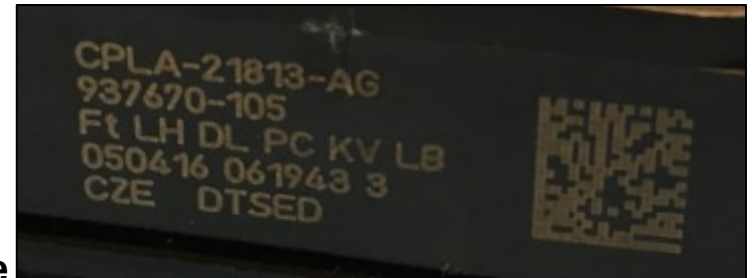
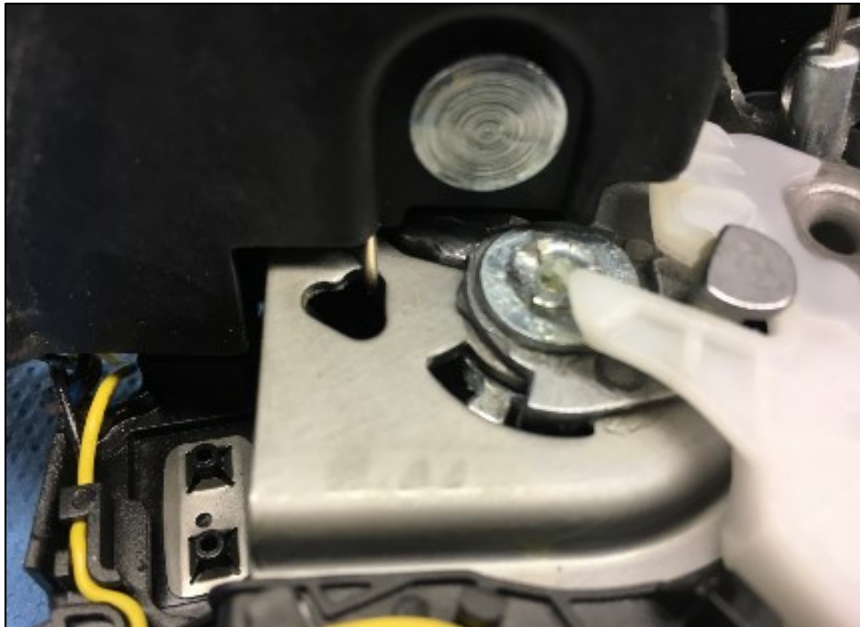
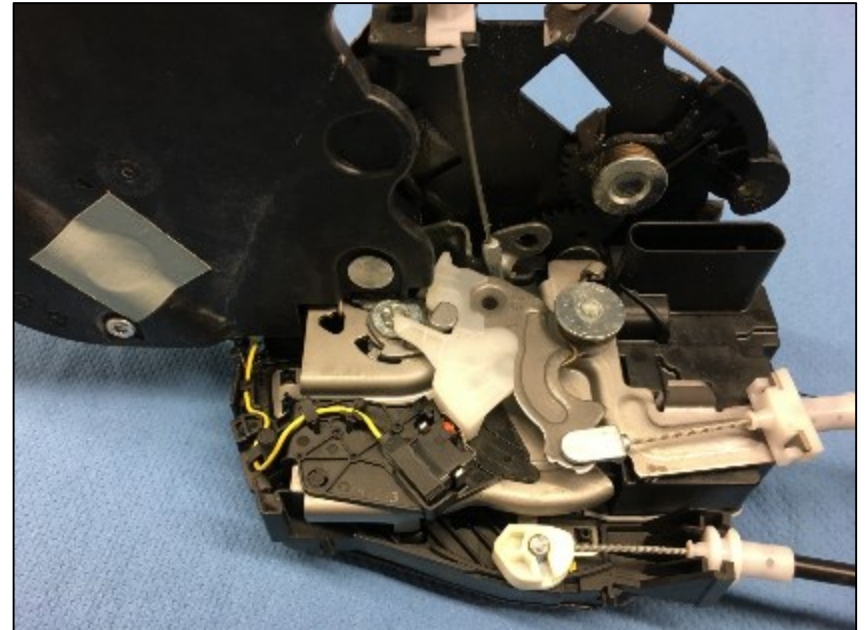
- Latch received with all levers in home-position
- no sticky-behavior opening from outside
- Blue particle not present on latch or box anymore

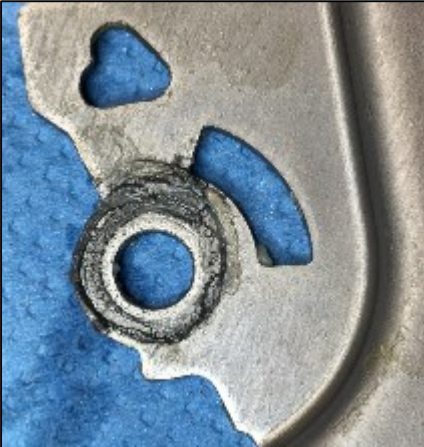
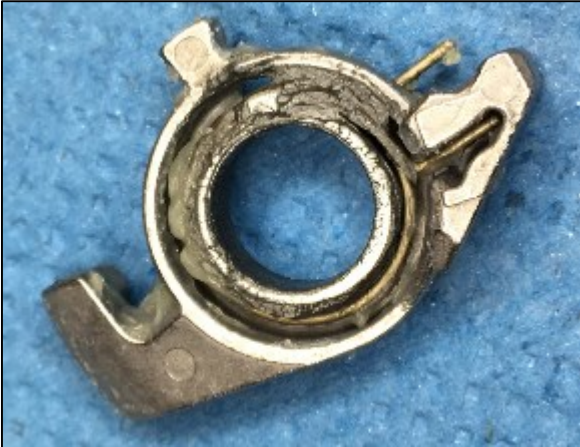
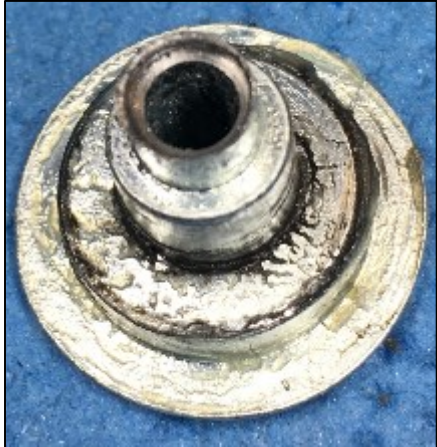
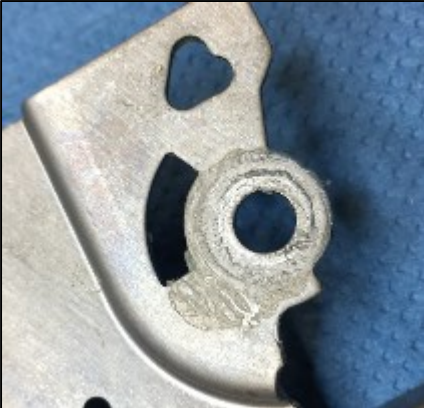
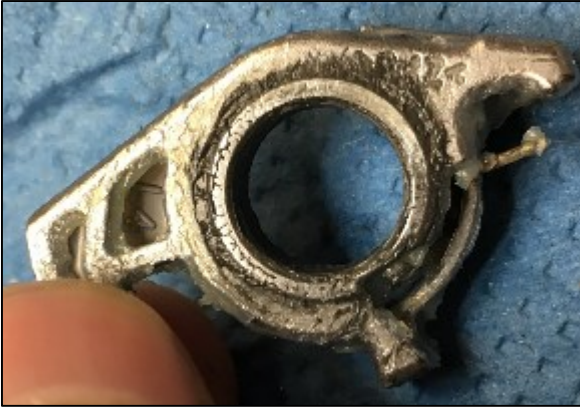
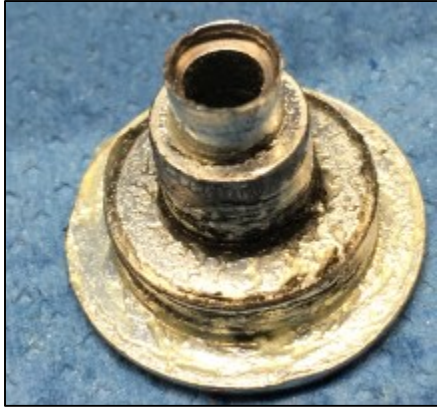
Tear down of latch – sub-assembly backplate disassembled

- Disassemble sub-assembly backplate with grease and abrasion

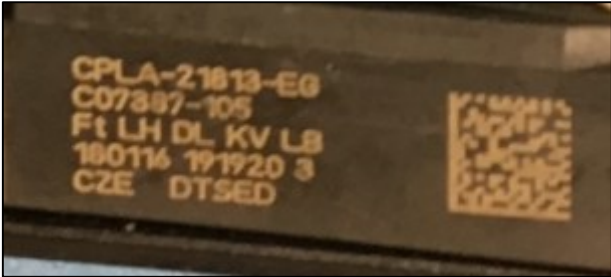
Visual inspection

- Latch received in jammed condition (not possible to latch)
- KV Transmission lever (zamak) jammed / KV plastic lever in home position

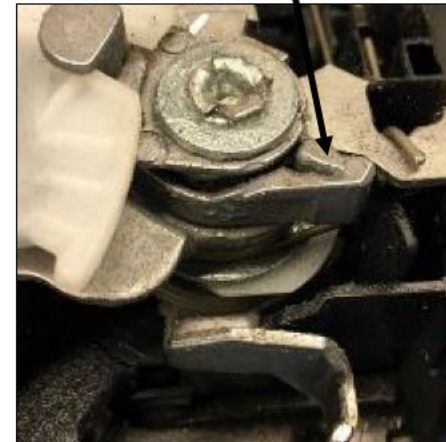
During disconnecting the pawl pin from the backplate sub-assy the jammed condition dissolved

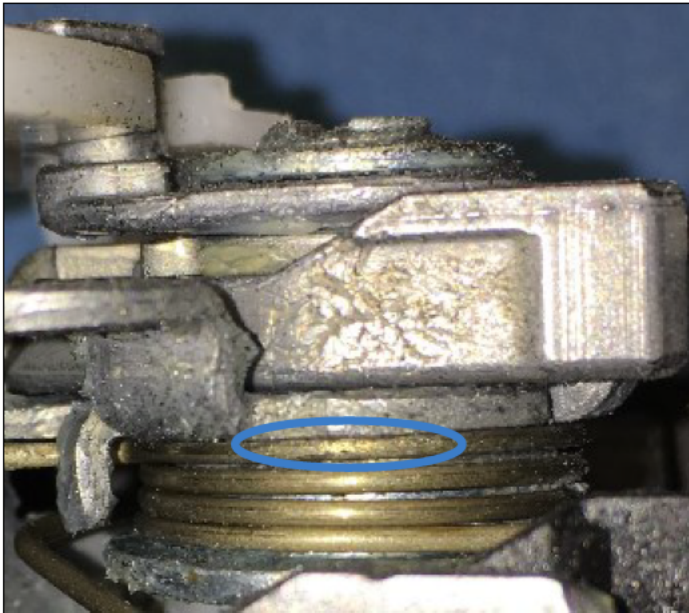
Tear down of latch – sub-assembly backplate dismantled from latch

Unjammed condition KV transmission lever

Measurement of gap between bushing and o/s transmission lever with one thickness gauge :

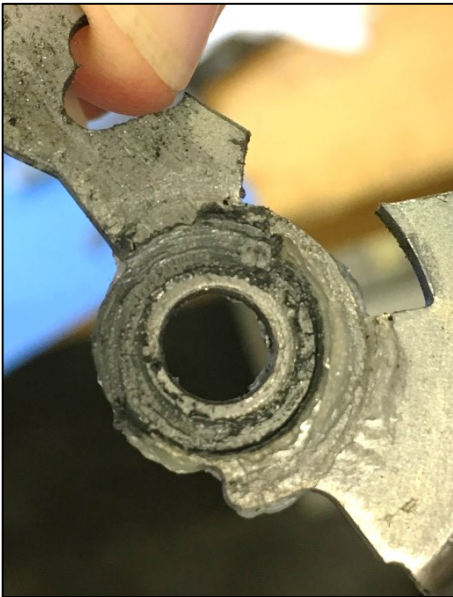
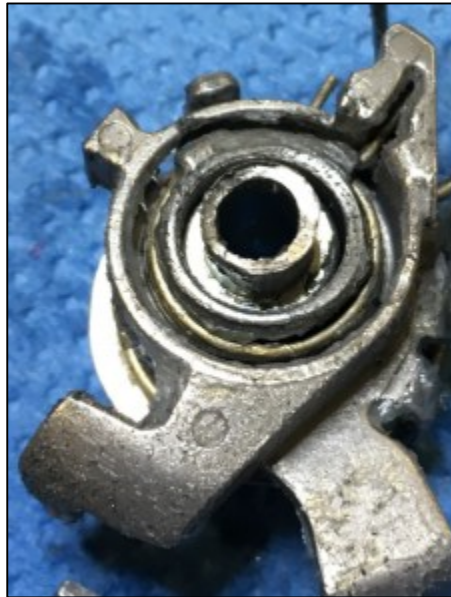
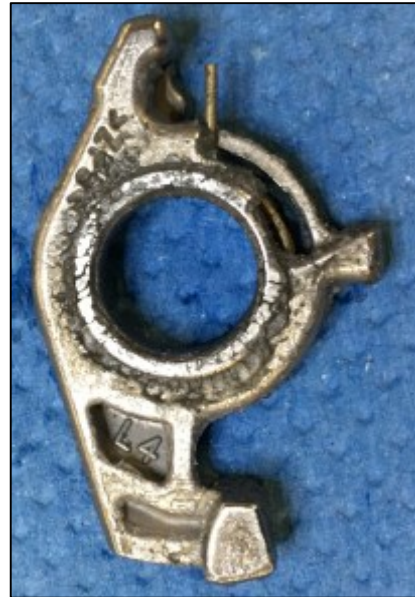
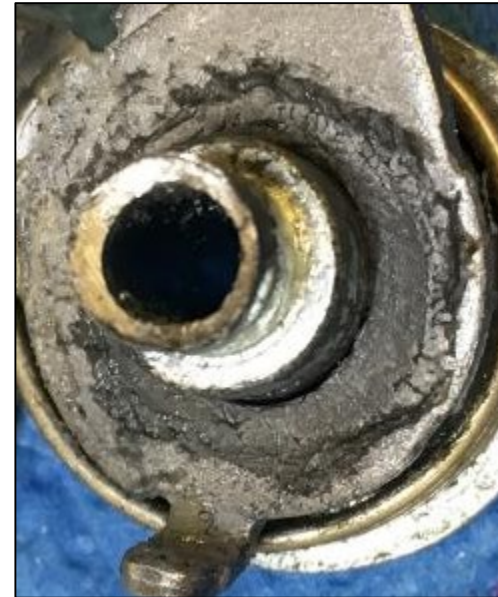
Tear down of latch – sub-assembly backplate single parts **brose**

Abrasion of KV-transmission lever visible – residues on contact surfaces of neighbour parts as well

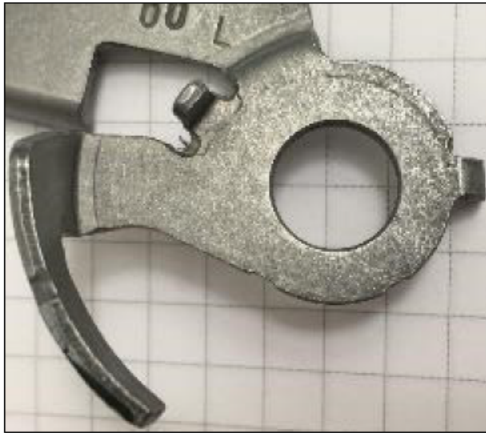
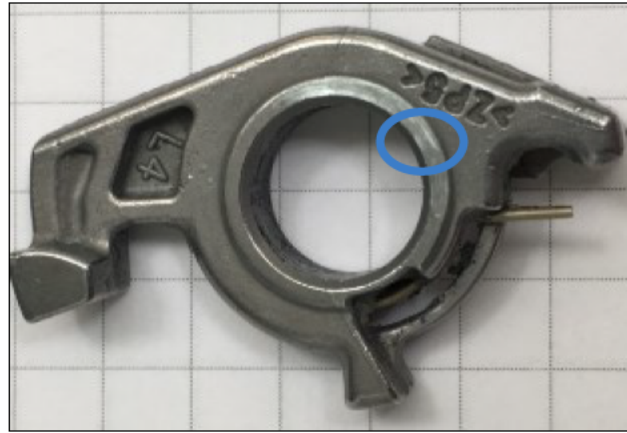
Tear down of latch – sub-assembly backplate single parts **brose**

Height measurement in
area of abrasion:
→ 4,92 mm

Drawing specification:
5,20 mm -0,05 mm

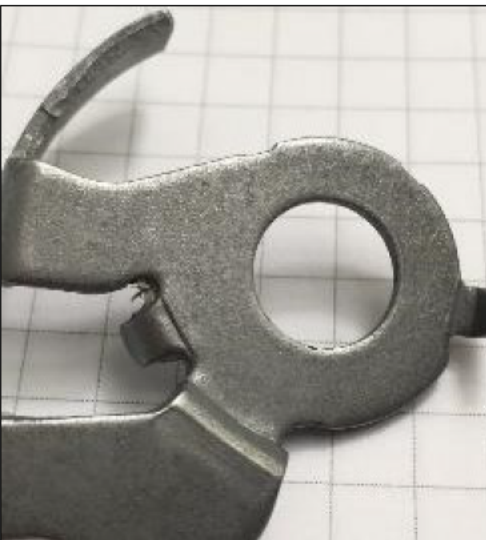
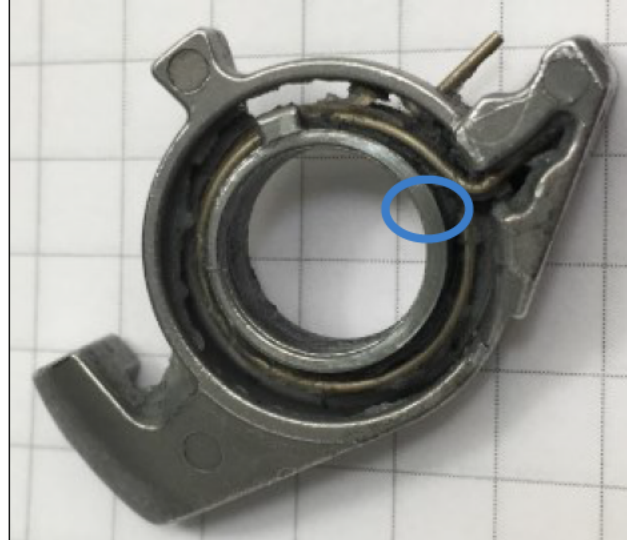
Height o/s transmission
lever:
1,54 mm

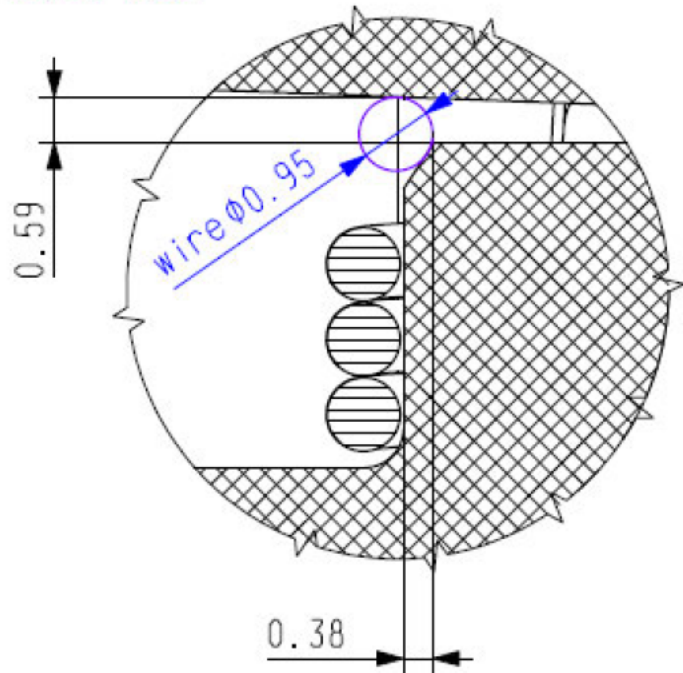
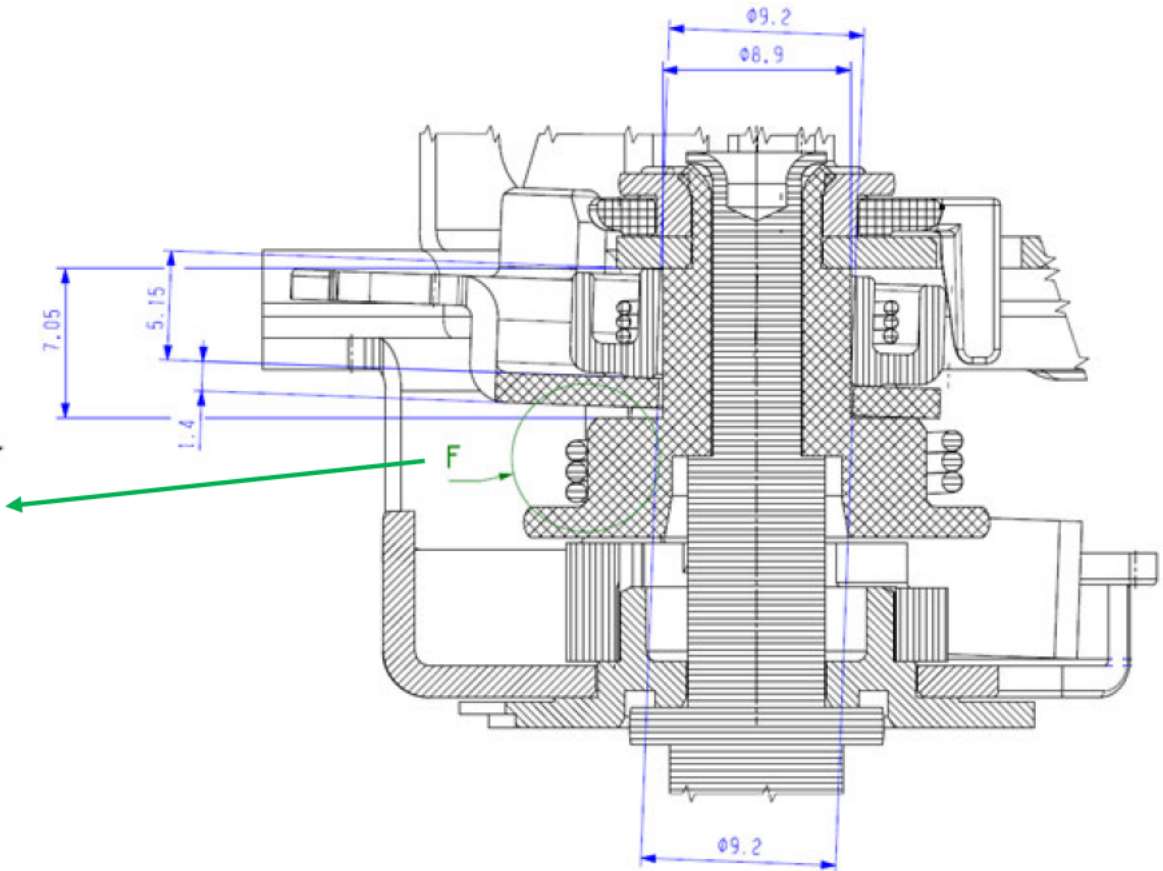
Detail F
10:1
worst case

- Tilting increases the gap from 0,5 mm to 0,59 mm
- Spring can not fully move between bushing and lever

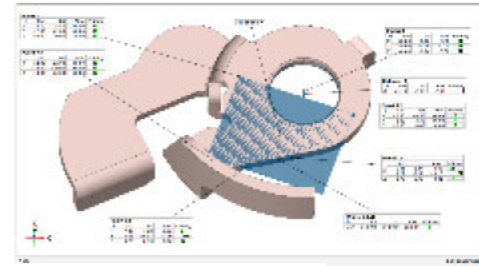
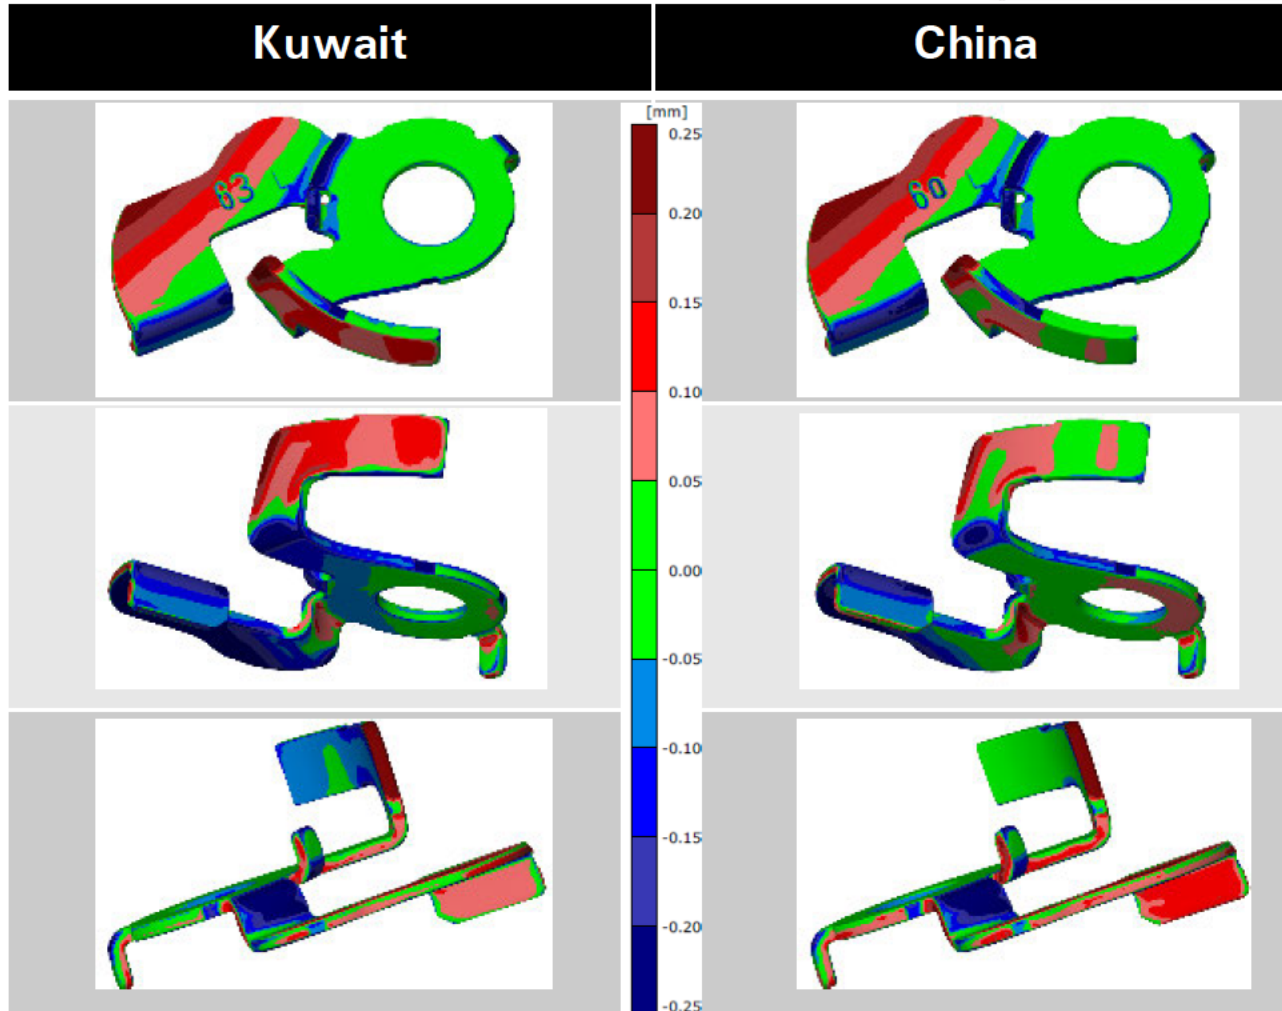
Single Part 3D scan O/S transmission lever

- Thickness of the lever **ok**
- Rotating area of the lever **ok**
- Parts within specification **ok**

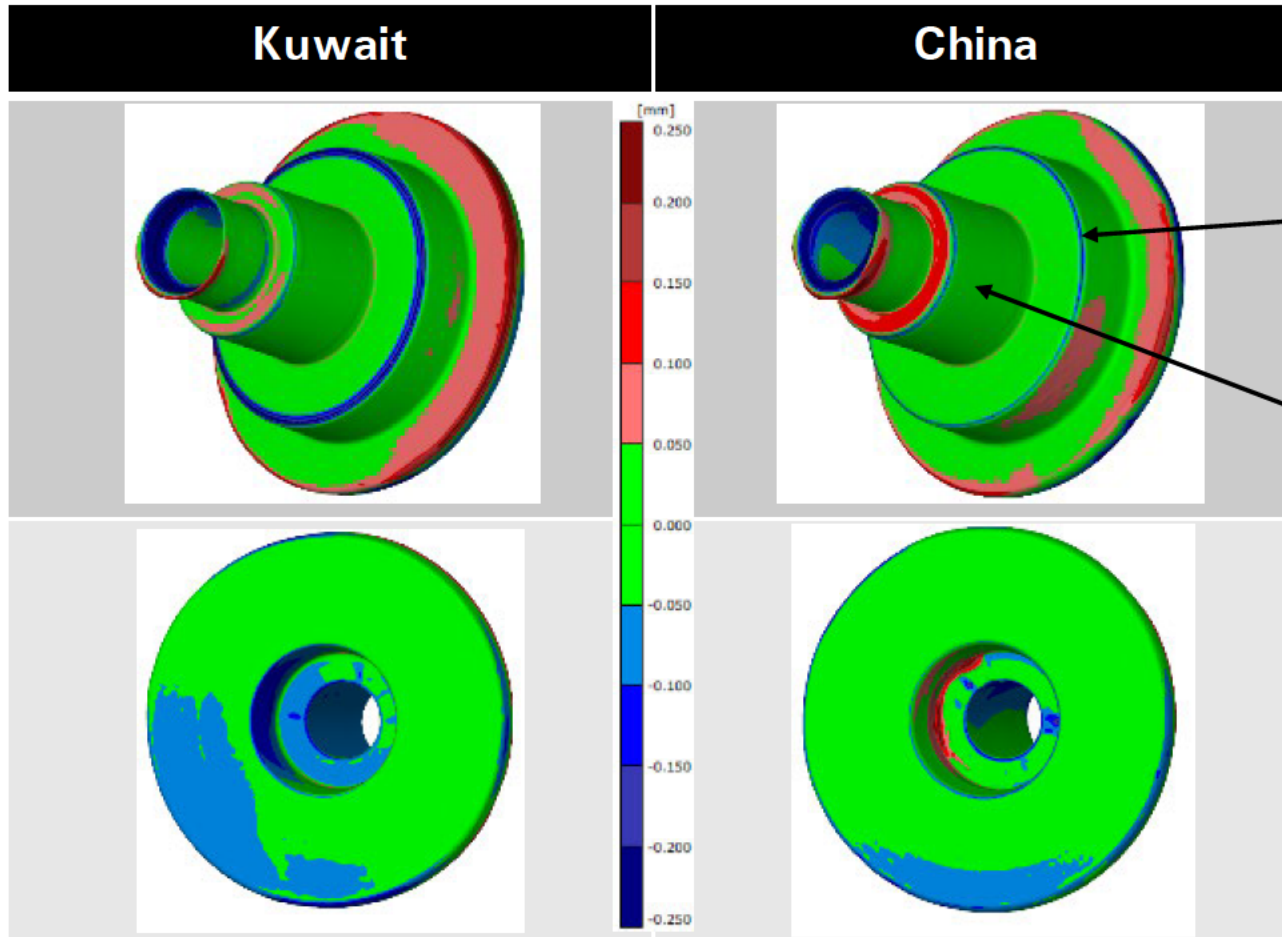
Single Part 3D scan Bushings O/S transmission

- Difference in the chamfer visible – see detailed results on page 39
- Step height on CN part higher than on KWT part – but both parts within specification **ok**

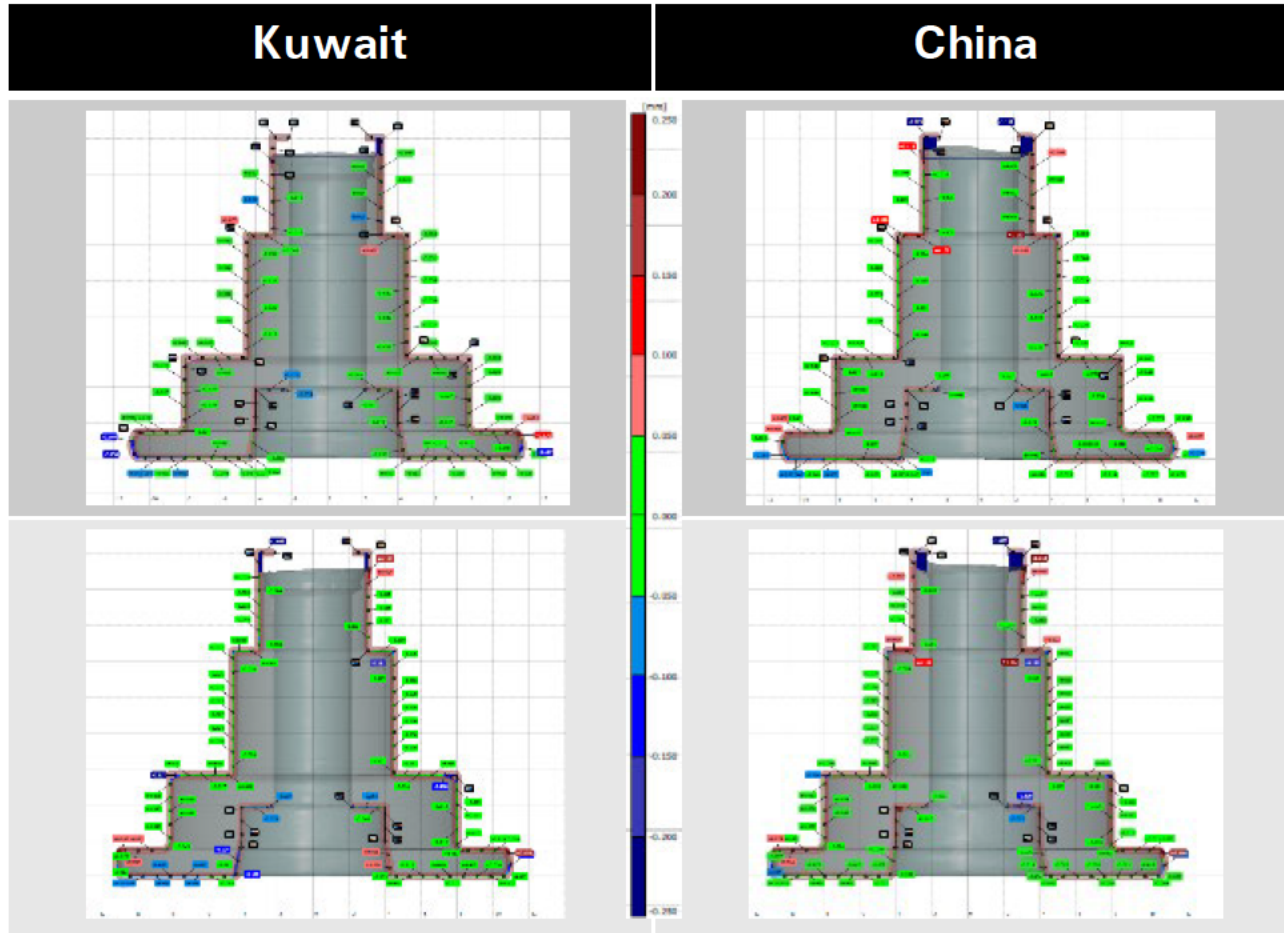
Single Part 3D scan Bushings O/S transmission - cut through

- Difference in the chamfer visible – see detailed results on page 39

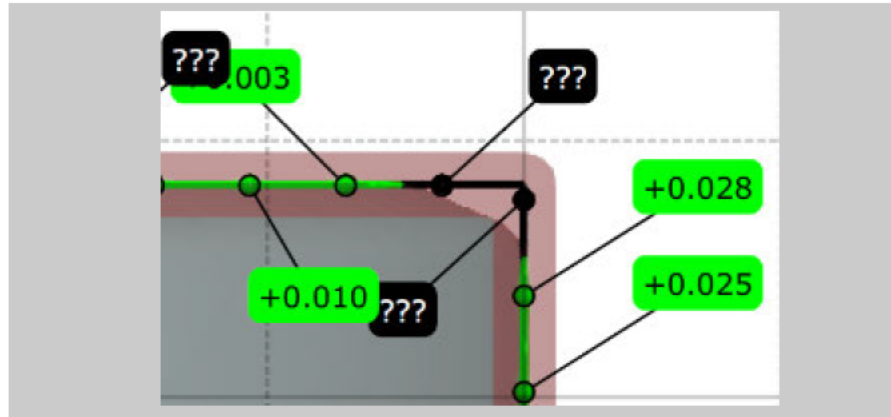
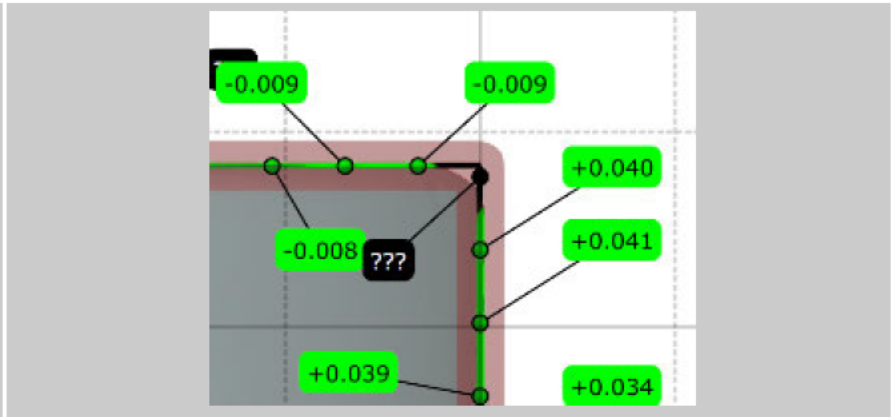
Measured with optical projection equipment:

X-direction: 0,70 mm – 0,77 mm (nok)
 Y-direction: 0,50 mm – 0,53 mm (nok)

- CN part (failure mode present) with borderline chamfer / KWT part (failure mode not present) with nok chamfer
- Supplier involvement to clarify quality situation

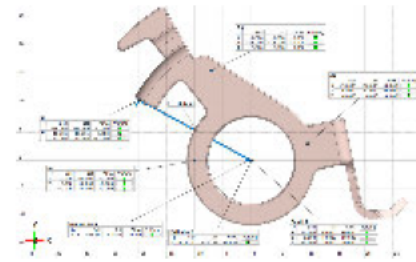
Single Part 3D scan I/S transmission lever

- Thickness of the lever **ok**
- Scratch marks on lever not visible in scan comparison – nothing on this lever indicates why it was in contact with o/s transmission lever

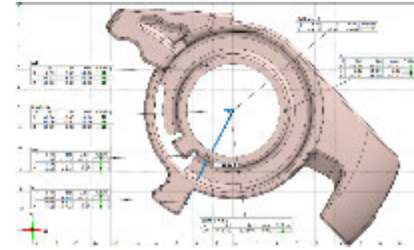
Single Part 3D scan KV transmission lever

- Wear out area of the lever too thin – 4,92 **nok**
- Other area of the lever too thin – 5,06 **nok**
- Supplier involvement to clarify quality situation

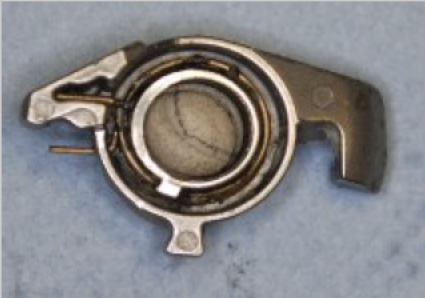
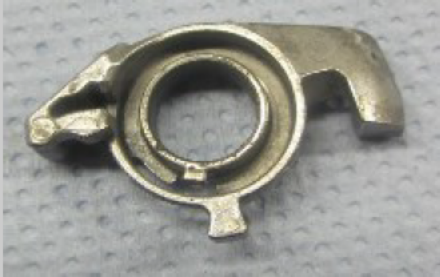
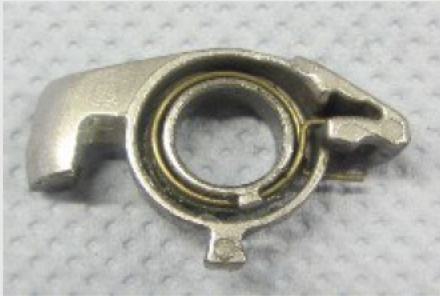
<ul style="list-style-type: none">- Test result ok – no function failure- High measurement result done today → 4,93 mm on wear out area	<ul style="list-style-type: none">- Test result ok – no function failure- No wear out area

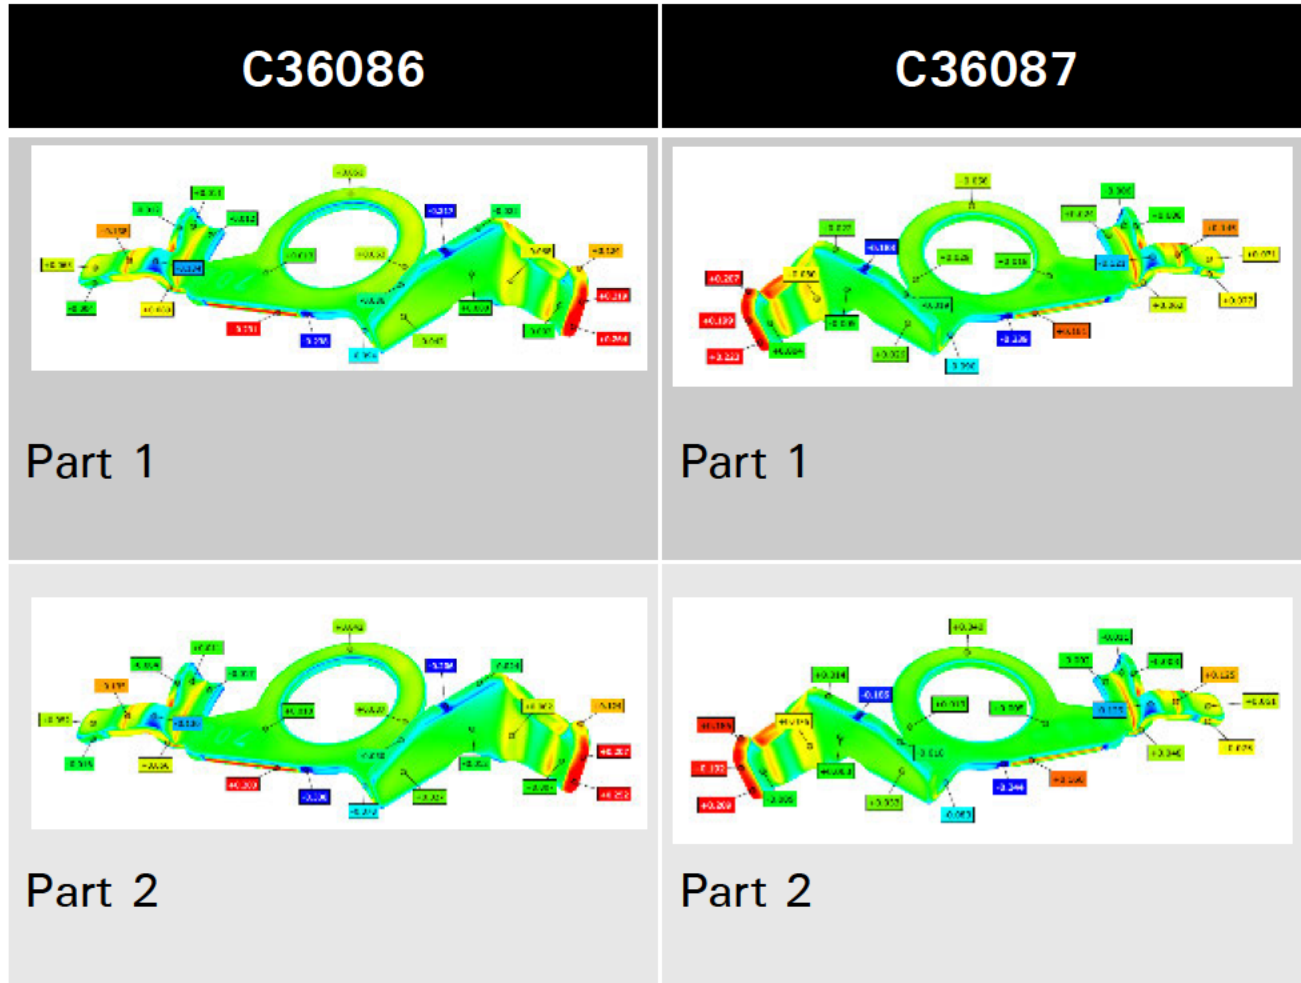
Single Part 3D scan – Current Production I/S transmission lever double pull

Conclusion:
- Parts have no deviation

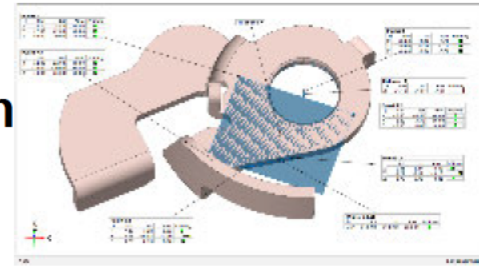
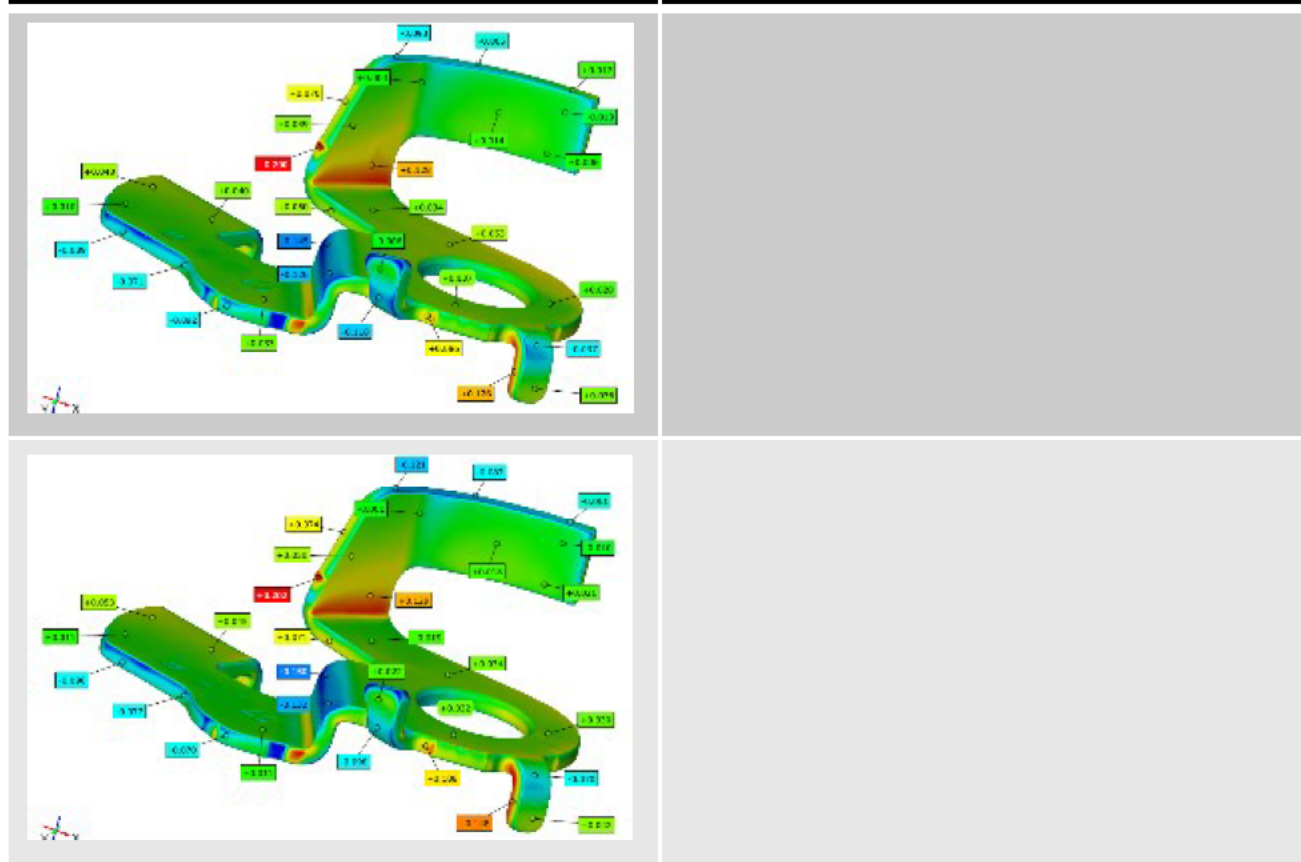
Single Part 3D scan – Current Production O/S transmission lever

Conclusion:
- Parts have no deviation

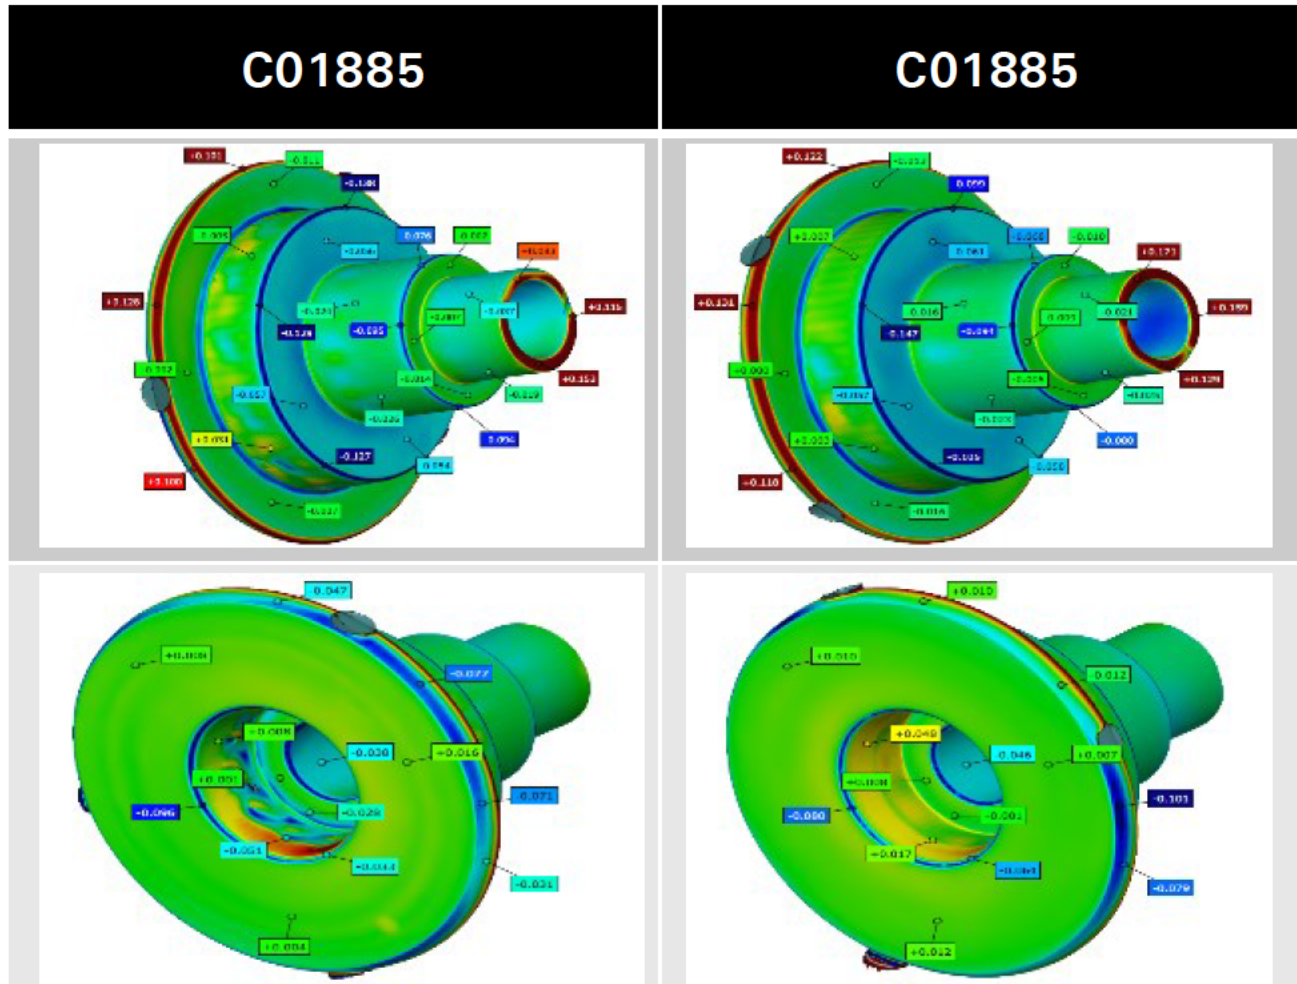
Single Part 3D scan–Current Production Bushing

Conclusion:
 - Parts have no deviation
