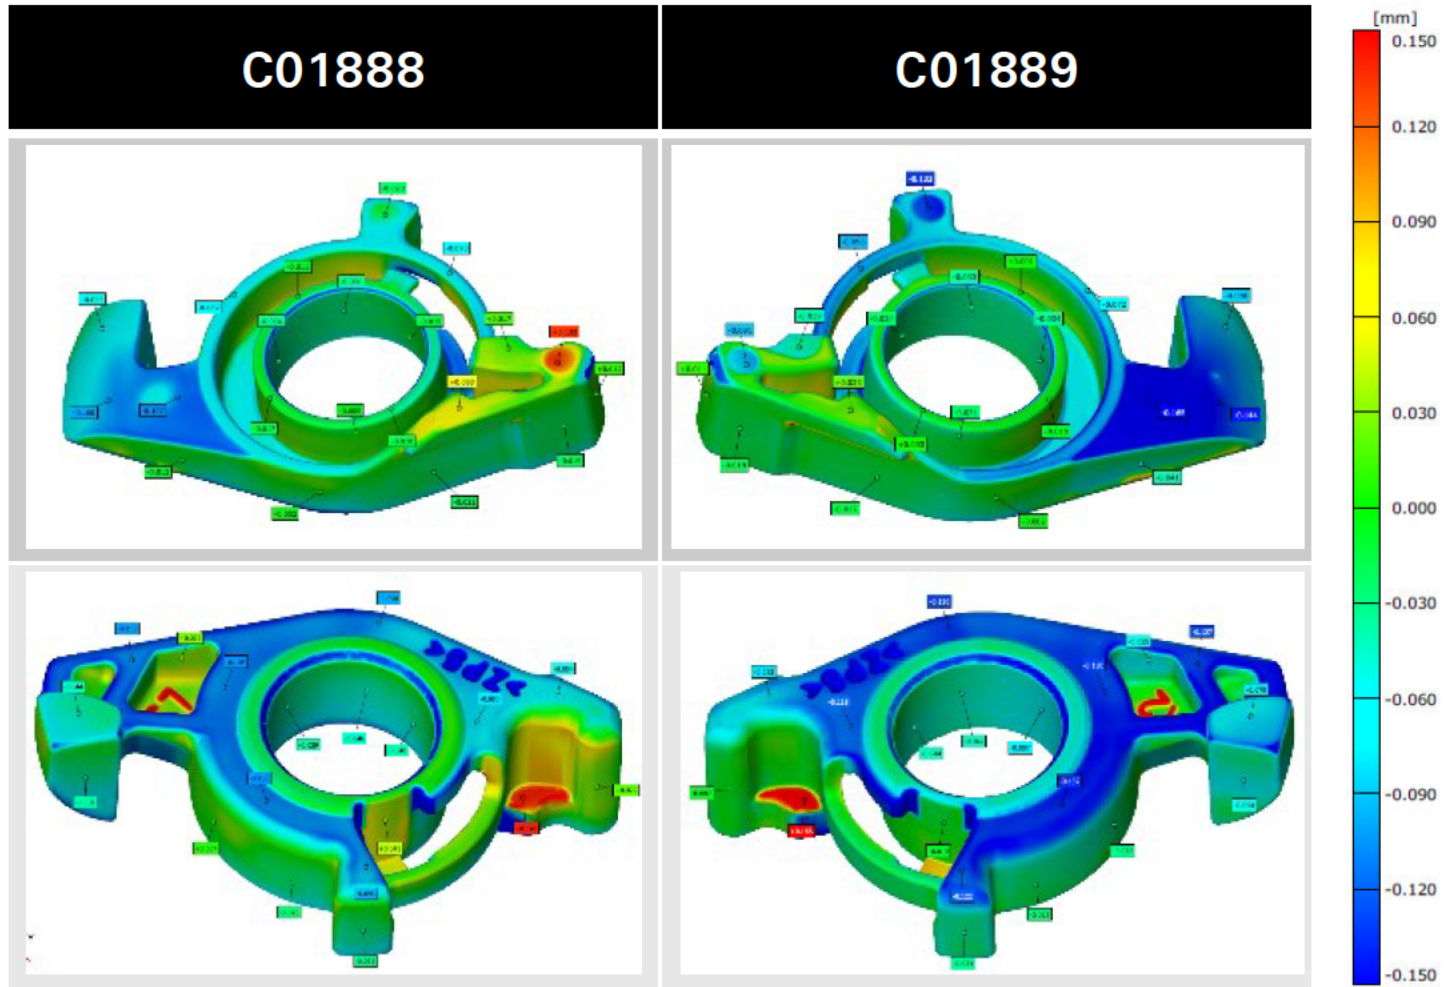
Single Part 3D scan–Current Production KV transmission lever

Conclusion:
- Parts have no deviation

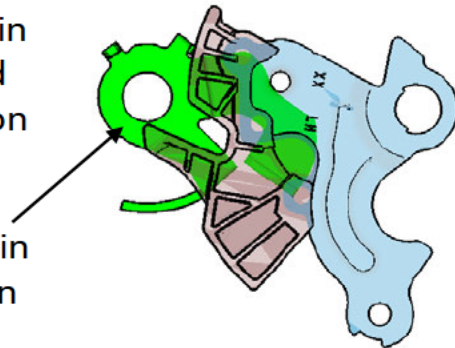
Lever can stay in jammed position

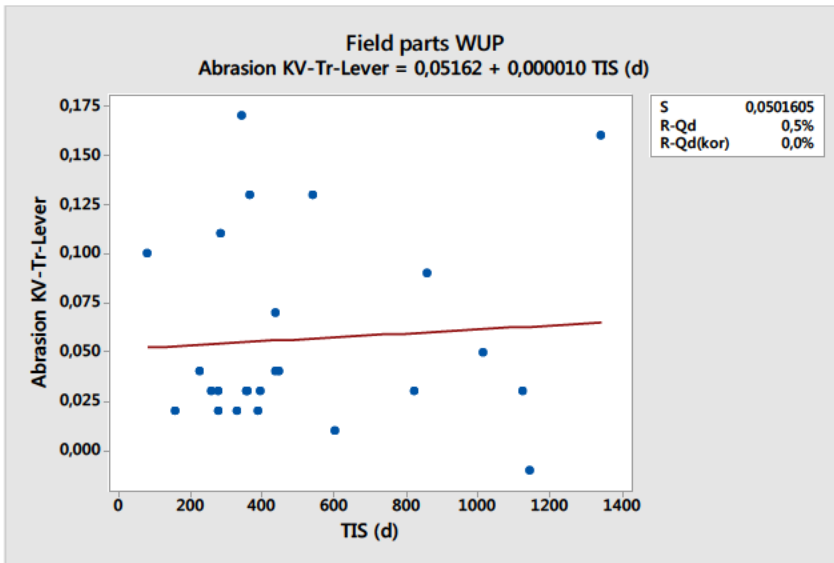
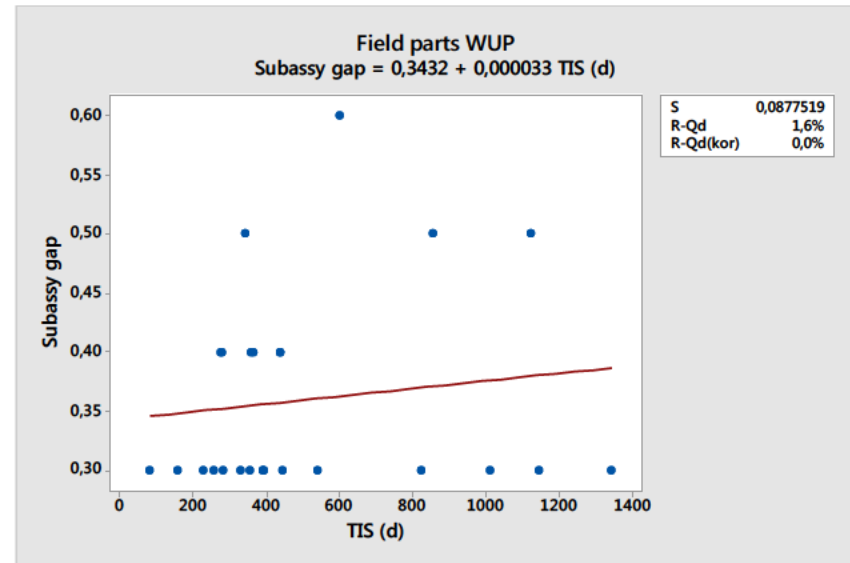
Mini-Tab Investigation

Conclusion: No influence of TIS for abrasion or gap

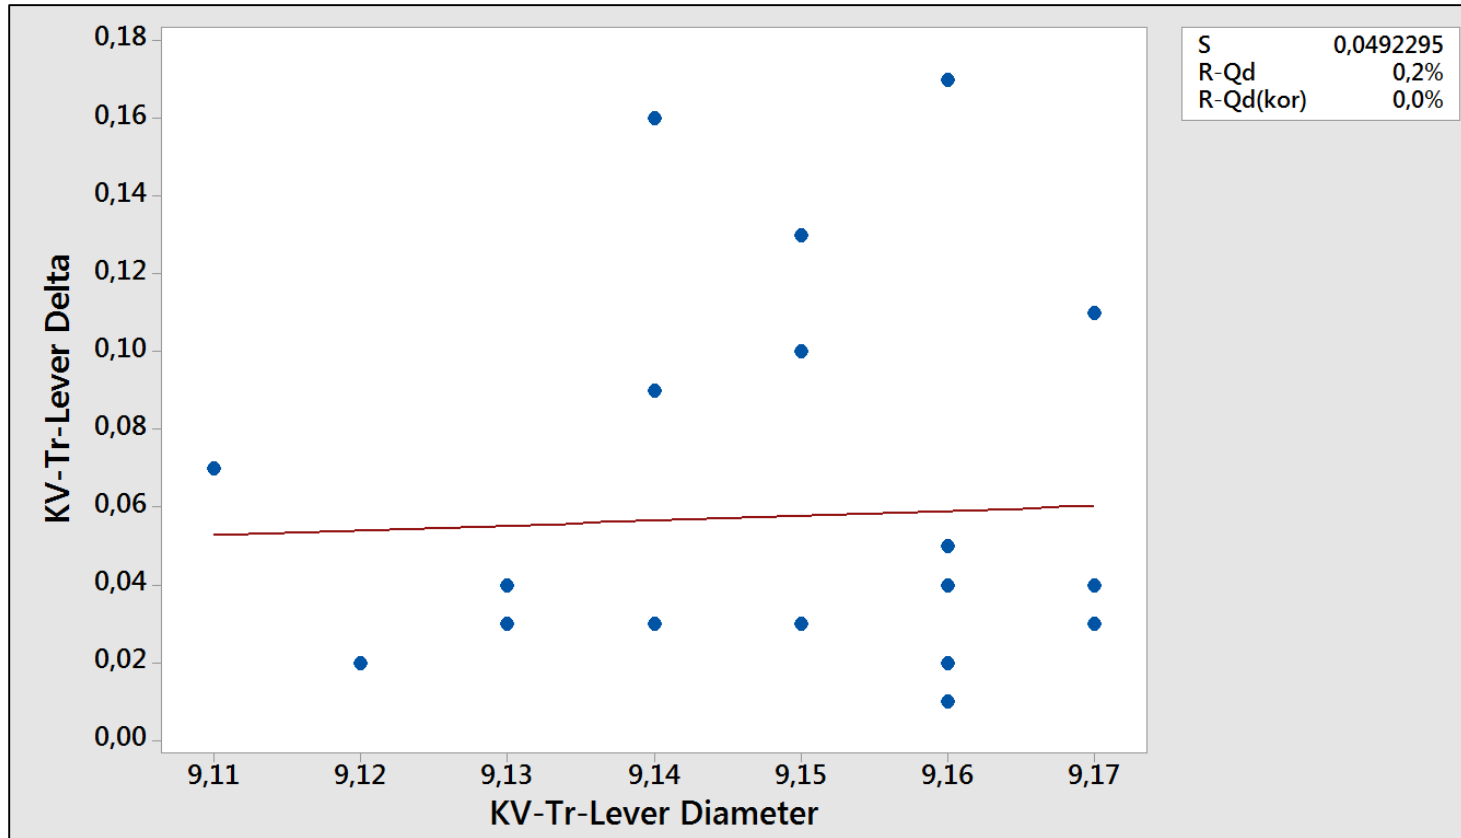
Mini-Tab Investigation

Based on current investigation, diameter KV transmission lever differences has no influence to abrasion

→ This has to be confirmed with more data

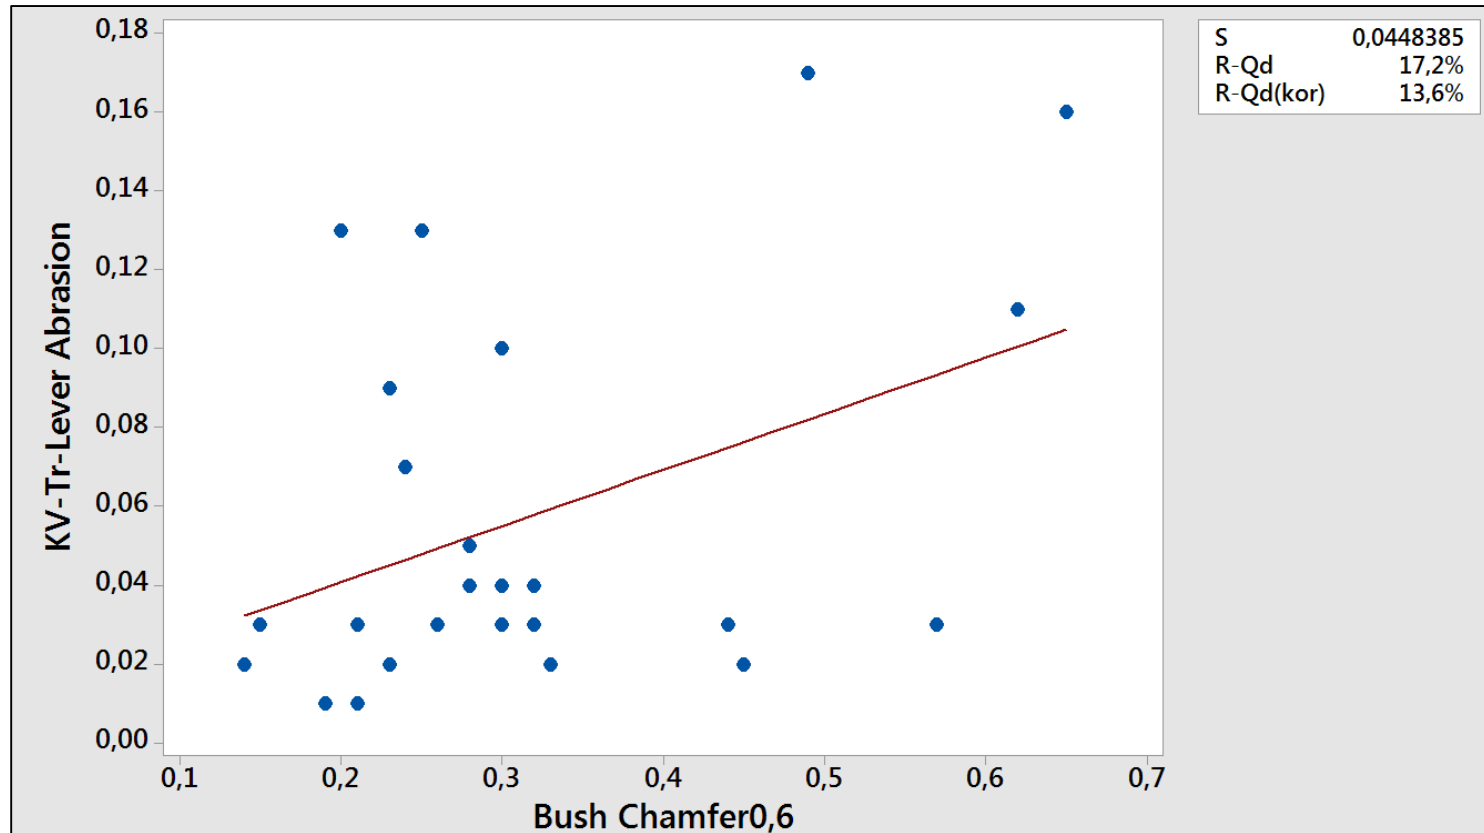
Mini-Tab Investigation

*Based on few available data: bigger axial chamfer leads to more abrasion
→ This has to be confirmed with more data*

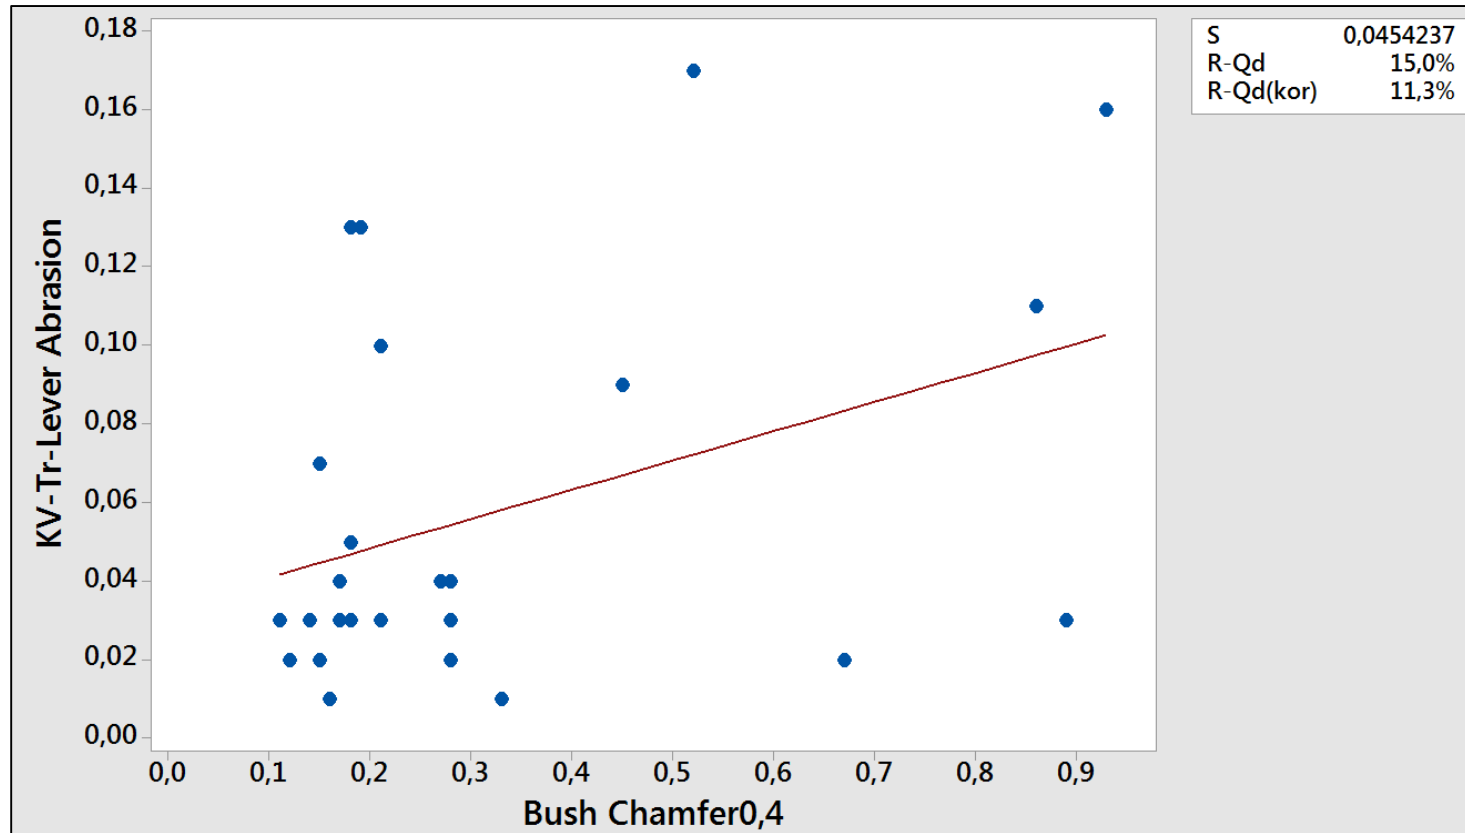
Mini-Tab Investigation

*Based on few available data: bigger radial chamfer leads to more abrasion
→ This has to be confirmed with more data*

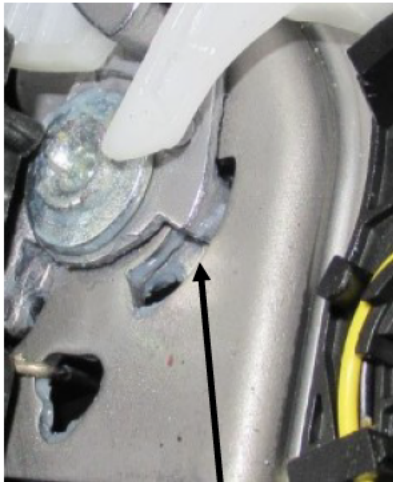
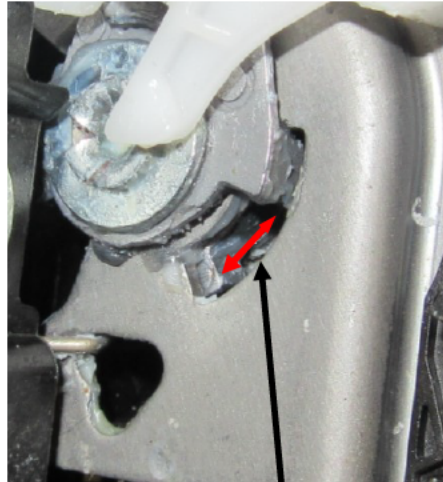
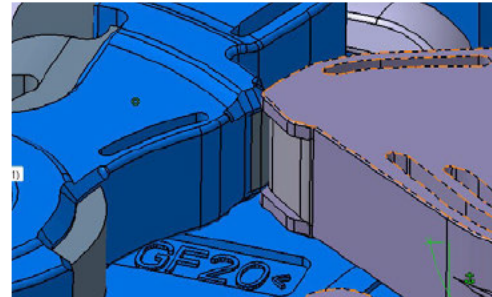
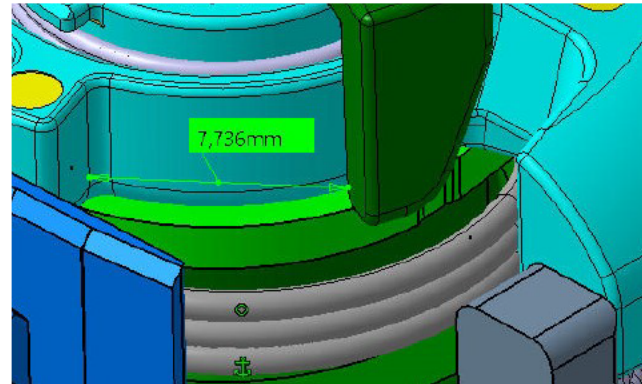
Response Criteria: Gap home position

Position of KV-transmission lever after passing test procedure

Home position
No Gap

Home position
With Gap

Critical Gap > 7,7mm

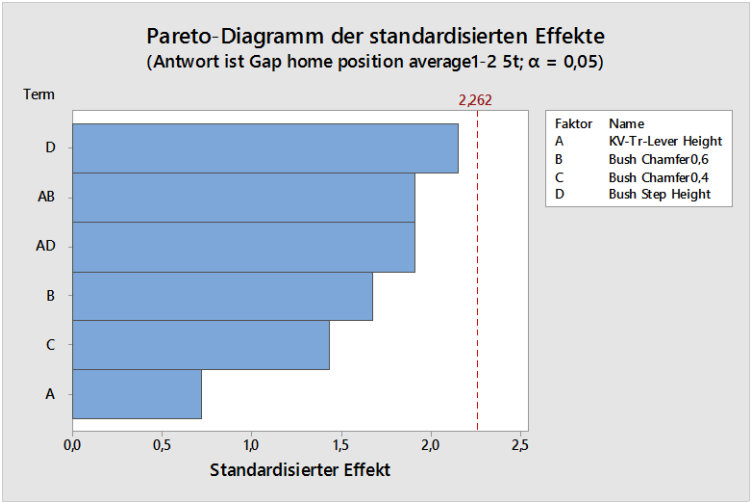
Zusammenfassung des Modells

R-Qd: 65,87% < 80%

-> DoE factors not completely explaining the result.

-> Additional factor(s) to consider.

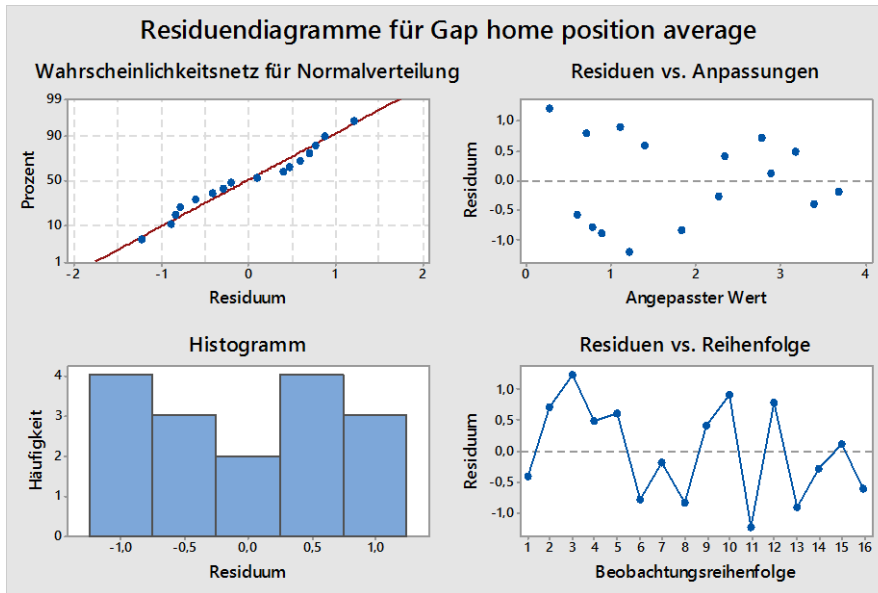
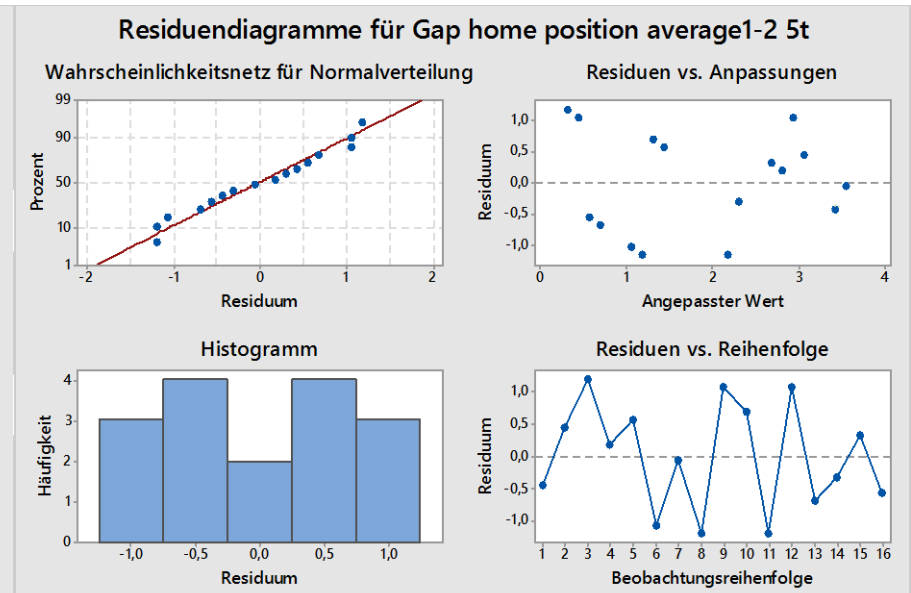
Graphical evaluation

Conclusion: Residual Charts sufficient

Histogram : shape with two „peaks“ at ends

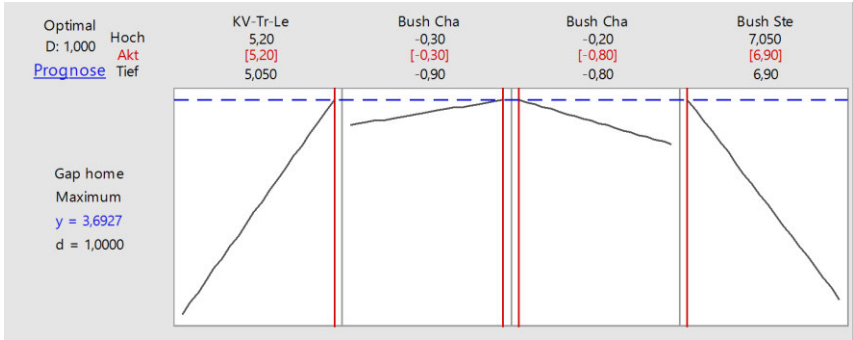
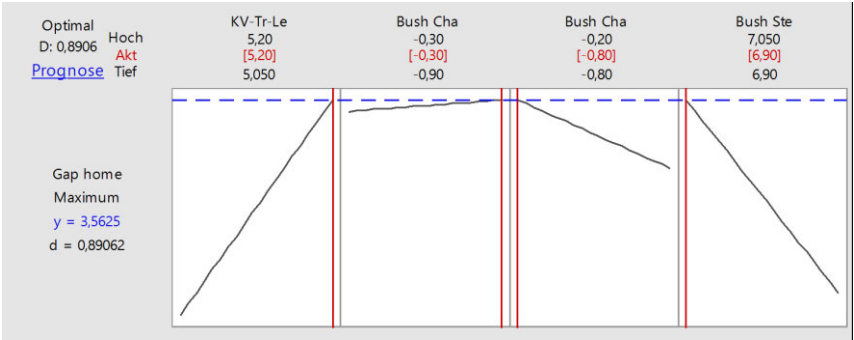
Maximum optimisation graph

- Both models are showing the same potential maximum gap position of approx 3,6 mm. Less than critical gap 7,7mm
- Maximum of 3,6 mm less than measured single value (5 or 8mm) shows that additional factor is to contribute. (see R-Qd value approx 65% < 80%)

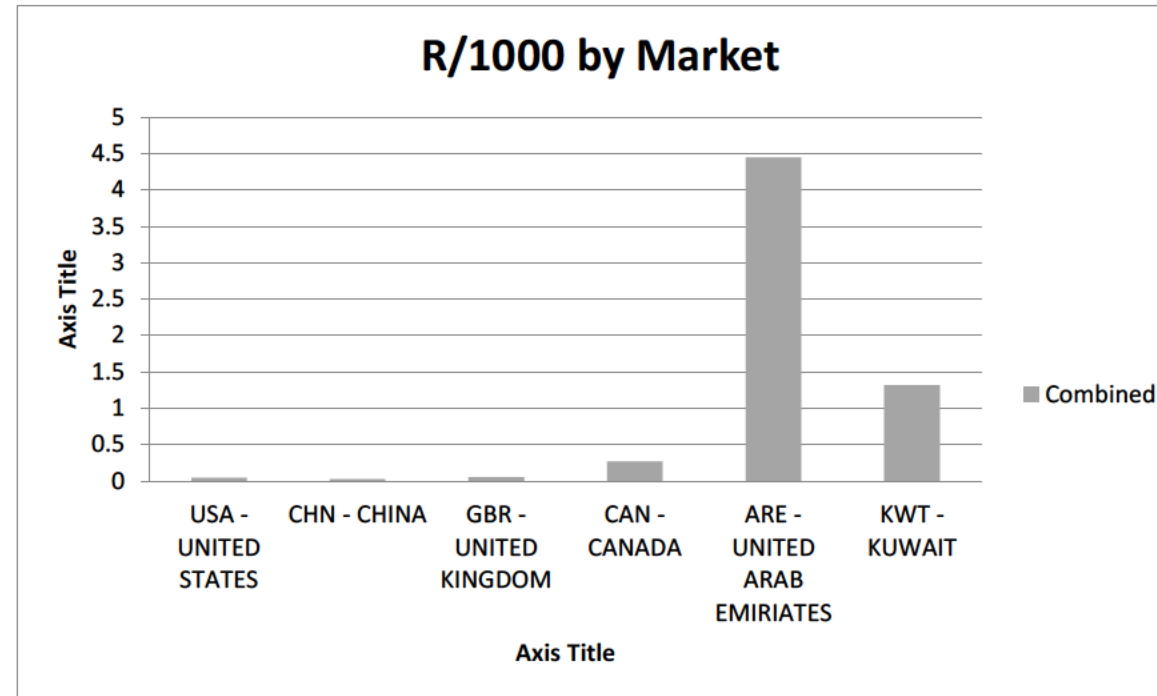
R/1000 Normalisation By Market

- Data from the vehicle population post production cut-off date (Mar 2015 onwards)
- Markets in descending order of sold vehicles in service
- Minimal R/1000 values everywhere except ARE and KWT
- However, other markets that have reported an occurrence are not identical climatic conditions to either ARE or KWT

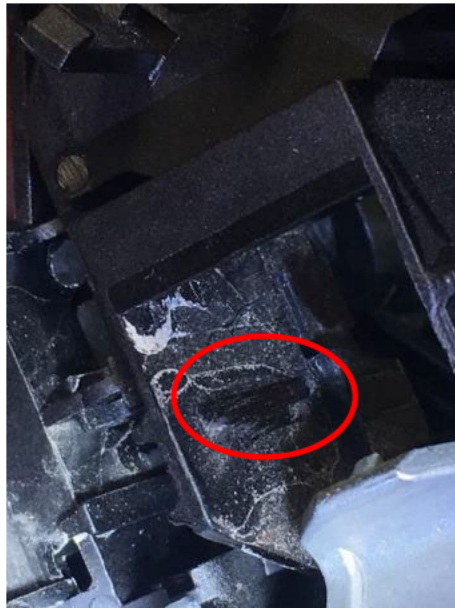
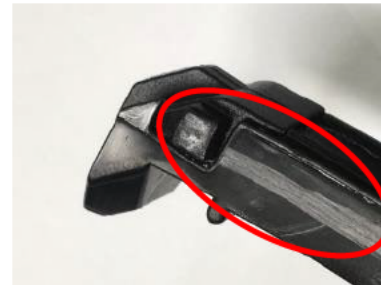
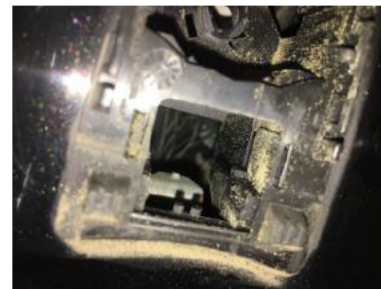
Problem Investigation/Verification

Problem Investigation/Verification: Visit to vehicle in Dubai August 2016. Customer reported a door opening post P068, vehicle held for investigation. Vehicle tested by JLR UK Engineer in market and unable to fault the latch. Open circuit condition evident on the vehicle, therefore P068 flash was a success. Vehicle in workshop, ambient temp circa 25°C. Unable to jam the handle in the workshop. Placed vehicle onto roof, high solar load, ambient temp 48°C. Soaked vehicle for two hours, and then able to jam three of the four handles on the vehicle on the first attempt.

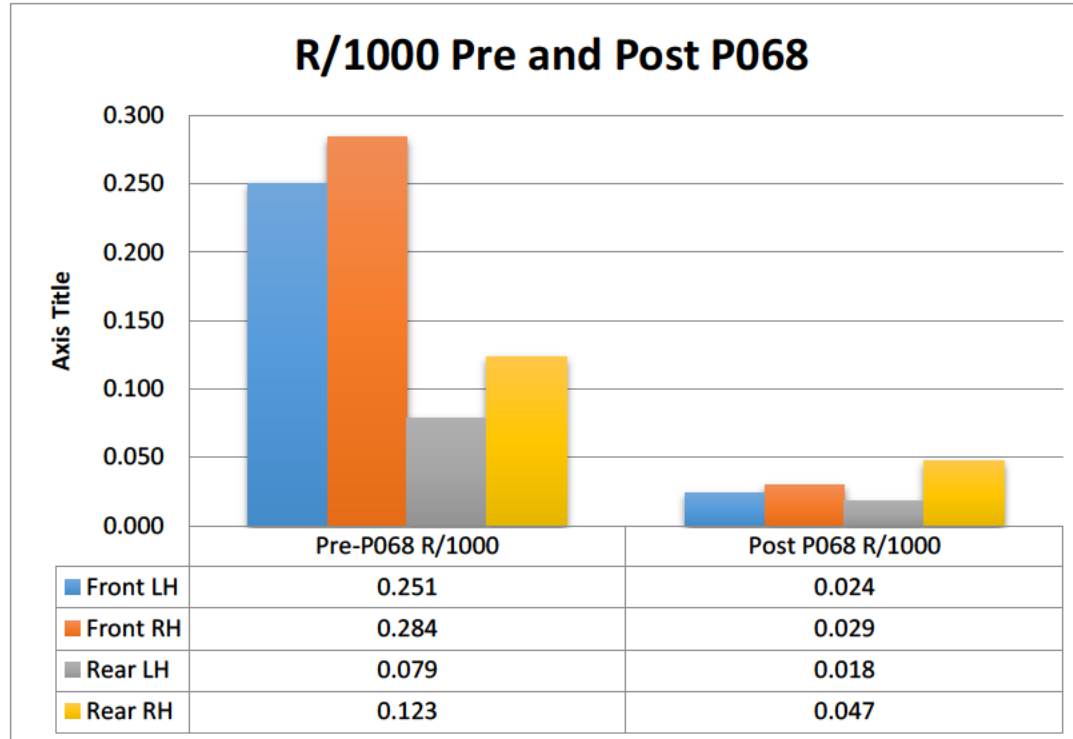
Normalised Data

- Once the data was normalised, an order of magnitude can be seen on front doors pre/post P068
- The same cannot be said of the rear doors, where the improvement has not been as significant

Before		After	
	Failures	Pre-P068 R/1000	Failures	Post P068 R/1000
Front LH	67	0.251	8.000	0.024
Front RH	76	0.284	10.000	0.029
Rear LH	21	0.079	6.000	0.018
Rear RH	33	0.123	16.000	0.047

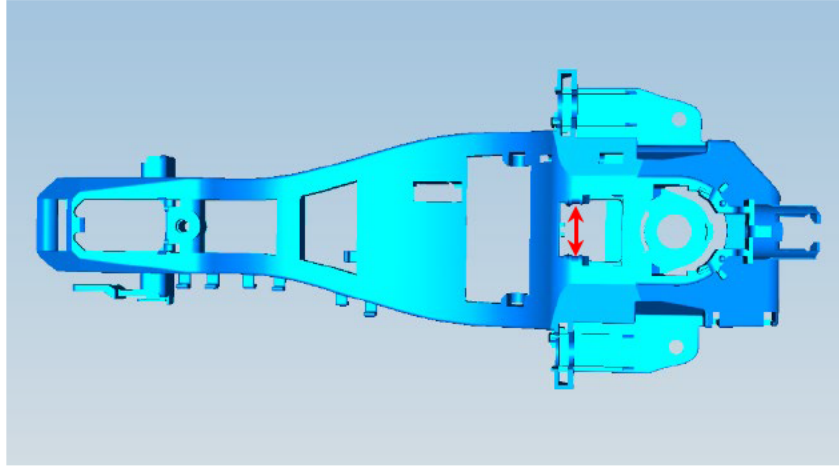
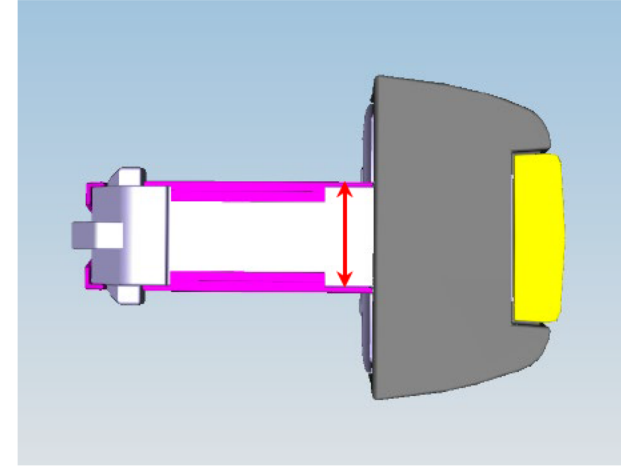
Material Behaviour Characteristics

PA66 GF30 is hygroscopic. In taking water on the part swells. Coupled with thermal expansion / contraction this may give rise to significant dimensional differences.

Study commissioned on various temperature and humidity levels with measurements being taken across the run channel in the handle chassis, and across the POM runner on the handle strap inner

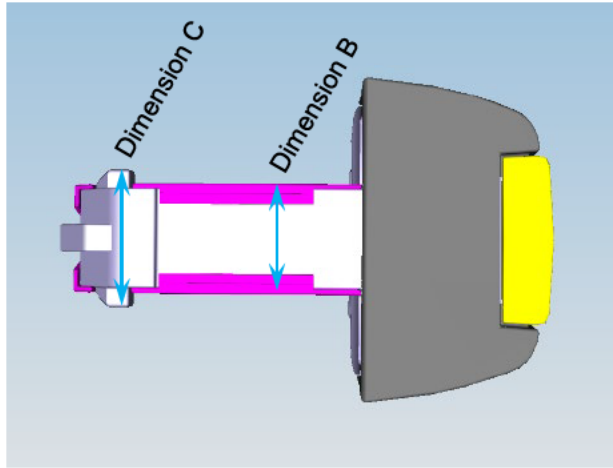
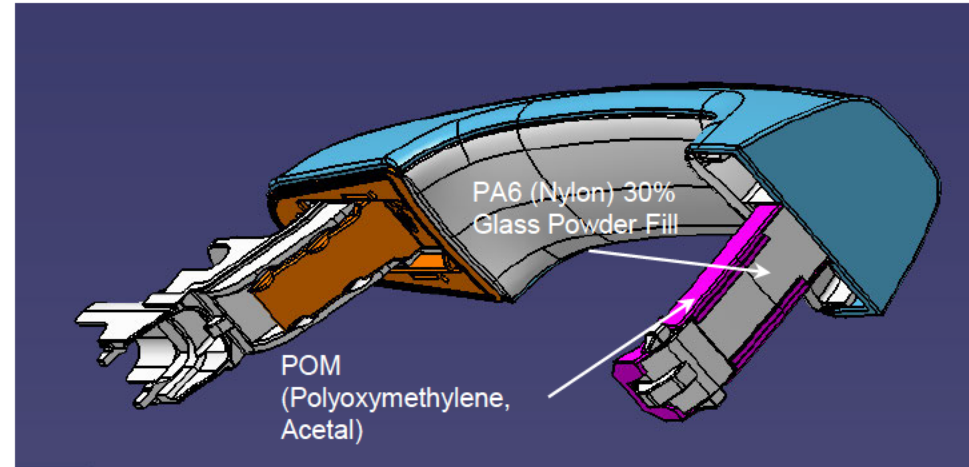
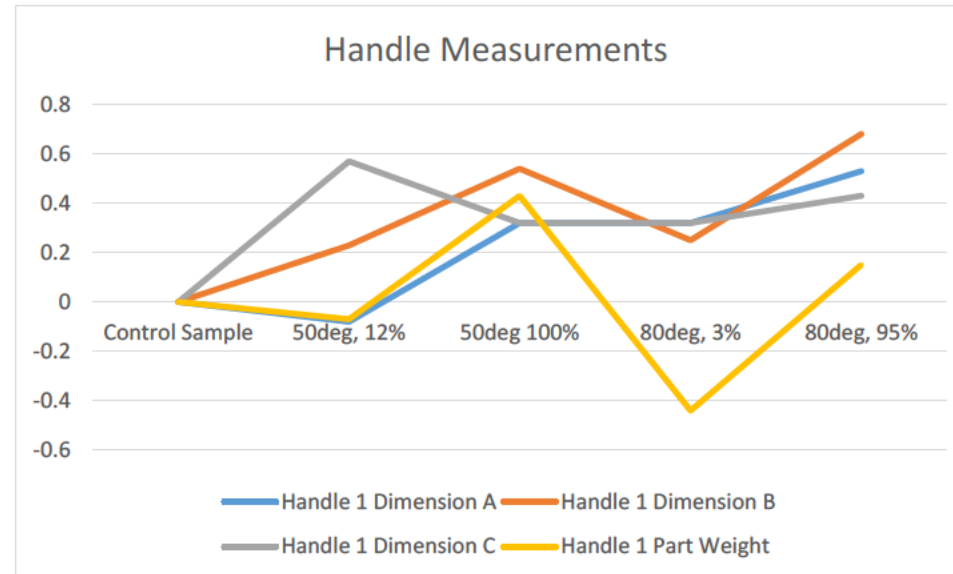
Handle Measurement

PA6 is hygroscopic, Acetal is not
Control sample is reference (0)
Graph is % deviation from control
All dimensions are external
Maximum deviation is 0.7%
Part has tendency to grow with both
heat and humidity

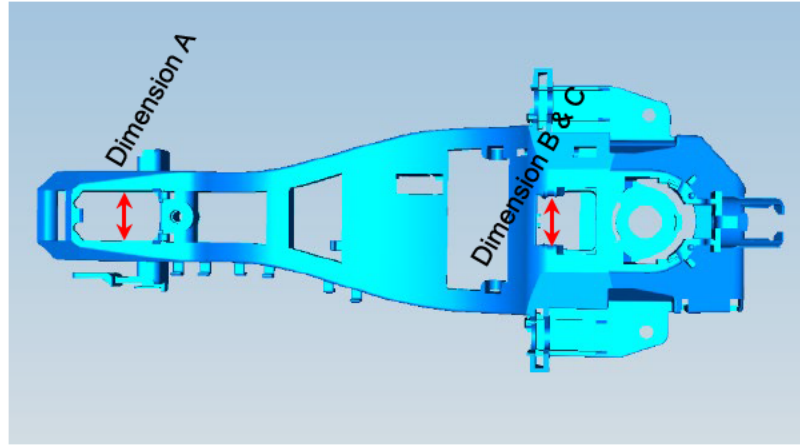
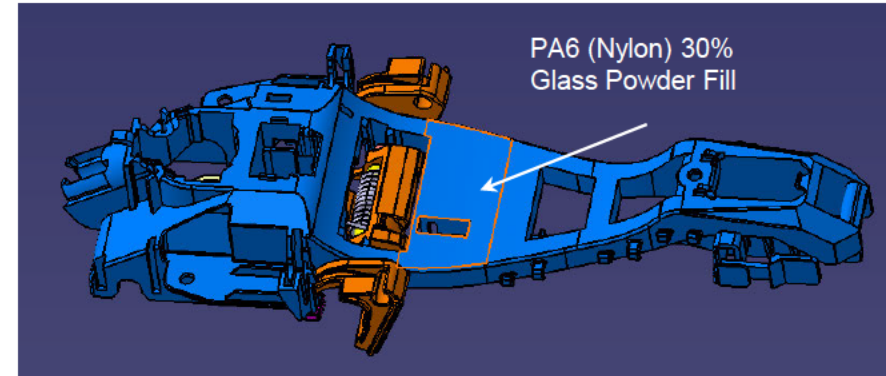
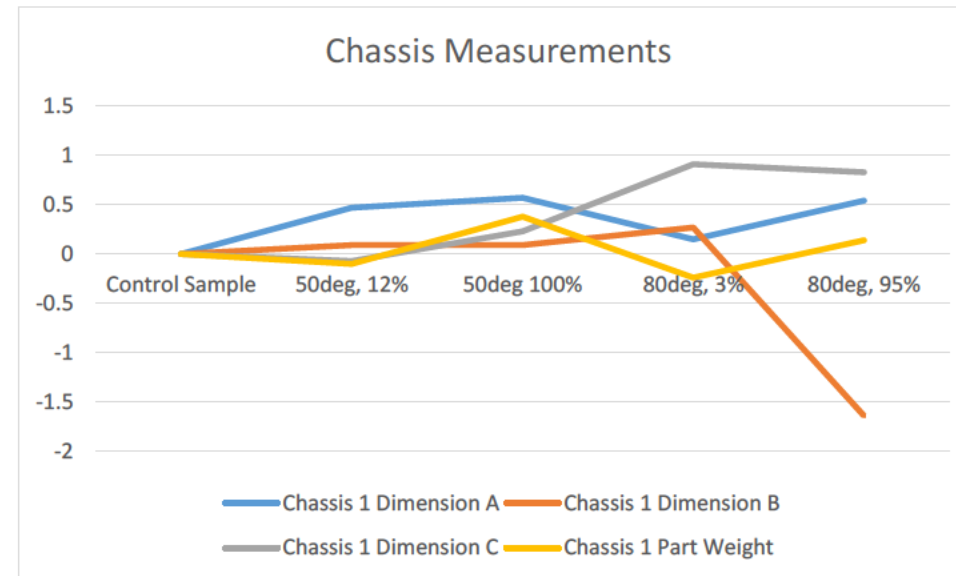
Chassis Measurement

PA6 is hygroscopic
Control sample is reference (0)
Graph is % deviation from control
All dimensions are internal
Maximum deviation is 1.64% - possible outlier. Next max 0.91%
Despite measures being internal, data indicates that the dimensions also grow with heat and humidity

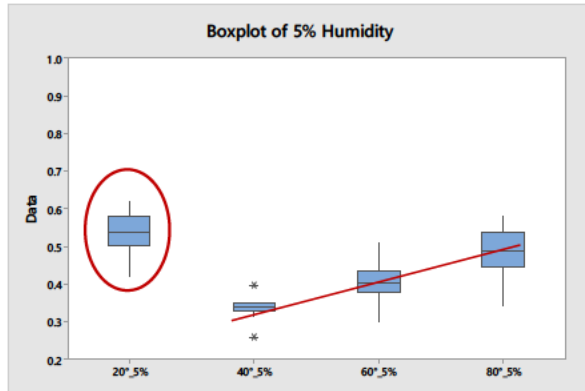
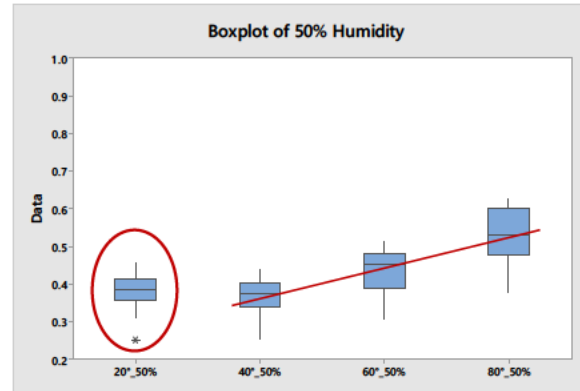
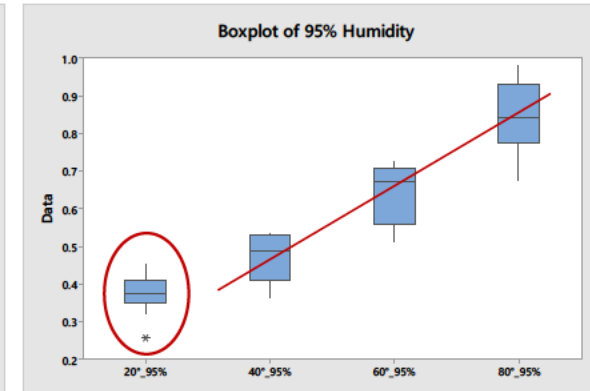
Handle Measurement

- Boxplots indicate that there is a trend for the handle to grow with temperature
- First boxplot (20 degrees) in both charts doesn't fit with the pattern
- From 40 degrees there is a steady and consistent growth
- The fact that 20 degrees doesn't fit is most likely because the POM sleeve has a minimum size – PA6 isn't being directly measured

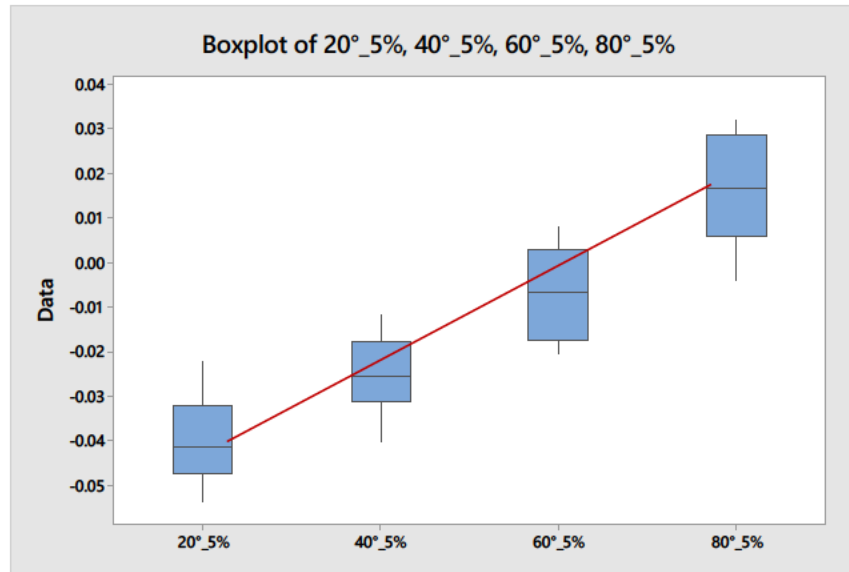
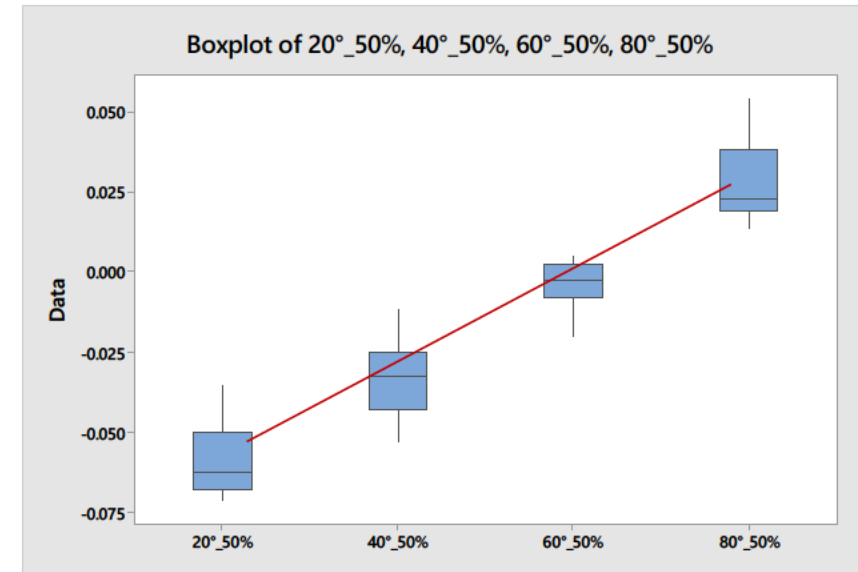
Handle Measurement

- As previous smooth rate of change observed, steady increase in size with temperature
- PA6 being directly measured, no POM sleeve
- Material behaves as expected

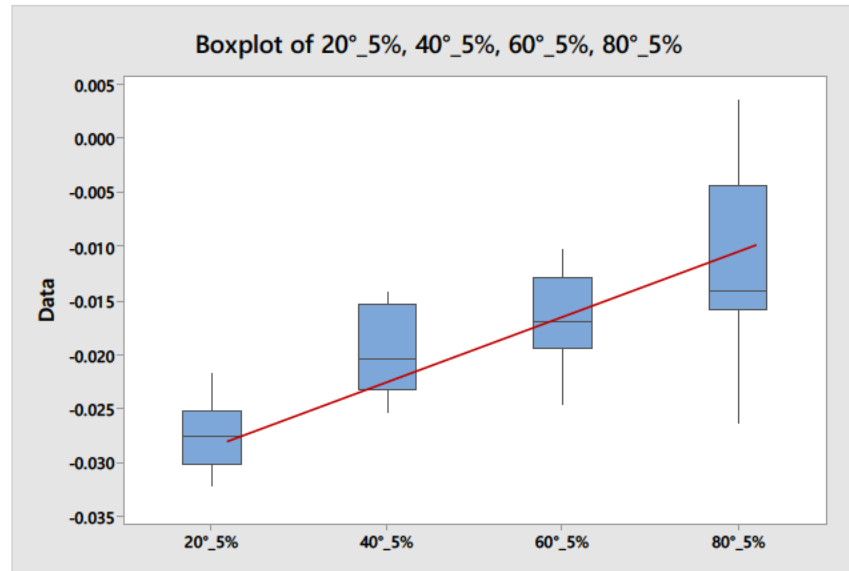
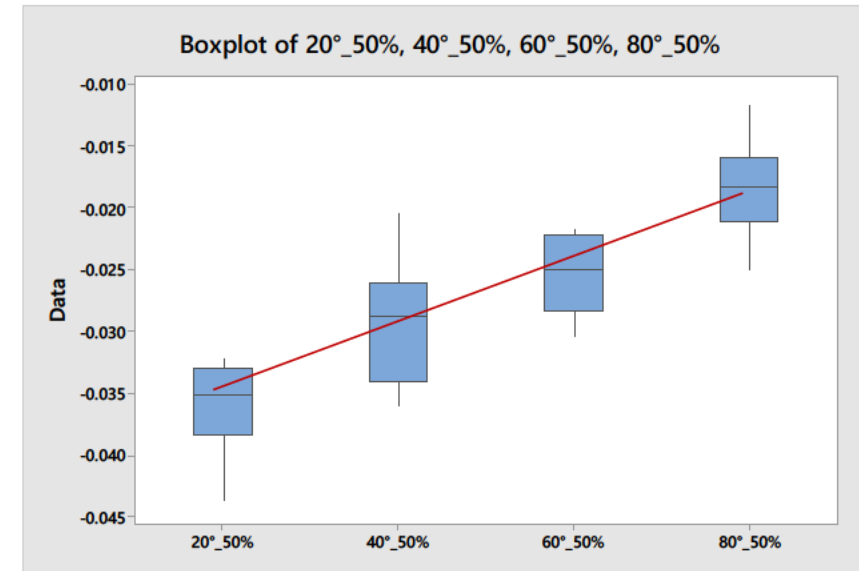
Chassis Measurement

- As previous smooth rate of change observed, steady increase in size with temperature
- PA6 being directly measured, no POM sleeve
- Material behaves as expected
- → As handle strap width increases, so does aperture in chassis in which it sits

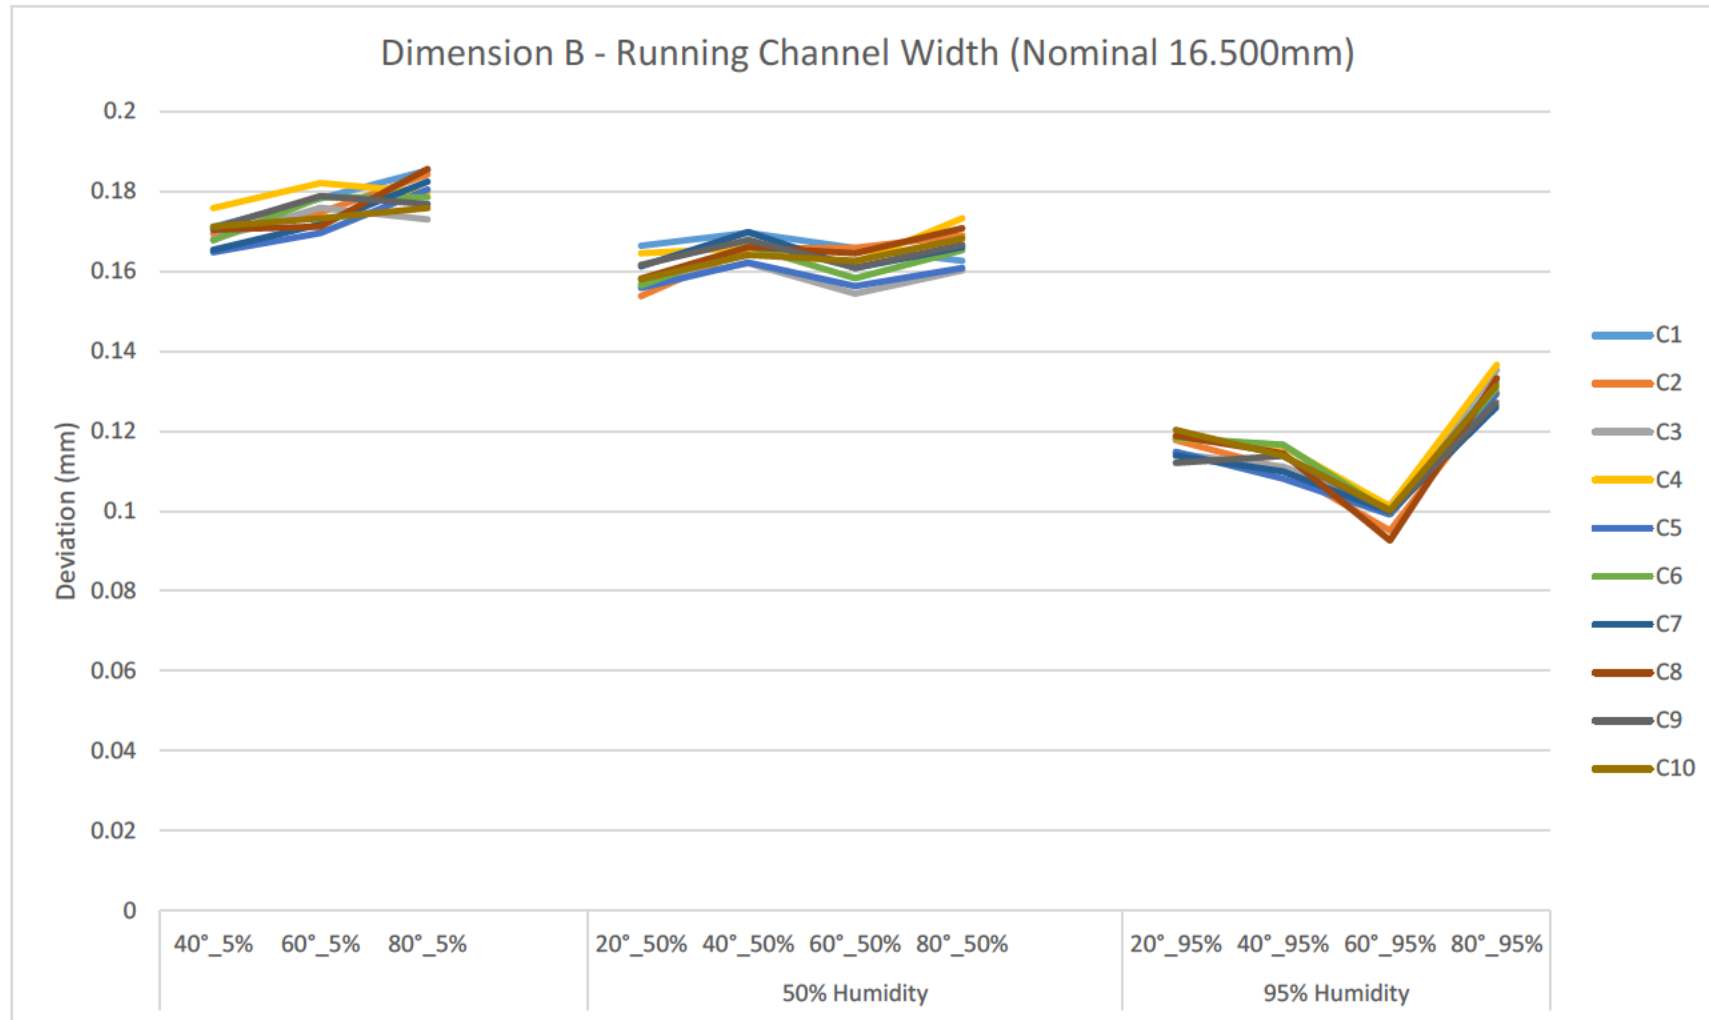
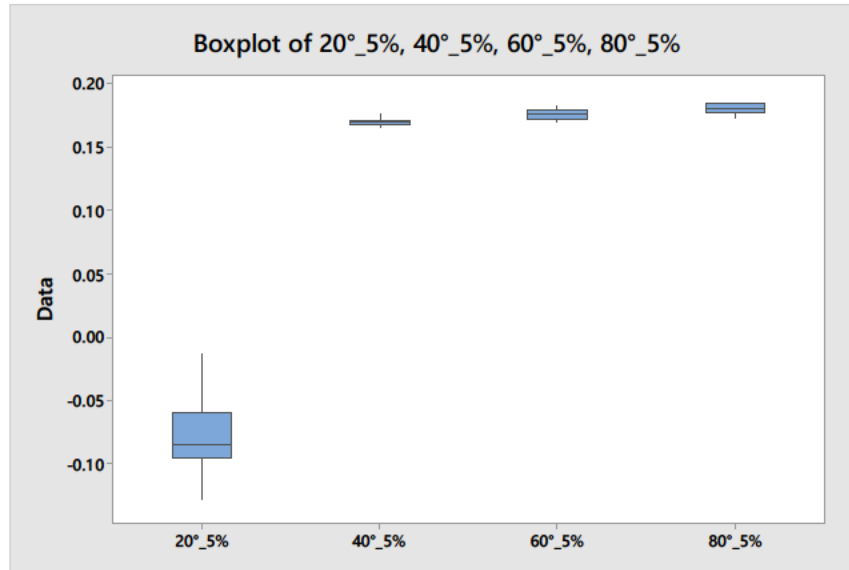
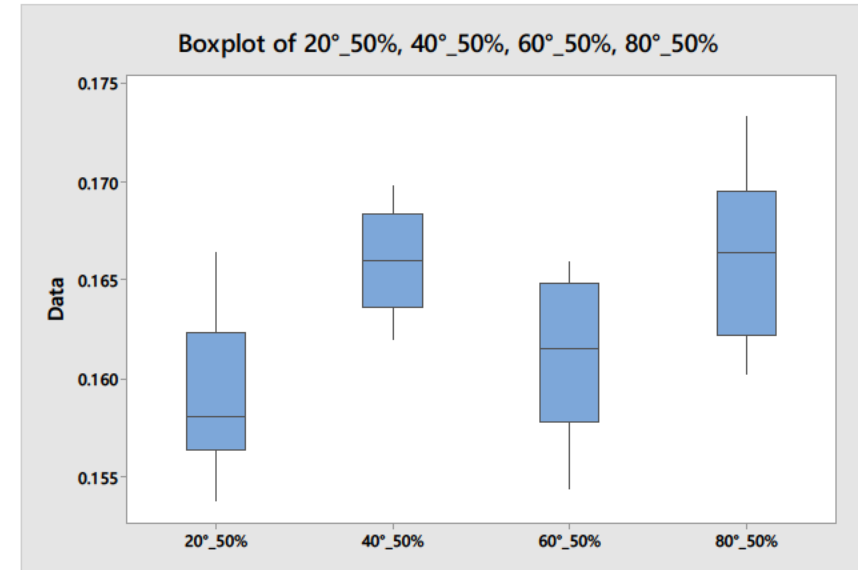
Chassis Measurement

- Very unusual data set at 20 degrees 5% - lack of equilibrium in the plastic before measurements were taken
- 6 hours initial soak not long enough to stabilise
- Soak time after humidity changes increased to compensate (24-48 hours)
- Not much movement in running channel width despite temperature and humidity changes
- → Running channel is stable through testing to date
