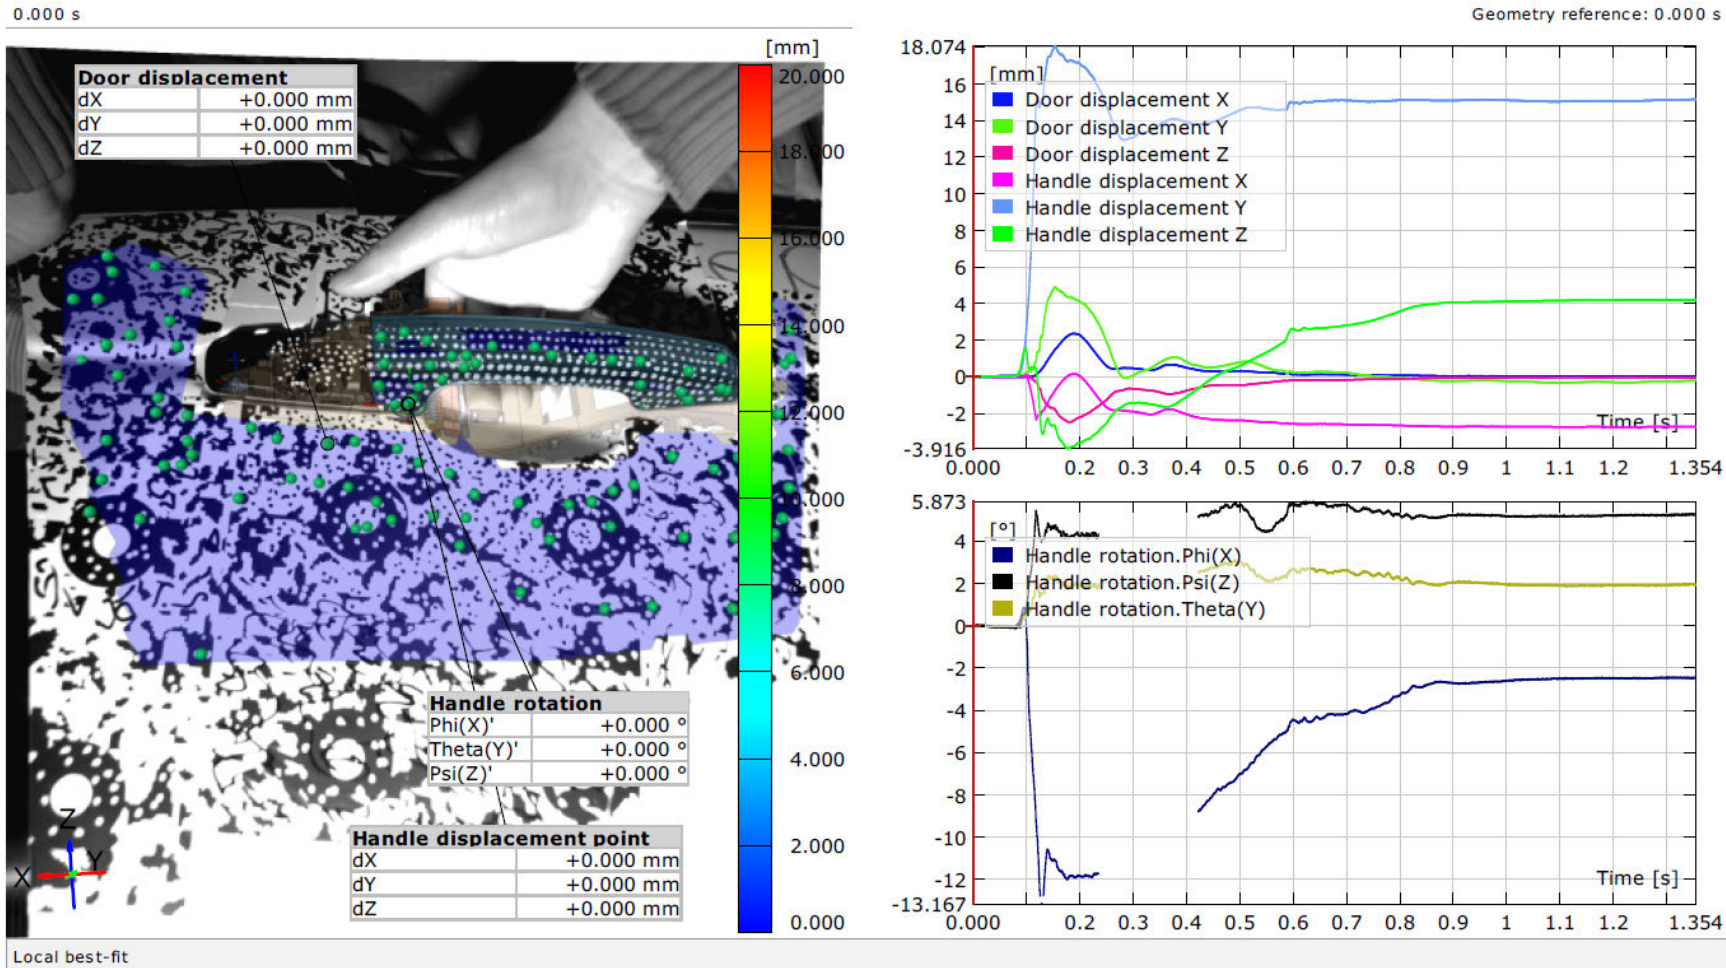
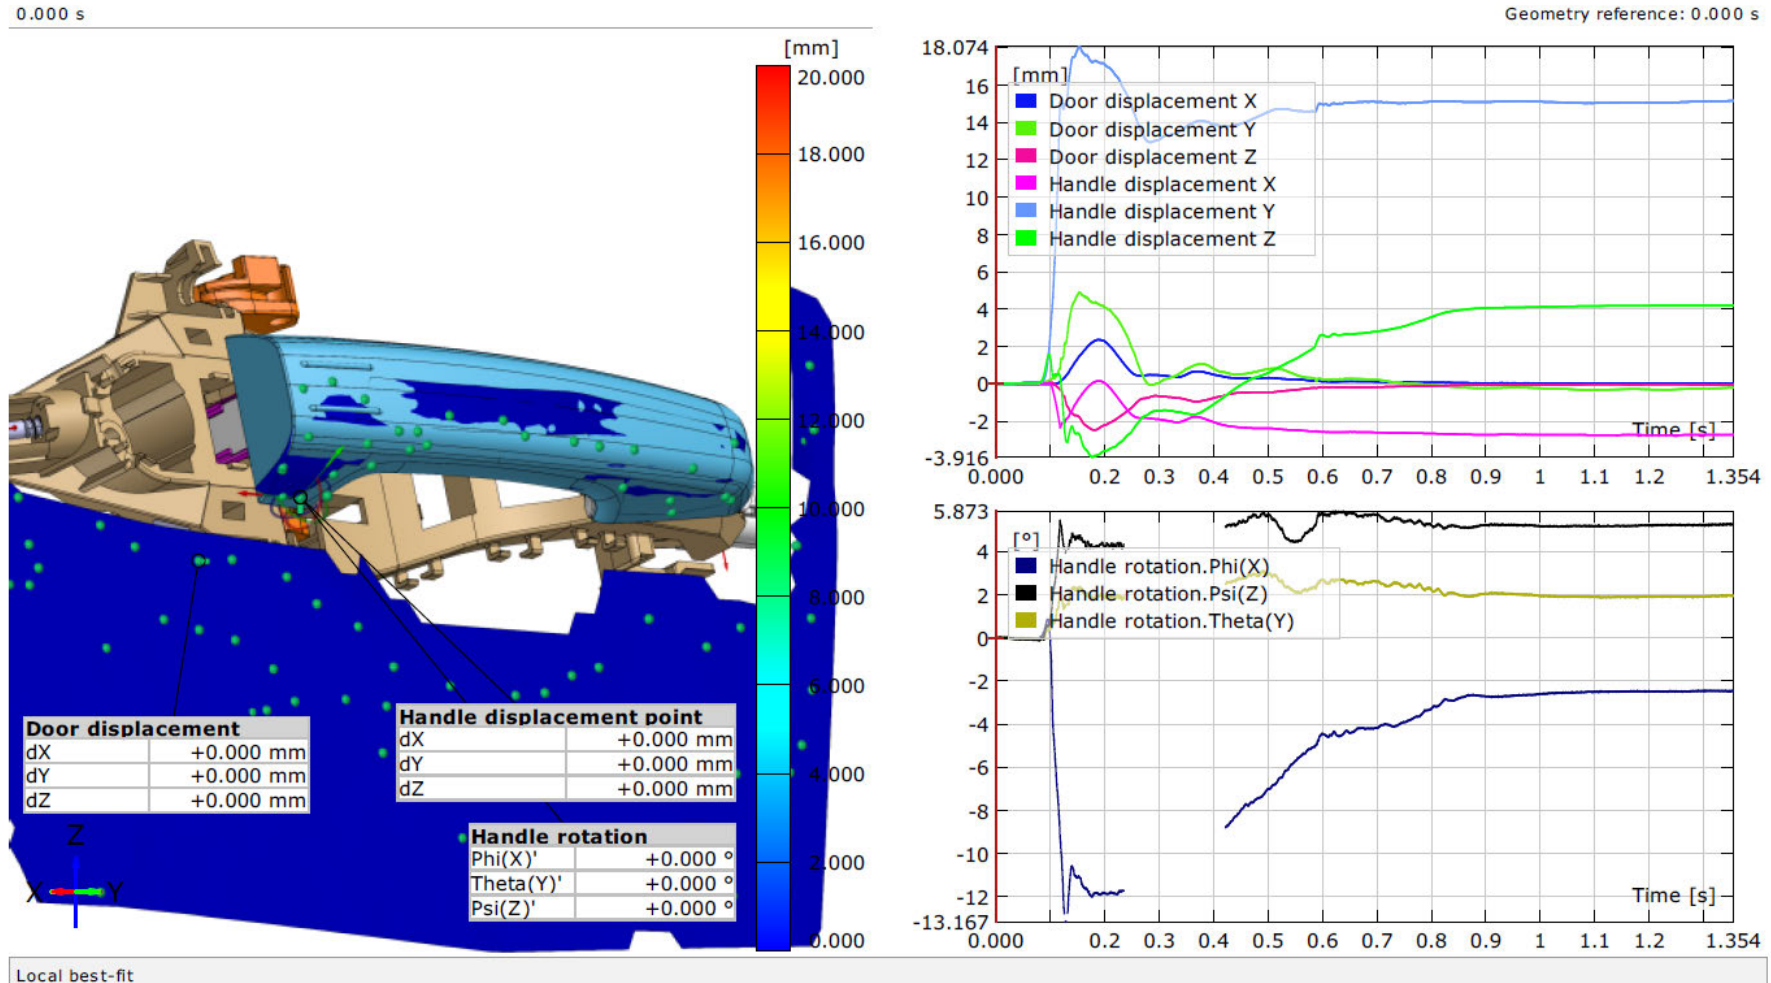
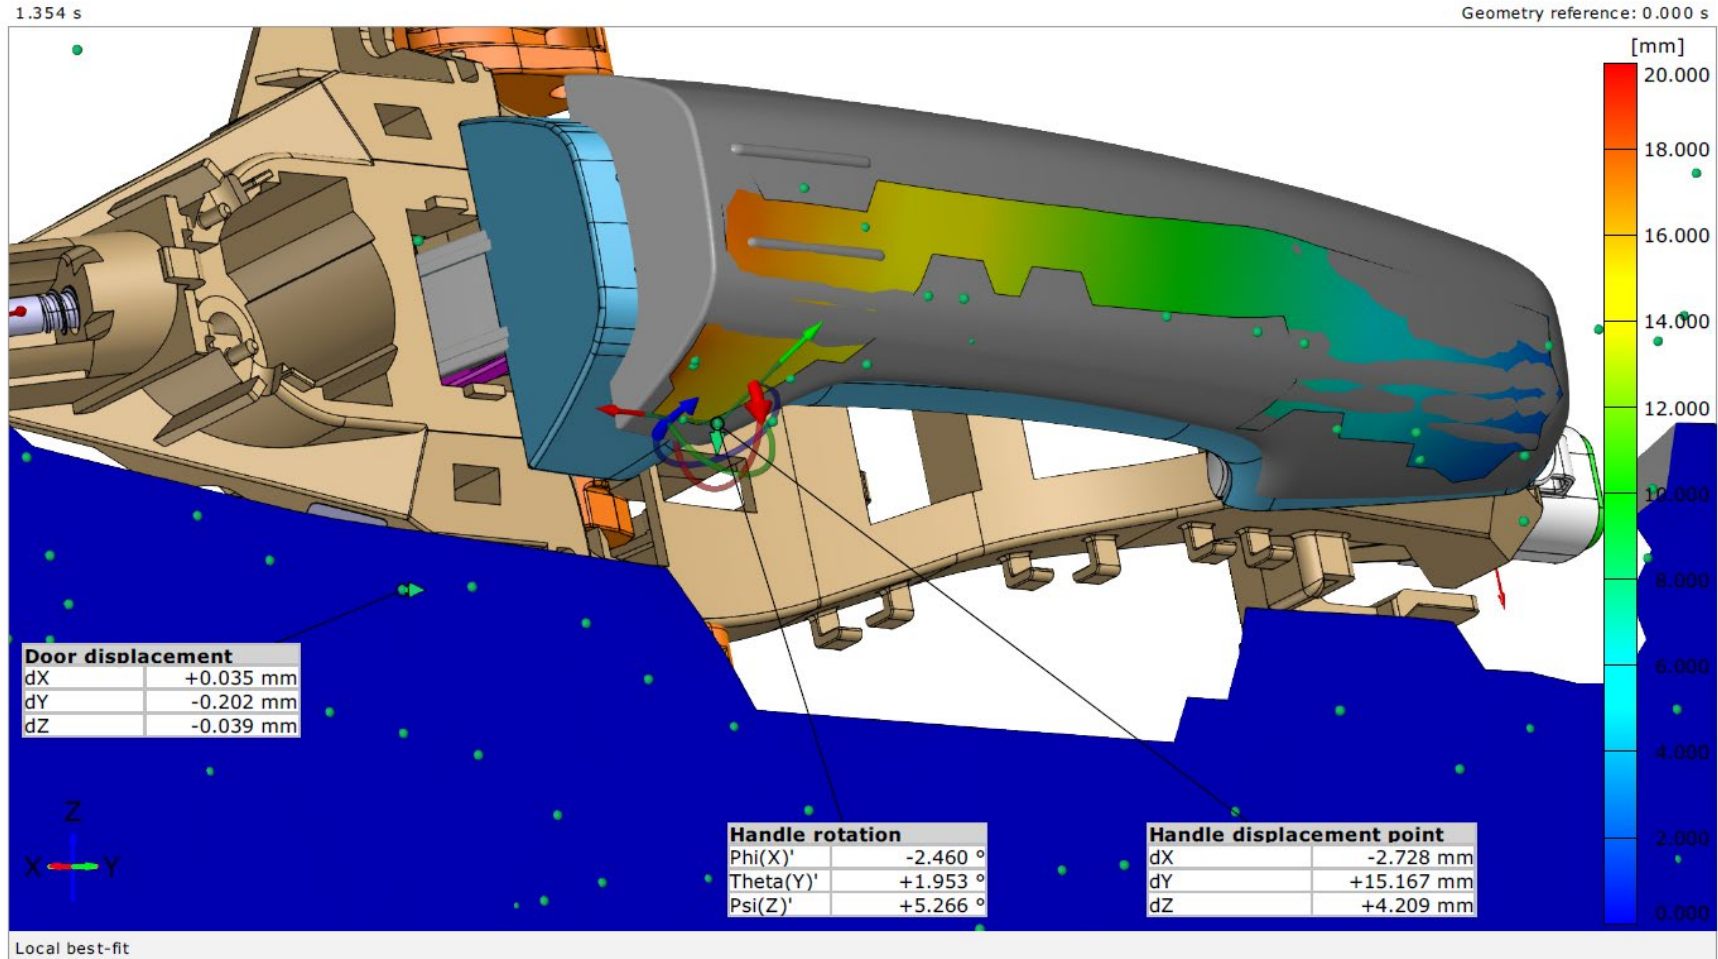
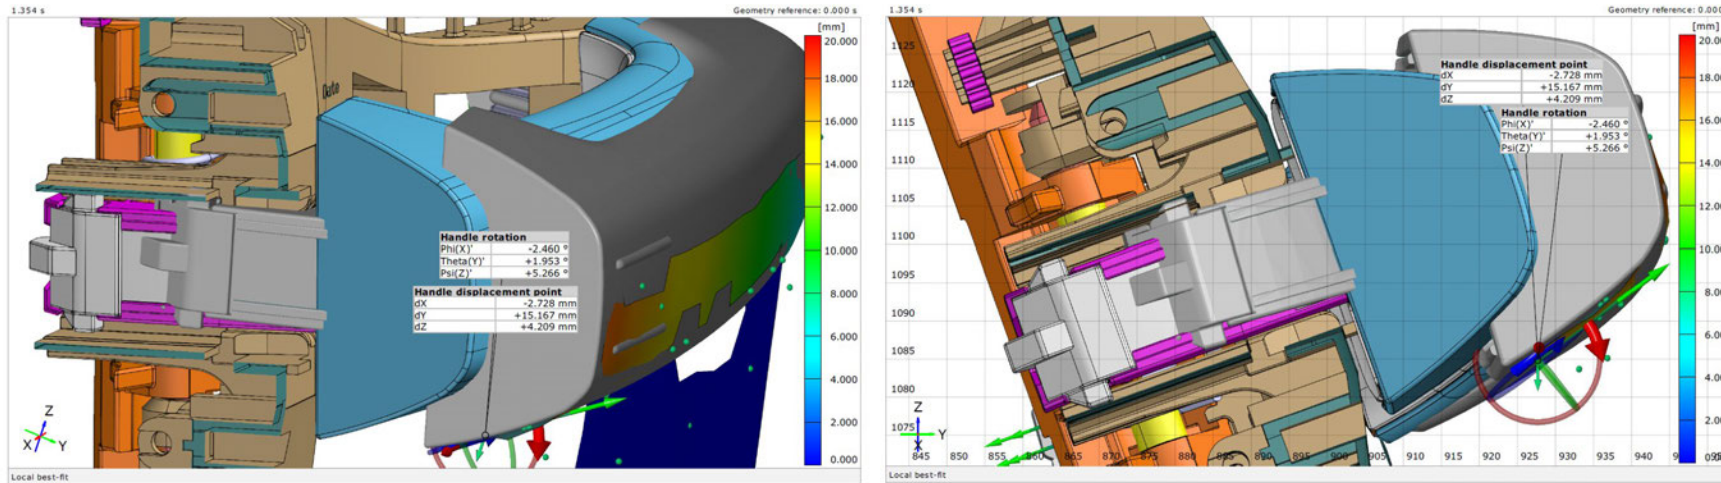
- Optical measurement techniques and high speed camera work give more insight
- Using latest CAD models there is clearly no jam where the handle used to stick on the leading edge of the chassis
- The jam at the rear is mitigated by the additional rib running backwards through the chassis
- Using the latest level parts we are unable to recreate the jam
- UNABLE TO DEVELOP RELIABLE MEASUREMENT SYSTEM

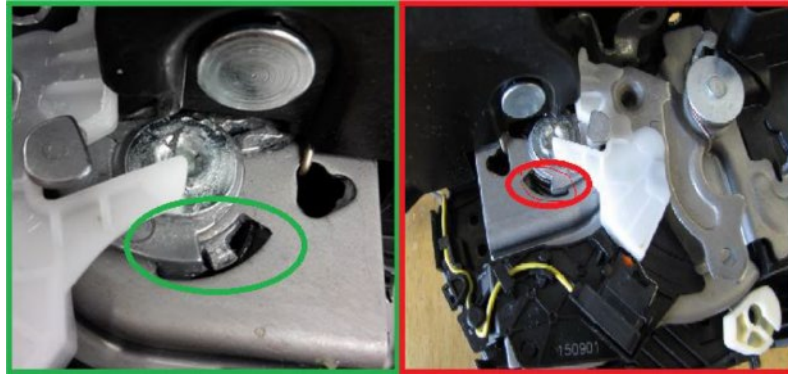
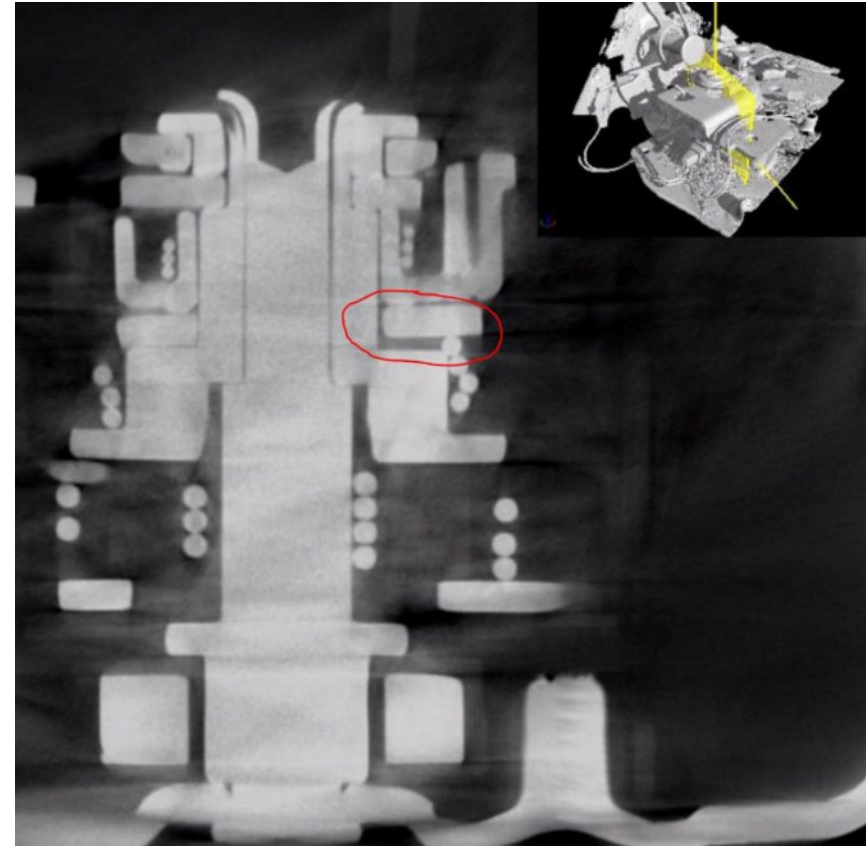
KV Transmission Lever Jam

- Chinese complaint of door unable to close
- Latch received at Brose
- KV lever in home position with no winds on the motor spindle
- KV transmission lever out of home position
- Pawl unable to lock claw and latch unable to be closed
- CT scan shows jammed spring on main rotational bush

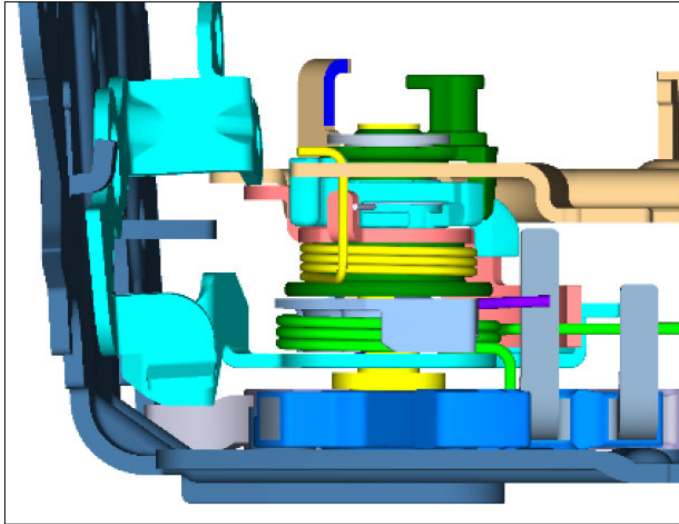
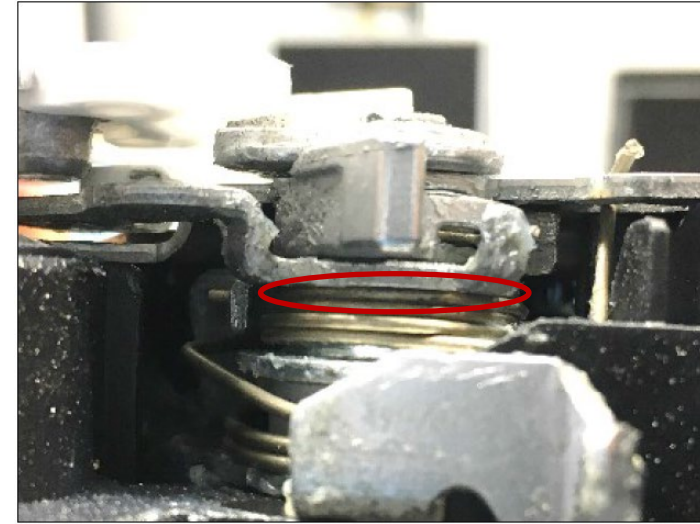
CAD image showing joint stack and how it should look
Careful teardown of the clutch left the jammed condition present until the pawl pin was removed
Error state present in the image above – spring clearly jammed between main bush and outside release chain transmission lever

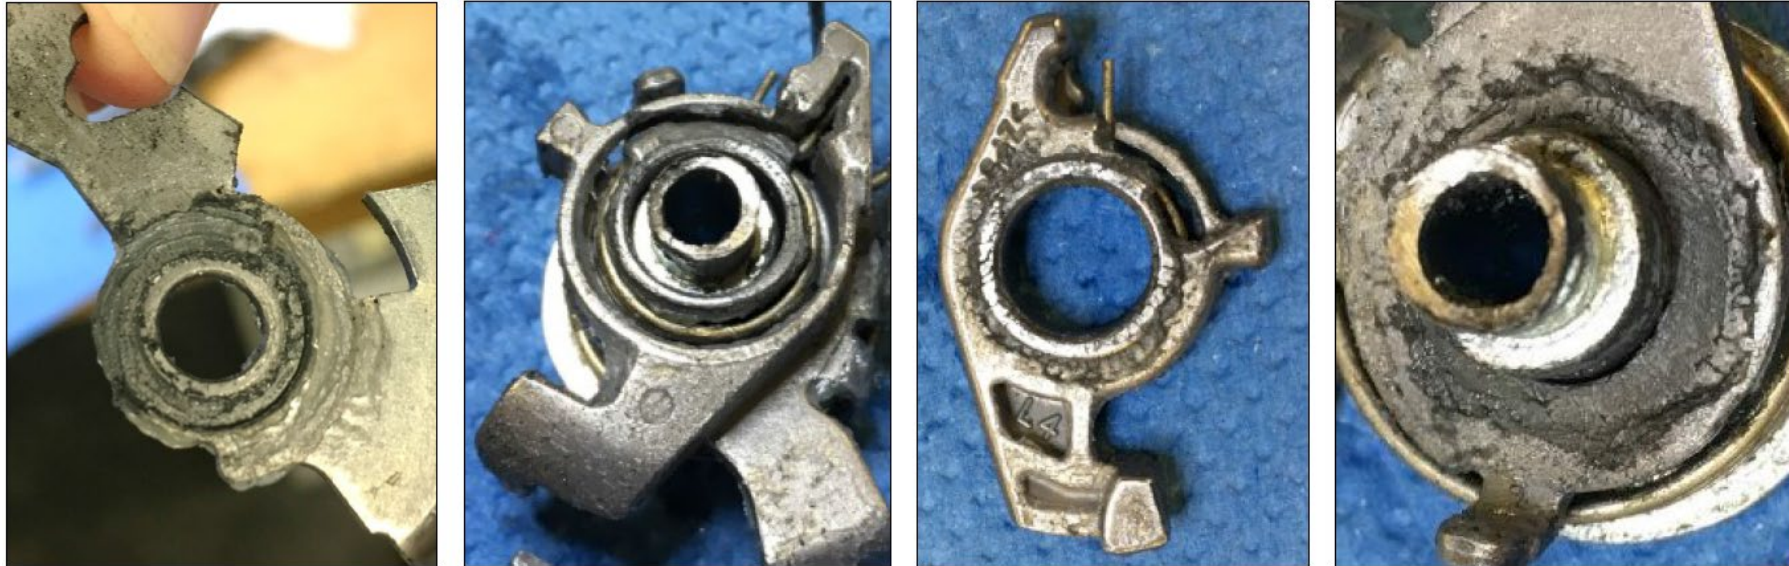
Tearing down the clutch mechanism revealed significant abrasion
The abrasion has left residues over the outside release chain transmission lever
and the KV transmission lever
The KV transmission lever is the part that has suffered from this abrasive contact

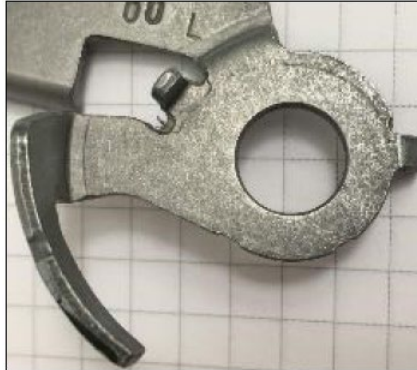
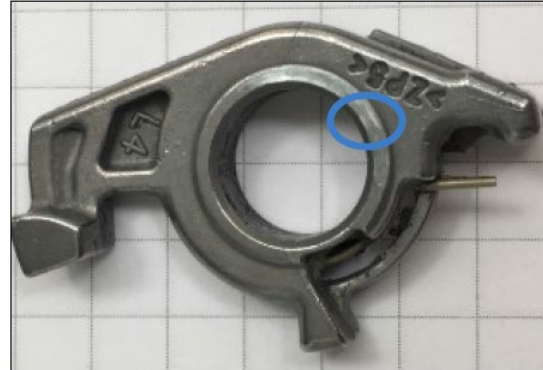
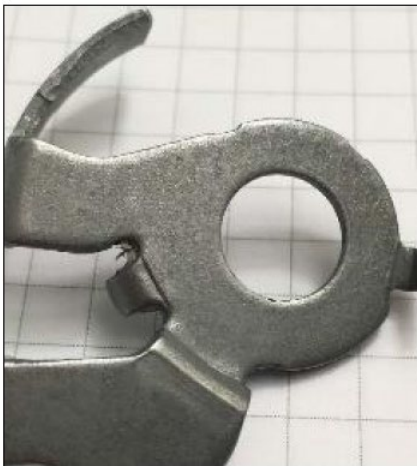
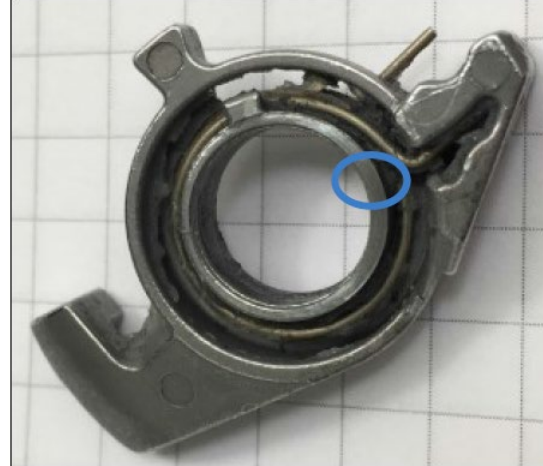
Abrasion area clearly visible on the KV transmission lever

Abraded, worn area of the lever is out of spec at 4.92mm

Supplier is engaged to resolve OOS conditions

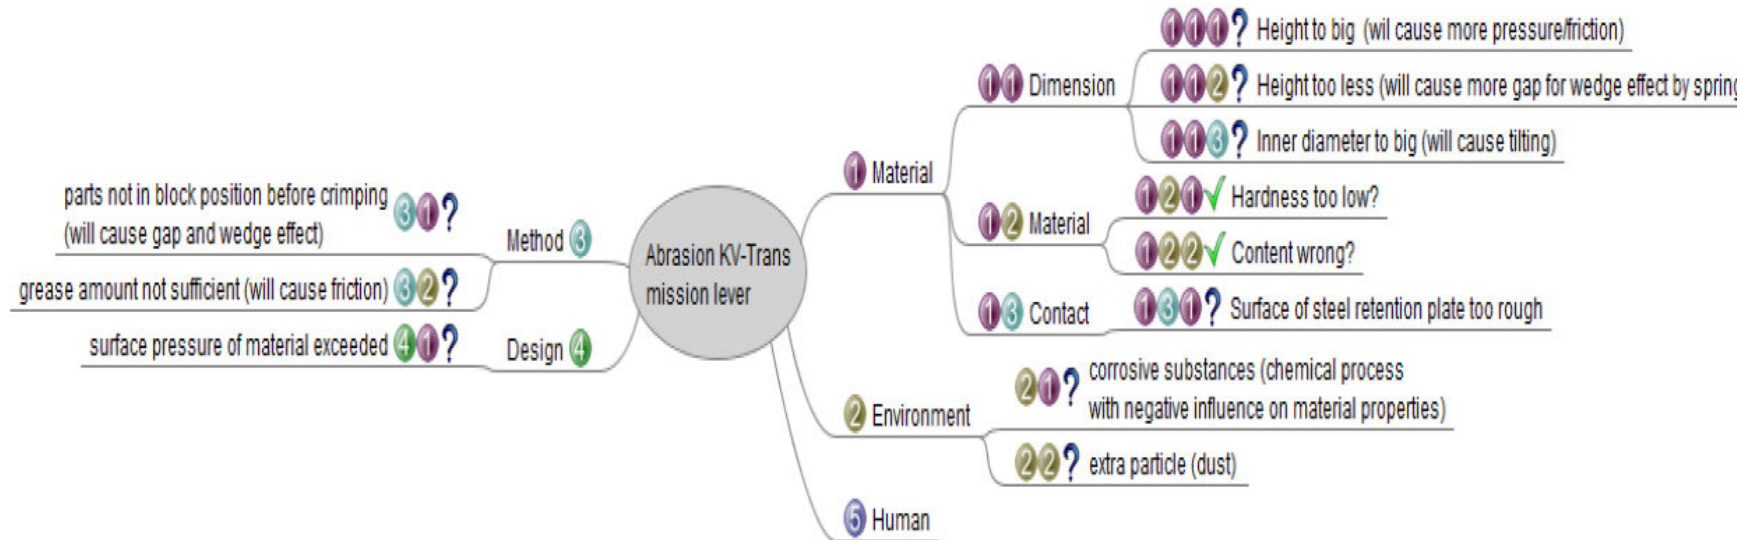
Abrasion was never evident during DV / KLT testing

Ishikawa under development to understand why the abrasion occurs

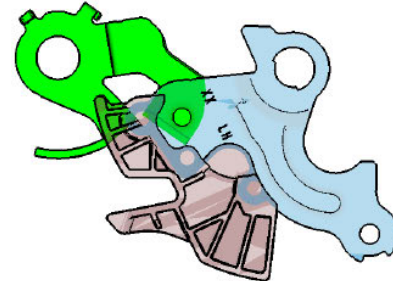
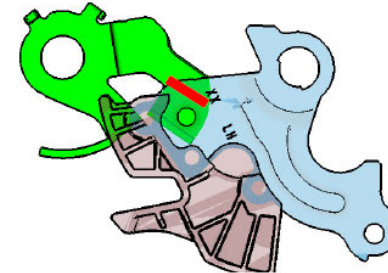
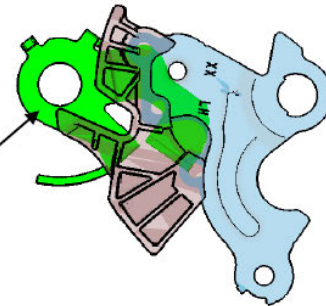
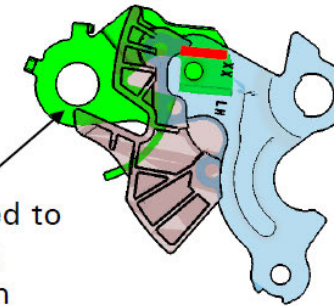
Lever can stay in jammed position

Modification of O/S transmission lever generates linkage also in resetting direction

Lever is forced to move back in home position

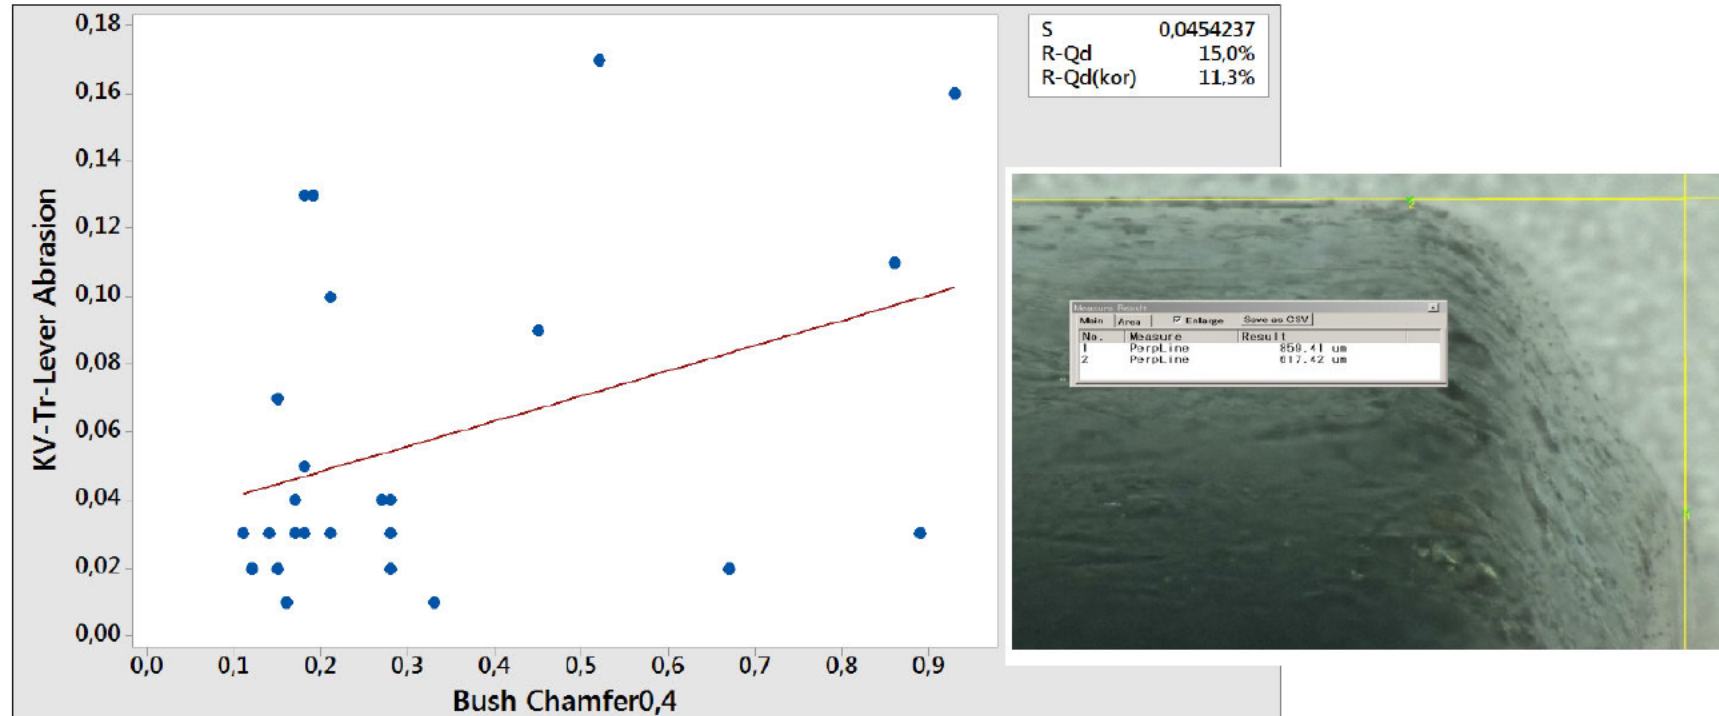
*Based on few available data: bigger radial chamfer leads to more abrasion
→ This has to be confirmed with more data*

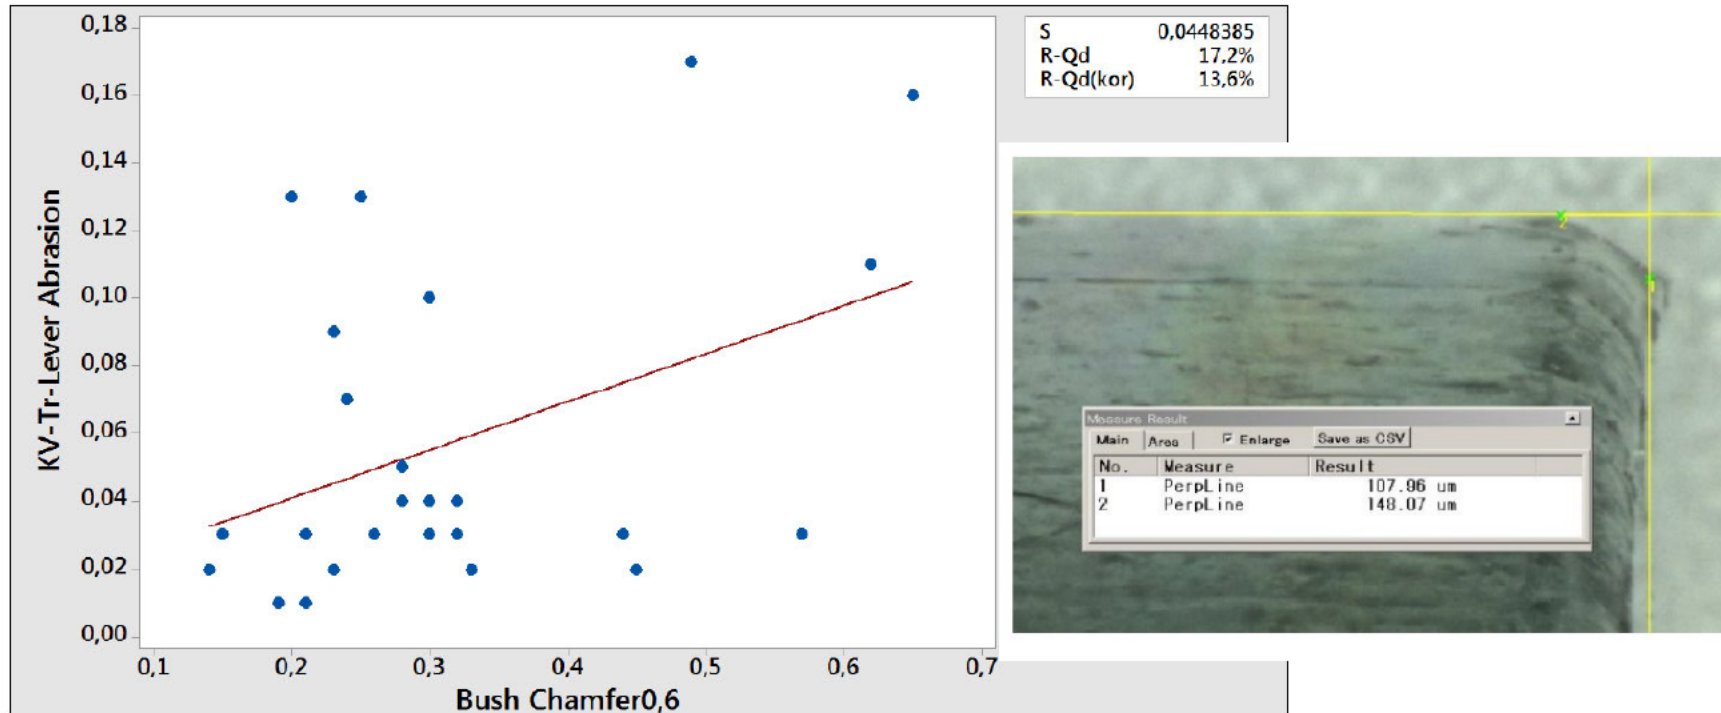
*Based on few available data: bigger axial chamfer leads to more abrasion
→ This has to be confirmed with more data*

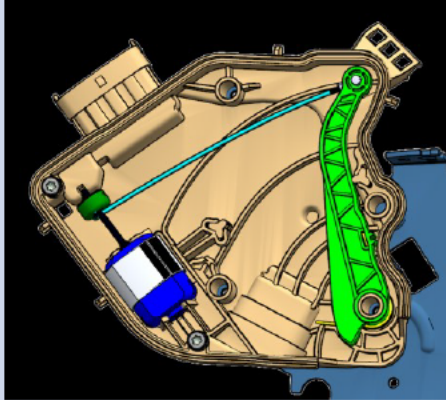
KV-Function disabled in RFA – explain technical effect to latch „jammed“

Failure mode	„cord will not unwind“ (P068)	Spring jams KV mechanism
<p>Technical influence of disabled KV function in RFA</p>

<p>- green KV lever will stay in home position – KV mechanism can not jam in activated position</p>

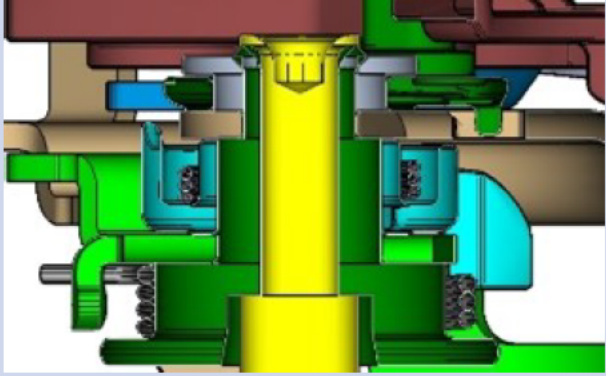
<p>- overall rotation angle of KV transmission lever (light blue) is reduced - Less tilting of KV transmission lever under load - different abrasion behavior expected</p>
<p>Will disabling the KV Function in the RFA solve the issue?</p>	<p>yes</p>	<p>no, spring could still move into the gap</p>

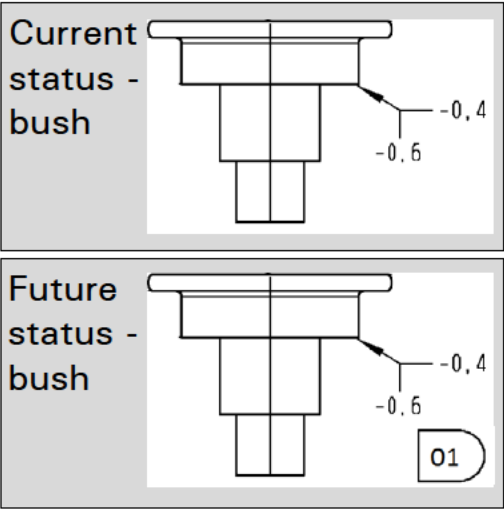
- Link failure consequence „door will not latch“ with „chamfer bush outside transmission lever too large“
→ Failure consequence „door will not latch“ will require severity of 10 in FMEA
- Change of severity will generate an CC evaluation
→ Bush supplier already implement 100% camera check on this characteristic
- Control of suppliers can further be improved:
 - Certified delivery

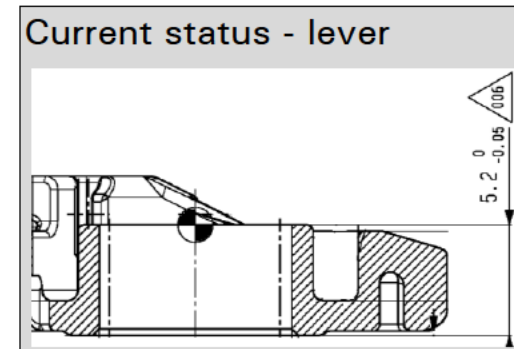
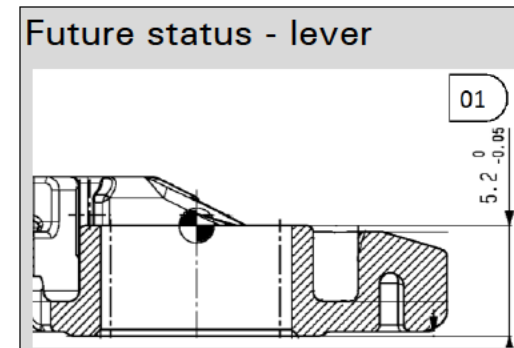
KV transmission lever

- Link failure consequence „door will not latch“ with „KV transmission lever too thin“
→ Failure consequence „door will not latch“ will require severity of 10 in FMEA
- Change of severity will generate an CC evaluation
→ Supplier needs to implement ongoing process control
- Control of suppliers can further be improved:
 - Spot check of delivered parts during incoming inspection at Brose

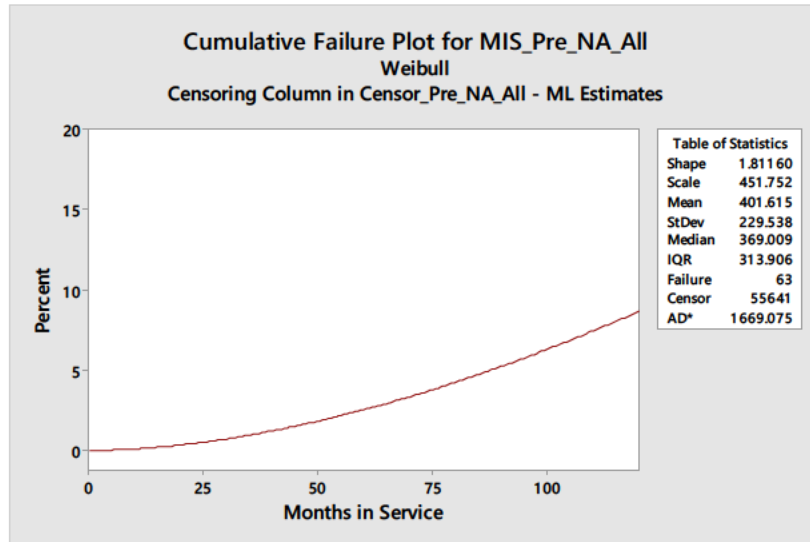
NHTSA PRE-P068 “FAILURE TO LATCH”

Pre-P068 action, the predicted parametric model indicates a worst case report rate of “Failure to Latch” of 180.7 R/1000 at ten years in service, covering all known failure modes. The global prediction for the same error state is 253.4 R/1000. Nominally the predicted failure rate is 82.9 R/1000.

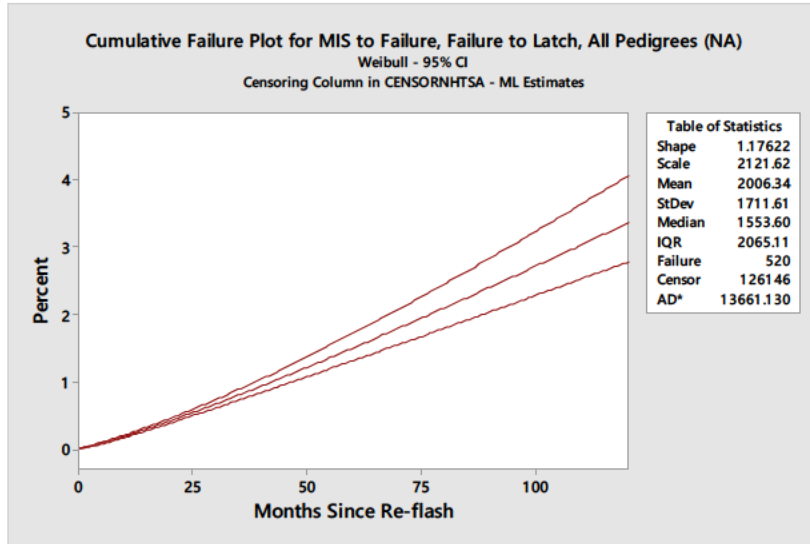
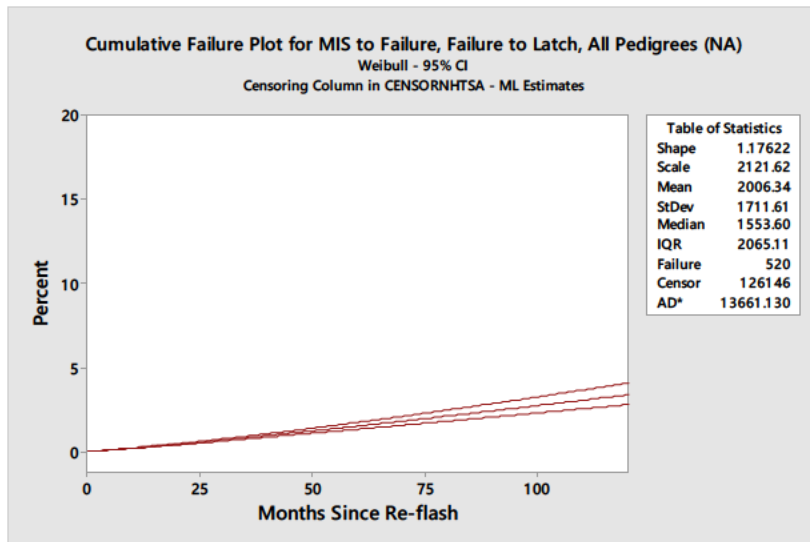
NHTSA POST P068 “FAILURE TO LATCH”

Post P068 action, the predicted parametric model indicates a worst case report rate of “Failure to Latch” of 39.25 R/1000 at ten years in service, covering all known failure modes. Nominally the prediction is 32.5 R/1000

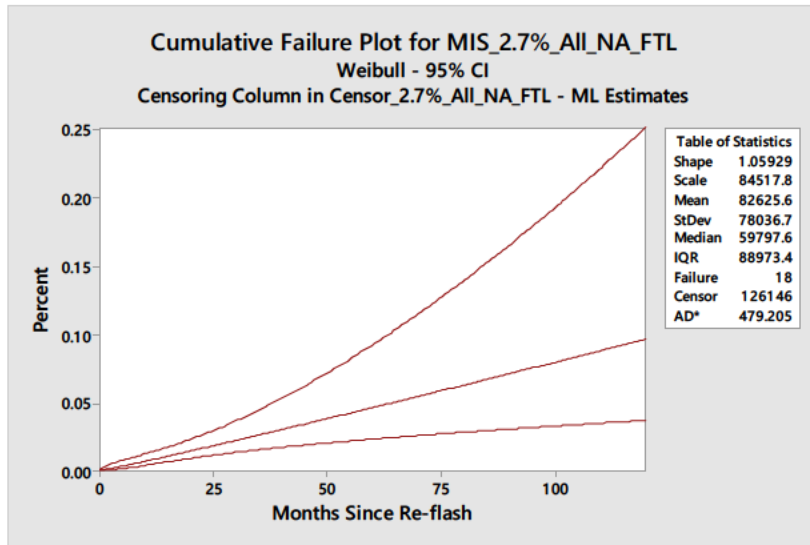
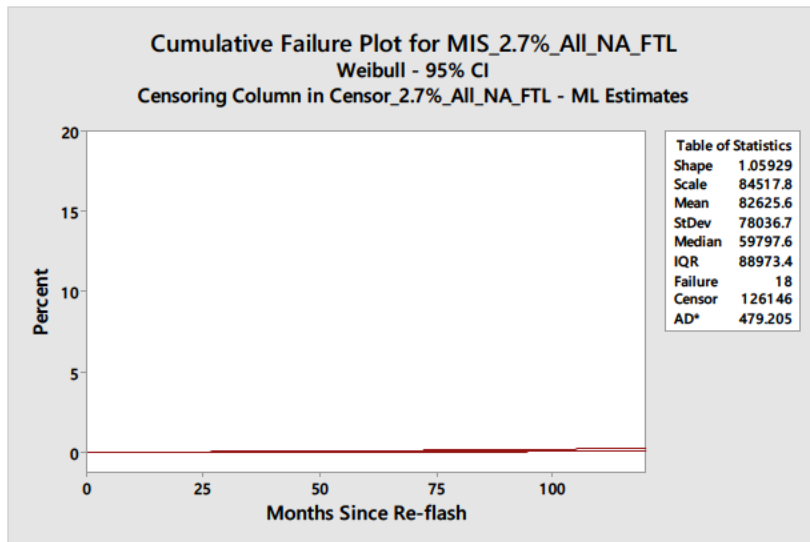
NHTSA POST P068 “FAILURE TO LATCH” – 2.7% MODIFIER

Post P068 action, using a modifier of 2.7% and applying this pre-processing to the quantity of reports, the model indicates a worst case report rate of “Failure to Latch” of 2.4 R/1000 at ten years in service, covering specifically corroded KV actuators. Nominally the prediction is 0.9R/1000

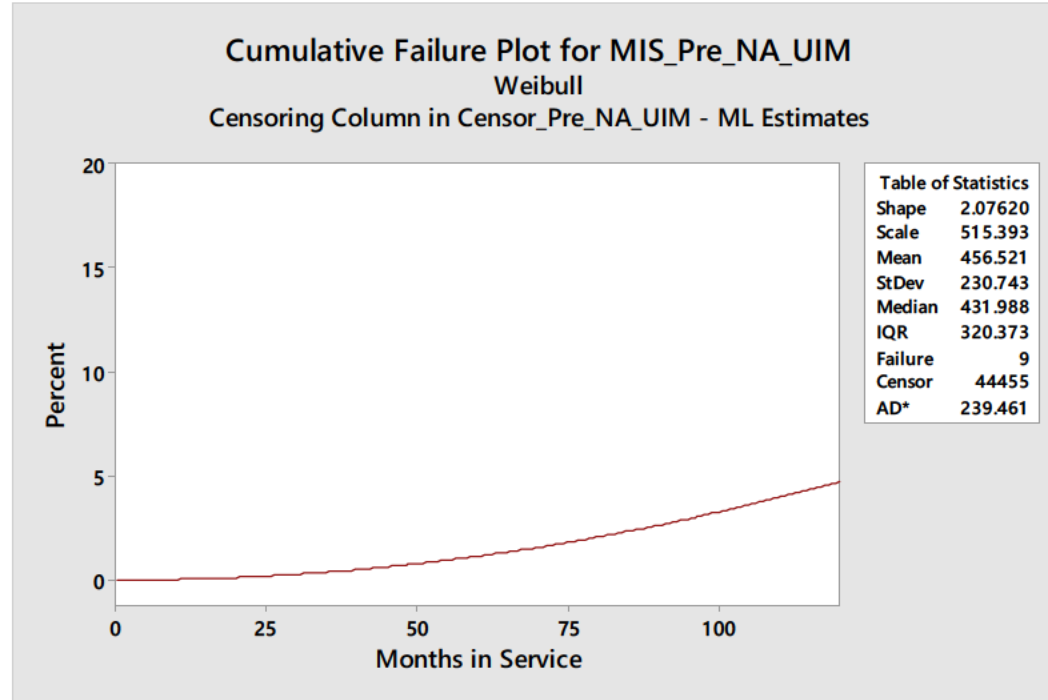
NHTSA PRE P068 “UNLATCHED IN MOTION (UIM)”

Pre-P068 action, the predicted parametric model indicates a nominal report rate of “Unlatched in Motion” of [45 R/1000](#) at ten years in service, covering all known failure modes

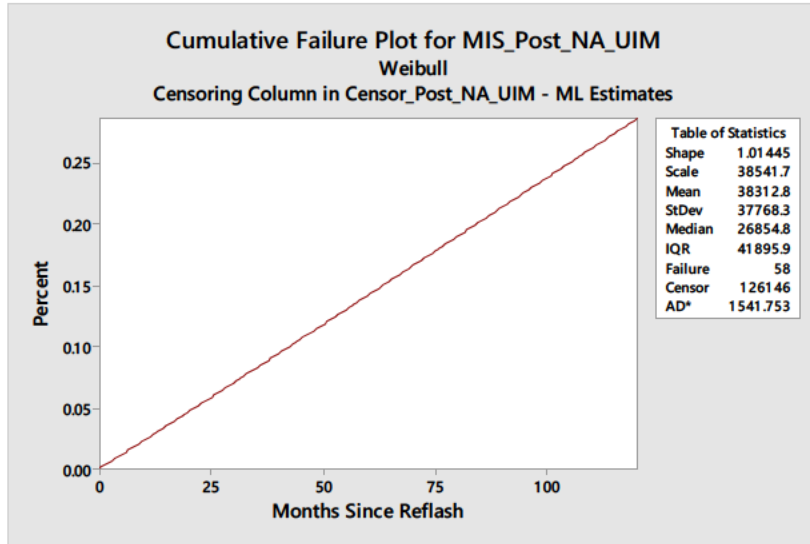
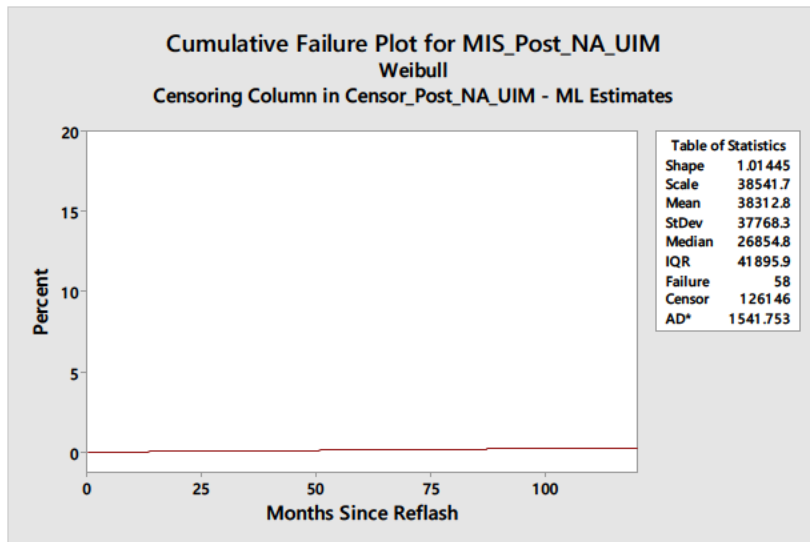
NHTSA POST P068 “UNLATCHED IN MOTION (UIM)”

Post P068 action, the predicted parametric model indicates a report rate of “Unlatched in Motion” at ten years in service, covering all known failure modes of 2.8 R/1000

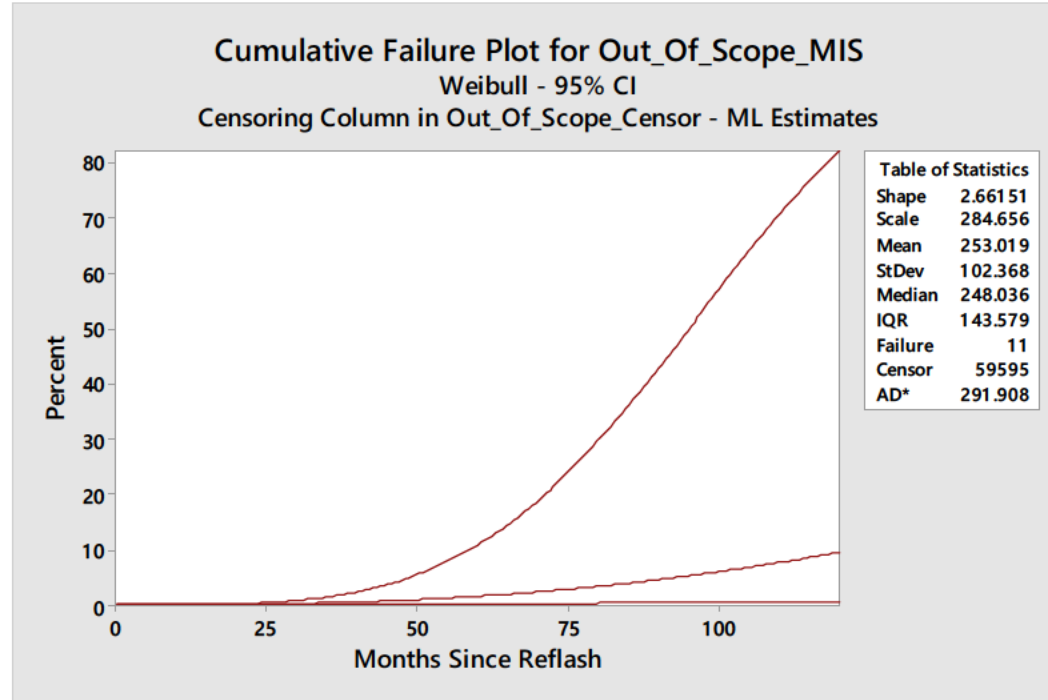
OUT OF SCOPE FAILURES

The Out Of Scope reports for Unlatched in Motion (UIM) have 11 reports post recall scope.

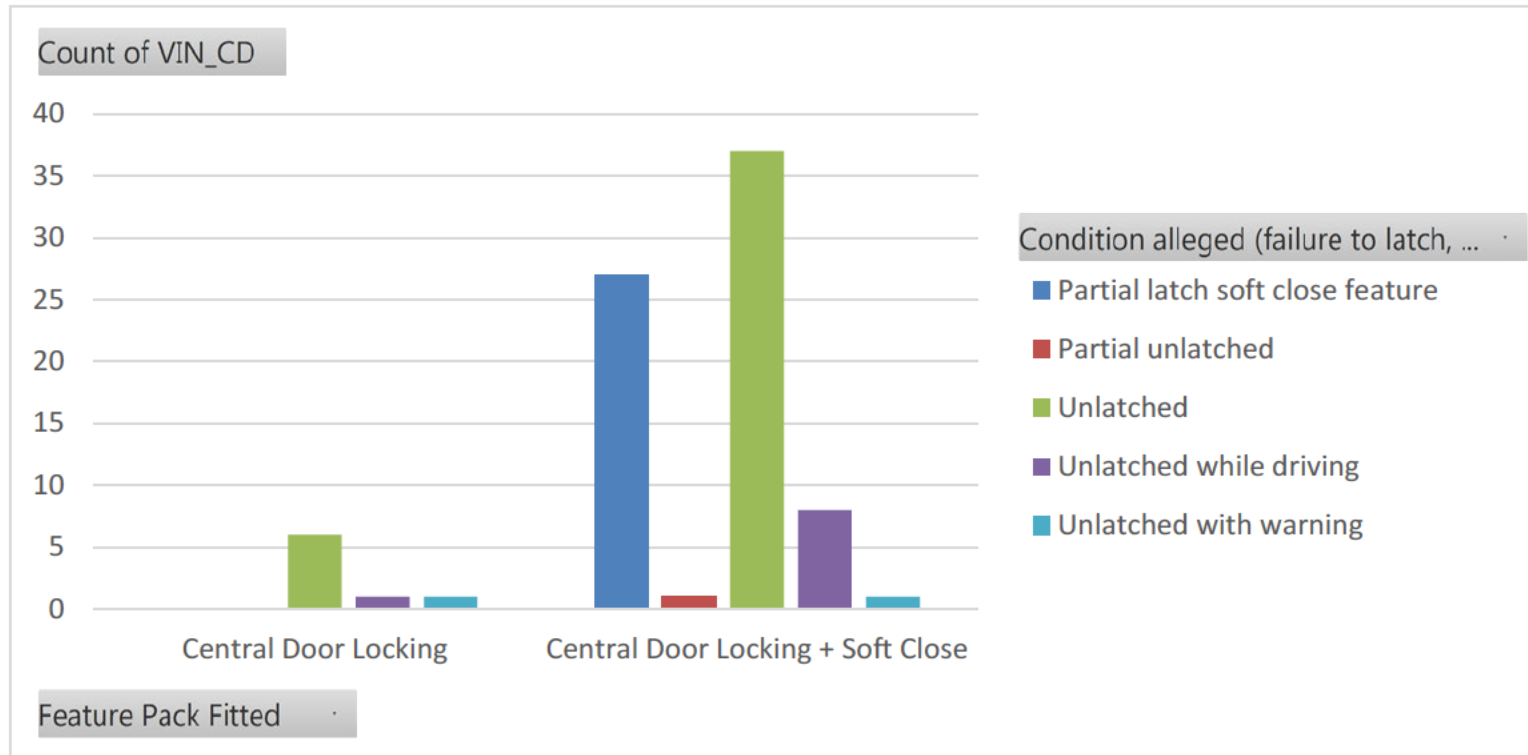
NHTSA FEATURE ANALYSIS – SOFT CLOSE

Most of the 84 originally confirmed reports come from vehicles fitted with a soft close feature

Of the 8 vehicles without soft close feature, 6 were reported as unable to latch, 1 unlatched while driving (which still does not mitigate the potential blind spot), and one unlatched with warning

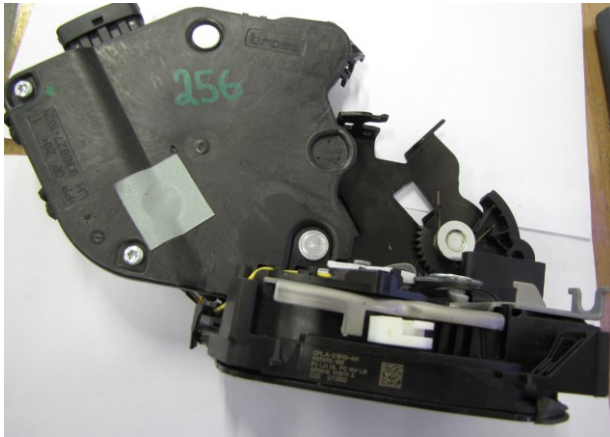
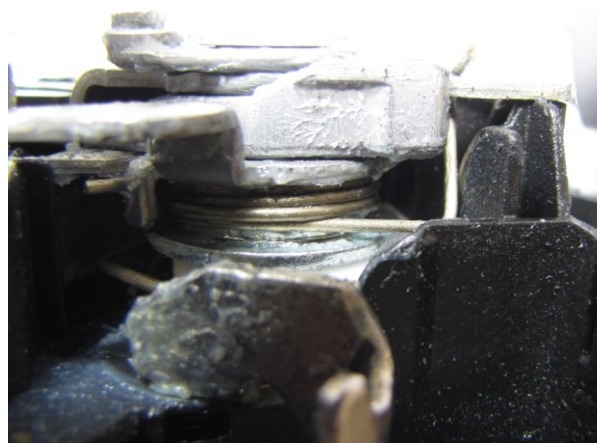
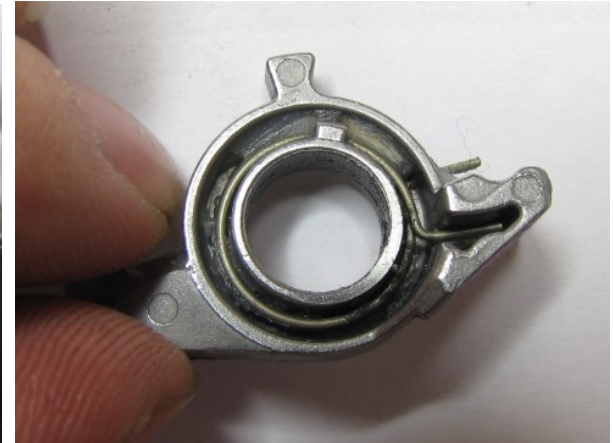
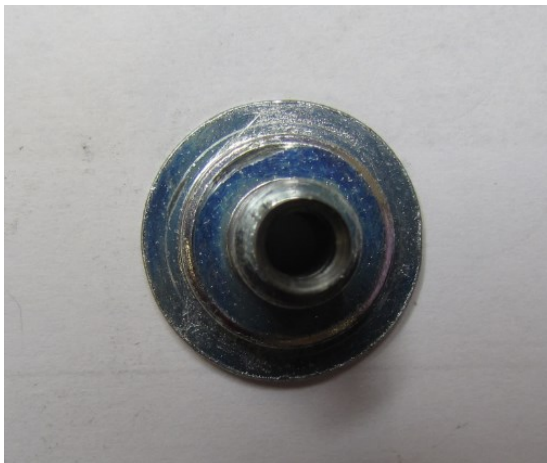
▪ Systematic disassembly:

- All single components have been assembled correctly,
- Abbrasion on KV transmission lever detected,
 - Height: 5,04/4,95mm
- Damage on bush surface from spring detected.

Conclusion: Spring winding jammed between outside release lever and bush as per L2CCA2BG5GG.
