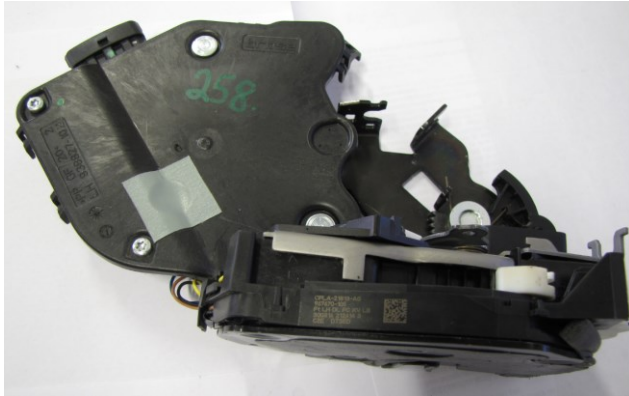
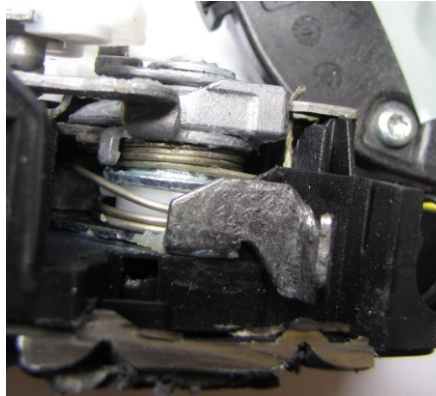
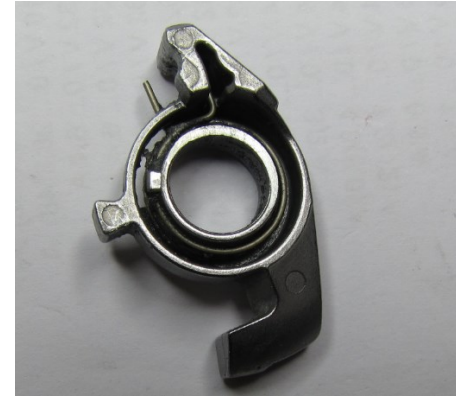
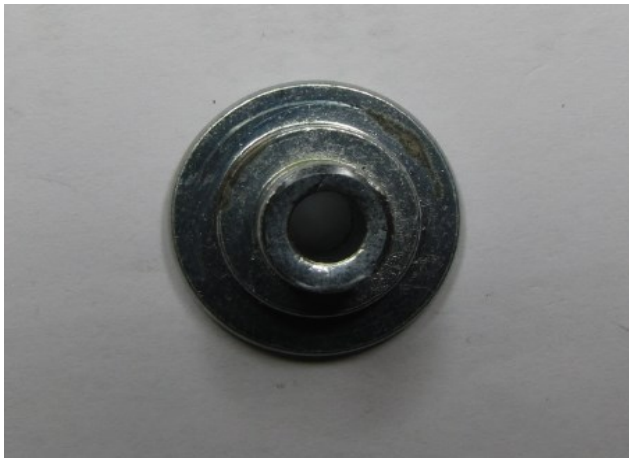
▪ Systematic disassembly:

- All single components have been assembled correctly,
- Abbrasion on KV transmission lever detected,
 - Height: 5,05/4,95mm
- Damage on bush surface from spring detected.

Conclusion: Spring winding jammed between outside release lever and bush as per L2CCA2BG5GG [REDACTED].

- 3D scan of KV transmission lever and bush, TBD CW39.
- Failure simulation:
 - Following carset to be build:
 - 2 latches:
 - bush with milled chamfer 0,1mm above the spec.
 - KV transmission lever from:
 - SALWA2VF1GA [REDACTED], height: 5,04/4,95mm,
 - L2CCA2BG5GG [REDACTED], height: TBD/4,92mm.
 - 2 latches:
 - Serial latches from current production.
- Test specification:
