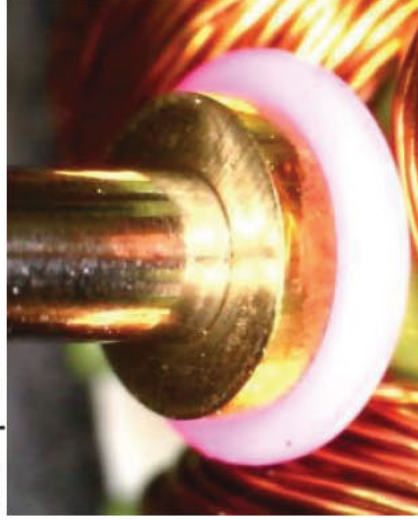
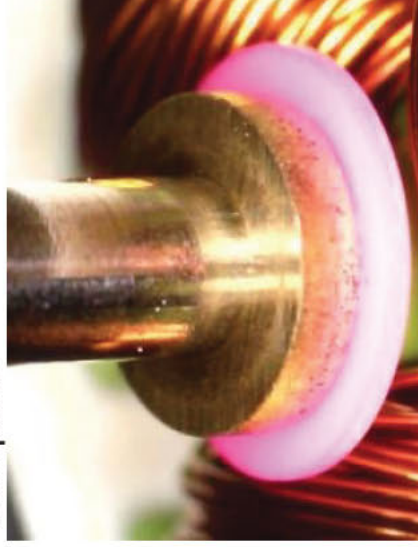
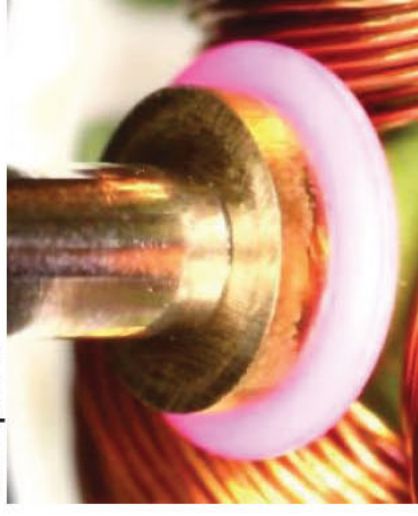
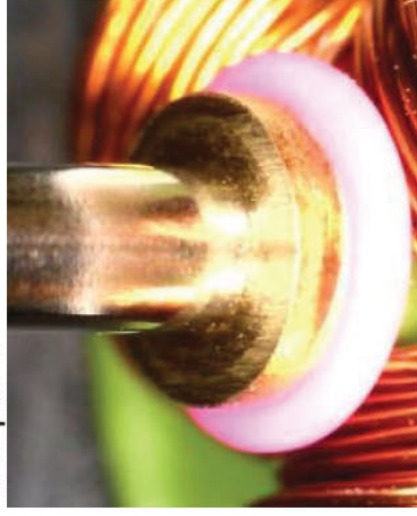
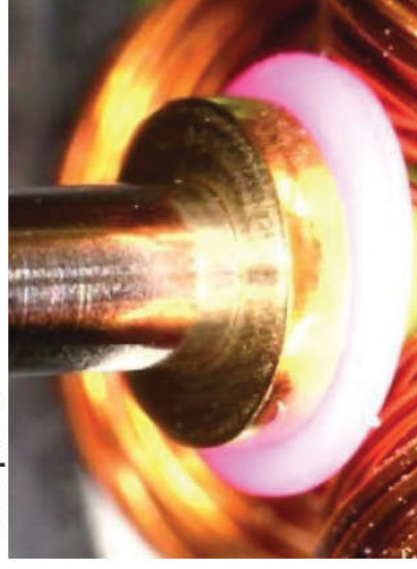
Conclusion:
No difference regarding roughness visually detectable on 5 washer surfaces in new condition.
Note:
Diameter washer: 3,75mm
Diameter shaft: 1,97mm

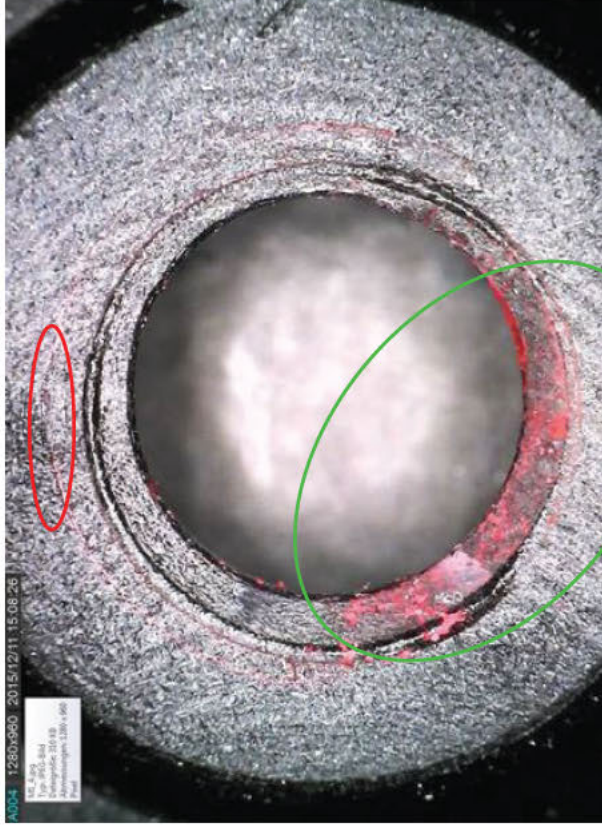
KV housing after testing

Main content of water will be stopped by sealing contour ✓

Slight water traces found inside of the sealing contour ✗

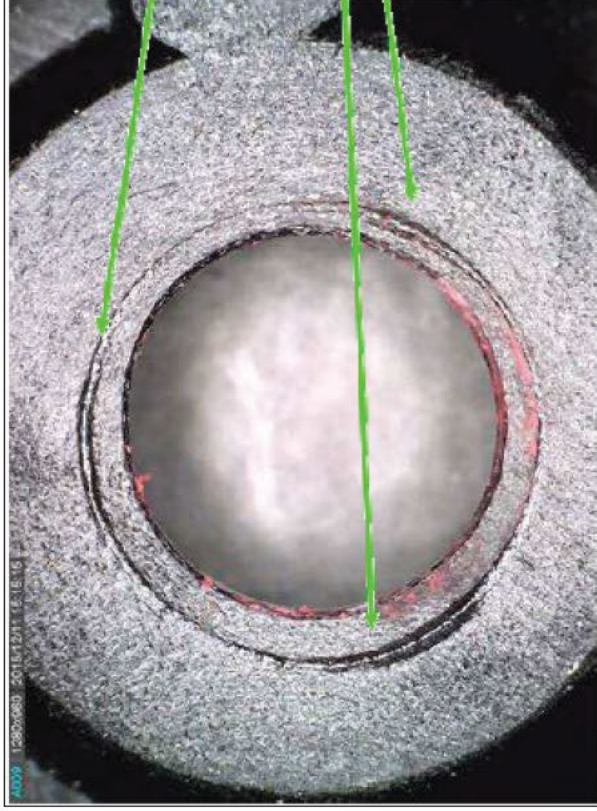
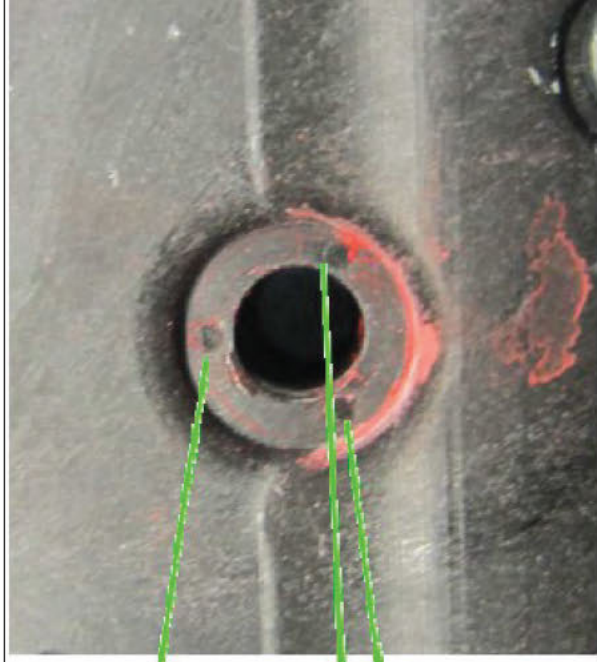
Sealing rib of KV housing is pressed into KV lid sufficiently in the area of the tolerance spots due to higher force during the riveting process. In the area between the tolerance spots the sealing contour is not pressed sufficiently into the KV lid.

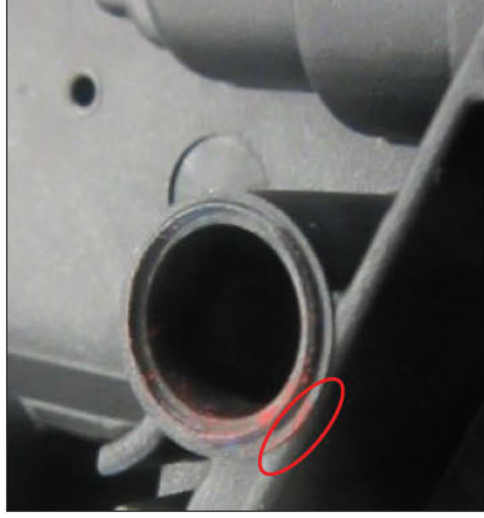
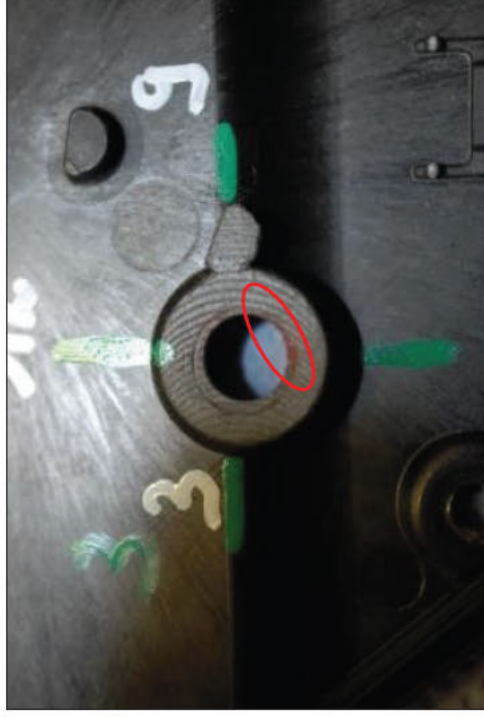
- Main content of water will be stopped by sealing contour** ✓
- No water is running to KV motor** ✓
- Slight water traces found inside of the sealing contour** ✗

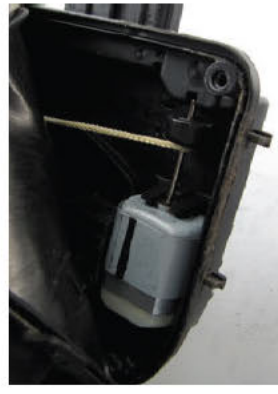
Latch received with 1 winding left on the motorshaft

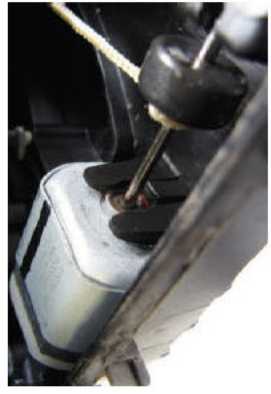
Front sinter bearing red corrosion, corrosion on housing visible, w/o grey sticker.

KV motor operation open circuit → 0.5winding left on the motor shaft after the 1st actuation, 0 winding on second attempt.

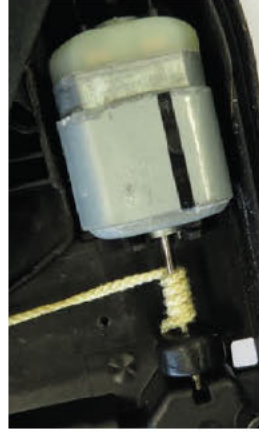
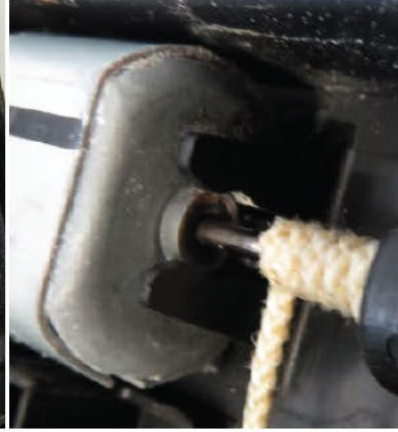
Latch received with 5 windings left on the motor shaft.

Front sinter bearing red, corrosion on housing visible.

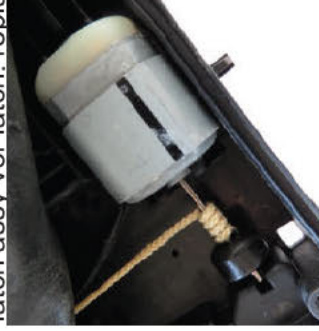
Latch received with 4 windings left on the motor shaft.

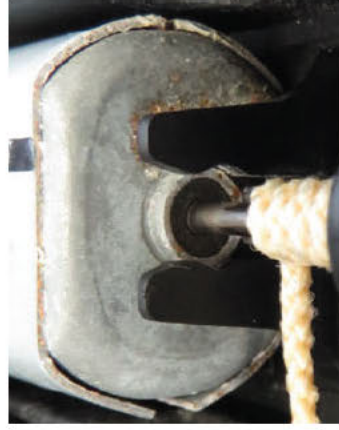
Front sinter bearing grey - corroded, red corrosion on the housing visible.

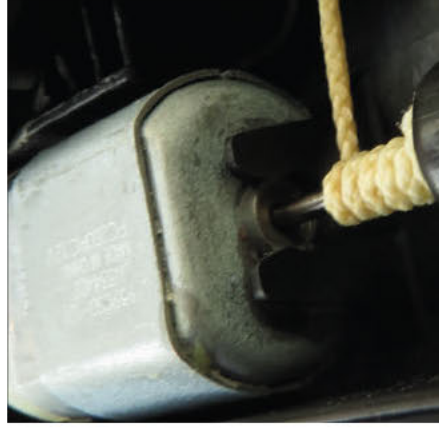
Front sinter bearing corroded and corrosion on the front side of motor found.

- [KV motor operation open circuit](#) → OK KV function, shaft re wound on the first attempt, 0 windings left.
- [KV motor operation short circuit](#) → NOK KV function, shaft is rotating, but 5 windings left.
- [KV operation first short then open](#) → NOK KV function on short, OK KV function on open.

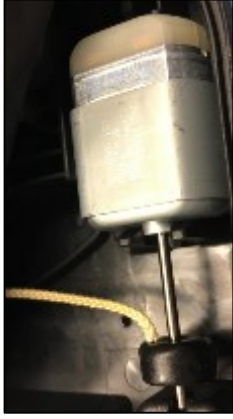
**Latch received completely unwound
– no leakage path visible**

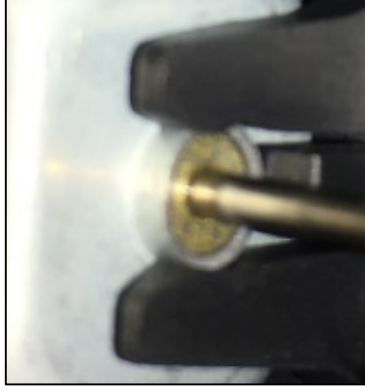
**Sinter bearing shiny, no corrosion on
motor housing visible**

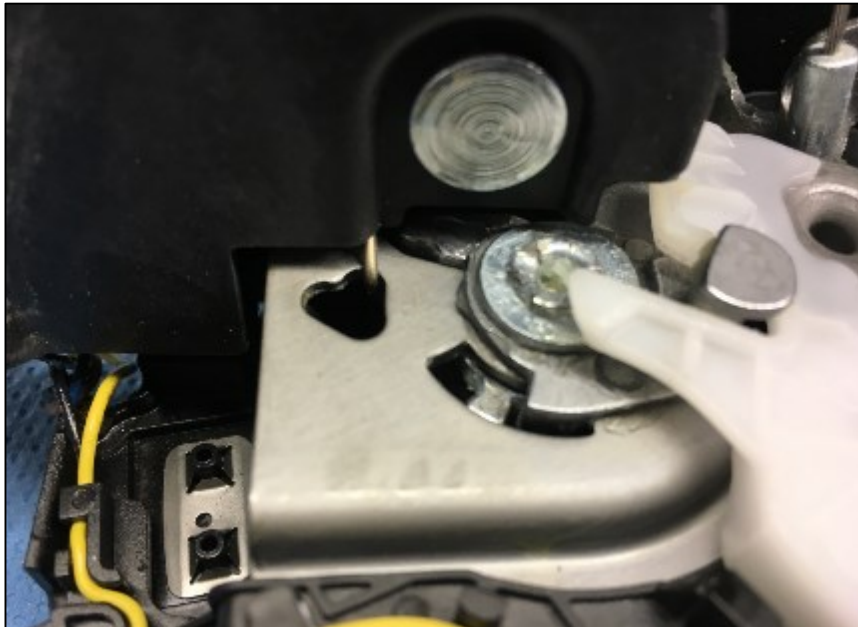
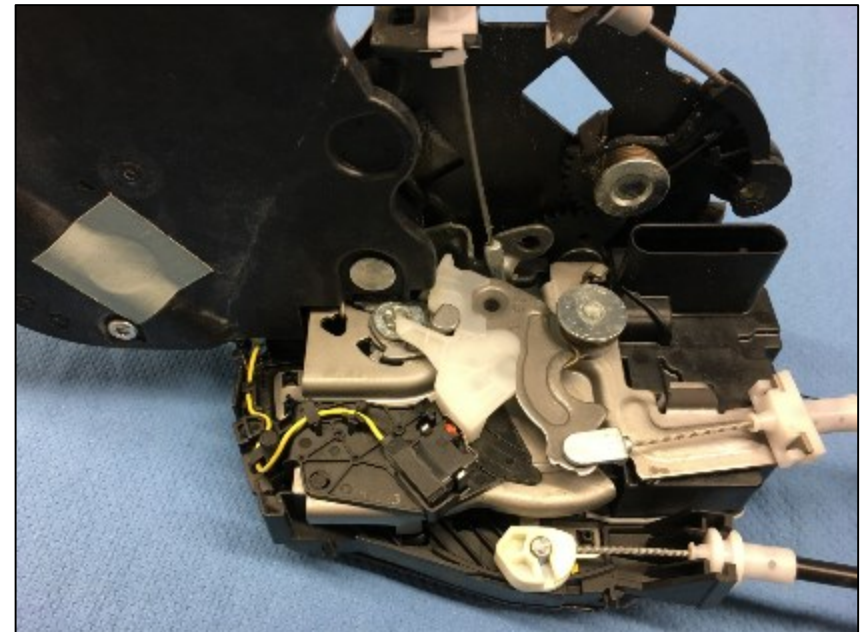
- Latch received with all levers in home-position
- no sticky-behavior opening from outside
- Blue particle not present on latch or box anymore

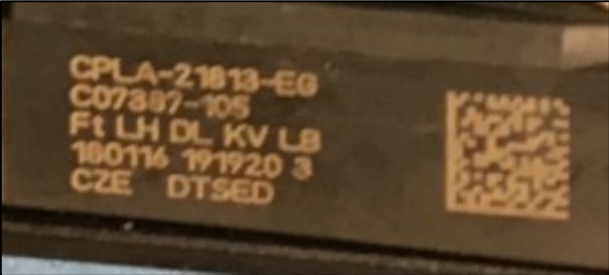
Visual inspection

- Latch received in jammed condition (not possible to latch)
- KV Transmission lever (zamak) jammed / KV plastic lever in home position

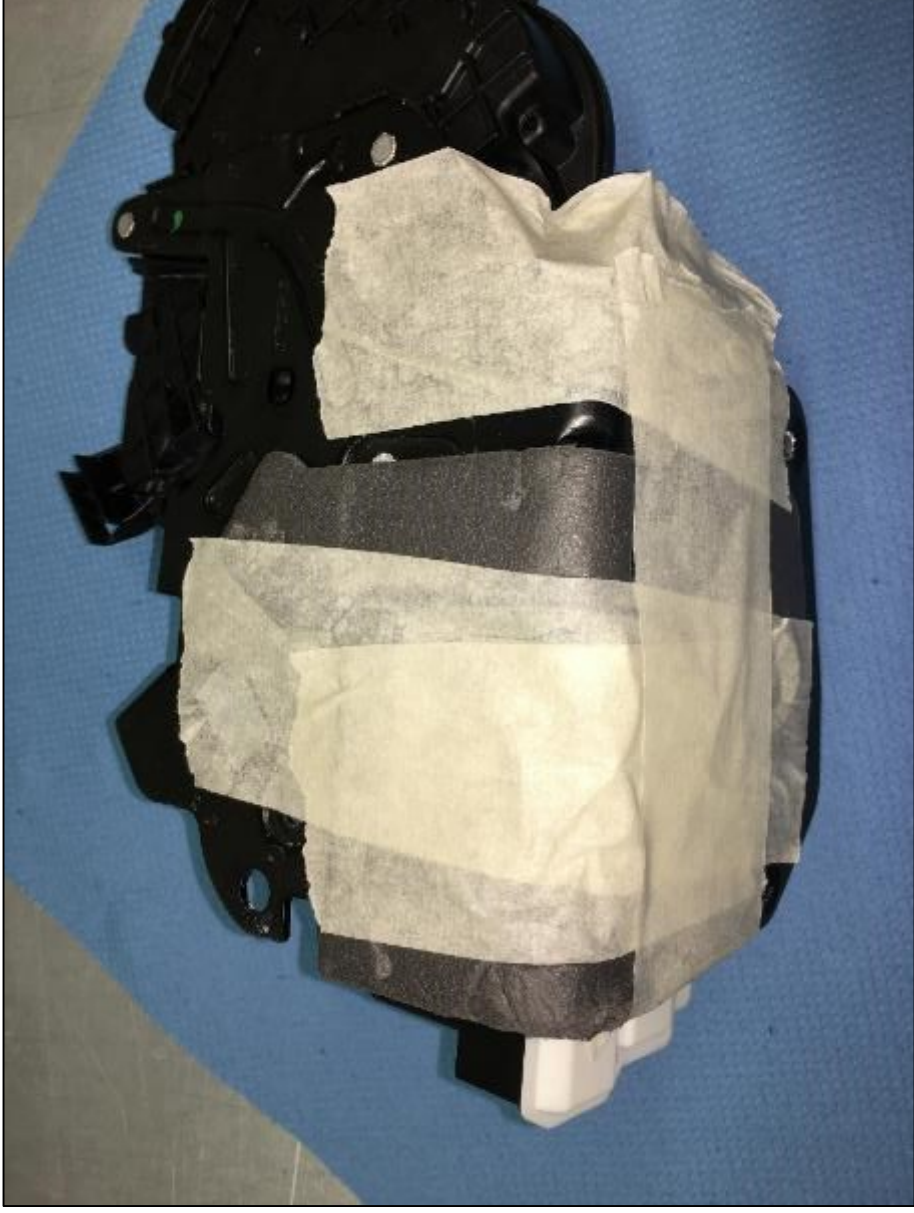
Tear down of latch – cut off retention plate with KV housing

- after cutting off retention plate the failed condition is still present
- spring between O/S transmission lever and bushing

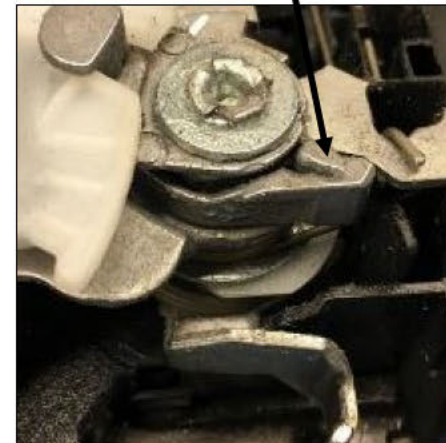
During disconnecting the pawl pin from the backplate sub-assy the jammed condition dissolved

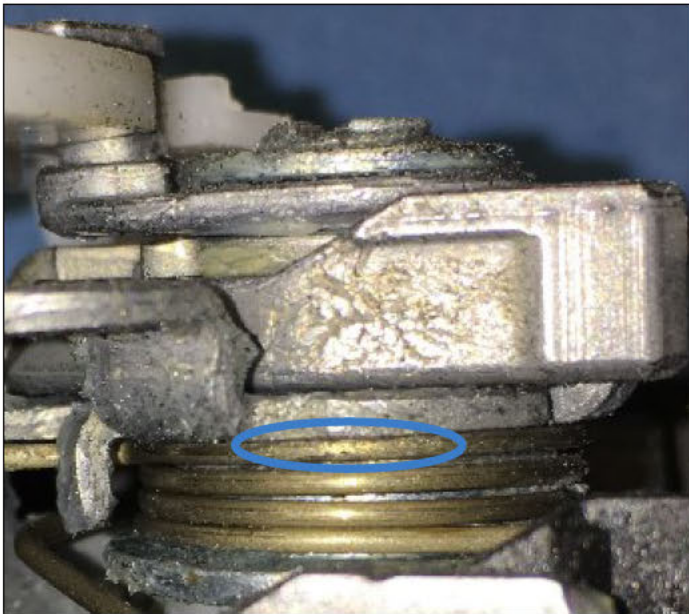
Tear down of latch – sub-assembly backplate dismounted from latch

Unjammed condition KV transmission lever

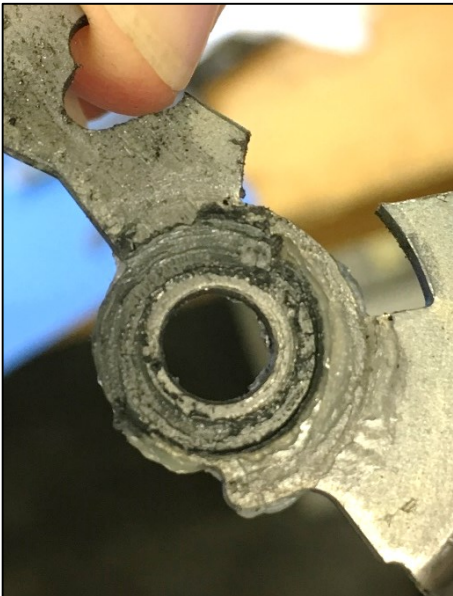
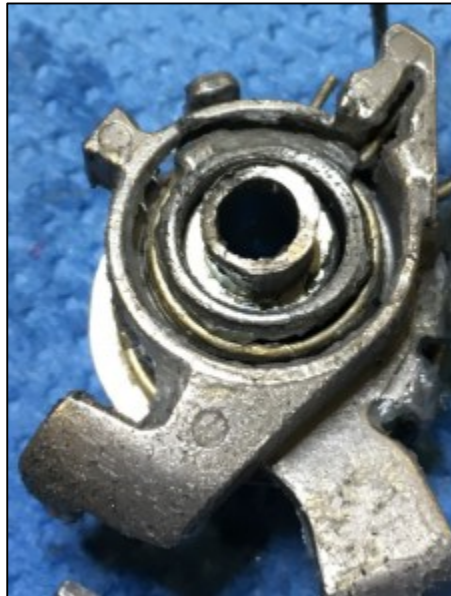
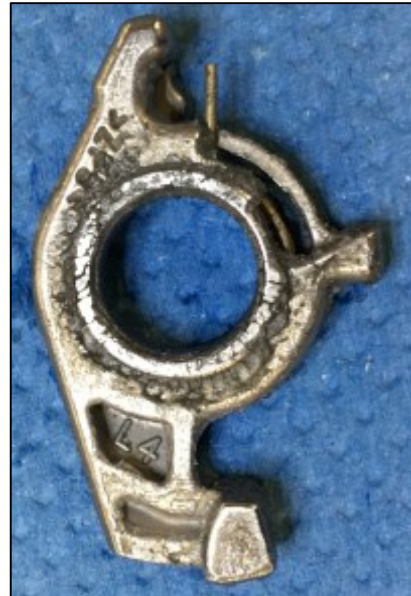
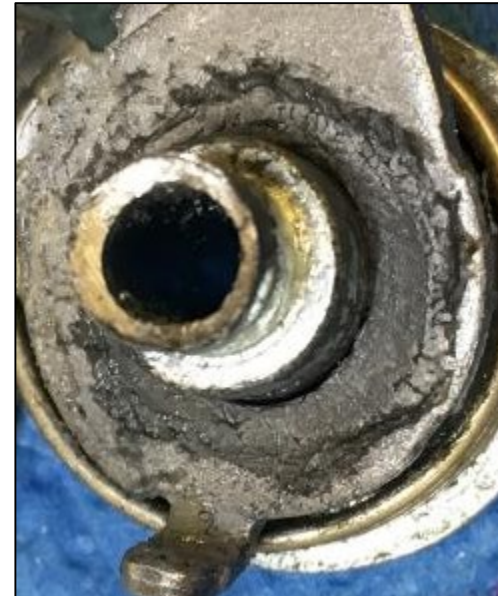
Tear down of latch – sub-assembly backplate single parts **brose**

Abrasion of KV-transmission lever visible – residues on contact surfaces of neighbour parts as well

- Material is ok. (COB Lab Report 5806)
- The abrasion is not based on a material failure

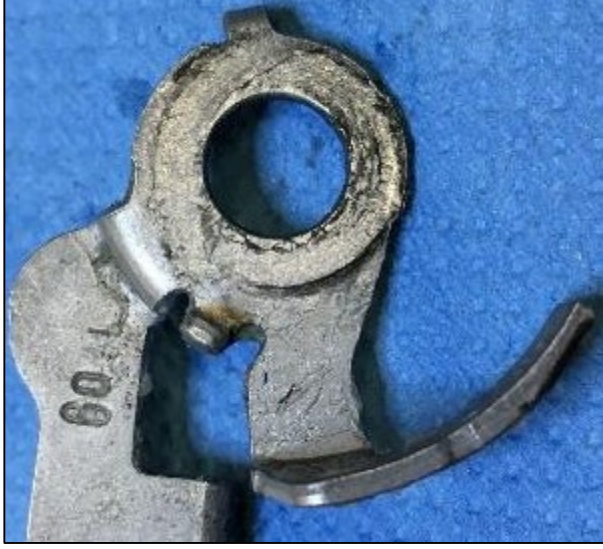
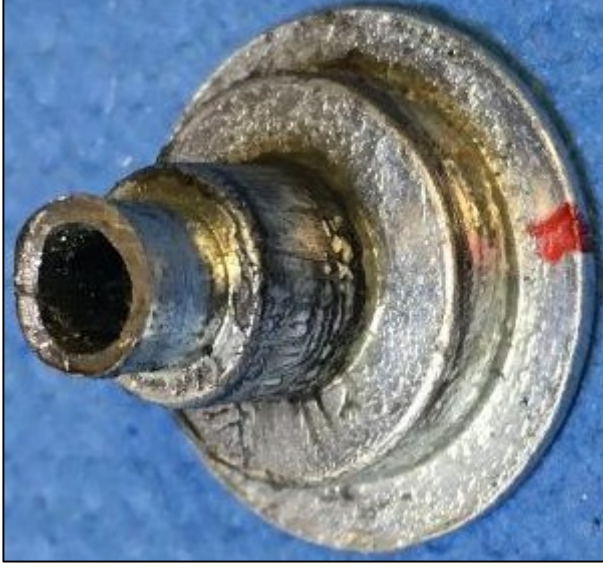
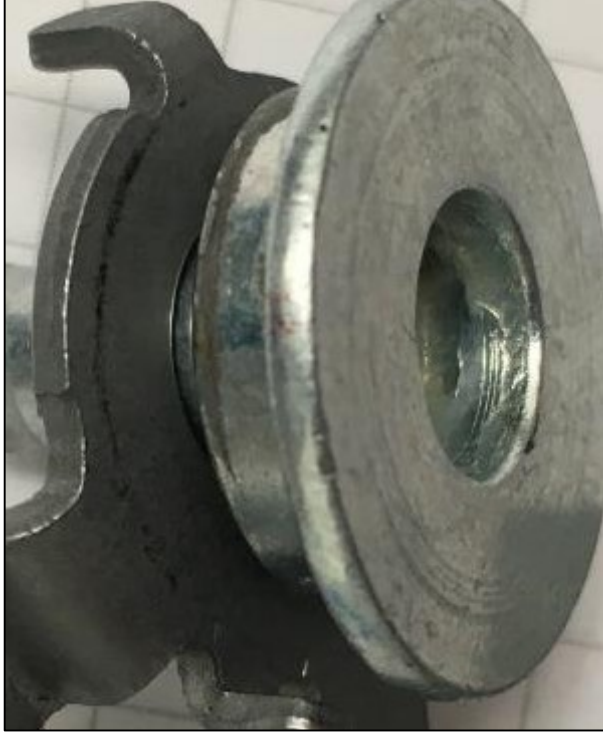
Tear down of latch – sub-assembly backplate single parts

Bushing height:
7 mm

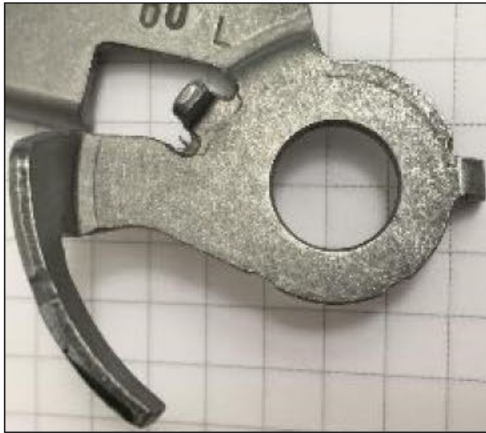
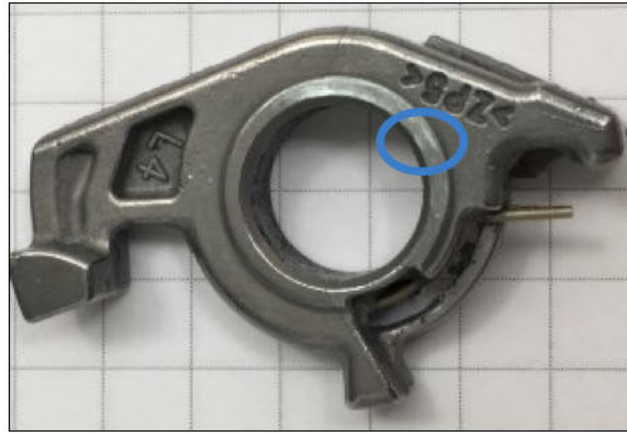
Tear down of latch – sub-assembly backplate single parts **brose**

Height measurement in
area of abrasion:
→ 4,92 mm

Drawing specification:
5,20 mm -0,05 mm

- Wear out area of the lever too thin – 4,92 **nok**
- Other area of the lever too thin – 5,06 **nok**
- Supplier involvement to clarify quality situation

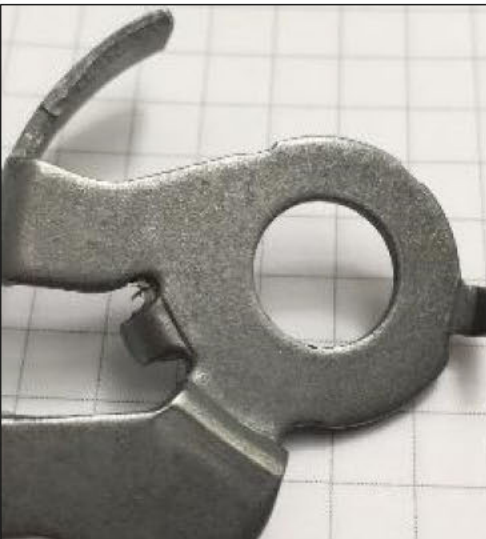
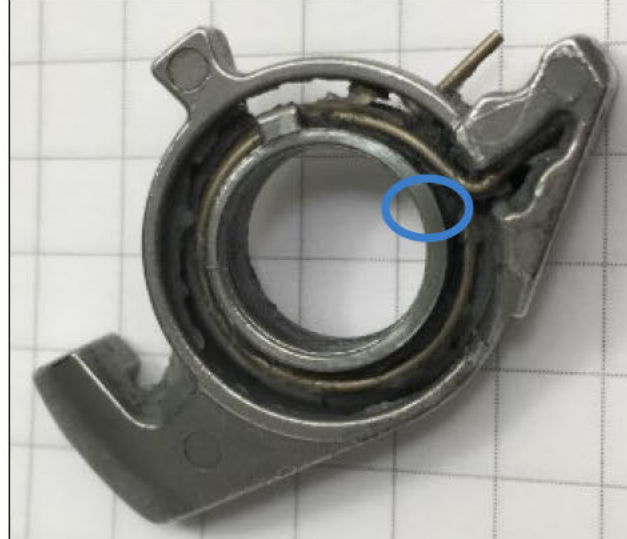
Height o/s transmission
lever:
1,54 mm

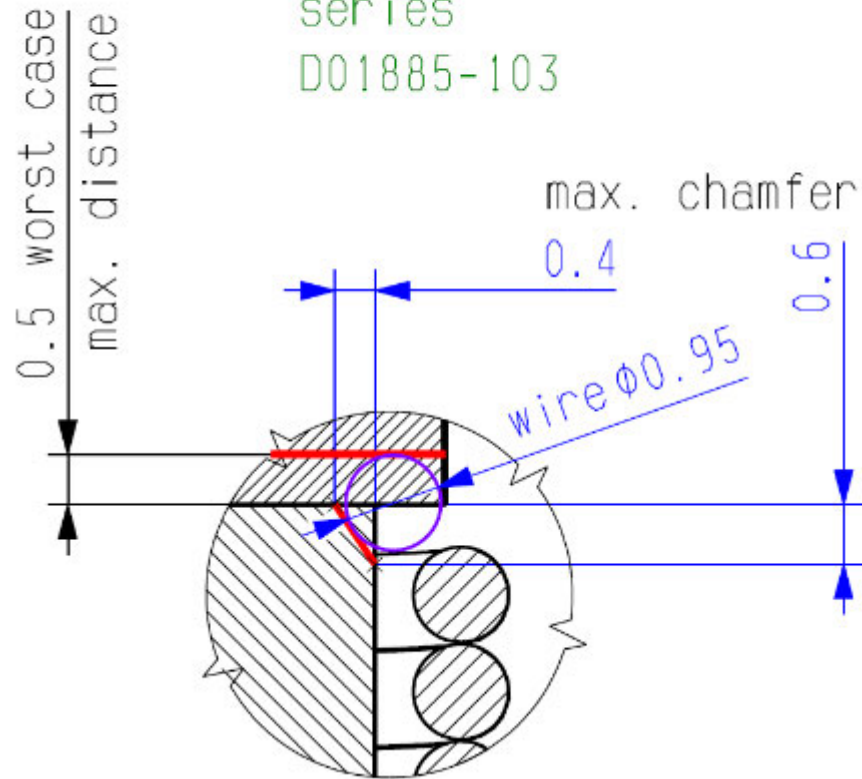
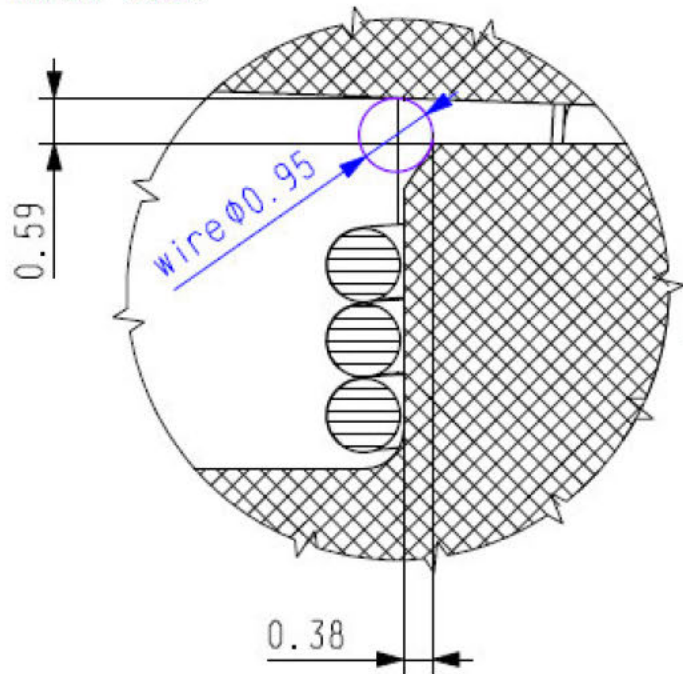
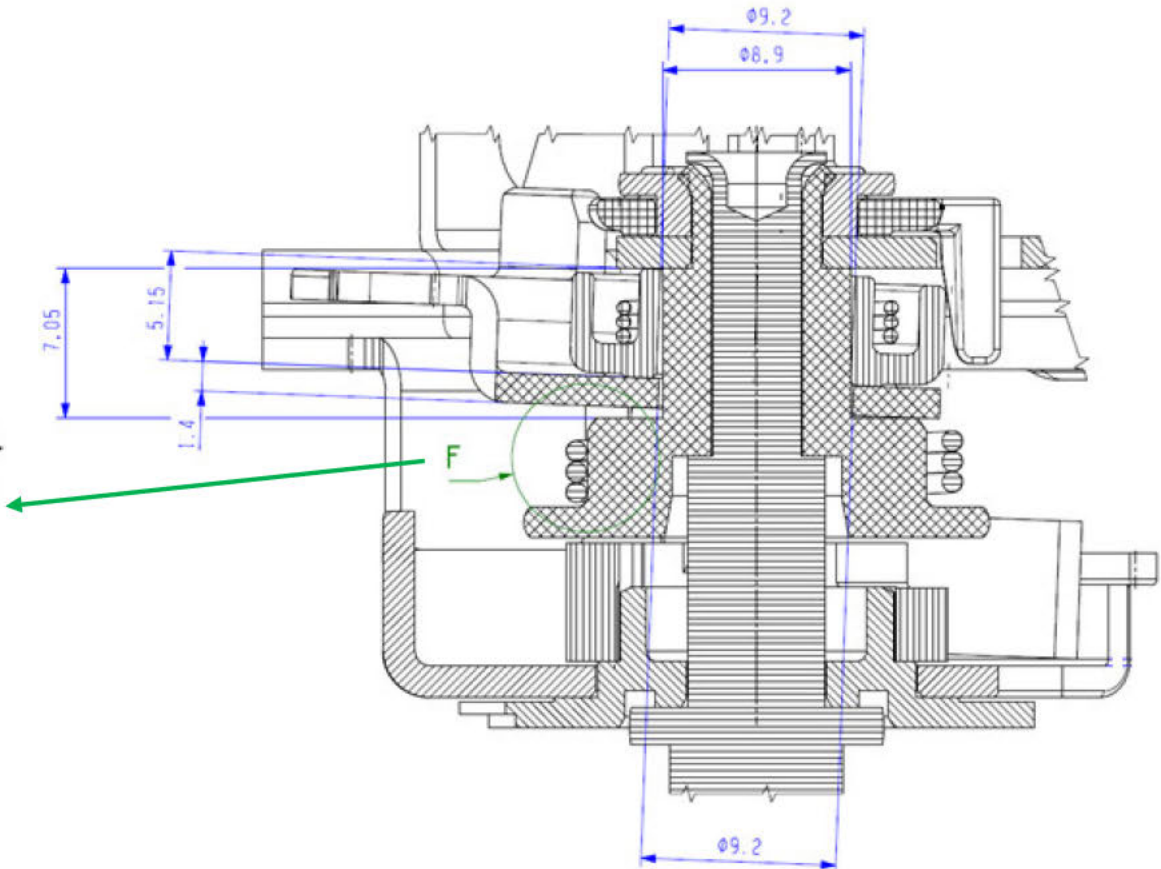
Tolerance study – tilted worst case

- Tilting increases the gap from $0,5$ mm to $0,59$ mm
- Spring can not fully move between bushing and lever

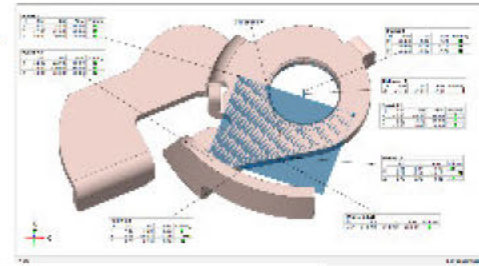
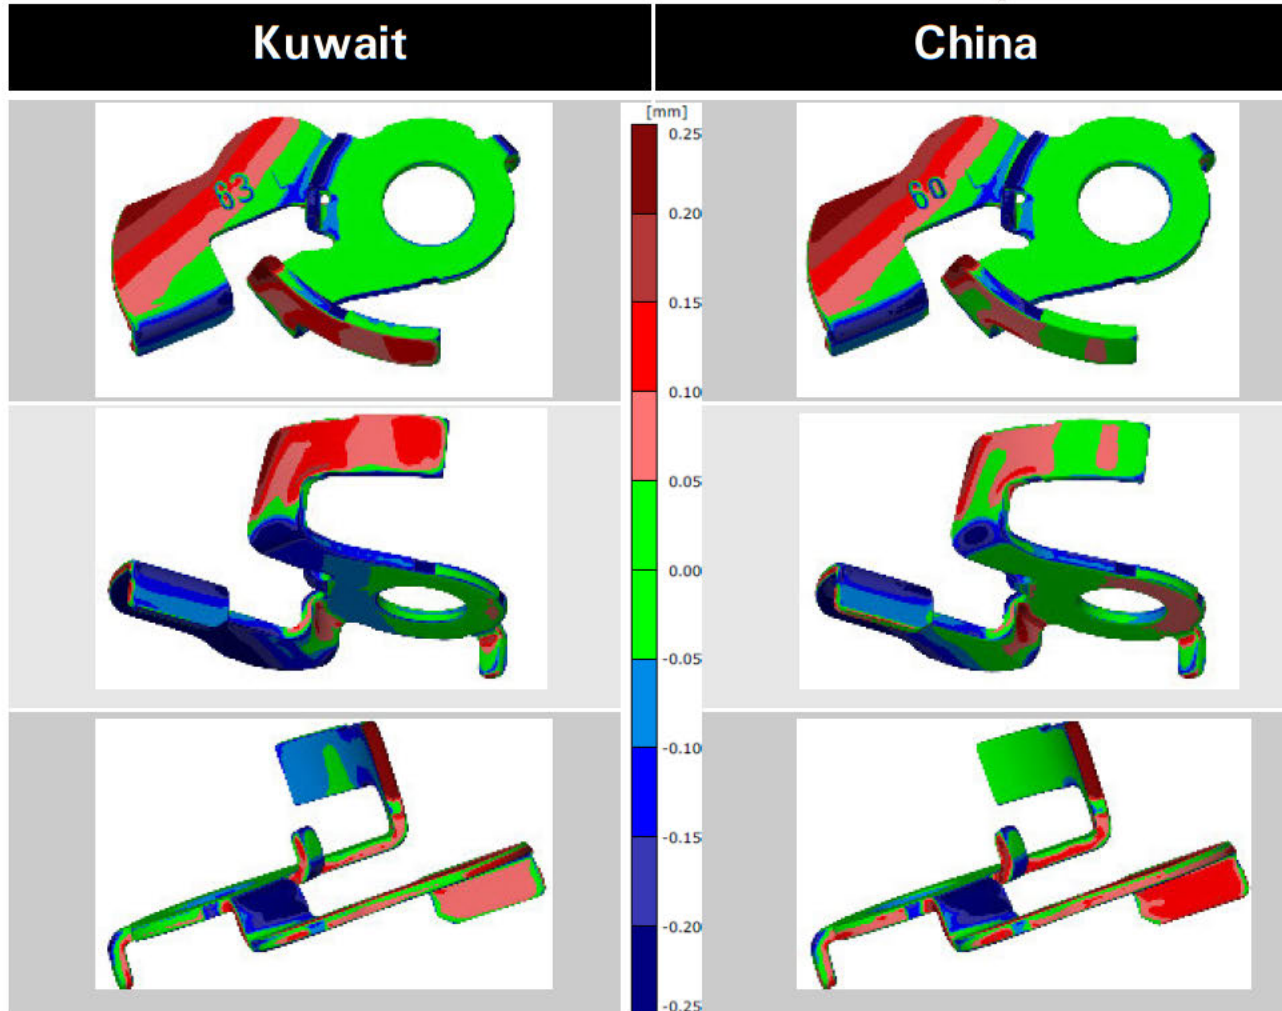
Single Part 3D scan O/S transmission lever

- Thickness of the lever **ok**
- Rotating area of the lever **ok**
- Parts within specification **ok**

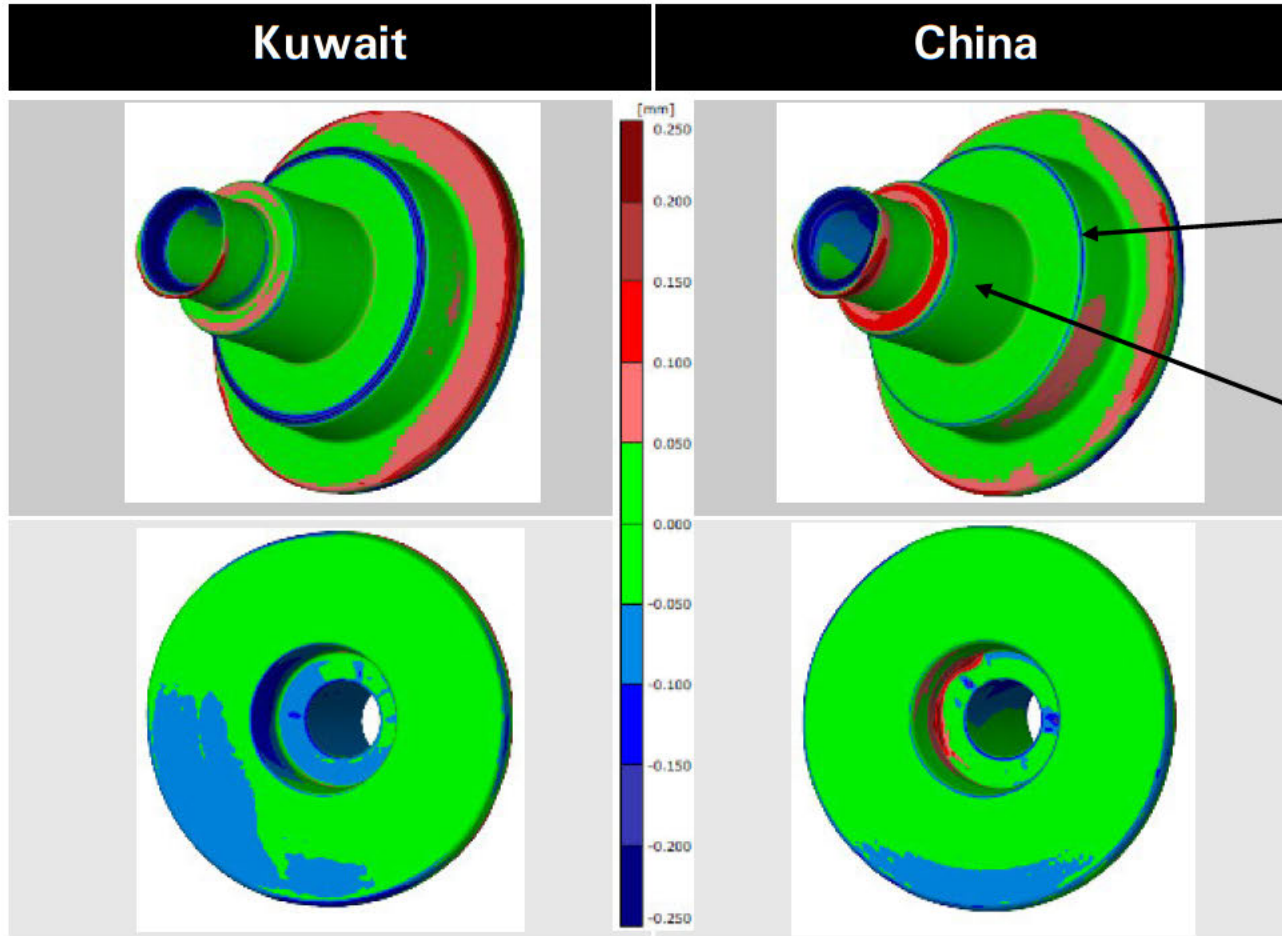
Single Part 3D scan Bushing O/S transmission

- Difference in the chamfer visible – see detailed results on page 39
- Step height on CN part higher than on KWT part – but both parts within specification **ok**

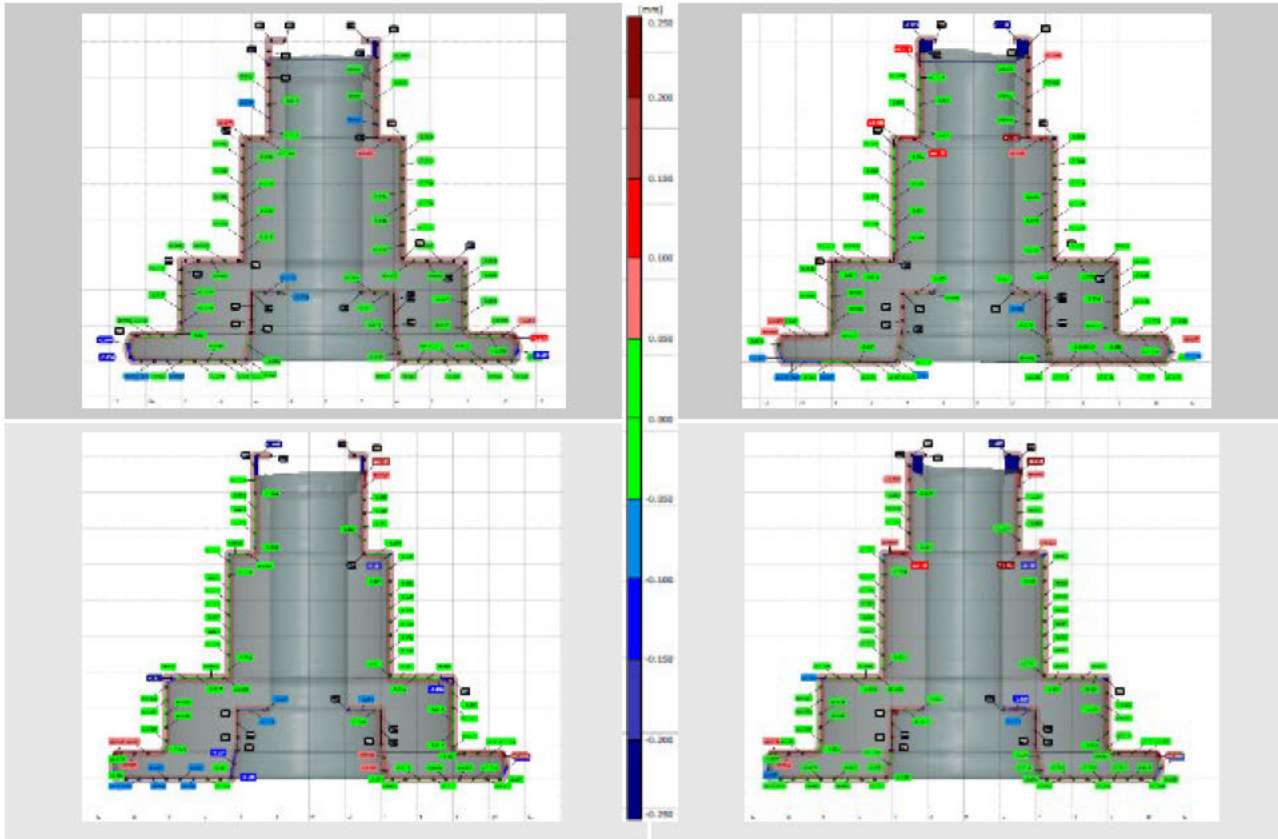
- Difference in the chamfer visible – see detailed results on page 39

Kuwait	China
<p>Measured with optical projection equipment:</p> <p>X-direction: 0,70 mm – 0,77 mm (nok) Y-direction: 0,50 mm – 0,53 mm (nok)</p>	<p>Measured with optical projection equipment:</p> <p>X-direction: 0,37 mm – 0,44 mm (nok – 0,04 mm out of spec) Y-direction: 0,23 mm – 0,35 mm (ok)</p>
<p>Conclusion:</p> <ul style="list-style-type: none"> - CN part (failure mode present) with borderline chamfer / KWT part (failure mode not present) with nok chamfer - Supplier involvement to clarify quality situation

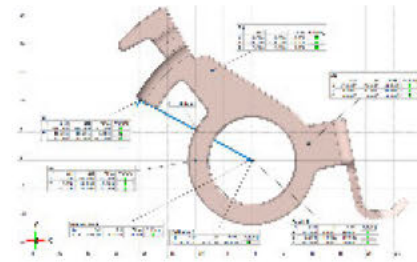
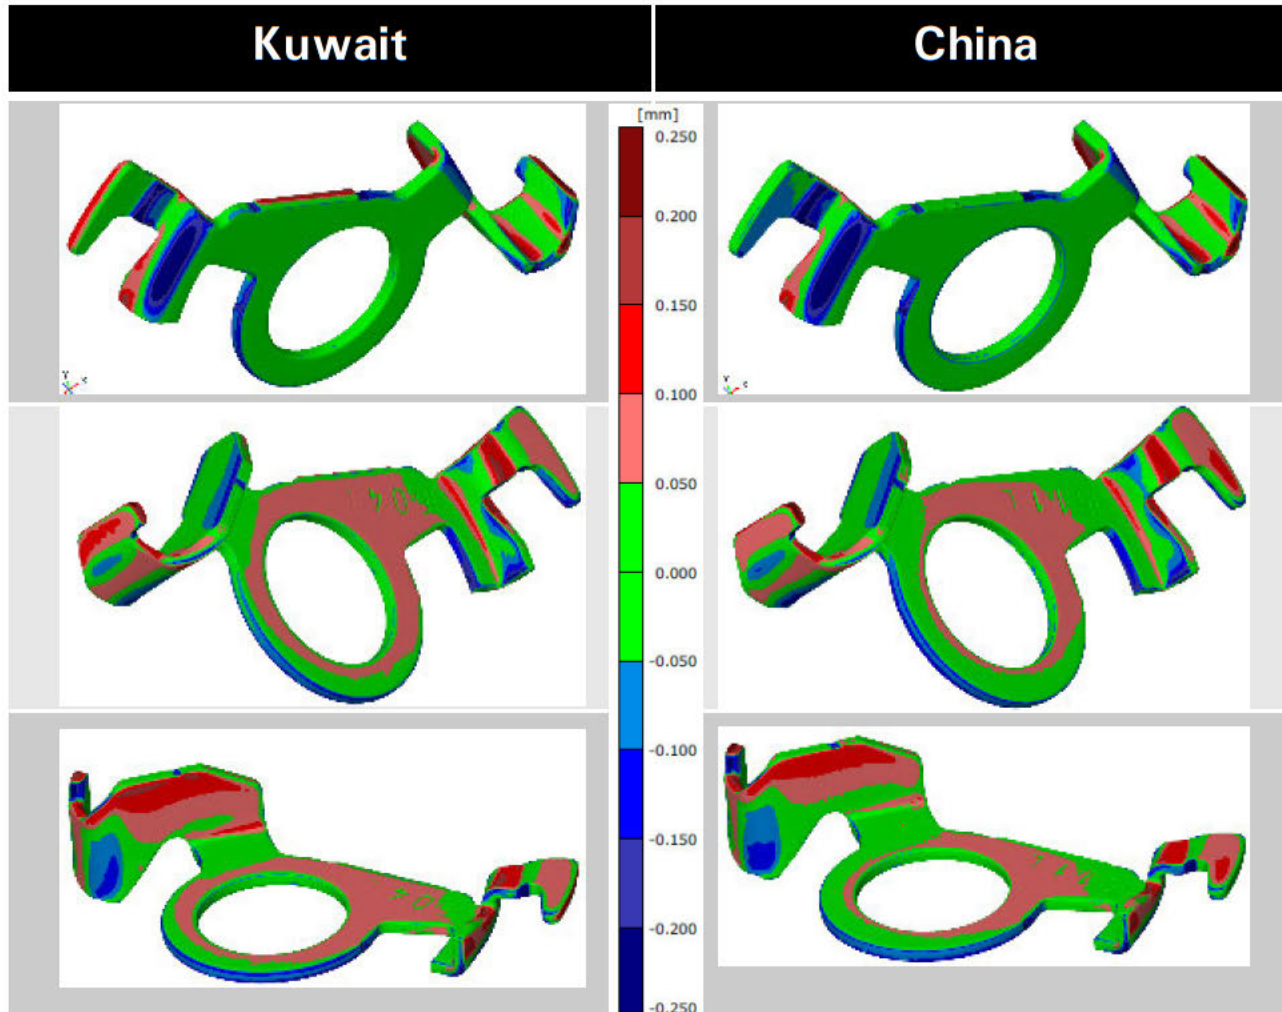
Single Part 3D scan I/S transmission lever

- Thickness of the lever **ok**
- Scratch marks on lever not visible in scan comparison – nothing on this lever indicates why it was in contact with o/s transmission lever

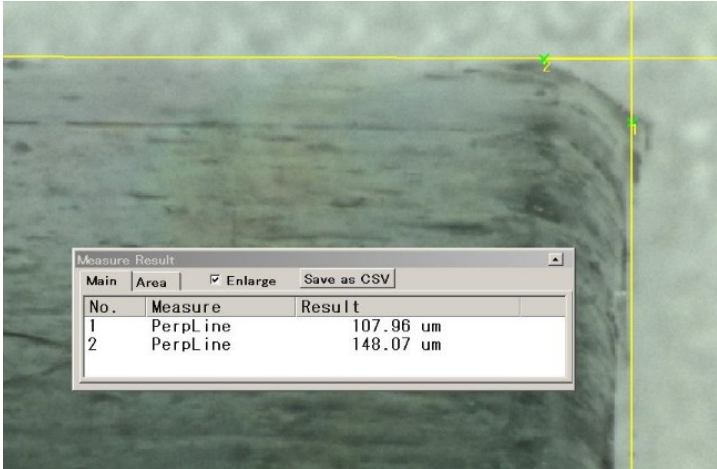
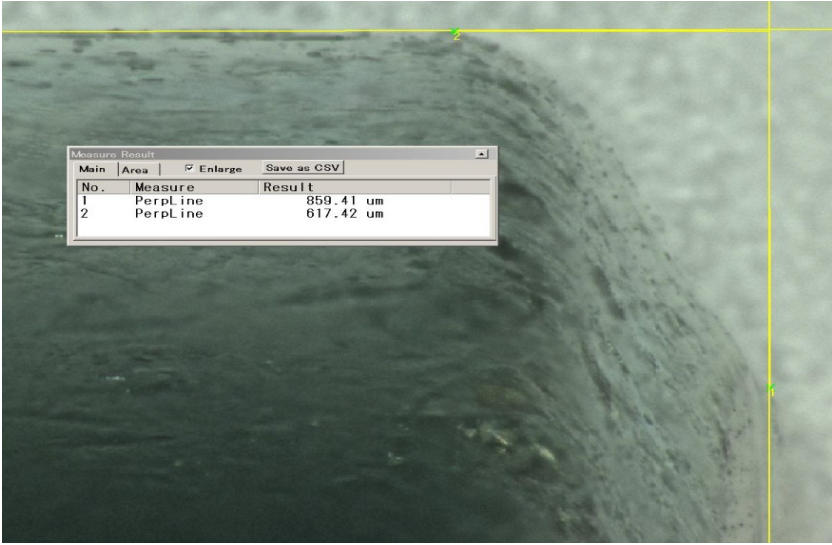
Component measurement chamfer

- Measured components from field parts with NTF
- Bush / chamfer
 - Clarification with logistics for relevant production dates 9/15-5/16
 - Supplier is informed
Needs shipping notes from Brose

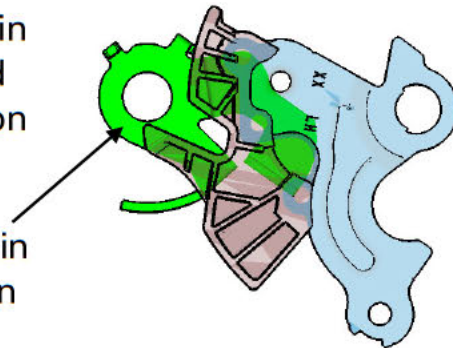
Lever can stay in jammed position

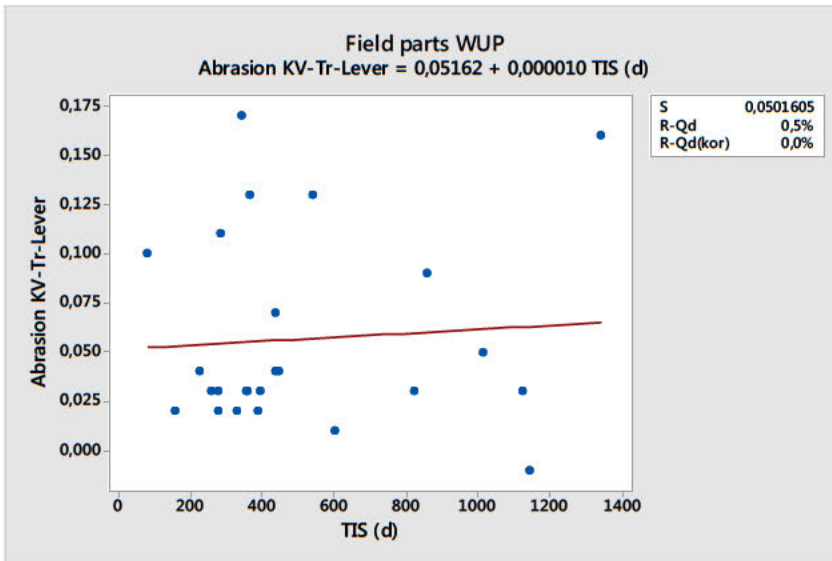
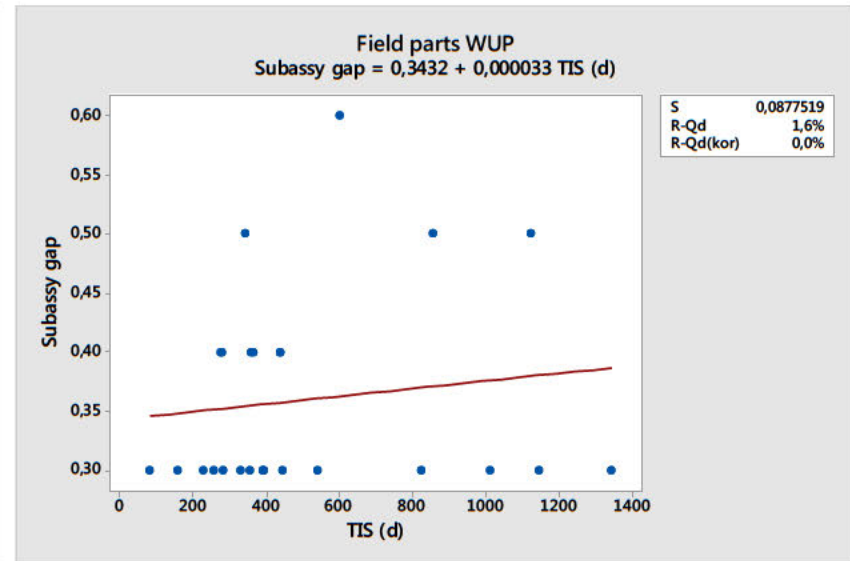
Mini-Tab Investigation

Conclusion: No influence of TIS for abrasion or gap

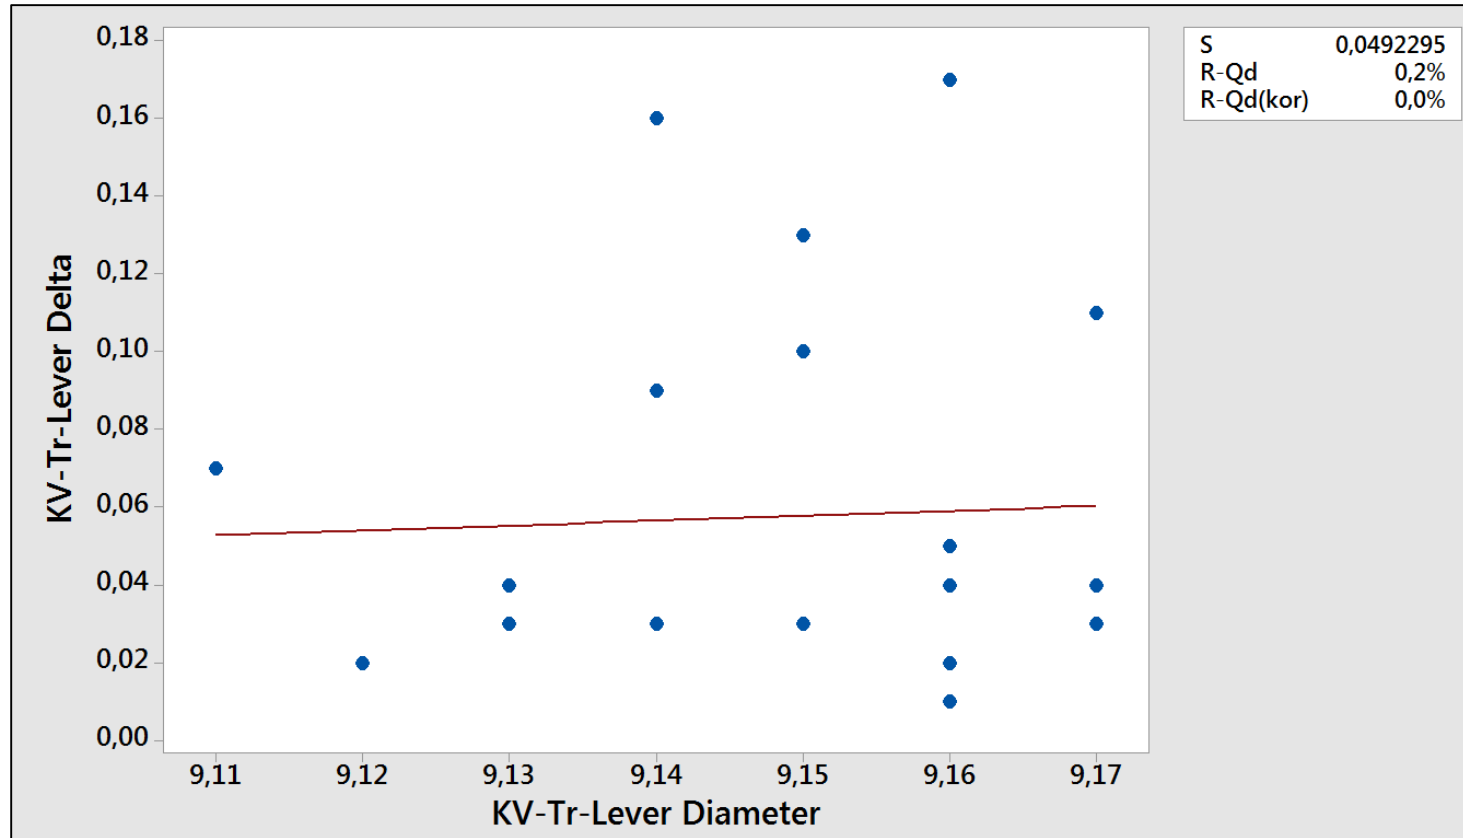
Mini-Tab Investigation

Based on current investigation, diameter KV transmission lever differences has no influence to abrasion
