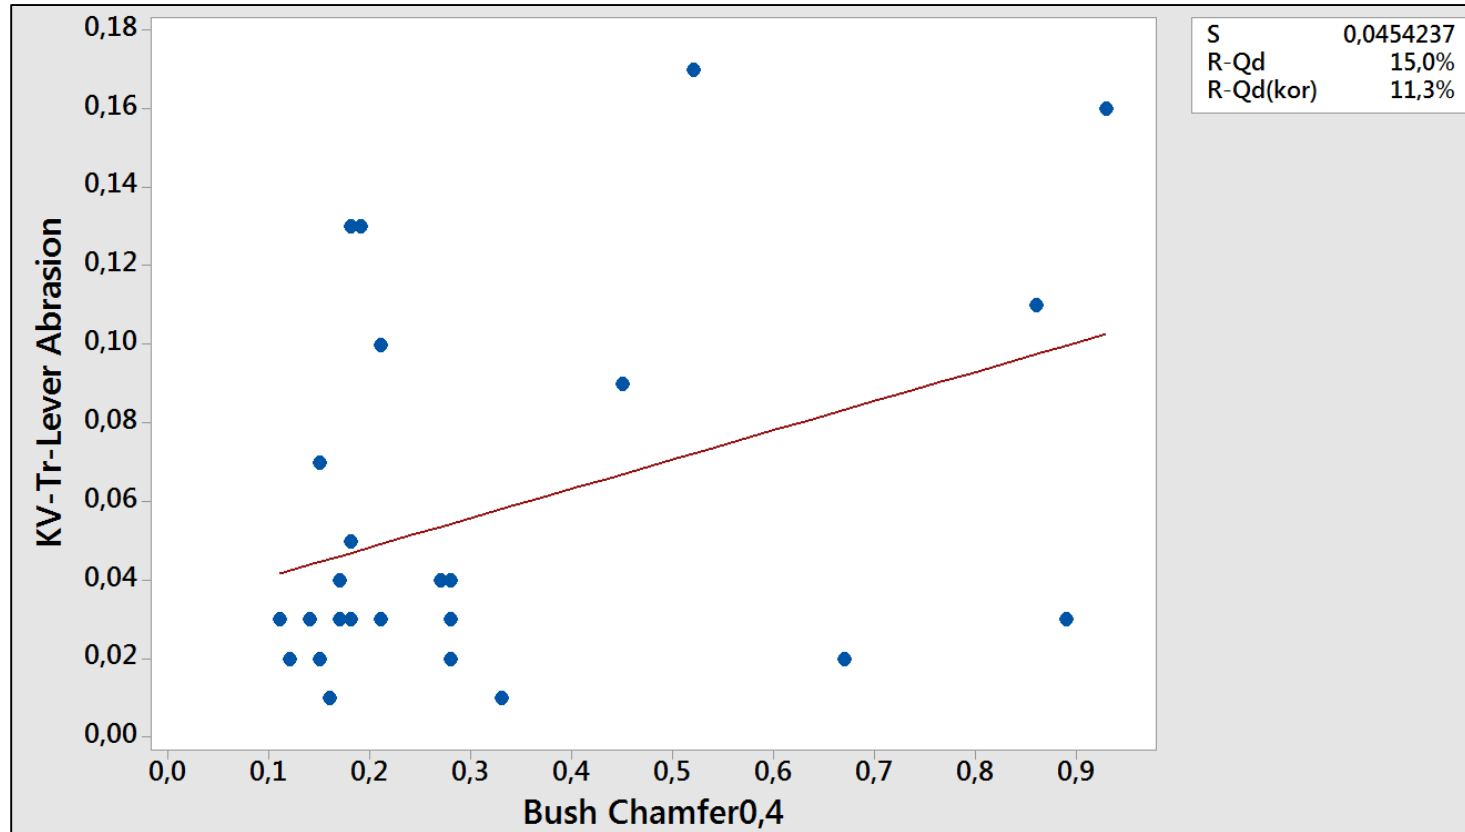
Mini-Tab Investigation

*Based on few available data: bigger radial chamfer leads to more abrasion
→ This has to be confirmed with more data*

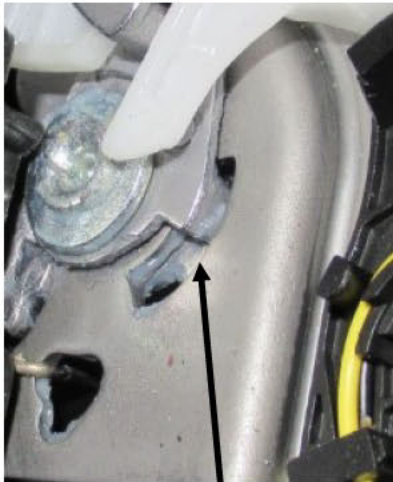
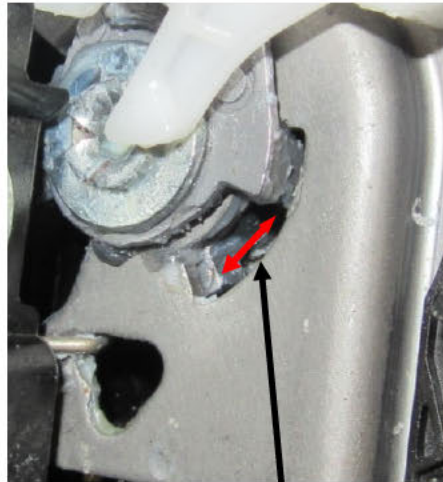
Position of KV-transmission lever after passing test procedure

Home position
No Gap

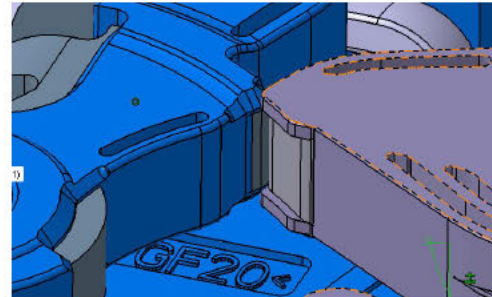
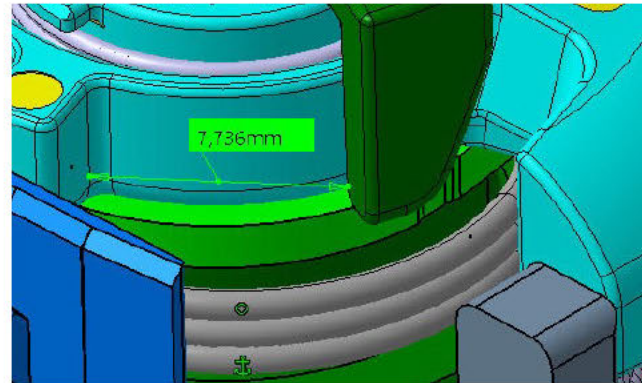
Home position
With Gap

Critical Gap > 7,7mm

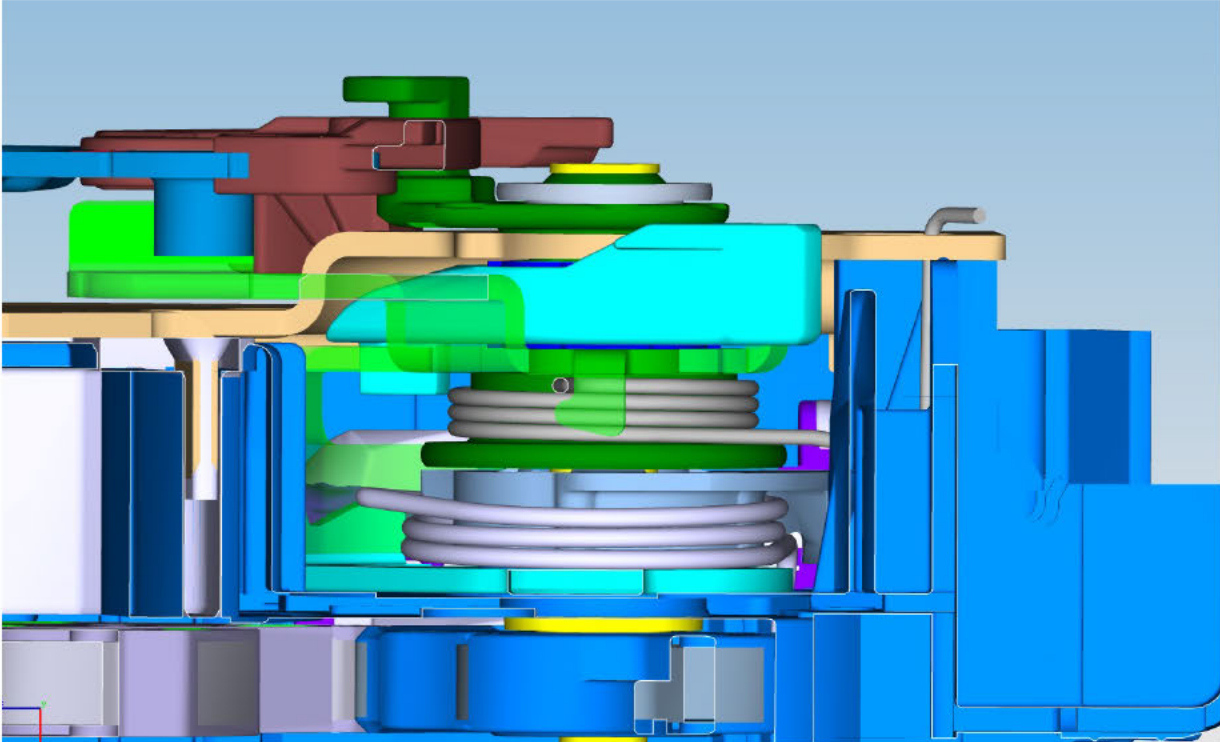
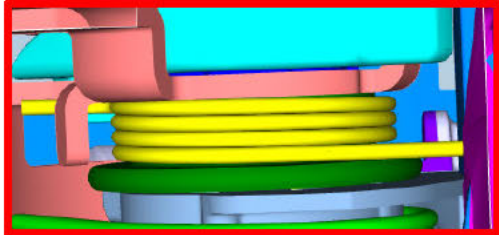
DoE Potential additional factor - Spring

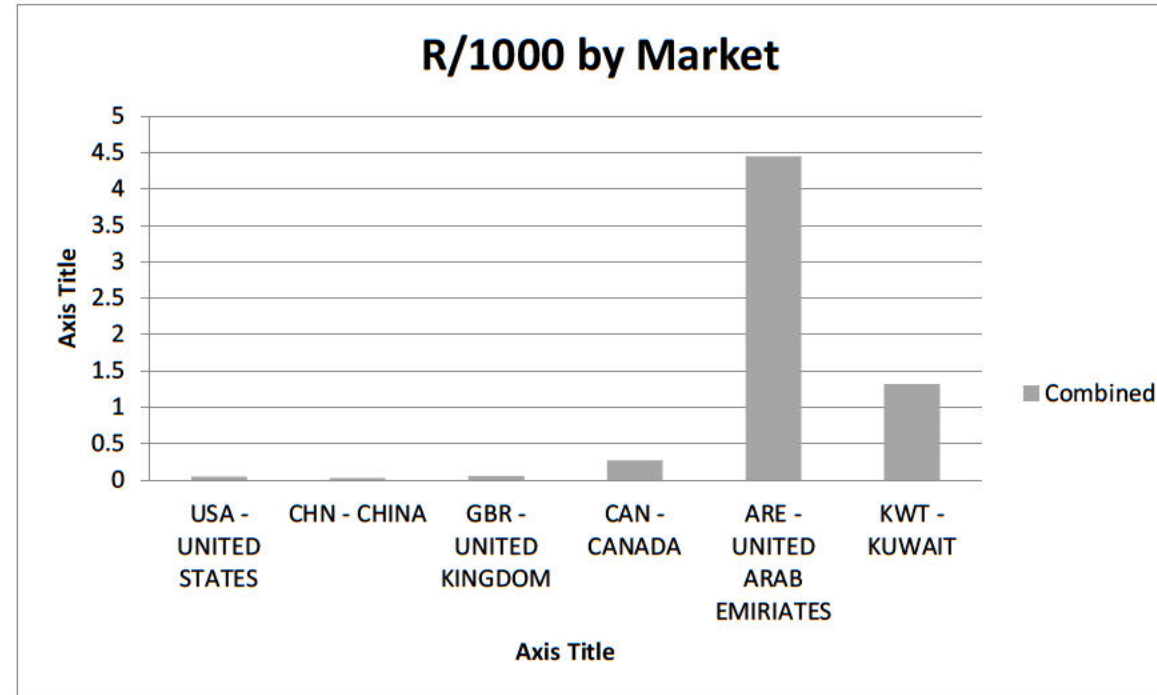
R/1000 Normalisation By Market

- Data from the vehicle population post production cut-off date (Mar 2015 onwards)
- Markets in descending order of sold vehicles in service
- Minimal R/1000 values everywhere except ARE and KWT
- However, other markets that have reported an occurrence are not identical climatic conditions to either ARE or KWT

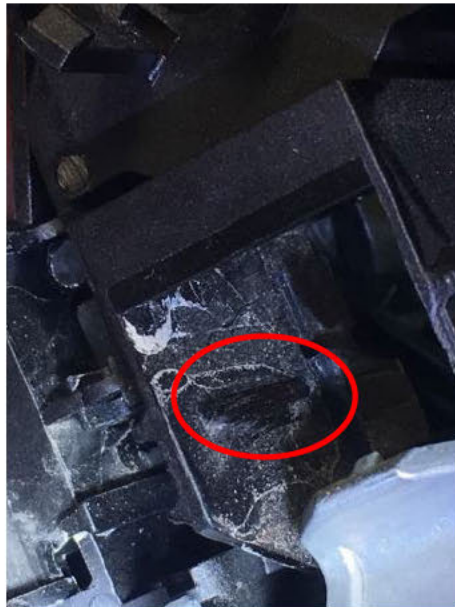
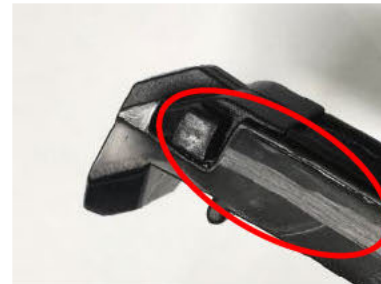
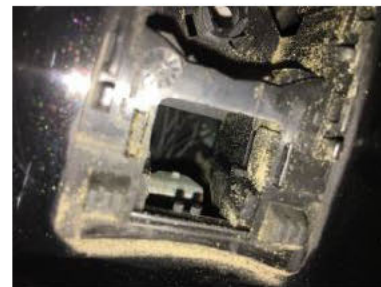
Problem Investigation/Verification: Visit to vehicle in Dubai August 2016. Customer reported a door opening post P068, vehicle held for investigation. Vehicle tested by JLR UK Engineer in market and unable to fault the latch. Open circuit condition evident on the vehicle, therefore P068 flash was a success. Vehicle in workshop, ambient temp circa 25°C. Unable to jam the handle in the workshop. Placed vehicle onto roof, high solar load, ambient temp 48°C. Soaked vehicle for two hours, and then able to jam three of the four handles on the vehicle on the first attempt.

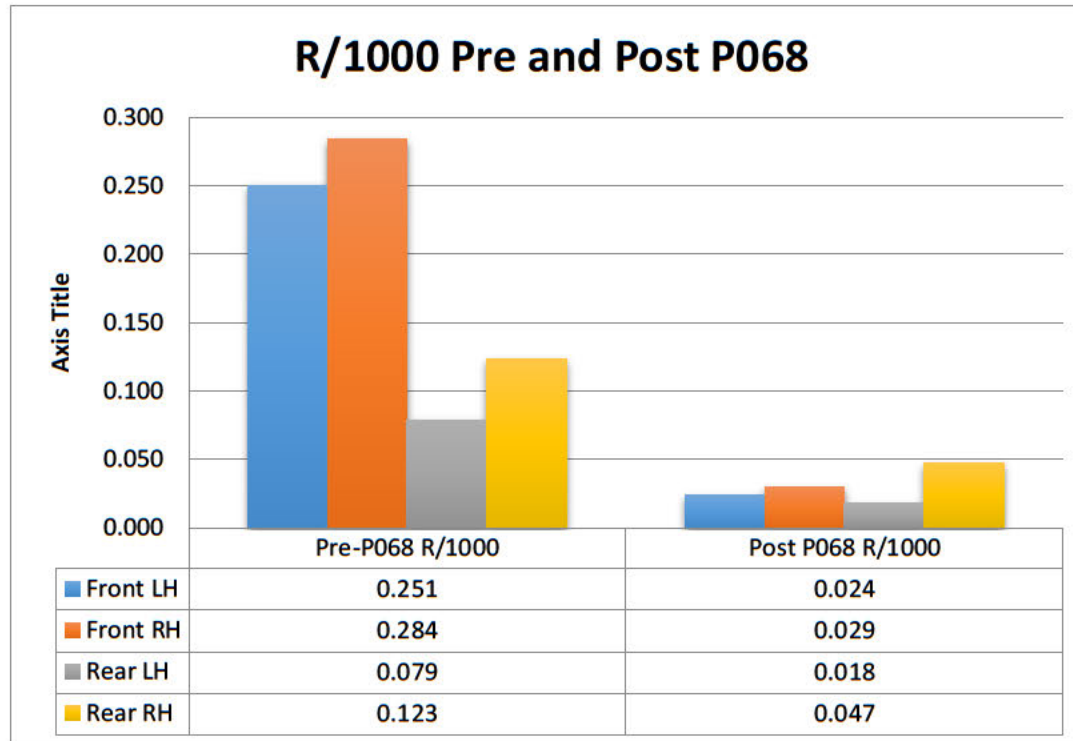
Normalised Data

- Once the data was normalised, an order of magnitude can be seen on front doors pre/post P068
- The same cannot be said of the rear doors, where the improvement has not been as significant

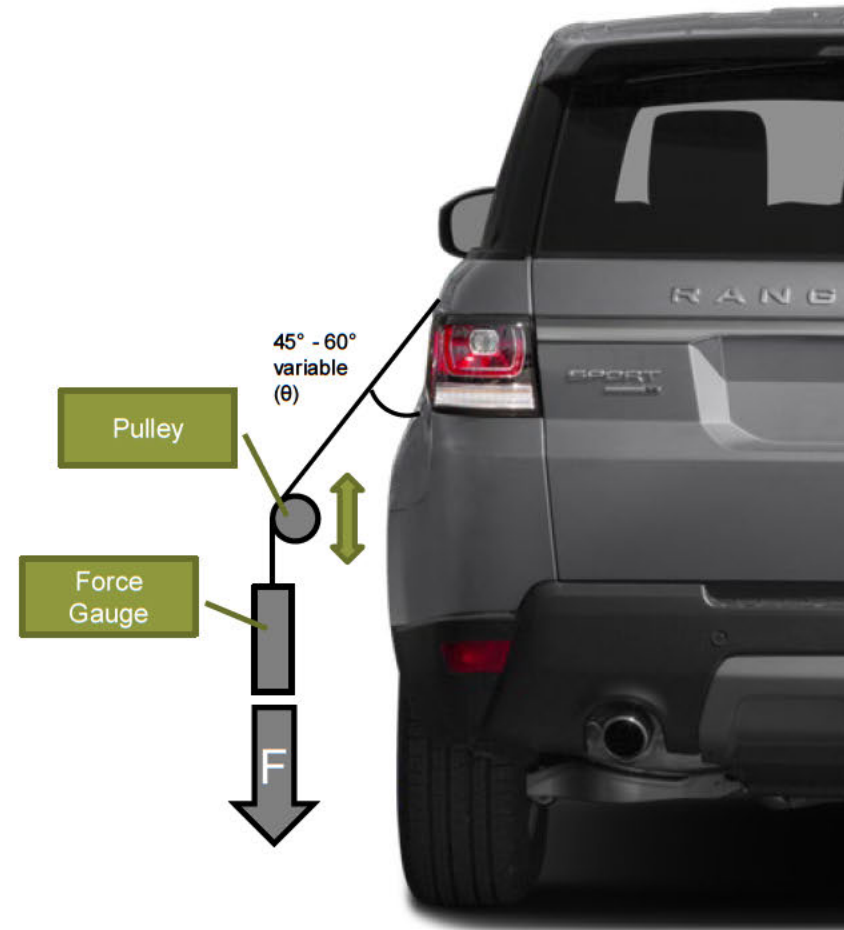
Force gauge used to measure force – force applied directly downwards

Resolution of actual force = $F \sin \theta$

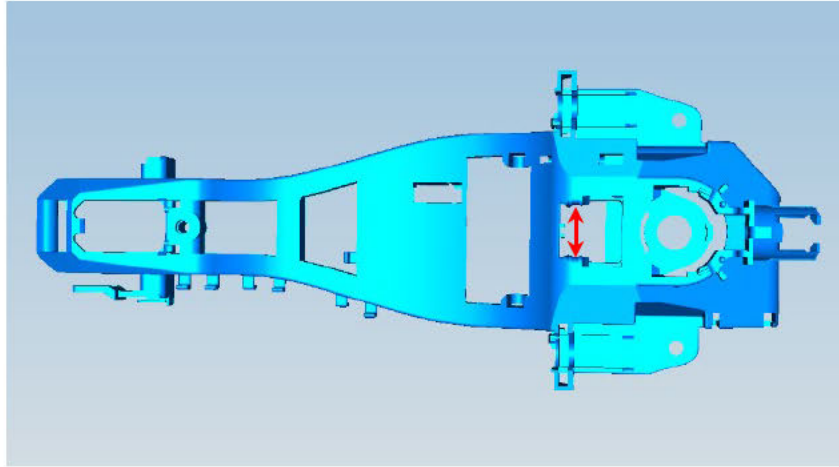
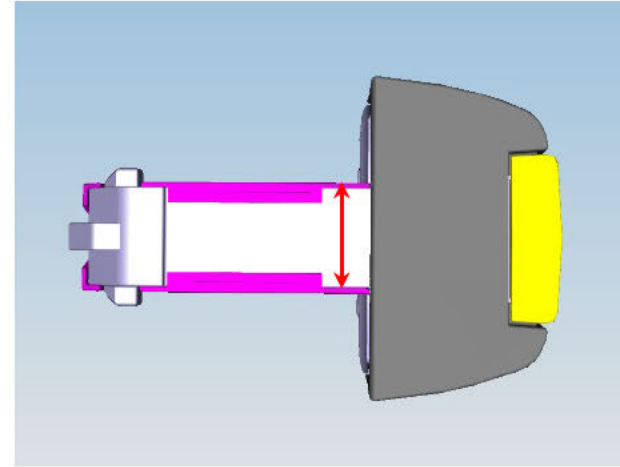
Material Behaviour Characteristics

PA66 GF30 is hygroscopic. In taking water on the part swells. Coupled with thermal expansion / contraction this may give rise to significant dimensional differences.

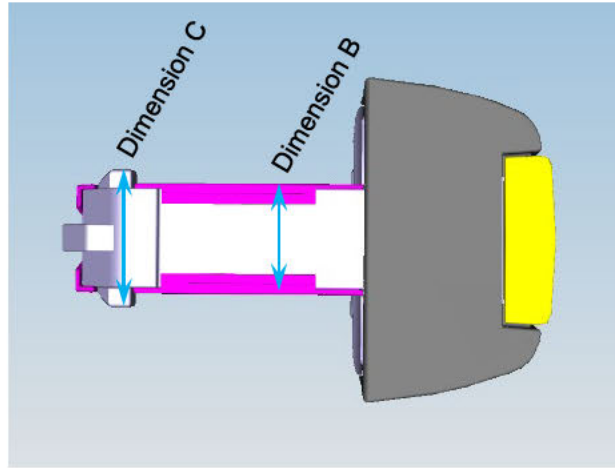
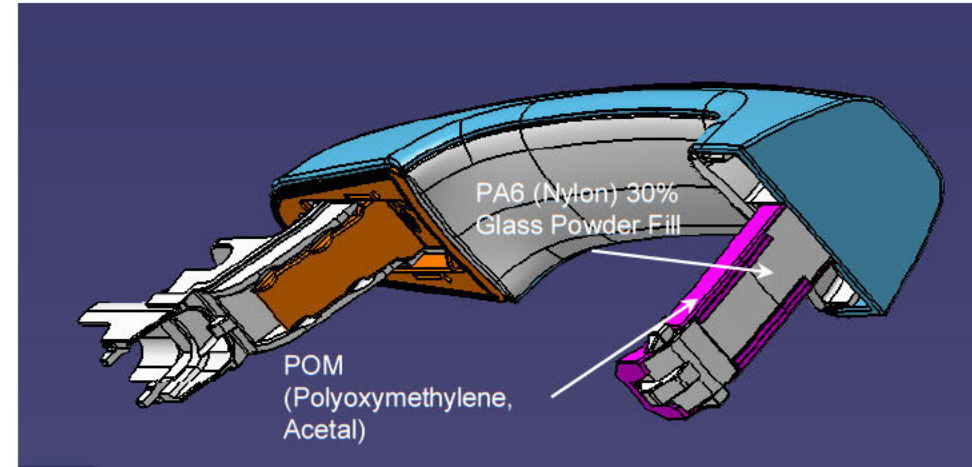
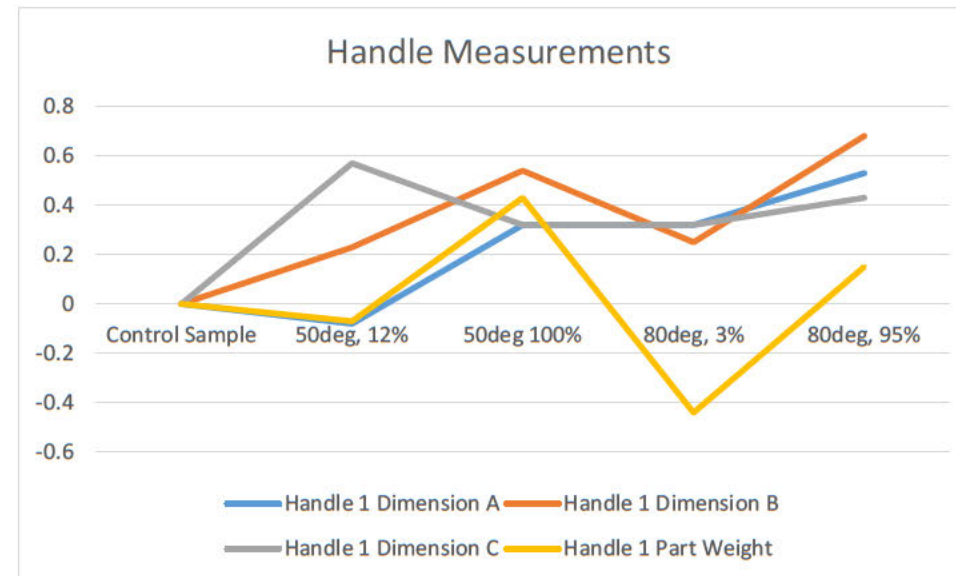
Handle Measurement

PA6 is hygroscopic, Acetal is not
Control sample is reference (0)
Graph is % deviation from control
All dimensions are external
Maximum deviation is 0.7%
Part has tendency to grow with both
heat and humidity

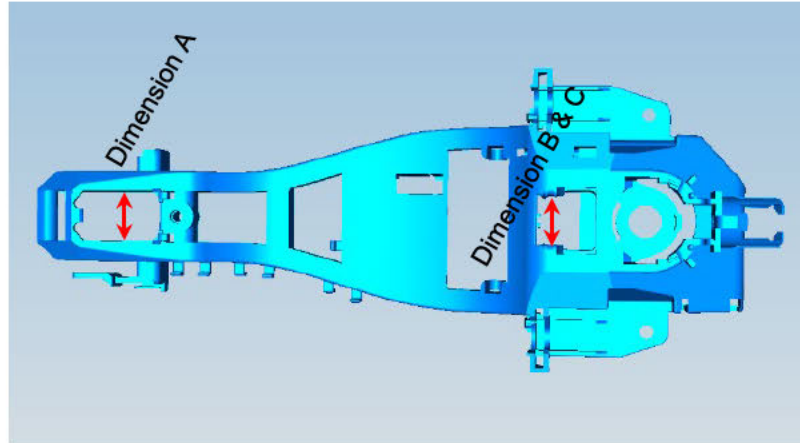
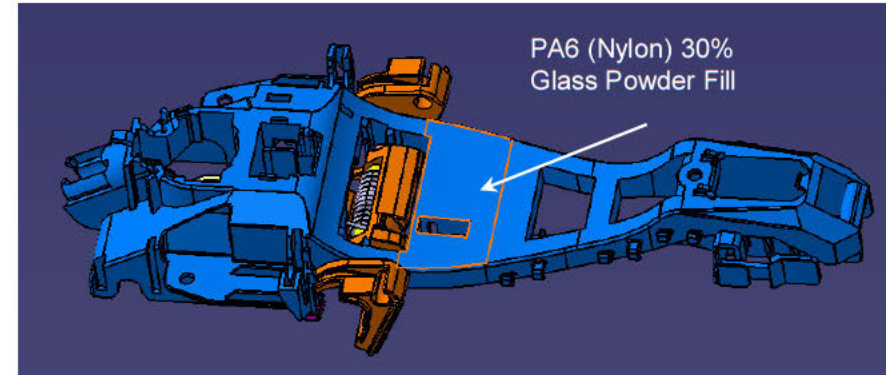
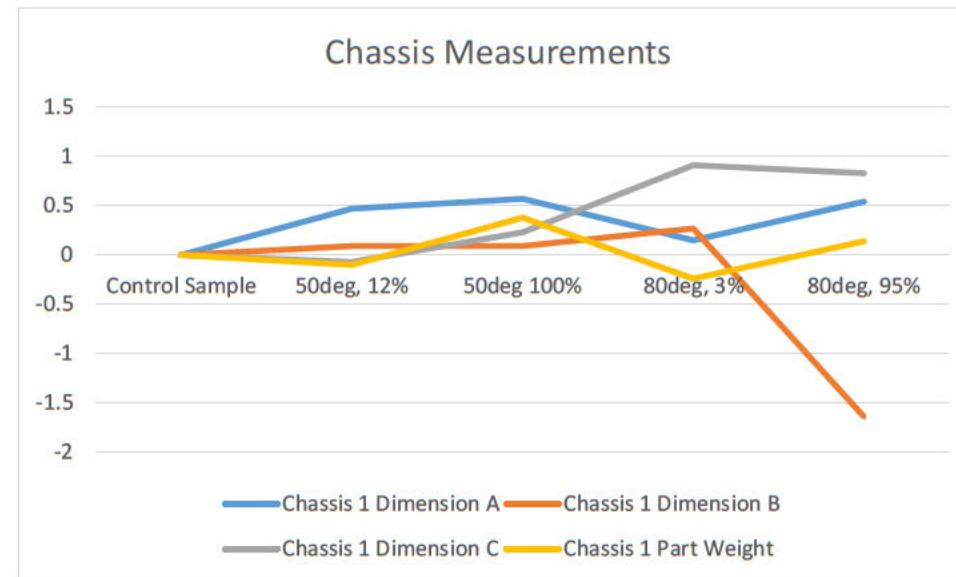
Chassis Measurement

PA6 is hygroscopic
Control sample is reference (0)
Graph is % deviation from control
All dimensions are internal
Maximum deviation is 1.64% - possible outlier. Next max 0.91%
Despite measures being internal, data indicates that the dimensions also grow with heat and humidity

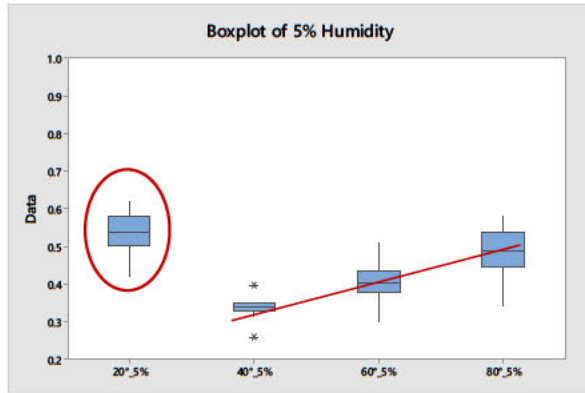
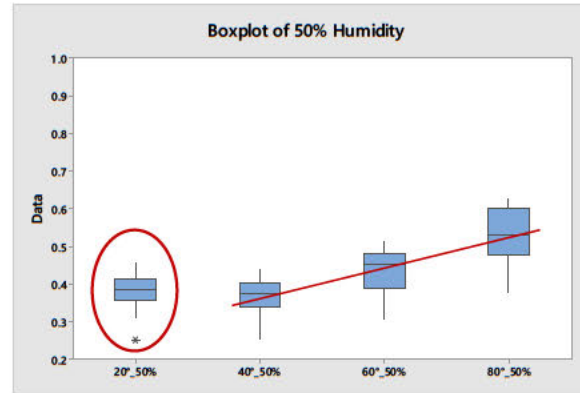
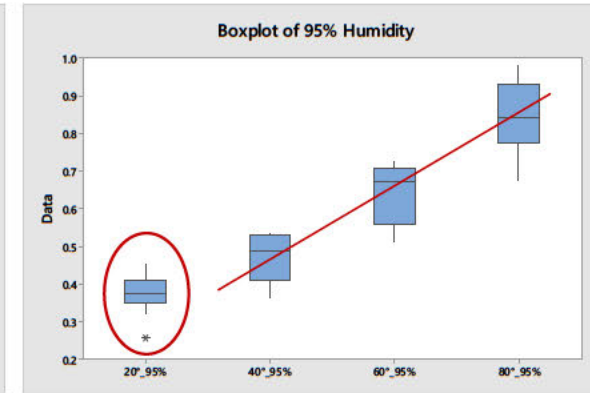
Handle Measurement

- Boxplots indicate that there is a trend for the handle to grow with temperature
- First boxplot (20 degrees) in both charts doesn't fit with the pattern
- From 40 degrees there is a steady and consistent growth
- The fact that 20 degrees doesn't fit is most likely because the POM sleeve has a minimum size – PA6 isn't being directly measured

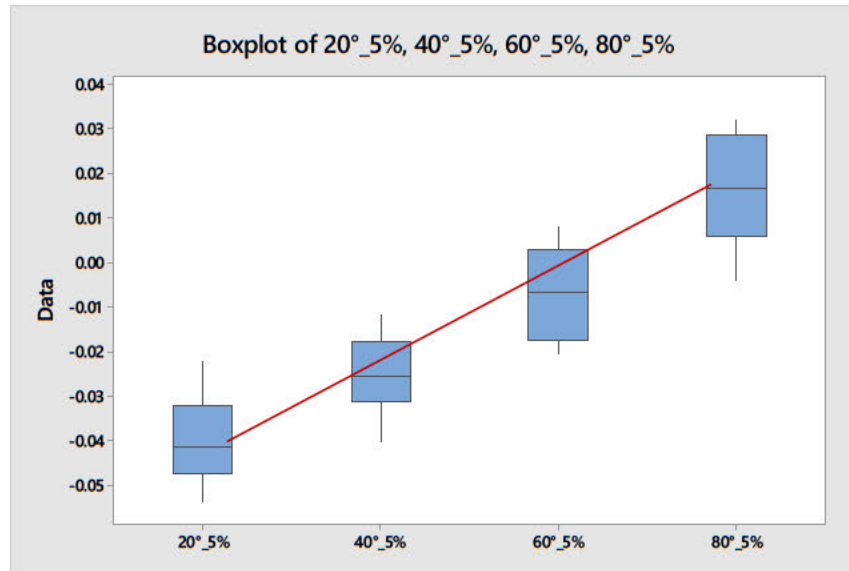
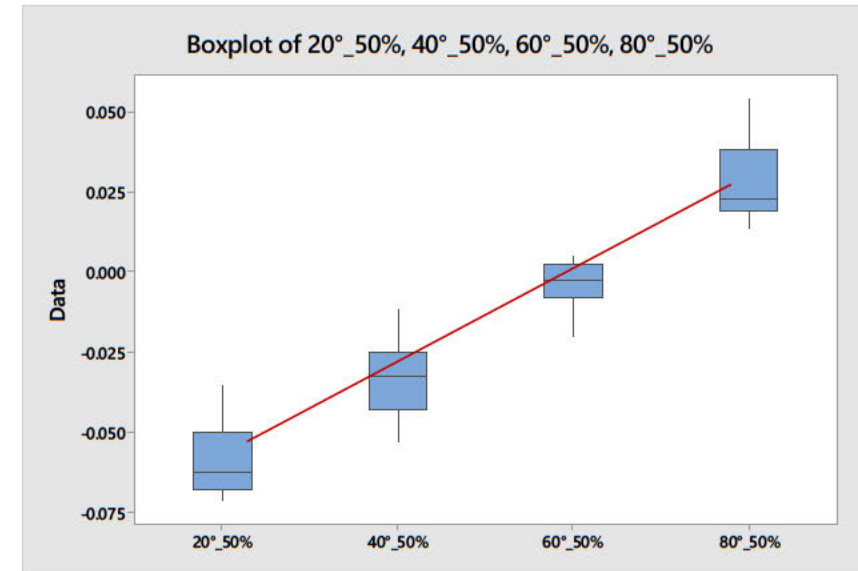
Handle Measurement

- As previous smooth rate of change observed, steady increase in size with temperature
- PA6 being directly measured, no POM sleeve
- Material behaves as expected

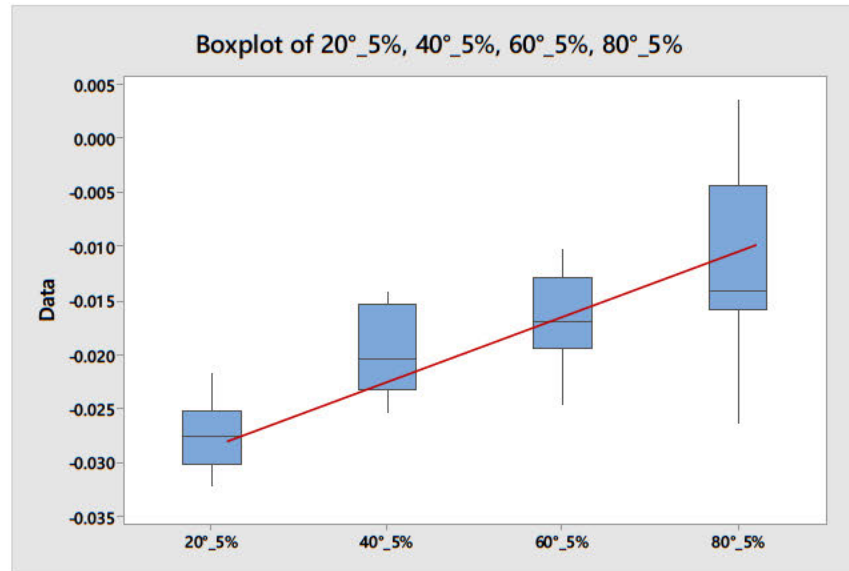
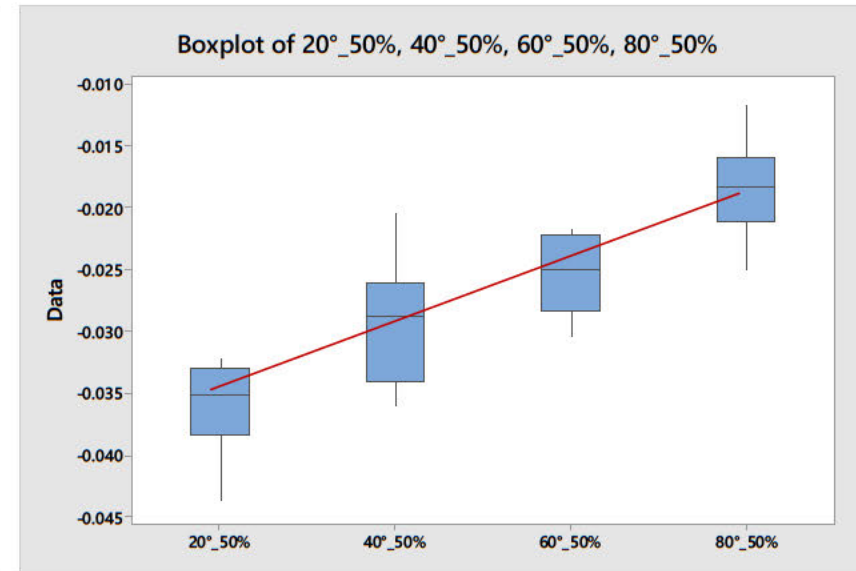
Chassis Measurement

- As previous smooth rate of change observed, steady increase in size with temperature
- PA6 being directly measured, no POM sleeve
- Material behaves as expected
- → As handle strap width increases, so does aperture in chassis in which it sits

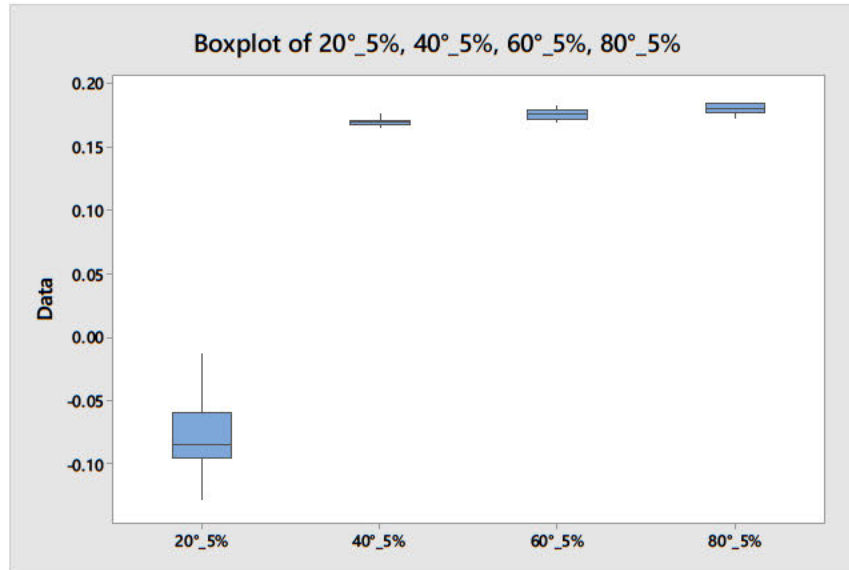
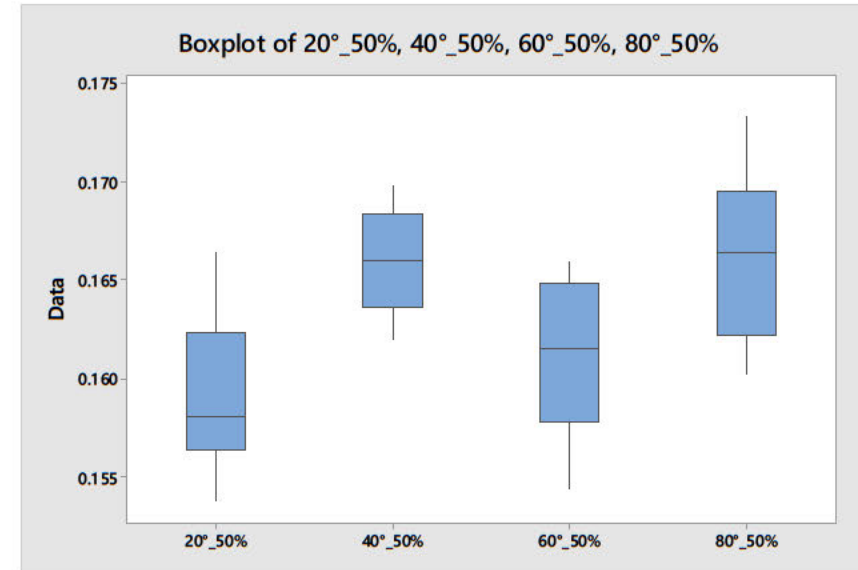
Chassis Measurement

- Very unusual data set at 20 degrees 5% - lack of equilibrium in the plastic before measurements were taken
- 6 hours initial soak not long enough to stabilise
- Soak time after humidity changes increased to compensate (24-48 hours)
- Not much movement in running channel width despite temperature and humidity changes
- → Running channel is stable through testing to date

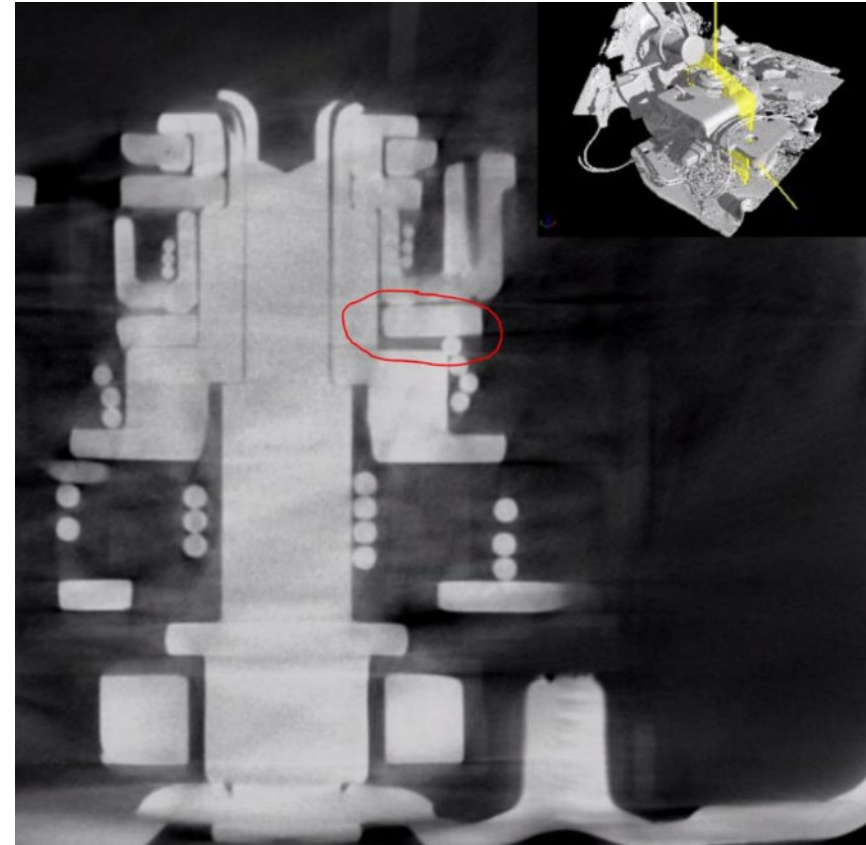
KV Transmission Lever Jam

- Chinese complaint of door unable to close
- Latch received at Brose
- KV lever in home position with no winds on the motor spindle
- KV transmission lever out of home position
- Pawl unable to lock claw and latch unable to be closed
- CT scan shows jammed spring on main rotational bush

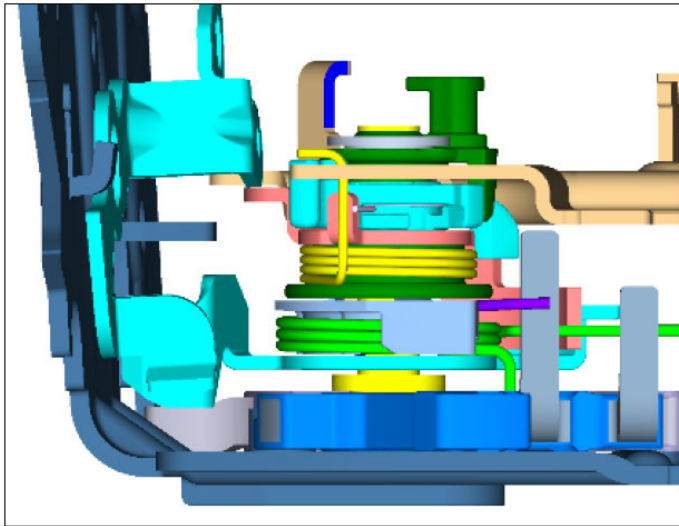
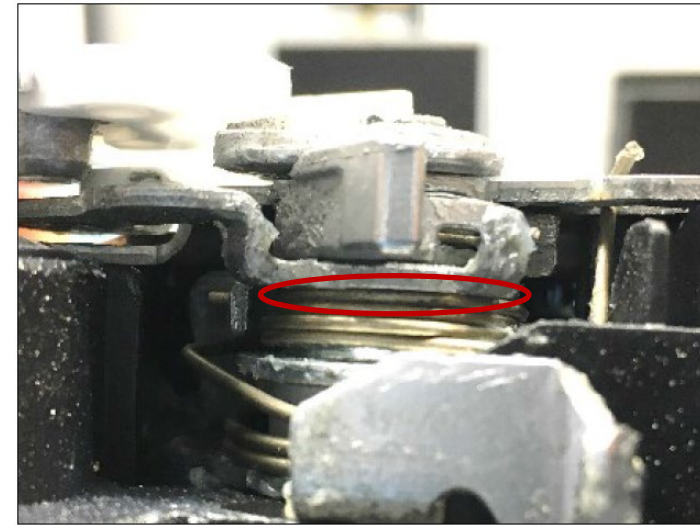
KV Transmission Lever Jam

CAD image showing joint stack and how it should look
Careful teardown of the clutch left the jammed condition present until the pawl pin was removed
Error state present in the image above – spring clearly jammed between main bush and outside release chain transmission lever

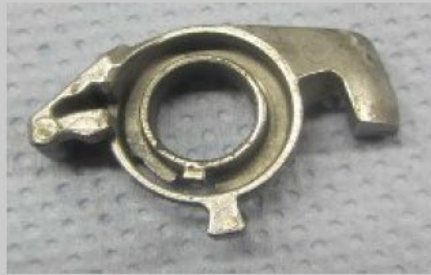
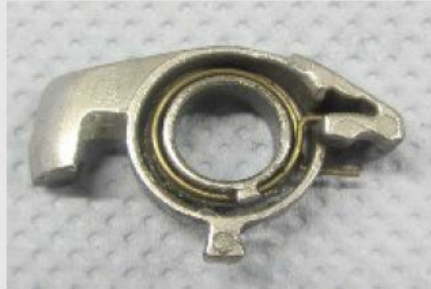
Durability test from comparable production period (beginning of 2016)	Durability test from beginning of 2017
LHF

<ul style="list-style-type: none">- Test result ok – no function failure- High measurement result done today → 4,93 mm on wear out area	<ul style="list-style-type: none">- Test result ok – no function failure- No wear out area

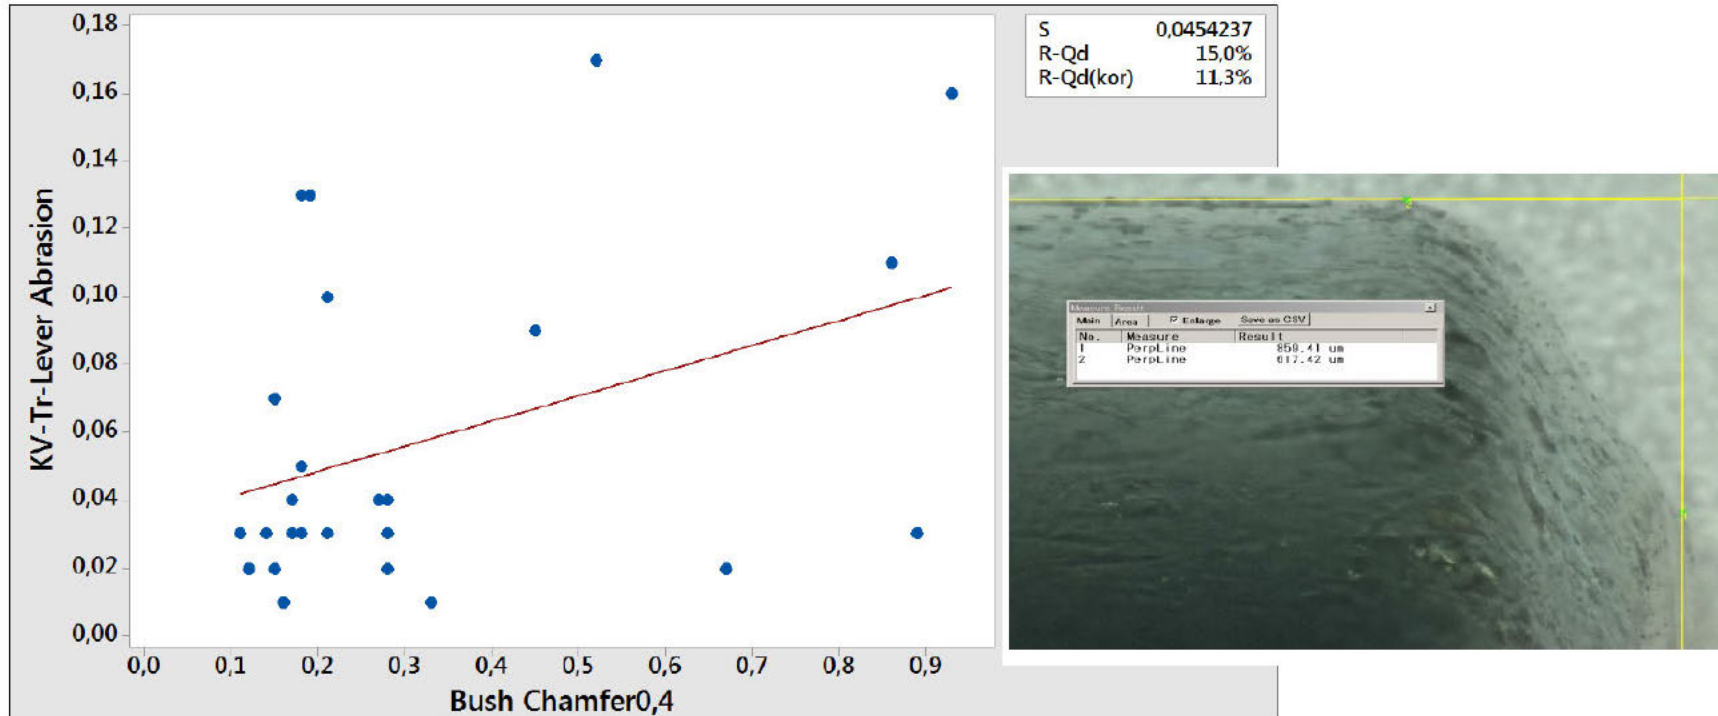
KV Transmission Lever Jam

Based on few available data: bigger radial chamfer leads to more abrasion

→ This has to be confirmed with more data

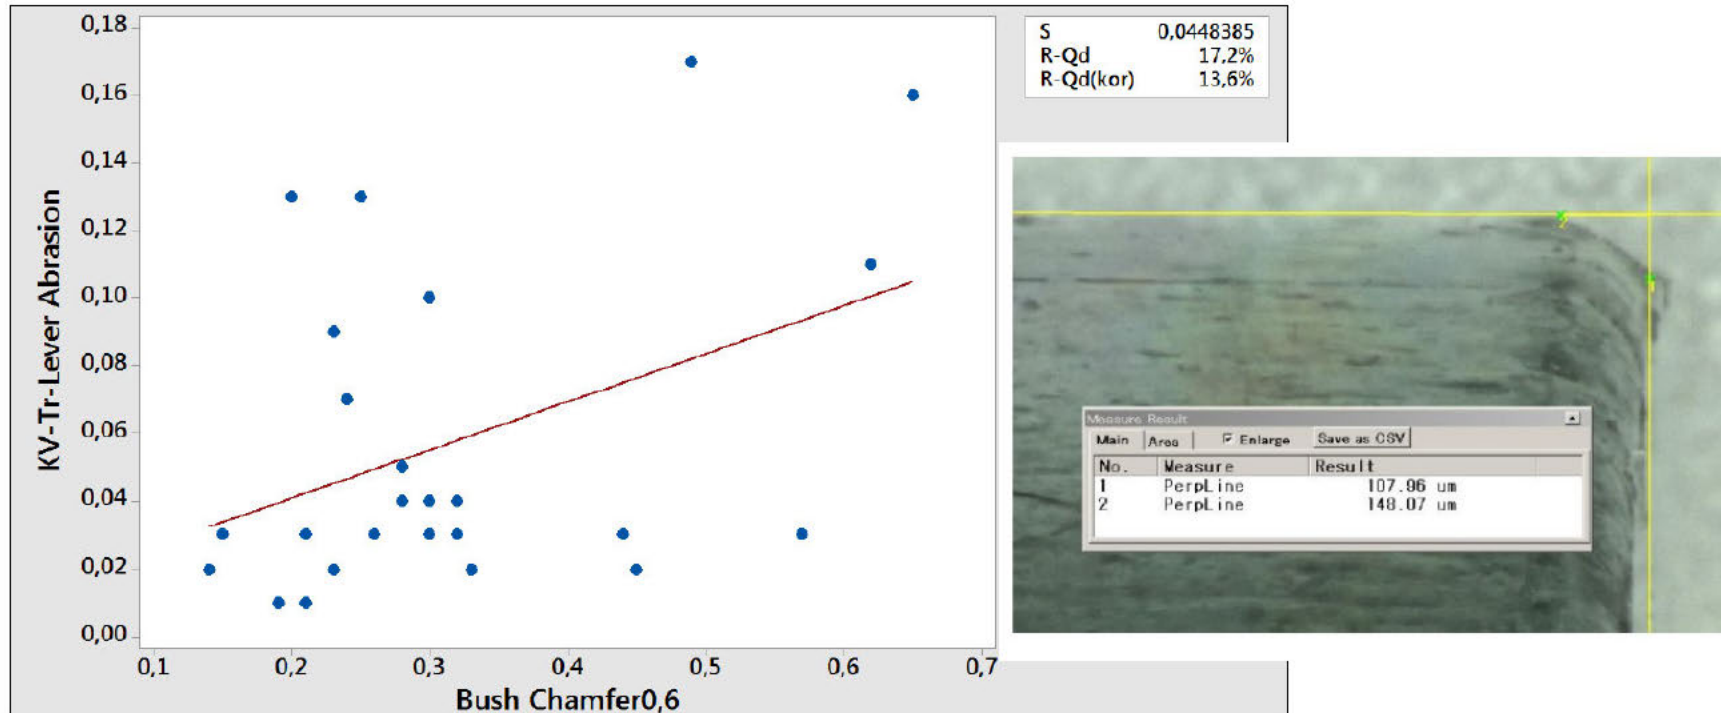
KV Transmission Lever Jam

*Based on few available data: bigger axial chamfer leads to more abrasion
→ This has to be confirmed with more data*

- Forced resetting of O/S transmission lever detailed planning to be done Q3-2018
- Investigate feasibility of smaller chamfer on bushing cw04/2018
- Investigate feasibility of more wear-resistant material of KV-transmission lever. ZP2 ordered. cw7/2018
Next step: abrasion test to compare with ZP5 (serial) cw10/2018

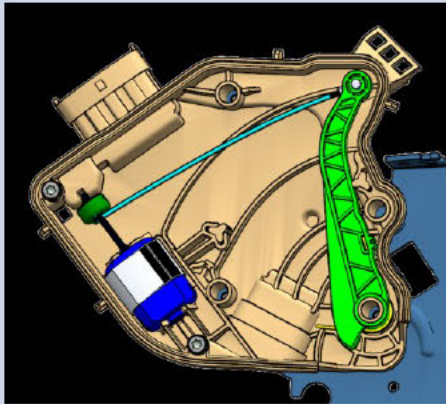
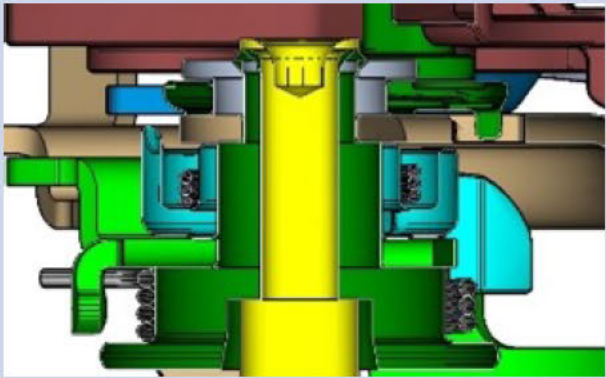
KV-Function disabled in RFA – explain technical effect to latch „jammed“

Failure mode	„cord will not unwind“ (P068)	Spring jams KV mechanism
<p>Technical influence of disabled KV function in RFA</p>

<p>- green KV lever will stay in home position – KV mechanism can not jam in activated position</p>

<p>- overall rotation angle of KV transmission lever (light blue) is reduced - Less tilting of KV transmission lever under load - different abrasion behavior expected</p>
<p>Will disabling the KV Function in the RFA solve the issue?</p>	<p>yes</p>	<p>no, spring could still move into the gap</p>

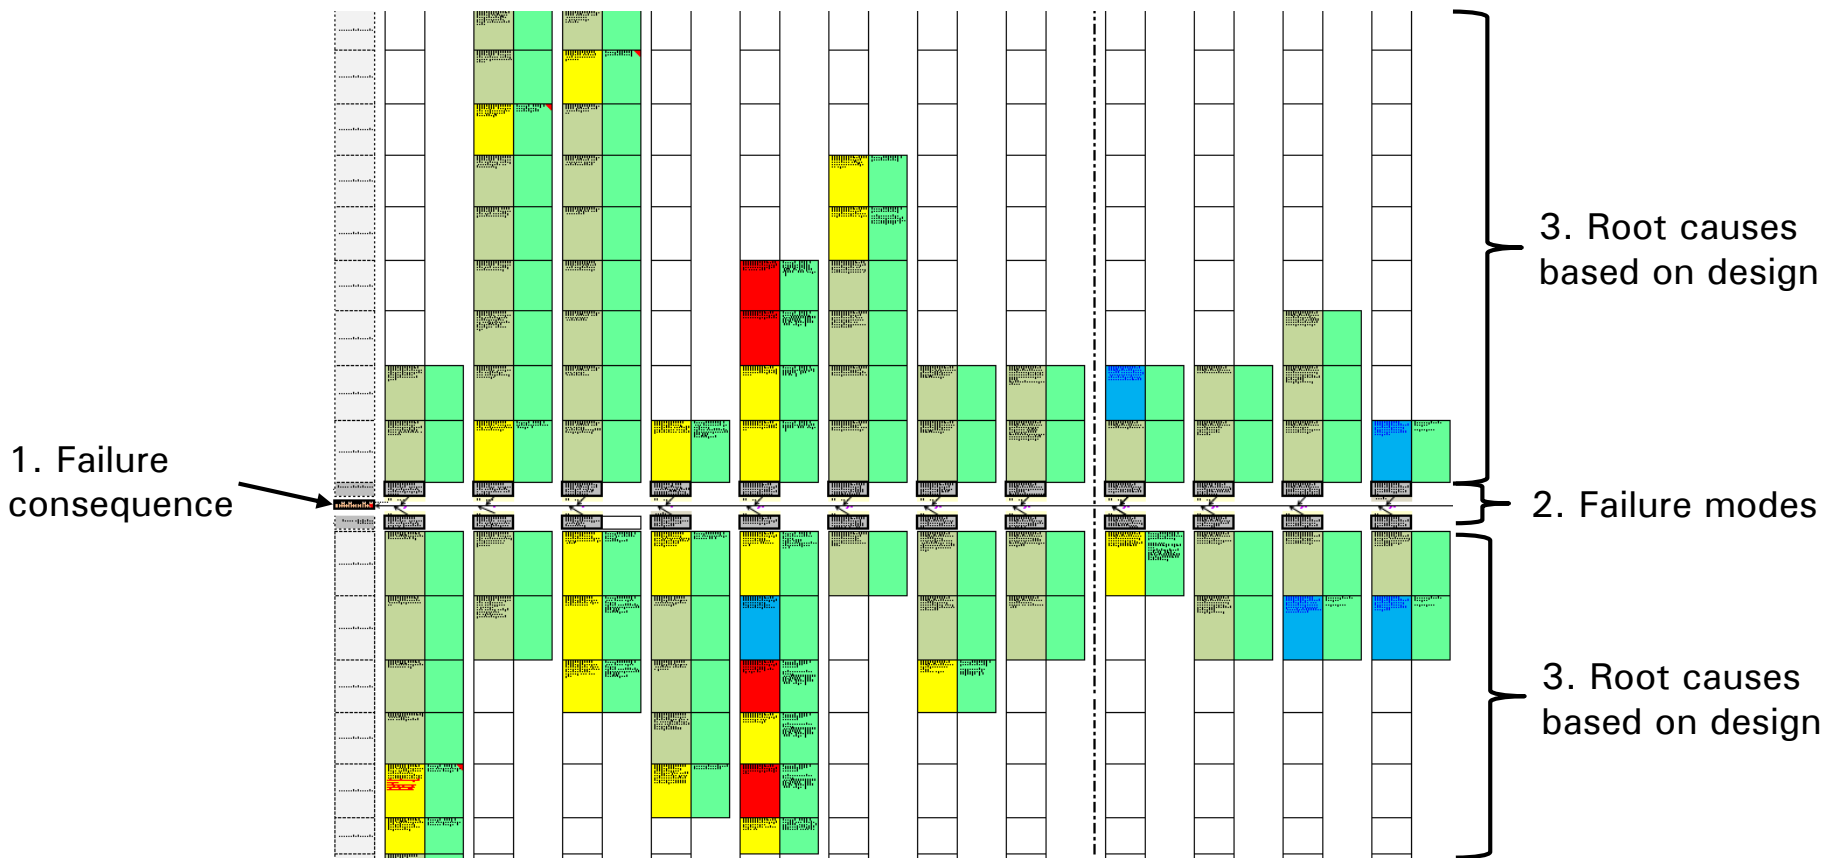
4. DFMEA review

- Evaluated failures that could lead to the failure consequence „door will not latch“

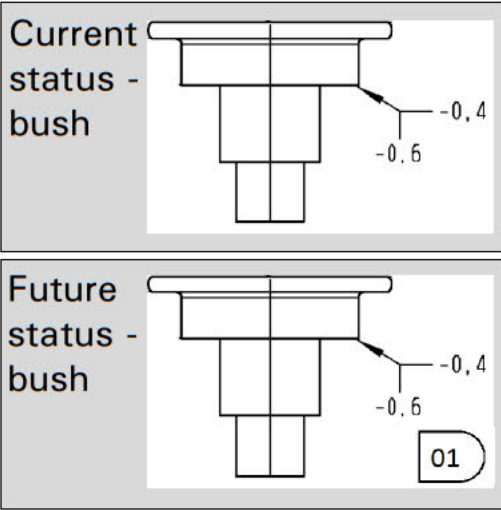
- Link failure consequence „door will not latch“ with „chamfer bush outside transmission lever too large“
→ Failure consequence „door will not latch“ will require severity of 10 in FMEA
- Change of severity will generate an CC evaluation
→ Bush supplier already implement 100% camera check on this characteristic
- Control of suppliers can further be improved:
 - Certified delivery

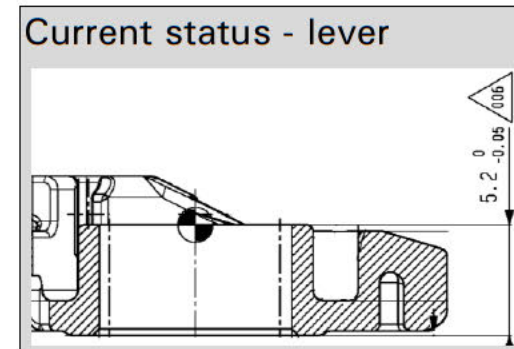
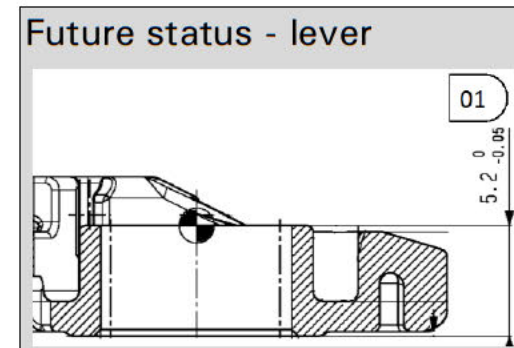
KV transmission lever

- Link failure consequence „door will not latch“ with „KV transmission lever too thin“
→ Failure consequence „door will not latch“ will require severity of 10 in FMEA
- Change of severity will generate an CC evaluation
→ Supplier needs to implement ongoing process control
- Control of suppliers can further be improved:
 - Spot check of delivered parts during incoming inspection at Brose

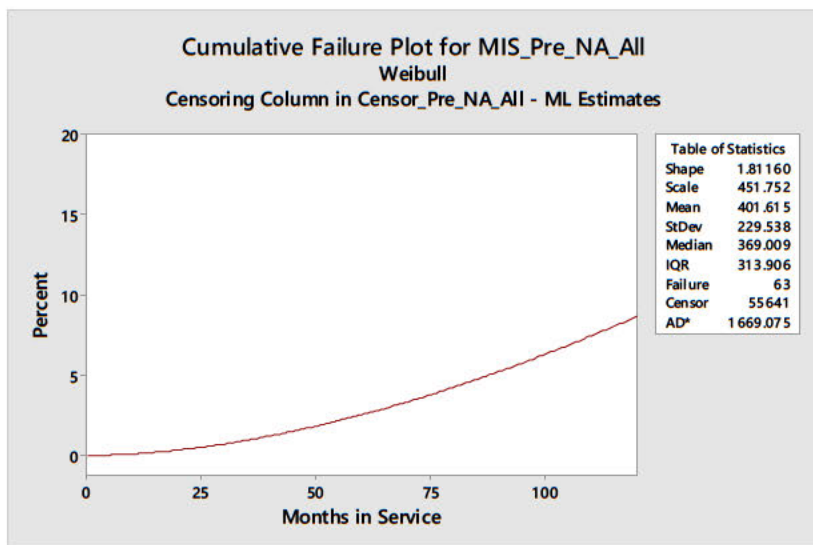
NHTSA PRE-P068 “FAILURE TO LATCH”

Pre-P068 action, the predicted parametric model indicates a worst case report rate of “Failure to Latch” of 180.7 R/1000 at ten years in service, covering all known failure modes. The global prediction for the same error state is 253.4 R/1000. Nominally the predicted failure rate is 82.9 R/1000.

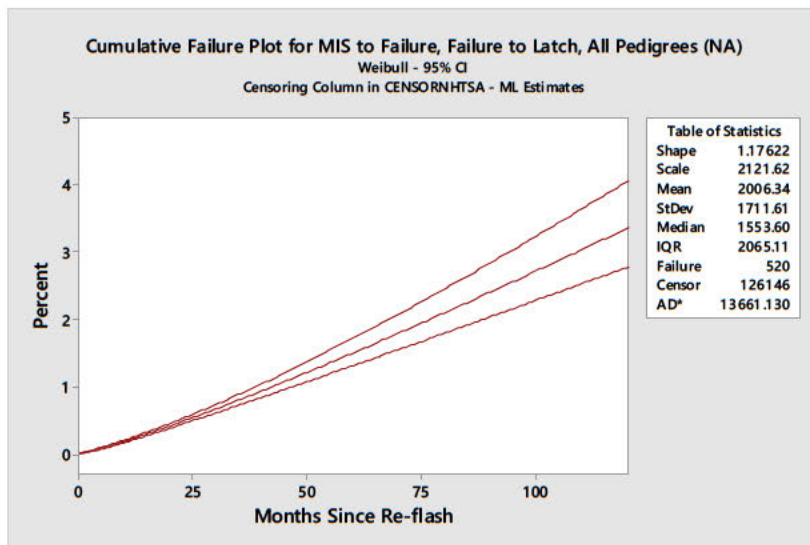
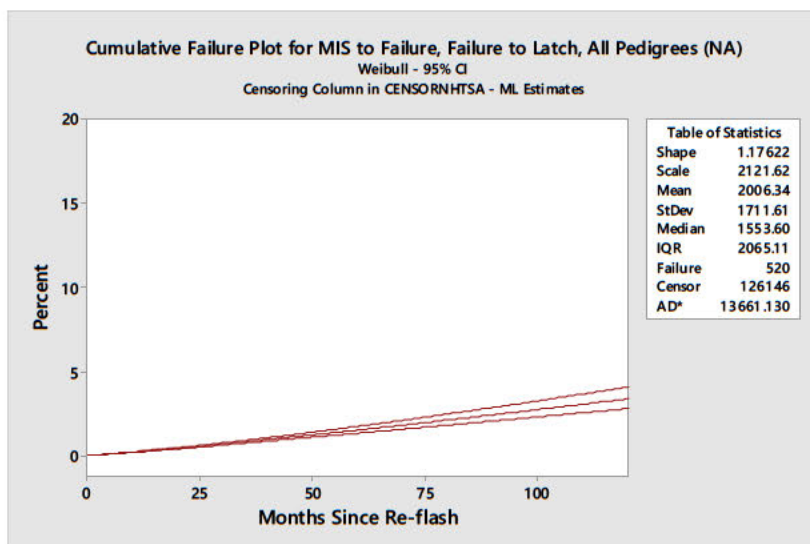
NHTSA POST P068 “FAILURE TO LATCH”

Post P068 action, the predicted parametric model indicates a worst case report rate of “Failure to Latch” of 39.25 R/1000 at ten years in service, covering all known failure modes. Nominally the prediction is 32.5 R/1000
