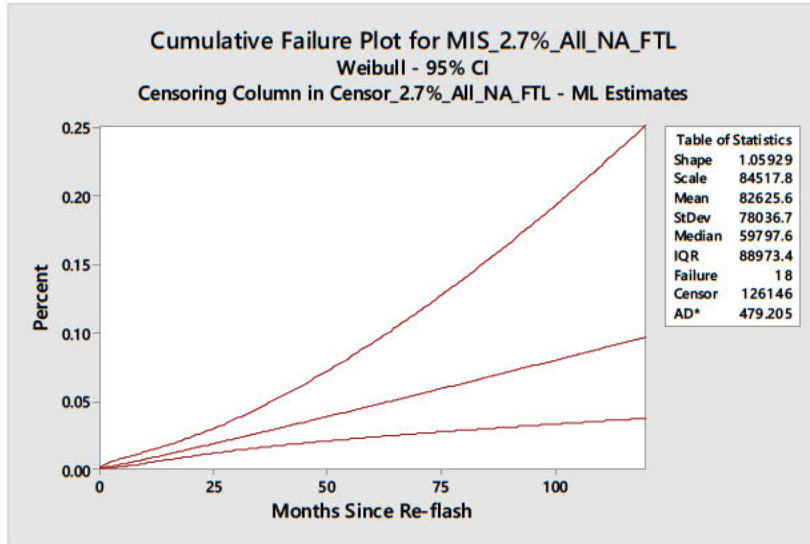
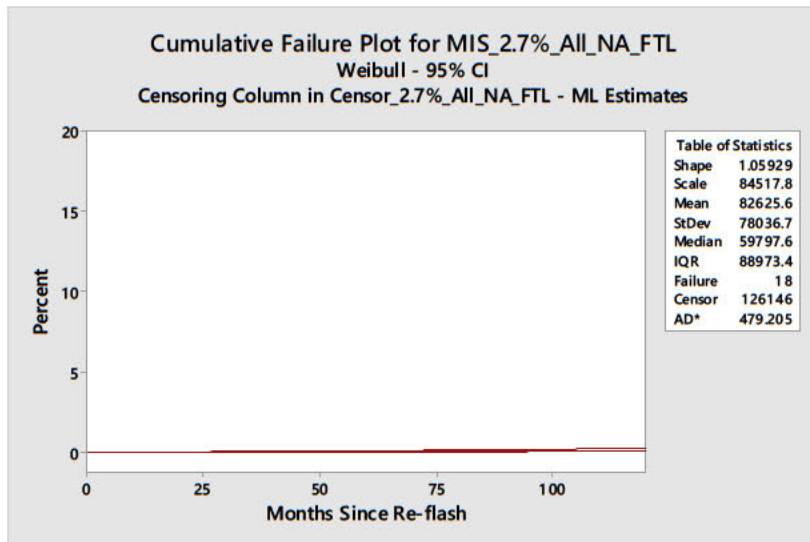
NHTSA POST P068 “FAILURE TO LATCH” – 2.7% MODIFIER

Post P068 action, using a modifier of 2.7% and applying this pre-processing to the quantity of reports, the model indicates a worst case report rate of “Failure to Latch” of 2.4 R/1000 at ten years in service, covering specifically corroded KV actuators. Nominally the prediction is 0.9R/1000

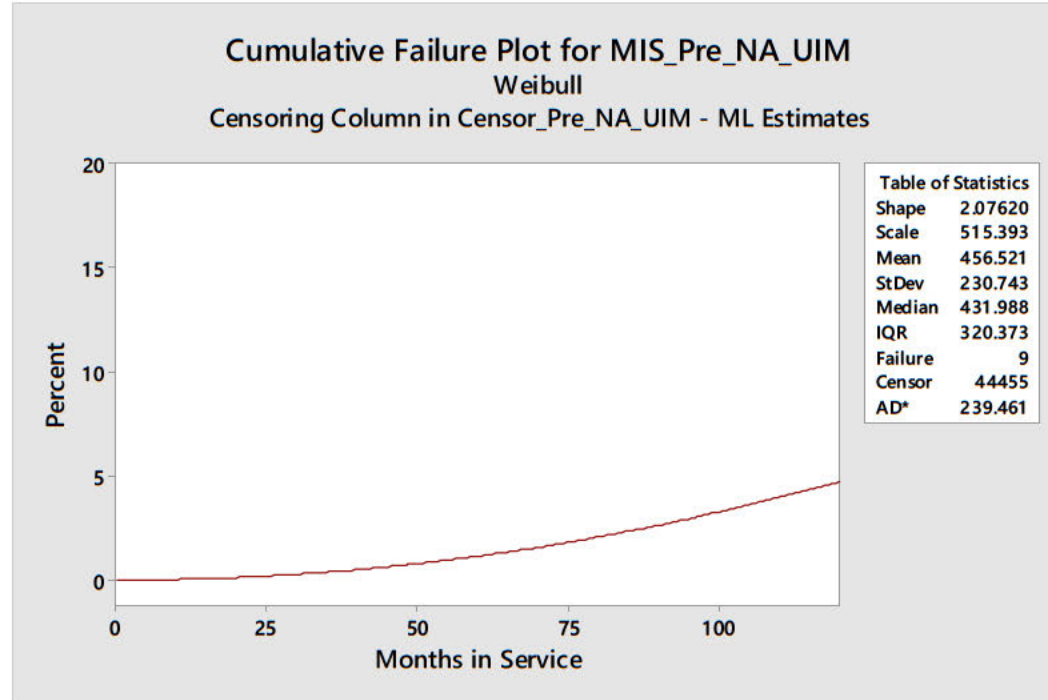
NHTSA PRE P068 “UNLATCHED IN MOTION (UIM)”

Pre-P068 action, the predicted parametric model indicates a nominal report rate of “Unlatched in Motion” of [45 R/1000](#) at ten years in service, covering all known failure modes

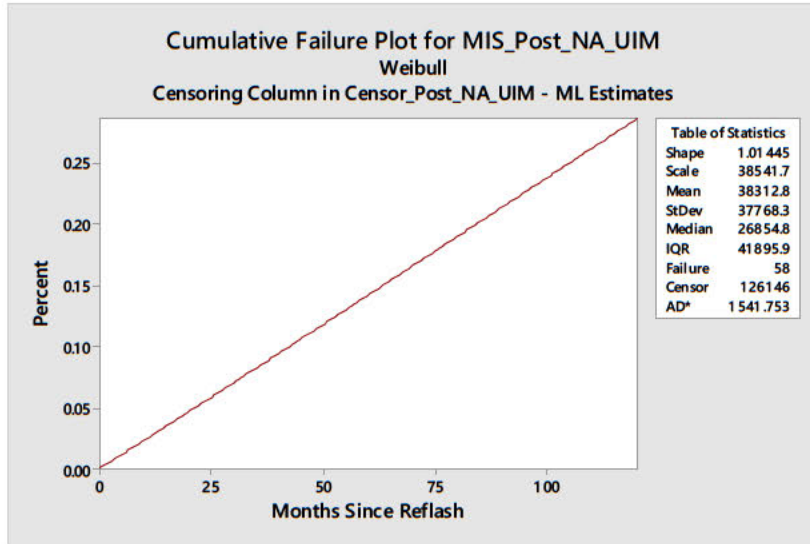
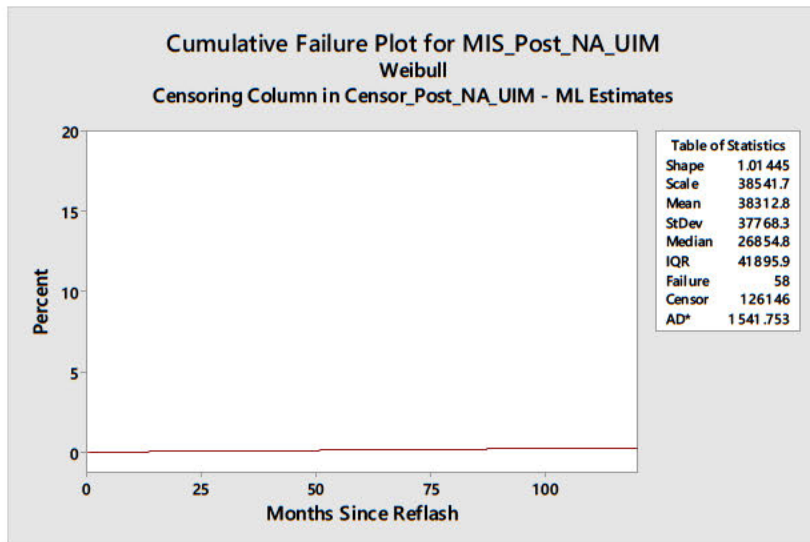
NHTSA POST P068 “UNLATCHED IN MOTION (UIM)”

Post P068 action, the predicted parametric model indicates a report rate of “Unlatched in Motion” at ten years in service, covering all known failure modes of 2.8 R/1000

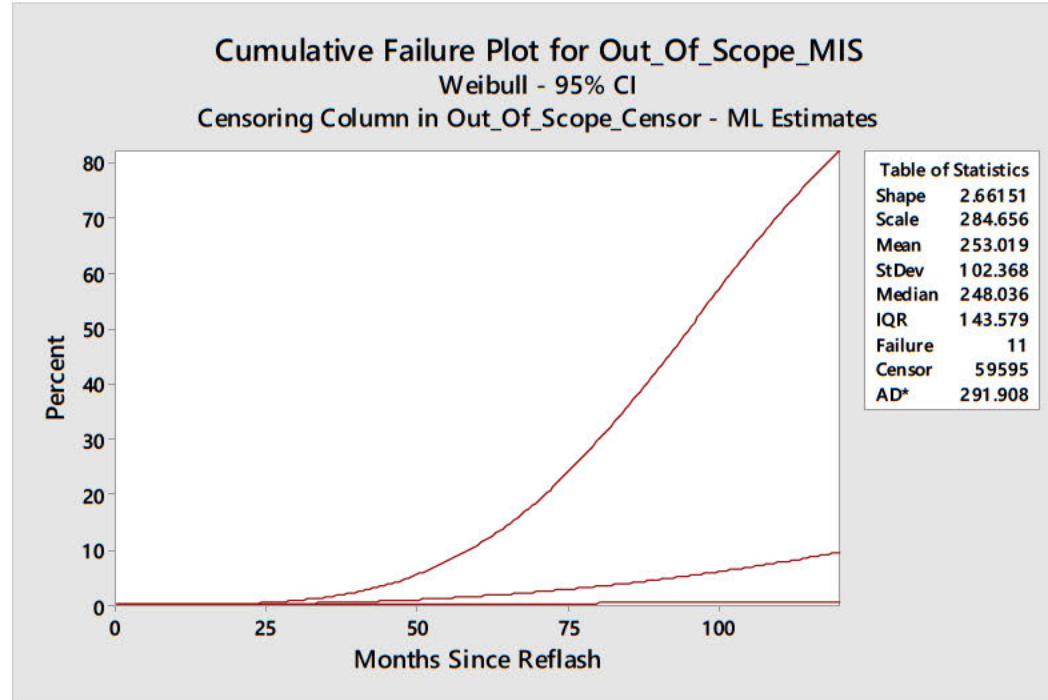
OUT OF SCOPE FAILURES

The Out Of Scope reports for Unlatched in Motion (UIM) have 11 reports post recall scope.

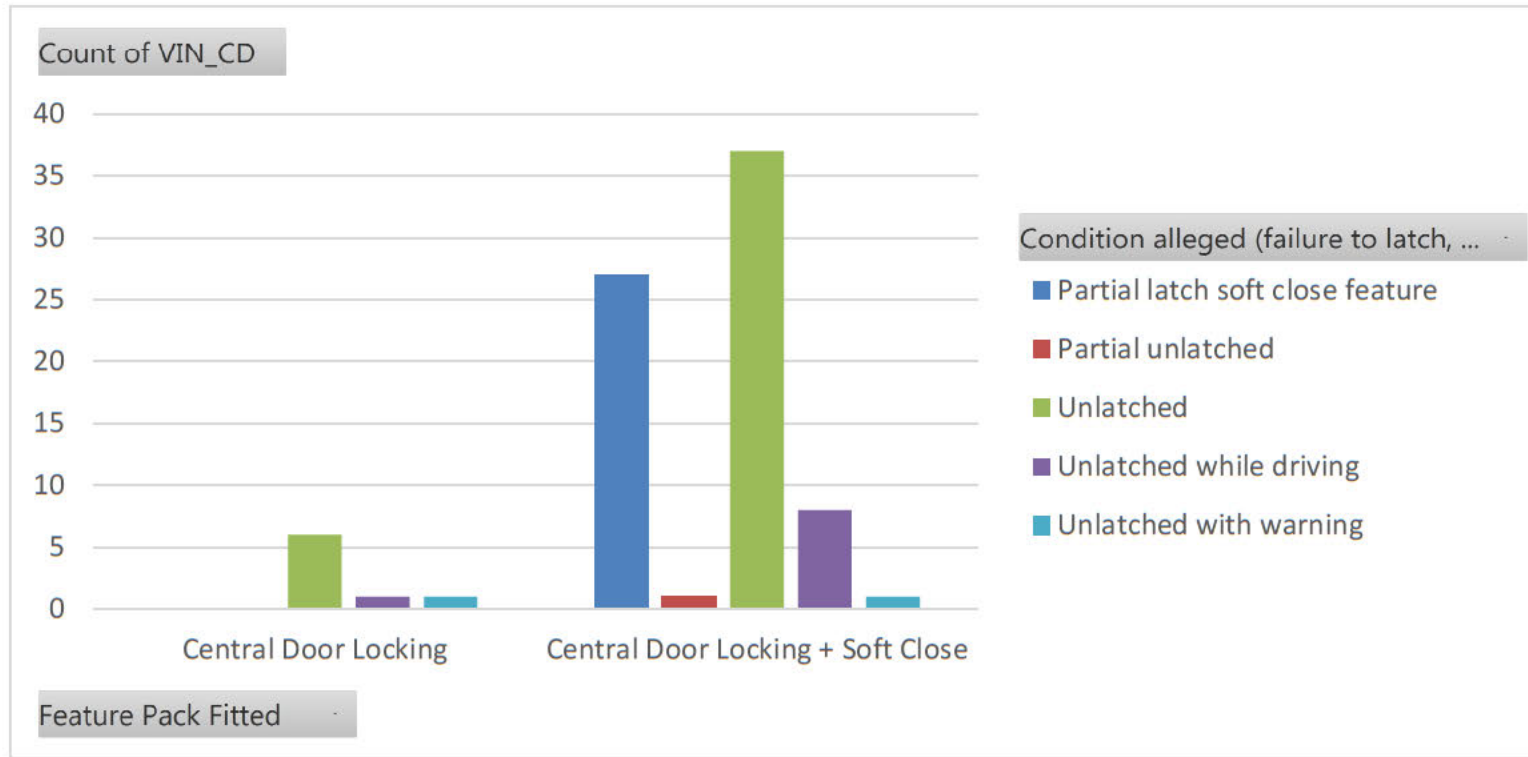
NHTSA FEATURE ANALYSIS – SOFT CLOSE

Most of the 84 originally confirmed reports come from vehicles fitted with a soft close feature

Of the 8 vehicles without soft close feature, 6 were reported as unable to latch, 1 unlatched while driving (which still does not mitigate the potential blind spot), and one unlatched with warning

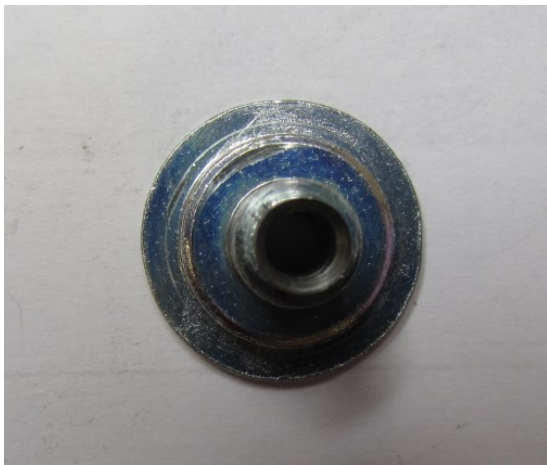
▪ **Systematic disassembly:**

- All single components have been assembled correctly,
- Abbrasion on KV transmission lever detected,
 - Height: 5,04/4,95mm
- Damage on bush surface from spring detected.

Conclusion: Spring winding jammed between outside release lever and bush as per

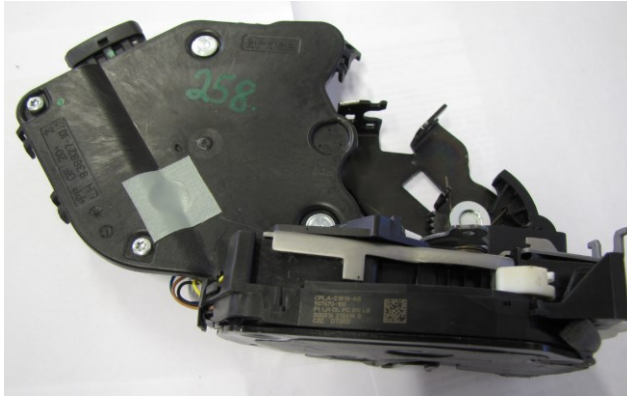
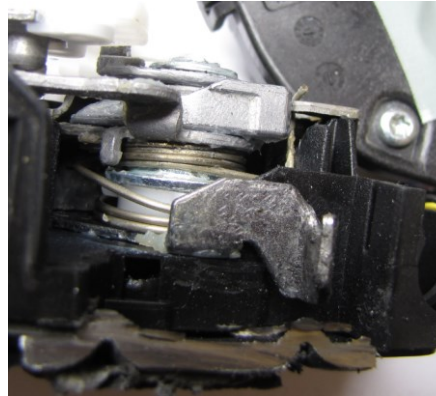
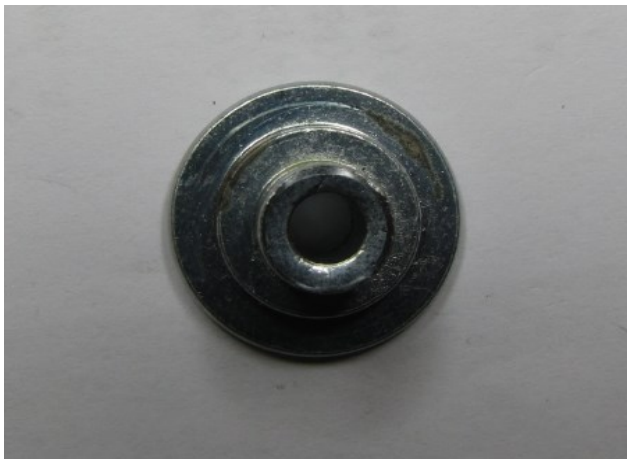
▪ Systematic disassembly:

- All single components have been assembled correctly,
- Abbrasion on KV transmission lever detected,
 - Height: 5,05/4,95mm
- Damage on bush surface from spring detected.

Conclusion: Spring winding jammed between outside release lever and bush as per

- 3D scan of KV transmission lever and bush, TBD CW39.
- Failure simulation:
 - Following carset to be build:
 - 2 latches:
 - bush with milled chamfer 0,1mm above the spec.
 - KV transmission lever from:
 - [REDACTED], height: 5,04/4,95mm,
 - [REDACTED], height: TBD/4,92mm.
 - 2 latches:
 - Serial latches from current production.
- Test specification:
