## ODI RESUME

| <b>Investigation:</b> | PE 19-005 | <b>Date Closed:</b> | 12/09/2021 |
| <b>Subject:</b> | Unintended Movement | | |

# PE19-005 Closing Report

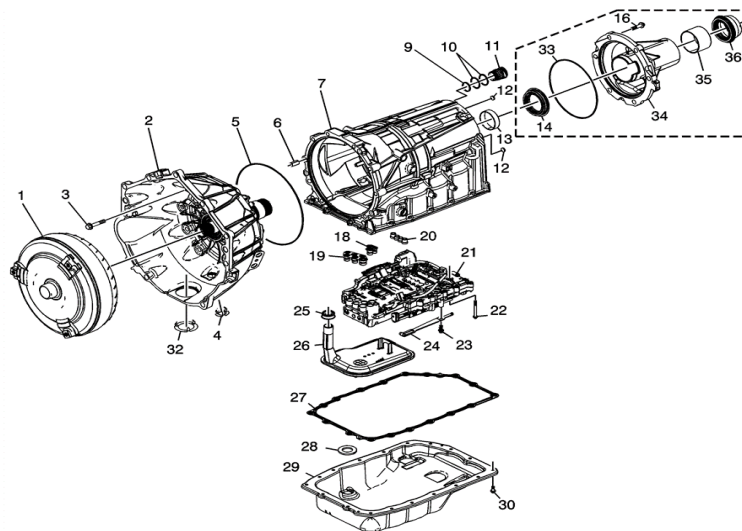
**Figure #1** Shows the transmission layout and torque multiplying method. The torque converter (1) is used to transmit power to the transmission. It contains the Torque Converter Clutch (TCC), Stator, Impeller, and Turbine. When requested by the (4) TCM, the TCC Solenoid (2) in the Control Body sends pressurized transmission fluid from the TCC Control Valve (3) in the front pump to the Torque Converter (1) to engage the TCC.
