PE19-004  
KIA  
6/28/2019  
DEFECT B  
TECHLINES  
TELLURIDE

PE19-004\_Expanded  
Scope\_Telluride\_Alleged Defect B

## Kia Motors America Technical Assistance Center

**Case Title:** MIL - PCM # U012D00 - P250400

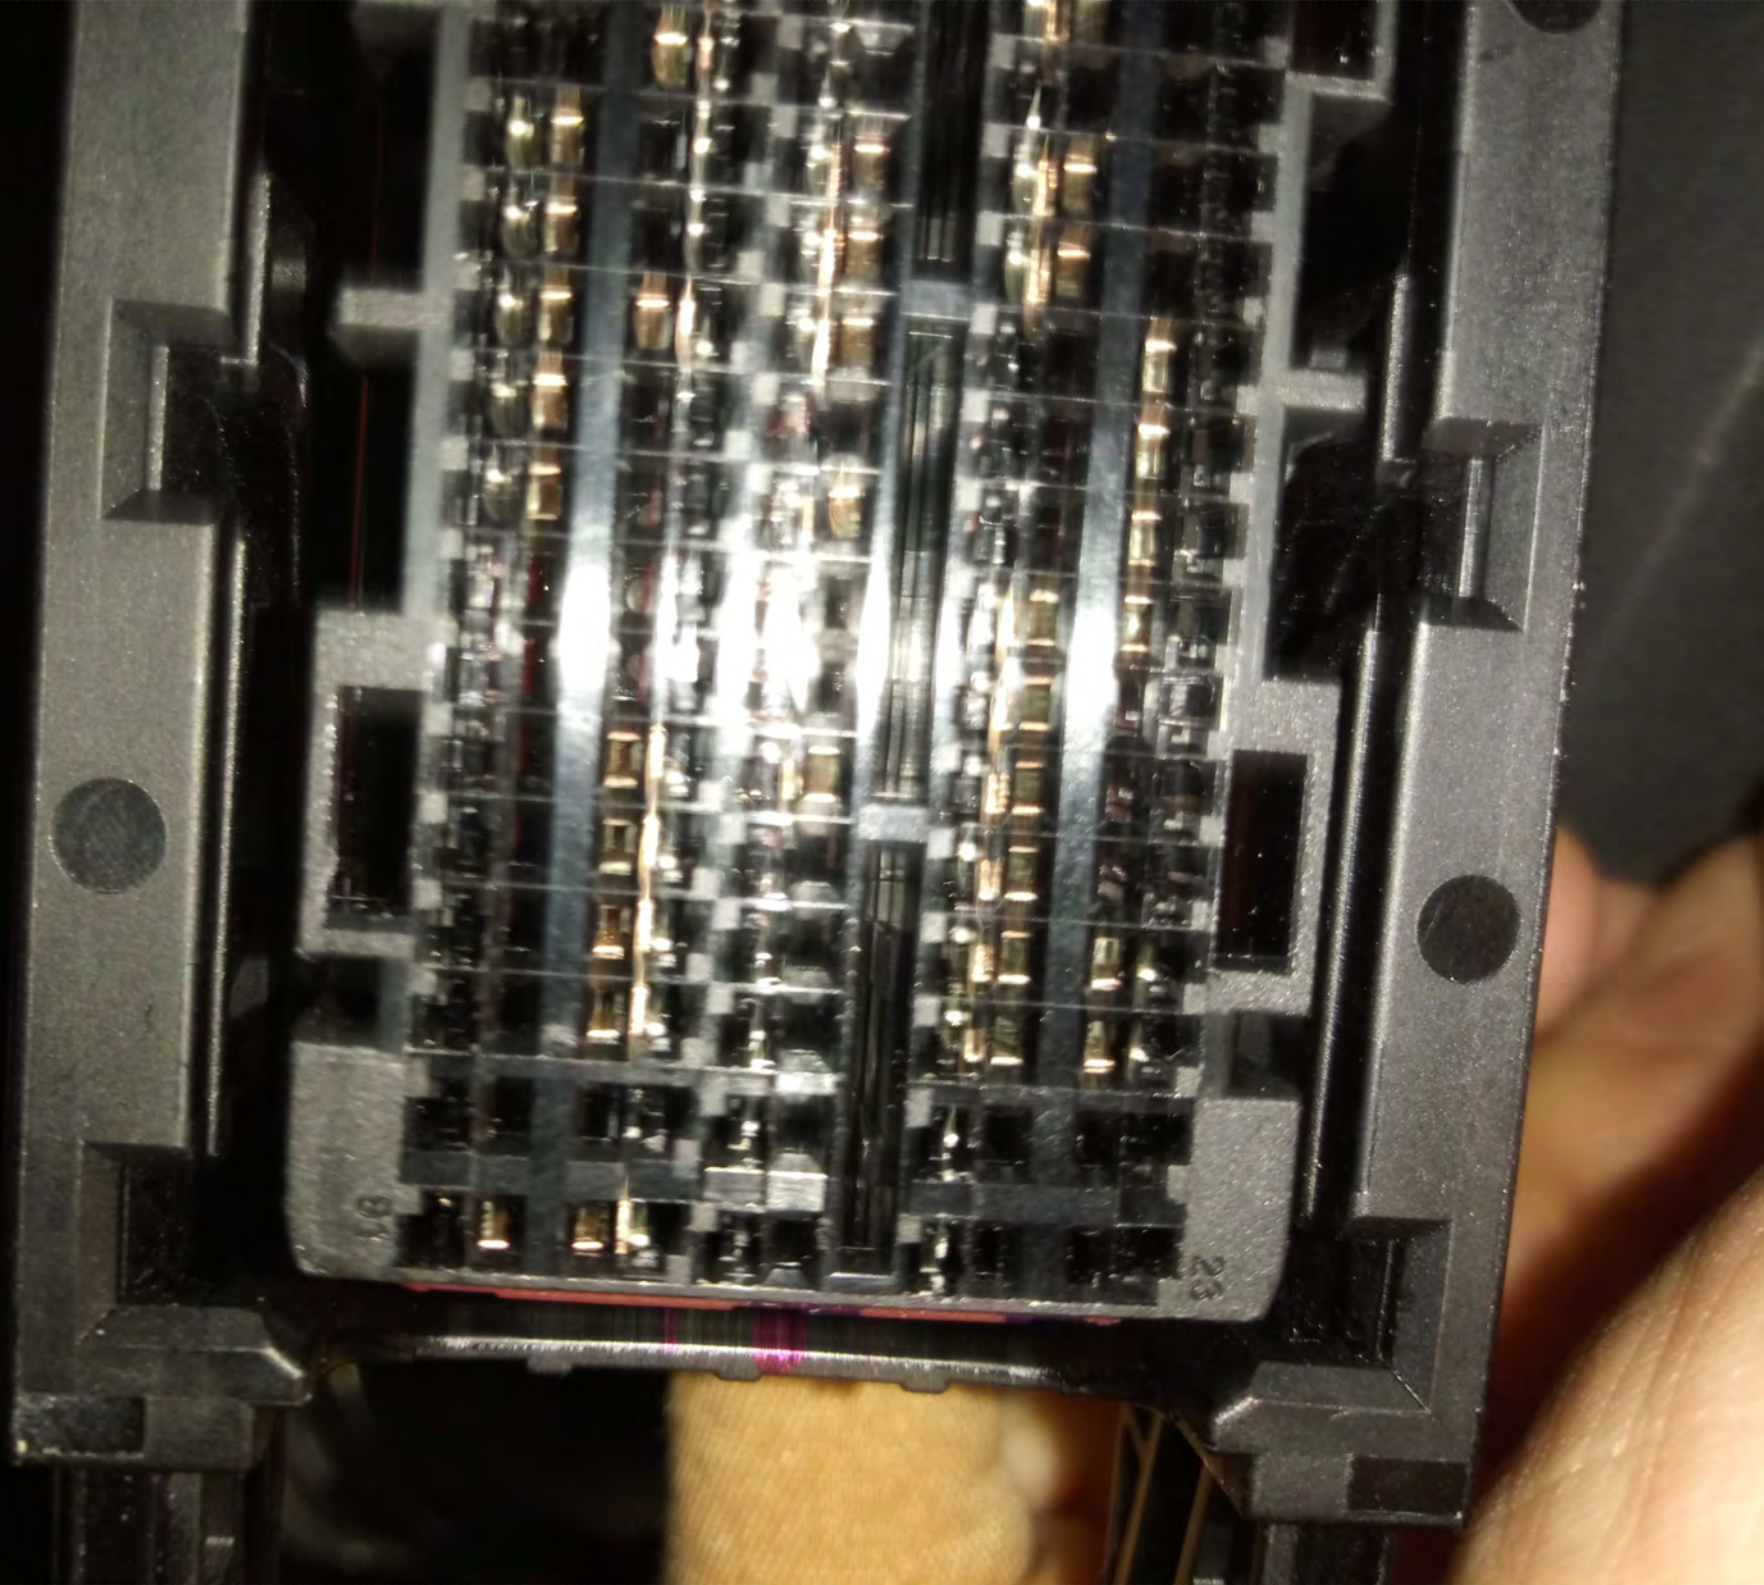
The harness and everything around there looked just fine, it isn't melted or burnt. The only damage was slight warp in the plastic on the positive terminal cover and a black spot on the metal of the terminal with the 10mm nut. Even though the fuse isn't blown or melted I was told to get an availability on it.

Resolution Summary: Replace fuse due to unsecure bolt

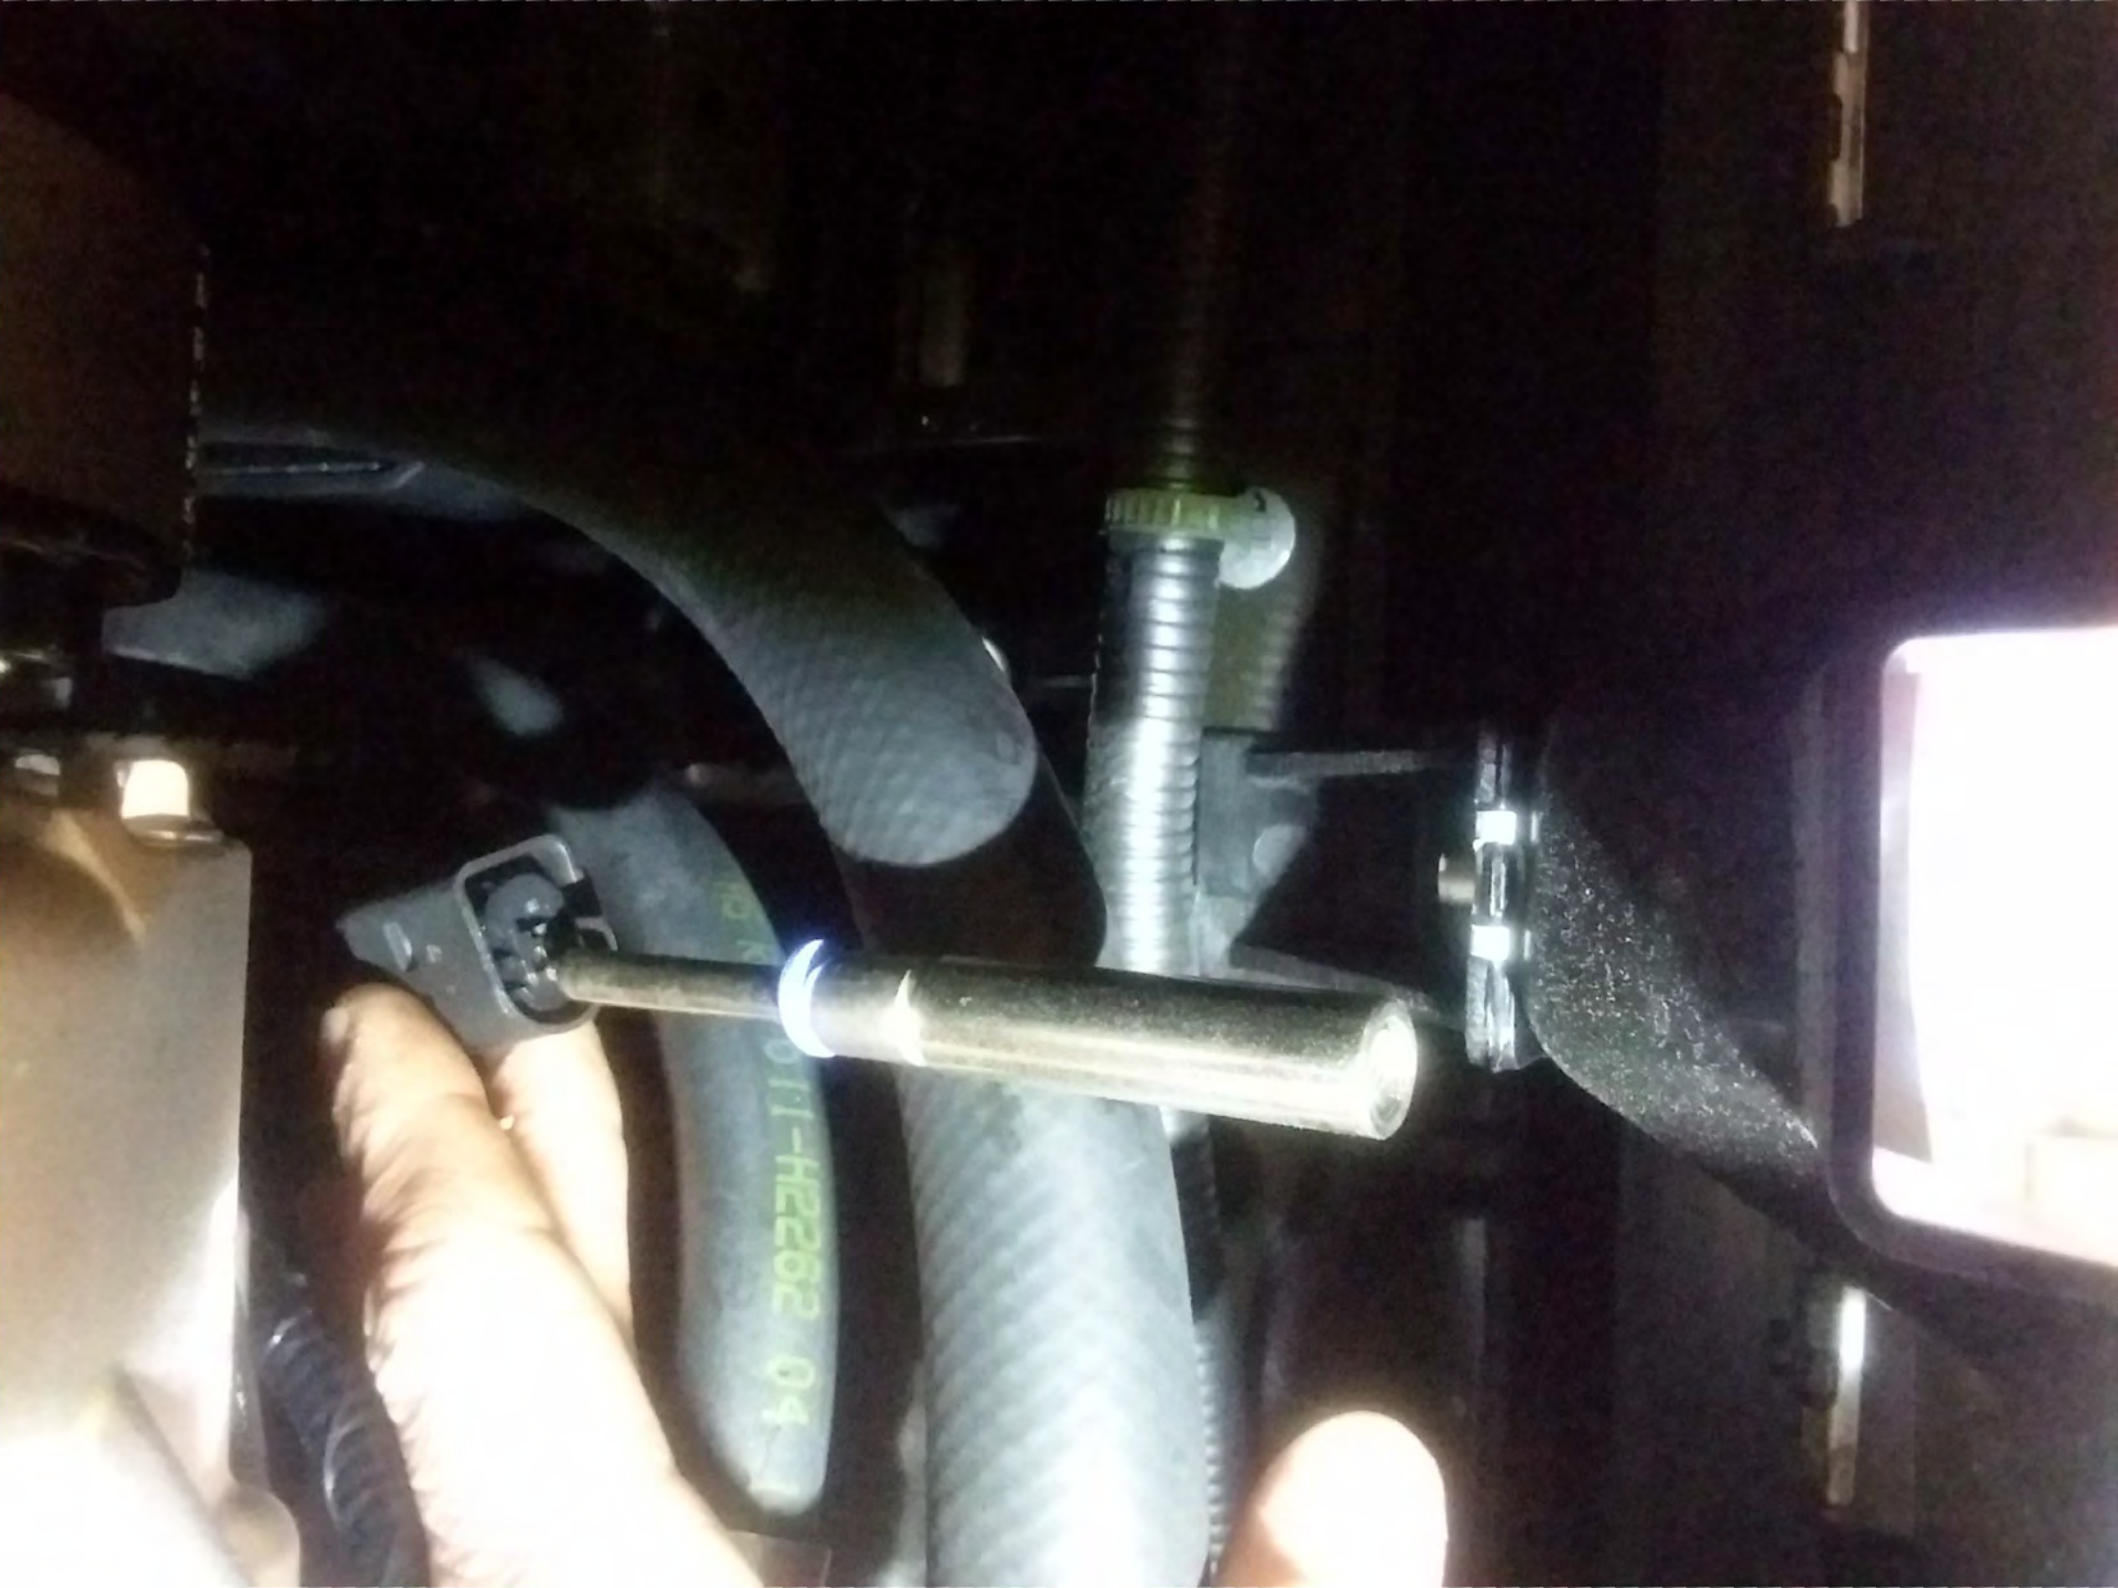
# TENSION GAUGE TOOL SET

The results of the full system test show no voltage coming from the alternator. And the tension gauge I used is the smallest gauge in the set, so I wouldn't damage anything, the tool set for the tension gauge says Box-8
